| <div style="display: inline-block; vertical-align: middle;"> Rolls-Royce Corporation<br/> P.O. Box 420<br/> Indianapolis, Indiana 46206-0420 USA </div> | | <div style="display: flex; justify-content: space-between;"> <div> PAGE<br/><b>1</b> </div> <div> OF<br/><b>83</b> </div> </div> | <div style="text-align: center;"> REPORT NO.<br/> <b>15FA8-072-PR</b> </div> |
| <b>TITLE</b><br><br>METALLURGICAL INVESTIGATION OF A THIRD STAGE TURBINE WHEEL P/N 23065818 REMOVED FROM M250-C20J ENGINE CAE832989 OPERATED BY FLY HANGAR 13 LLC. | | PREPARED<br><br><div style="text-align: center;"><i>Signatures on File</i></div> | |

**Part Name:** Third Stage Turbine Wheel  
**Part Number:** 23065818  
**Part S/N:** X597059  
**Total Part Time:** 930 Hours (TSO)  
**Engine Model:** M250-C20J  
**Engine S/N:** CAE832989  
**Removal Station:** Rolls-Royce Corporation, Indianapolis, IN.  
**User:** Fly Hangar 13 LLC

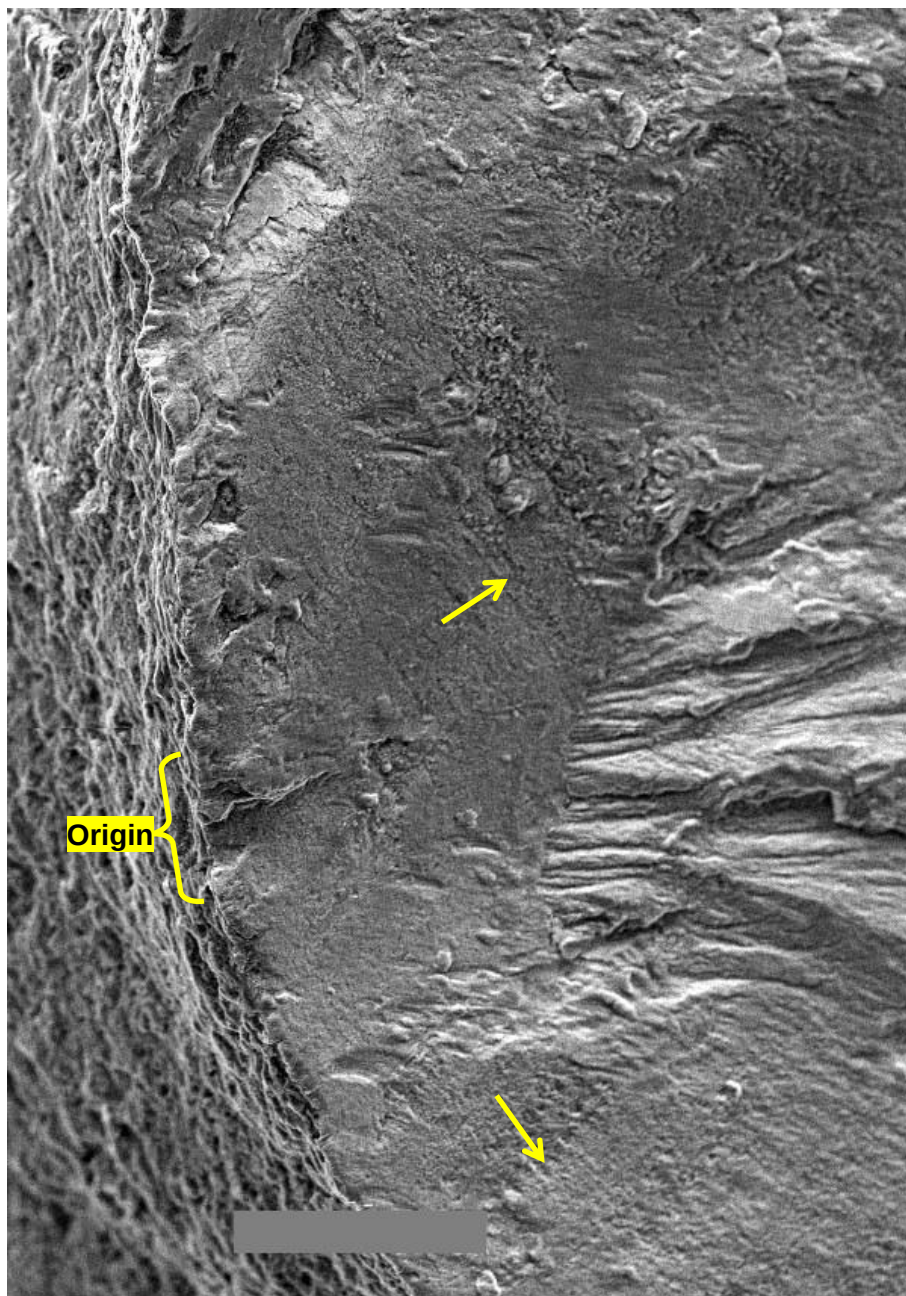
**Figure 18.** Detailed view of the airfoil No. 2 fatigue origin. The arrows show the crack propagation directions.

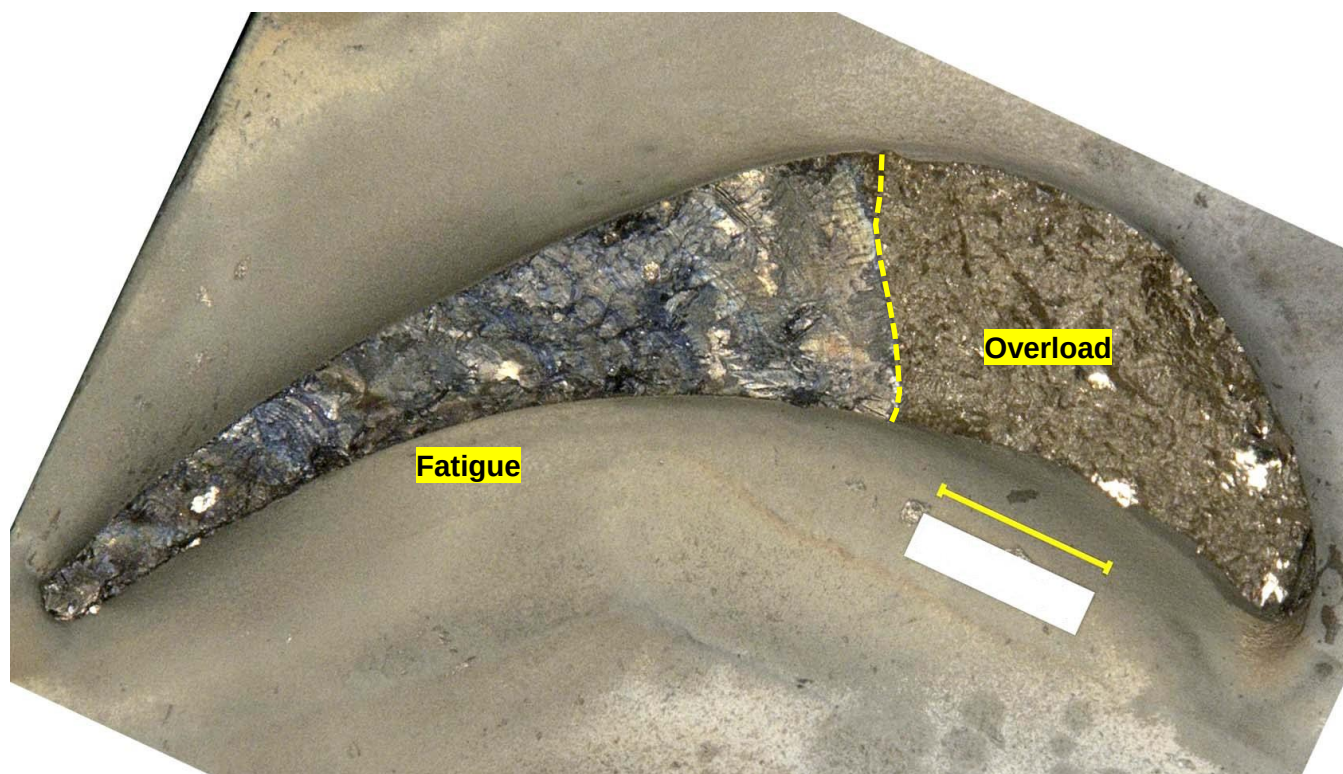
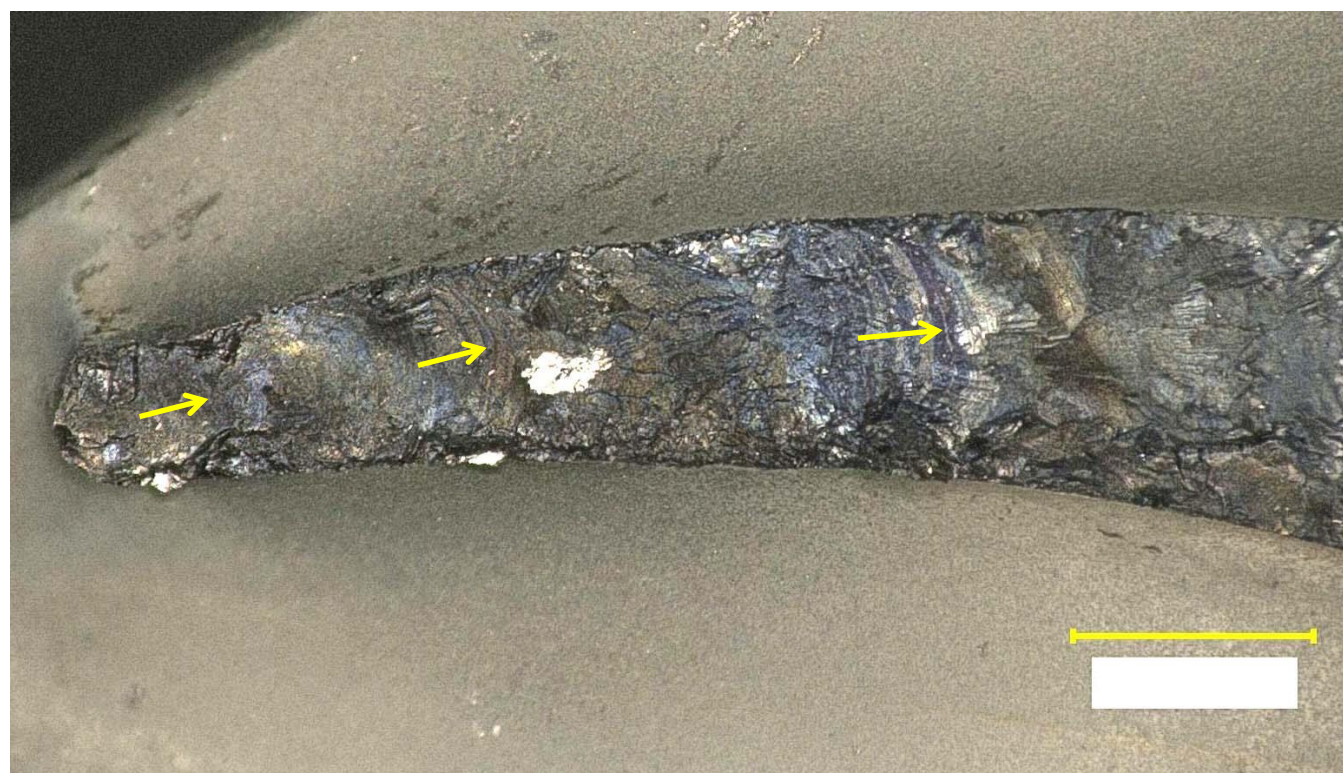
Figure 20 shows a radial view of the airfoil No. 3 fracture. The crack initiated from the trailing edge and progressed approximately 0.51 inch long in fatigue before final fracture occurred in overload. The rim surface was low angle lit to show the casting wax weld location in relationship to the airfoil trailing edge (Figure 21). The crack initiated approximately 0.042 inch above the rim at a Stage I fatigue facet. The facet angled sharply inward toward the rim as illustrated in Figure 22 before turning and progressing transversely across the airfoil. Scanning electron microscope (SEM) images of the origin area are shown in Figure 23 through Figure 25. No obvious material anomalies were observed at the origin.

Figure 20. Photographs showing the fractured third stage turbine wheel airfoil No. 3.

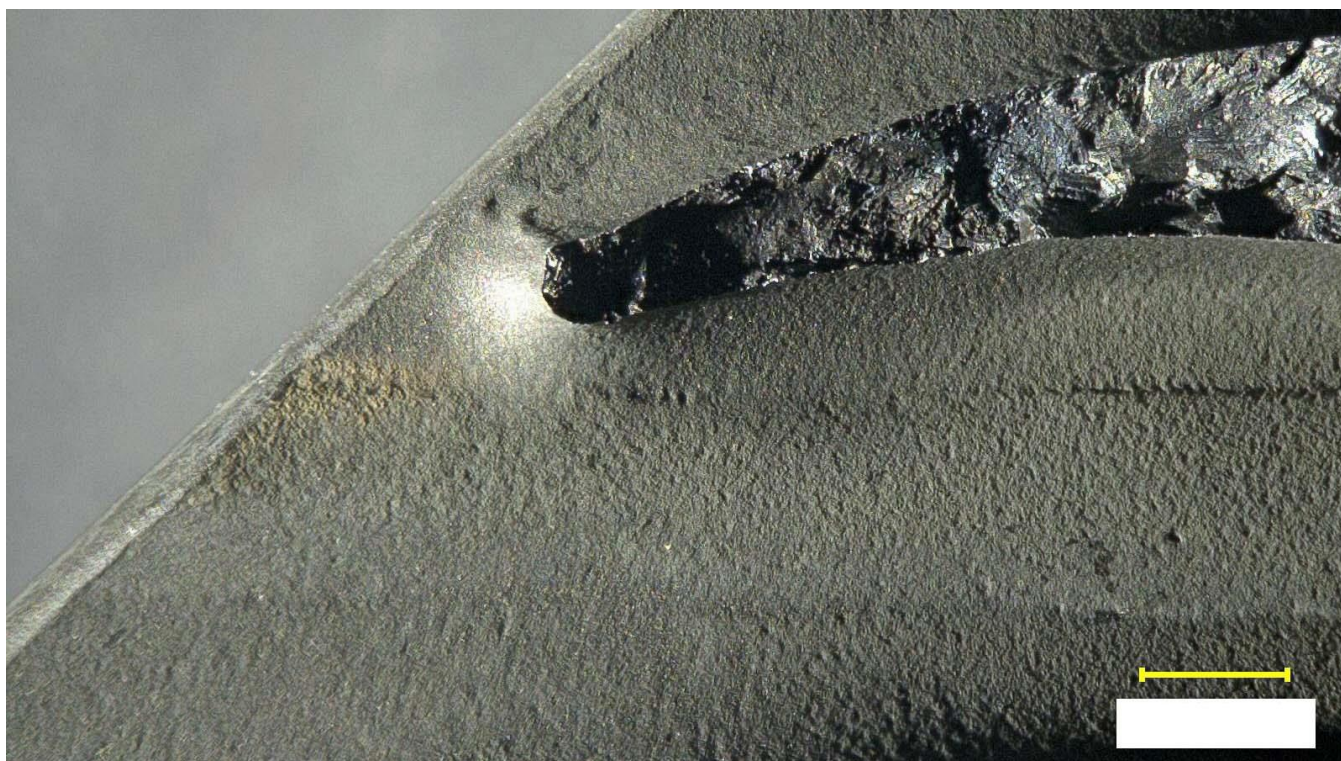
**Figure 21. Low angle lighting showing the casting wax weld adjacent to the airfoil No. 3 trailing edge.**

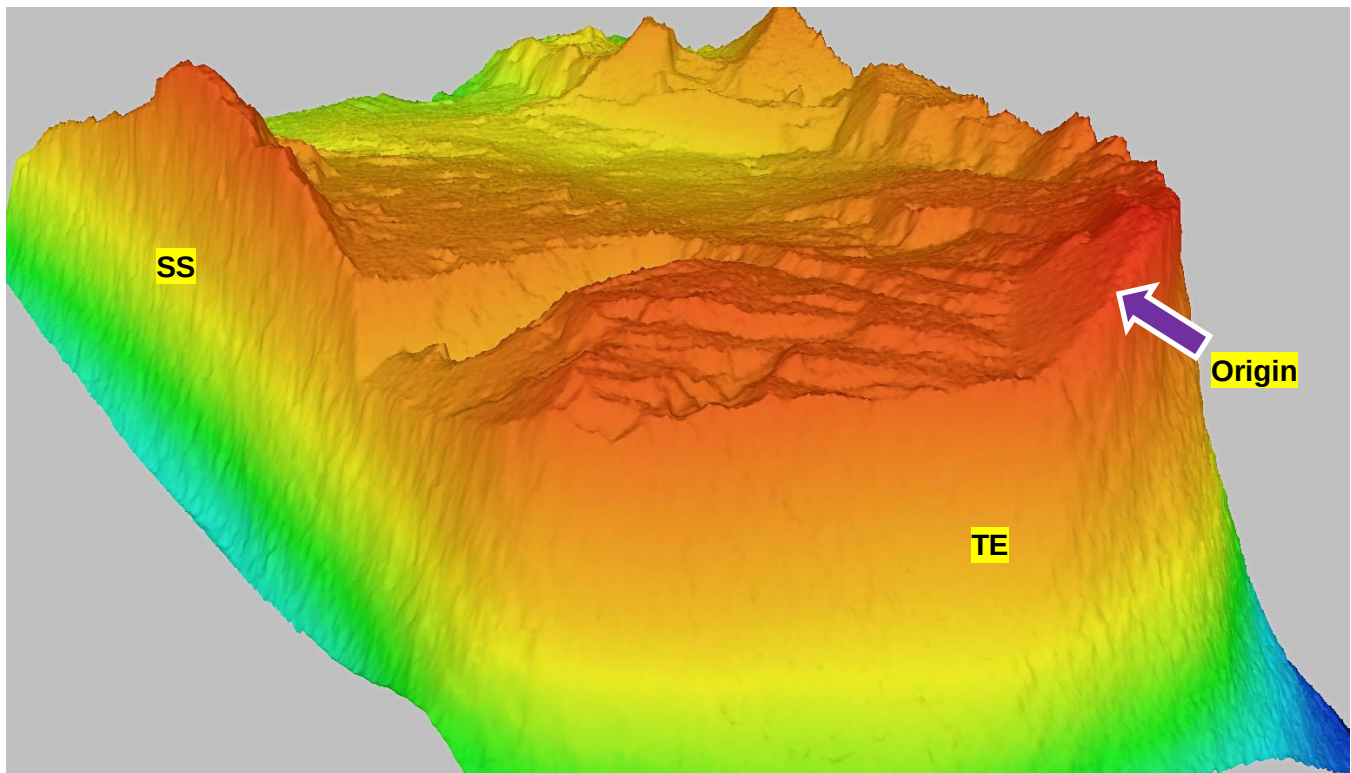
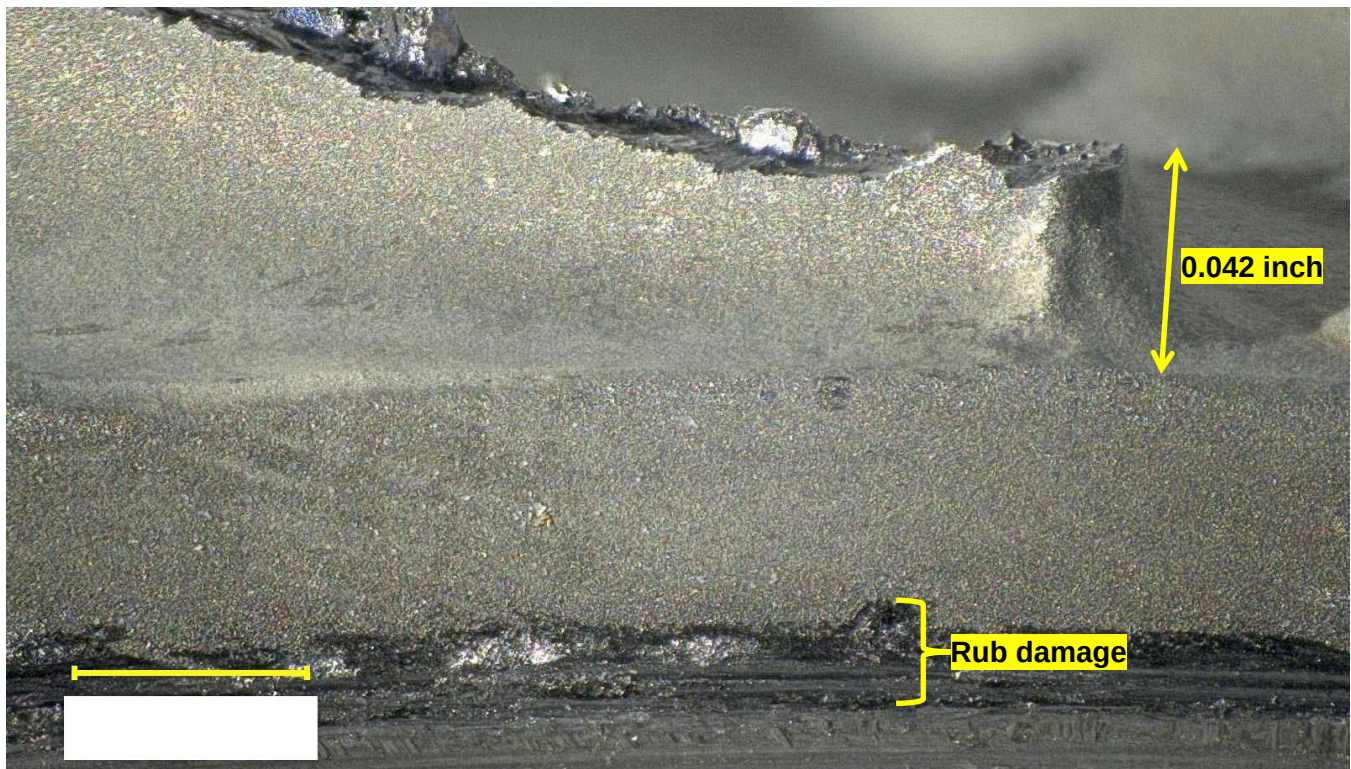
**Figure 22.** The lower image shows a view perpendicular to the rim face of the airfoil No. 3 fracture. The upper image was generated with a CLSM showing the orientation of the fatigue crack. Note the rub damage on the rim face.

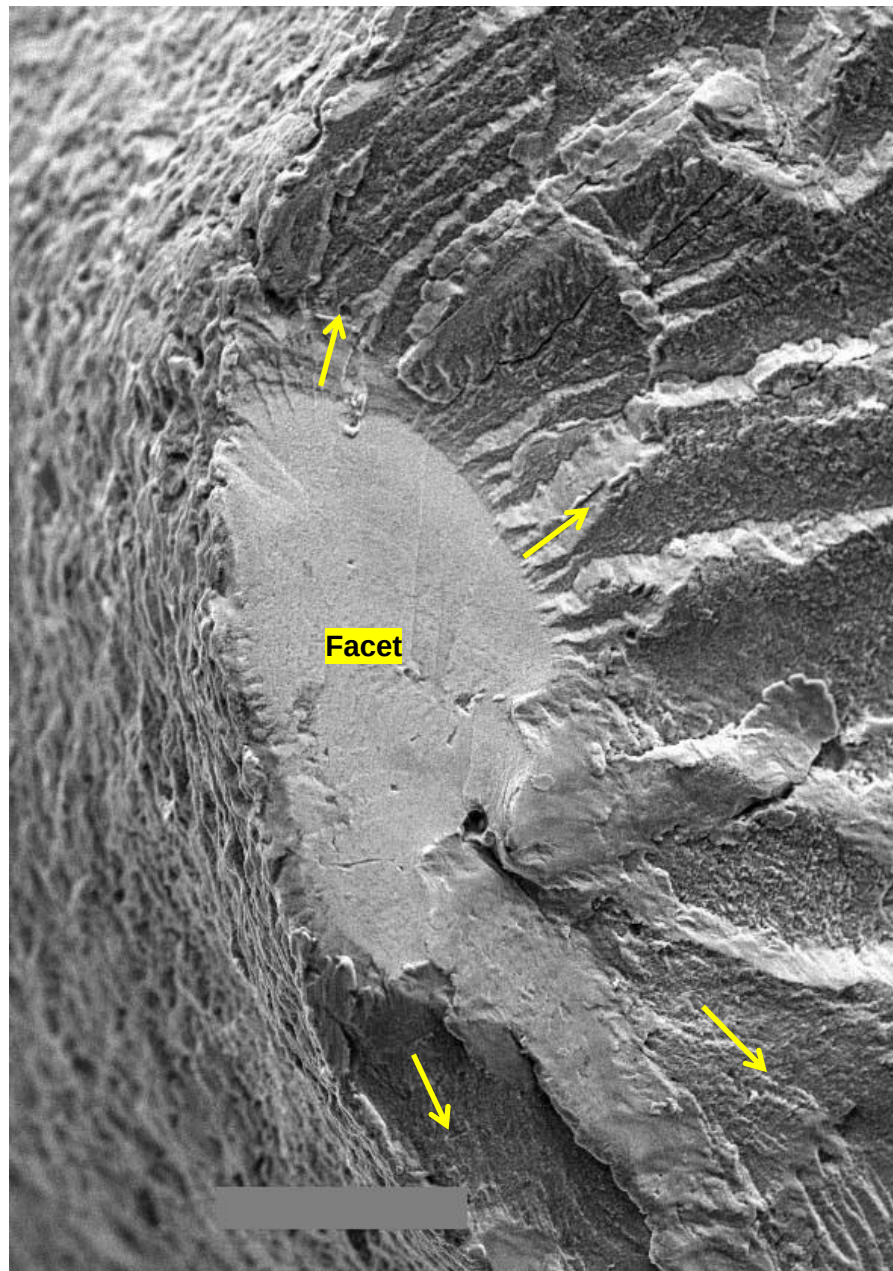
**Figure 24. Detailed view of the airfoil No. 3 fatigue origin. The arrows show the crack propagation directions emanating from the facet.**

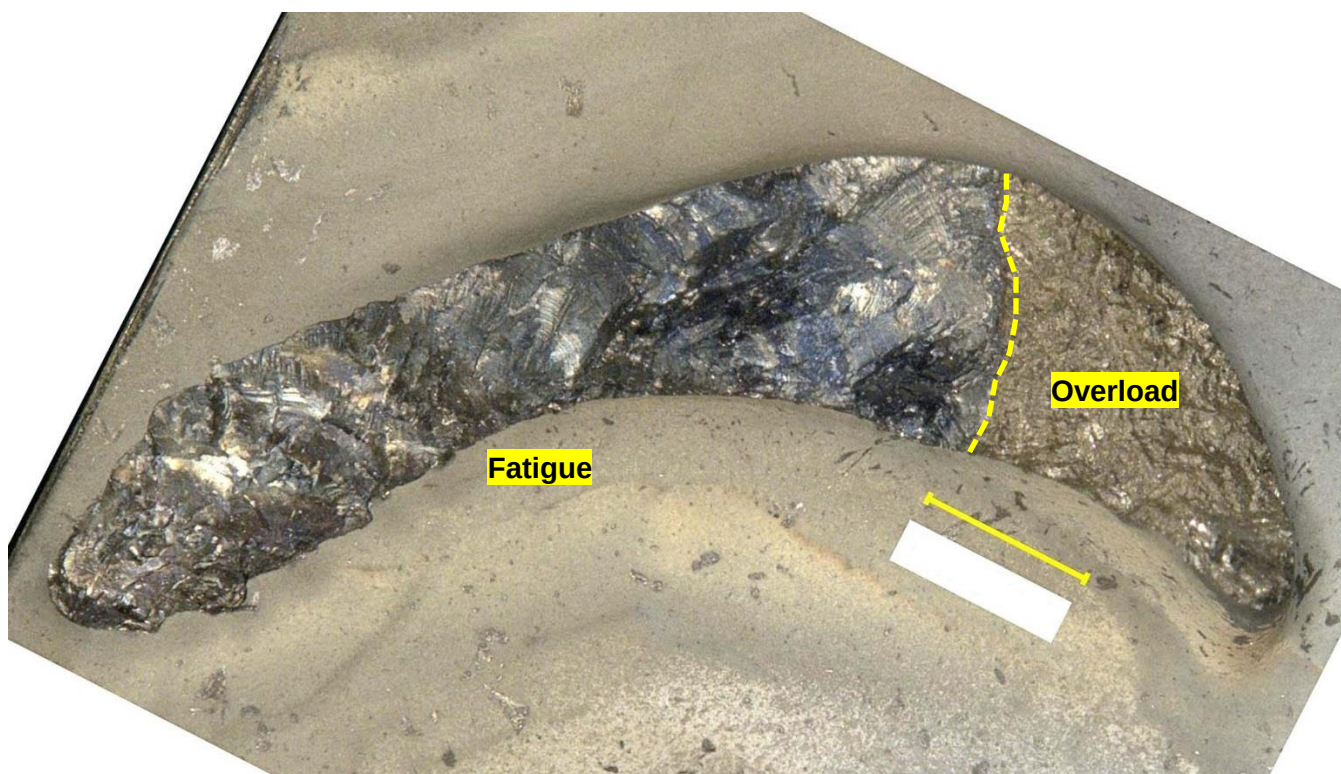
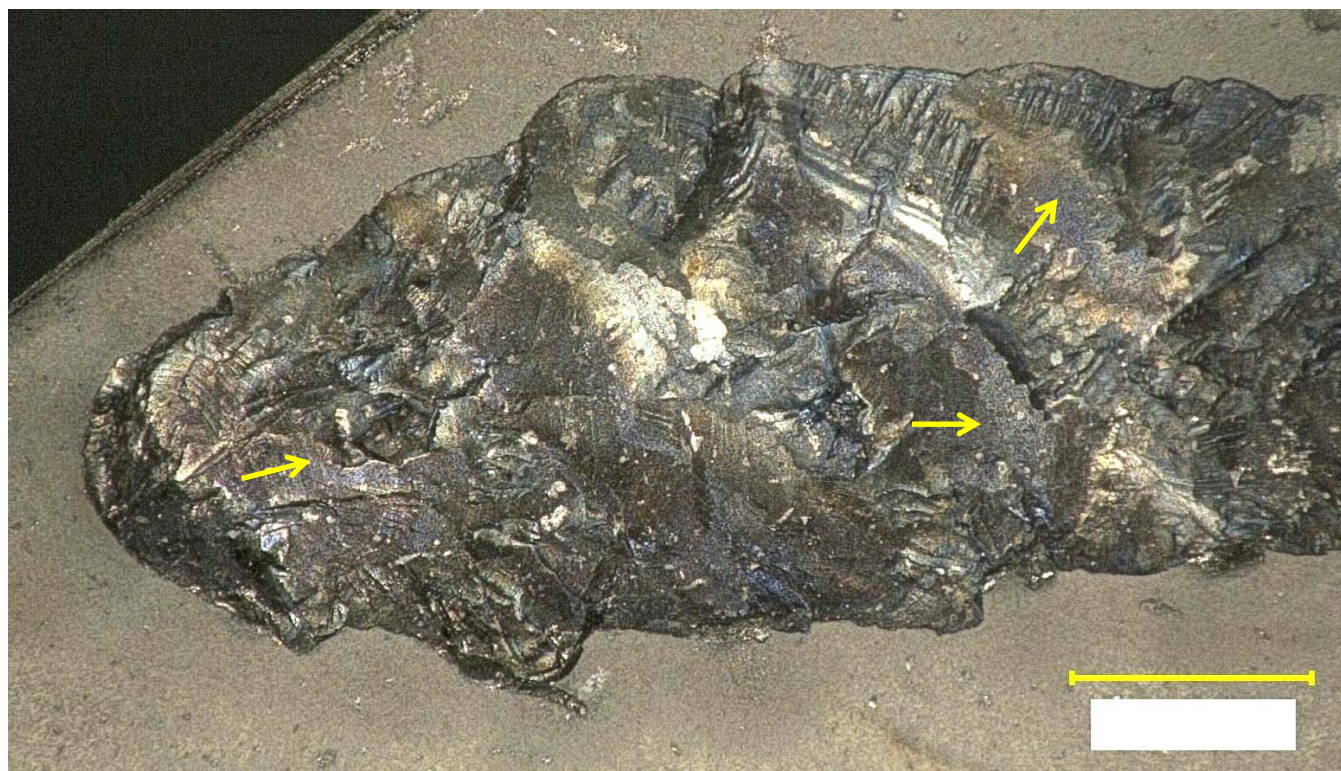
Figure 26 shows a radial view of the airfoil No. 22 fracture. The crack initiated from the trailing edge and progressed approximately 0.58 inch long in fatigue before final fracture occurred in overload. The rim surface was low angle lit to show the casting wax weld location in relationship to the airfoil trailing edge (Figure 27). The crack initiated approximately 0.015 inch above the rim and angled inward toward the rim as illustrated in Figure 28. Scanning electron microscope (SEM) images of the origin area are shown in Figure 29 through Figure 31. No obvious material anomalies were observed at the origin.

Figure 26. Photographs showing the fractured third stage turbine wheel airfoil No. 22.

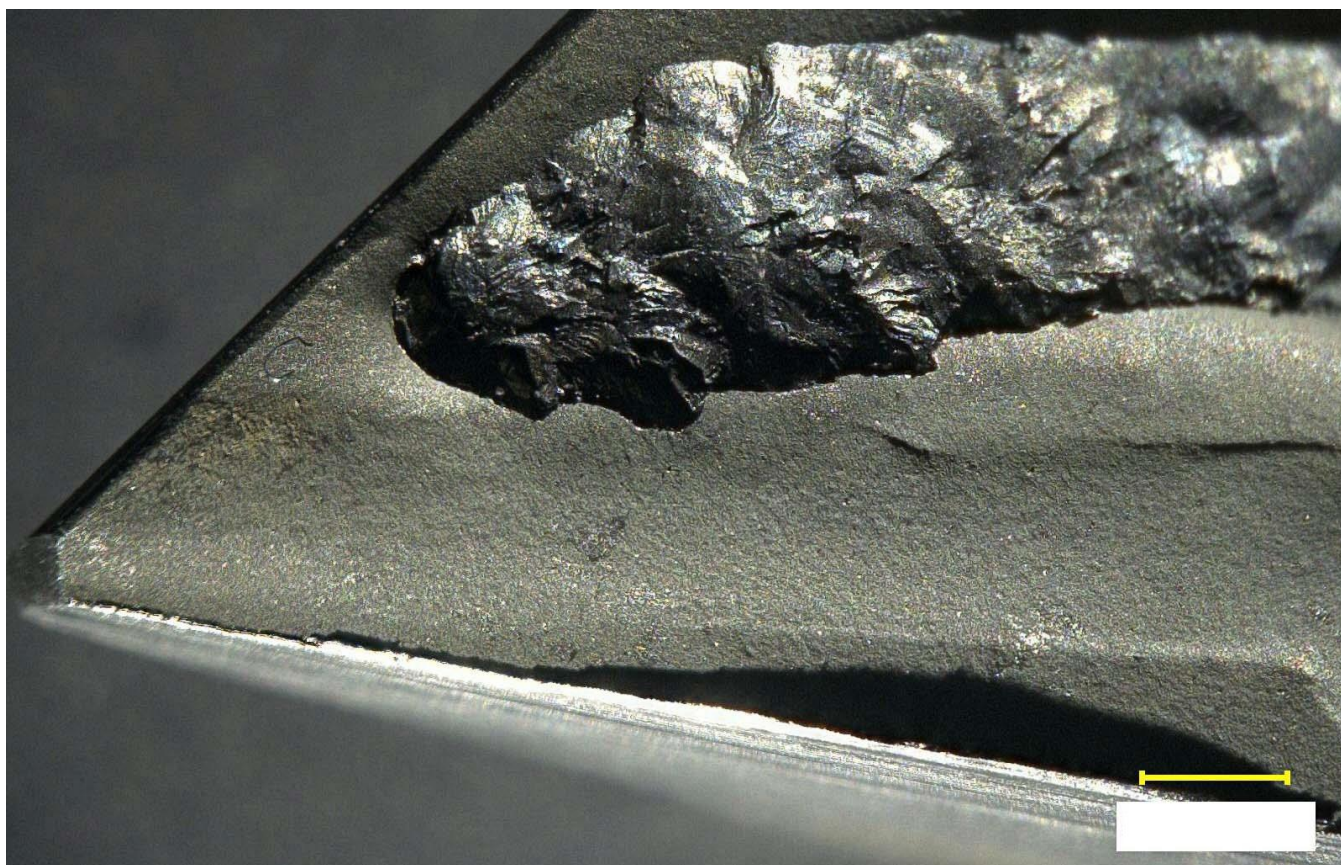
**Figure 27. Low angle lighting showing the casting wax weld adjacent to the airfoil No. 22 trailing edge.**

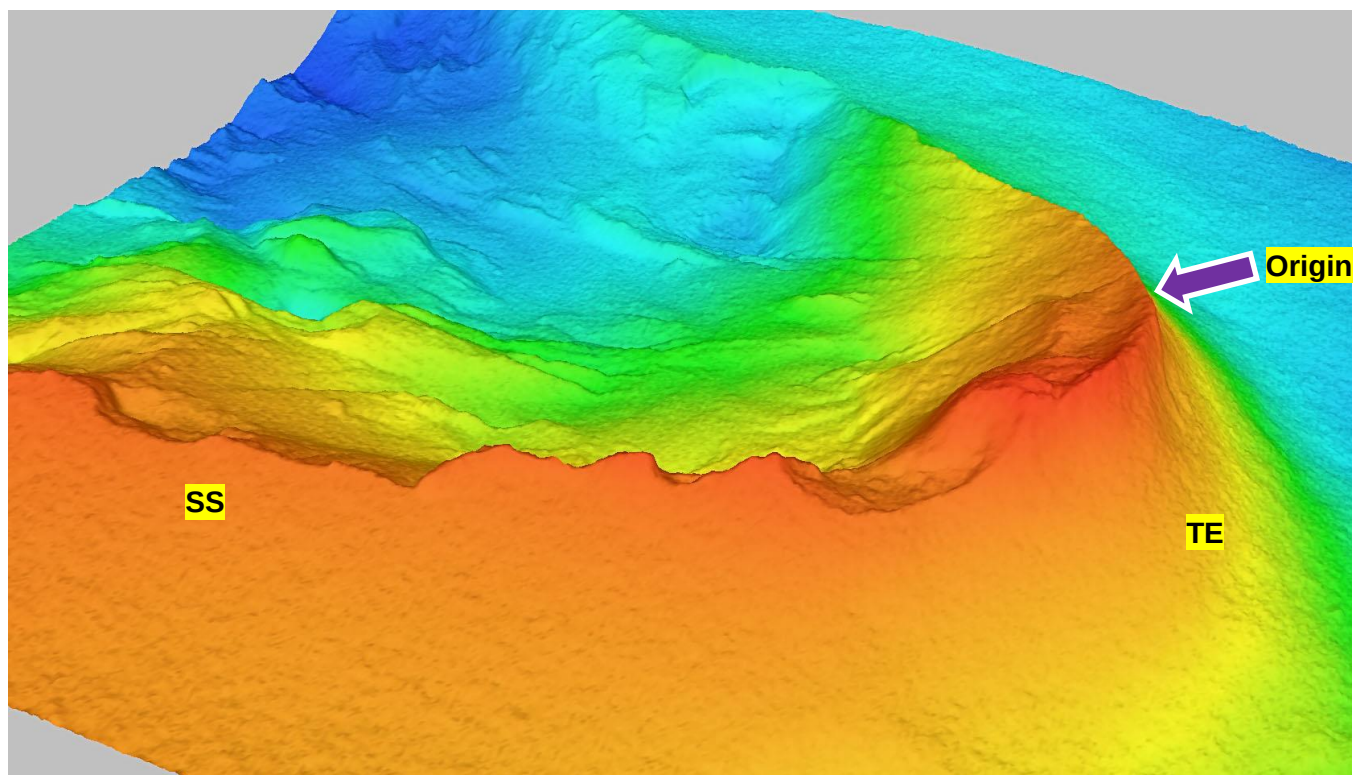
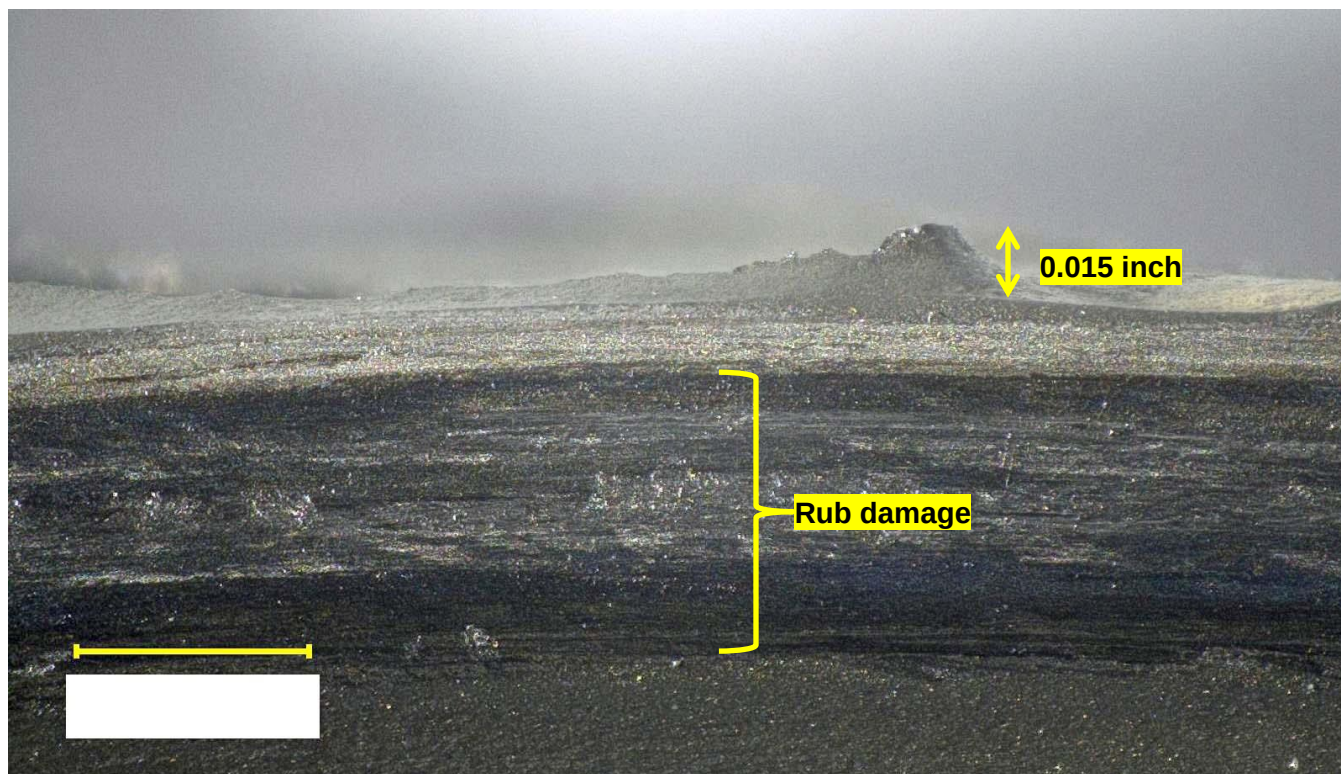
Figure 28. The lower image shows a view perpendicular to the rim face of the airfoil No. 22 fracture. The upper image was generated with a CLSM showing the orientation of the fatigue crack. Note the rub damage on the rim face.

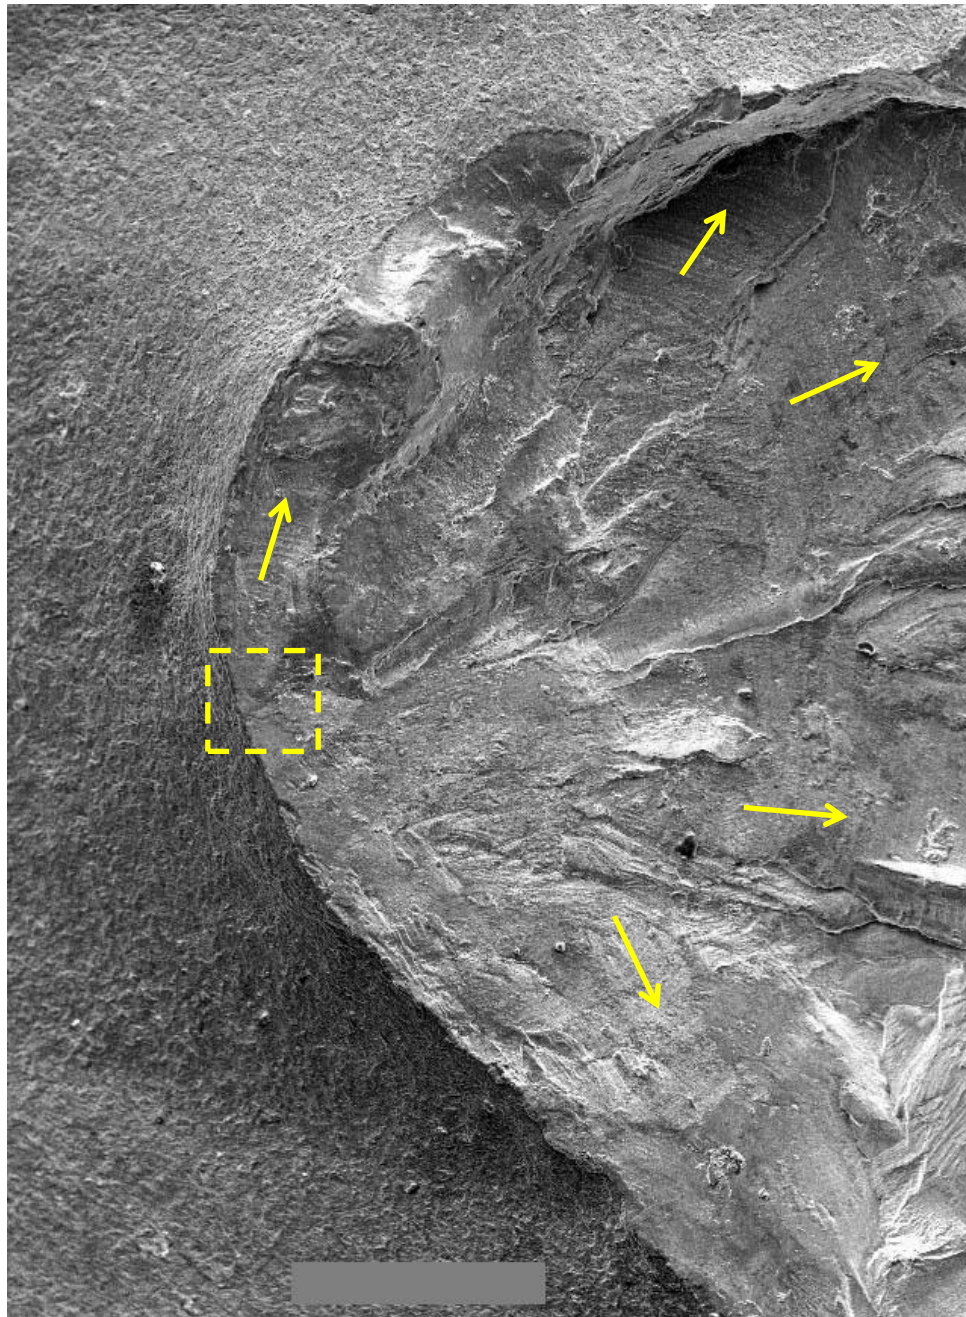
**Figure 29. SEM photograph of the airfoil No. 22 crack origin area. The arrows show the crack propagation directions. Detailed views of the fatigue origin are shown in the following figure.**

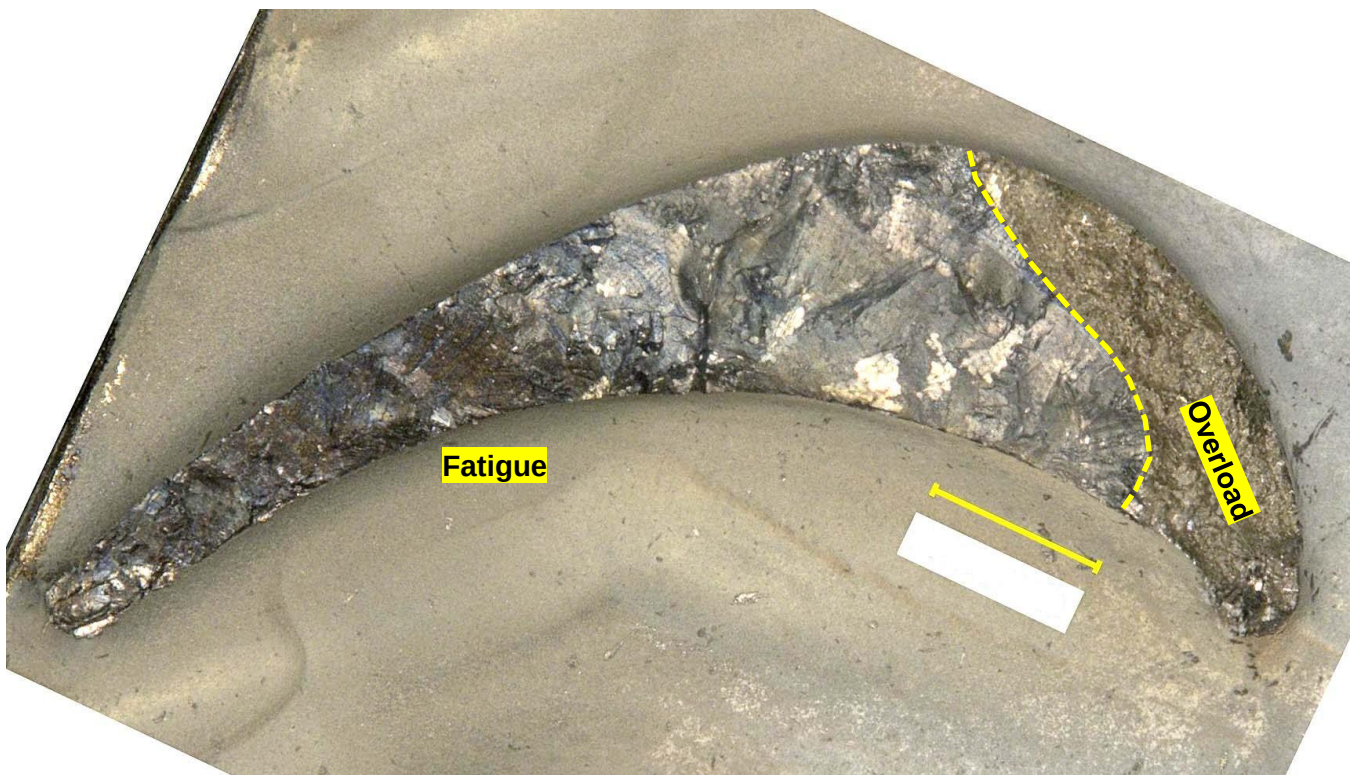
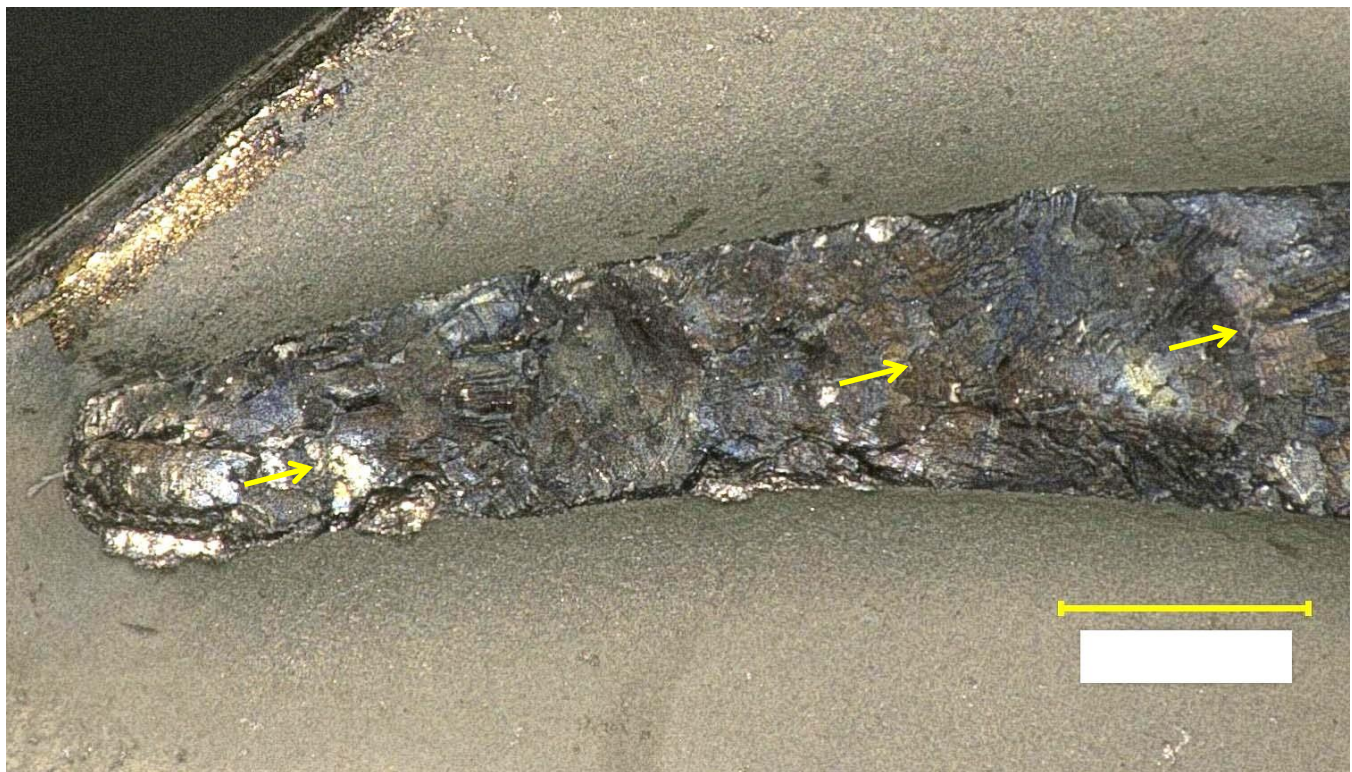
Figure 32 shows a radial view of the airfoil No. 24 fracture. The crack initiated from the trailing edge and progressed approximately 0.55 inch long in fatigue before final fracture occurred in overload. The rim surface was low angle lit to show the casting wax weld location in relationship to the airfoil trailing edge (Figure 33). The crack initiated approximately 0.026 inch above the rim and angled inward toward the rim as illustrated in Figure 34. Scanning electron microscope (SEM) images of the origin area are shown in Figure 35 through Figure 37. No obvious material anomalies were observed at the origin.

Figure 32. Photographs showing the fractured third stage turbine wheel airfoil No. 24.

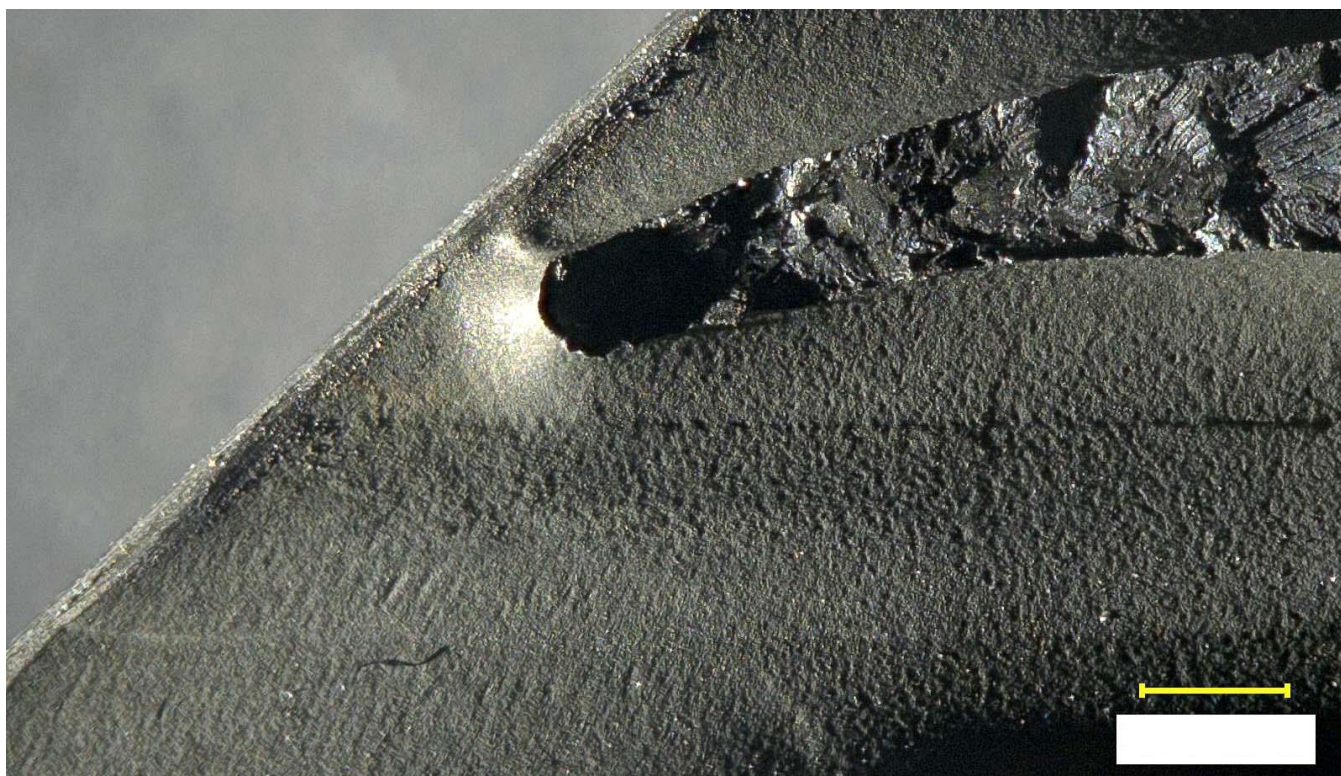
**Figure 33. Low angle lighting showing the casting wax weld adjacent to the airfoil No. 24 trailing edge.**

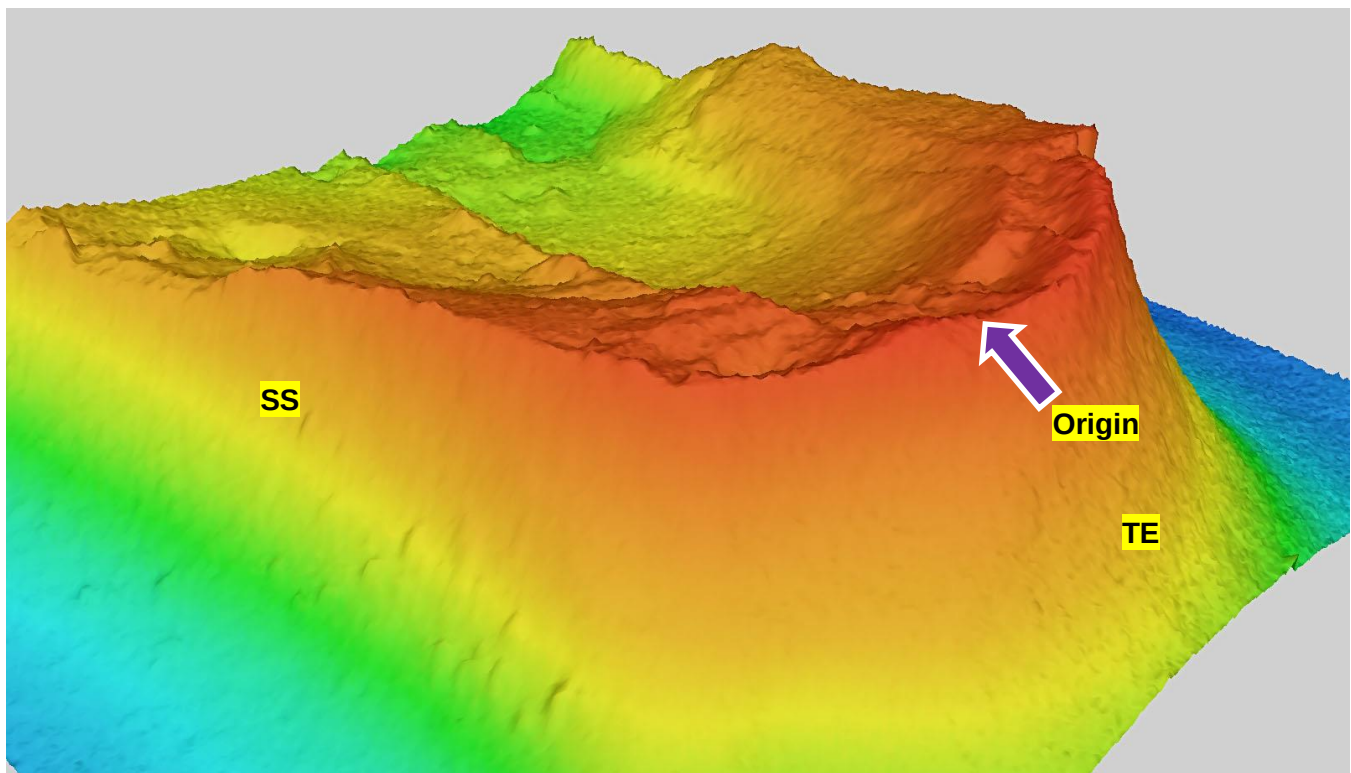
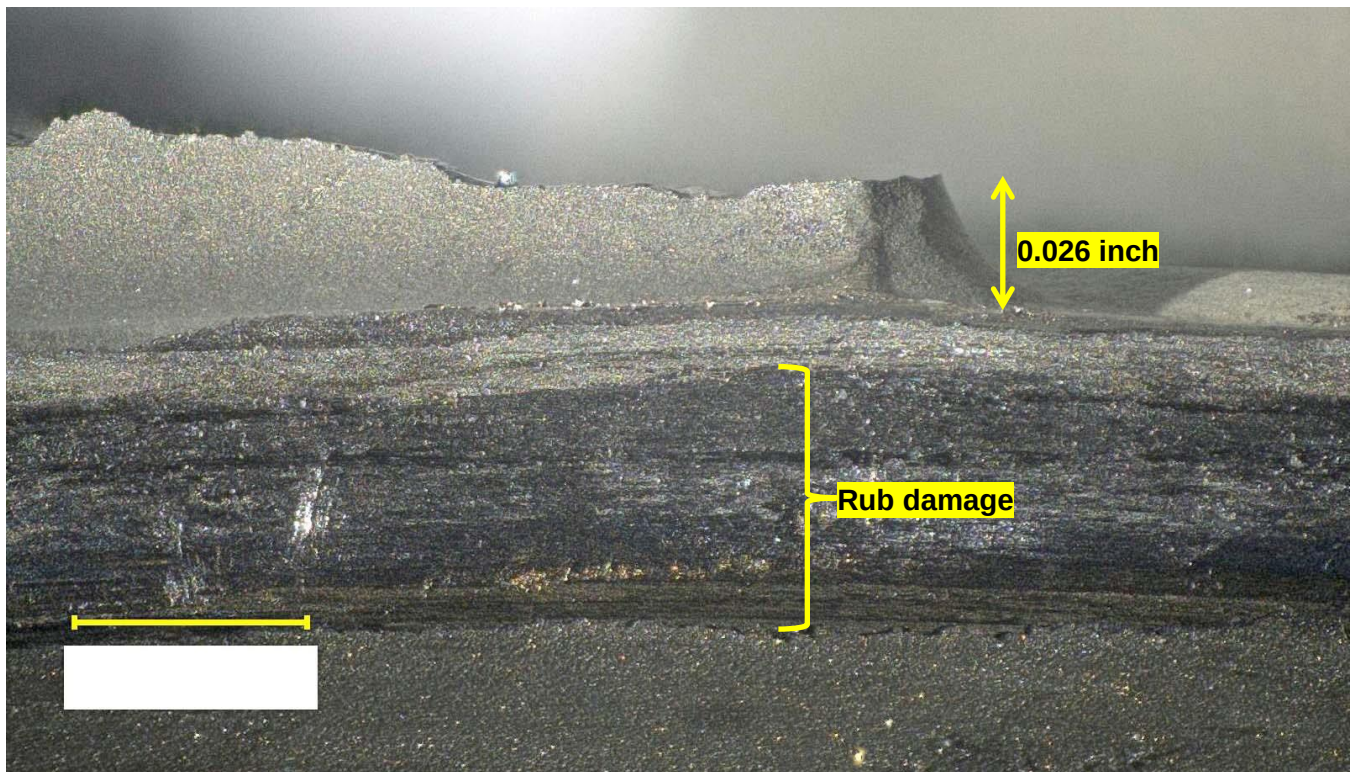
**Figure 34.** The lower image shows a view perpendicular to the rim face of the airfoil No. 24 fracture. The upper image was generated with a CLSM showing the orientation of the fatigue crack. Note the rub damage on the rim face.

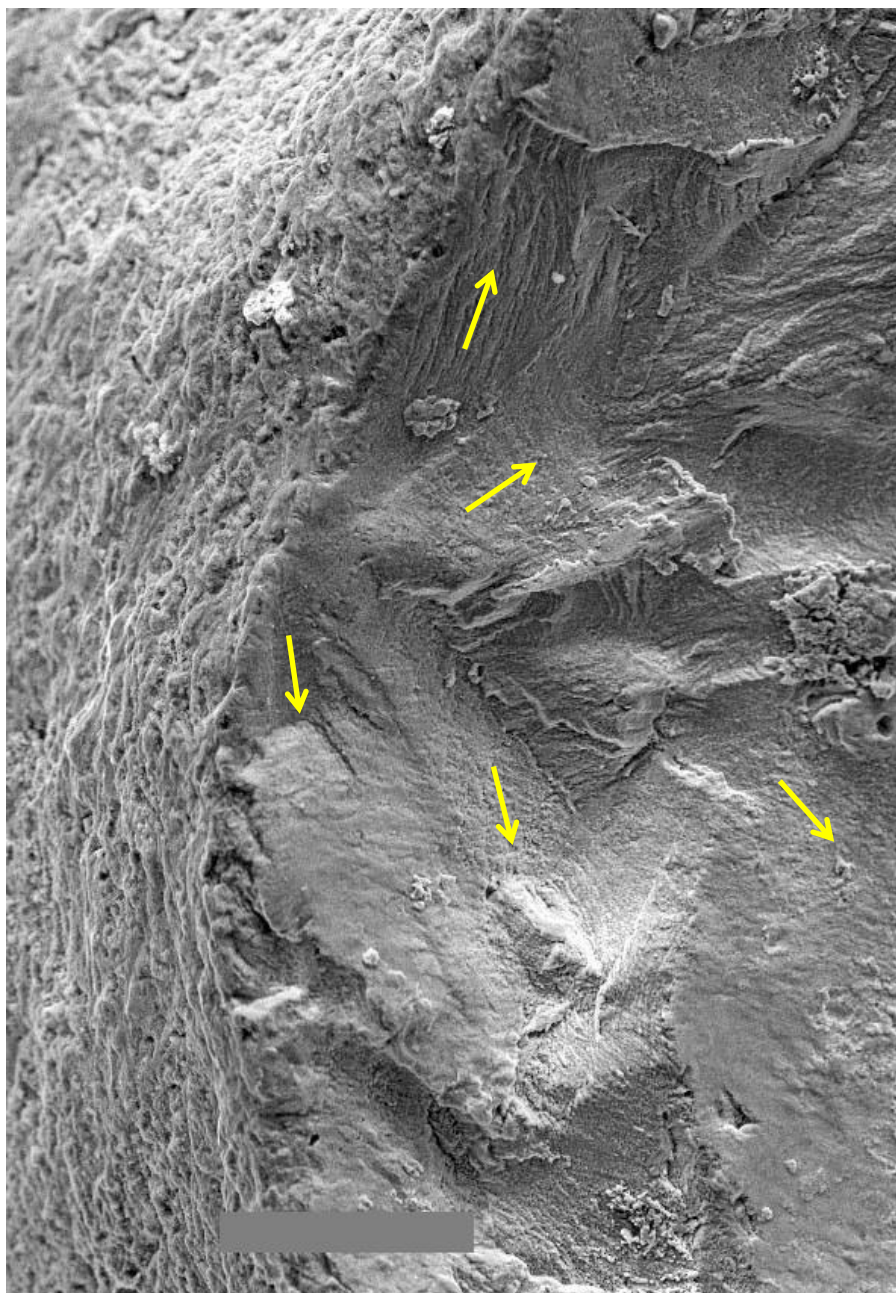
**Figure 35. SEM photograph of the airfoil No. 24 crack origin area. The arrows show the crack propagation directions. A detailed view of the fatigue origin is shown in the following figure.**

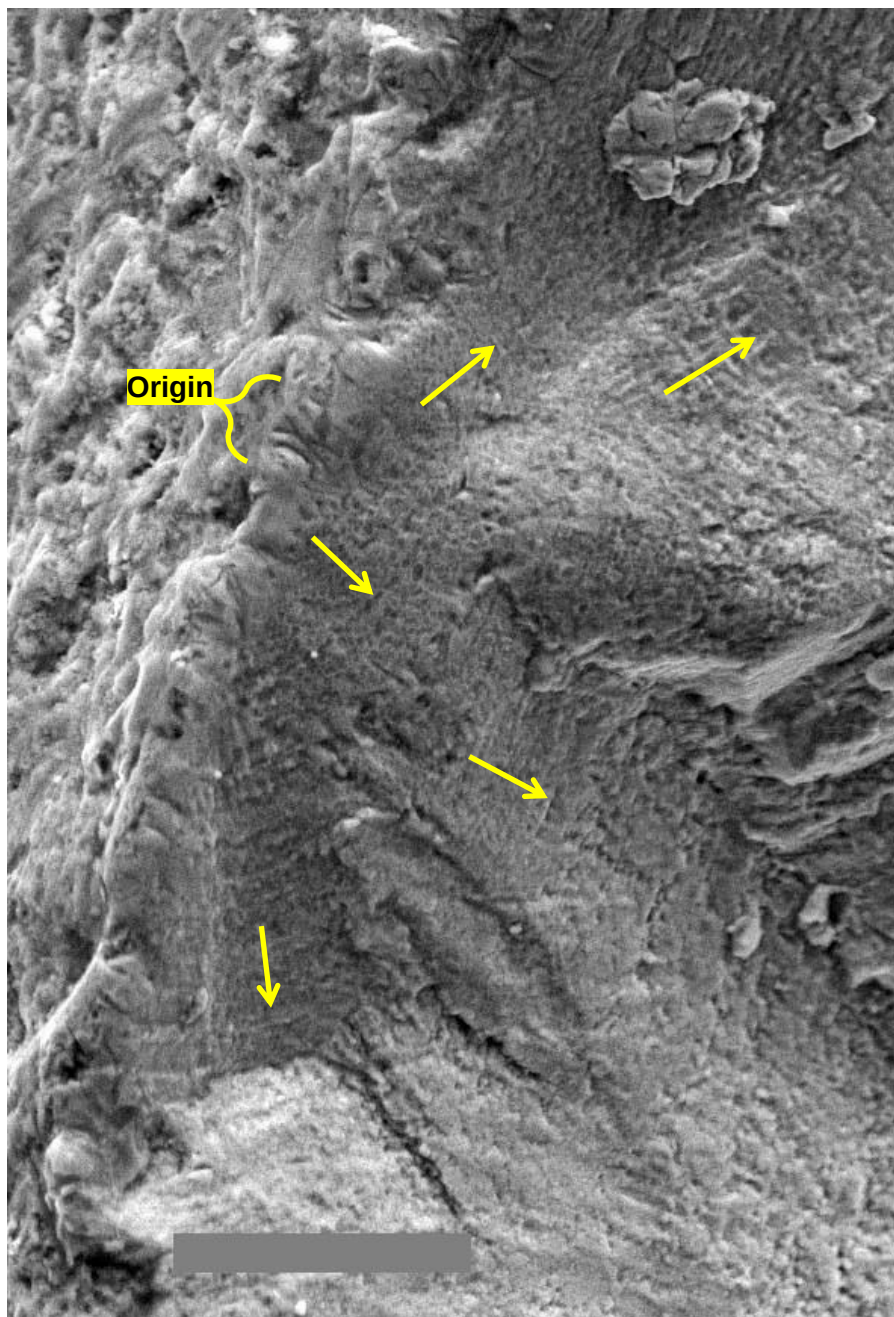
Figure 36. Detailed view of the airfoil No. 24 fatigue origin.
