| <div style="display: inline-block; vertical-align: middle;"> Rolls-Royce Corporation<br/> P.O. Box 420<br/> Indianapolis, Indiana 46206-0420 USA </div> | | <div style="display: flex; justify-content: space-between;"> <div> PAGE<br/><b>1</b> </div> <div> OF<br/><b>83</b> </div> </div> | <div style="text-align: center;"> REPORT NO.<br/> <b>15FA8-072-PR</b> </div> |
| <b>TITLE</b><br><br>METALLURGICAL INVESTIGATION OF A THIRD STAGE TURBINE WHEEL P/N 23065818 REMOVED FROM M250-C20J ENGINE CAE832989 OPERATED BY FLY HANGAR 13 LLC. | | PREPARED<br><br><div style="text-align: center;"><i>Signatures on File</i></div> | |

**Part Name:** Third Stage Turbine Wheel  
**Part Number:** 23065818  
**Part S/N:** X597059  
**Total Part Time:** 930 Hours (TSO)  
**Engine Model:** M250-C20J  
**Engine S/N:** CAE832989  
**Removal Station:** Rolls-Royce Corporation, Indianapolis, IN.  
**User:** Fly Hangar 13 LLC

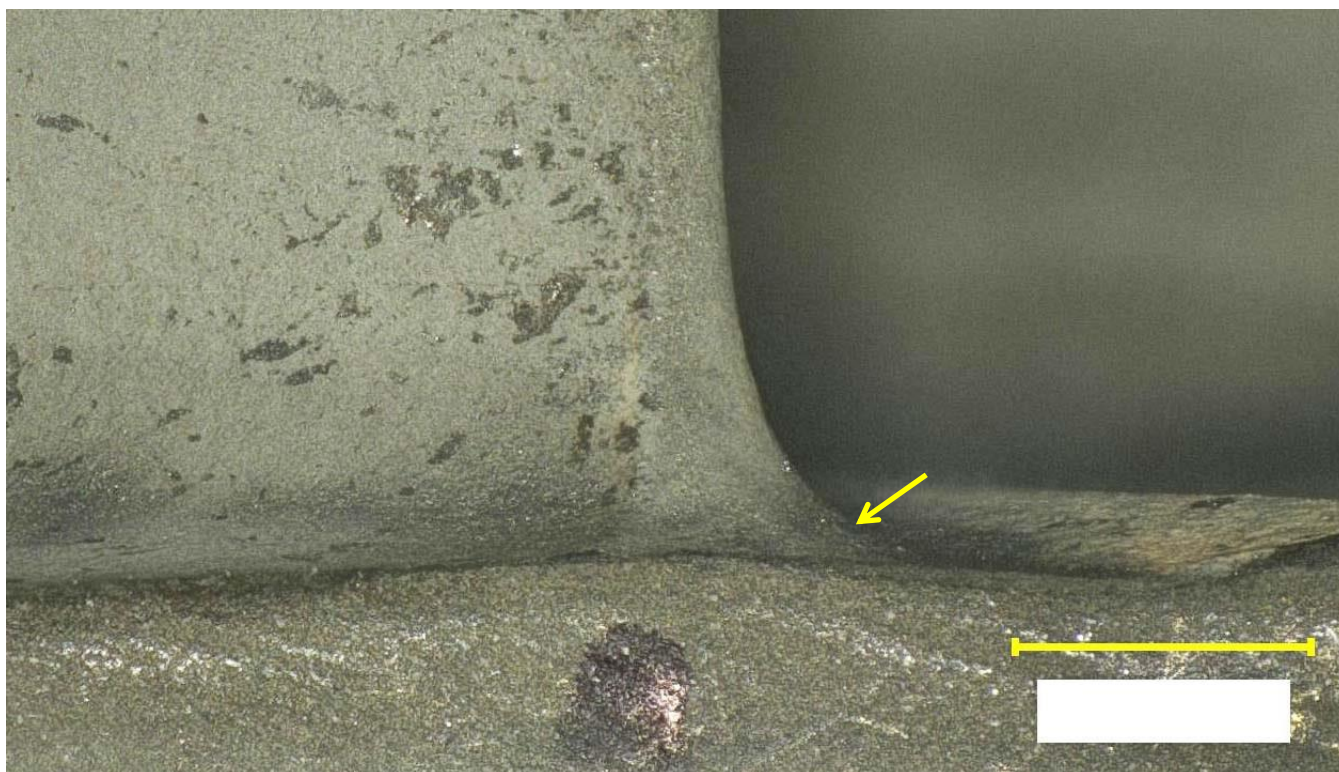
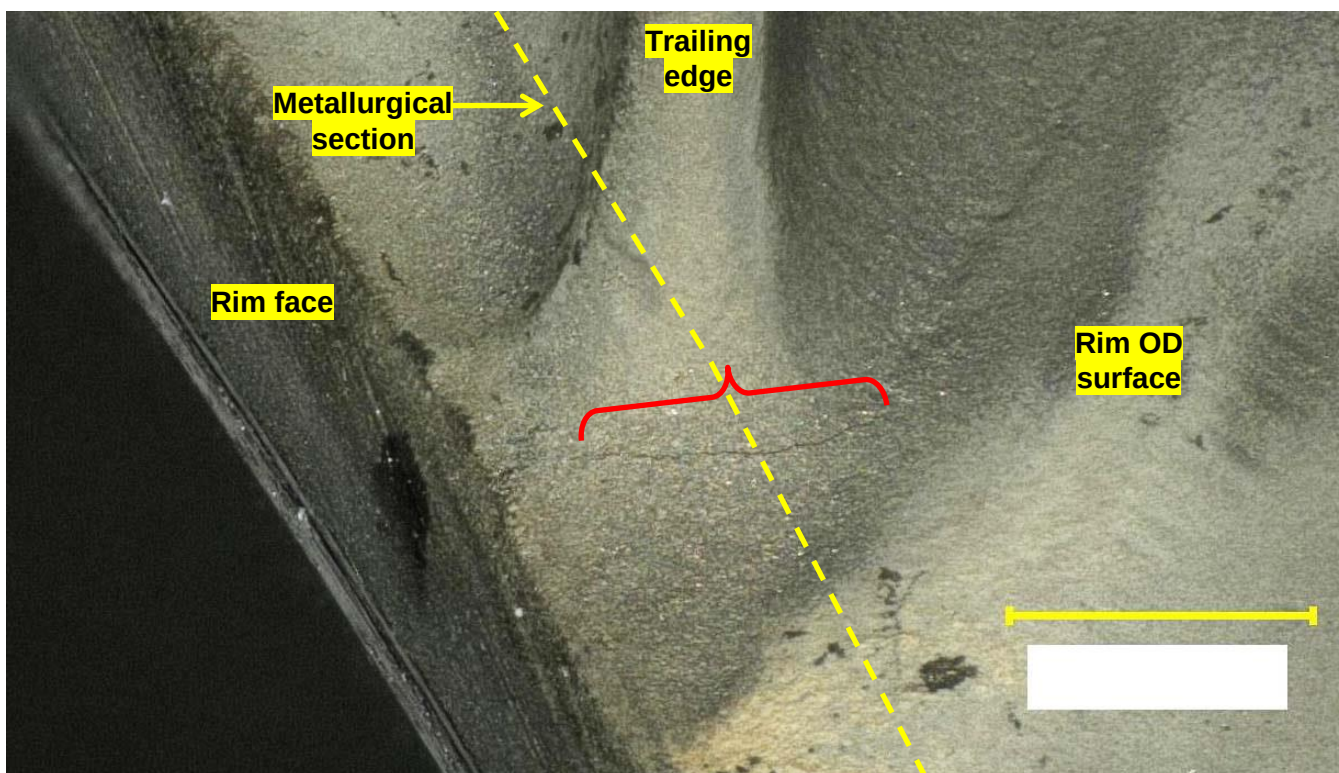
A rim crack measuring approximately 0.05 inch long and oriented radially was observed near the trailing edge root area of airfoil No. 8 as shown in Figure 38. A cross-section through the crack is shown in Figure 39 and Figure 40. The crack length measured 0.022 inch. The crack was transgranular and oxidized but no alloy depletion was observed along the crack path.

Figure 38. Photographs of the rim crack at the airfoil No. 8 trailing edge root. The dashed line identifies the orientation of the metallurgical section.

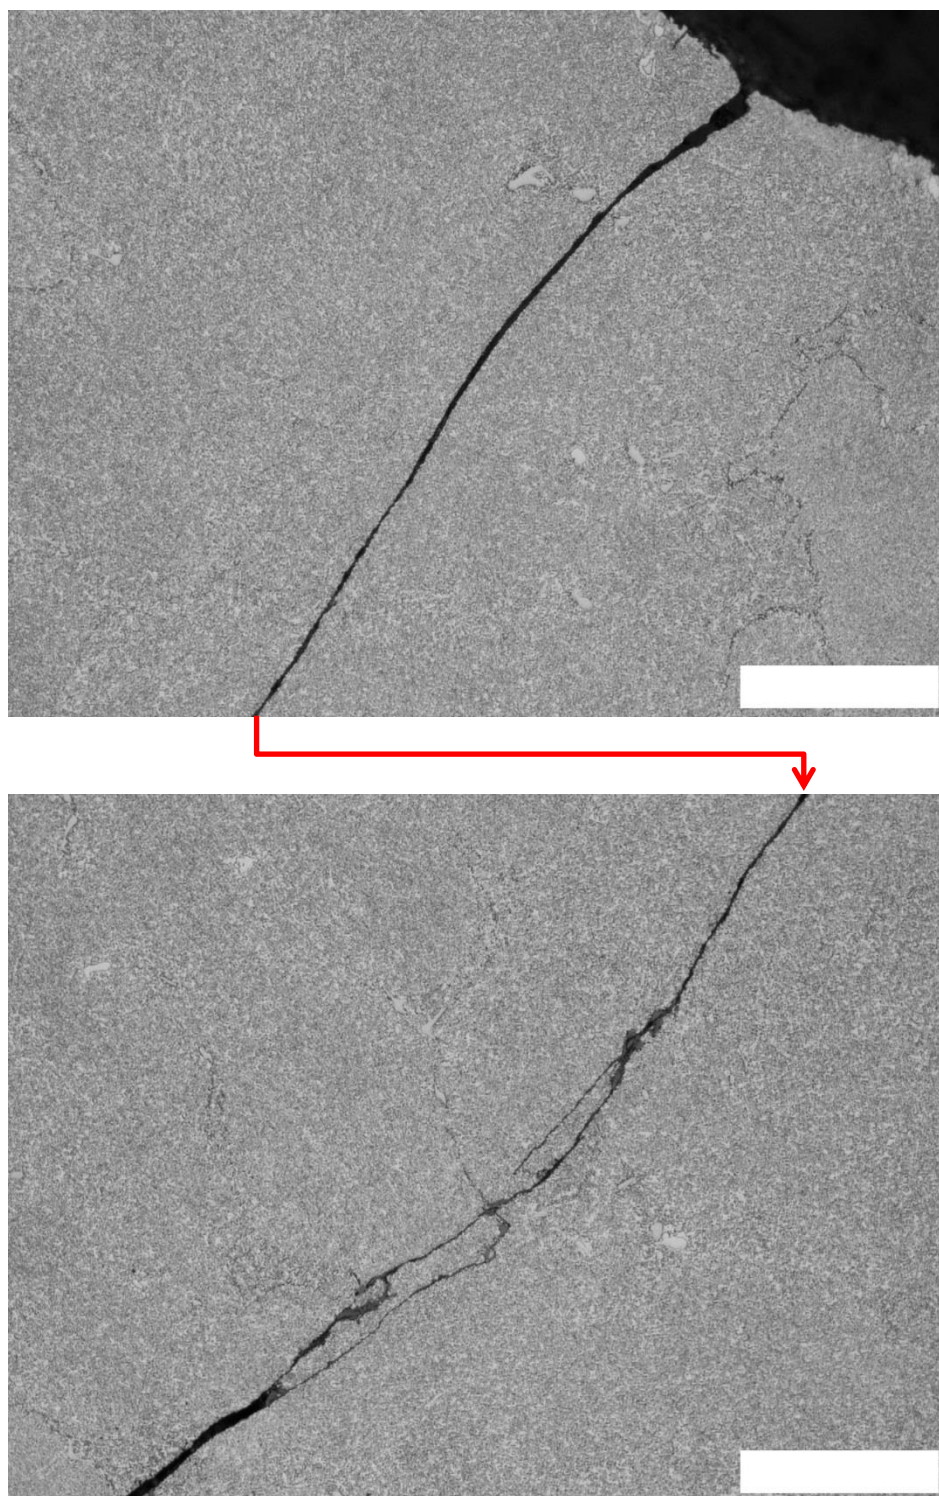
**Figure 40. Detailed views of the fatigue crack at the rim surface. Etchant: MT**

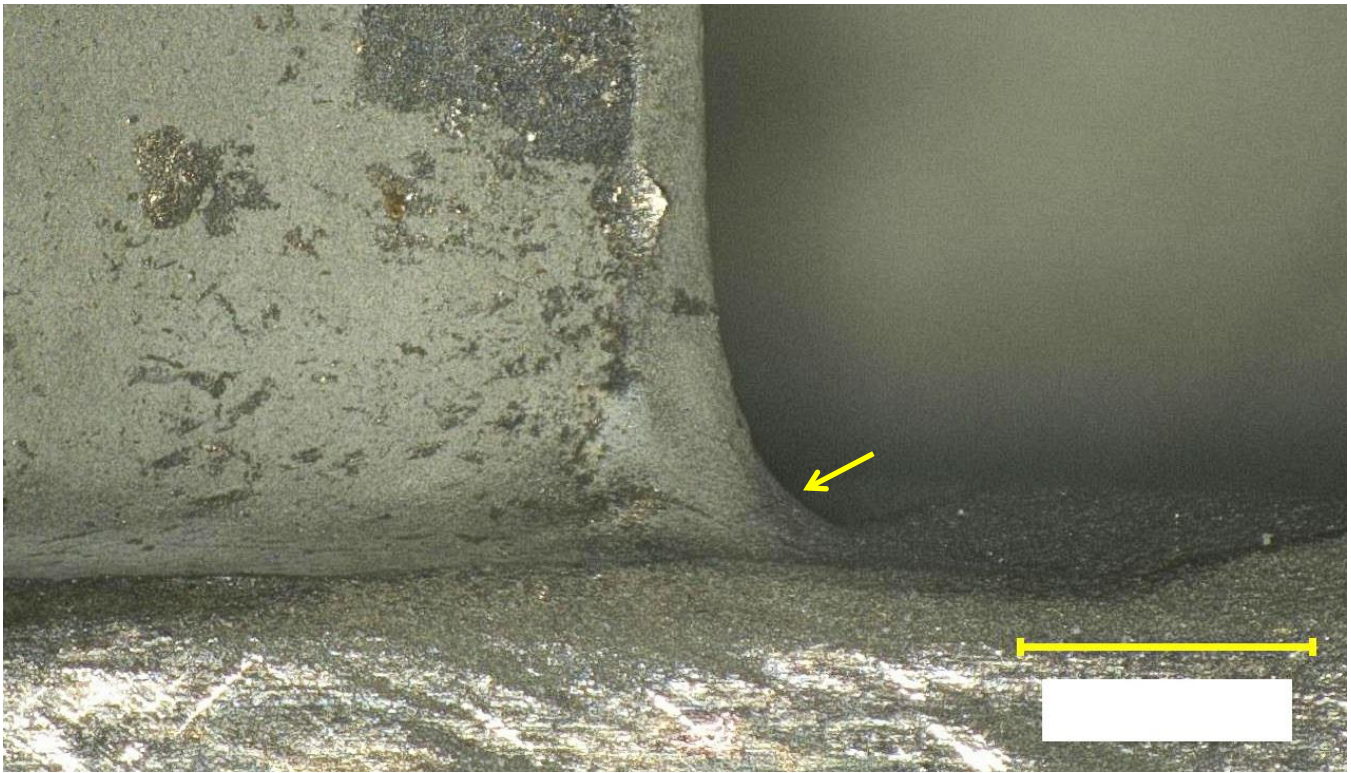
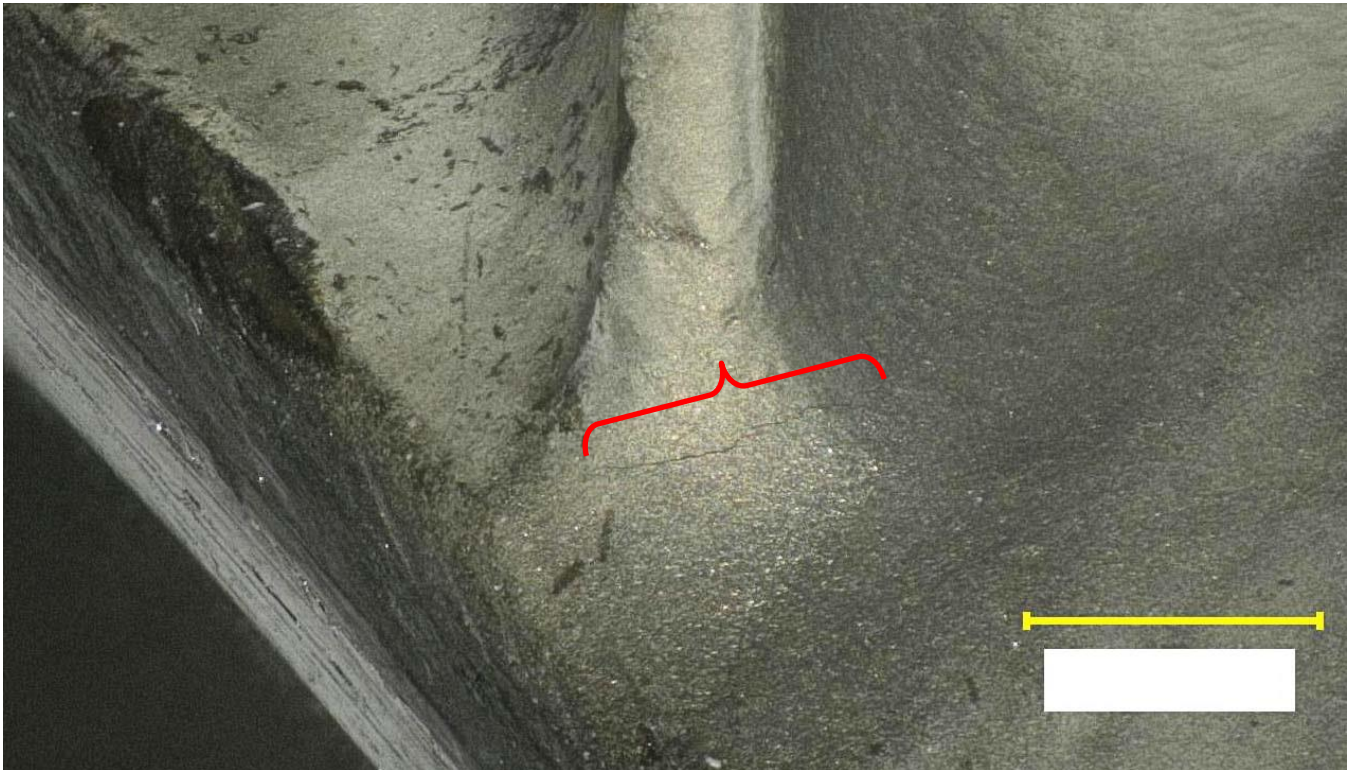
Another rim crack was observed near the trailing edge root area of airfoil No. 15 as shown in Figure 41. The crack was opened in the laboratory and is shown in Figure 42 and Figure 43. Two cracks initiated on two parallel planes and the total crack width measured 0.056 inch and the total depth measured 0.022 inch.

**Figure 41. Photographs of the rim crack at the airfoil No. 15 trailing edge root.**

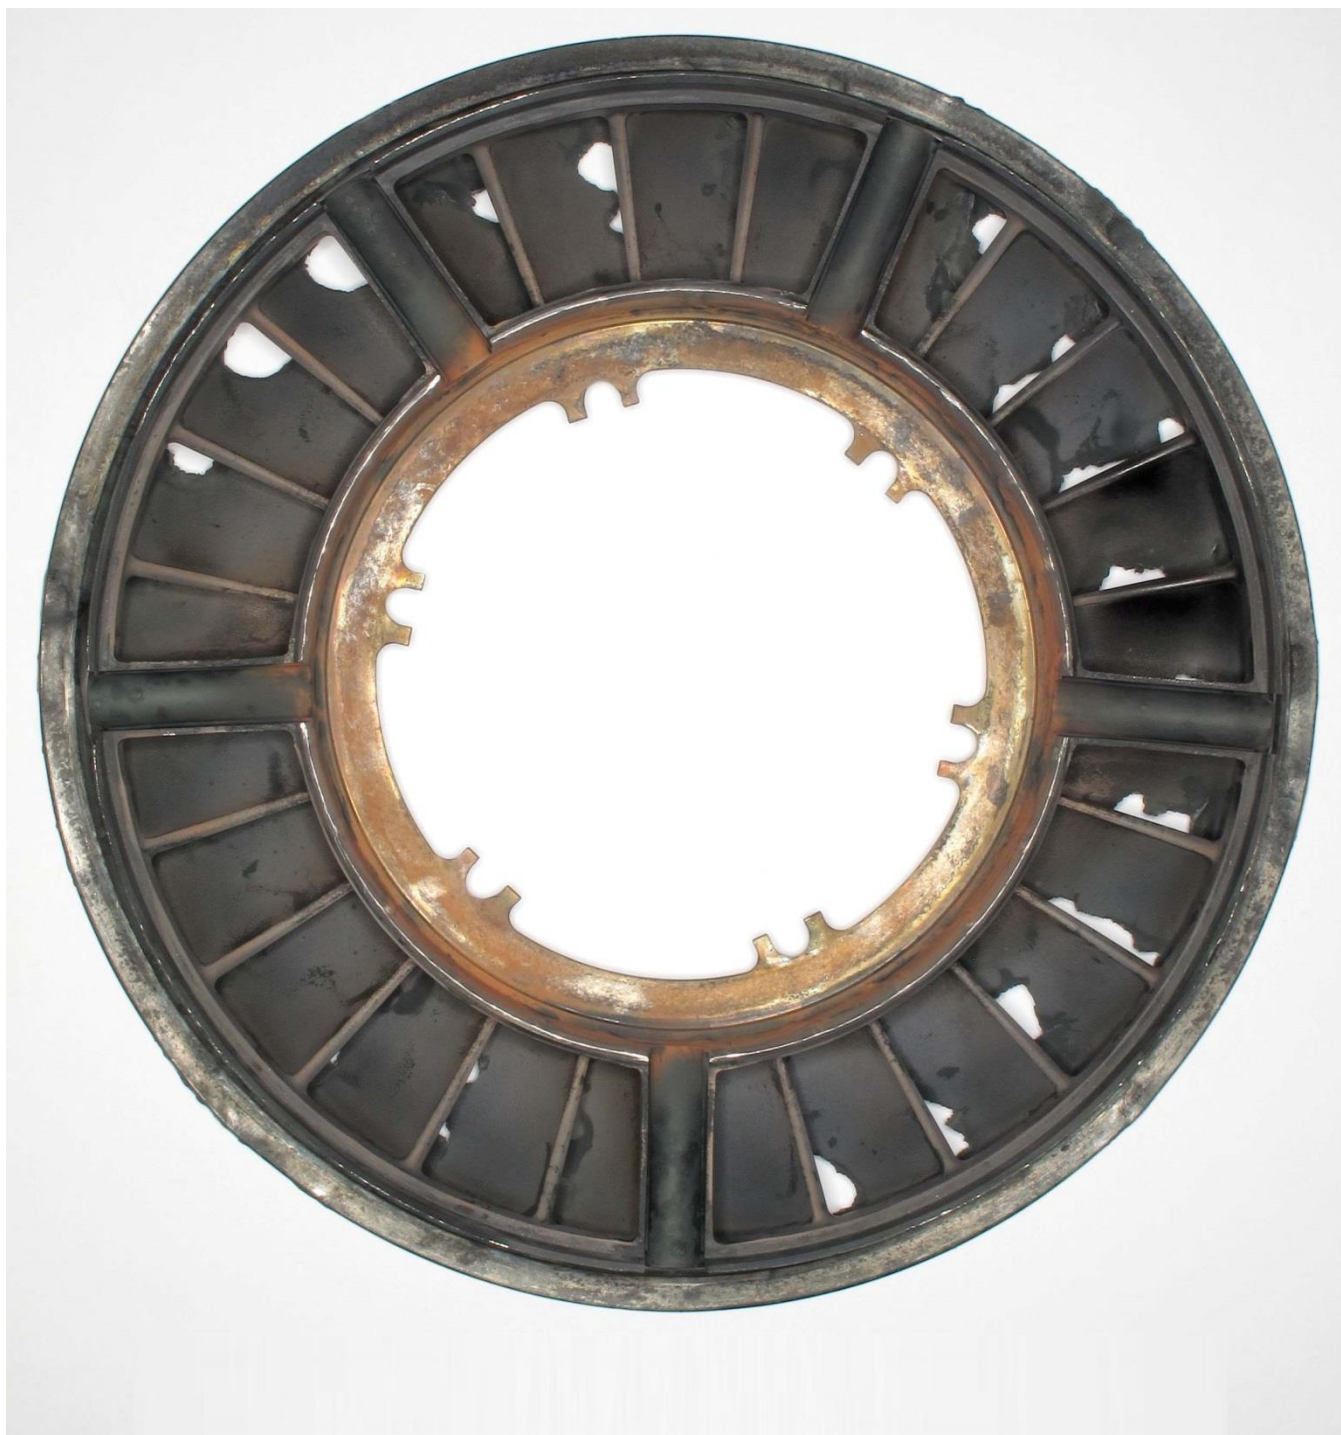
Figure 44 and Figure 45 show leading edge (aft looking forward) and trailing edge (forward looking aft) views of the third stage turbine nozzle respectively. Several of the trailing edge surfaces were impact damaged and material was liberated. The rim surface outboard of the airfoils (TE view) shows significant scoring and impact damage. The hub positioning tabs were not damaged. No destructive evaluations of the nozzle were conducted.

**Figure 44. Aft looking forward view of the third stage turbine nozzle.**

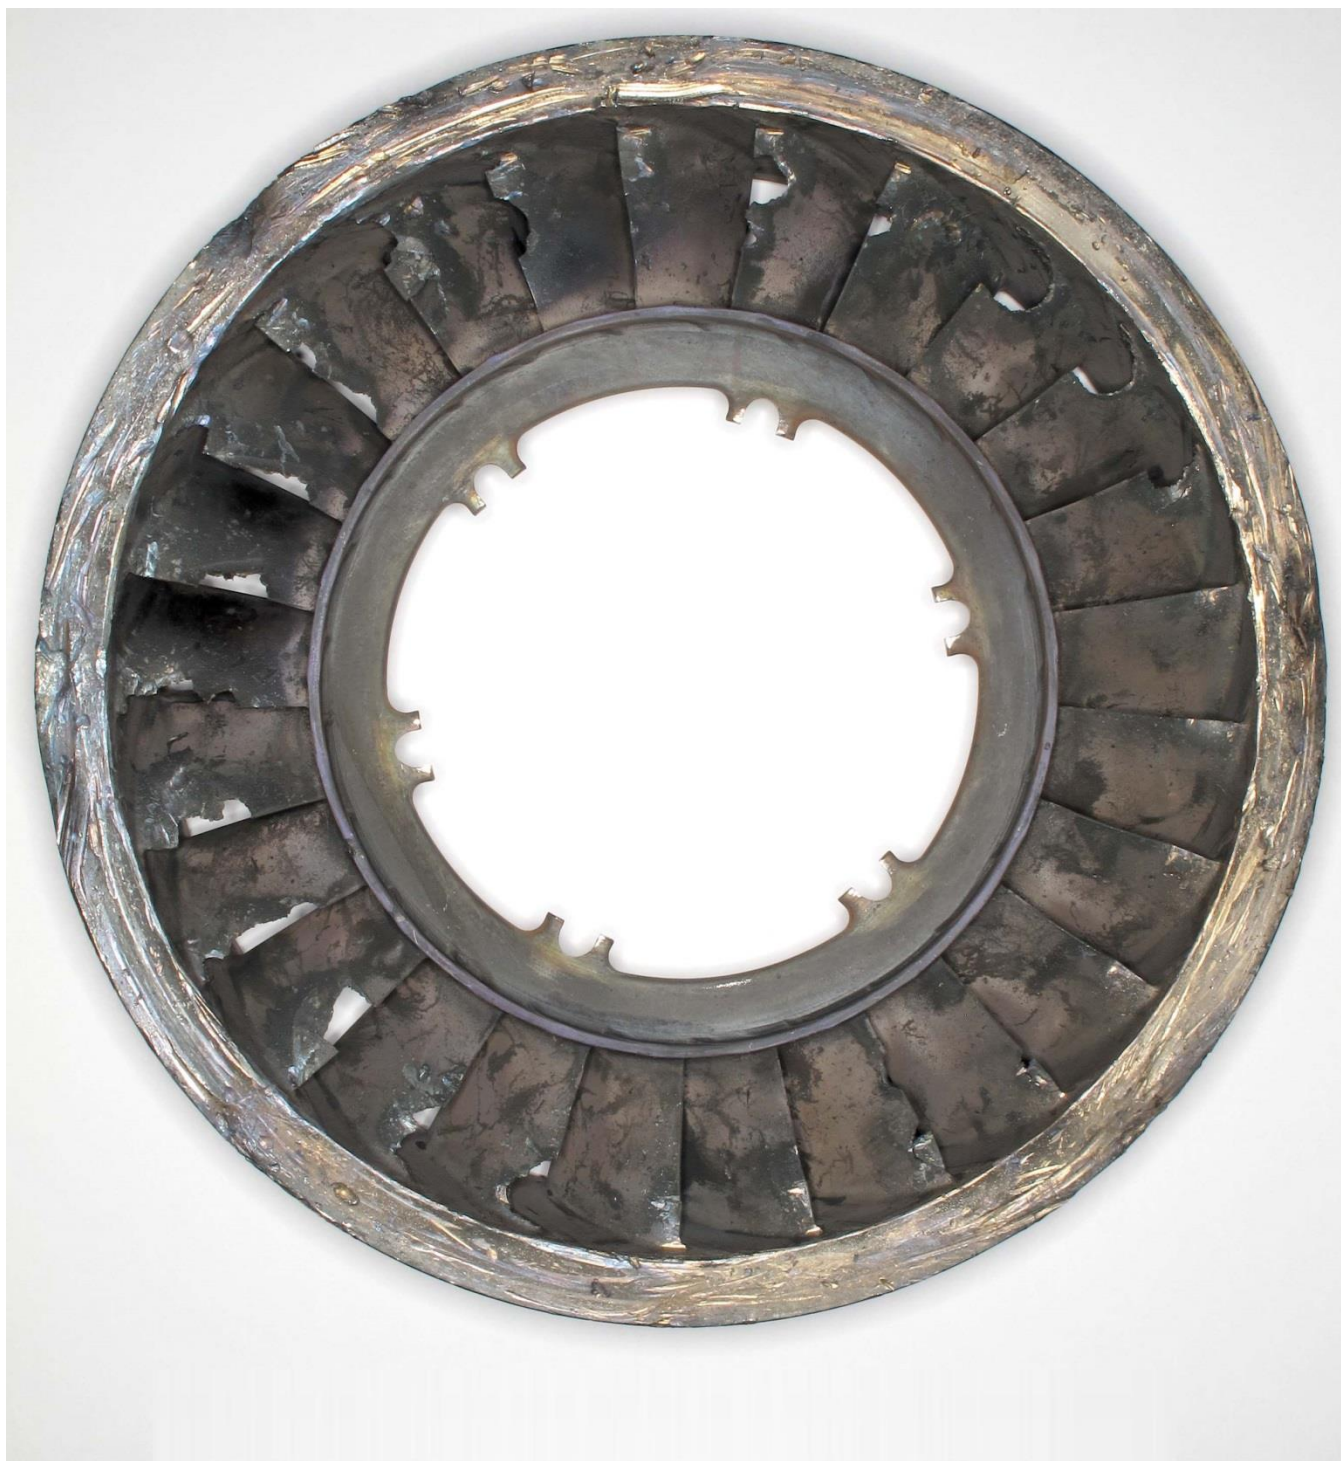
**Figure 45. Forward looking aft view of the third stage turbine nozzle showing the damage to the trailing edge vane surfaces.**

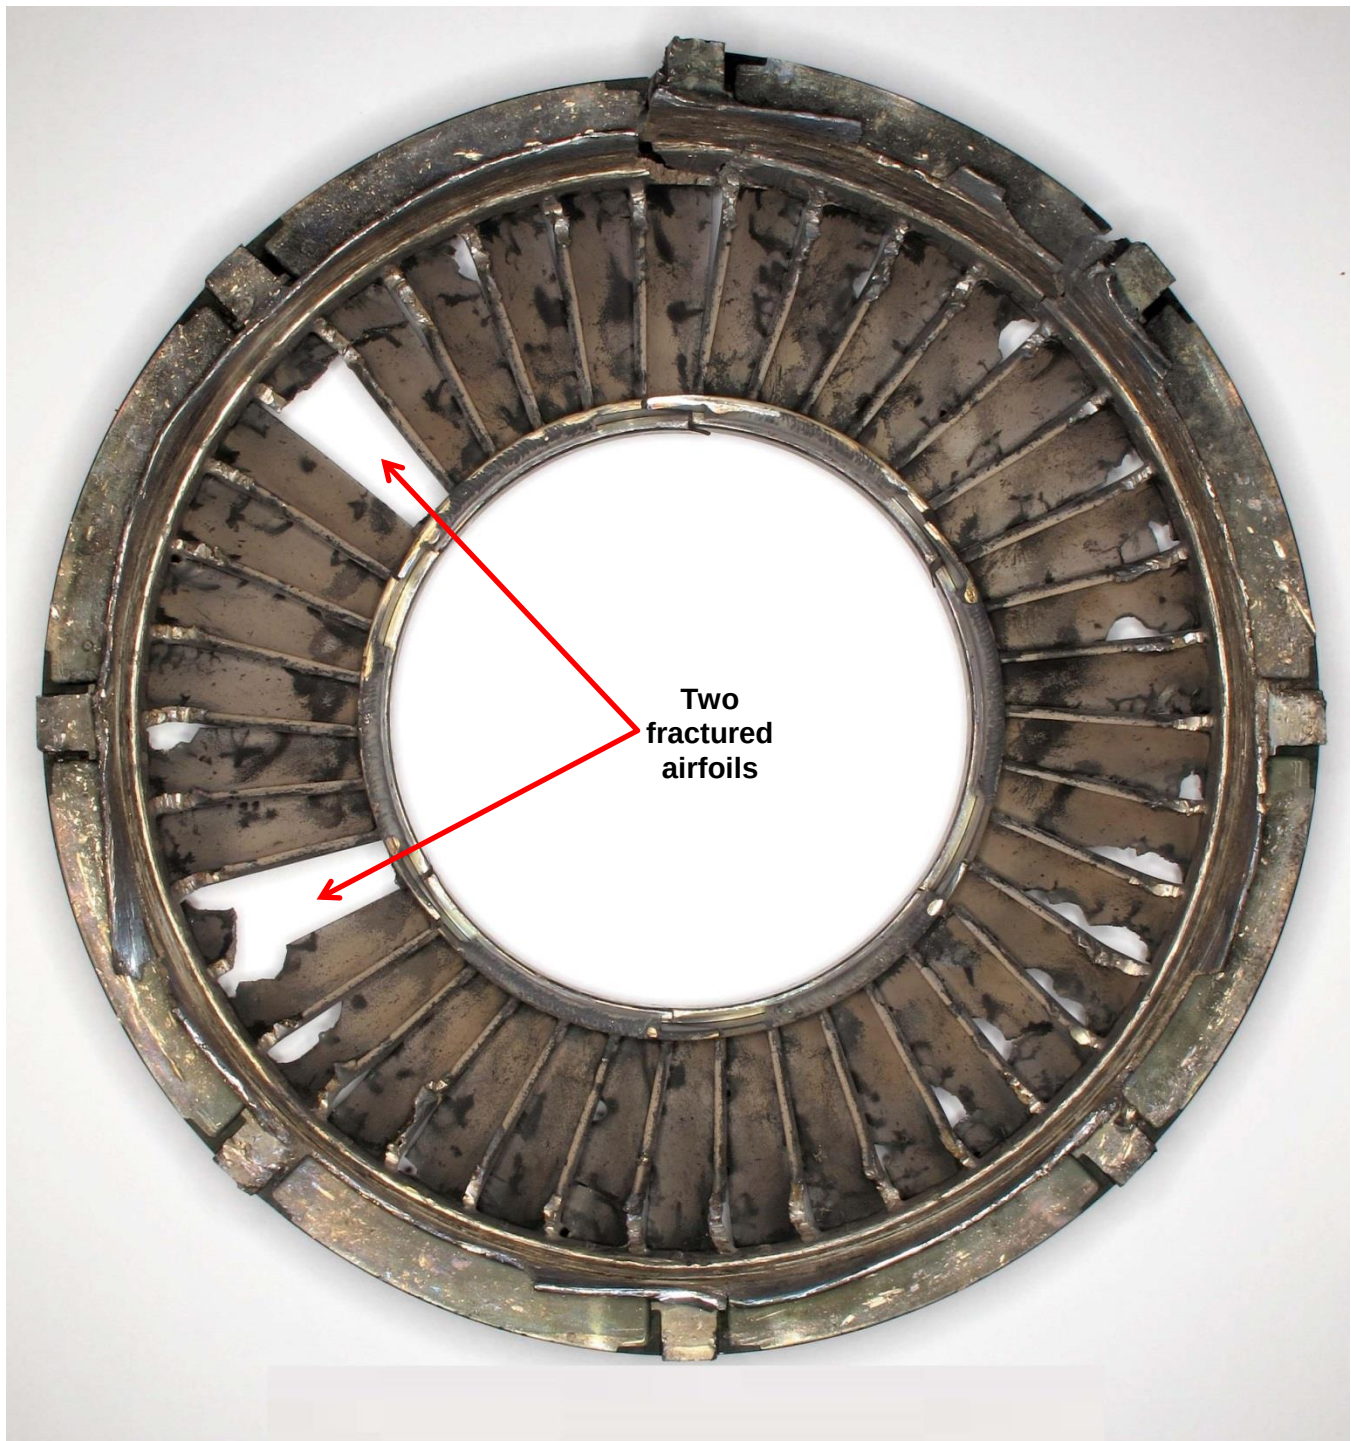
Figure 46 and Figure 47 show leading edge (aft looking forward) and trailing edge (forward looking aft) views of the fourth stage turbine nozzle assembly respectively. Two airfoils were missing and examination of the fracture surfaces revealed features consistent with overload. The outboard portions of all of the leading edge surfaces were damaged and several of the trailing edge surfaces were impact damaged and material was liberated. The separated diaphragm will be discussed below.

**Figure 46. Aft looking forward view of the fourth stage turbine nozzle assembly. Note two airfoils and the diaphragm had separated from the assembly.**

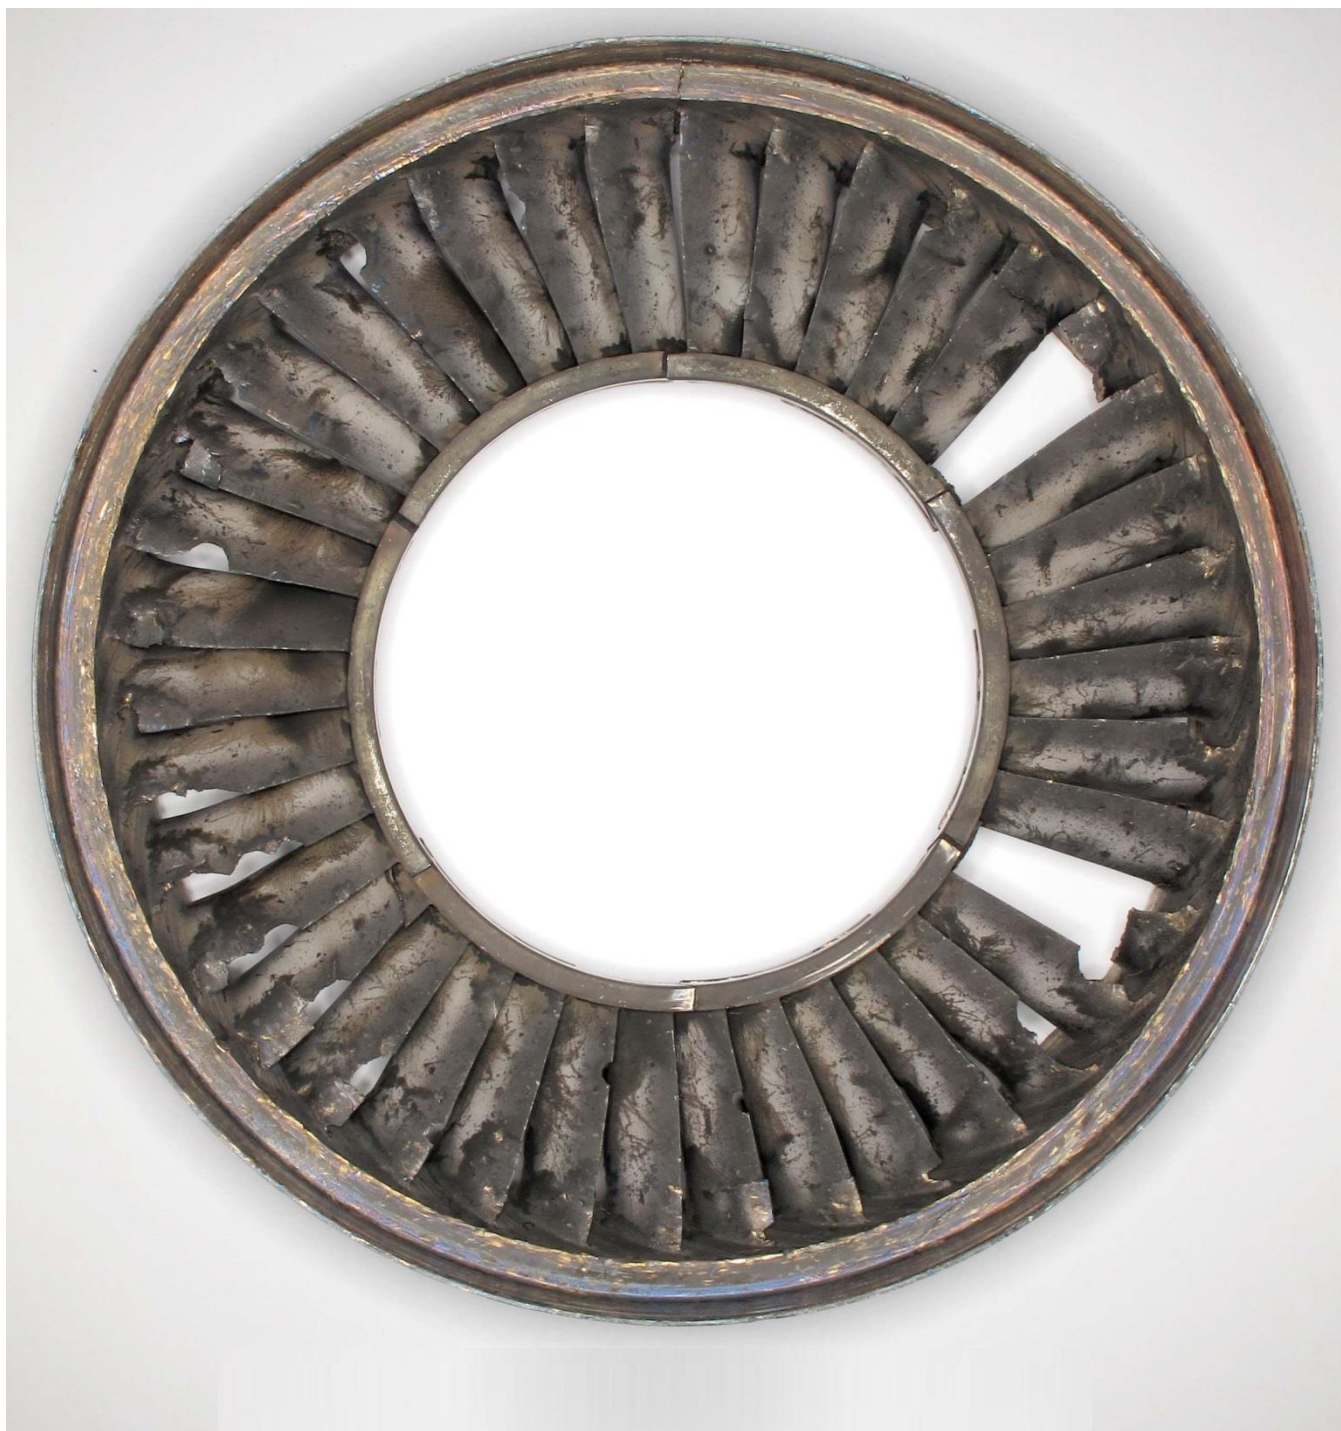
**Figure 47. Forward looking aft view of the fourth stage turbine nozzle assembly showing the damage to the vane trailing edge surfaces.**

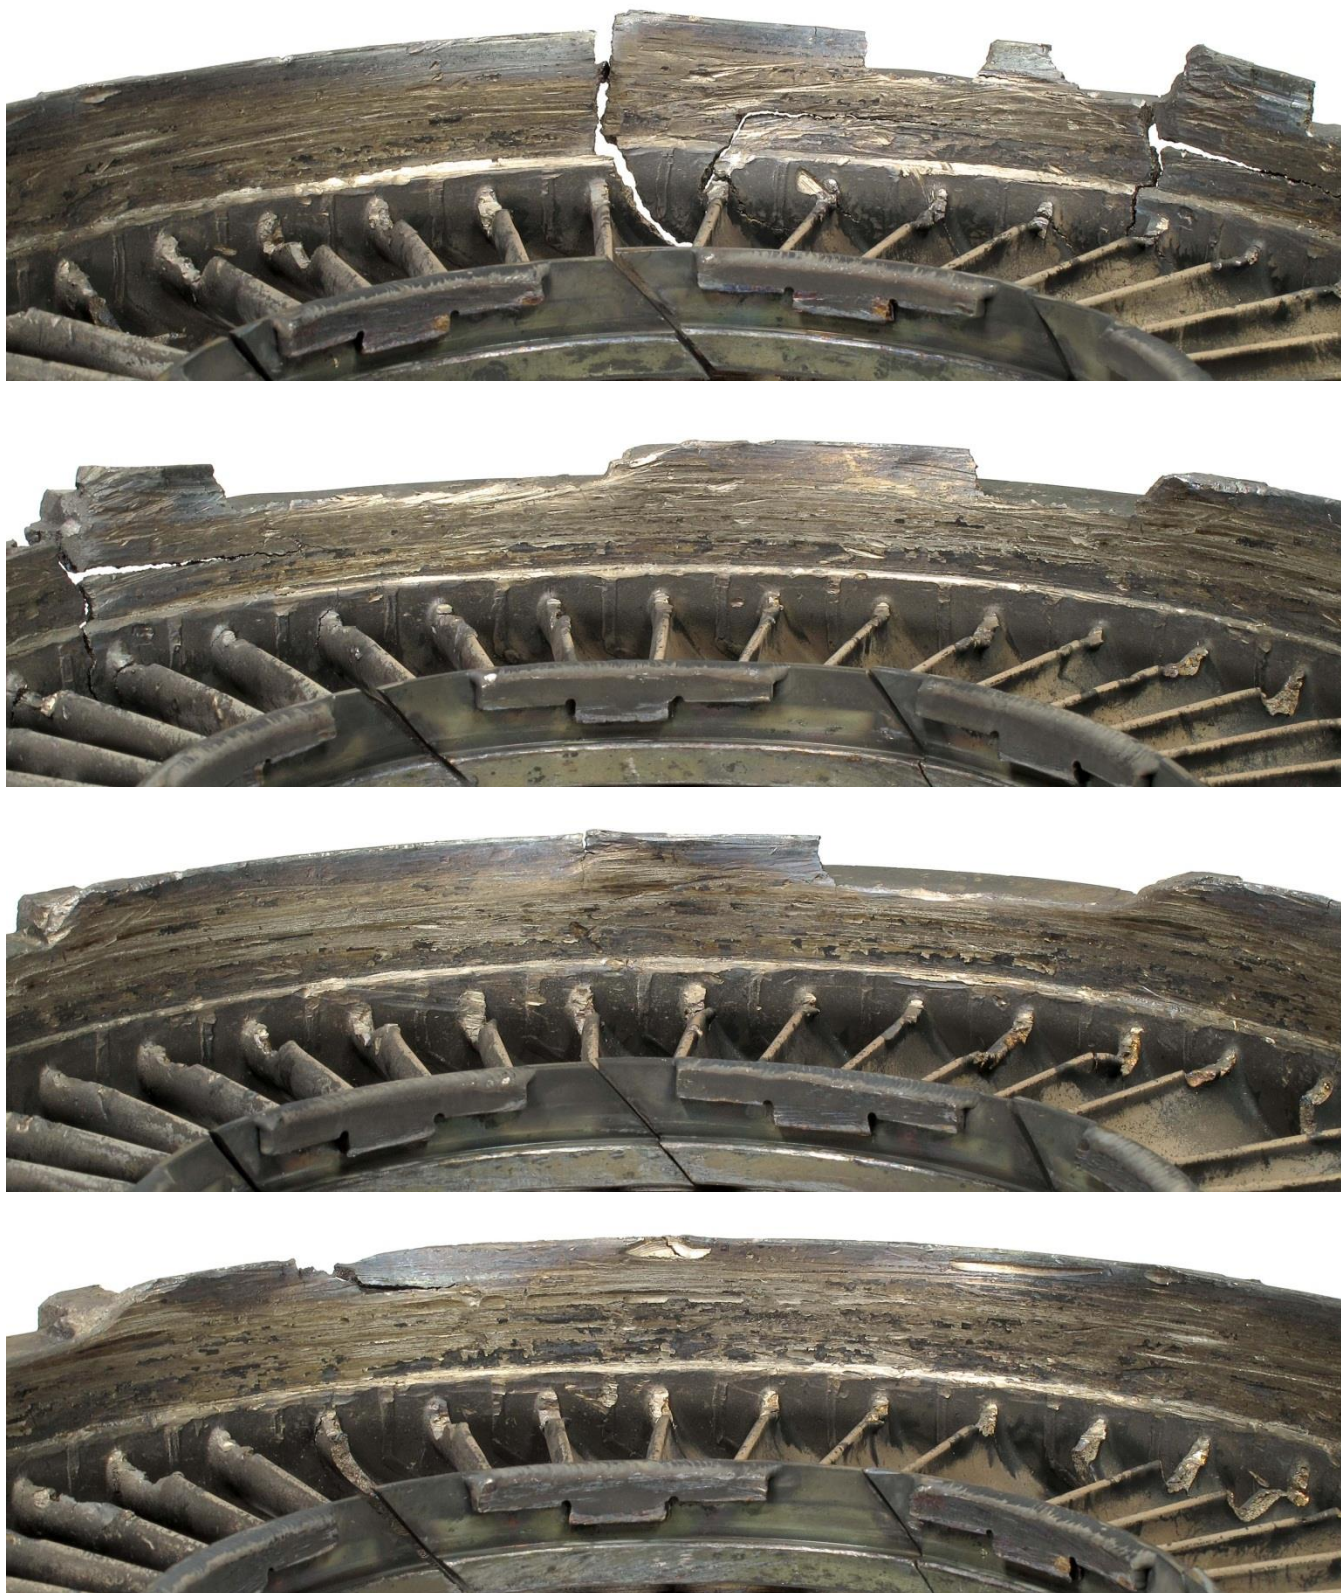
Four views of the blade track for the third stage turbine wheel are shown in Figure 48. Portions of the blade track were fractured and missing. The entire circumference of the blade track was rubbed from contact against the third stage turbine wheel shroud and knife seals.

**Figure 48. 90-degree views showing the damage to the fourth stage turbine nozzle blade track for the third stage turbine wheel.**

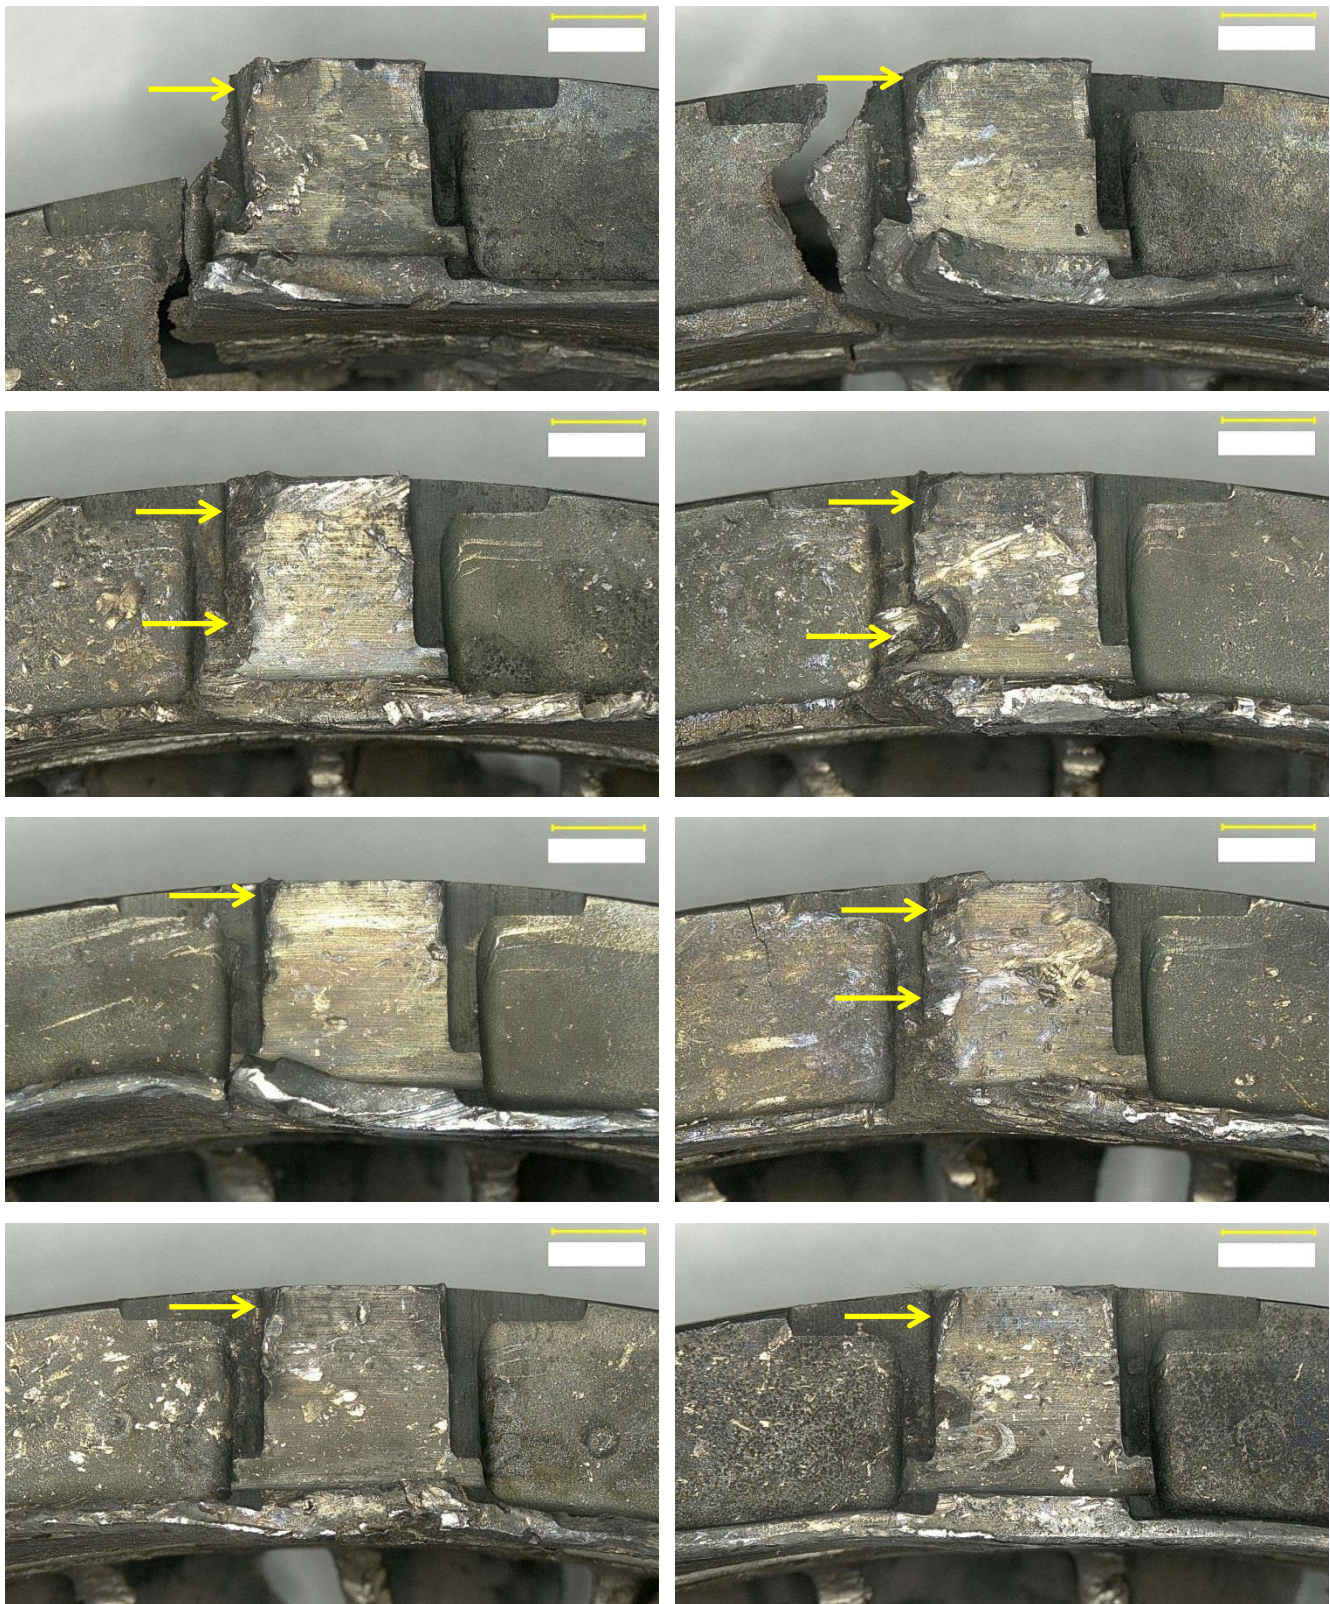
Impact damage was also observed on the eight positioning tabs around the outer diameter as illustrated in Figure 49. The damage is located on the side of the tang opposite the direction of the power turbine rotation. In addition, the diaphragm detached from the bore and is shown in Figure 50 through Figure 52.

**Figure 49. Photographs documenting the damage to the fourth stage turbine nozzle positioning tangs (arrows). Note the damage is on the side of the tang opposite the direction of the PT rotation.**

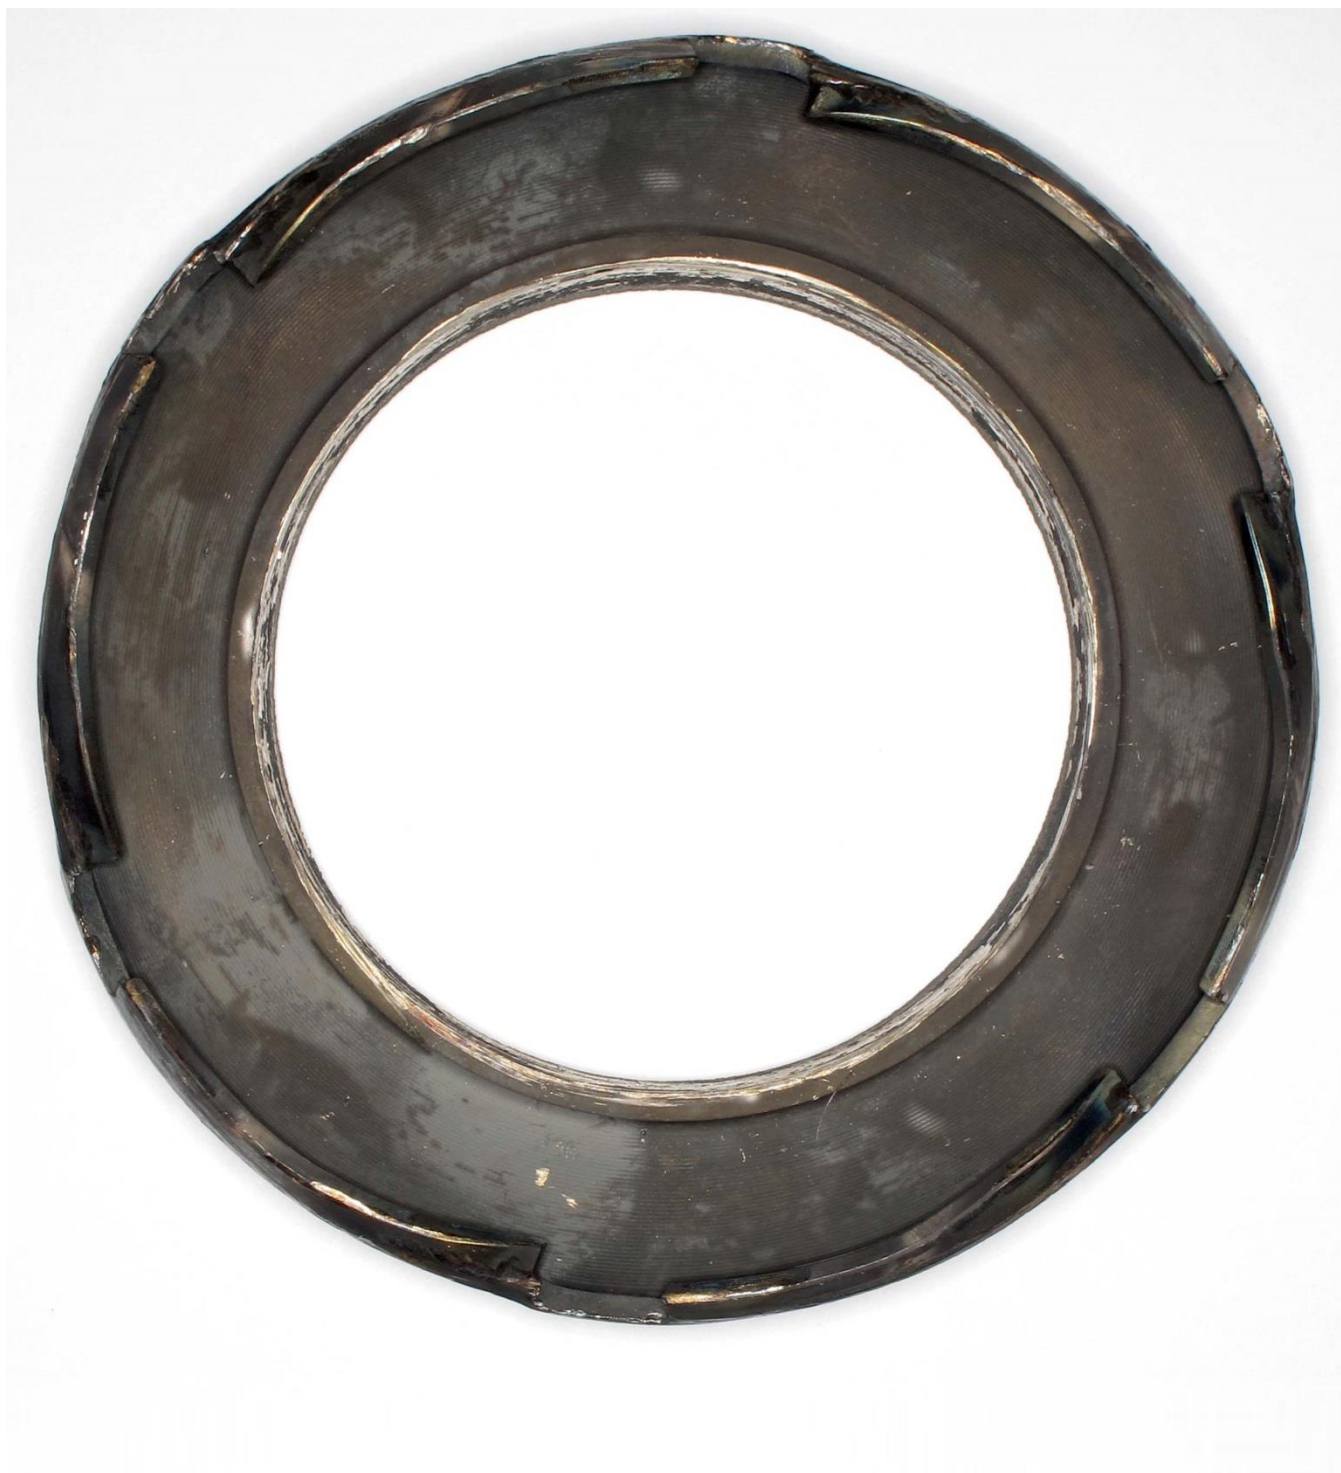
**Figure 50. Photograph of the diaphragm that detached from the bore of the fourth stage turbine nozzle (aft looking forward view).**

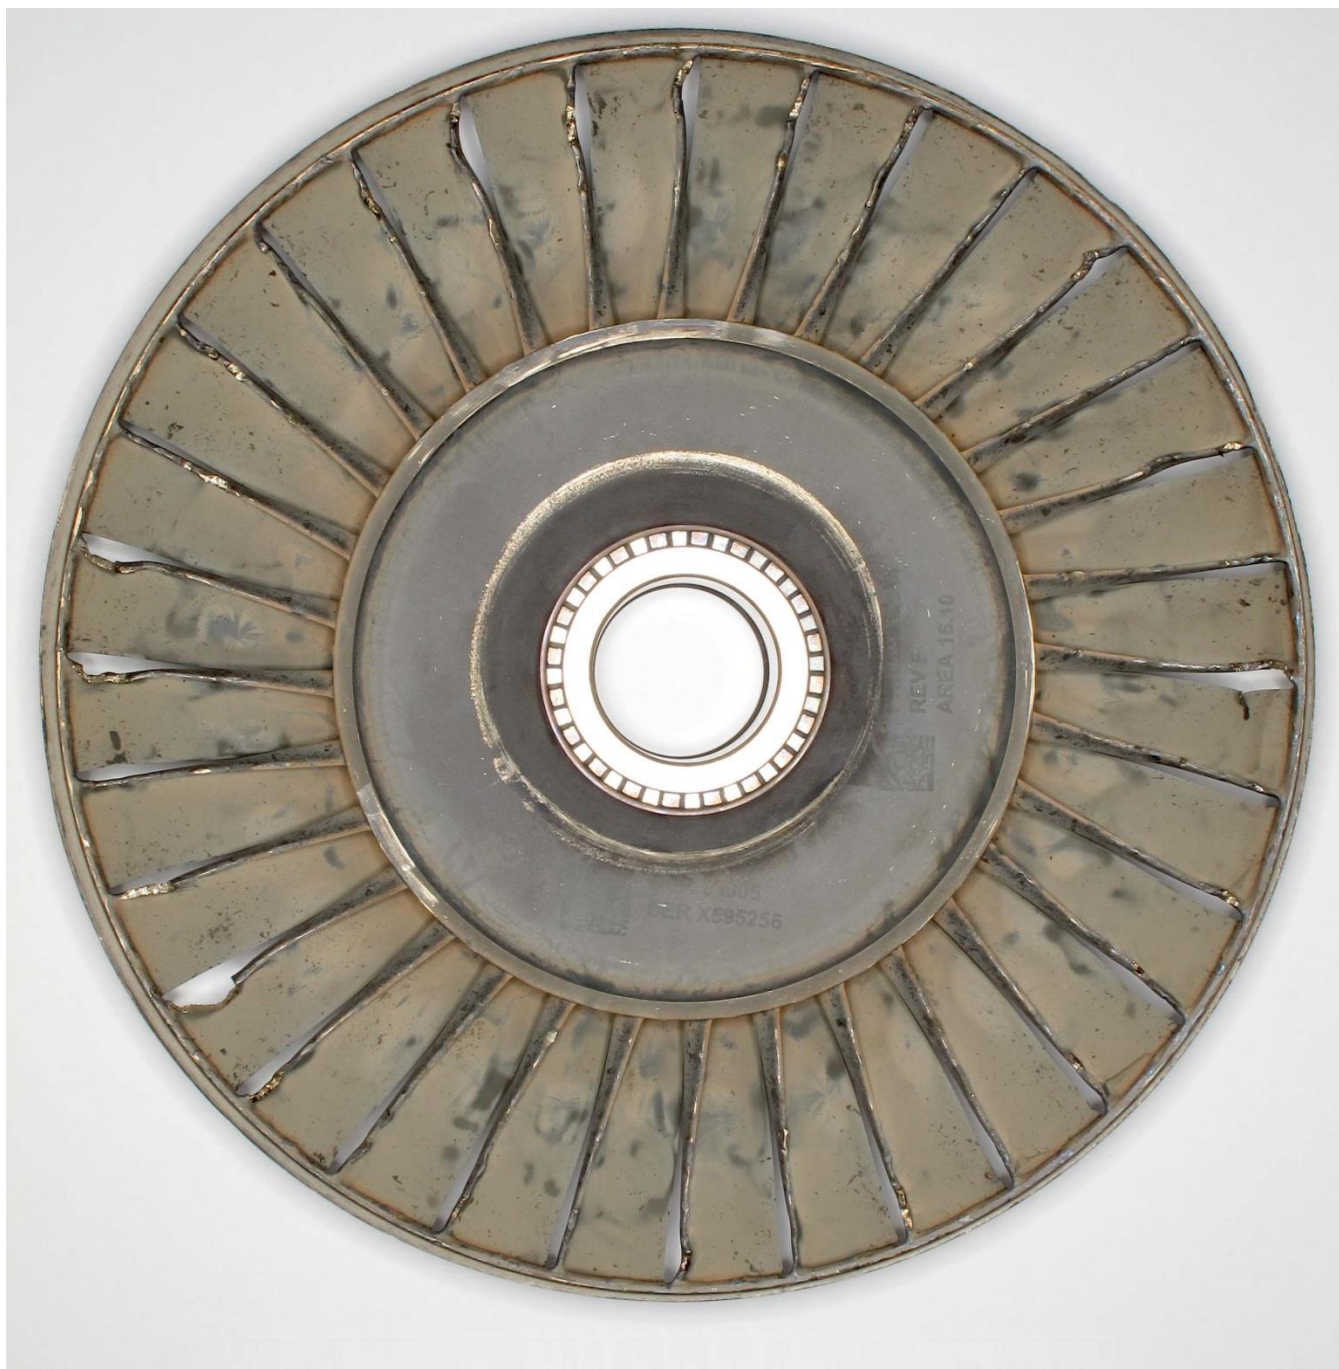
Figure 53 and Figure 54 show leading edge (aft looking forward) and trailing edge (forward looking aft) views of the fourth stage turbine wheel respectively. All of the airfoils were intact but many were impact damaged. No destructive evaluations of the fourth stage turbine wheel were conducted.

**Figure 53. Aft looking forward view of the fourth stage turbine wheel. Note the damage to the airfoil leading edge surfaces.**
