| <div style="display: inline-block; vertical-align: middle;"> Rolls-Royce Corporation<br/> P.O. Box 420<br/> Indianapolis, Indiana 46206-0420 USA </div> | | <div style="display: flex; justify-content: space-between;"> <div> PAGE<br/><b>1</b> </div> <div> OF<br/><b>83</b> </div> </div> | <div style="text-align: center;"> REPORT NO.<br/> <b>15FA8-072-PR</b> </div> |
| <b>TITLE</b><br><br>METALLURGICAL INVESTIGATION OF A THIRD STAGE TURBINE WHEEL P/N 23065818 REMOVED FROM M250-C20J ENGINE CAE832989 OPERATED BY FLY HANGAR 13 LLC. | | PREPARED<br><br><div style="text-align: center;"><i>Signatures on File</i></div> | |

**Part Name:** Third Stage Turbine Wheel  
**Part Number:** 23065818  
**Part S/N:** X597059  
**Total Part Time:** 930 Hours (TSO)  
**Engine Model:** M250-C20J  
**Engine S/N:** CAE832989  
**Removal Station:** Rolls-Royce Corporation, Indianapolis, IN.  
**User:** Fly Hangar 13 LLC

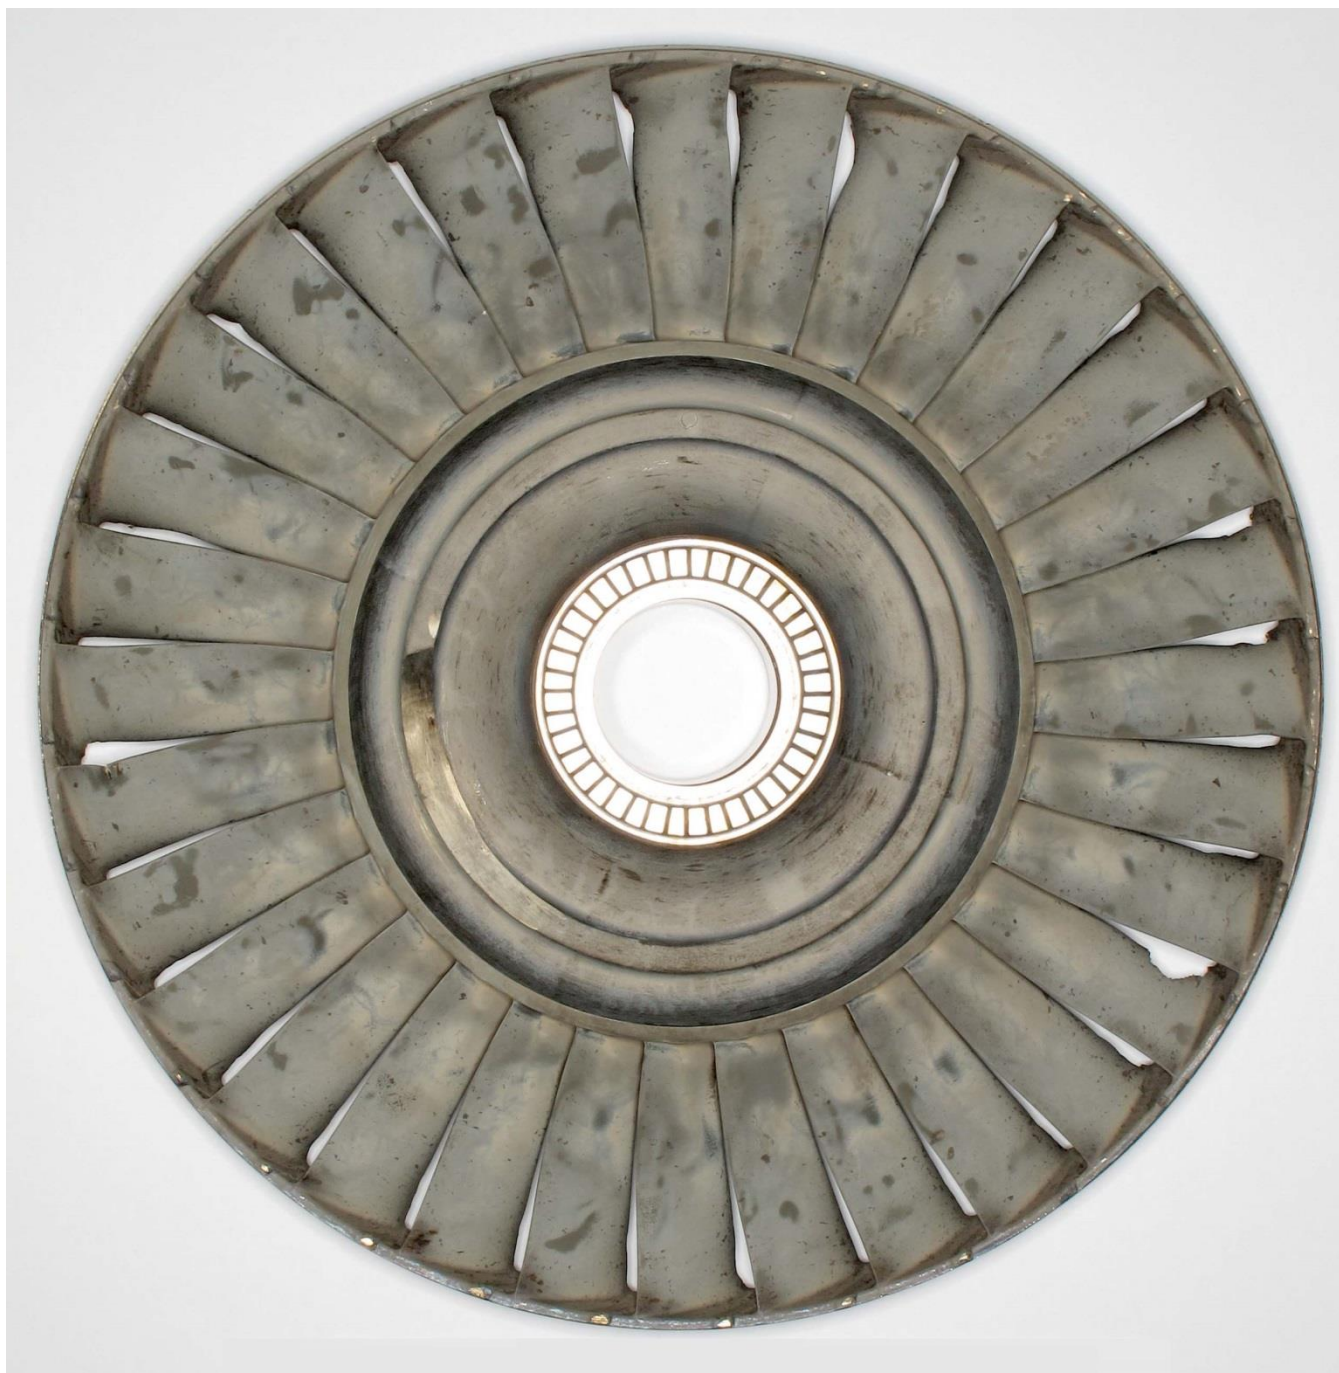
Figure 53 and Figure 54 show leading edge (aft looking forward) and trailing edge (forward looking aft) views of the fourth stage turbine wheel respectively. All of the airfoils were intact but many were impact damaged. No destructive evaluations of the fourth stage turbine wheel were conducted.

**Figure 54. Forward looking aft view of the fourth stage turbine wheel.**

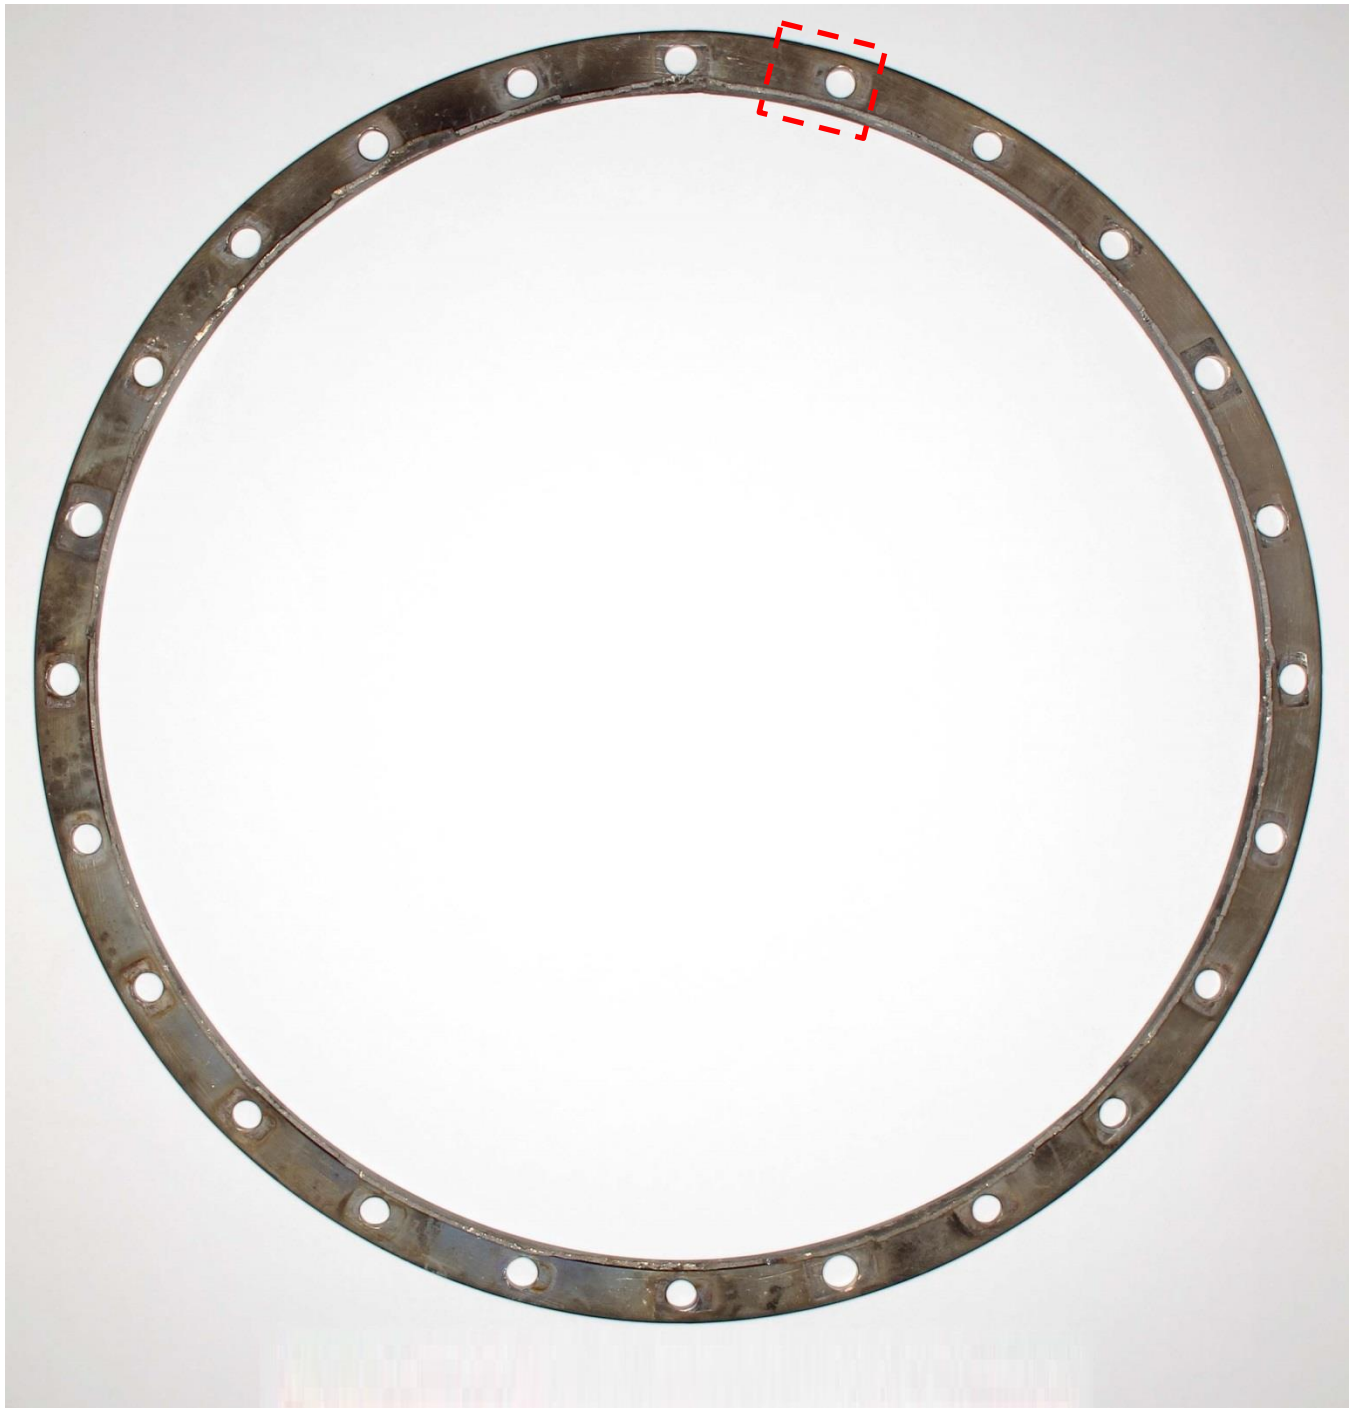
The aft flange of the exhaust collector cracked and separated and is shown in Figure 55. Representative photographs of the fracture are shown in Figure 56. The fracture features were consistent around the circumference and were indicative of overload.

**Figure 55. Forward looking aft view of the fractured exhaust collector flange. Detailed photographs of the boxed area are shown in the following figures.**

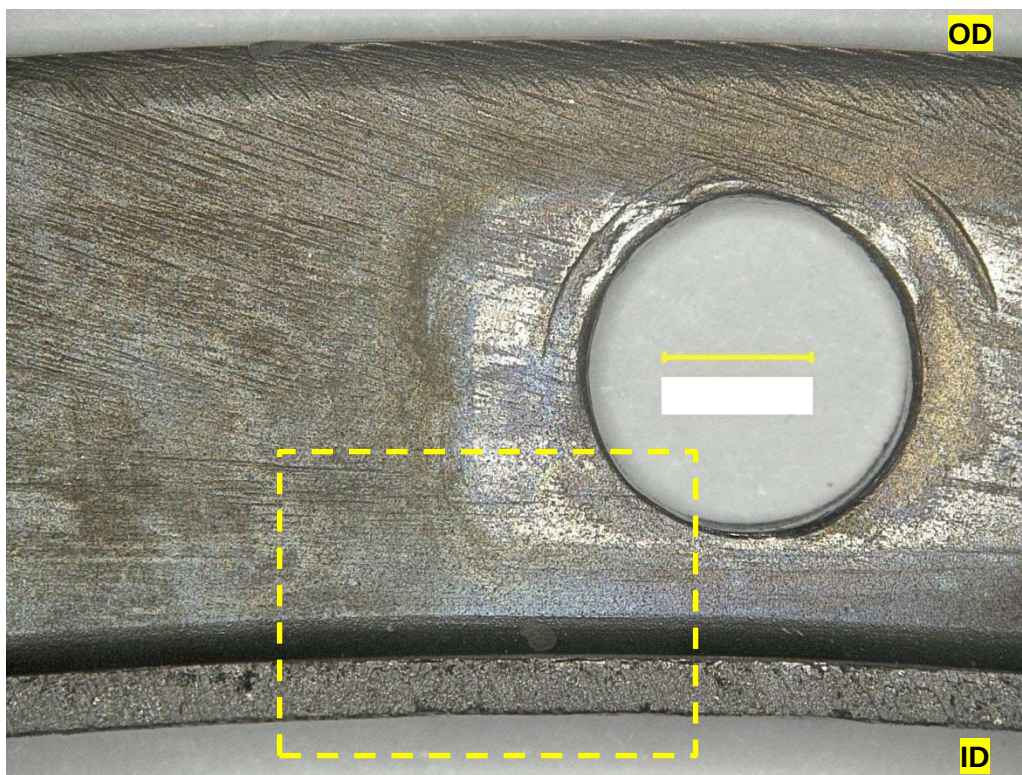
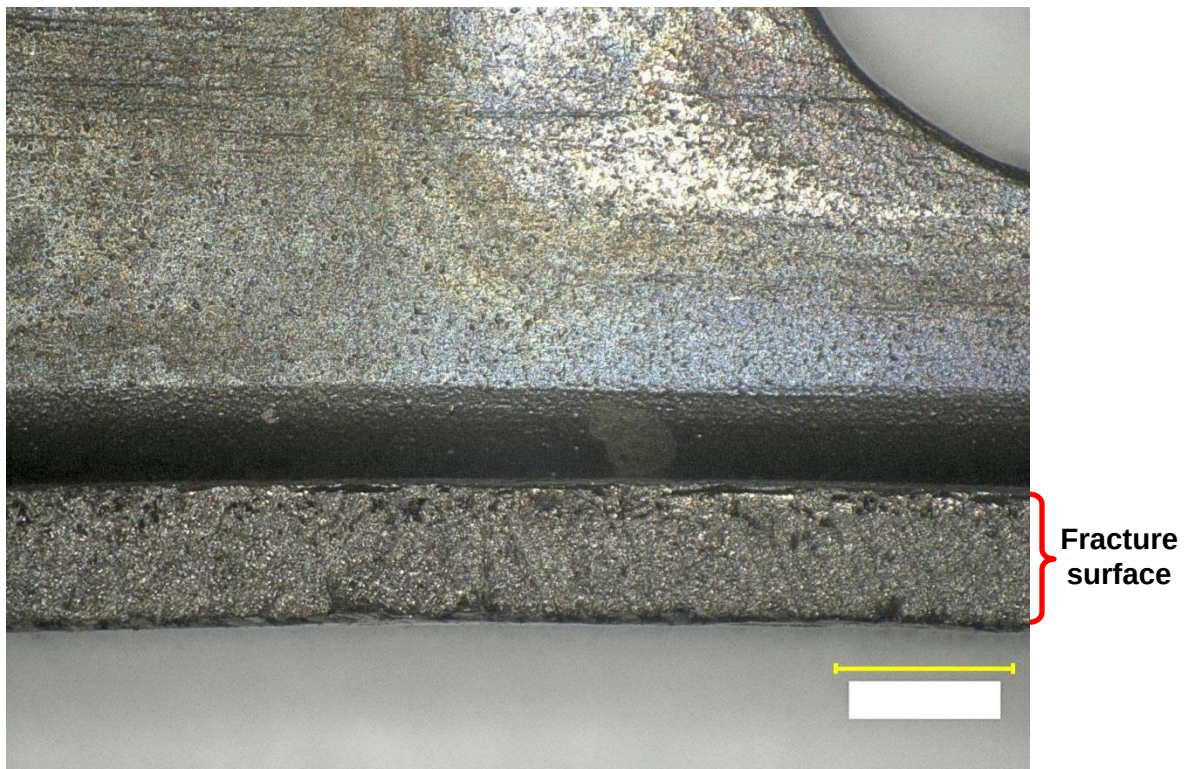
**Figure 56. Photographs of a representative area around the circumference of the fractured exhaust collector flange.**

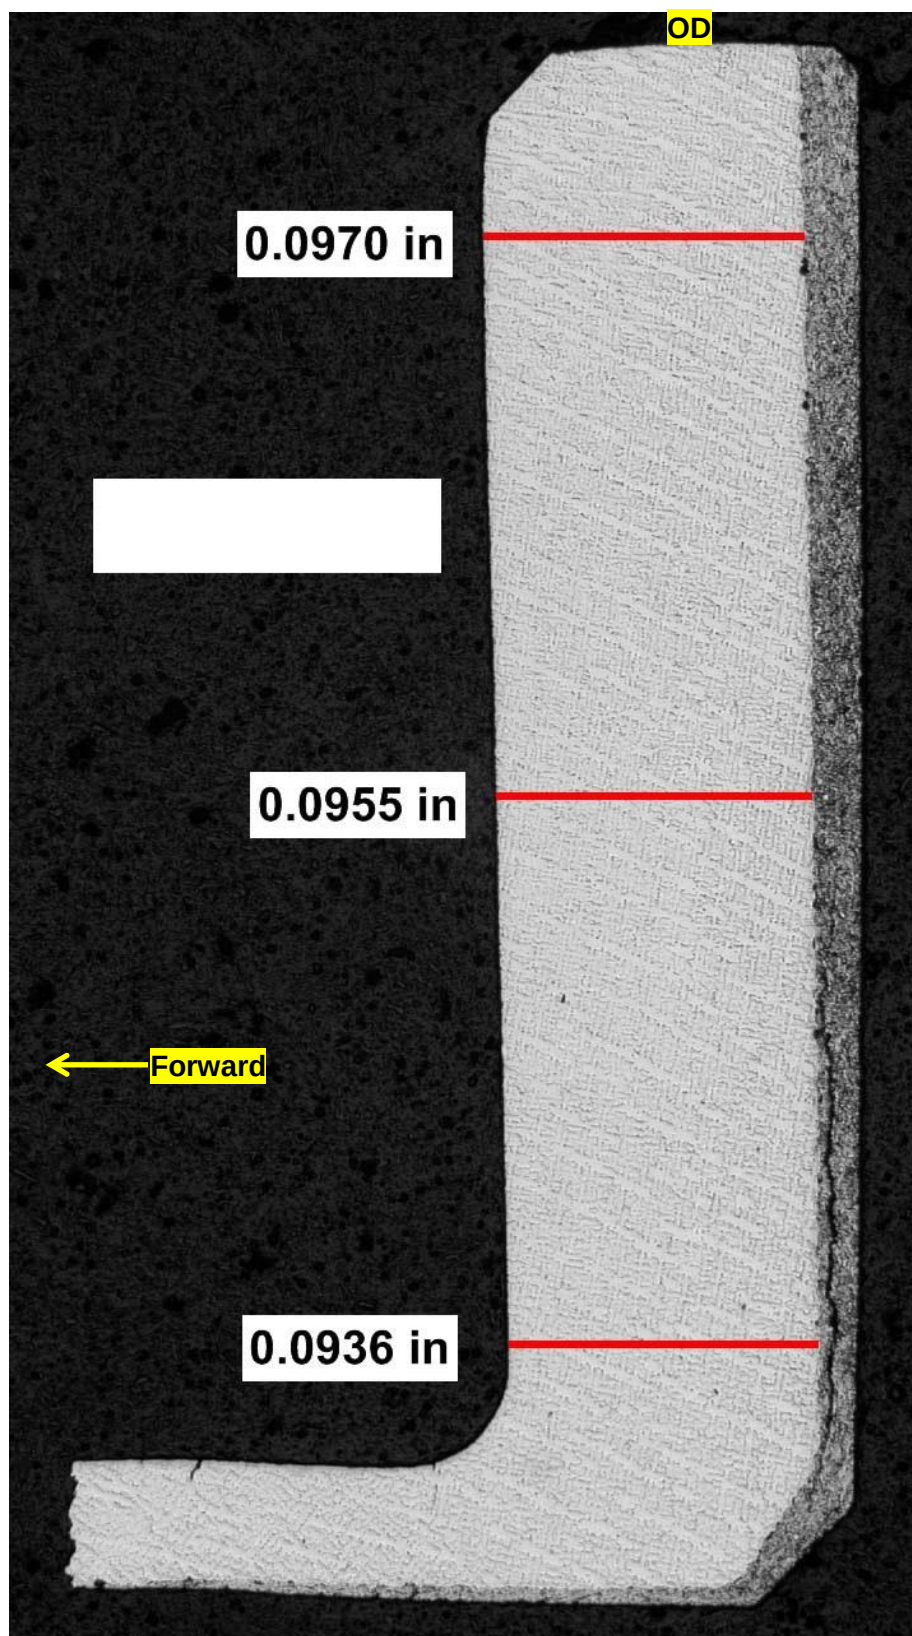
A cross-section through the flange is shown in Figure 59. The aft surface and ID surface of the flange had been dimensionally restored with thermal spray. The parent material in the flange wall was slightly tapered and measured 0.0936 inch thick near the inboard portion of the flange and 0.0970 inch thick near the outer diameter. The ID wall thickness was also tapered and measured 0.0347 inch near the fracture and 0.0370 inch thick adjacent to the flange fillet radius. A representative photograph of the thermal spray microstructure is shown in the lower image in Figure 60. There were a few cracks in the thermal spray coating and along the OD surface of the wall, forward of the flange.

**Figure 59. Cross-section through the fractured exhaust collector flange showing the thermal spray dimensional restoration of the bolted flange surface and ID surface.**

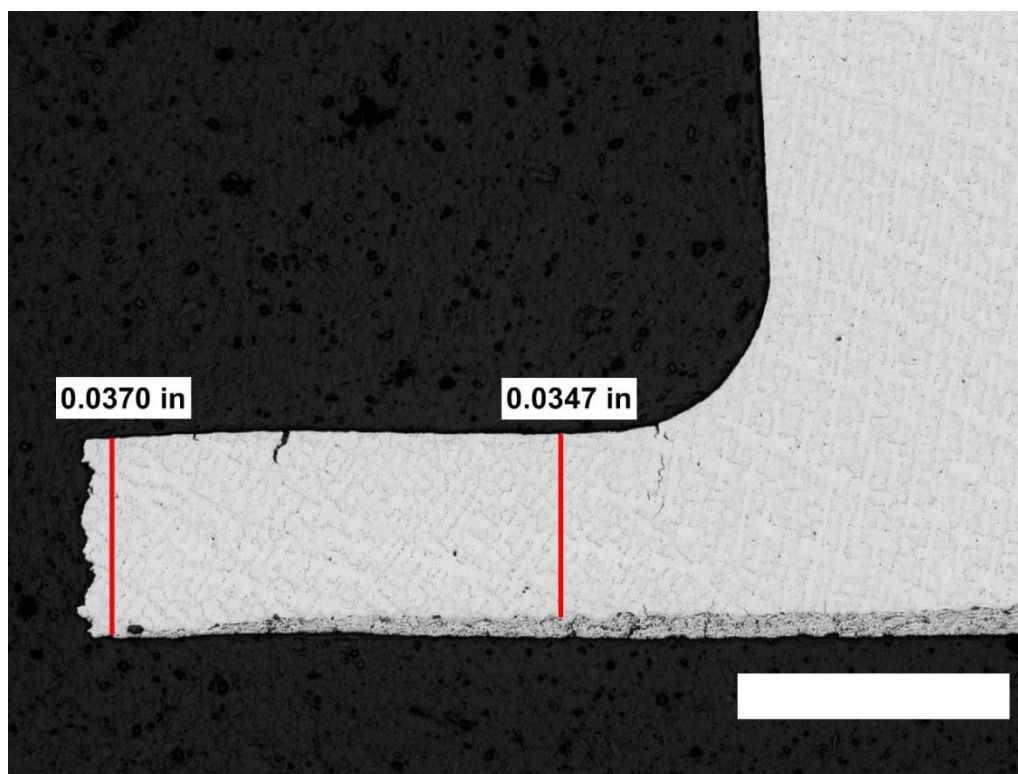
**Figure 60.** The upper photograph shows the wall thickness of the exhaust collector dash 2 detail. The lower photograph shows a representative photograph of the thermal spray material used for dimensional restoration.

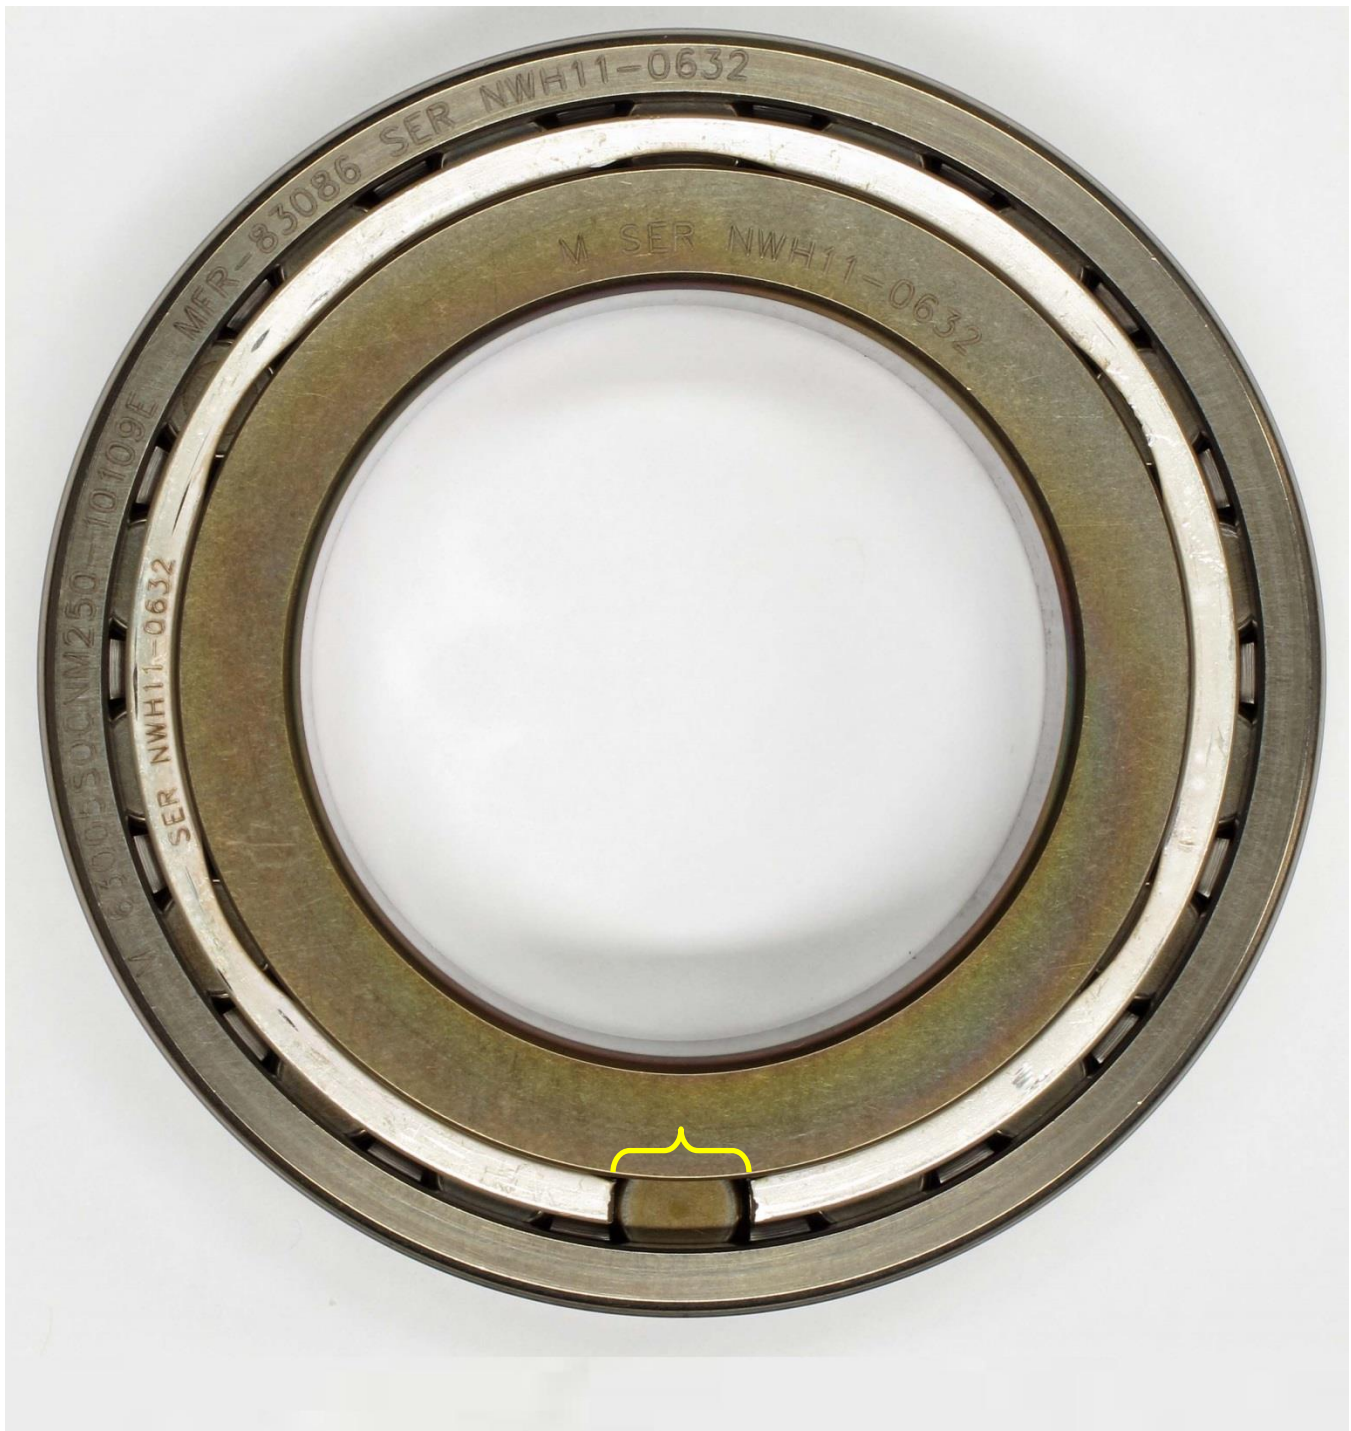
The No. 4 bearing was removed from the pinion gear as shown in Figure 61. End views of the bearing (Figure 62 and Figure 63) revealed the separator was fractured and the aft side end wall from one of the aft pockets liberated (Figure 62). The liberated section was one of the six (6) scalloped pocket that was slightly smaller (radial thickness) than in other areas. This fractured and liberated section was recovered. The forward side rail was also cracked at the same pocket location (Figure 63), but was not liberated. The OD surface of the outer ring exhibited circumferential score marks (Figure 64).

**Figure 62.** Aft looking forward view of the No. 4 bearing. The bracket highlights the portion of the separator that fractured.

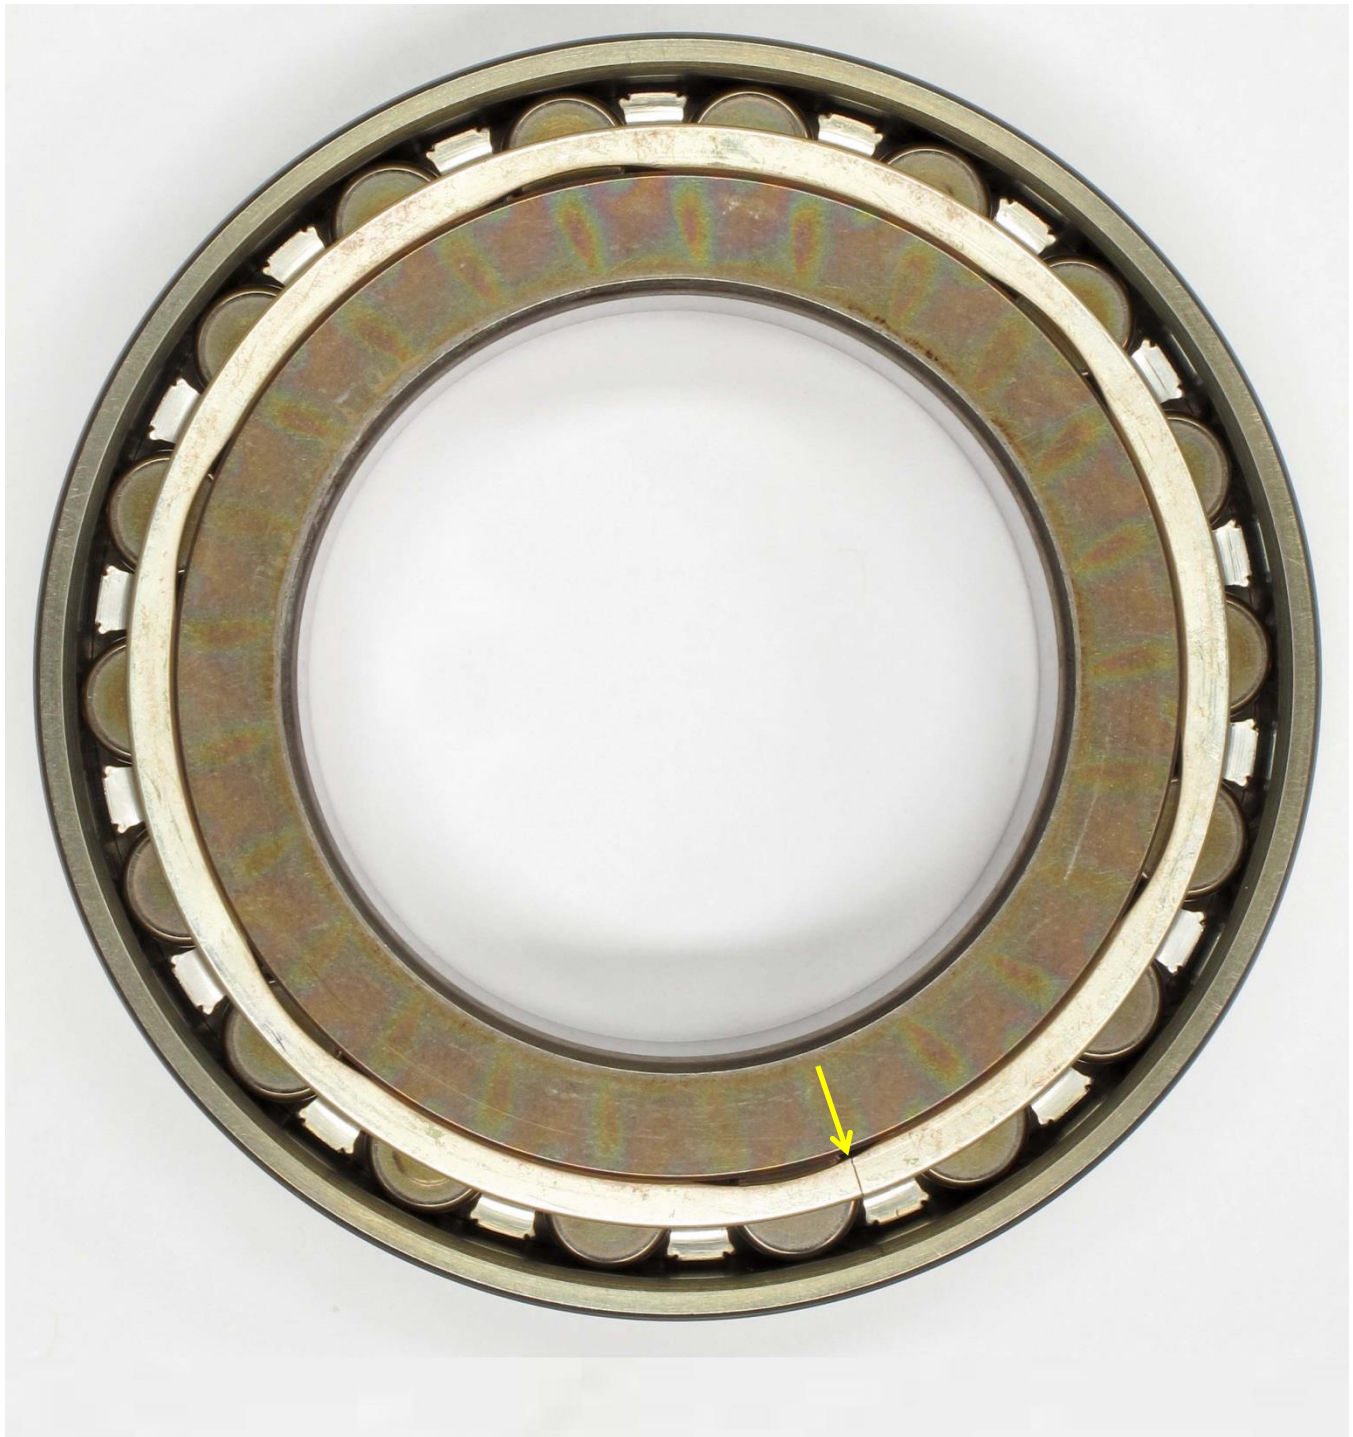
**Figure 63. Forward looking aft view of the No. 4 bearing. The arrow points to a crack in the separator that aligns with the mission section shown in the previous figure.**

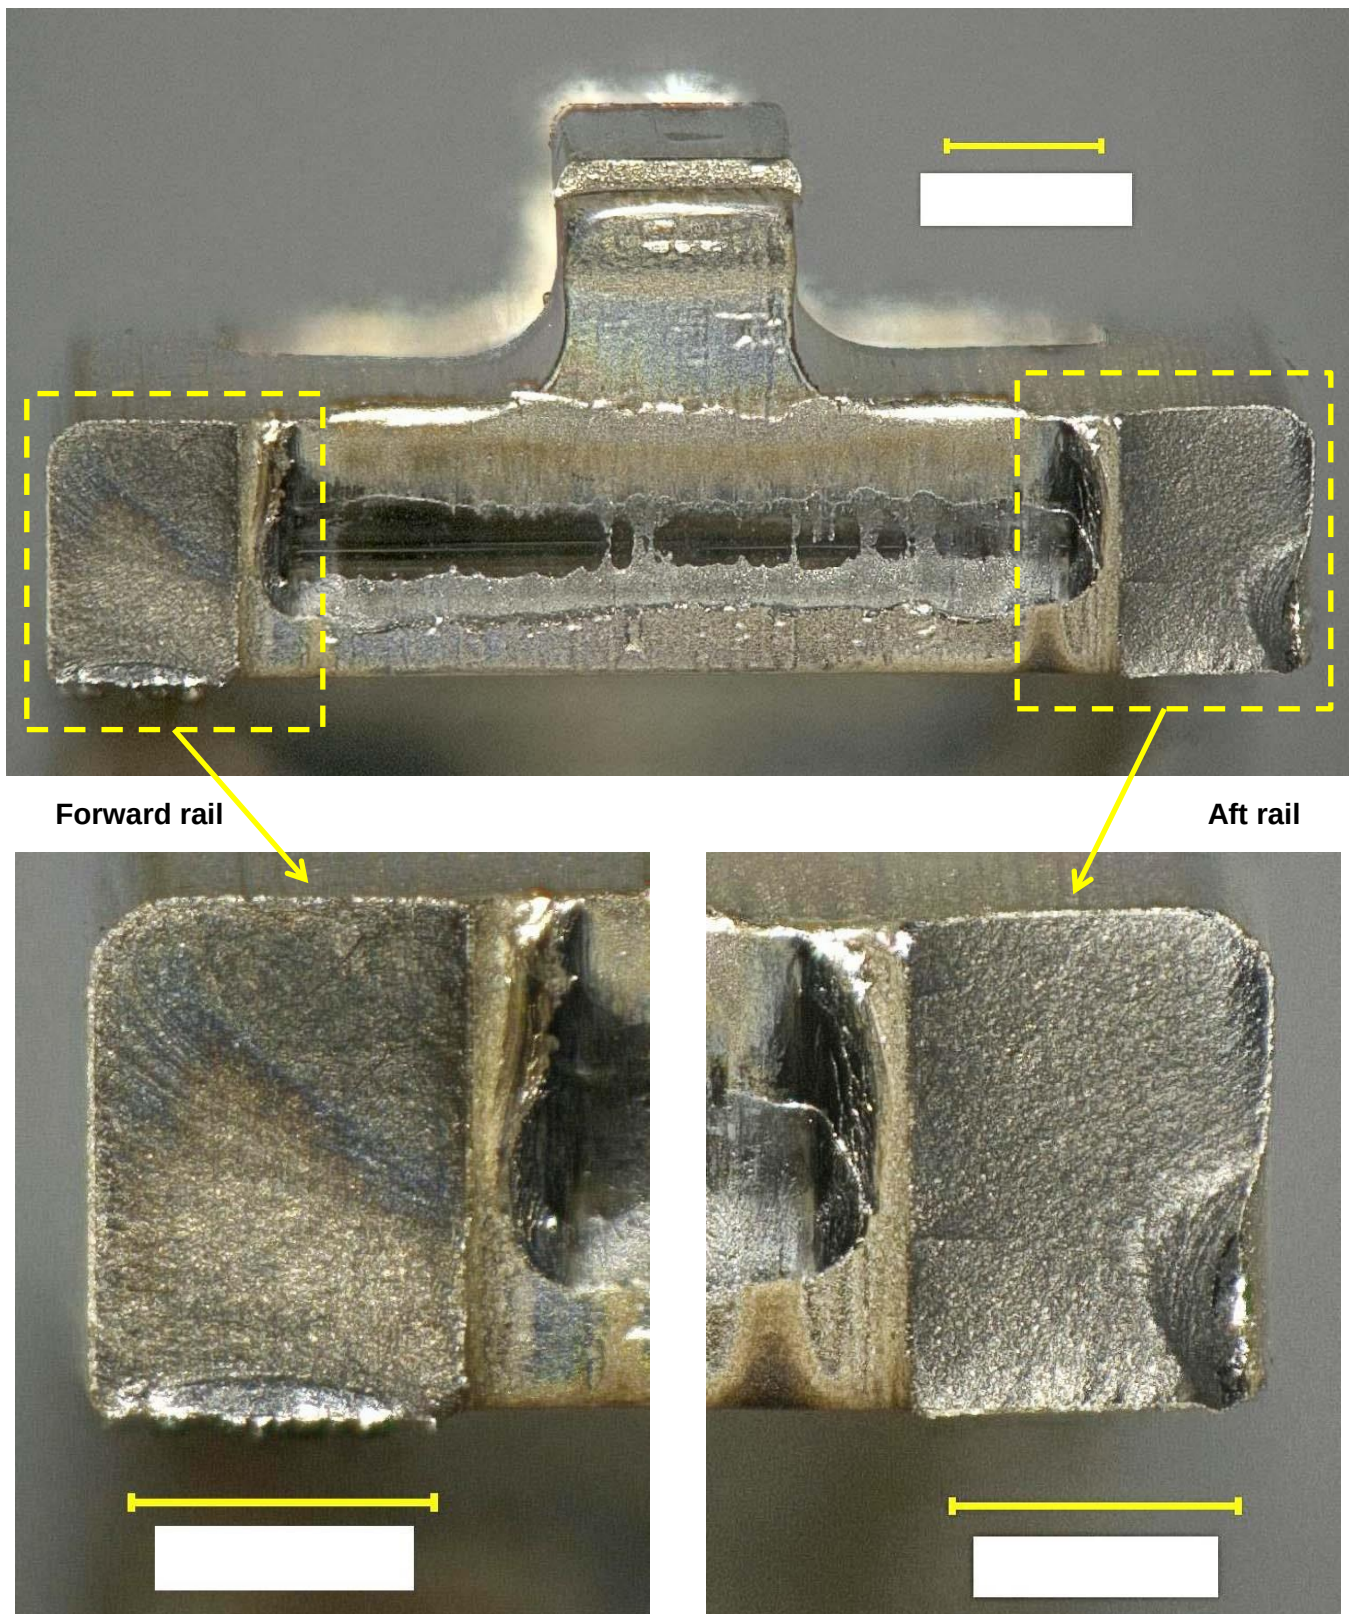
The bearing was disassembled and the separator fractures are shown in Figure 65 and Figure 66. The fracture showed beach marks consistent with fatigue progression. Detailed fractographic evaluations of the fractures were not conducted.

Figure 65. Photographs documenting the No. 4 bearing separator fractures.

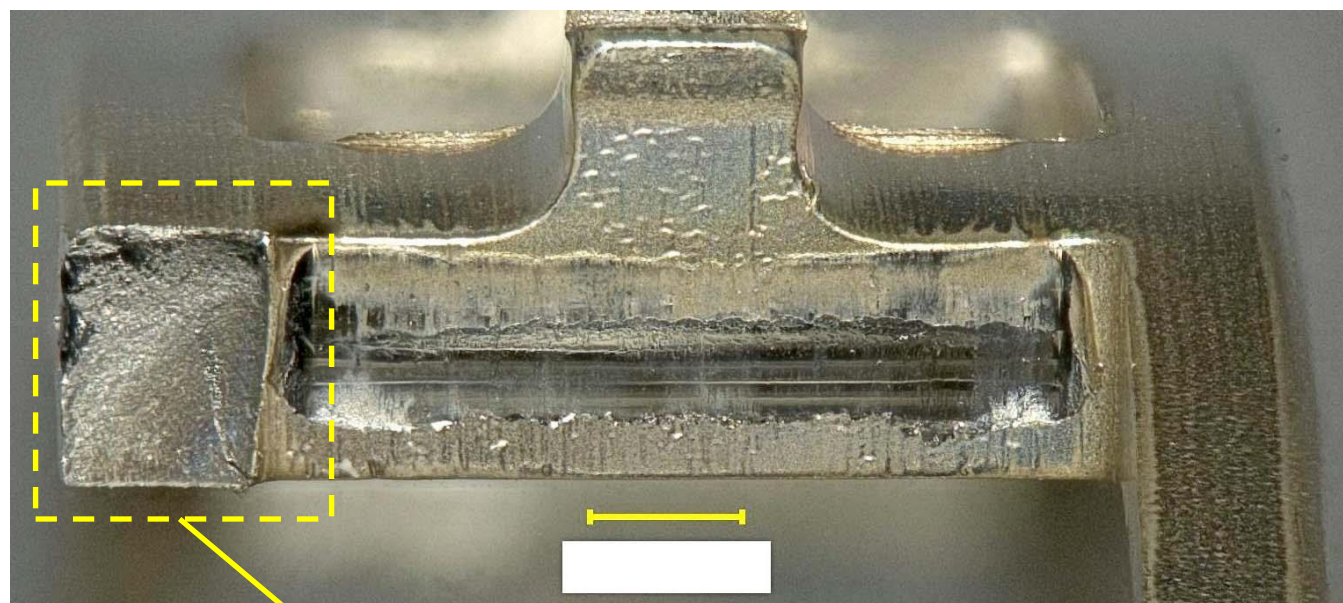
Figure 66. Photographs documenting the No. 4 bearing separator fractures.

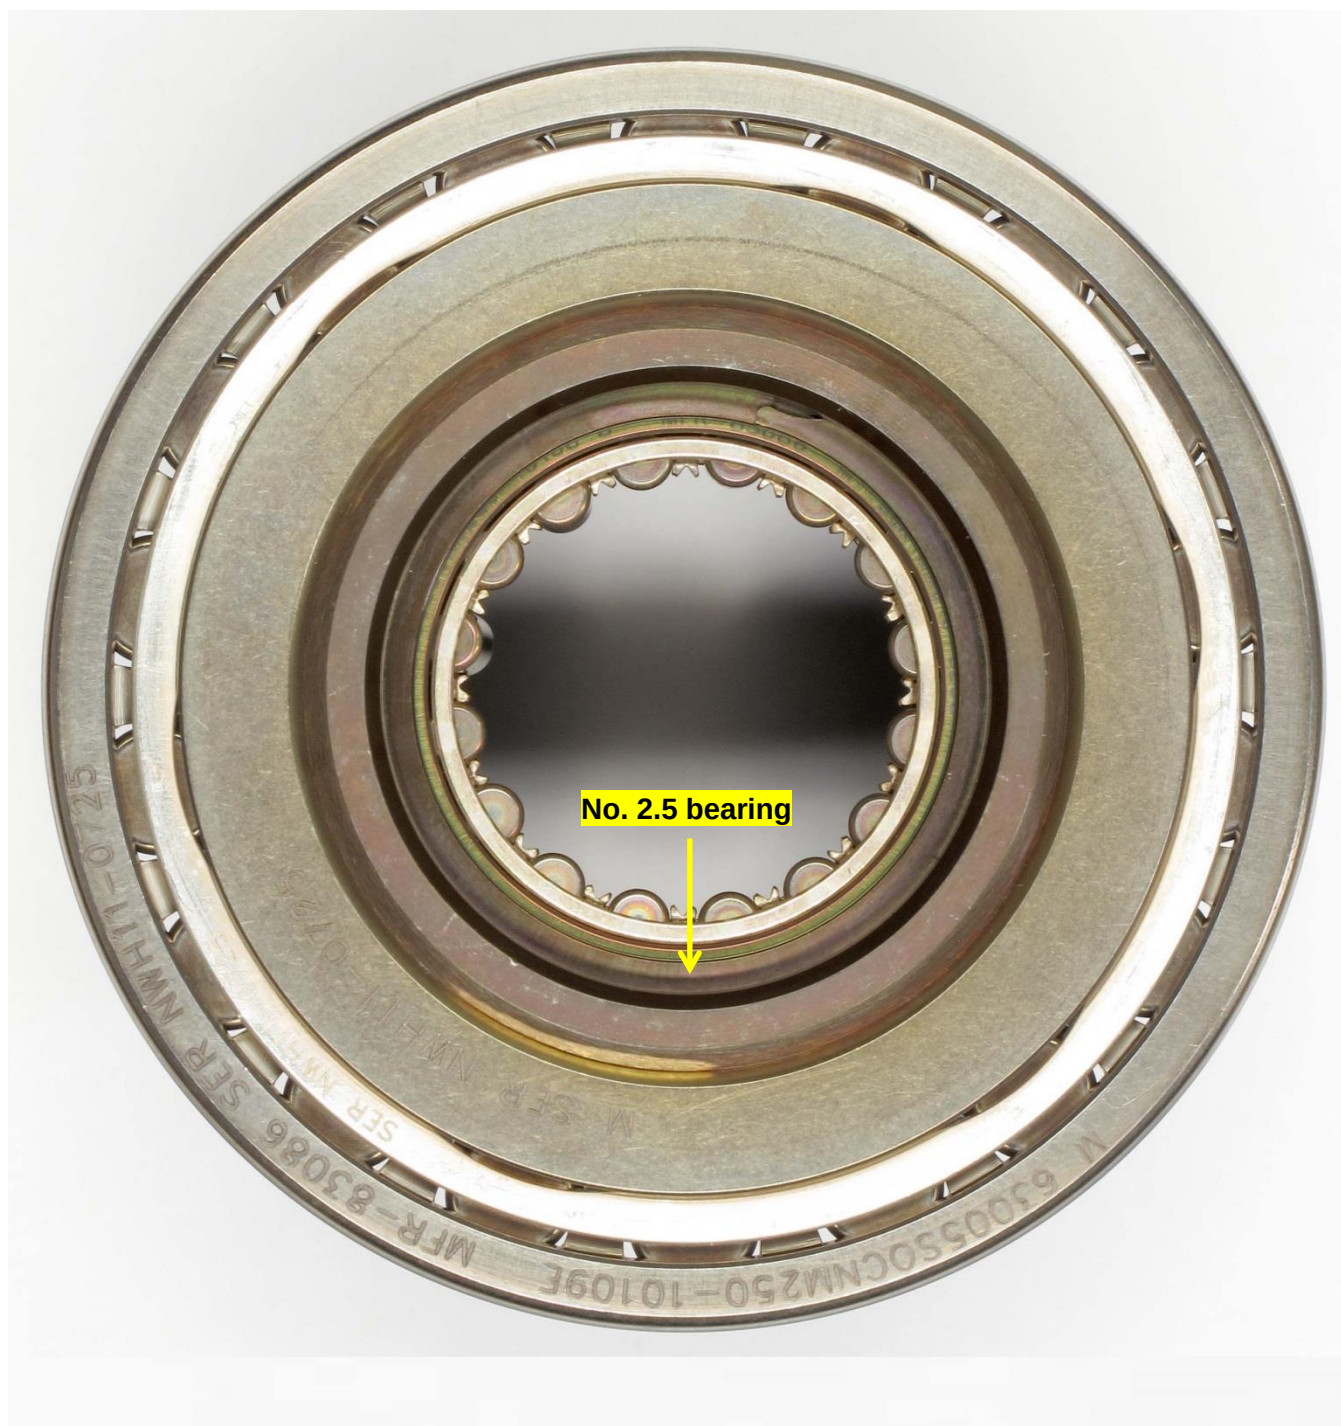
A forward looking aft view of the No. 3 bearing still installed on the pinion gear is shown in Figure 67. Also shown is the No 2 ½ bearing in the center of the pinion gear. No cracks were observed on either side of the separator and no score marks were seen on the outer ring OD (Figure 68). No destructive evaluations of the No. 3 bearing were conducted.

**Figure 67. Forward looking aft view of the No. 3 bearing.**

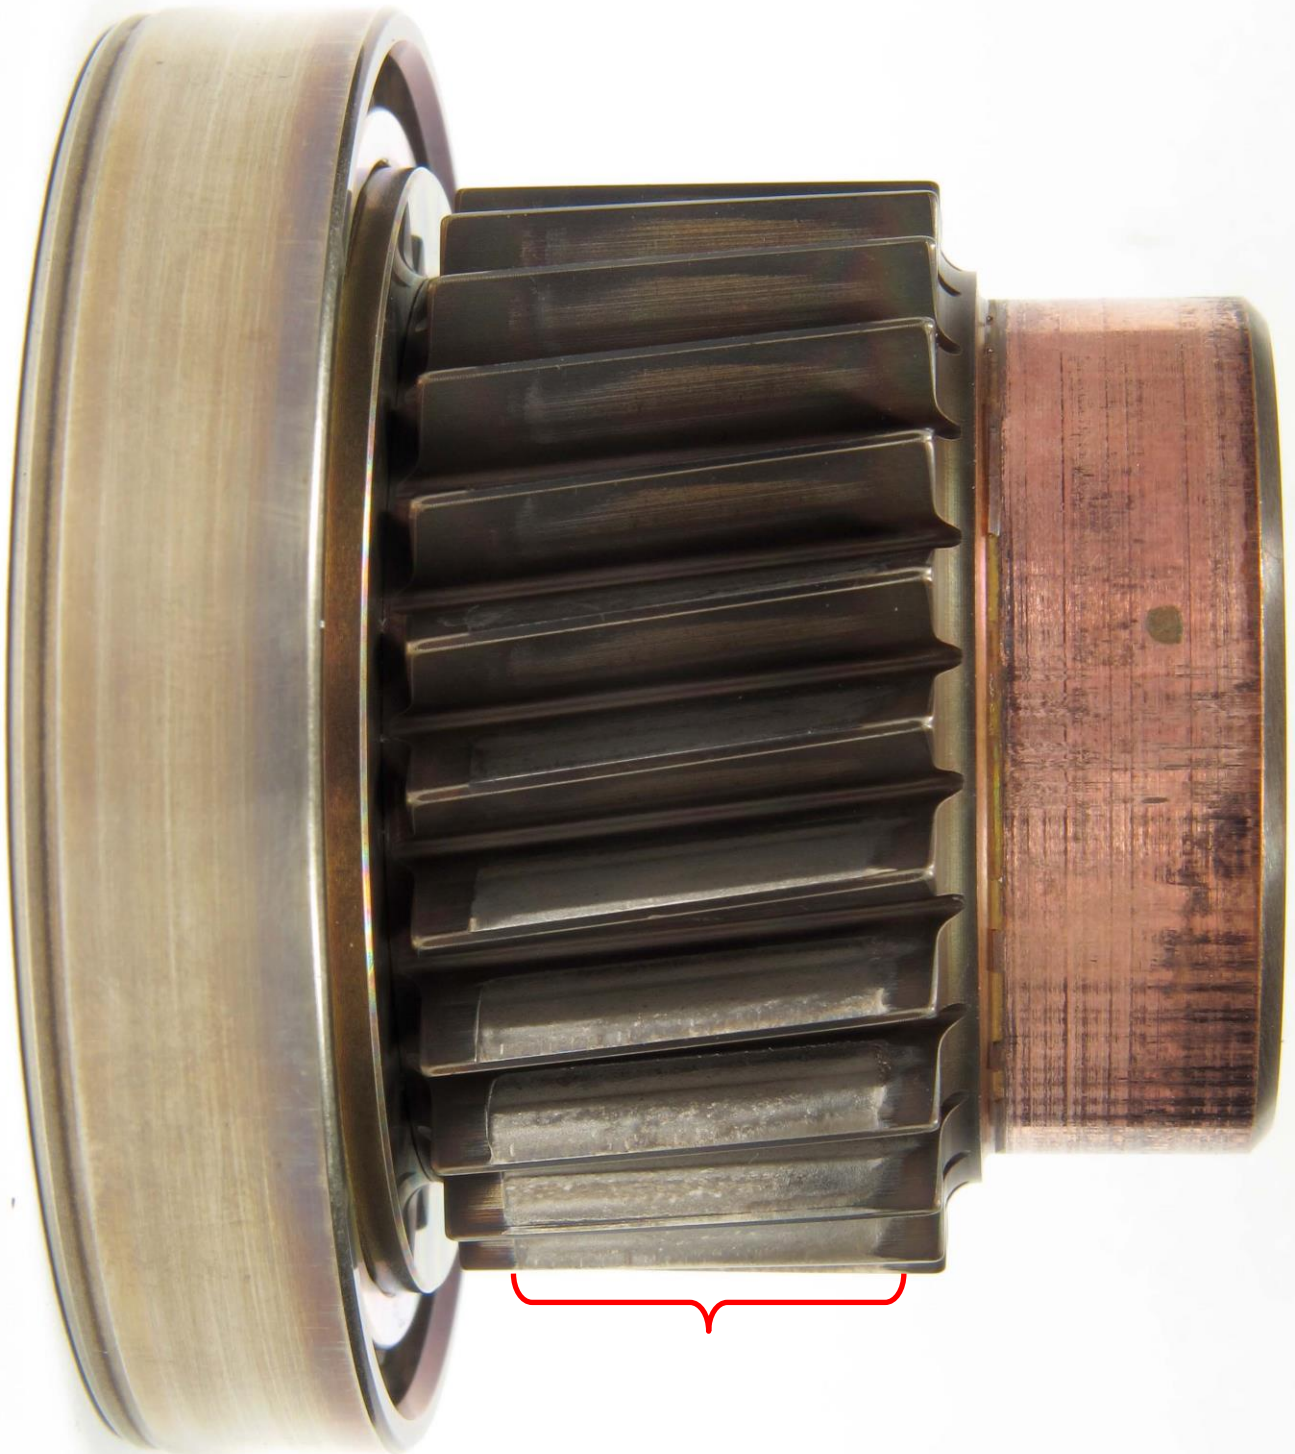
The pinion gear was examined under magnification and no teeth were chipped or spalled. A wear pattern was evident on the drive side of the gear teeth as shown in Figure 68. The internal splines that engage the power turbine to pinion gear coupling were undamaged. No destructive evaluations of the pinion gear were conducted.

**Figure 68. Detailed view of the wear pattern (bracket) on the pinion gear teeth (drive side).**

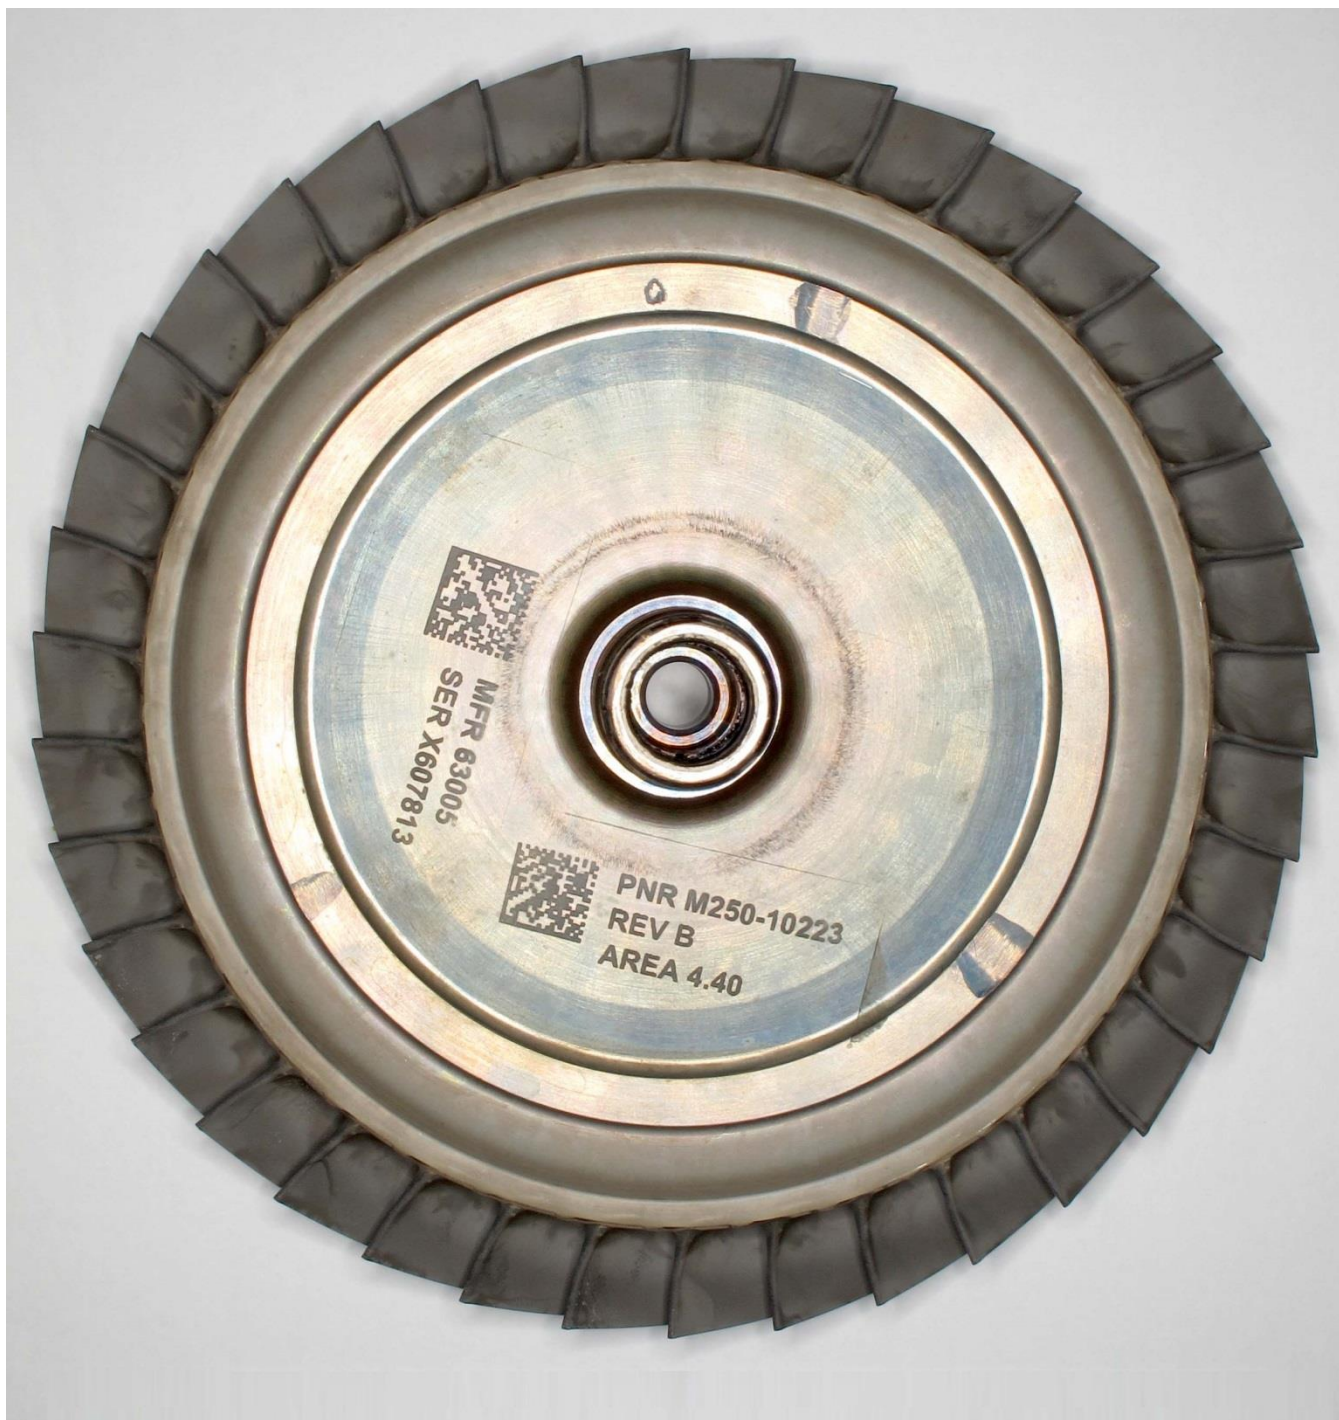
Figure 69 shows a leading edge (aft looking forward) view of the first stage turbine wheel. All of the airfoils were intact and no obvious thermal distress or damage was observed on any of the airfoils. No destructive evaluations of the first stage turbine wheel were conducted.

Figure 69. Aft looking forward view of the first stage turbine wheel.
