| <div style="display: inline-block; vertical-align: middle;"> Rolls-Royce Corporation<br/> P.O. Box 420<br/> Indianapolis, Indiana 46206-0420 USA </div> | | <div style="display: flex; justify-content: space-between;"> <div> PAGE<br/><b>1</b> </div> <div> OF<br/><b>83</b> </div> </div> | <div style="text-align: center;"> REPORT NO.<br/> <b>15FA8-072-PR</b> </div> |
| <b>TITLE</b><br><br>METALLURGICAL INVESTIGATION OF A THIRD STAGE TURBINE WHEEL P/N 23065818 REMOVED FROM M250-C20J ENGINE CAE832989 OPERATED BY FLY HANGAR 13 LLC. | | PREPARED<br><br><div style="text-align: center;"><i>Signatures on File</i></div> | |

**Part Name:** Third Stage Turbine Wheel  
**Part Number:** 23065818  
**Part S/N:** X597059  
**Total Part Time:** 930 Hours (TSO)  
**Engine Model:** M250-C20J  
**Engine S/N:** CAE832989  
**Removal Station:** Rolls-Royce Corporation, Indianapolis, IN.  
**User:** Fly Hangar 13 LLC

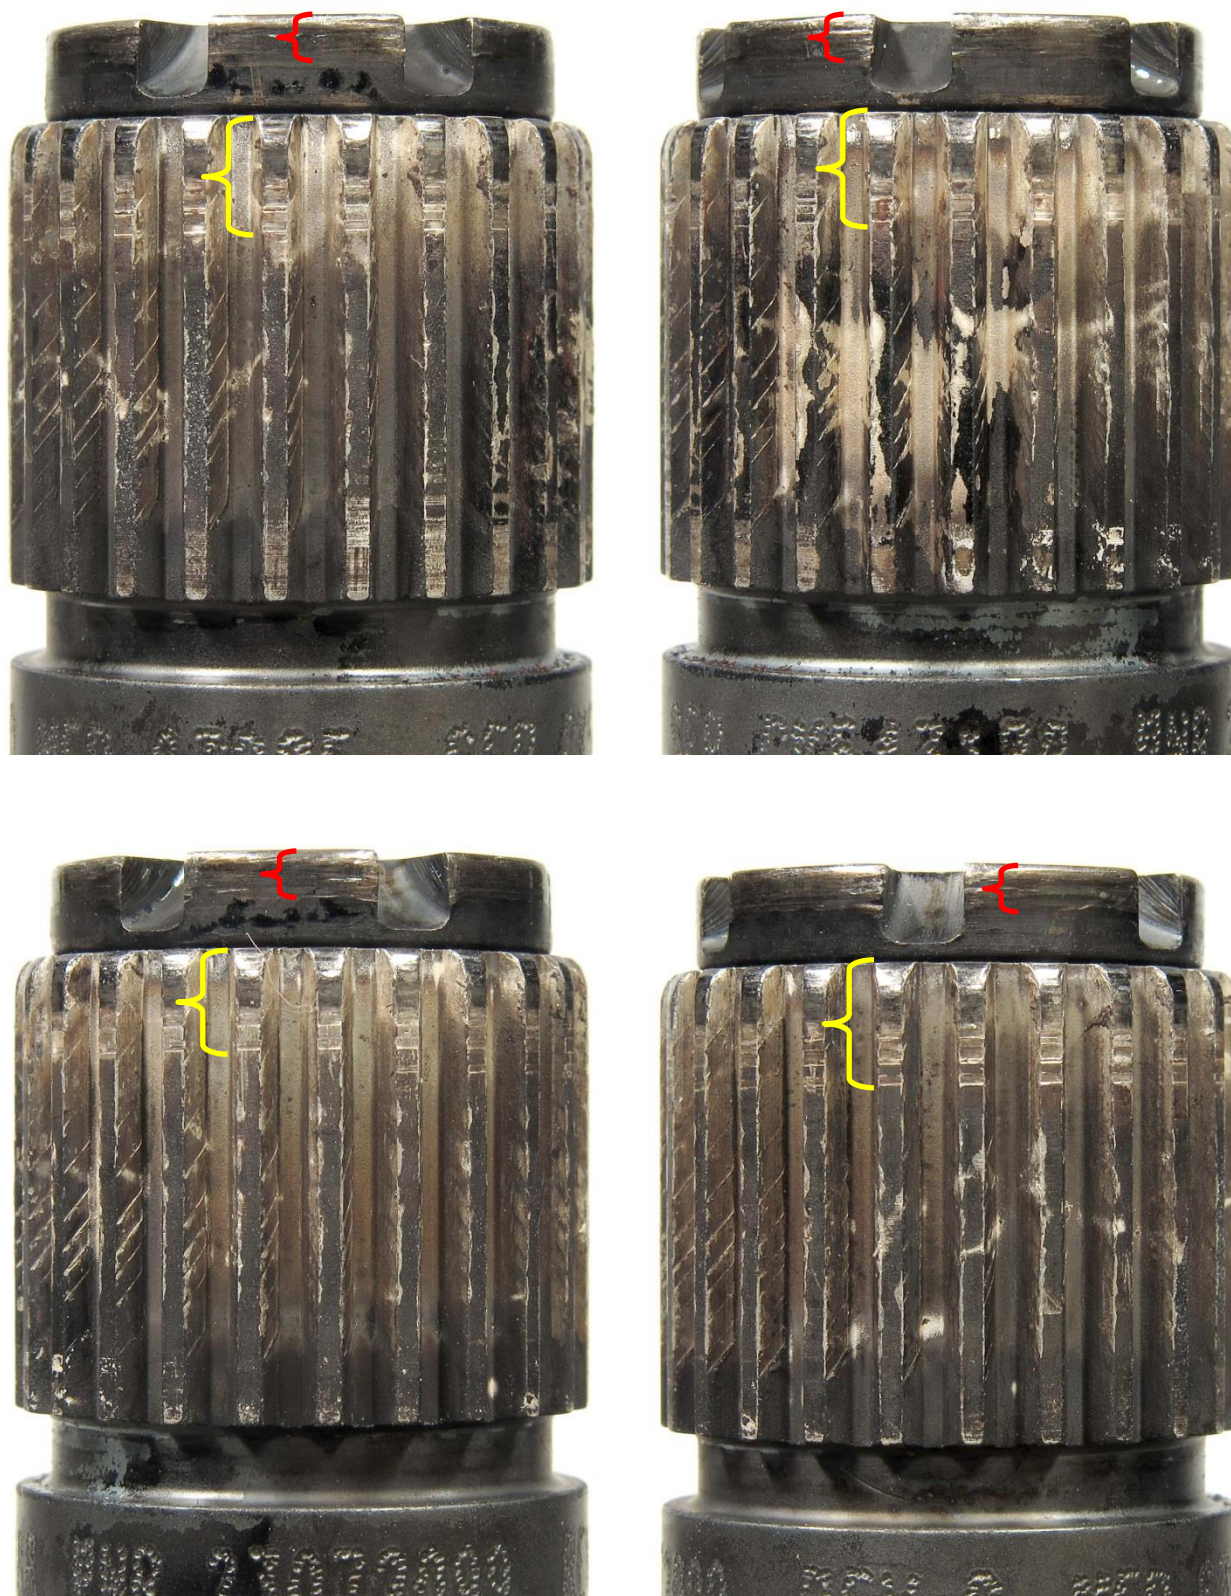
The turbine tie bolt and nut used to clamp the first and second stage turbine wheels are shown in Figure 71. The OD surface of the tie bolt head was damaged as well as the forward portion of the turbine splined adapter splines (Figure 72). Multiple diagonal cracks were also evident on the drive side of the turbine splined adapter splines.

**Figure 72. 90-degree views of the wear damage to the head of the turbine tie bolt (red bracket) and turbine splined adapter (yellow bracket).**

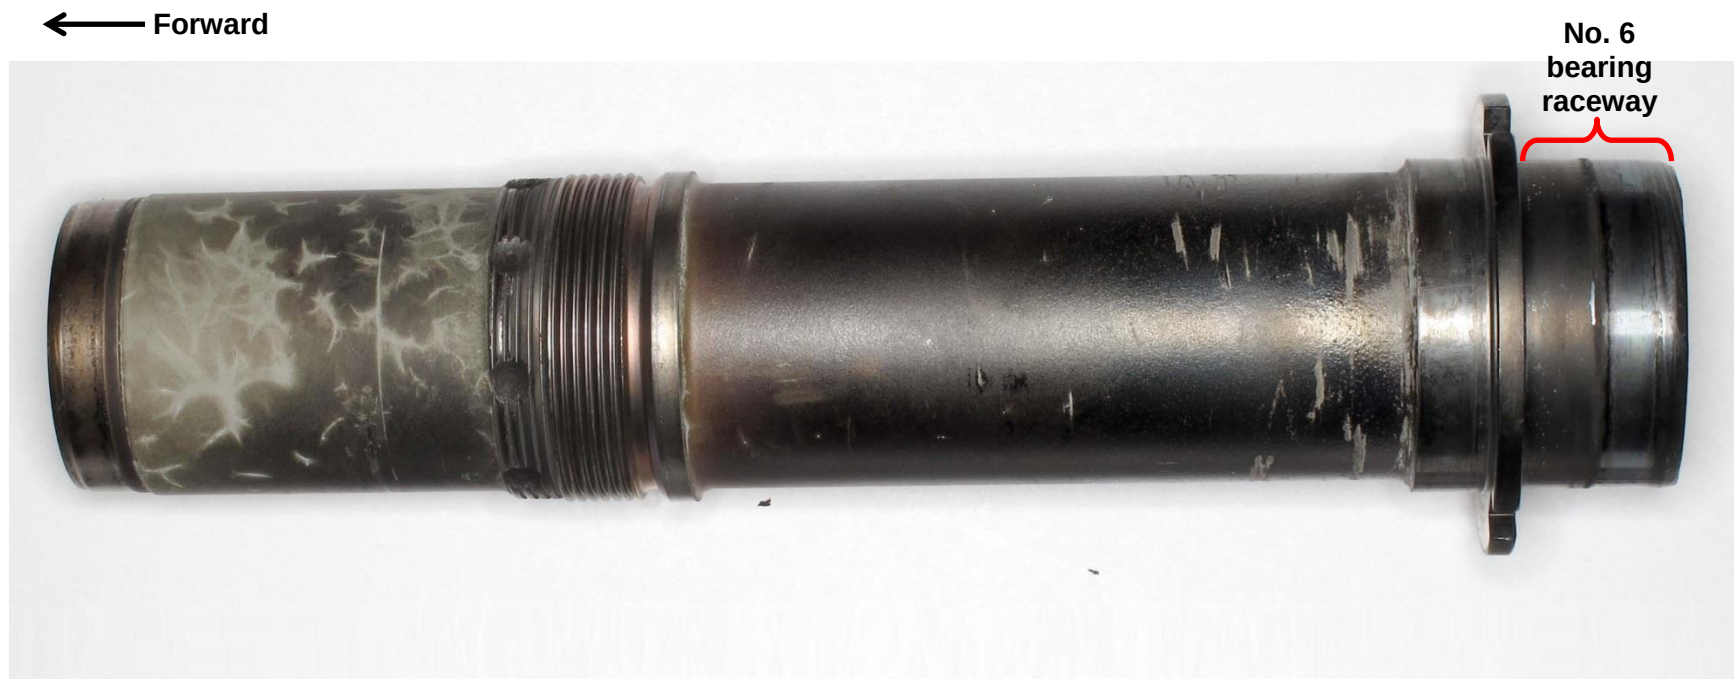
The power turbine inner shaft is shown in Figure 73. A few rub marks were observed on the OD of the shaft. The ID surface of the shaft at the aft end was scored as shown in Figure 74 through Figure 76. No destructive evaluations of the shaft were conducted.

Figure 73. Photograph of the power turbine inner shaft.

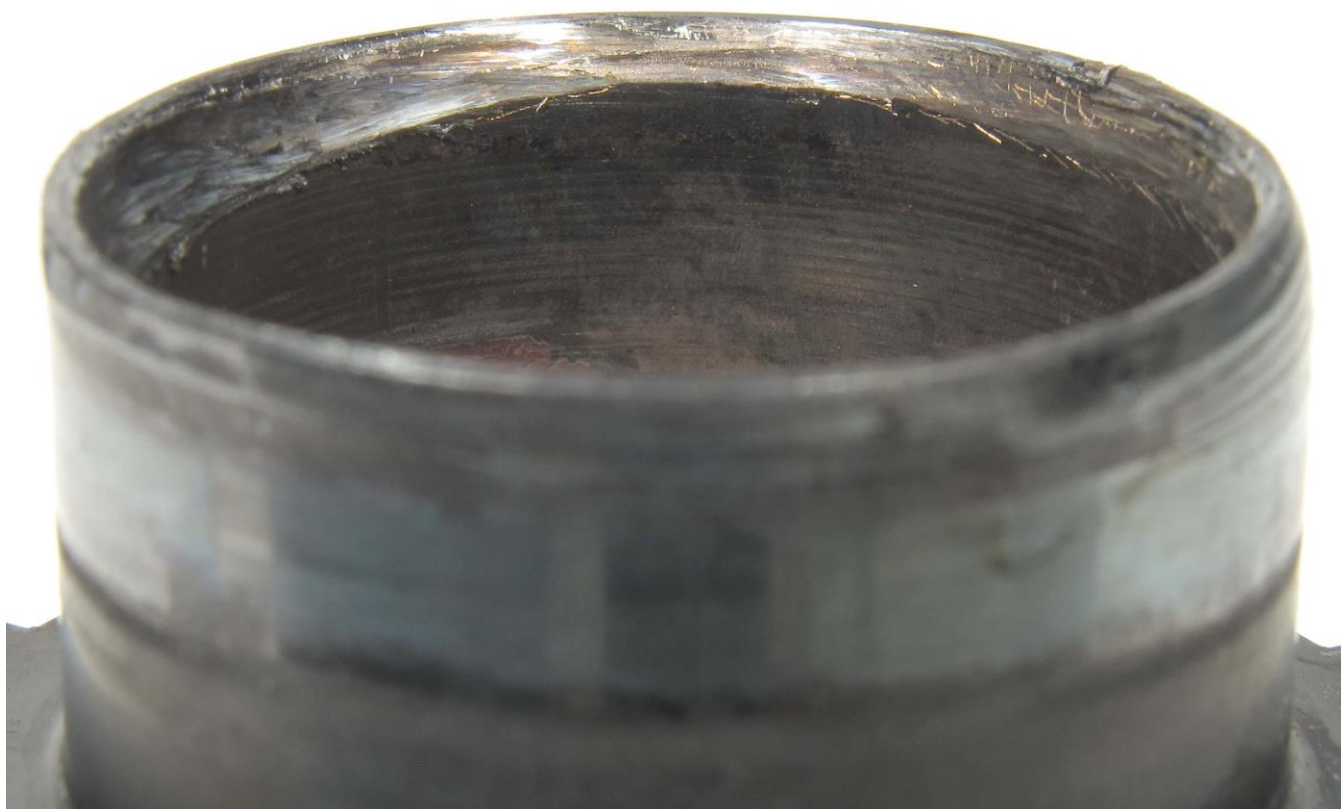
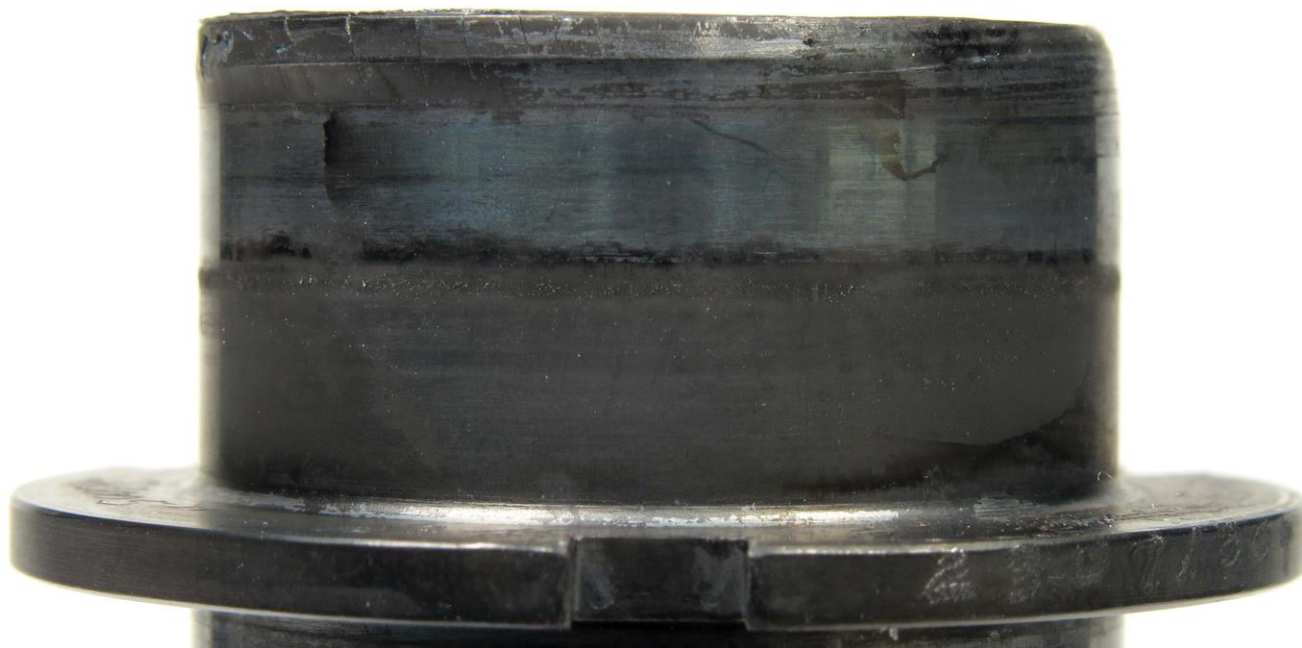
0-degrees

**Figure 74. Photographs showing the damage to the ID surface at the aft end of the power turbine inner shaft (upper image). The lower image shows the condition of the No. 6 bearing inner ring raceway.**

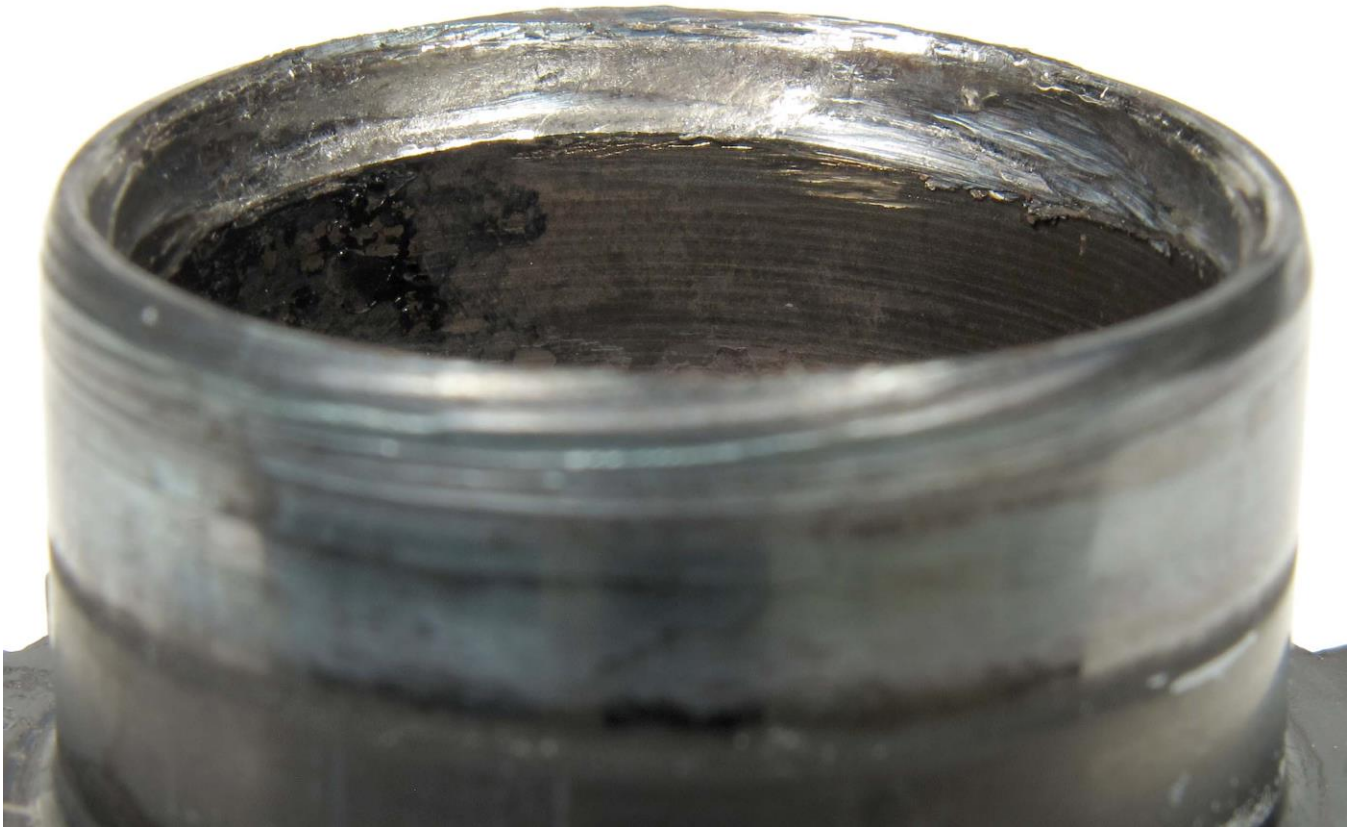
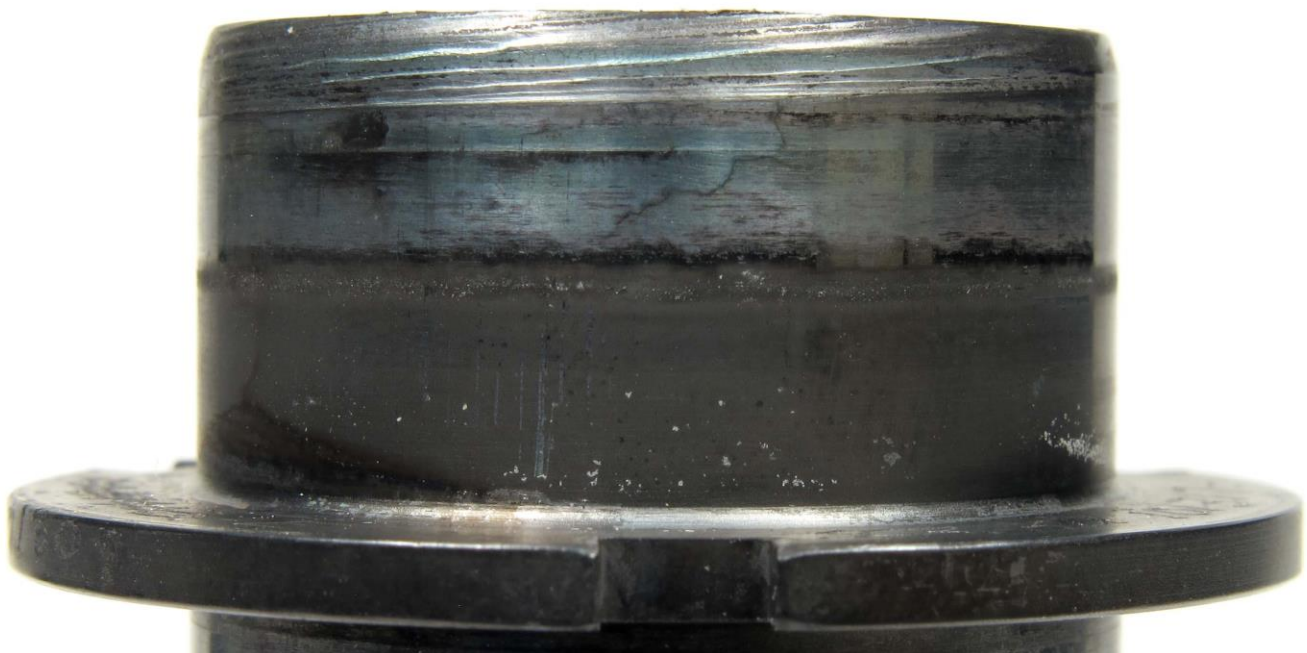
120-degrees

**Figure 75. Photographs showing the damage to the ID surface at the aft end of the power turbine inner shaft (upper image). The lower image shows the condition of the No. 6 bearing inner ring raceway.**

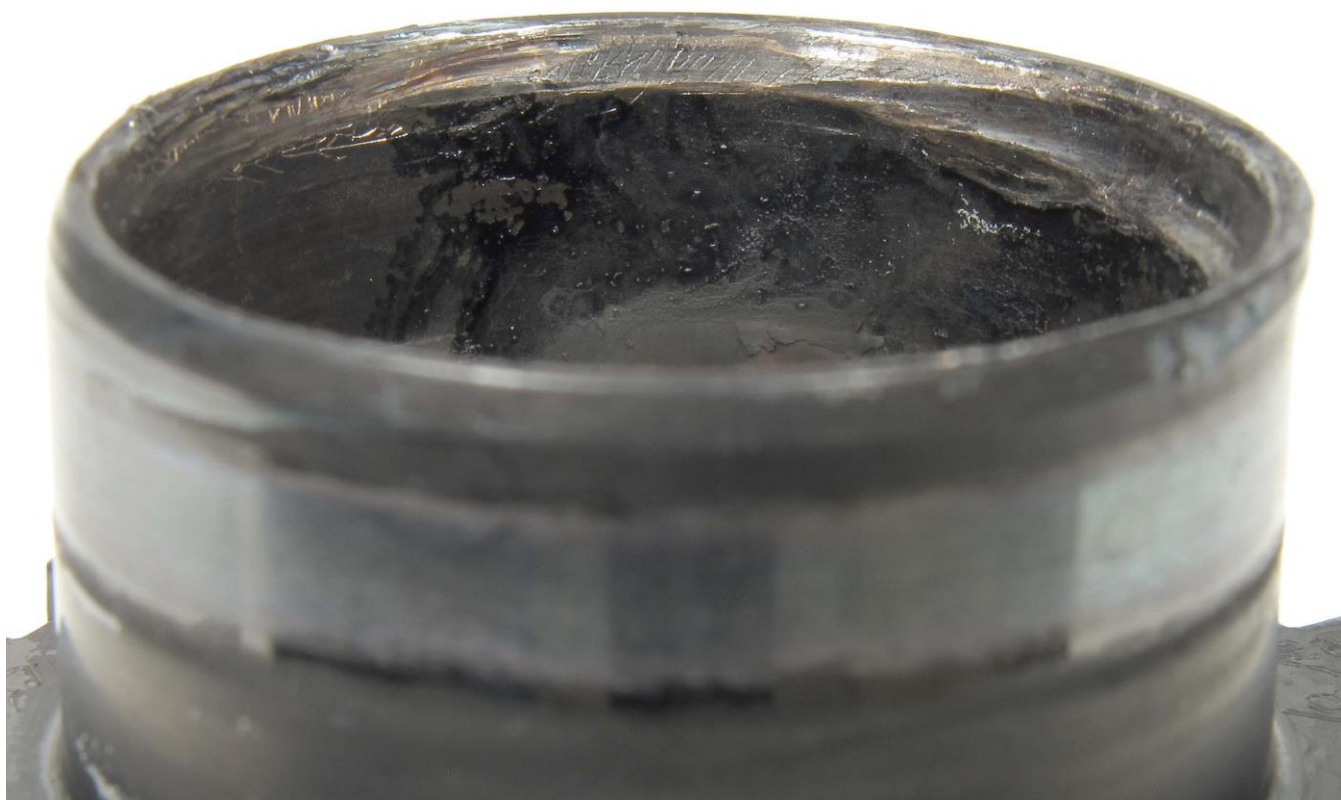
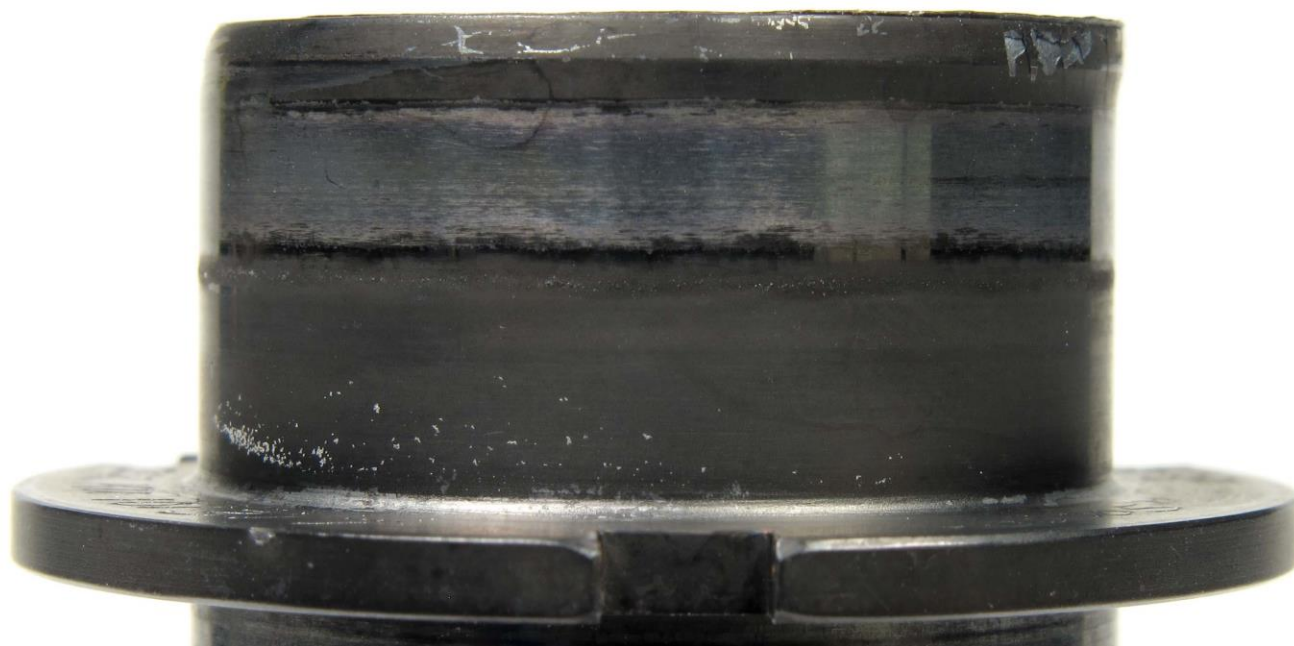
240-degrees

**Figure 76. Photographs showing the damage to the ID surface at the aft end of the power turbine inner shaft (upper image). The lower image shows the condition of the No. 6 bearing inner ring raceway.**
