# Engine Investigation

Allison  
M250-C20J  
Engine CAE 832989

Bell 206B  
Registration: N5743W

Accident date: August 18, 2015  
Investigation date: August 26, 2015  
At Rolls- Royce: October 5, 2015  
Report date: March 15, 2017

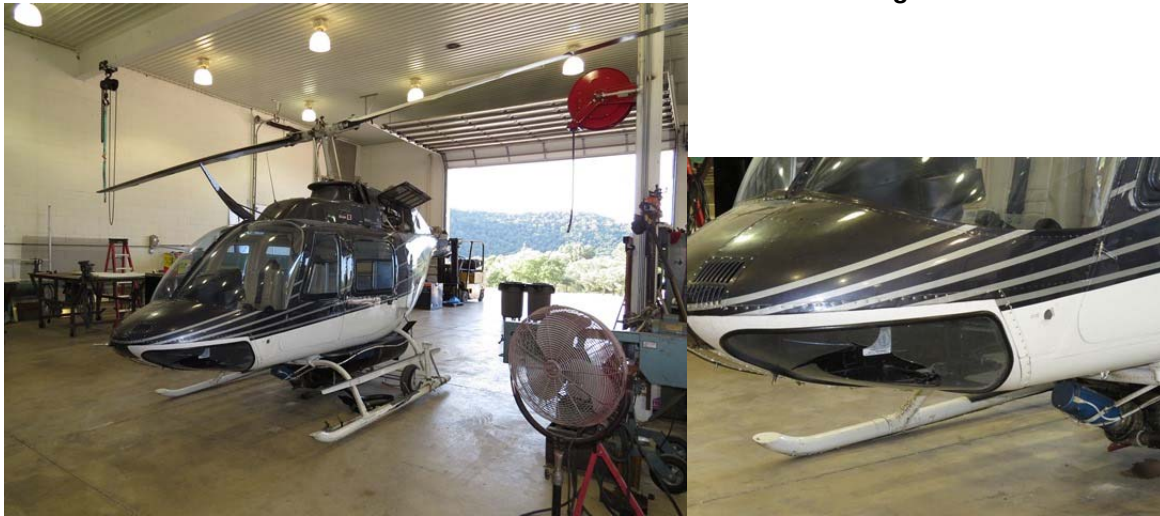
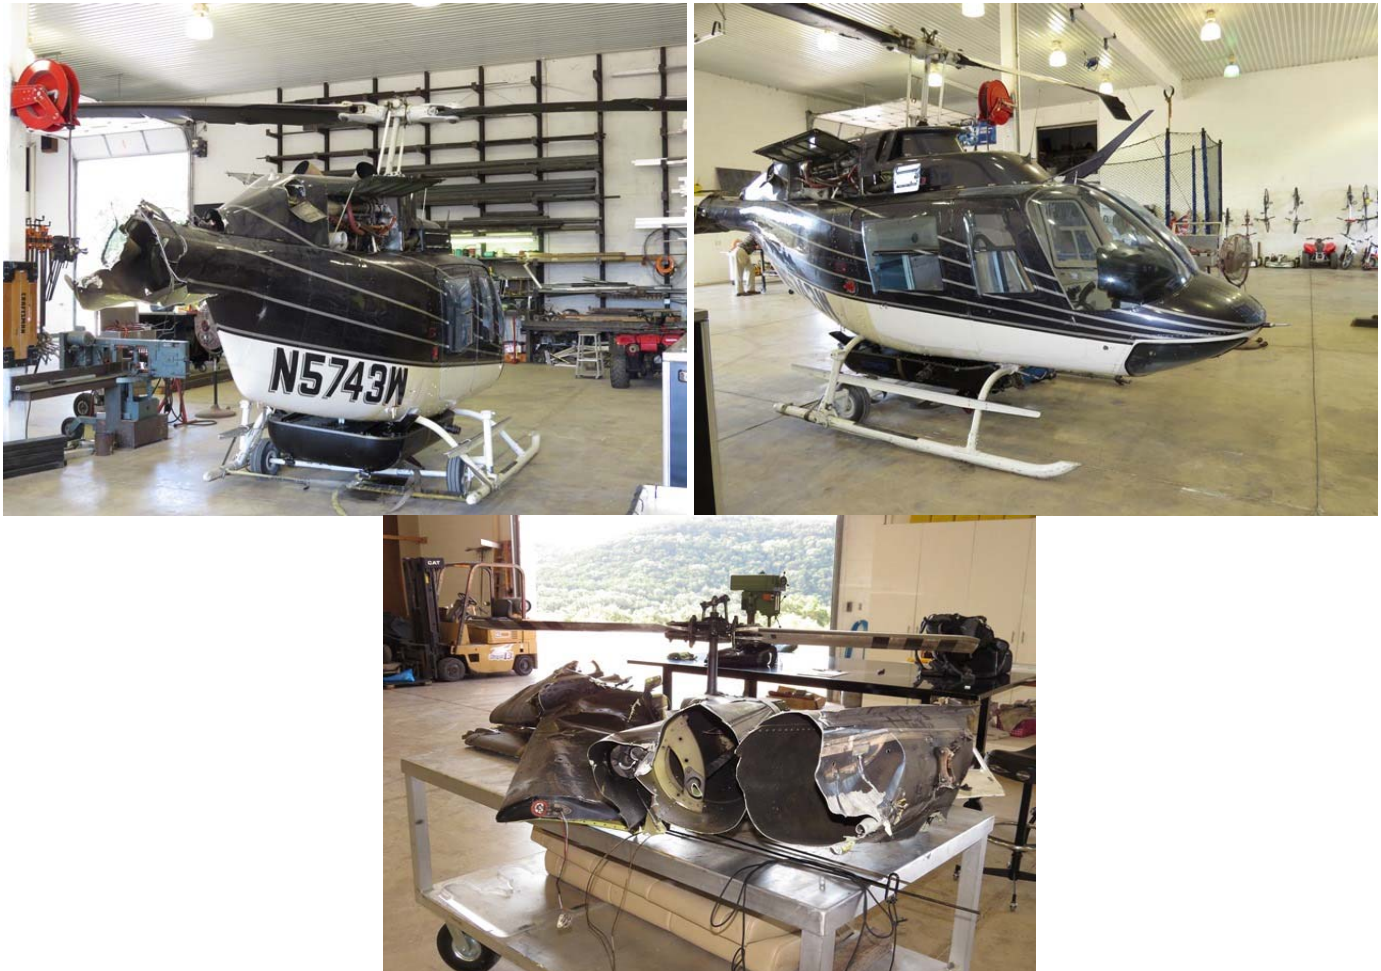
Fig 1

The helicopter was positioned upright on dollies with the landing skids remaining attached. The left front chin bubble had been broken out. The tail boom had been separated as a result of a main rotor blade strike and was in two sections. The tail rotor gear box remained attached to the aft section of the tail boom and both tail rotor blades remained attached and were visually normal. Both main rotor blades remained attached to the rotor head. Both blades retained their lengths and both exhibited areas of scratches, skin tears and spanwise bending. (Fig 1)

Helicopter as Recovered

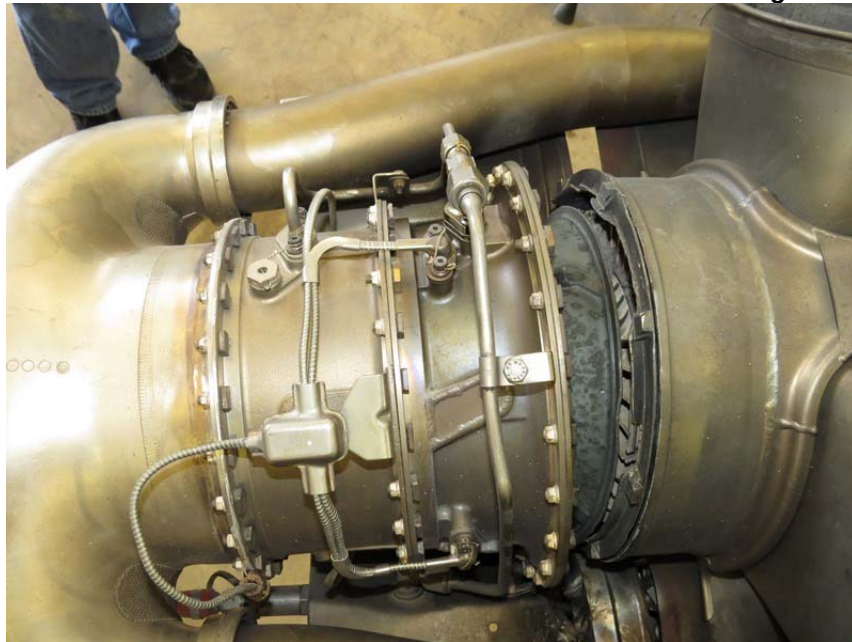
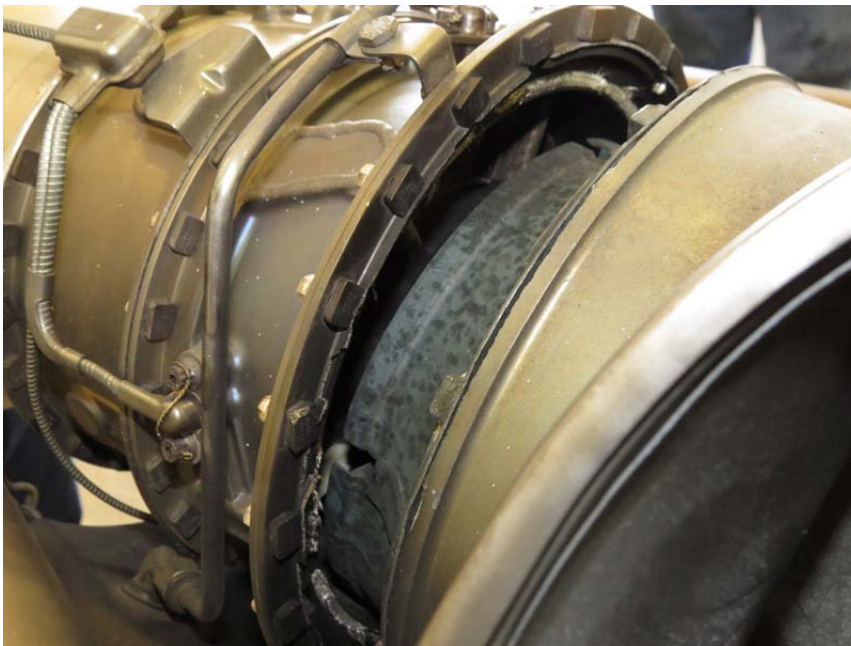
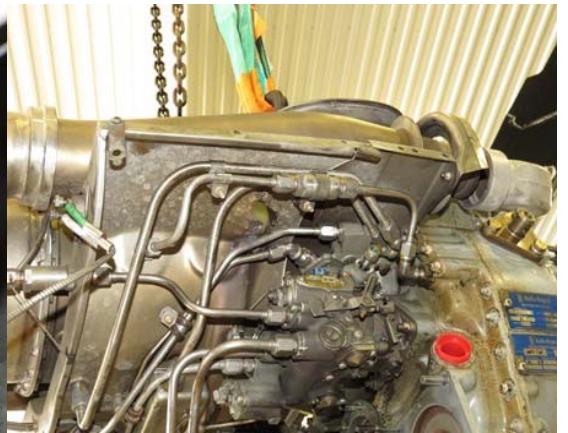
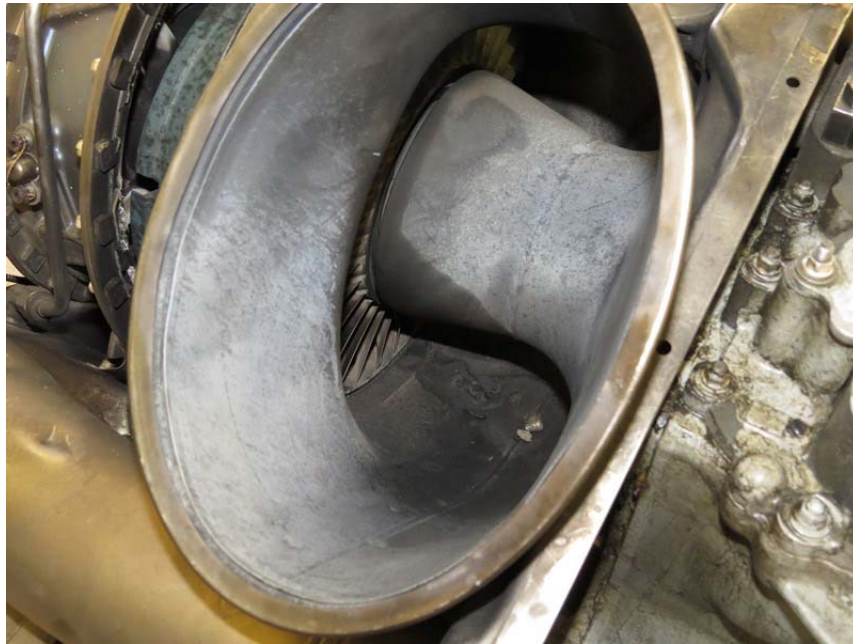
Fig 3

Both the gas producer support and power turbine supports were visually normal and displayed no damage. The aft exhaust collector support flange was cracked around the entire circumference of and separated. Both stage one and stage two nozzles and wheels were in their normal positions with none exhibiting any damage or anomalies.

Turbine as Recovered

Interior of Exhaust Collector Support

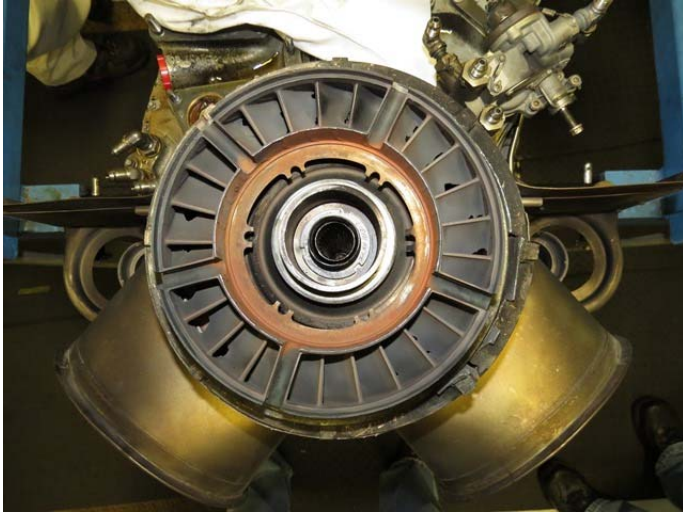
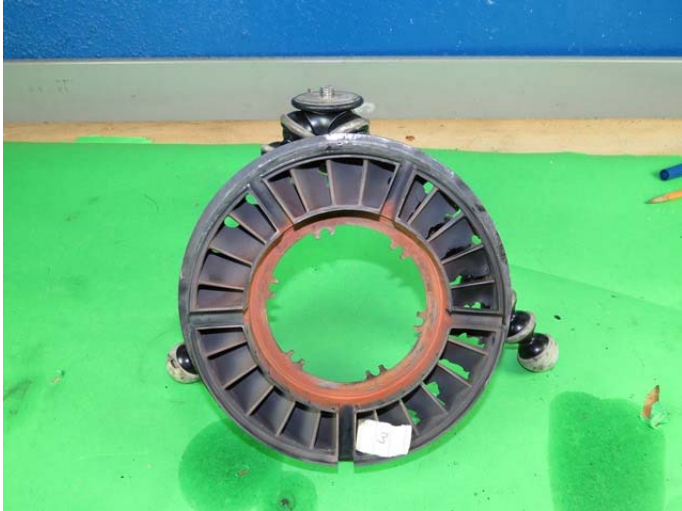
Stage 3 Nozzle

The stage three nozzle remained in position but displayed evidence of impact damage to the trailing edges of multiple vanes with areas of impact damage and scoring noted to the outer rim aft face.

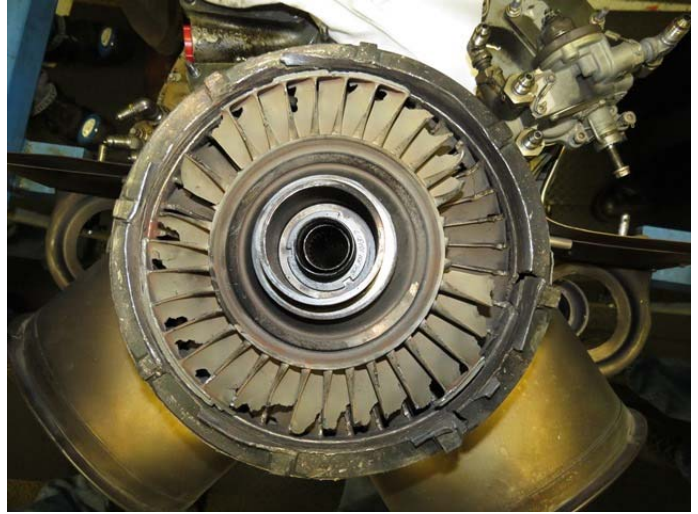
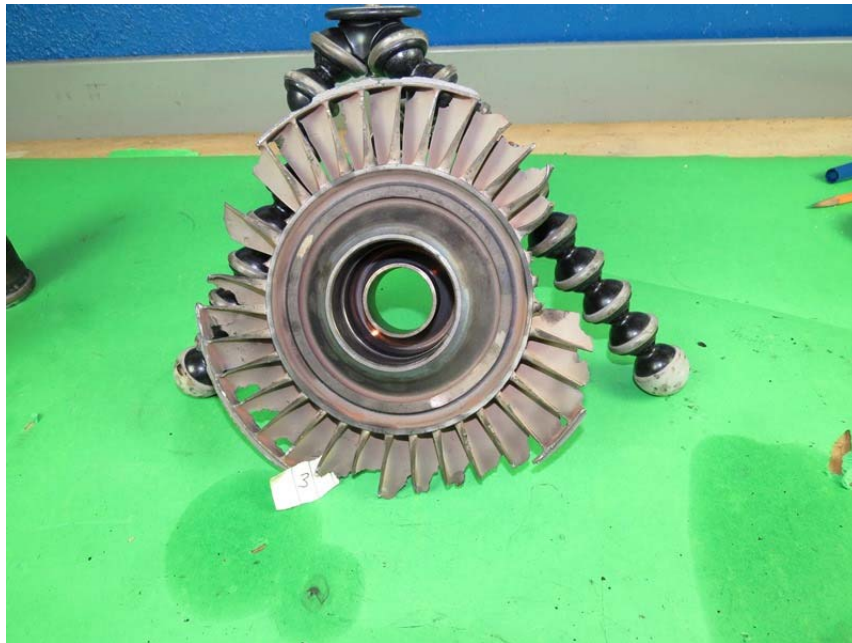
Stage 3 Turbine Wheel

The stage three wheel remained mated to the stage four nozzle and wheel. Five blades were liberated from the wheel just outboard of the inner rim. The balance of the blades displayed impact damage with the majority of the outer shroud being absent. Remained portions of the shroud spanned seven blades, six blades and two blades respectively. The remaining portions of the shroud displayed rotational rub damage from contact with the blade track.

- Five airfoils on the third stage turbine wheel cracked in fatigue, initiating from the trailing edge root area and progressing forward until final fracture occurred in overload. All five cracks initiated and progressed in high cycle fatigue. Two additional cracks were found in the trailing edge side of the wheel rim, consistent with thermal fatigue cracking.
- Damage observed and documented on the other components was considered secondary to the liberation of five airfoils on the third stage turbine wheel.
- At the conclusion of extensive engineering testing, a single root cause could not be identified for the liberation of the airfoils on the stage three turbine wheel.

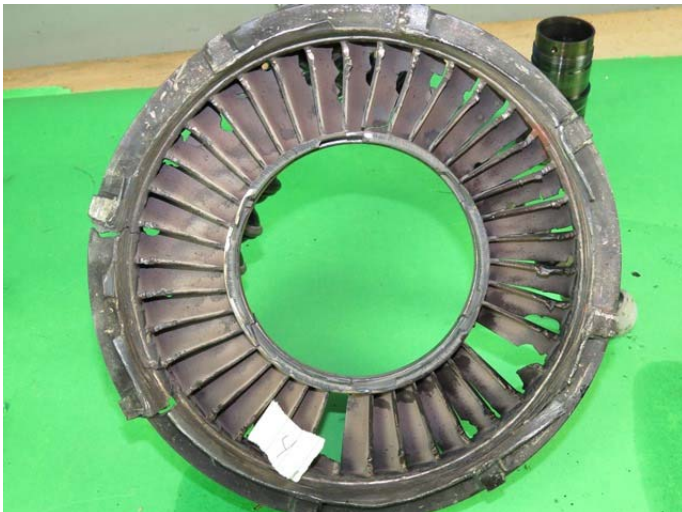
Stage Four Nozzle Pressure Side

The stage four nozzle remained in position with two airfoils absent. The outboard portions of all of the leading edge surfaces were damaged and several of the trailing edge surfaces were impact damaged. The diaphragm was detached from the bore. The entire circumference of the blade track was heavily rubbed from contact against the third stage turbine wheel shroud and knife seals.

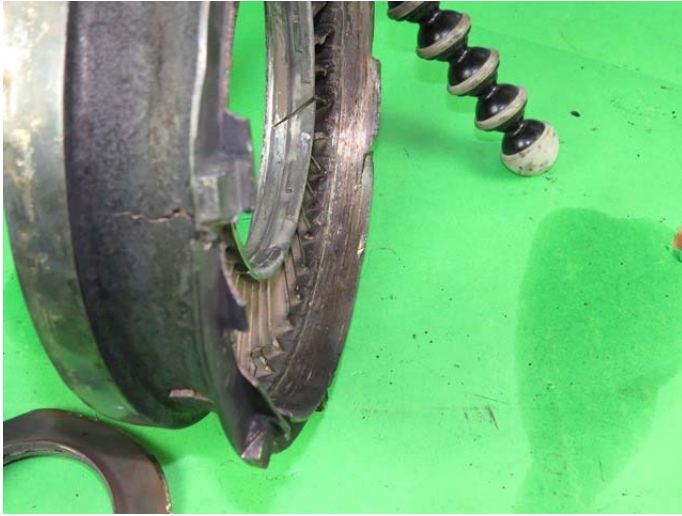
Stage Four Wheel Blade Track

Portions of the blade track were fractured and missing. Impact damage was also noted on the eight positioning tabs around the outer diameter. The stage four wheel remained in position with all of the airfoils present however the majority displayed impact damage. (Fig 9)

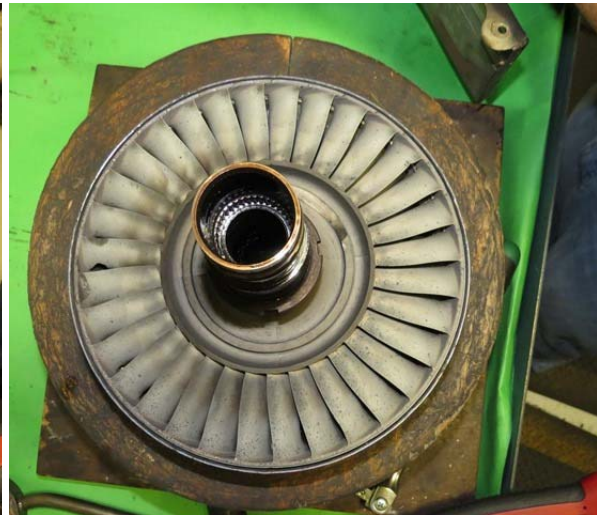
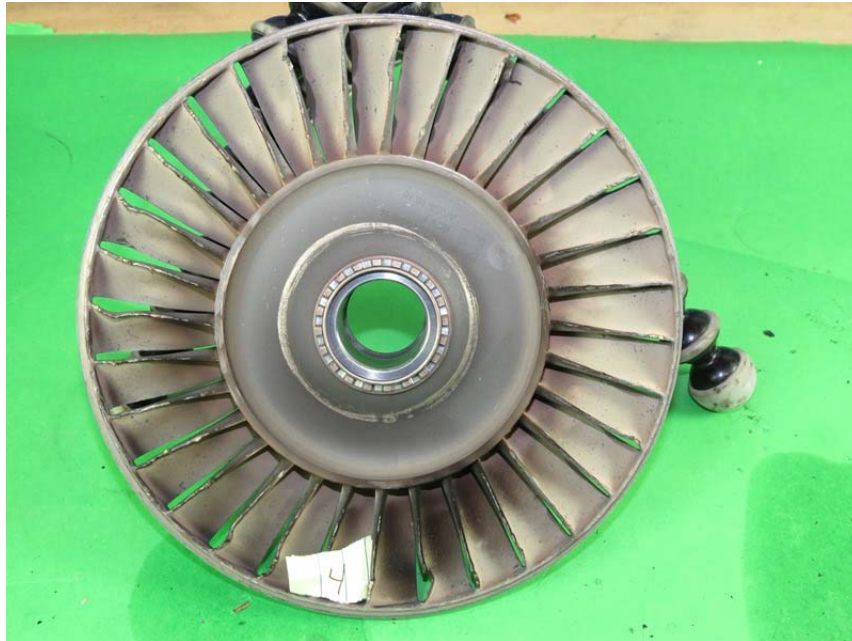
Stage Four Wheel Suction Side

Stage Four Wheel Pressure Side

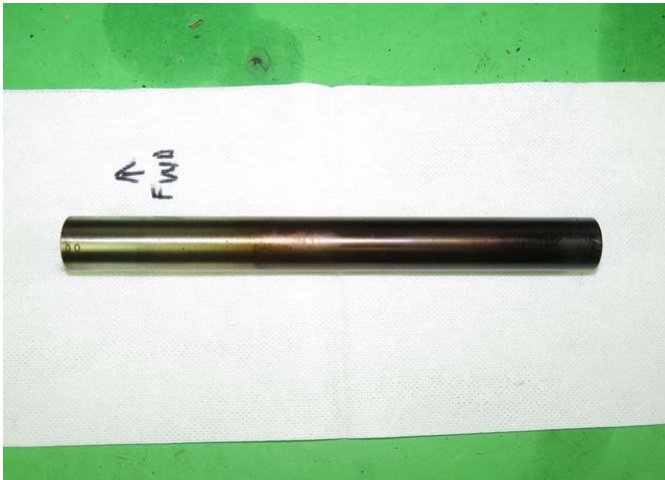
Turbine to Compressor Coupling

undamaged. The turbine to compressor coupling exhibited light score marks on the aft end but was otherwise visually normal with the internal splines appearing visually normal and undamaged. N2 shafting consisting of the power turbine inner shaft, power turbine outer shaft and power turbine to pinion gear coupling were all visually examined. The power turbine inner shaft displayed light score marks on the aft end forward of the #6 bearing race. Additional scoring was noted to the inside of the aft end of the shaft. The power turbine outer shaft was normal visually normal with no visible damage. The power turbine to pinion gear coupling was visually normal with no visible damage. (Fig 10)

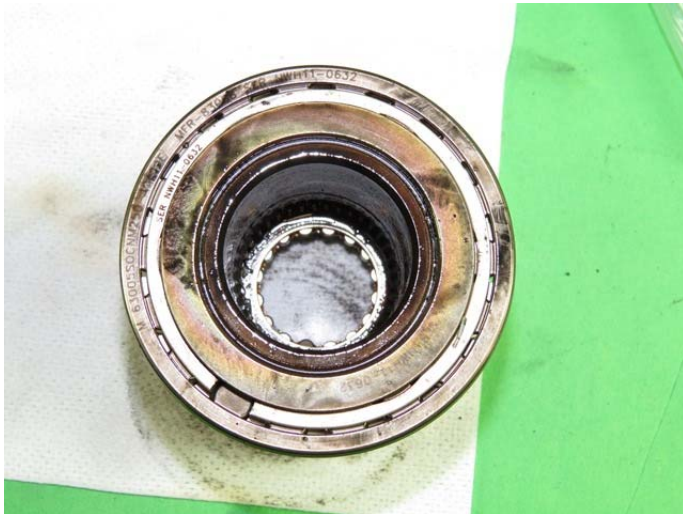
#4 Bearing

The #4 bearing was found in positon however the retaining ring was dislodged. Visual examination revealed an aft section of the separator to have fractured and a small section to have liberated from the separator. (Fig 11)

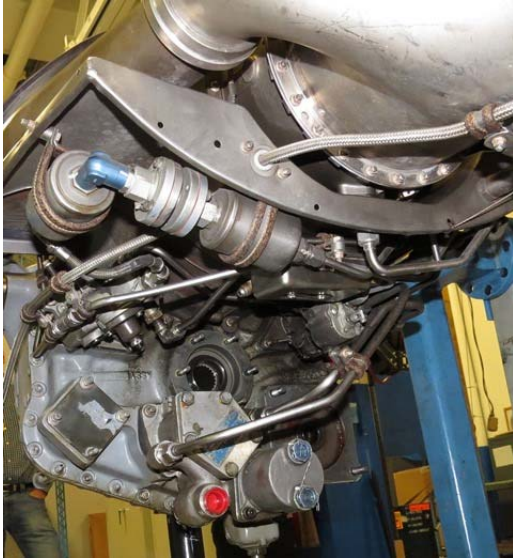
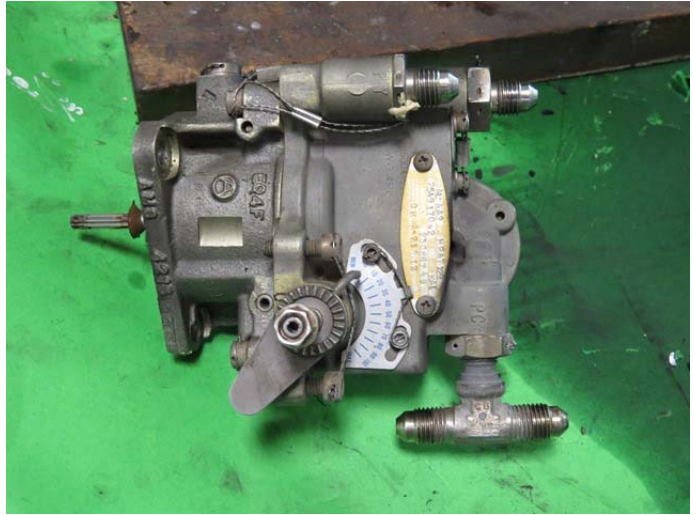
Power Turbine Governor

The power turbine governor and fuel control unit were normal in appearance with no visible external damage. At removal of the power turbine governor the drive splines pulled off of the end of the main drive shaft and remained lodged within the accessory gear box. Removal of the fuel control unit revealed no visible damage and the main drive shaft to be rotationally free and smooth. Manual operation of both the fuel control unit throttle arm and the power turbine governor control arm resulted in correct movement with full and smooth travel from stop to stop. [\(Fig 13\)](#)
