**NATIONAL TRANSPORTATION SAFETY BOARD**  
Vehicle Recorder Division  
Washington, DC 20594

## **Onboard Image Recorder**

**Specialist's Factual Report**  
**By Sean Payne**

| Aircraft: | Robinson Helicopter R44 II, N445HS |

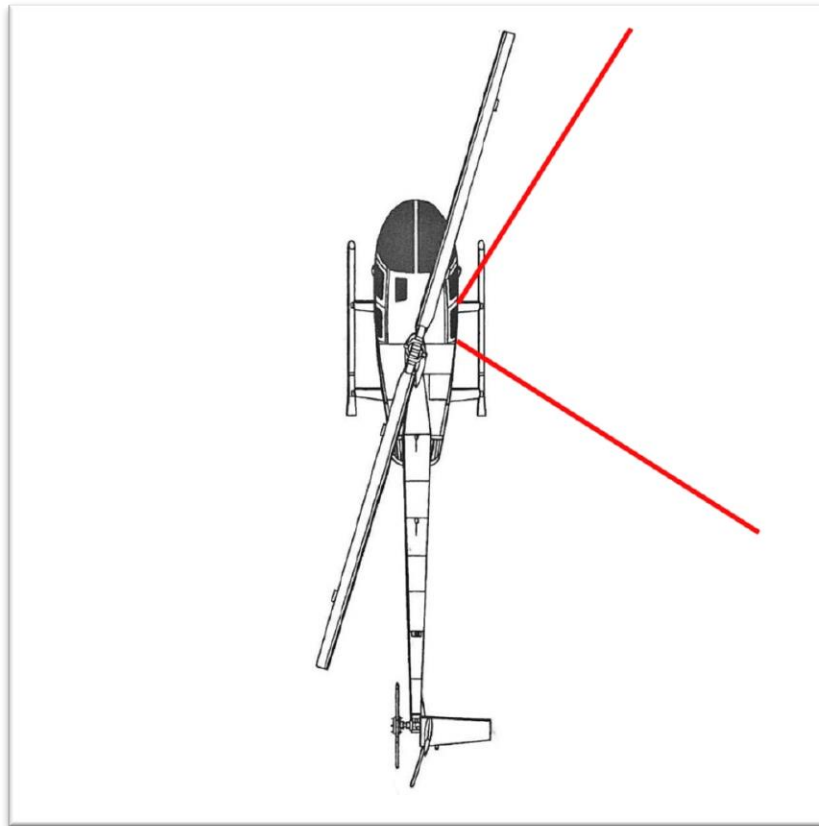
The recording was captured by a videographer seated in the back right seat of the rotorcraft. The recording only provides a view from the accident rotorcraft (N445HS) filming another rotorcraft engaging in aerial hunting (N300WZ). For most of the recording, no part of the accident rotorcraft is captured in the recording due to the focal length being used by the camera operator. Because the recording's field of view does not capture any part of the accident rotorcraft during the accident sequence, it is difficult to judge the camera's orientation as compared to the accident rotorcraft's orientation. An estimation of the camera operator's field of view is provided in figure 1 below.

**Figure 1. The rear seat camera operator's field of view represented in red.**

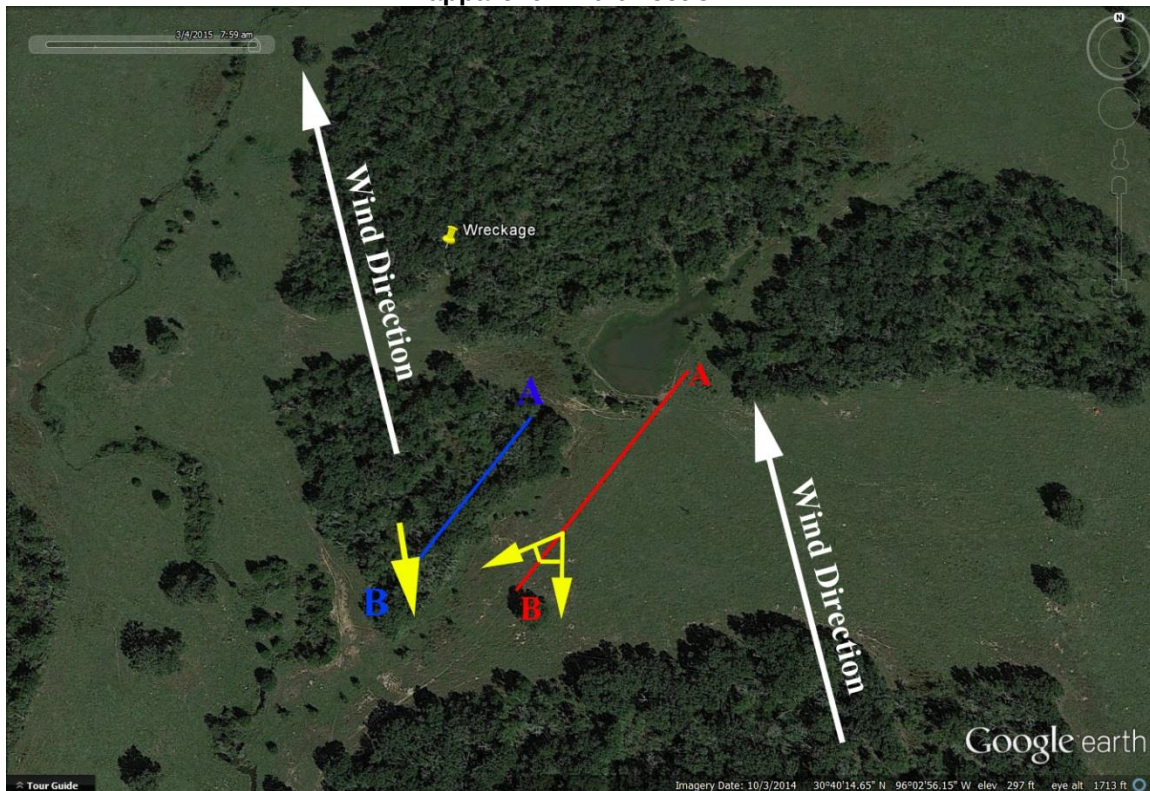
Figure 2 is a depiction of each rotorcraft's ground track overlaid on a Google Earth satellite view of the accident area. The blue path describes the ground track of the N300WZ engaged in hunting activities. The red path describes the accident rotorcraft's ground track, N445HS. Points A and B represent the start position and end position (time of the onset of N445HS's spin) of each rotorcraft across the ground. A yellow arrow represents the heading of N300WZ. A set of yellow arrows represents the range of possible headings for N445HS. White arrows represent the perceived surface wind conditions apparent from the recording.

**Figure 2. A depiction of each rotorcraft's ground track, their respective headings and the apparent wind direction.**
