# NATIONAL TRANSPORTATION SAFETY BOARD

MATERIALS LABORATORY FACTUAL REPORT

Report No. 16-044

Place : Ketchum, Oklahoma  
Date : August 25, 2015  
Vehicle : Robinson R44 II, N444KD  
NTSB No. : CEN15LA379  
Investigator : Jim Silliman, AS-CEN

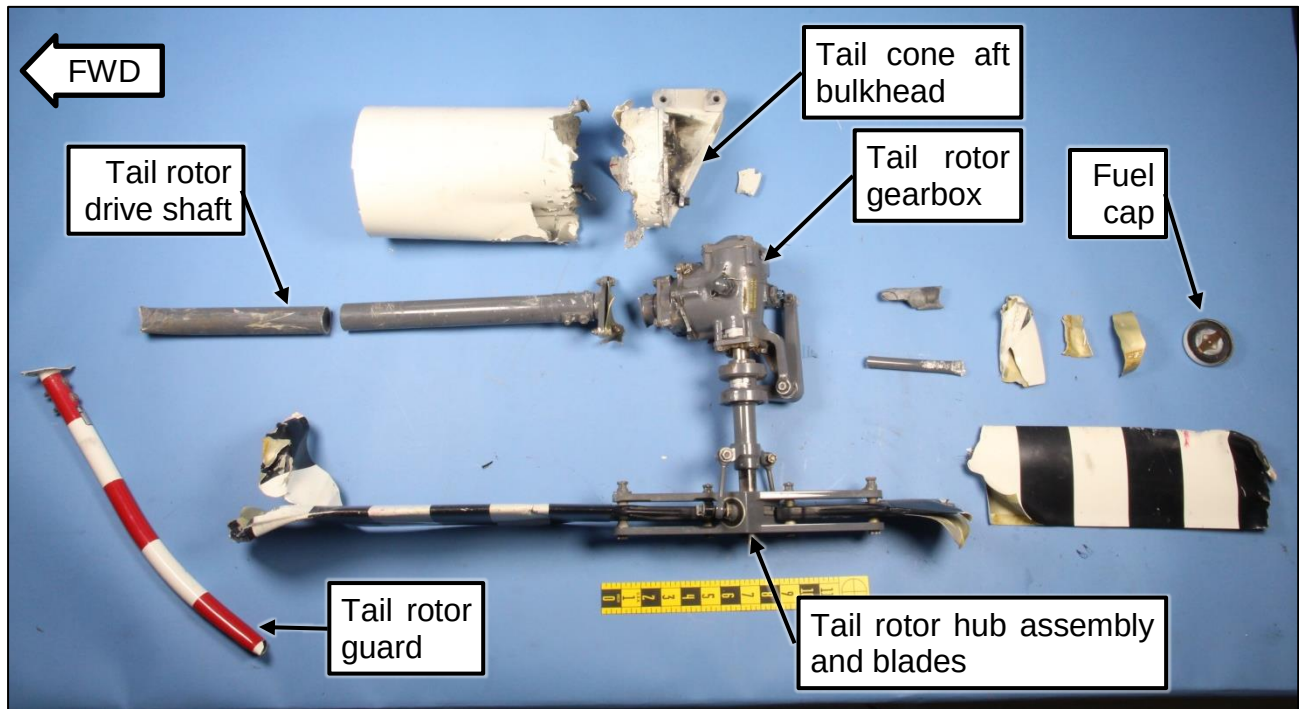
An overall view of the submitted tail components is shown in figure 1. The tail cone was fractured around its circumference just forward of the aft bulkhead. The tail rotor drive shaft was fractured at the aft flexible coupling, and the tail rotor gearbox was fractured from the aft bulkhead. The tail rotor blades were fractured into multiple pieces, and the tip end was missing from one of the blades.

Figure 1. Overall view of the submitted components.

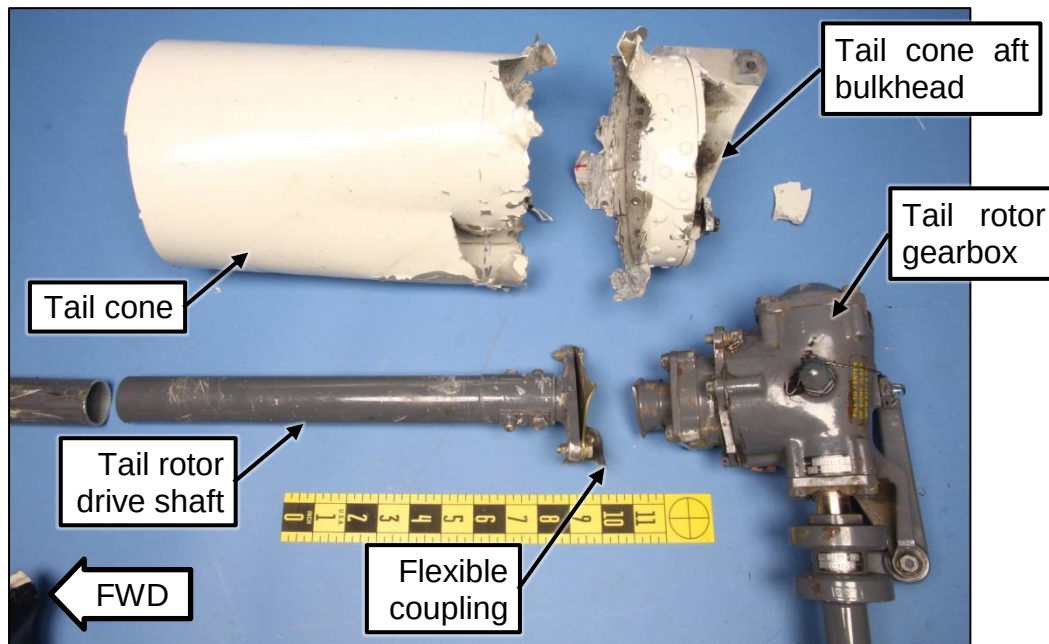
A closer view of the tail cone and drive shaft fractures is shown in figure 2. The tail cone had circumferential sliding contact damage on the interior surface, and fractures were deformed outward consistent with contact with the tail rotor drive shaft flexible coupling flanges. Flanges for the tail rotor gearbox input shaft at the aft side of the flexible coupling were fractured from the shaft, and one of the flange pieces remained attached to the flexible coupling plate. At the opposite side of the coupling plate, the attachment ear of the plate was fractured and missing. All fractures for the flexible coupling were damaged by post-fracture damage, but remaining surfaces showed slant fractures consistent with overstress fracture.

Figure 2. Closer view of the fractured tail boom and tail rotor drive shaft.

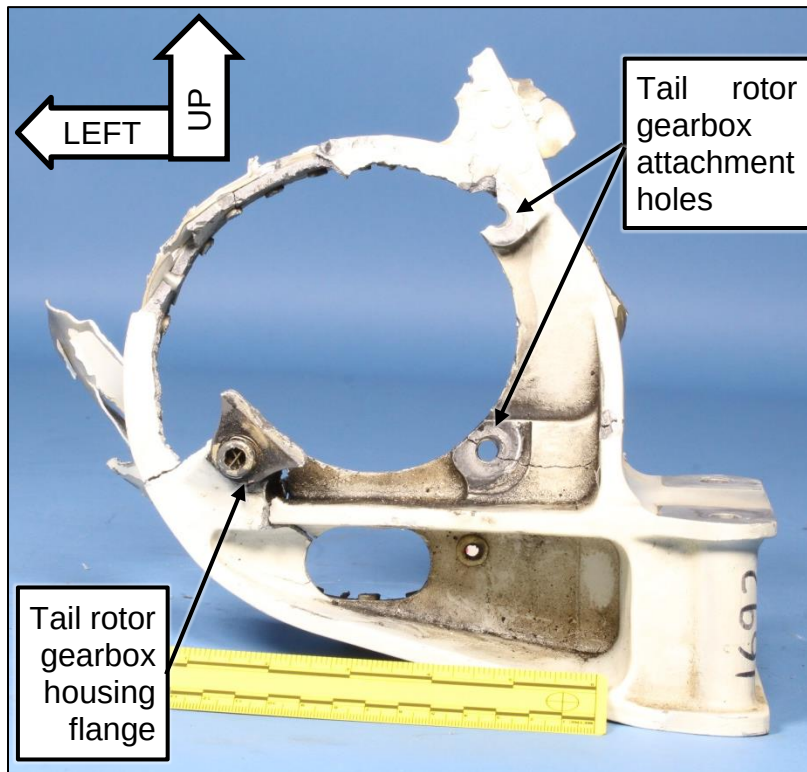
The tail cone aft bulkhead as viewed from the aft looking forward is shown in figure 3. Pieces of the aft face were missing around the upper left half of the bulkhead, including the upper left threaded hole for attaching the tail rotor gearbox. A fractured flange piece from the tail rotor gearbox housing remained attached at the lower left tail rotor gearbox attachment position. The aft bulkhead was fractured through the upper right tail rotor gearbox attachment hole, and a crack intersected the lower right

Figure 3. Tail cone aft bulkhead as viewed looking forward.

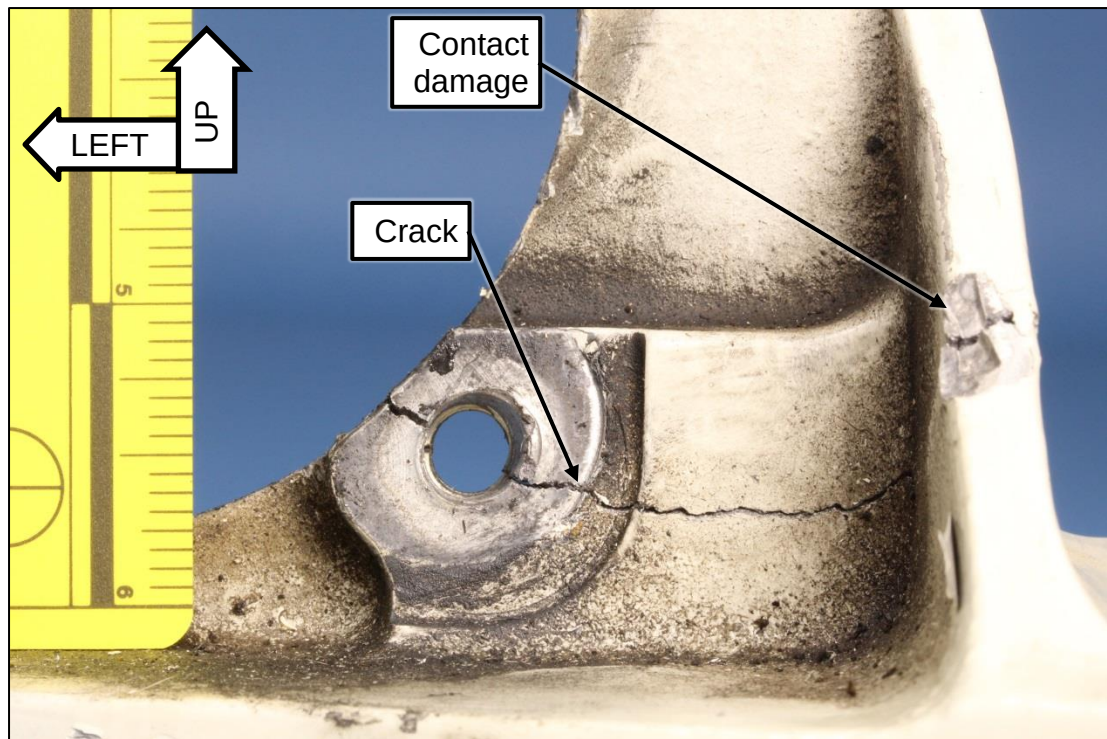
attachment hole. A closer view of the crack intersecting the lower right attachment hole is shown in figure 4. The crack also intersected an area of contact damage on the upper inboard corner of the corner gusset section. The upper right tail rotor gearbox attachment hole had several sheared threads, and threads at the lower right attachment hole were mostly sheared.

Fracture features around the tail cone aft bulkhead were examined using a stereo microscope. Many areas showed post-fracture damage, but all remaining fracture features had rough matte gray features consistent with overstress fracture. Additionally, the aft bulkhead was sectioned and rivets were removed to facilitate examination of the fracture features for the crack that intersected the lower right attachment hole. After the crack was opened, the observed fracture features had a rough matte gray appearance consistent with overstress fracture. Using oblique lighting methods, the fracture features for the opened crack had a subtle radial pattern that emanated from the area of damage at the aft gusset section. No evidence of a preexisting crack was observed on any of the fractures in the tail cone aft bulkhead.

Figure 4. Close view of a crack intersecting both the lower right tail rotor housing attachment hole and the indicated area of contact damage on the aft flange.

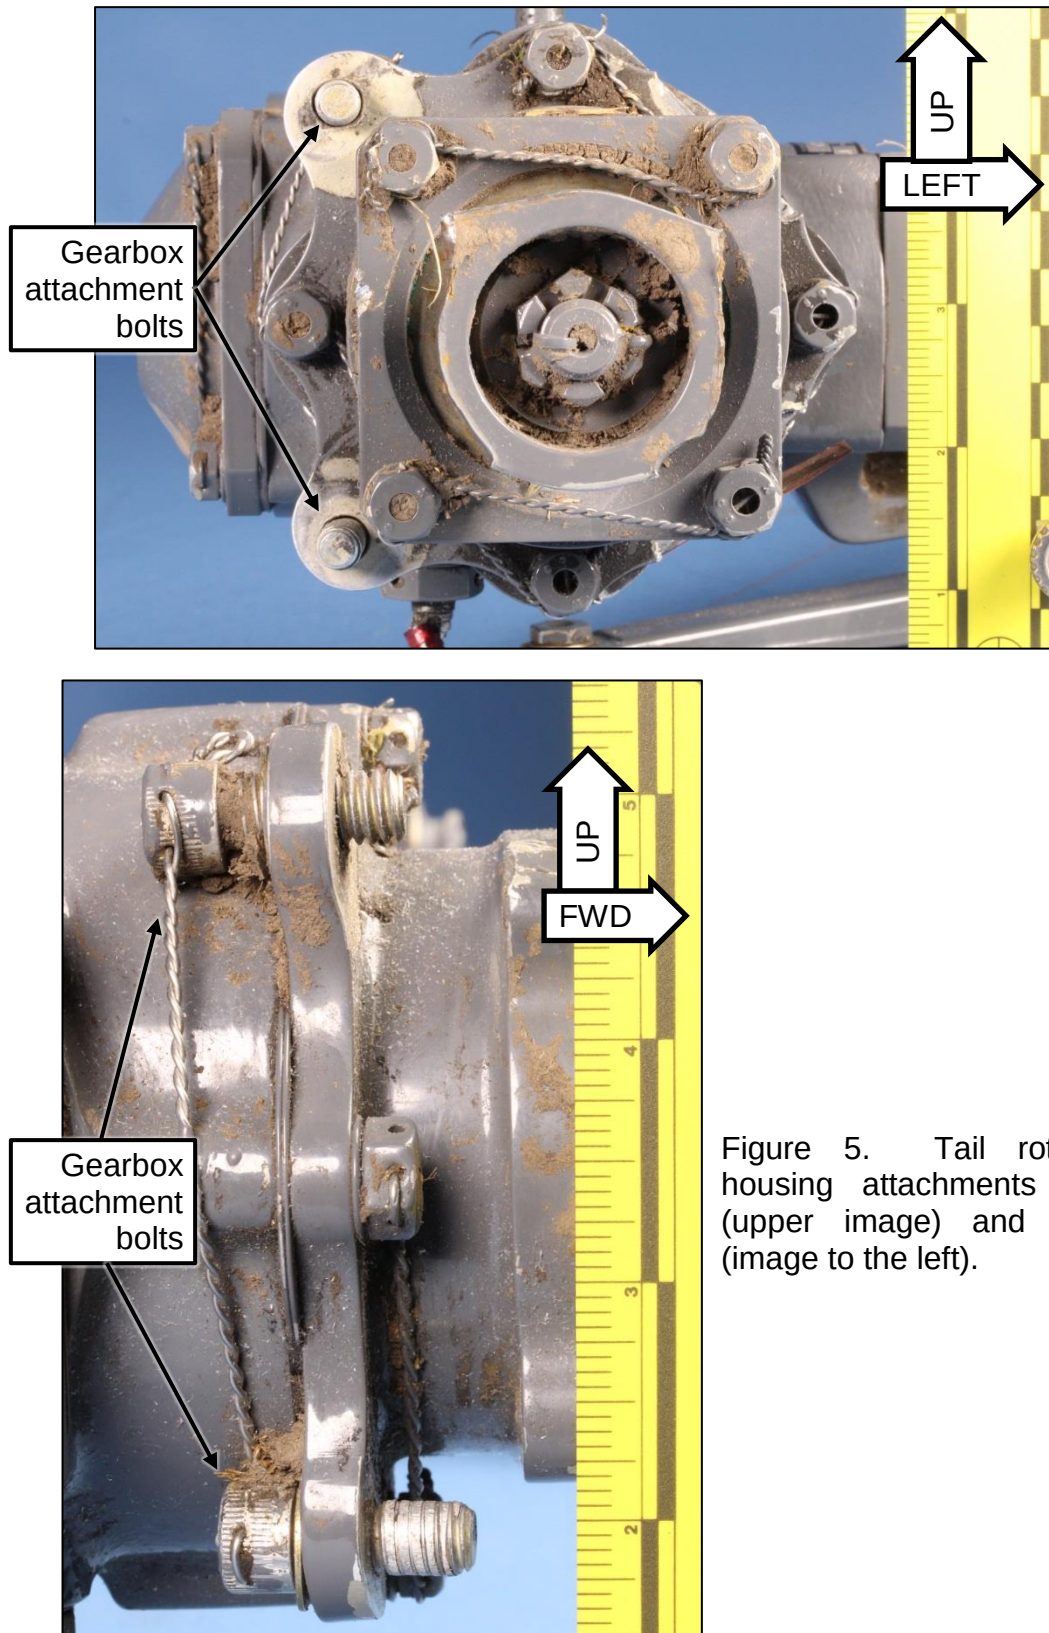
The attachment locations on the tail rotor gearbox housing are shown in figures 5 and 6. As shown in figure 5, the attachment bolts remained in place within the right side of the attachment flange. Thread remnants from the aft bulkhead were trapped within the threaded shank of the lower right attachment bolt. Ears of the flanges at the right side of the gearbox housing were bent slightly aft, consistent with the left side of the gearbox housing displacing aft relative to the attached right side.

Figure 5. Tail rotor gearbox housing attachments looking aft (upper image) and looking left (image to the left).

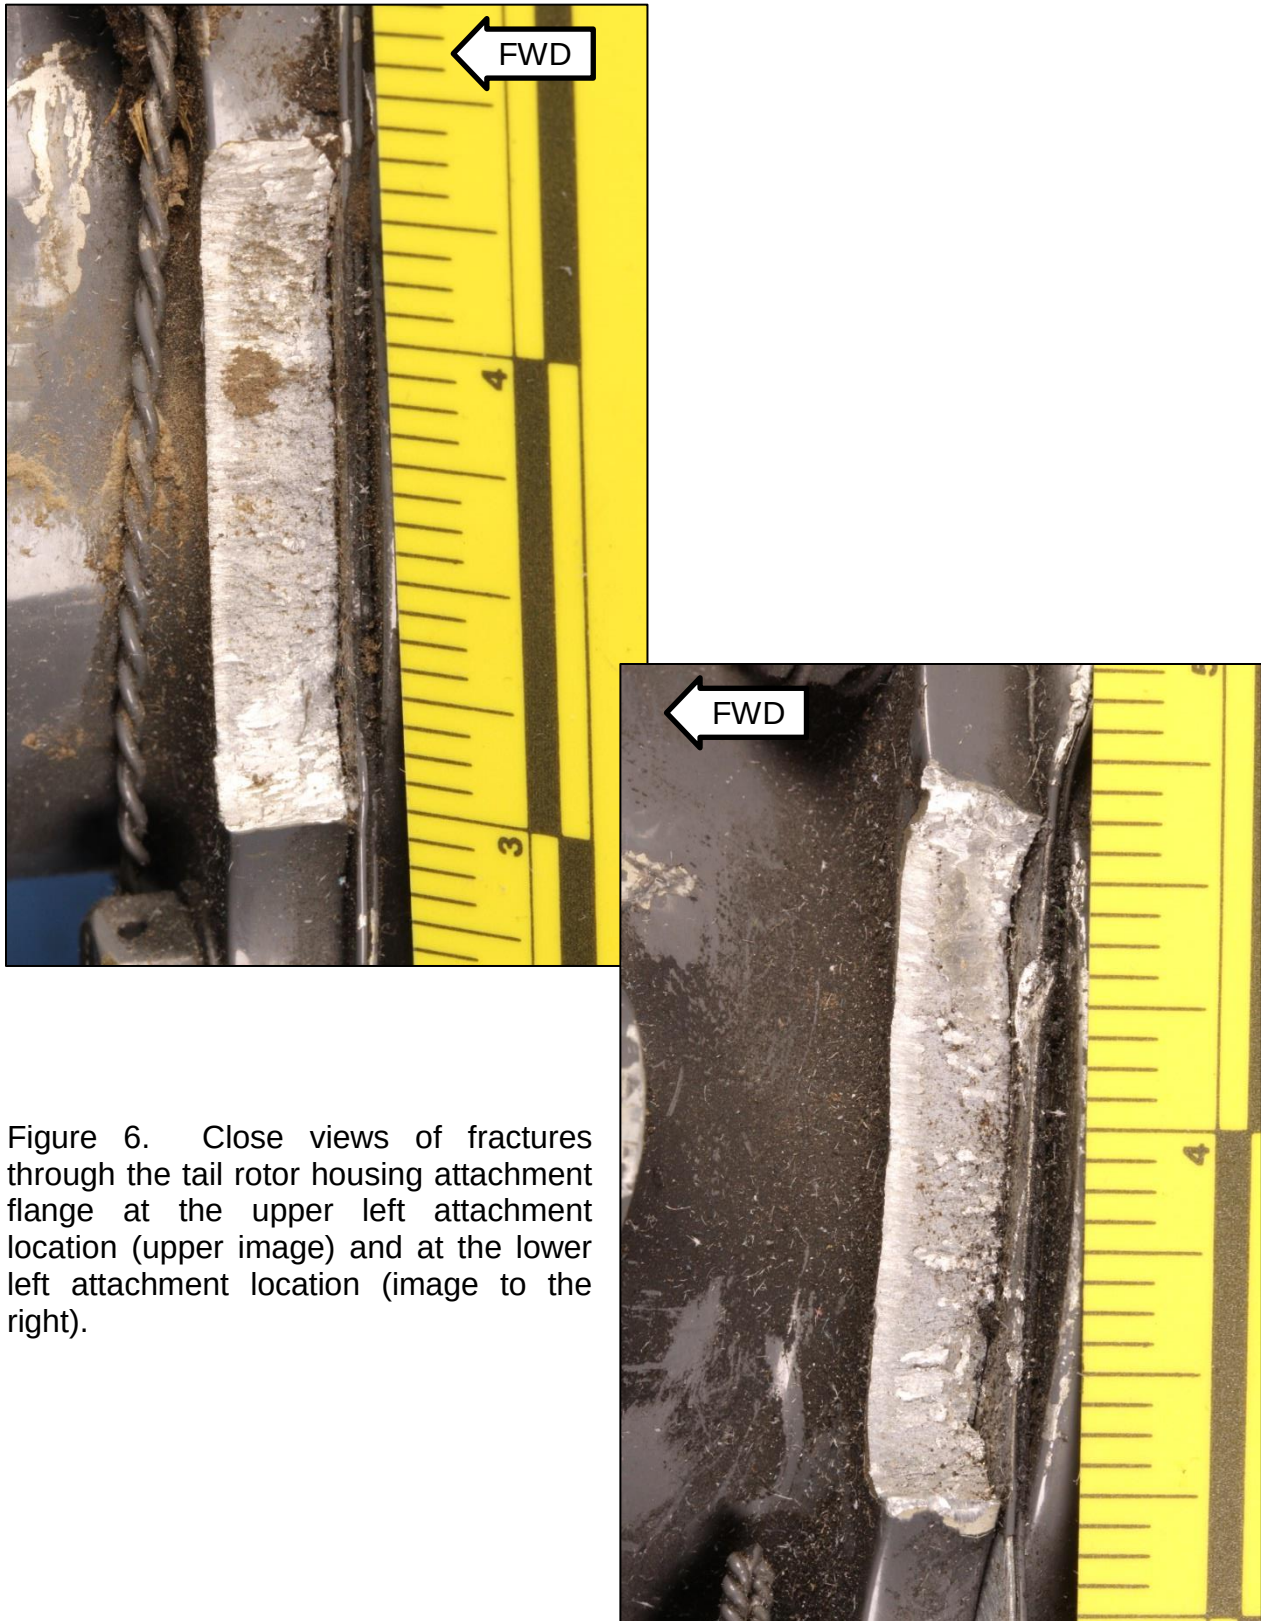
The tail rotor gearbox flange was fractured at the two attachment locations at the left side of the gearbox. Fracture features, shown in figure 6, were rough and matte gray consistent with overstress fracture. The forward edges of the inboard faces of the fractures had smeared features with a lip at the edge of the fracture consistent with sliding post-fracture contact with the mating side of the fracture as the tail rotor gearbox moved aft relative to the fractured flange pieces at the left side of the gearbox.

Figure 6. Close views of fractures through the tail rotor housing attachment flange at the upper left attachment location (upper image) and at the lower left attachment location (image to the right).

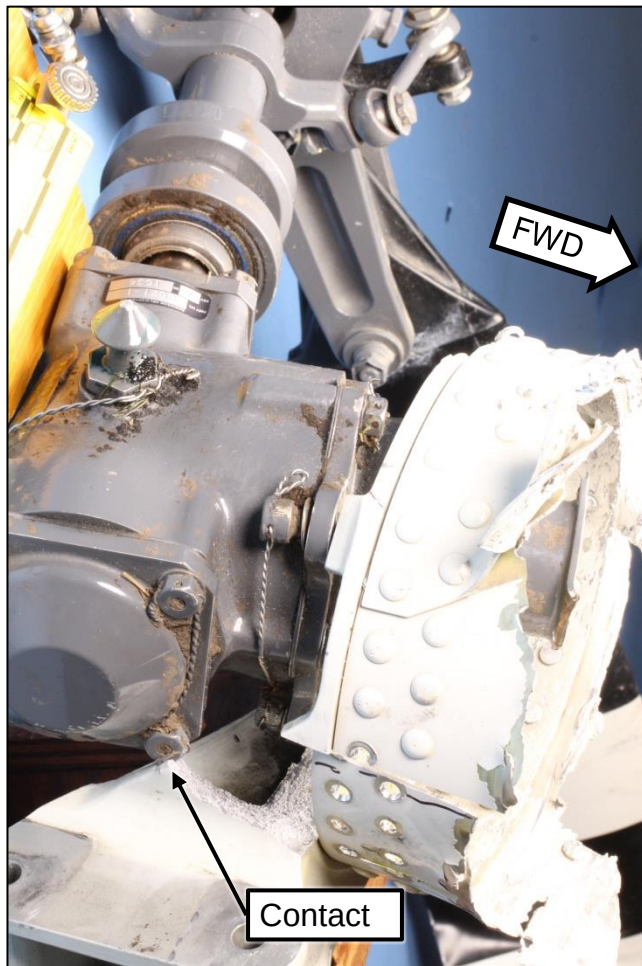
A view of the tail rotor gearbox positioned at the aft side of the aft bulkhead is shown in figure 7 with the left side of the gearbox displaced aft relative to the right side. In this view, the aft bulkhead had been sectioned and rivets removed to facilitate examination of the fracture features of the crack intersecting the lower right attachment hole. As shown in this view, the area of contact on the gusset section of the aft bulkhead (see figure 4) corresponded to contact with a bolt head on the displaced tail rotor gearbox.

Figure 7. Tail rotor gearbox positioned at the aft side of the tail cone aft bulkhead after sectioning to open the crack through the lower right attachment hole. An area of corresponding contact between a bolt head on the lower right side of the gearbox and corresponding deformation on the aft bulkhead is indicated. (See figure 4 for a view of the crack and contact damage on the aft bulkhead).

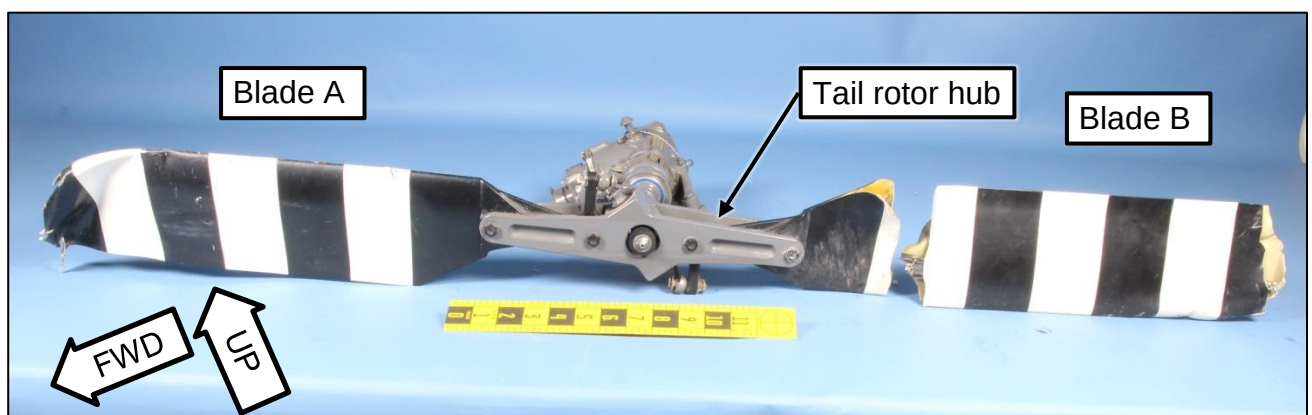
An overall view of the tail rotor hub and larger blade pieces is shown in figure 8 as viewed looking at the outboard faces. The hub was intact, but showed evidence of substantial teetering. The teeter stop shown in figure 9 had contact marks corresponding to heavy contact with the hub, and radial cracks were associated with the contact areas on diametrically opposite sides of the elastomer teeter stop. Heavy contact between the tail rotor output shaft and the hub associated with teetering was observed at the inboard side of the hub as shown in figure 10. Contact marks on the output shaft were observed on two diametrically opposite faces of the output shaft. Additionally, a contact mark was observed on the inboard face of the hub corresponding to contact with the pitch control assembly. The mark on the hub corresponding to contact with the pitch control assembly was only observed in the area shown in figure 10 and was not observed at the diametrically opposite side.

Figure 8. Overall view of the tail rotor hub and larger blade pieces.

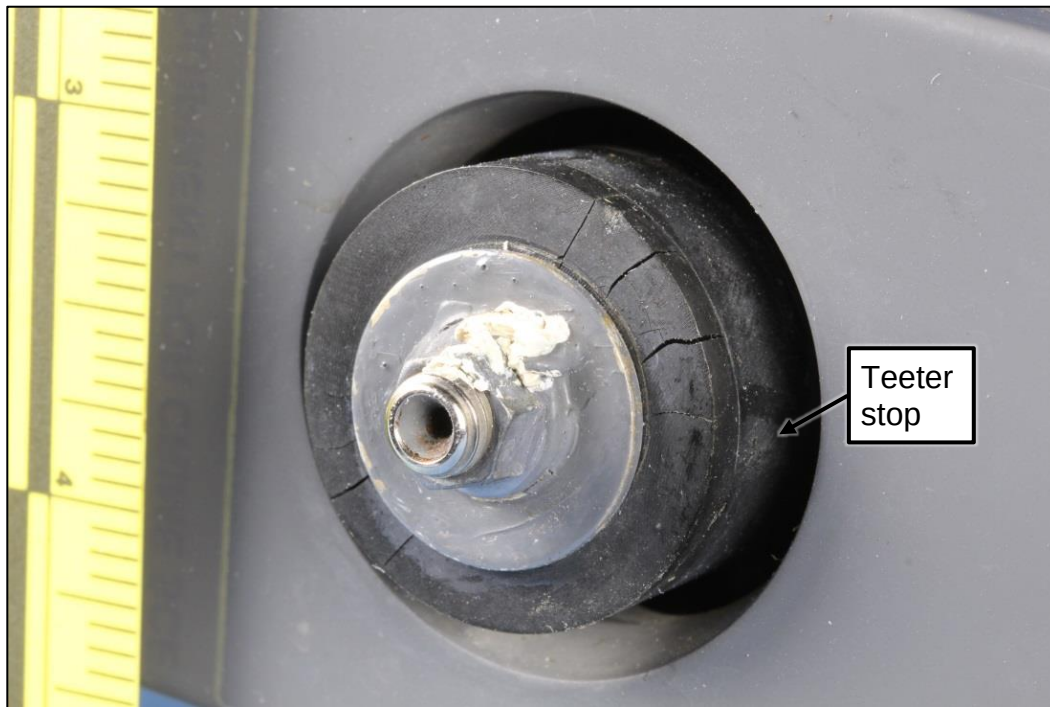
Figure 9. Close view of the teeter stop. The stop was deformed corresponding to contact with the hub, and radial cracks were present adjacent to the contact area.

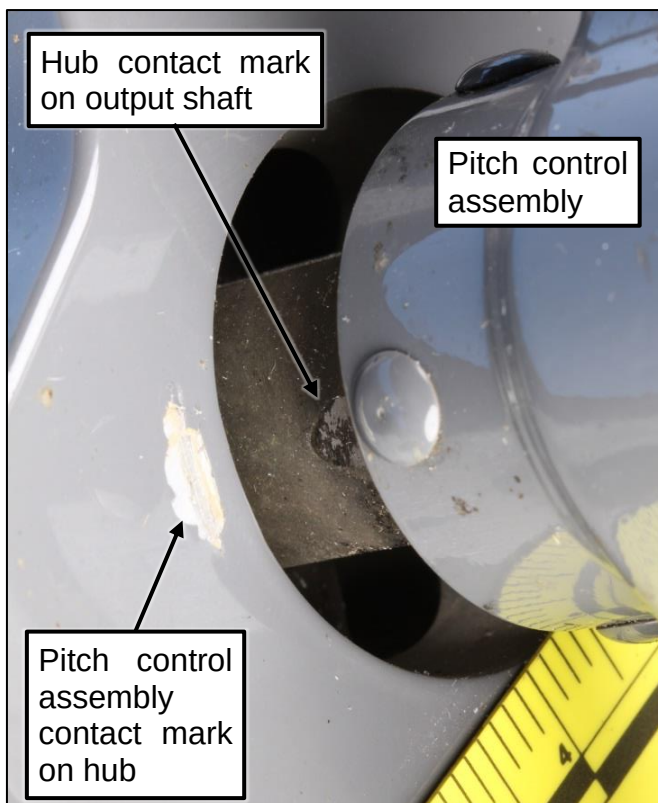
Figure 10. Inboard side of the hub showing contact areas between the hub and both the output shaft and the pitch control assembly.

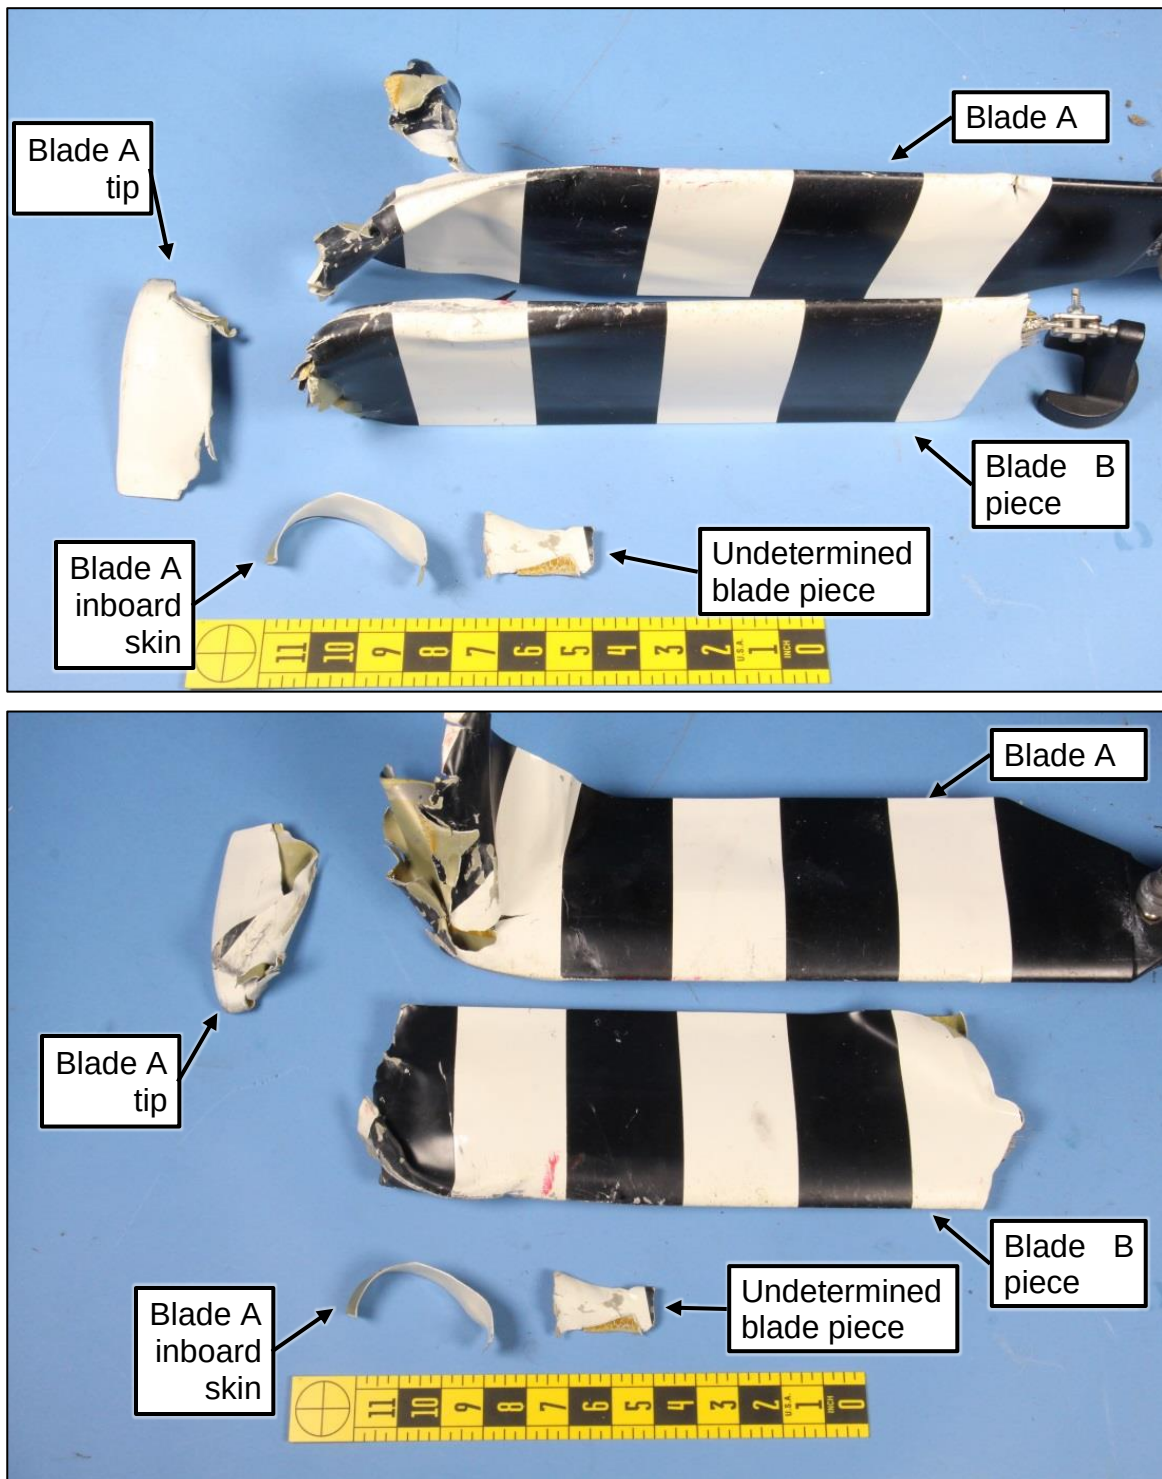
Overall views of the tail rotor blades are shown in figures 10 and 11. For reference in this report, the tail rotor blades were arbitrarily labeled A and B as shown in figure 10. Fracture matching (see figure 12) showed two of the separate pieces recovered from a blade tip were from blade A as identified in figure 11.

The middle portion of blade B is placed adjacent to blade A in figure 11. The tips of both blades were fractured in nearly the same location with leading edge crushing and deformation toward the trailing edge. Also, the leading edge of blade A had a crack at nearly the same location as the fractured inboard end of the blade B piece shown in figure 11.

Figure 11. Blades A and B placed side by side showing symmetric damage patterns looking at both the outboard (upper image) and inboard (lower image) faces of the blades.

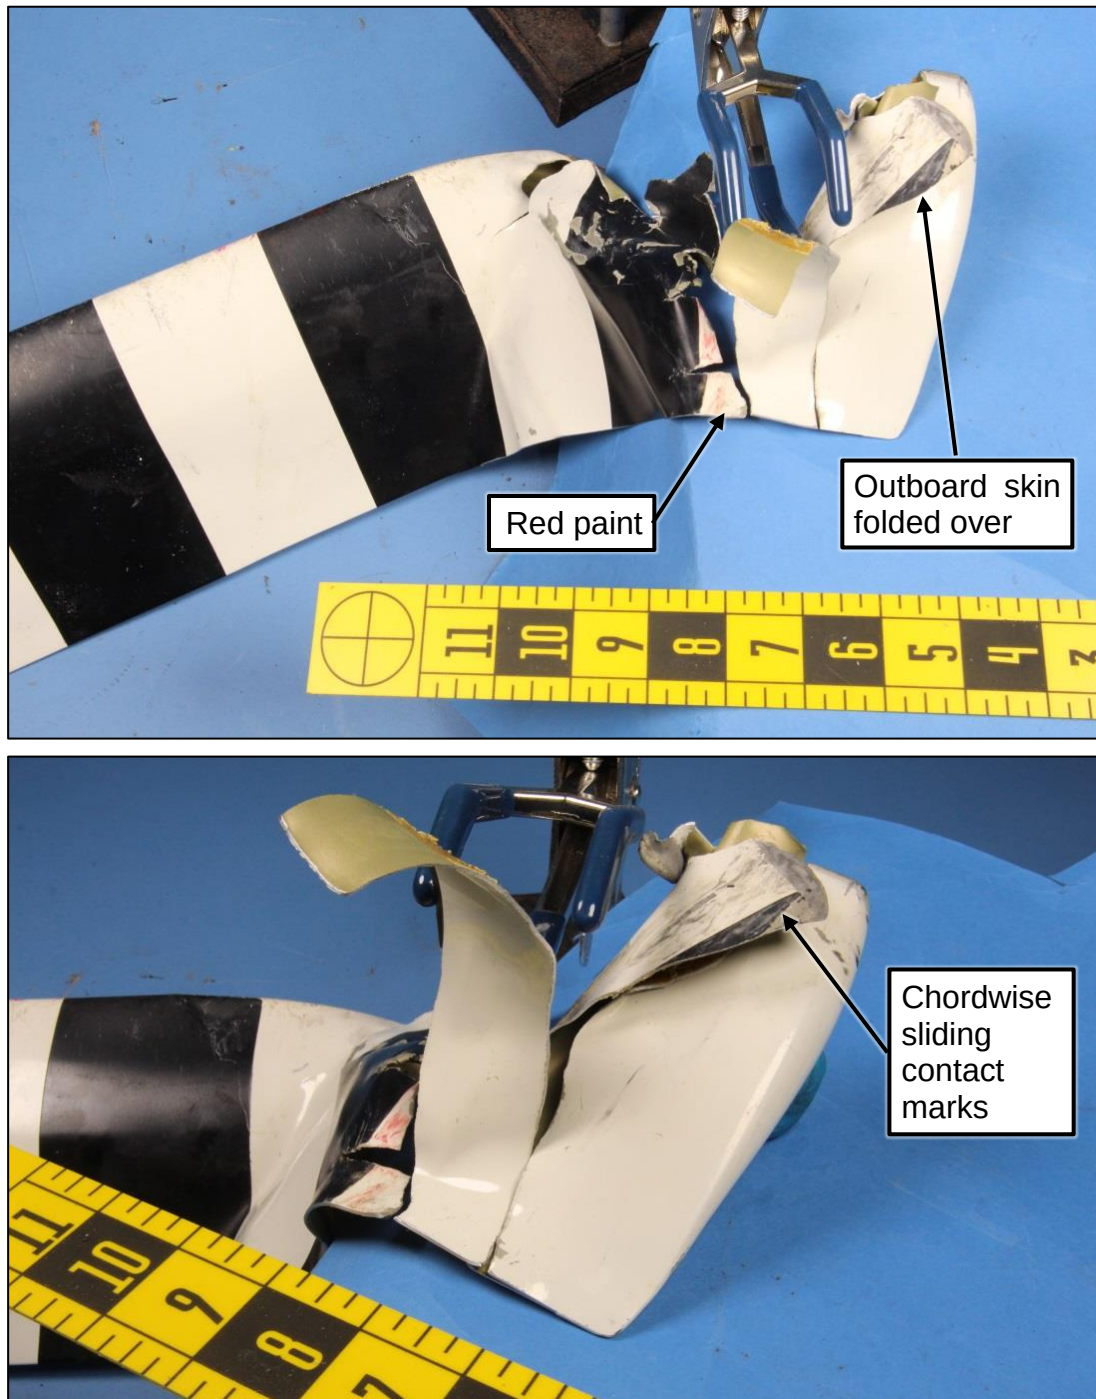
Views of the inboard face of blade A at the tip end with mating fractures placed adjacent to each other are shown in figure 12. Red paint transfer was observed on the inboard side of the fracture near the trailing edge, but the paint transfer did not continue across the fracture to the adjacent fractured skin piece. The inboard skin of the blade was crushed from the leading edge and displaced inboard. On the tip piece, the outboard skin was folded over the inboard face as indicated in the upper image in figure 12. Two sets of overlapping sliding contact marks were observed on face of the folded piece of outboard skin. The underlying sliding contact marks were oriented in the chordwise direction corresponding to the original position of the outboard skin. Overlapping sliding contact marks were angled relative to the underlying marks and were oriented in the chordwise direction corresponding to the folded position shown in figure 12.

Figure 12. Two views of the tip end of blade A, inboard face, with mating fractures placed in close proximity. The outboard skin of the blade tip piece was folded over the inboard face with chordwise sliding contact marks aligned with the original orientation and overlapping sliding contact marks oriented chordwise in the folded position.

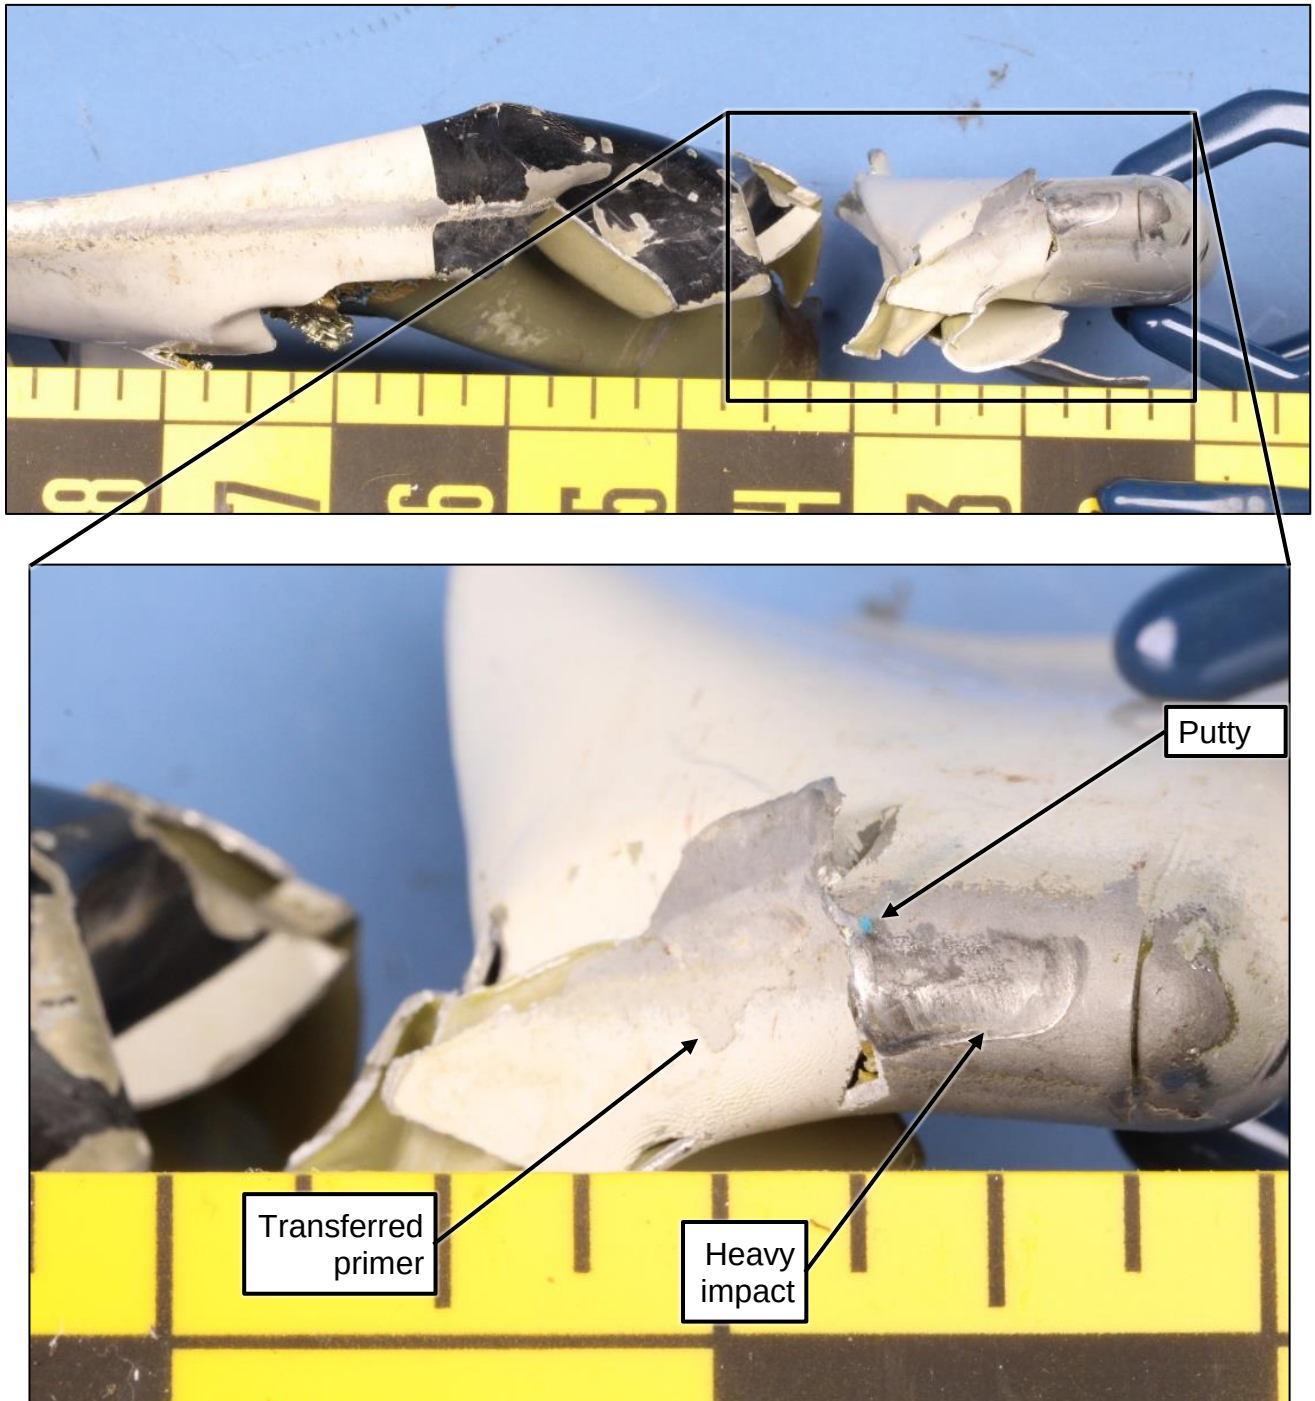
Close views of the crushed leading edge of the blade A tip area are shown in figure 13. Heavy impact consistent with contact with a metallic object was observed at the blade tip leading edge as indicated in figure 13. Adjacent to the heavy contact area, the leading edge was crushed, and gray material consistent with primer was observed on the leading edge surface, also indicated in figure 13. The primer material was analyzed using energy dispersive x-ray spectroscopy (EDS). Additionally, a sample of paint and primer was sampled from the tail cone and also analyzed using EDS. The EDS spectrum of the transferred primer on the blade A leading edge was comparable to the primer sampled from the tail cone.

Figure 13. Blade A leading edge tip damage showing an area of heavy impact and an area of transferred material consistent with primer.

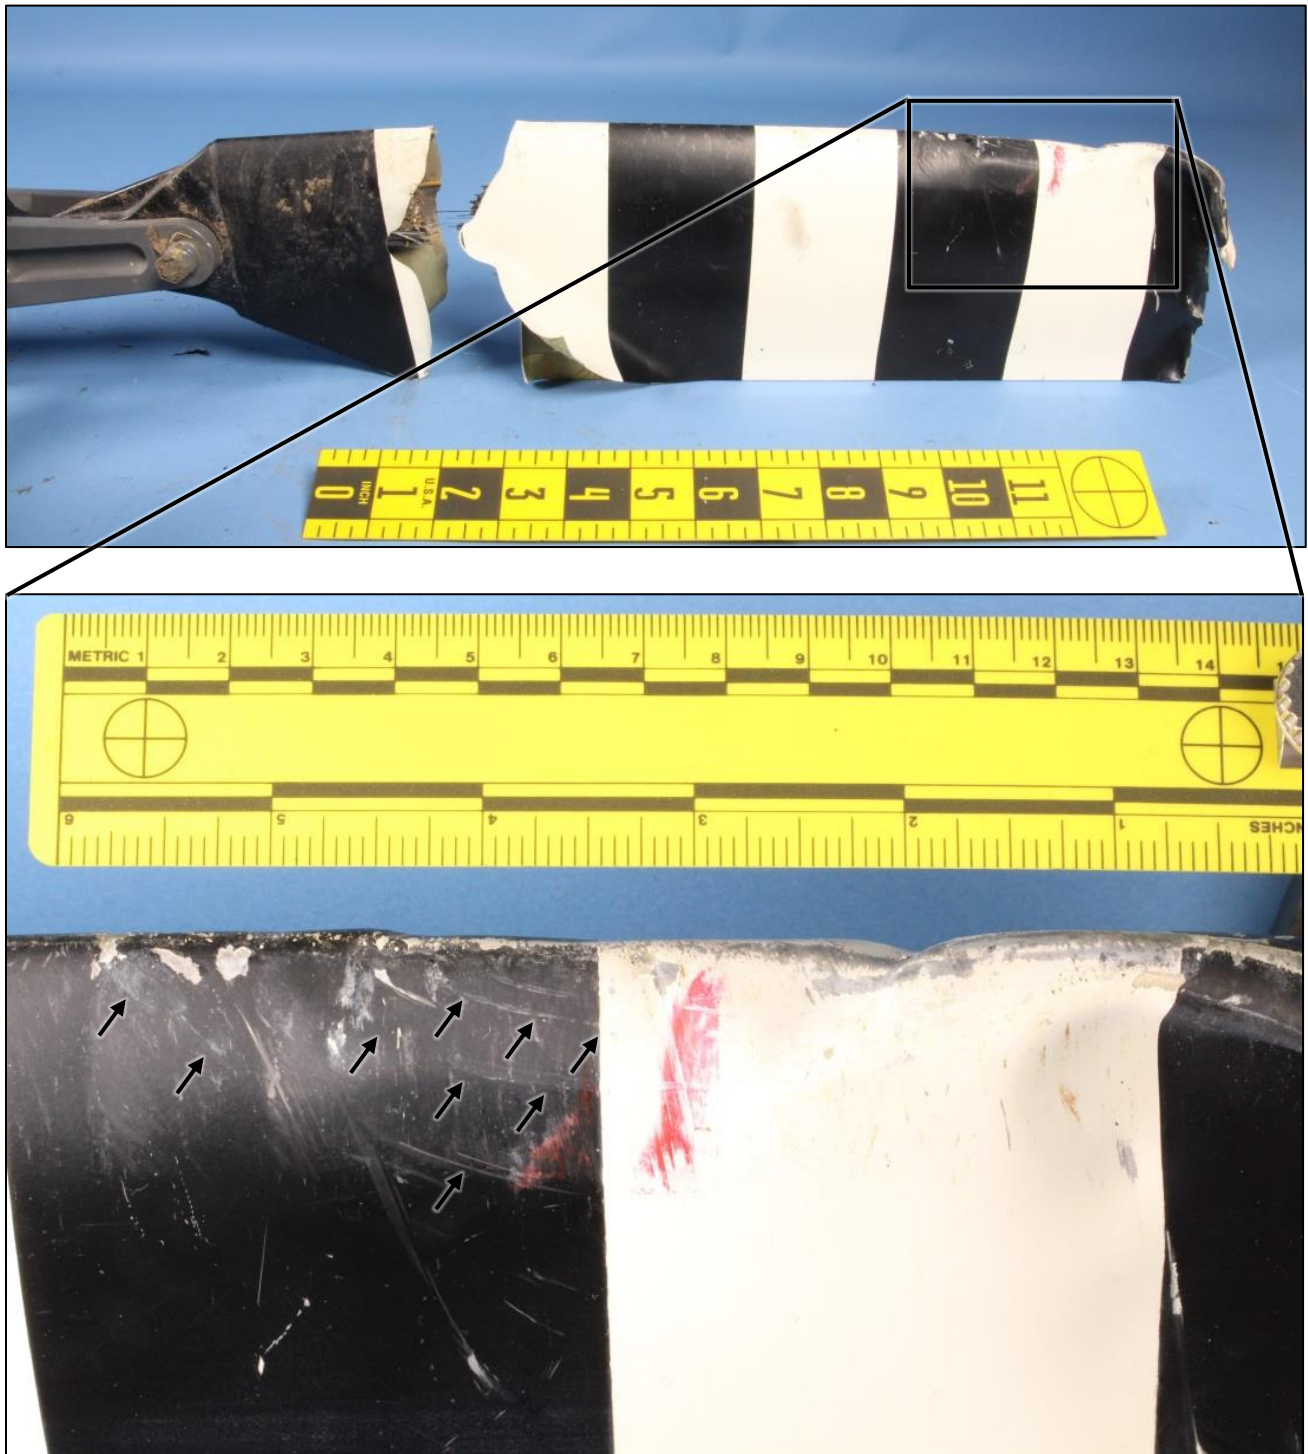
Impact marks and paint transfer at the leading edge of blade B are shown in figure 14. The leading edge was deformed, and sliding contact marks and paint transfer were present on the inboard face as shown in the lower image in figure 14. Unlabeled arrows in figure 14 indicate sliding contact marks associated with white paint transfer. The contact marks curved from the leading edge toward a spanwise orientation toward the tip, crossing over the area of red paint transfer.

Figure 14. Inboard side of blade B leading edge showing an area of contact damage and paint transfer marks. Unlabeled arrows in the lower image indicate sliding contact marks with white paint transfer curving from the leading edge toward the spanwise direction toward the blade tip.

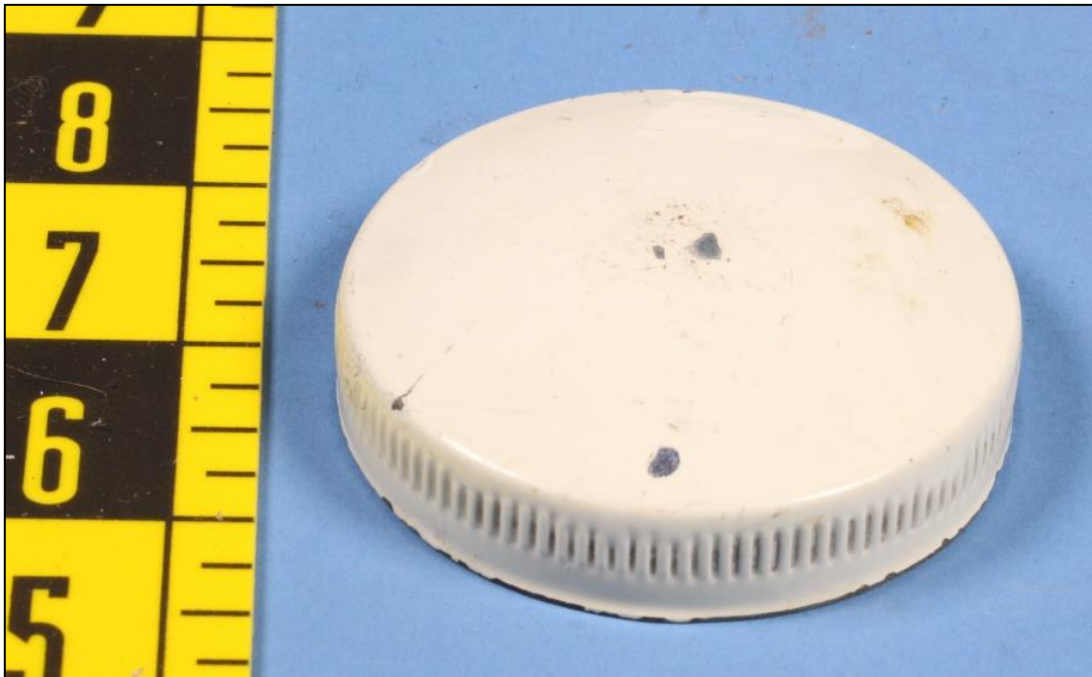
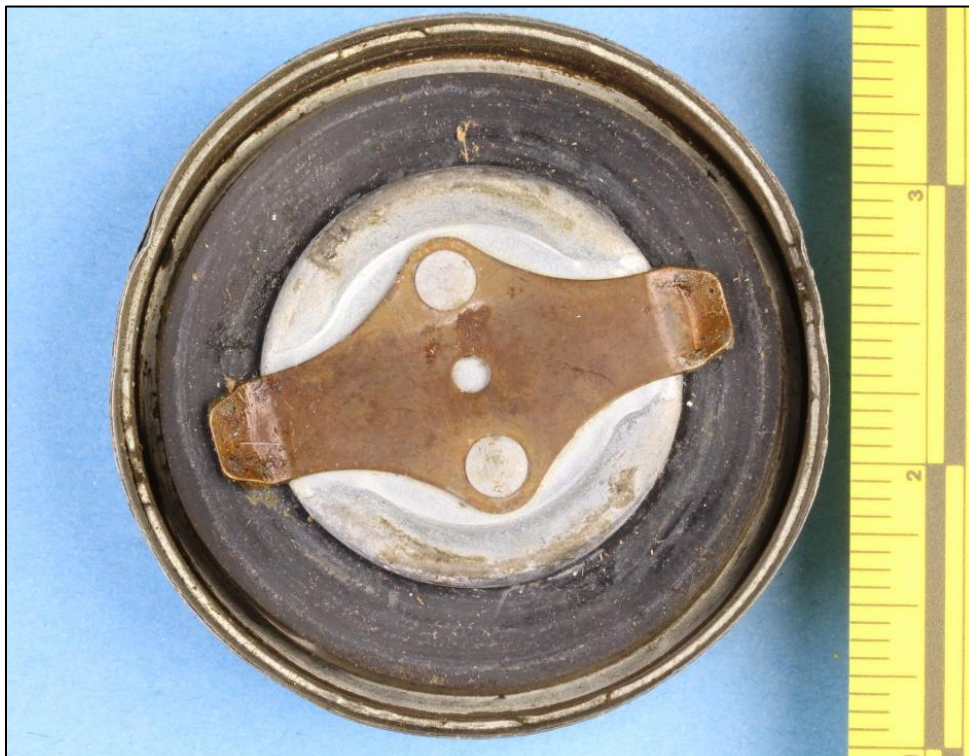
The fuel cap was recovered near the start of the debris trail from the accident helicopter. Close views of the fuel cap are shown in figure 15. No evidence of heavy impact marks or paint transfer from the tail rotor blades were observed on the fuel cap.

Figure 15. Exterior (upper image) and interior (lower image) faces of the fuel cap.
