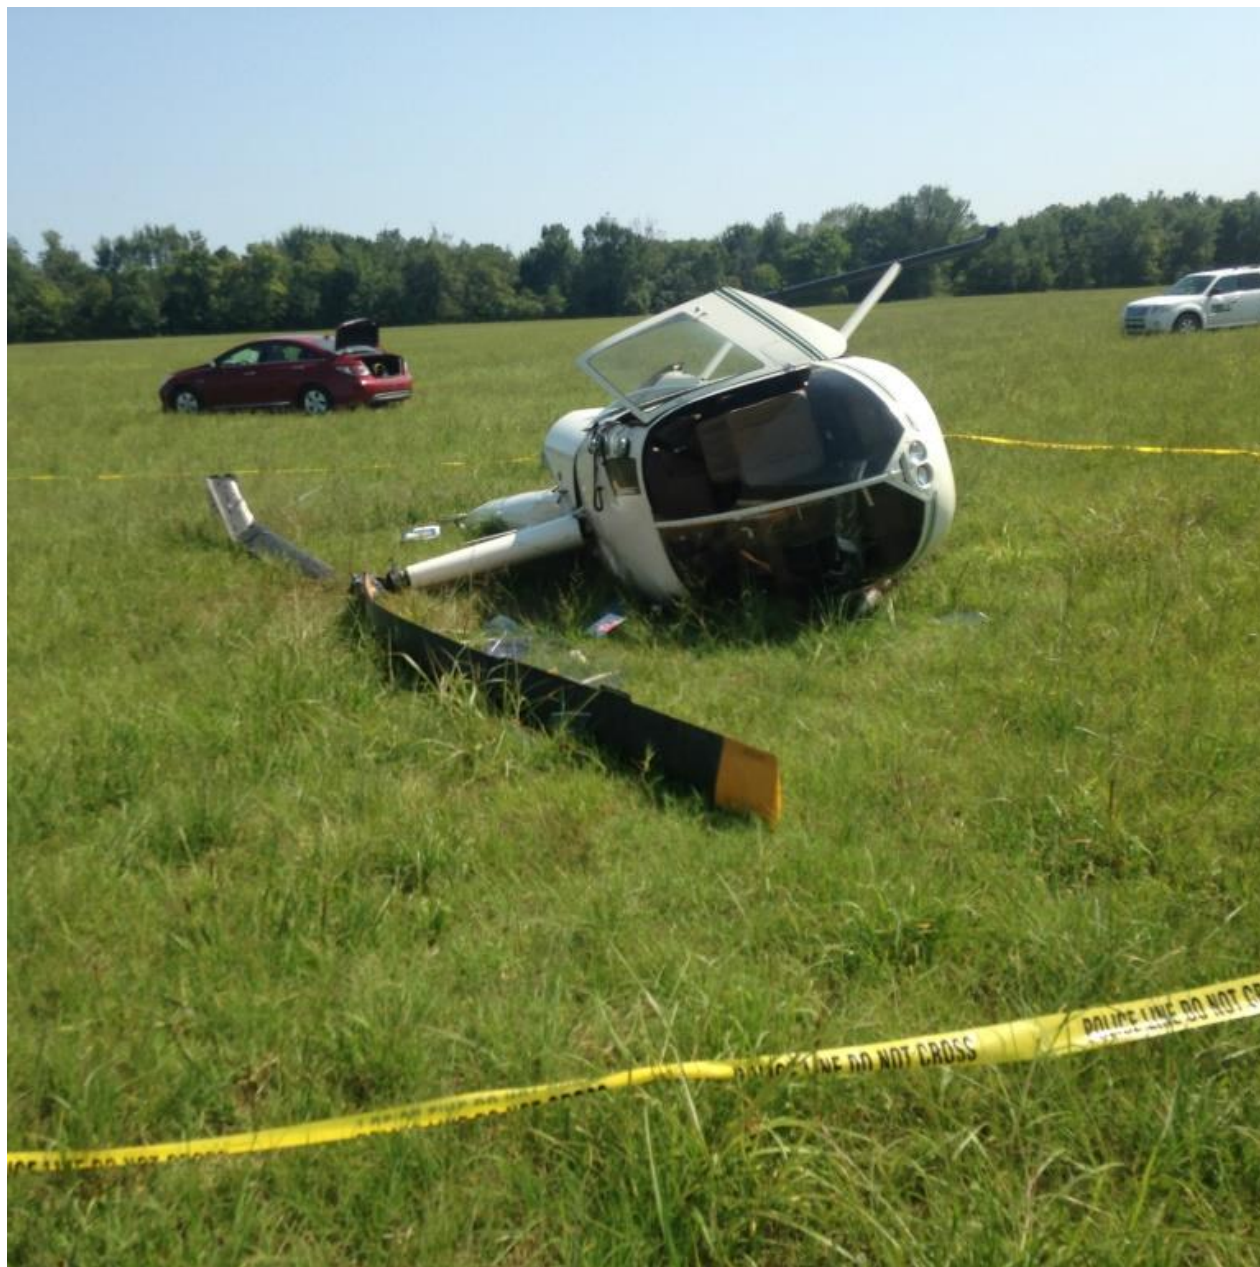
**Photo 1 – View from the front of the R-44 laying on its side**

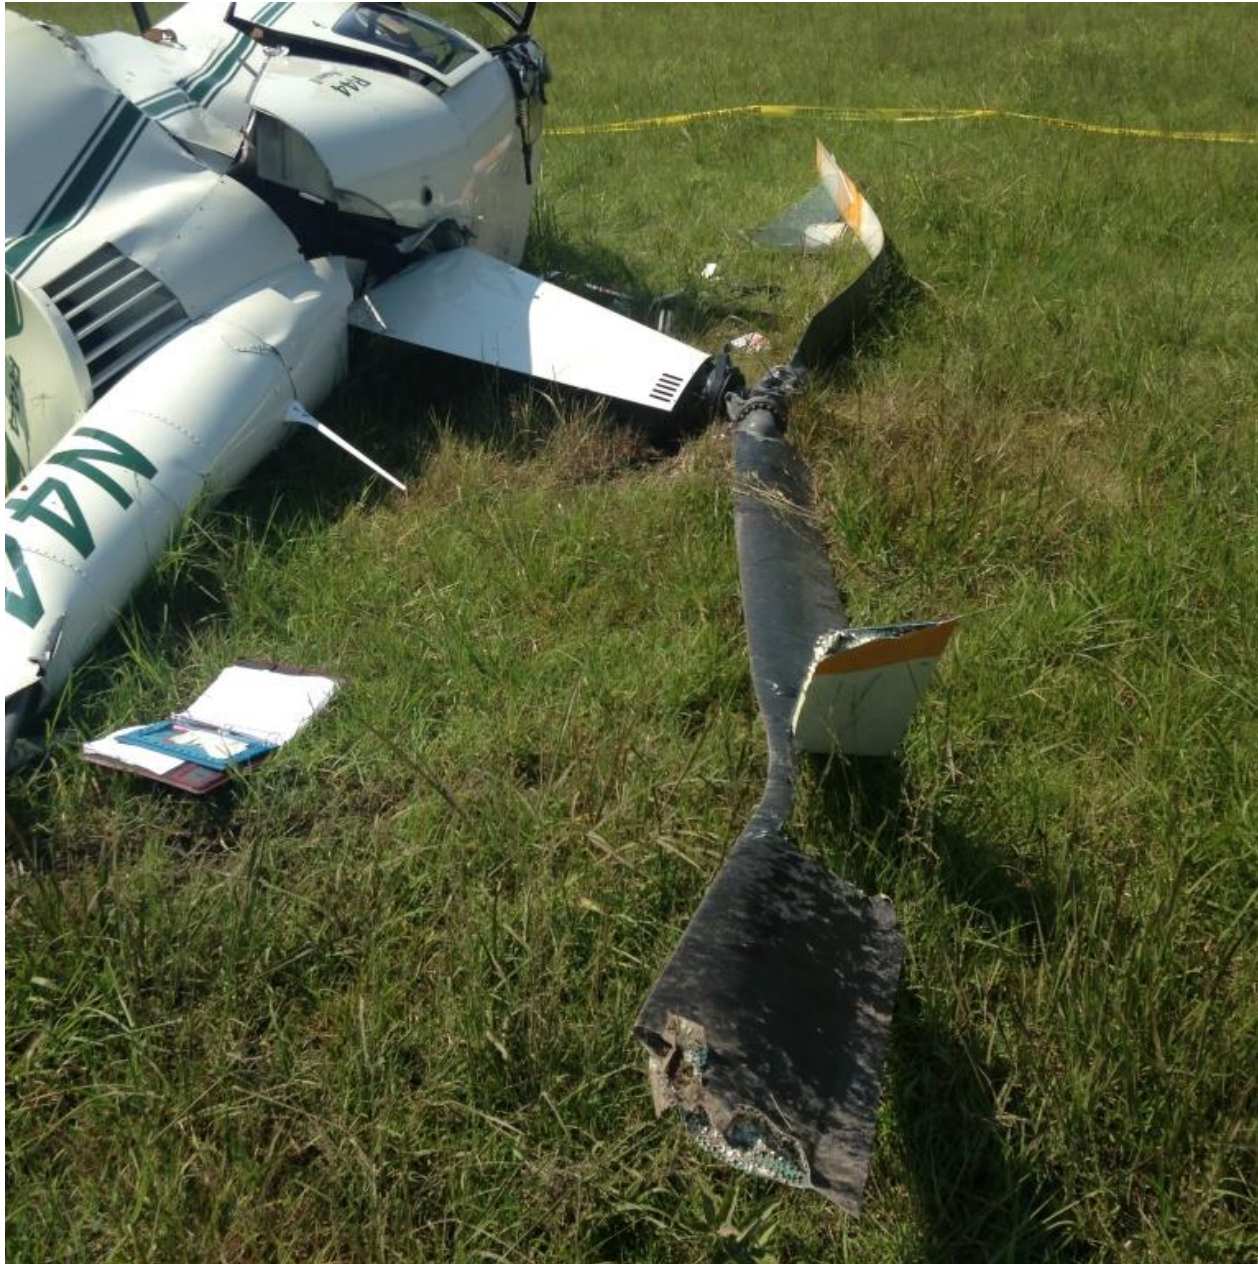
**Photo 2 – View of the main rotor blades and top of the helicopter**

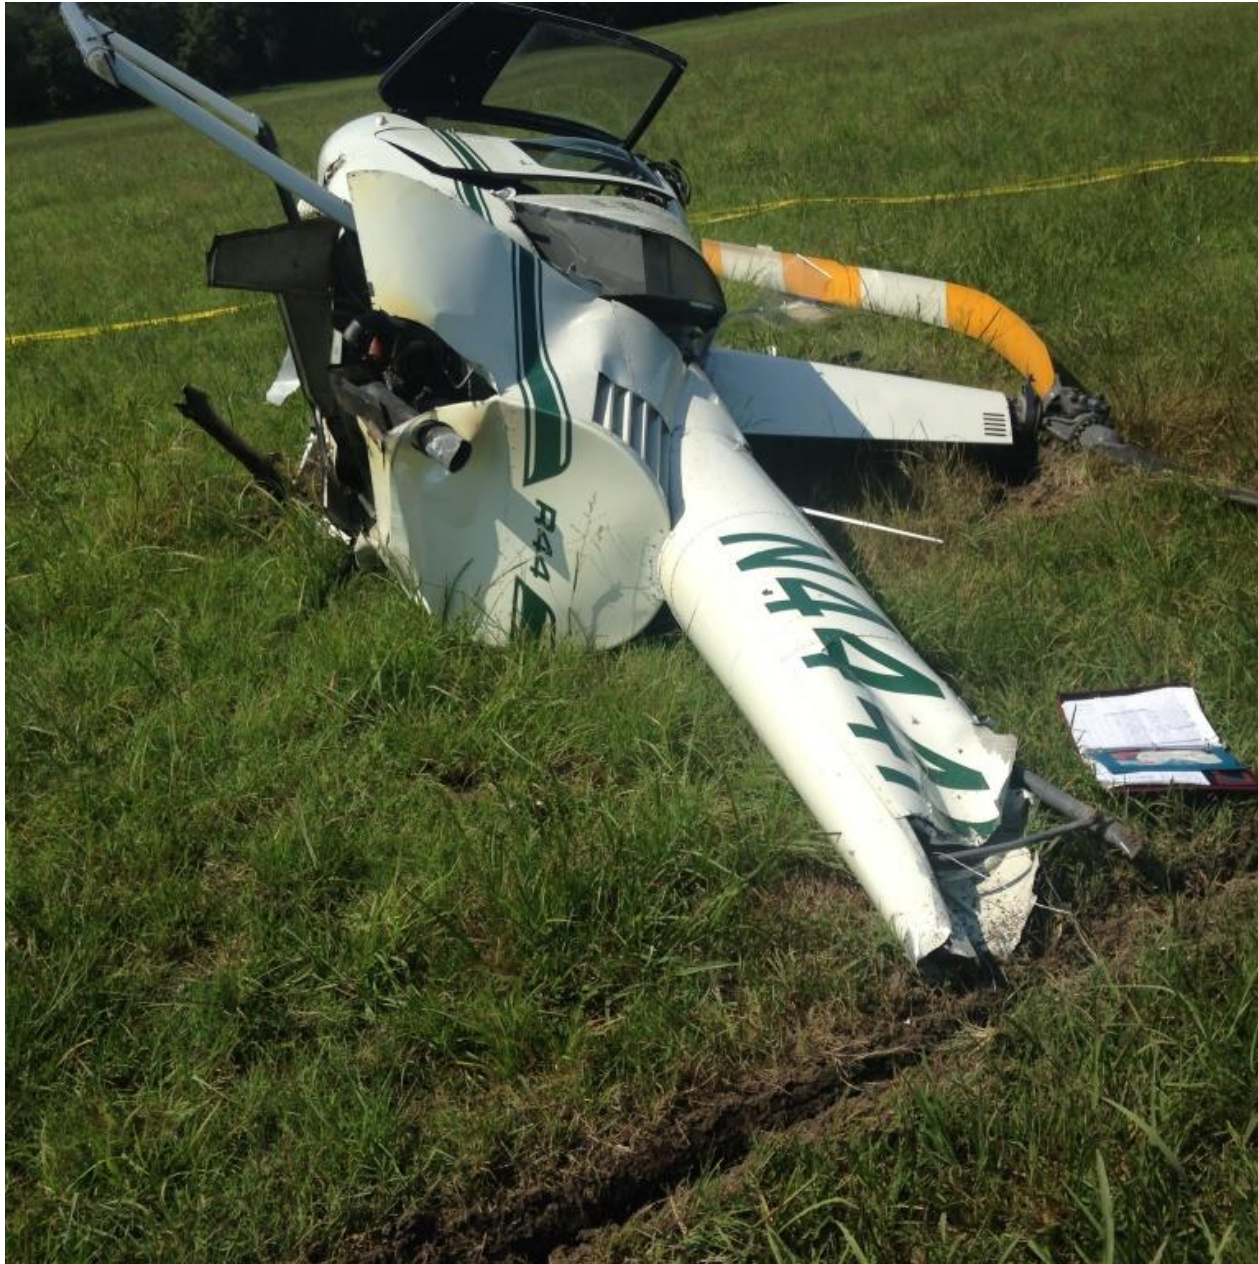
**Photo 3 – View of the helicopter from the rear**

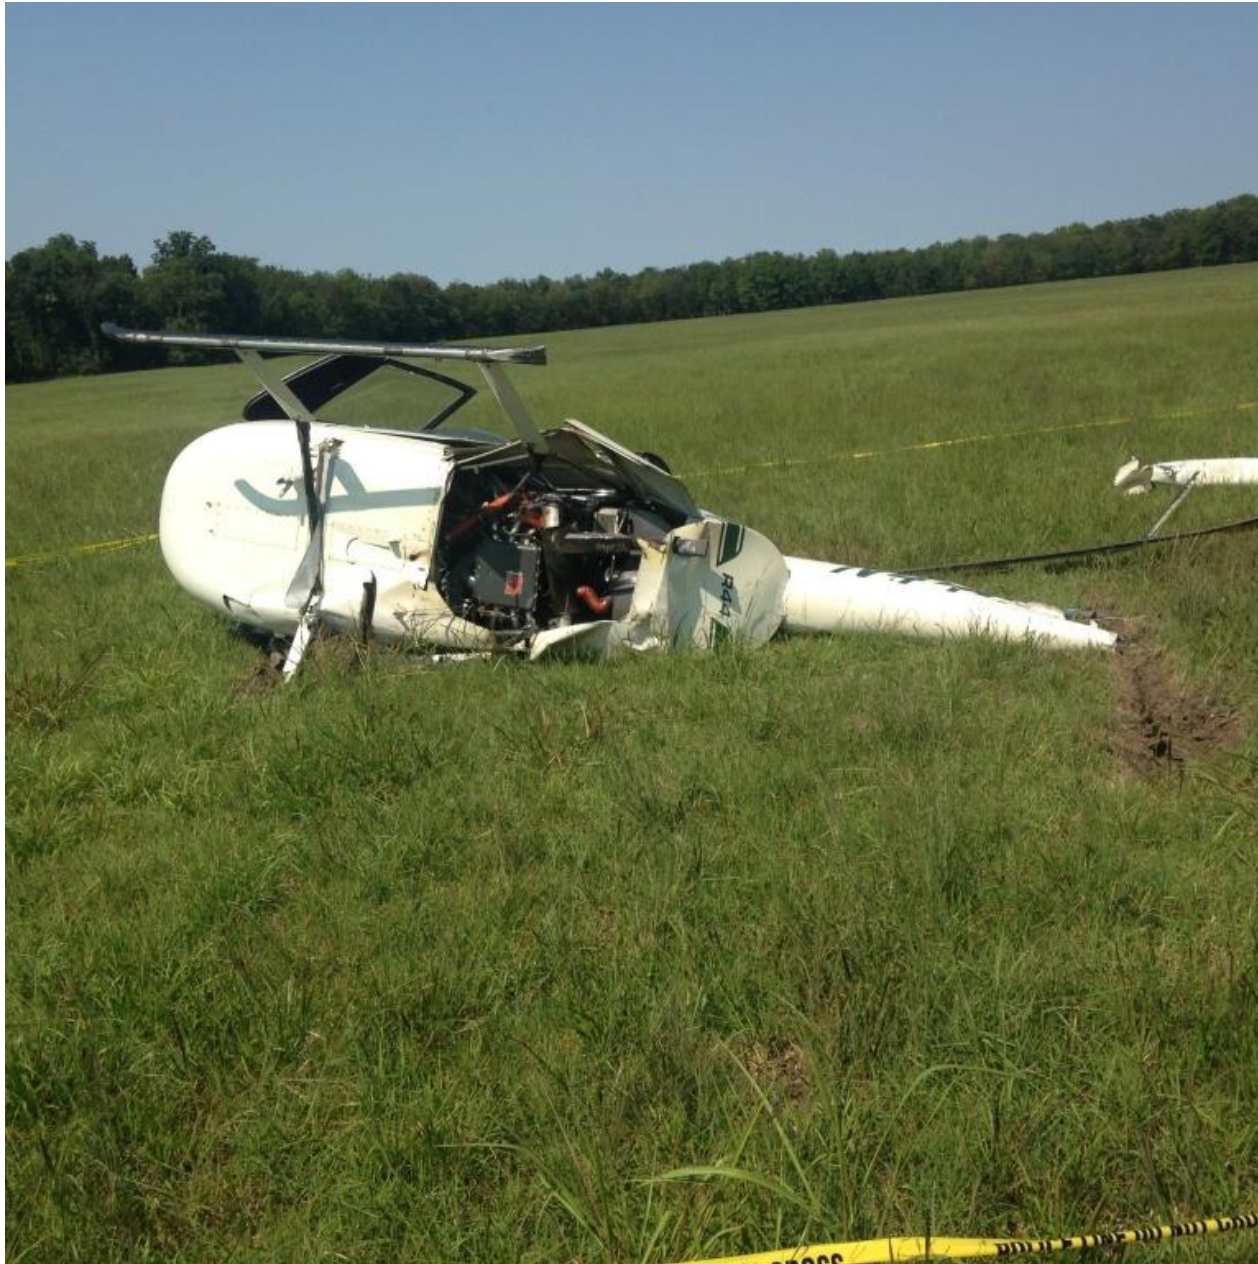
**Photo 4 – View of the underside of the helicopter**

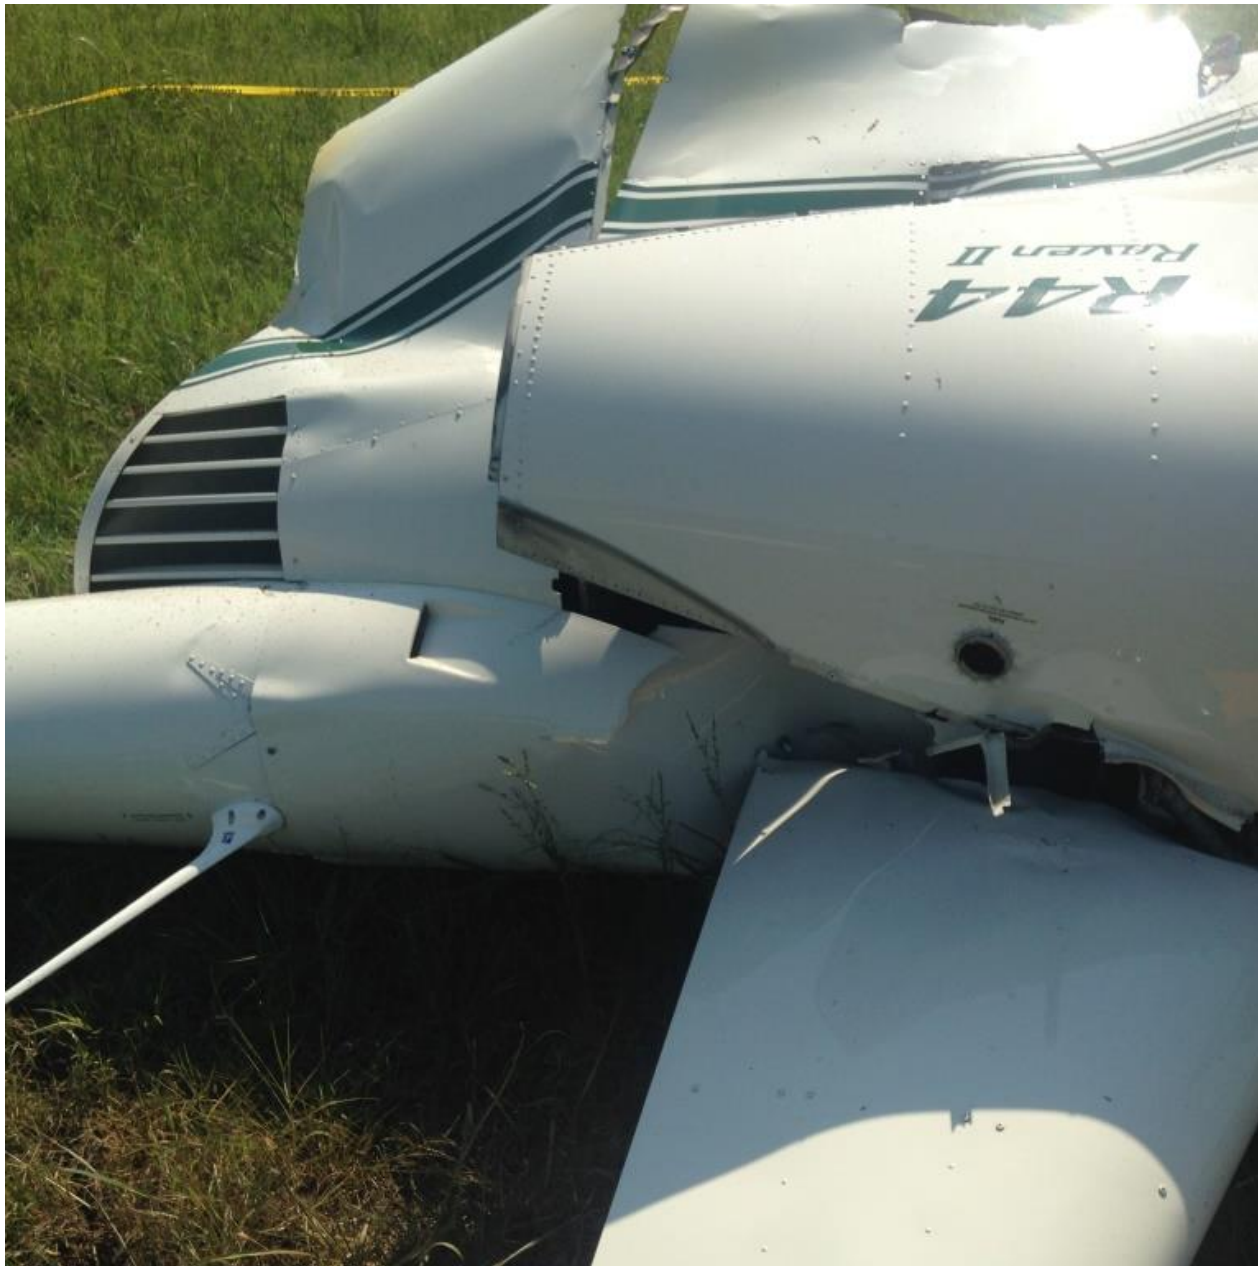
**Photo 5 – View of the top of the helicopter**

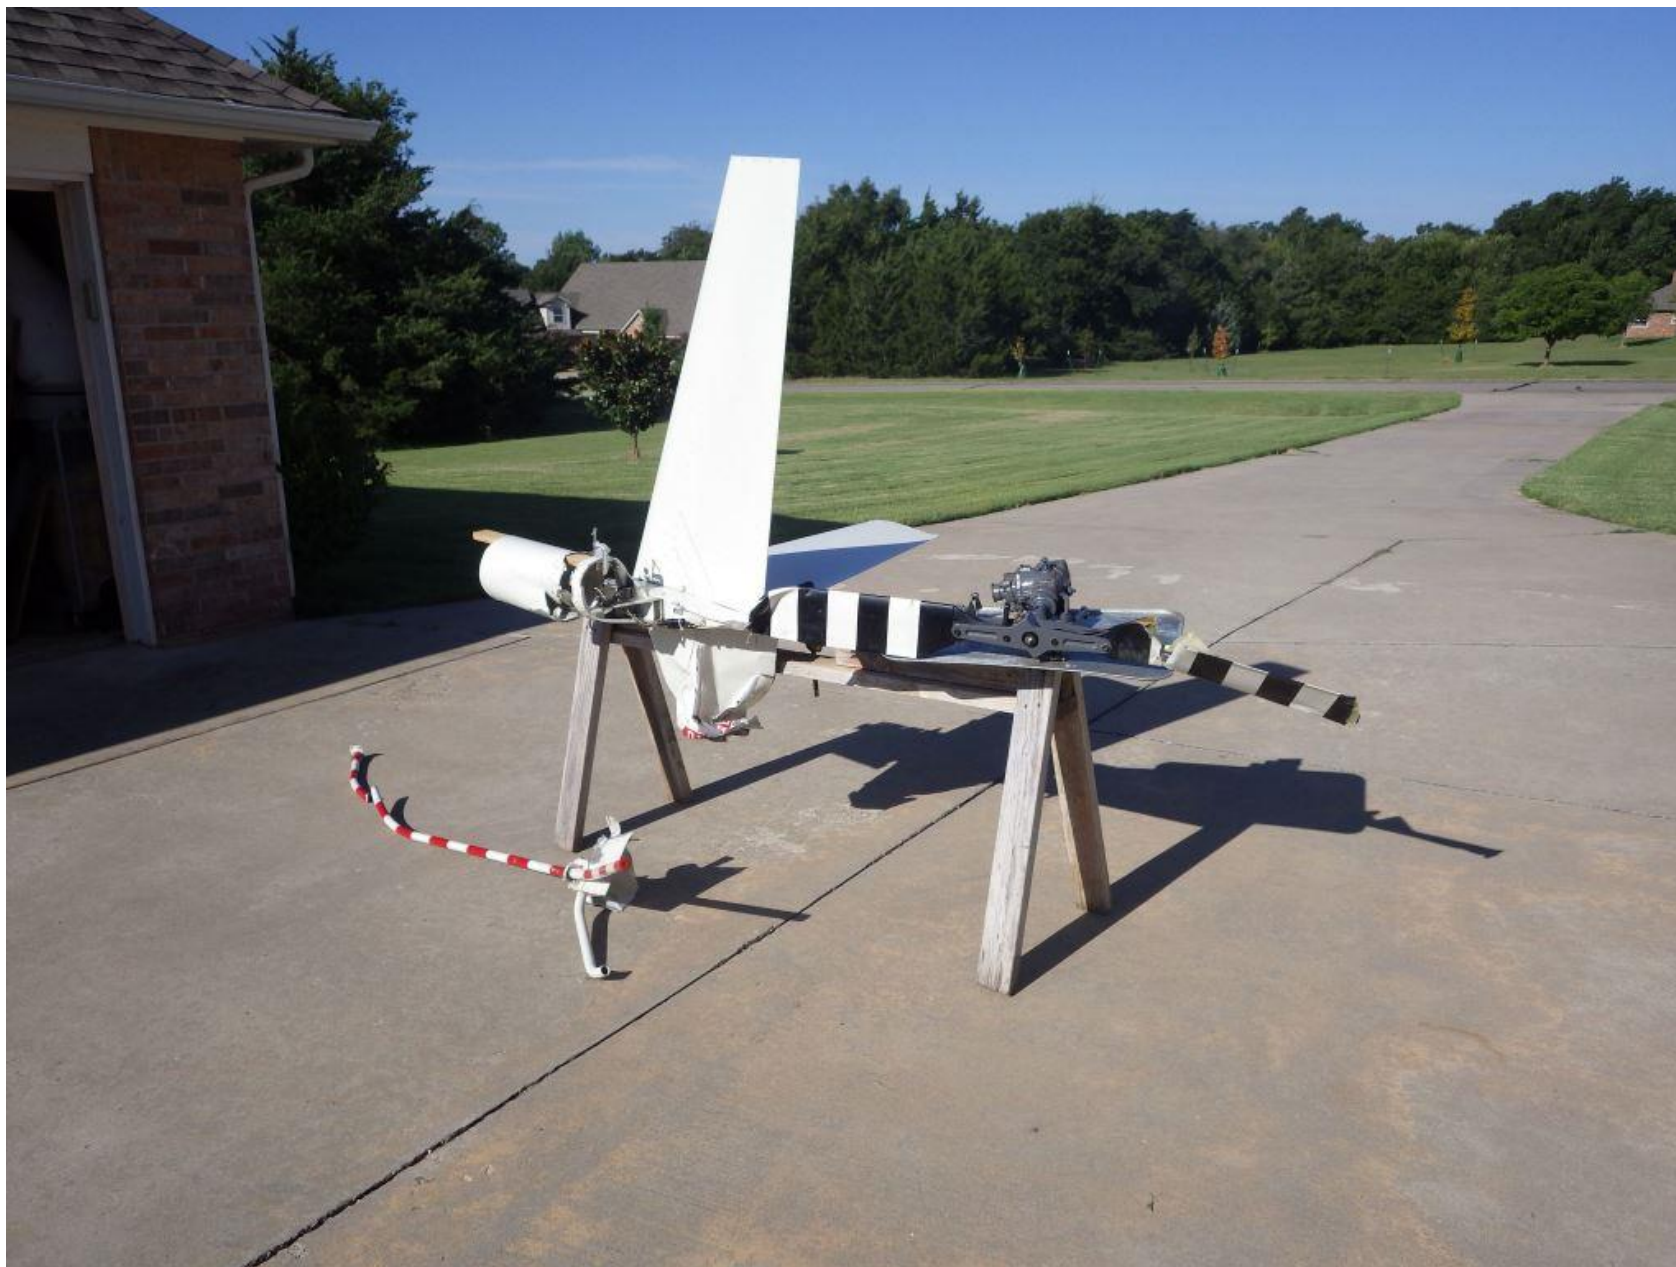
**Photo 6 – A mockup of the empennage and tail rotor gearbox and tail rotor blades**

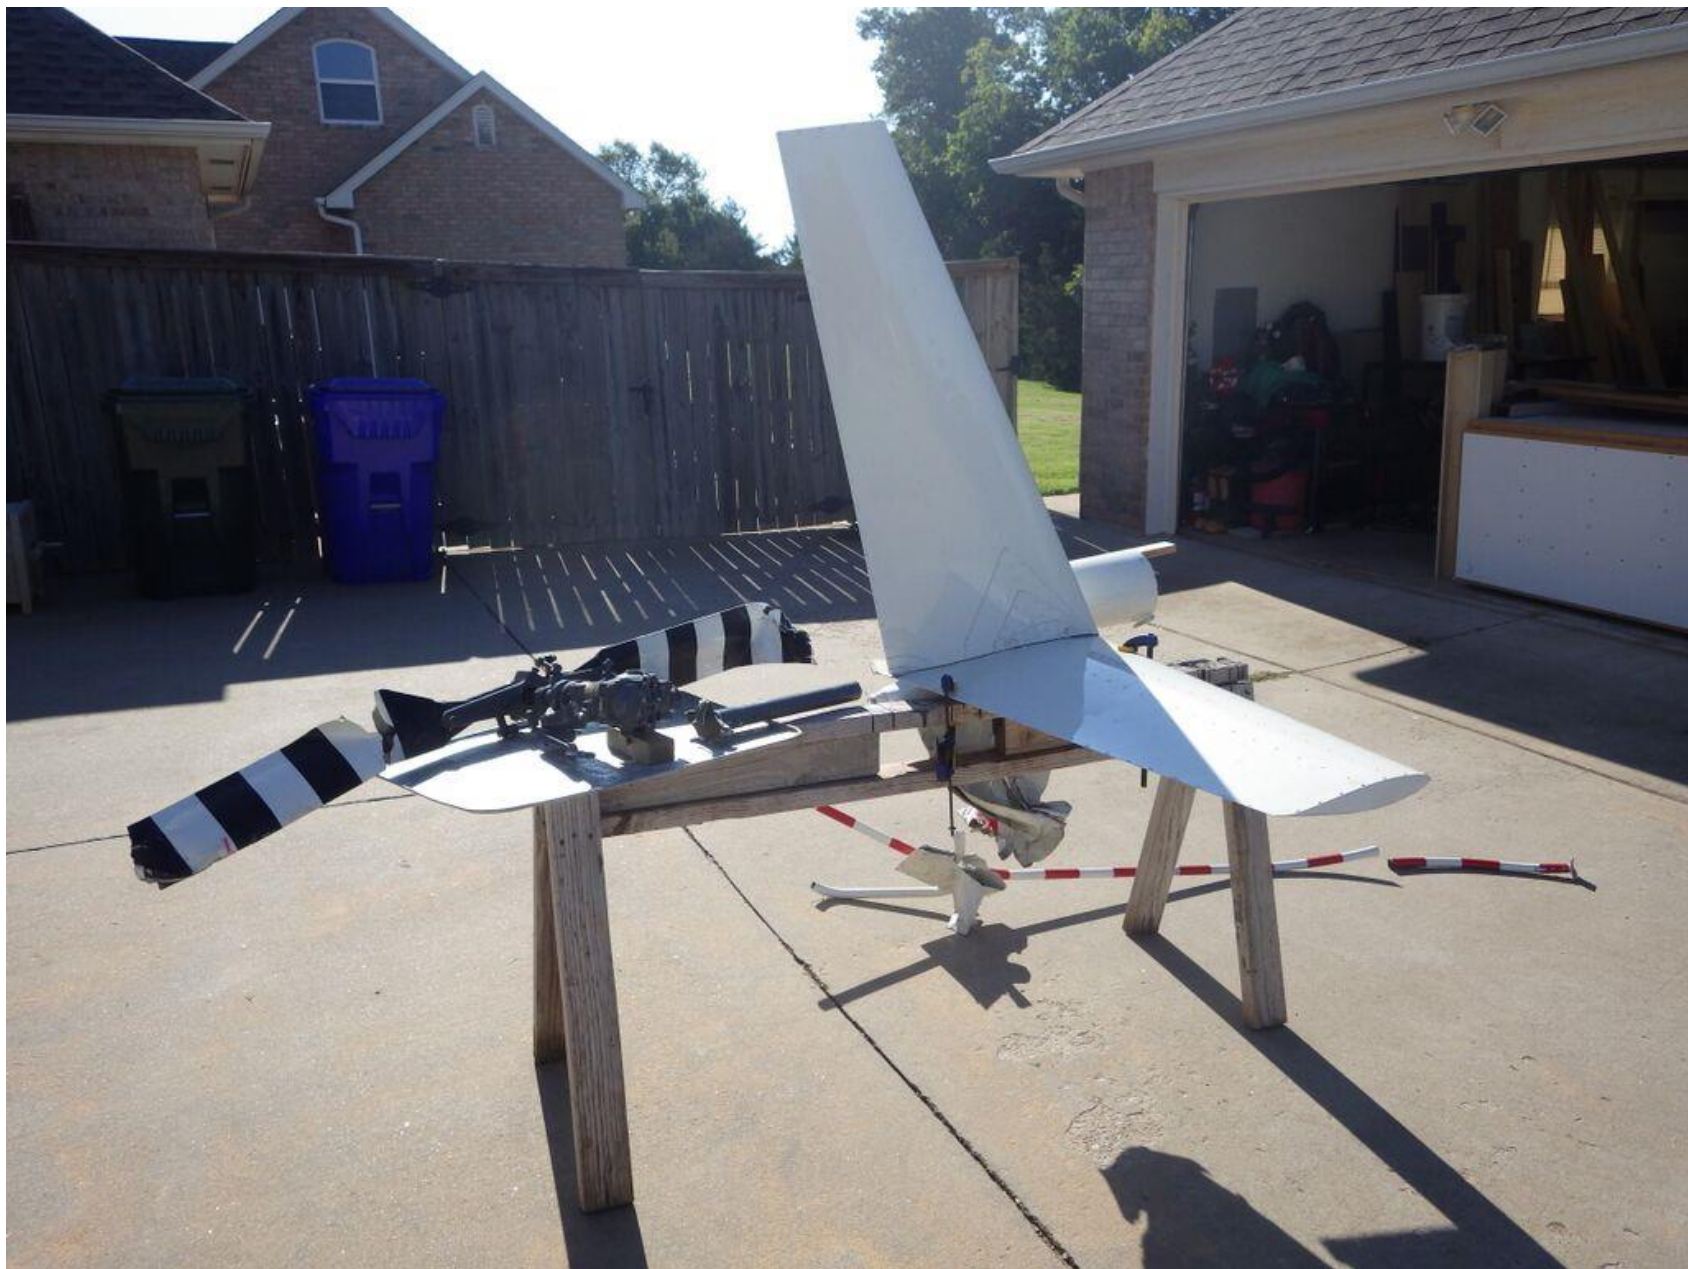
**Photo 7 – View of the mockup of the tail rotor and empennage**

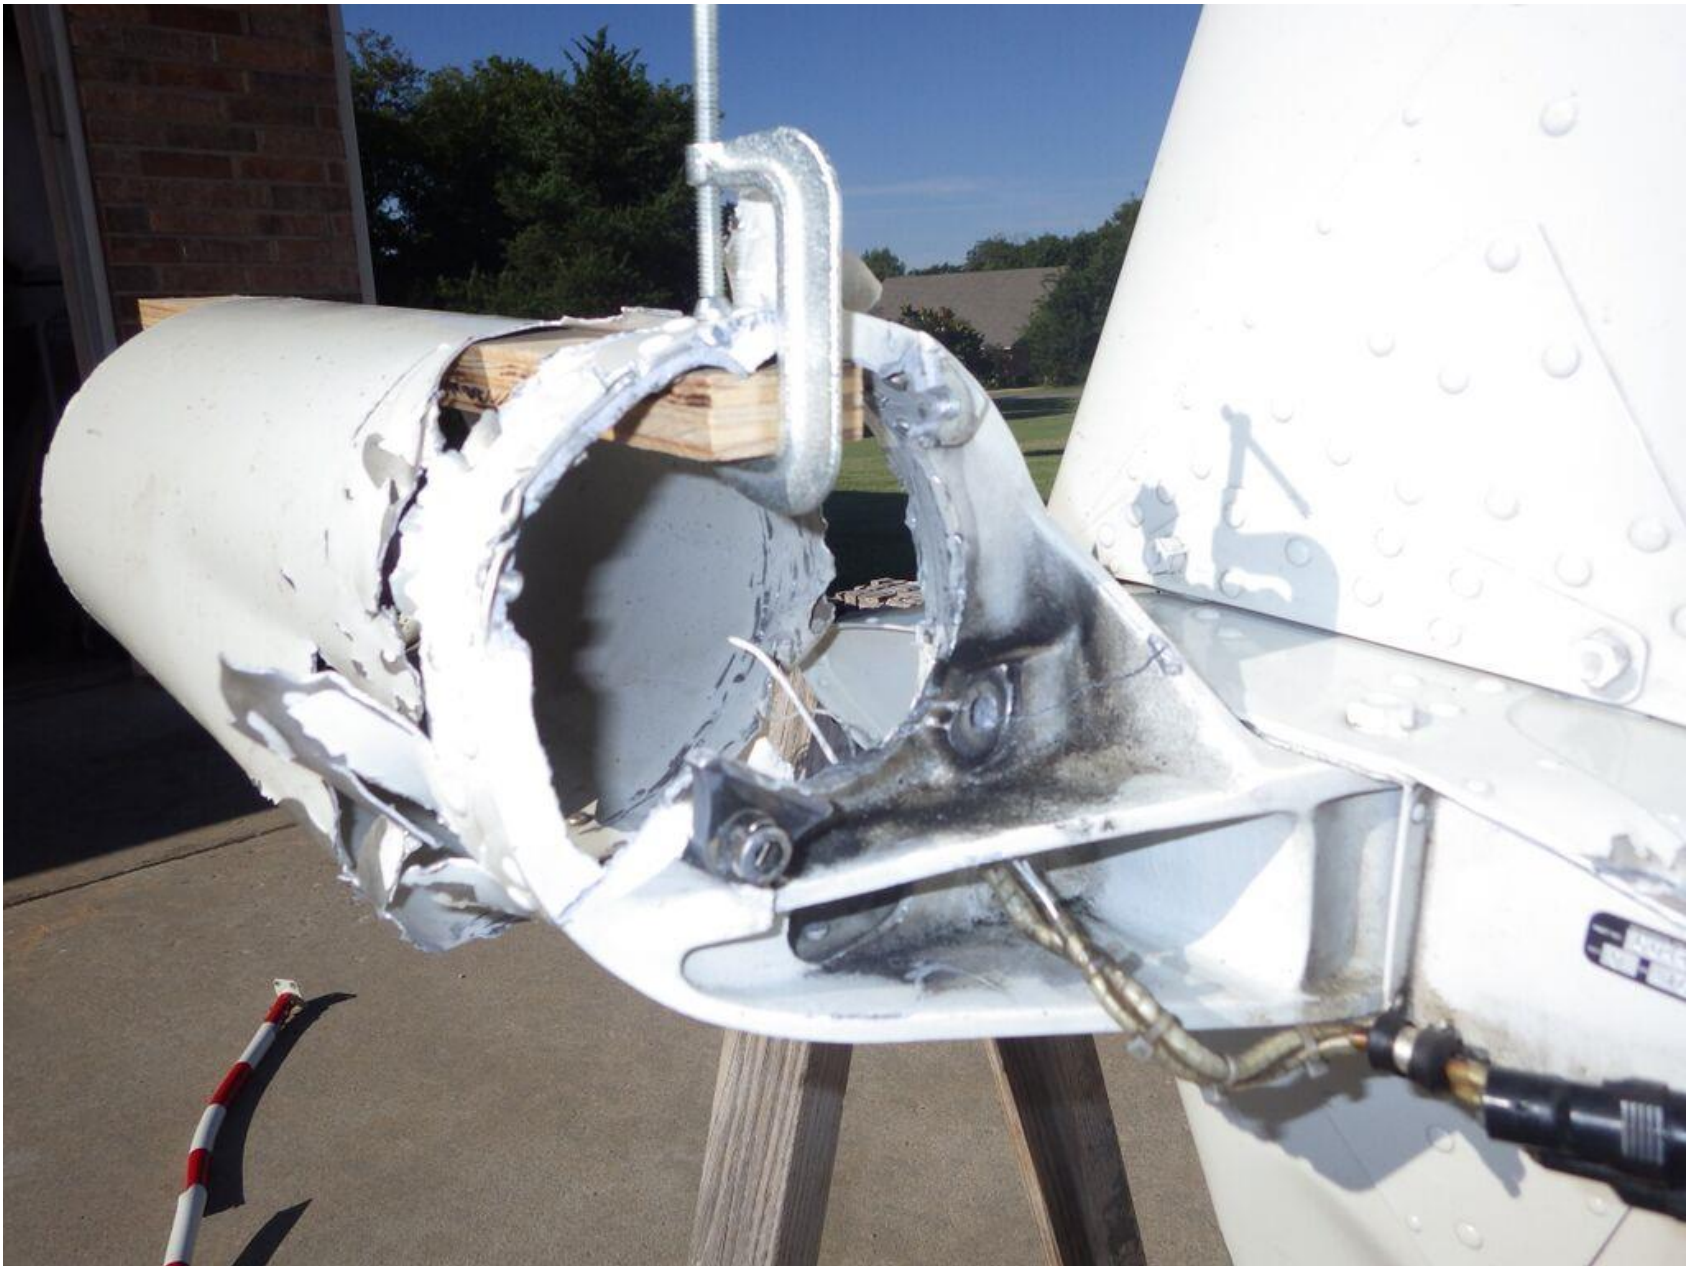
**Photo 8 – View of the tail boom where the tail rotor gearbox was attached**

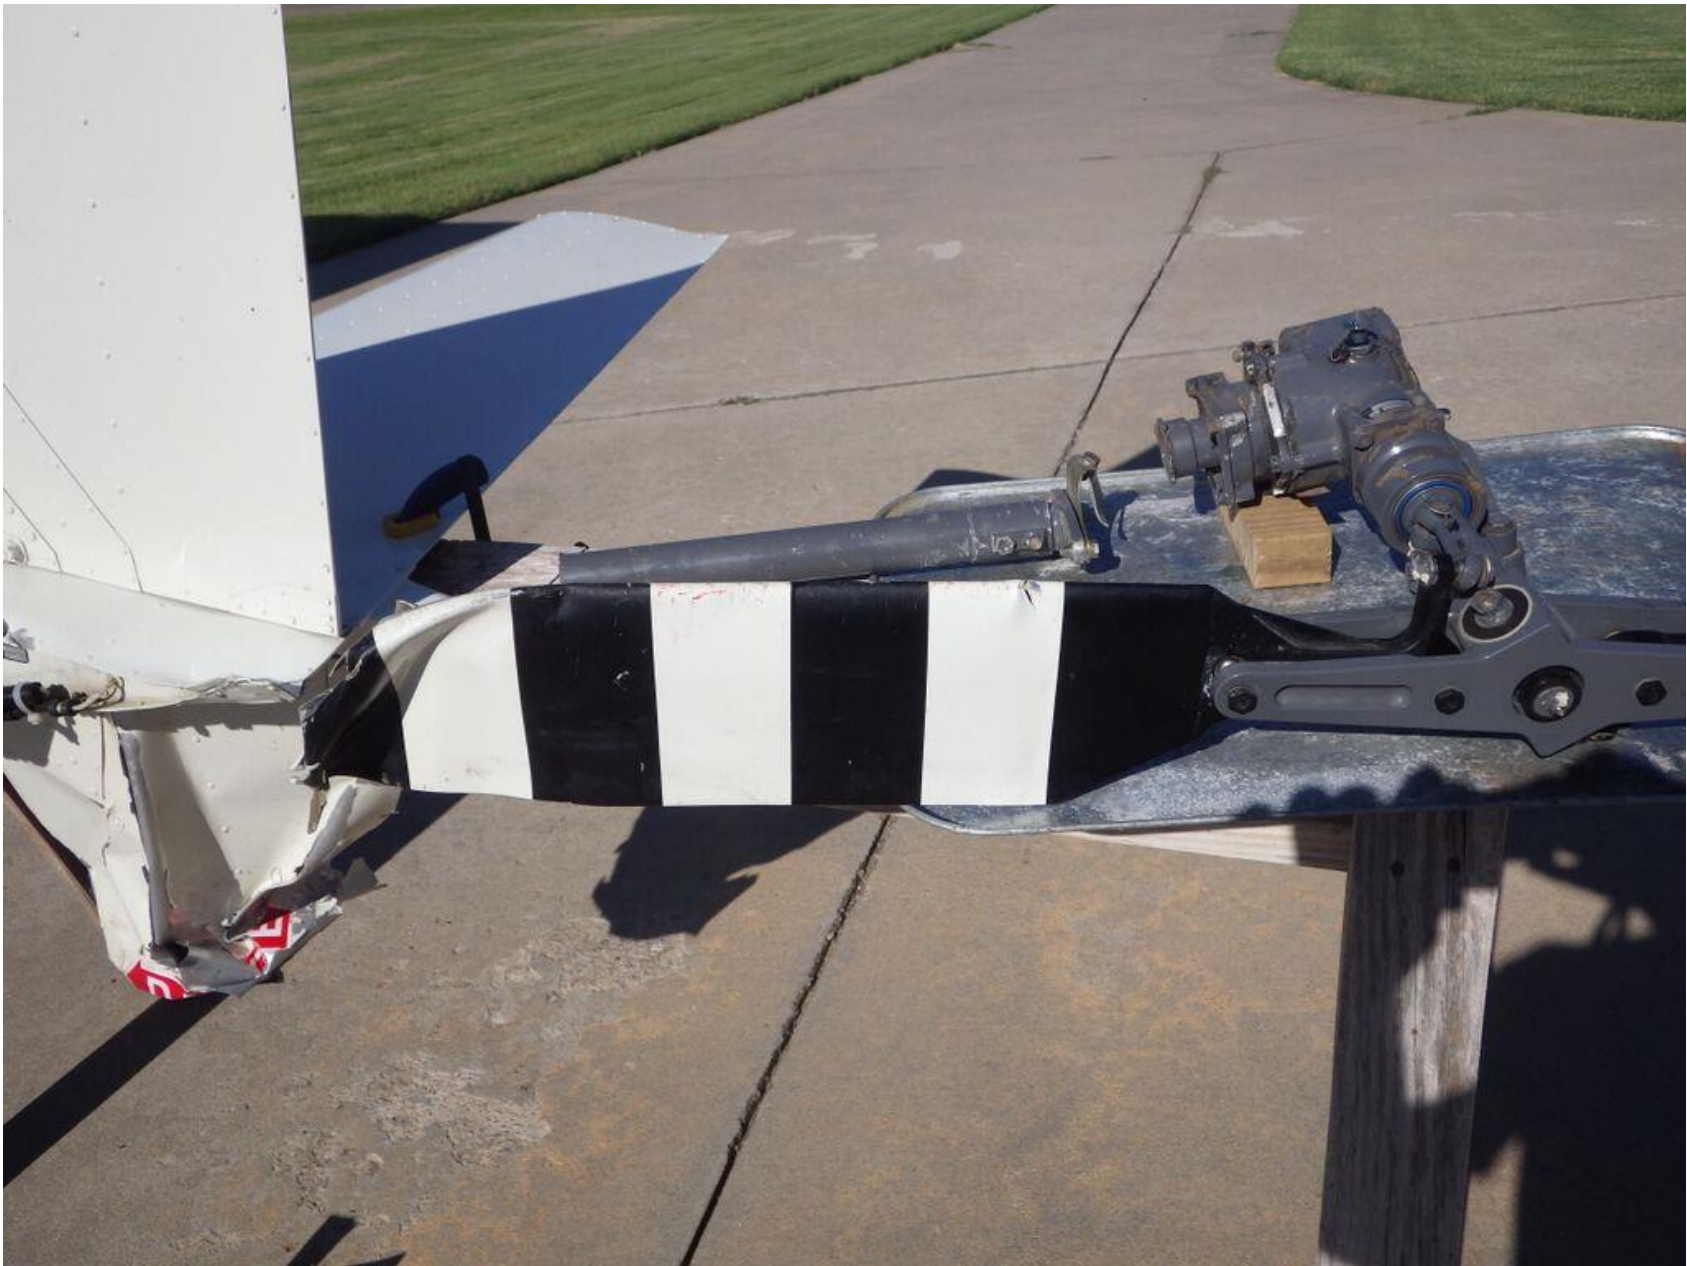
**Photo 9 – View of tail rotor gearbox and one of the tail rotor blades**

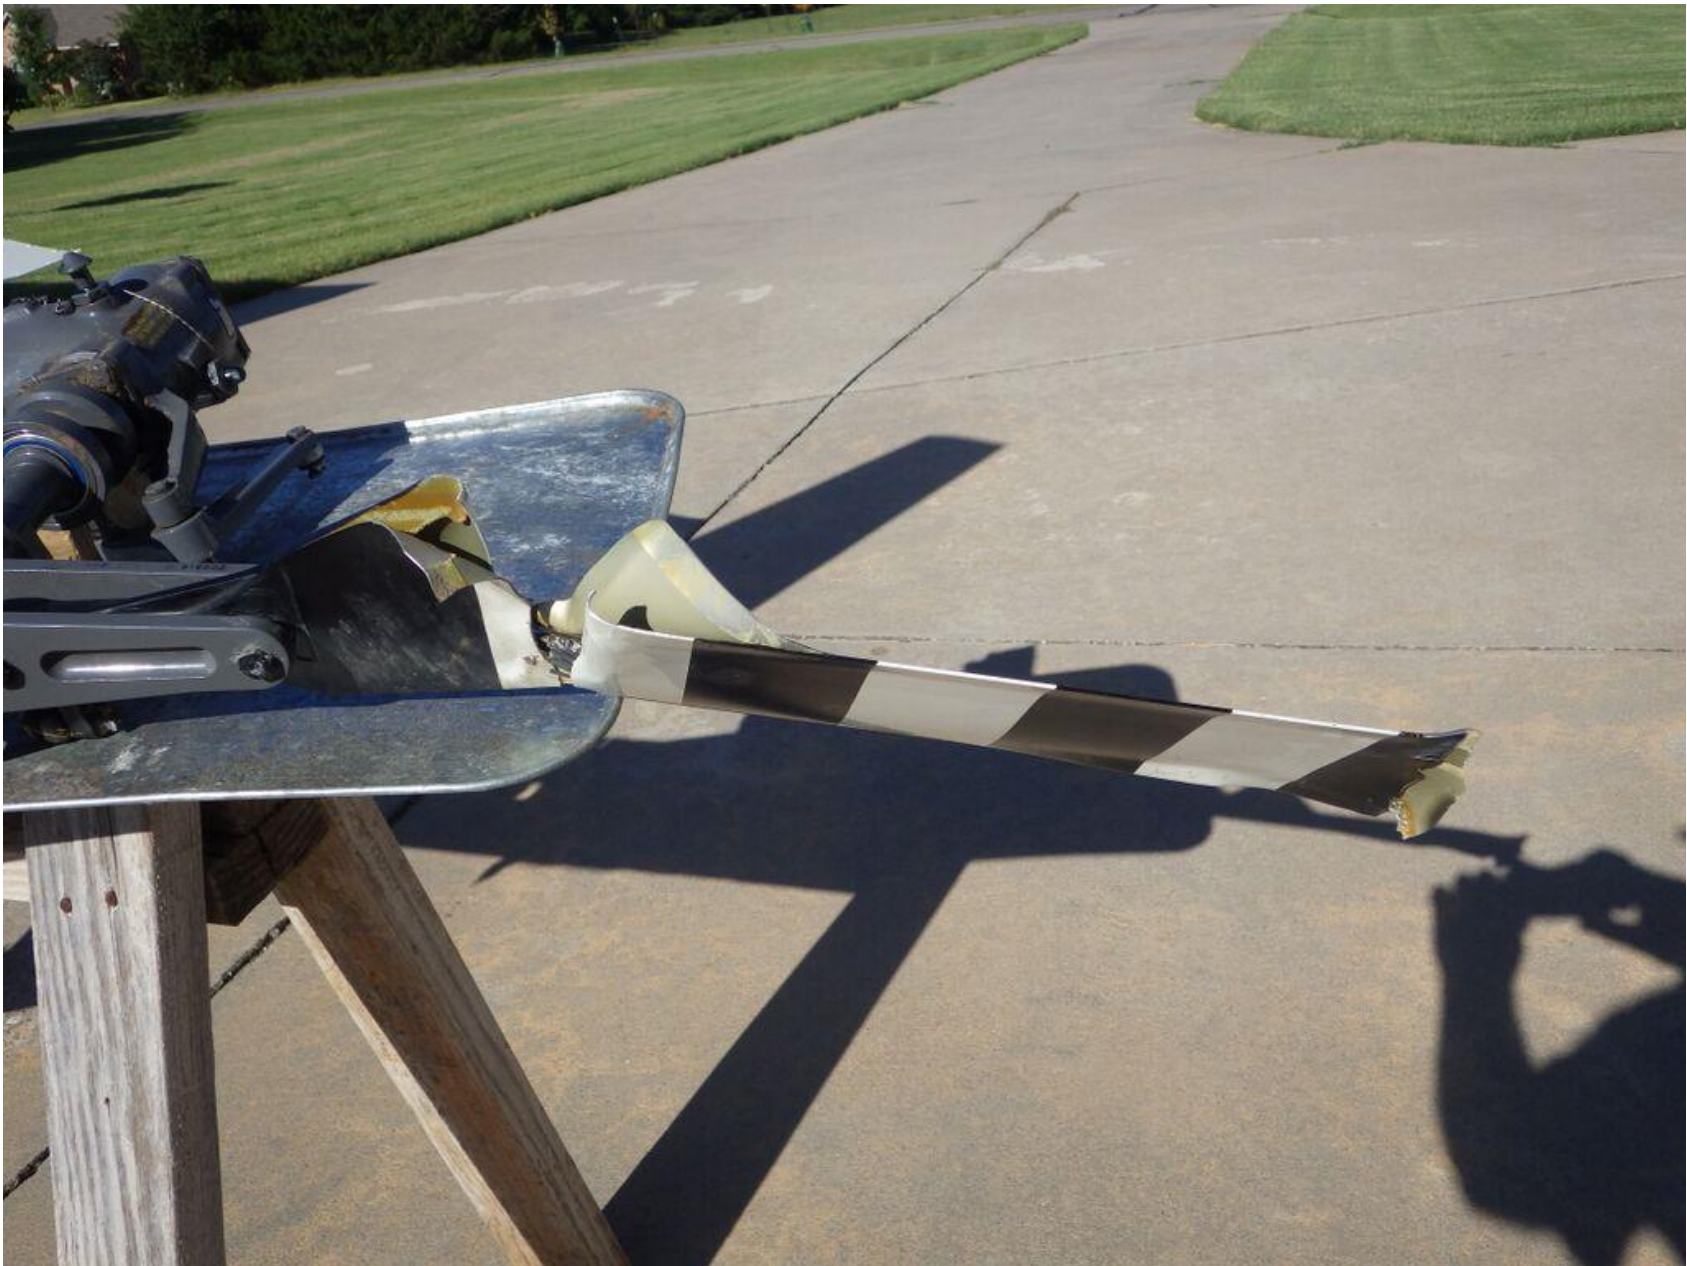
**Photo 10 – View of the other tail rotor blade**

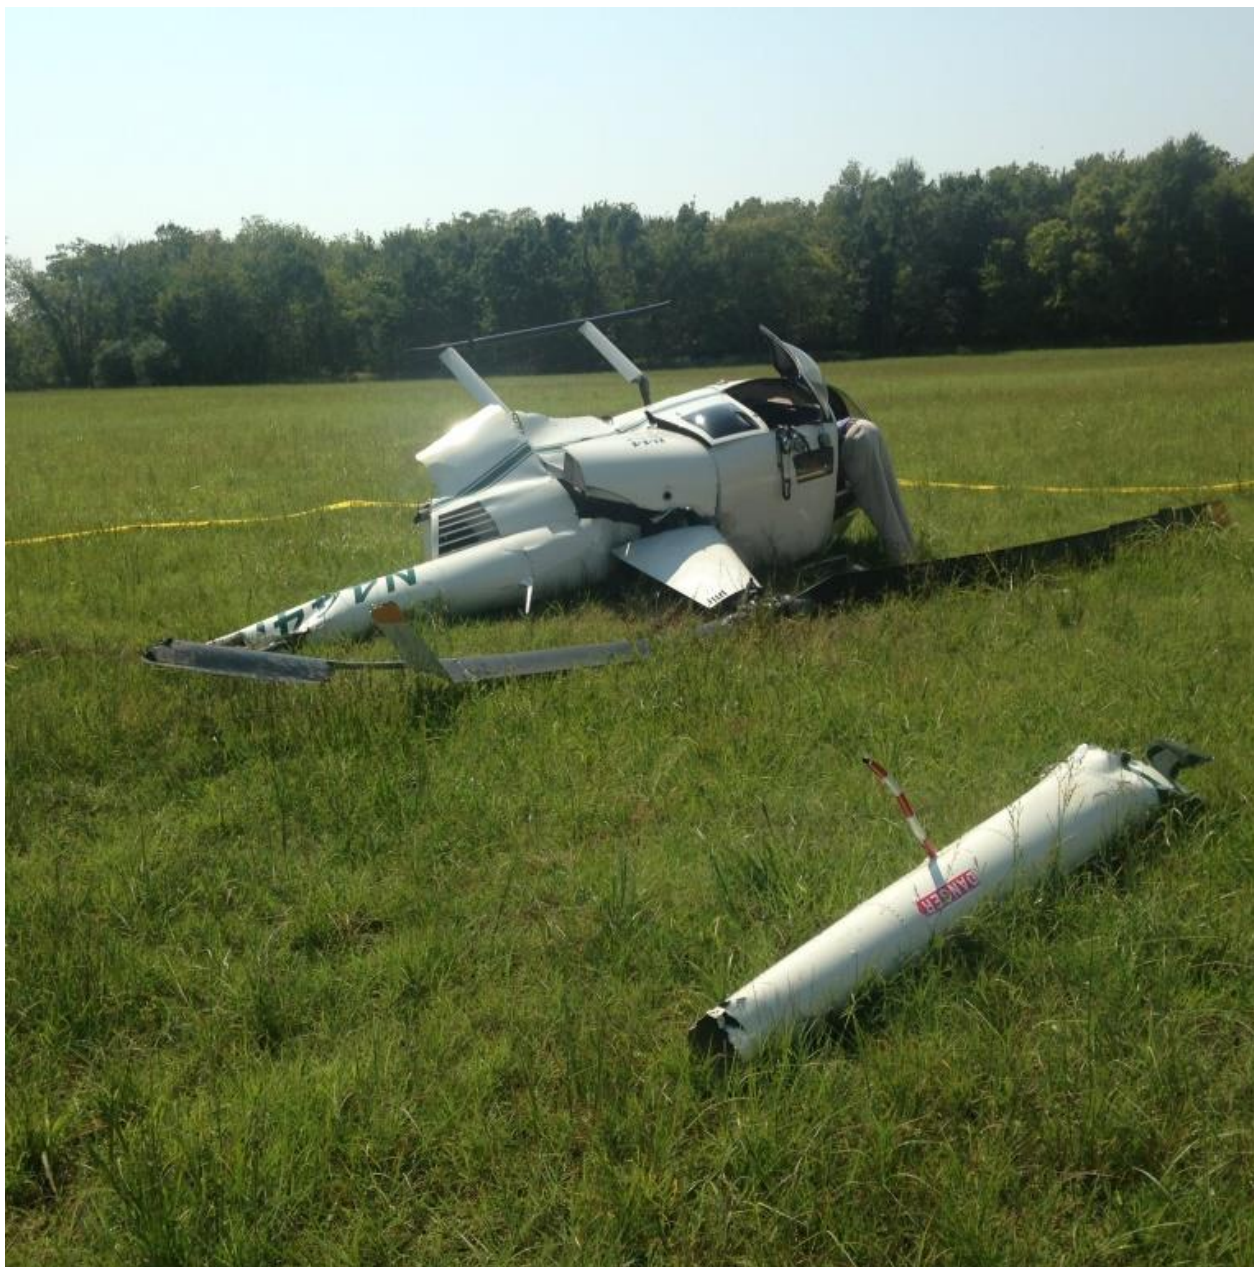
**Photo 11 – View of about a 6 ft section of the tail boom at the main wreckage site**

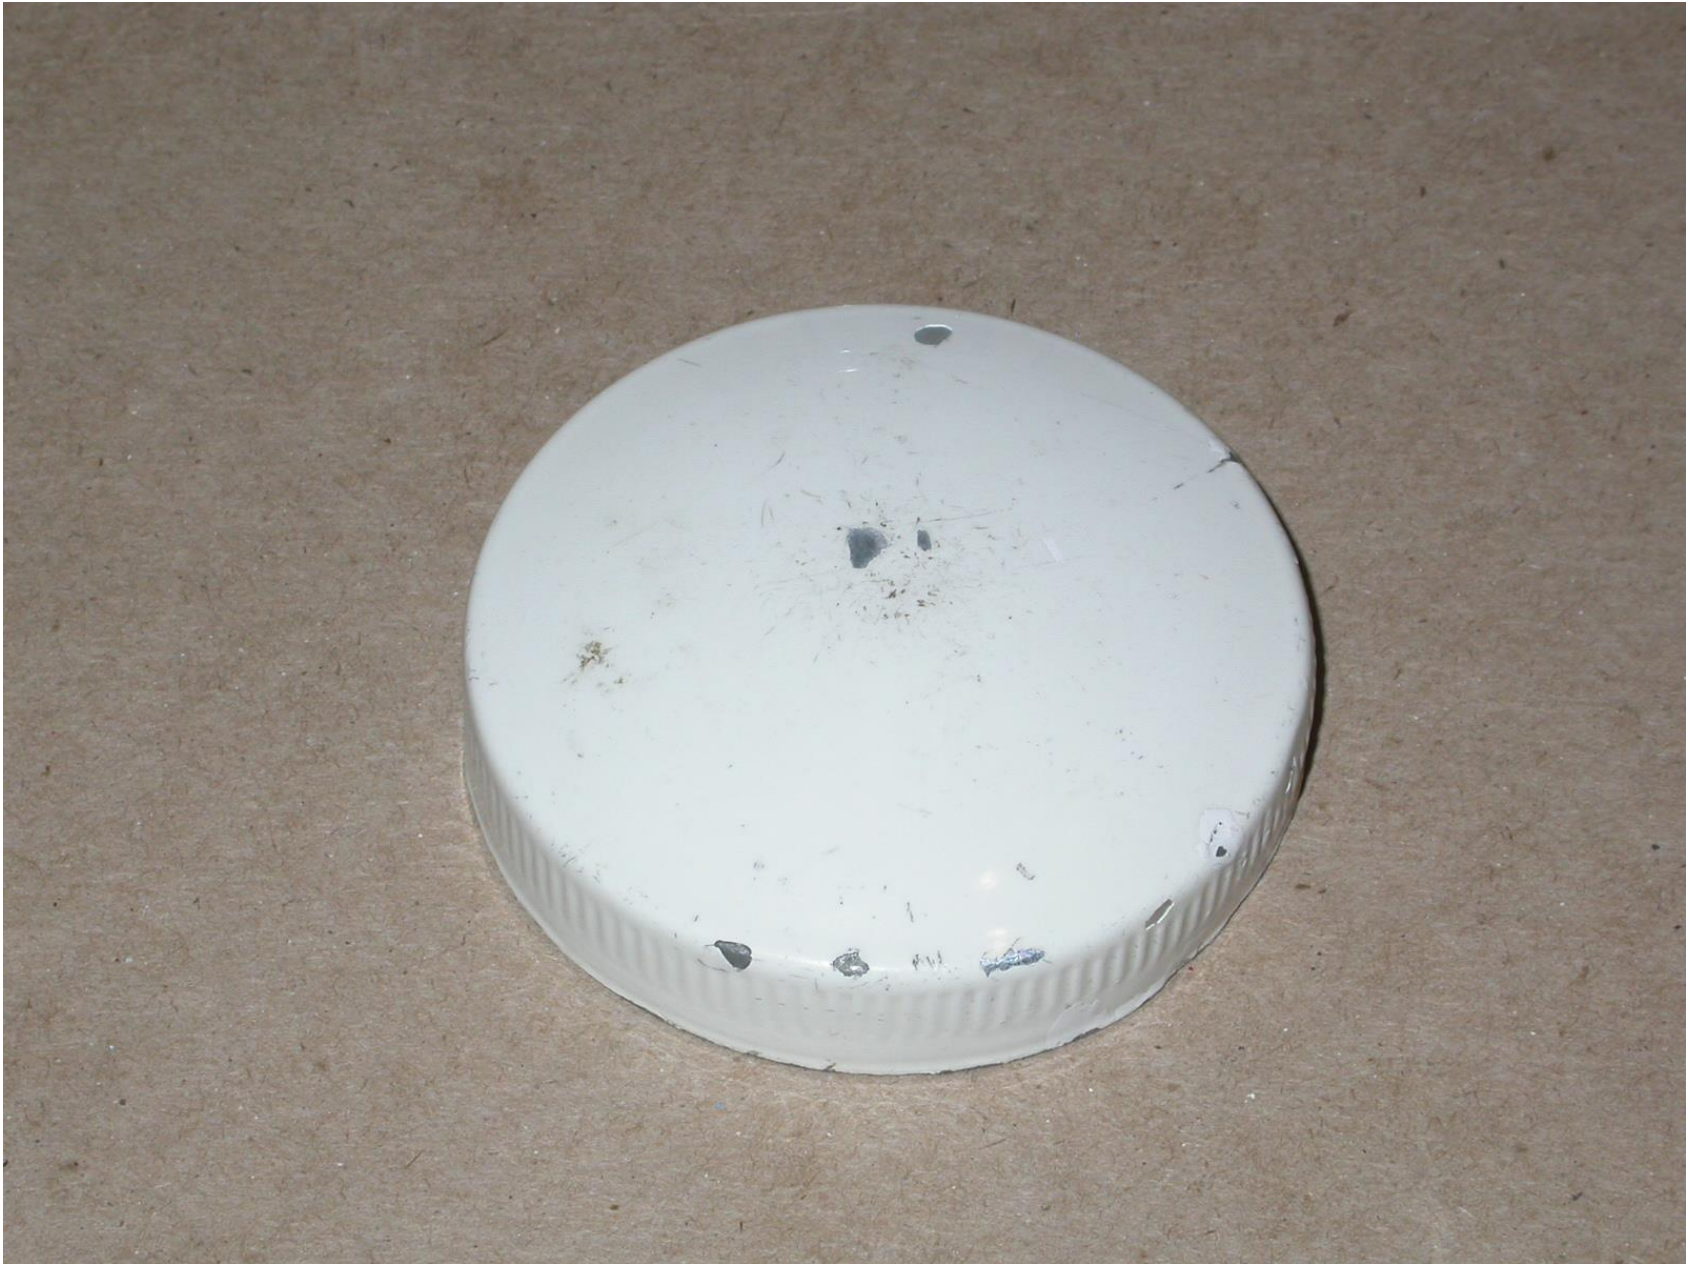
**Photo 12 – Photo of the top of the fuel cap**
