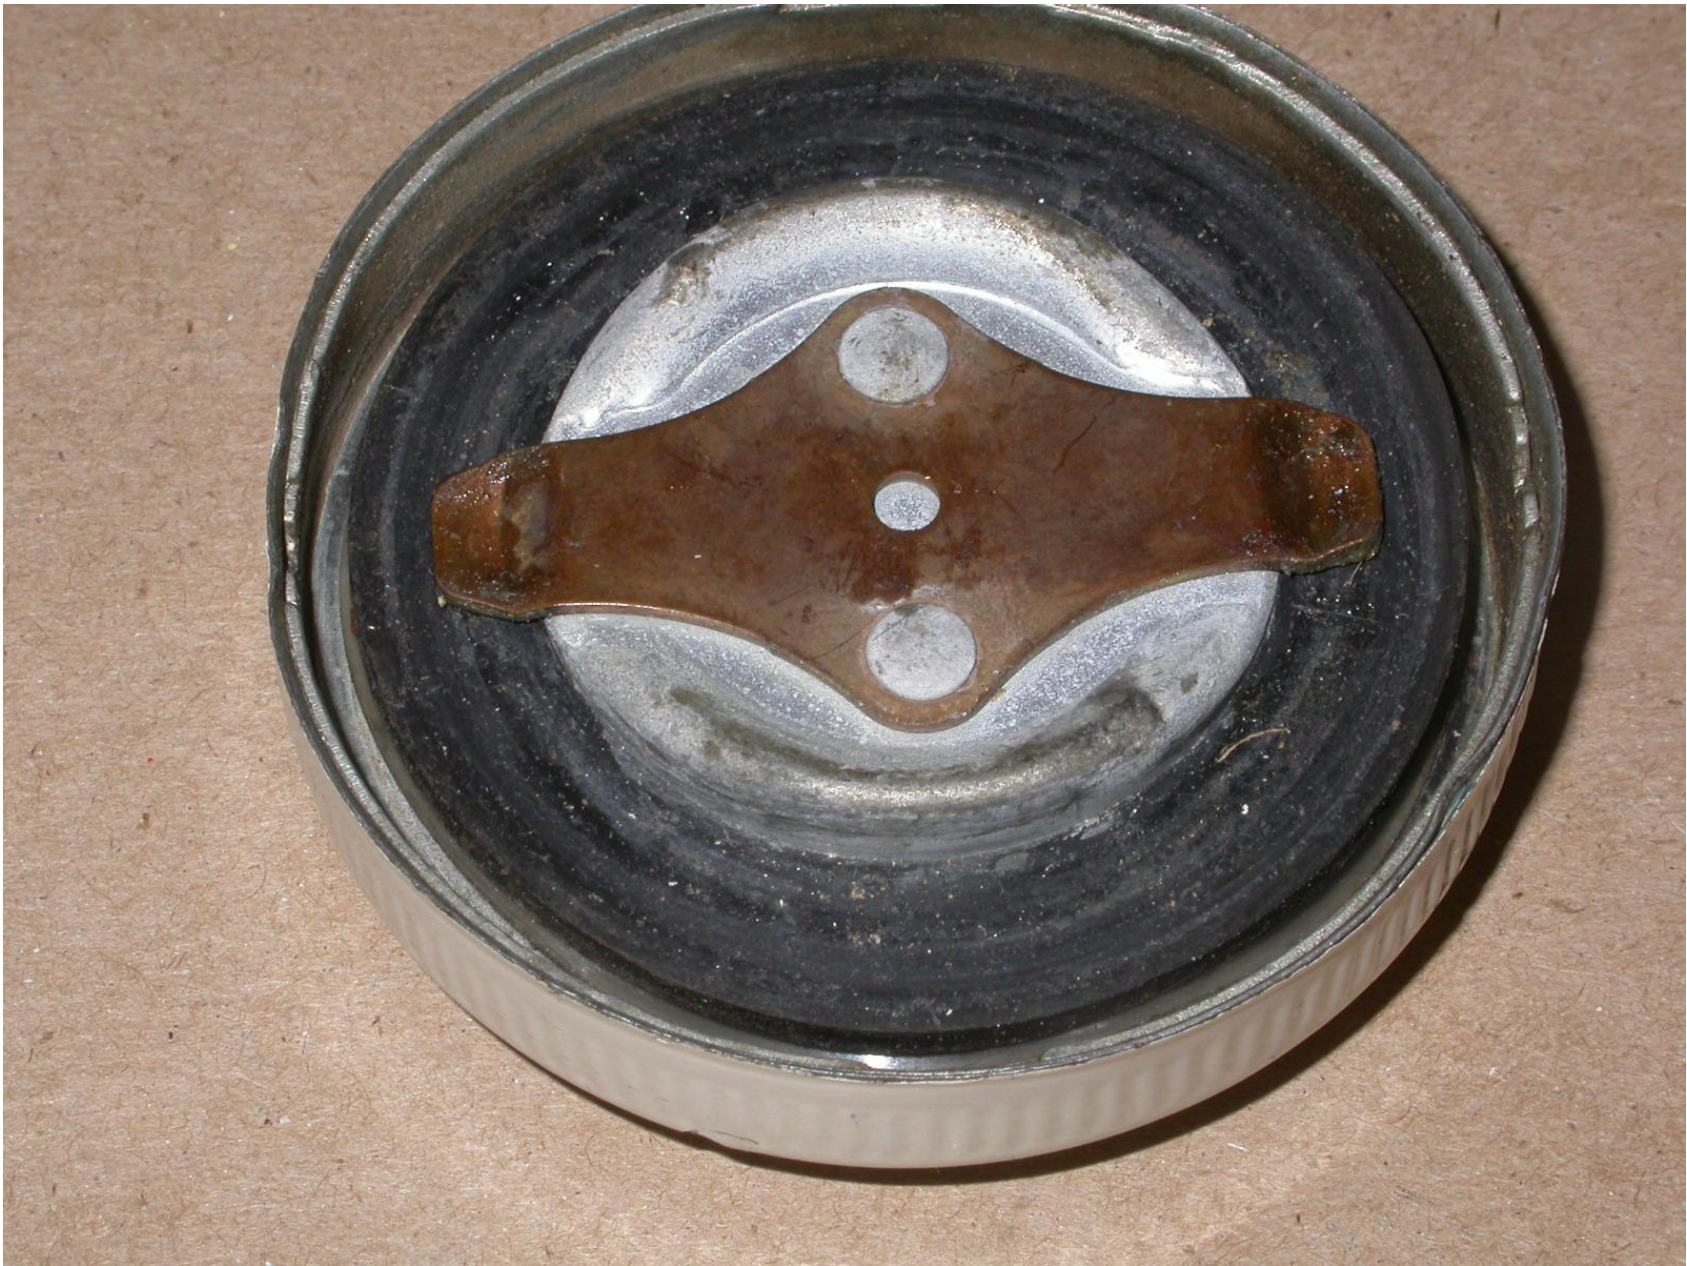
**Photo 13 – View of the underside of the fuel cap**

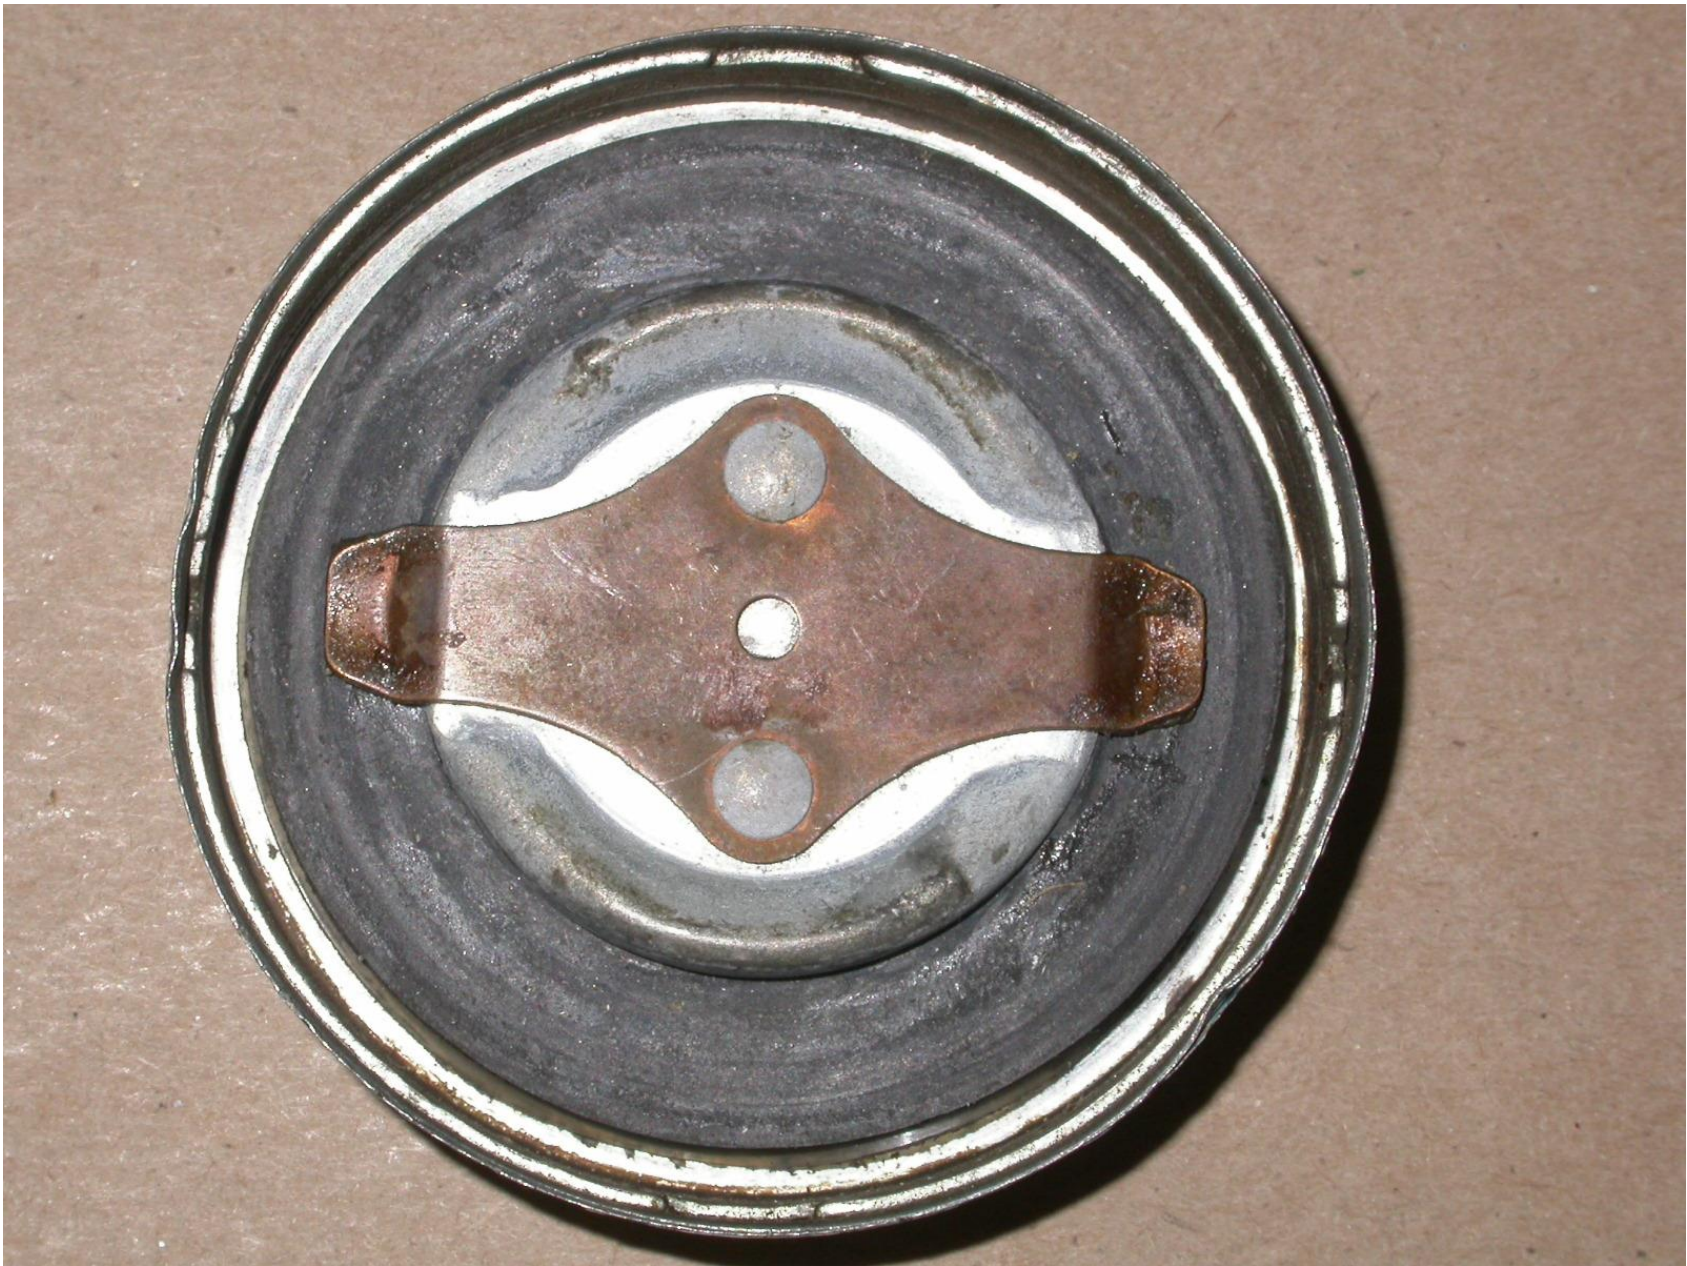
**Photo 14 – View of the underside of the fuel cap**

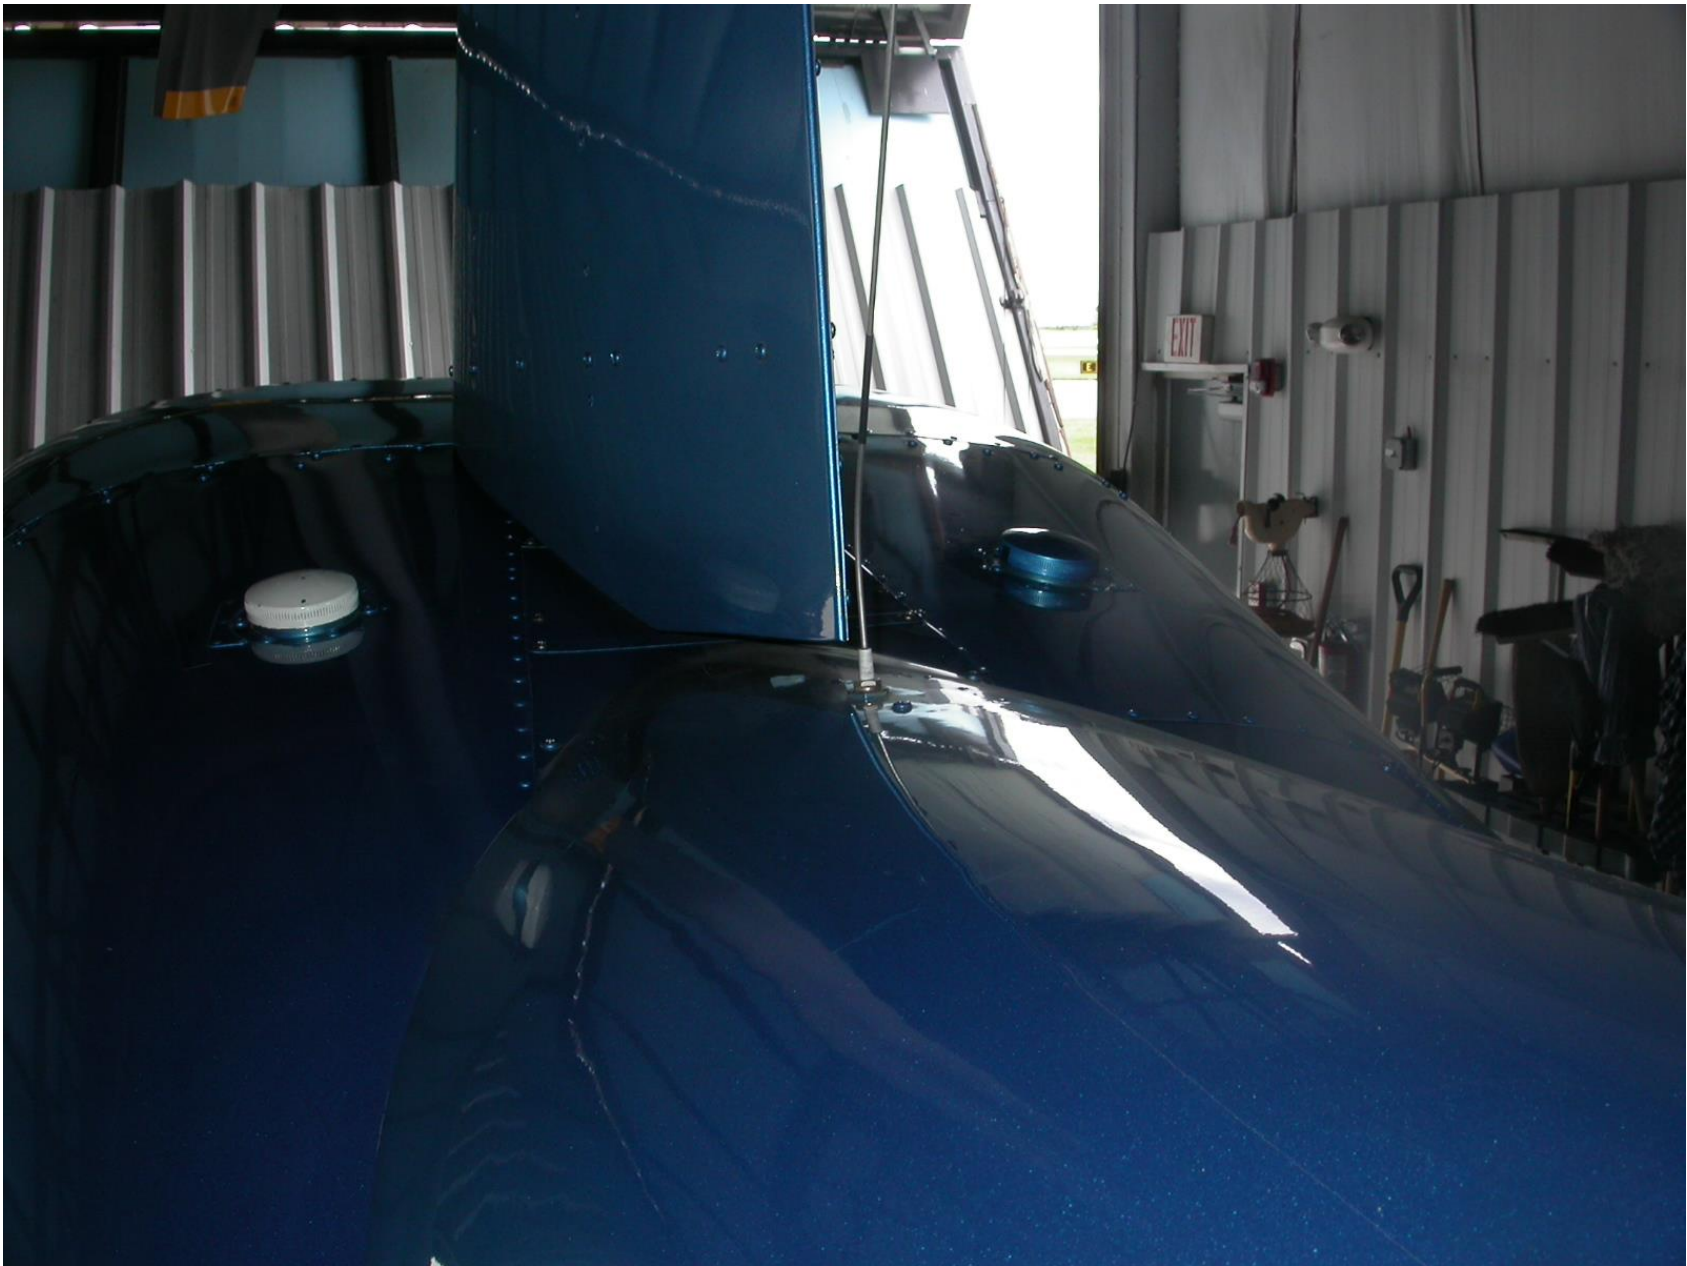
**Photo 15 – Accident fuel cap installed on exemplar R-44**

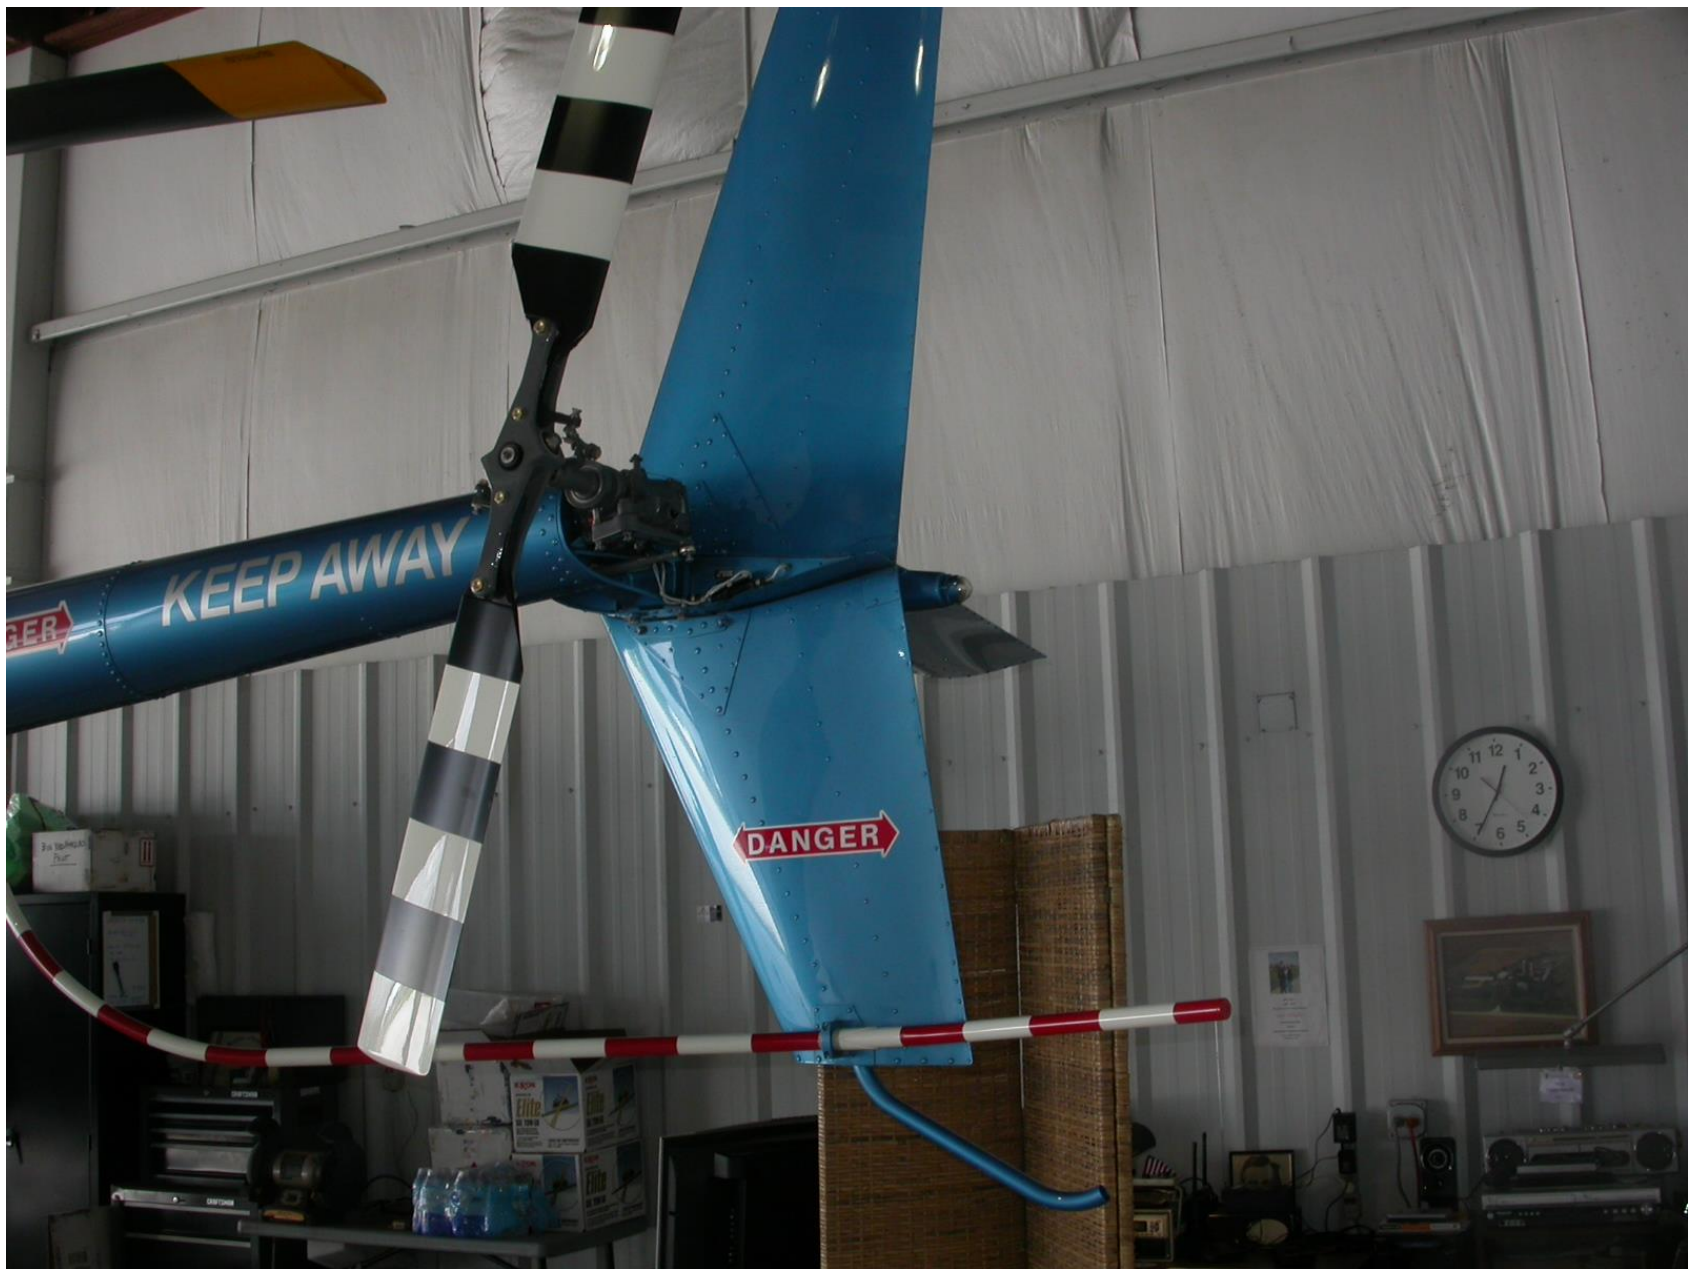
**Photo 16 – View of exemplar R-44 tail rotor and empennage**
