# AIRFRAME ACCIDENT REPORT

Air Tractor, Inc.  
ID # CEN15LA389

DATE: 8/27/15 ~12:05pm local

AIRCRAFT: AT-502B 502B-0303 N61267

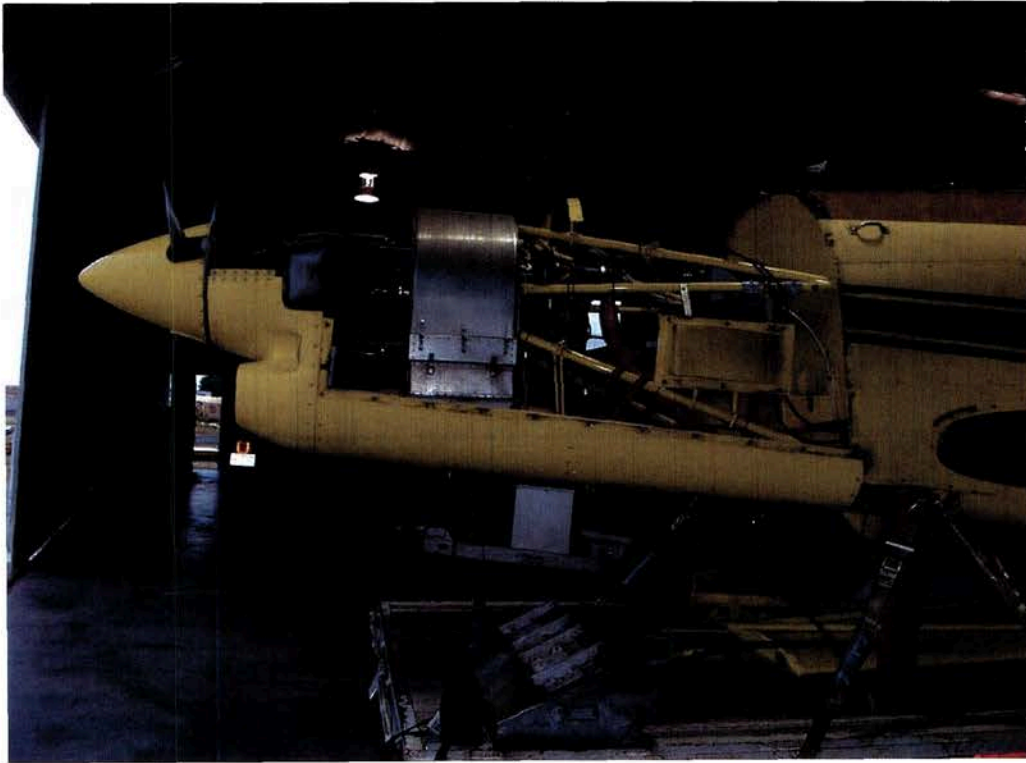
The aircraft was mostly intact with upper and side engine cowling removed for examination purposes. The aircraft was equipped with a Cascade engine installation with a Walters M601 engine. The fuselage was largely undamaged. Both wings and horizontal tail surfaces had been removed during the recovery. The ailerons and flaps had been removed from the wings.

**Forward Fuselage and Engine Installation as examined**

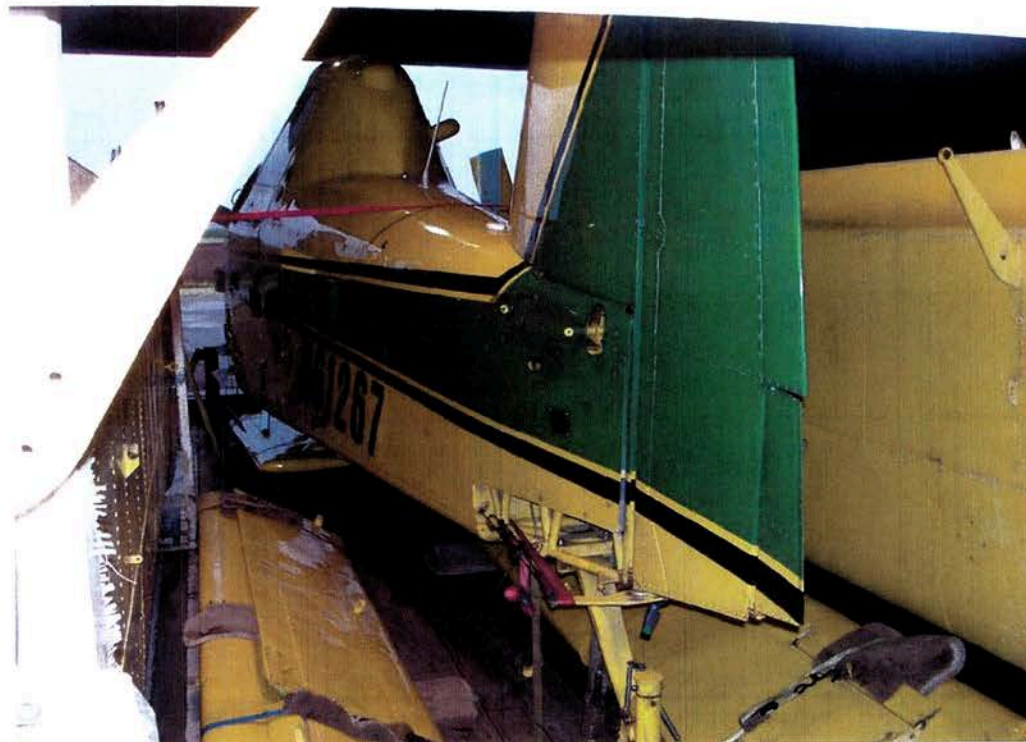
**Aft Fuselage as examined**

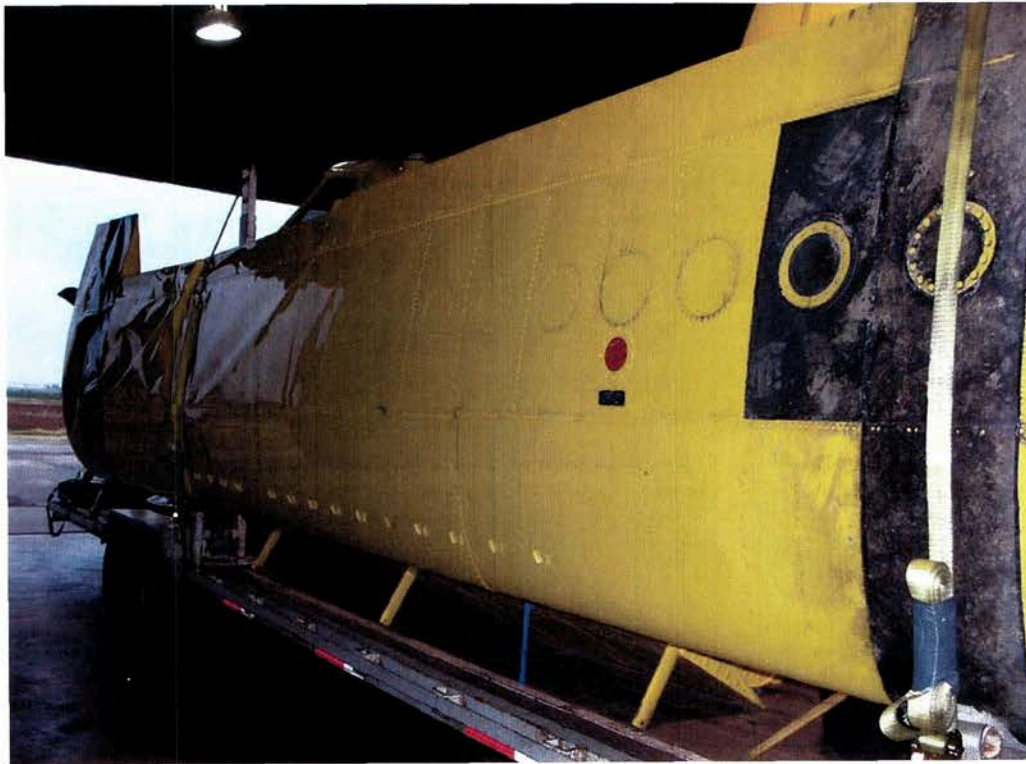
The lefthand wing appeared undamaged. The righthand wing showed damage to the portion of the wing outboard of the flap. The damage consisted of wrinkled wing skins, main/rear spar damage, and likely other internal damage. The outboard portion of the wing was deflected upwards.

**Damage to Righthand Wing**

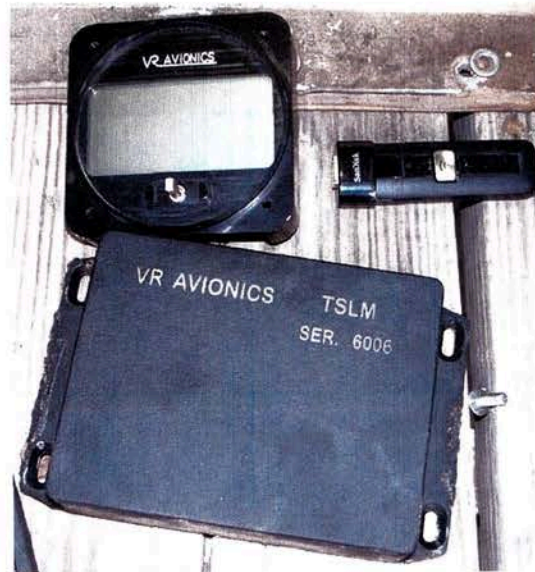
Mr. Tom Latson (NTSB) recovered three devices from the aircraft for further examination. This included a 32GB SanDisk USB memory stick that likely contains GPS data from the Satloc Bantam system, a Turbine Start Limit & Monitor (TSLM) (s/n: 6006) by VR Avionics, and the TSLM output screen by VR Avionics.

**Recovered Data Devices**

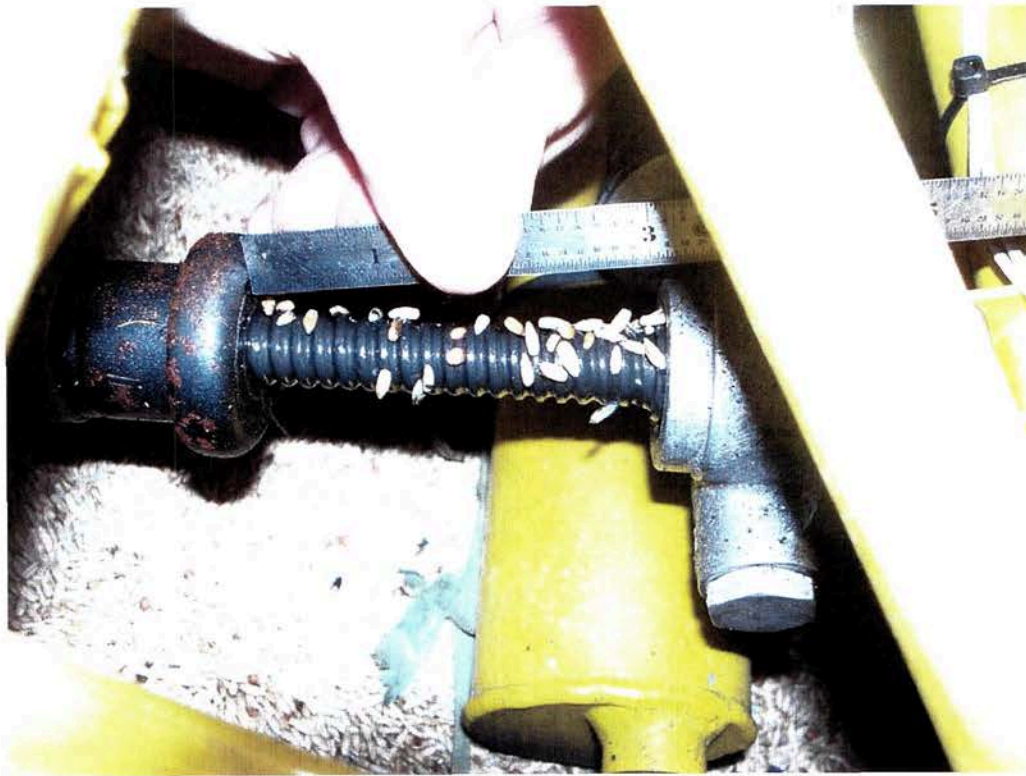
The flap actuator was extended. This extension was measured to be approximately 3 1/8 inches, which correlates to approximately 24 degrees of flap extension. The maximum flap extension is 26 degrees on this aircraft. Lynn Hooker of George's Aircraft indicated that the flaps had not been moved or repositioned during the recovery process. This flap position is consistent with a landing configuration.

**Measurement of Flap Actuator**
