## ALERT SERVICE BULLETIN

**429-15-16**

**MODEL AFFECTED:** 429

**SUBJECT:** TAIL ROTOR PITCH LINK BEARING, INSPECTION  
AND UPGRADE OF.

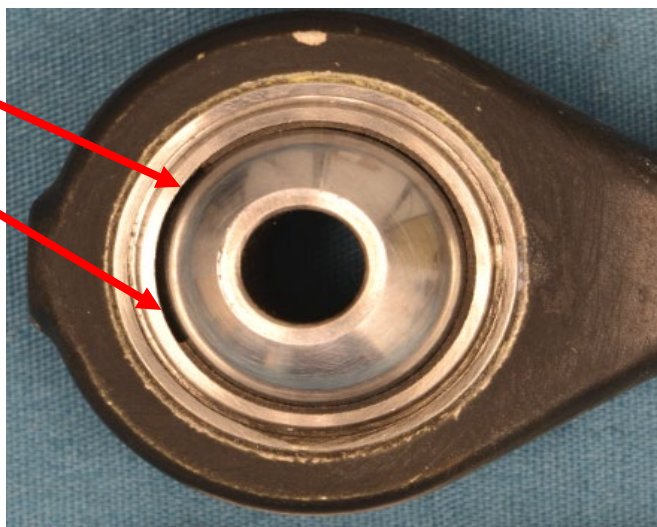
**Figure 1 – Tail Rotor Pitch Link Bearing Liner**

4. Perform a dimensional check of both axial and radial play (BHT-429-MM-1, Chapter 67). With a 10X magnifying glass, visually inspect the bearing liner condition for cracks or deterioration of the liner or if the liner extrudes out of the plane (Figure 1).

**Missing Liner**

- a. Replace any bearing that exceeds the allowable limits and/or if cracks or deterioration of the bearing liner are noted.
    - i. Perform **Part II** of this ASB or replace the affected tail rotor pitch link assembly with an acceptable part.

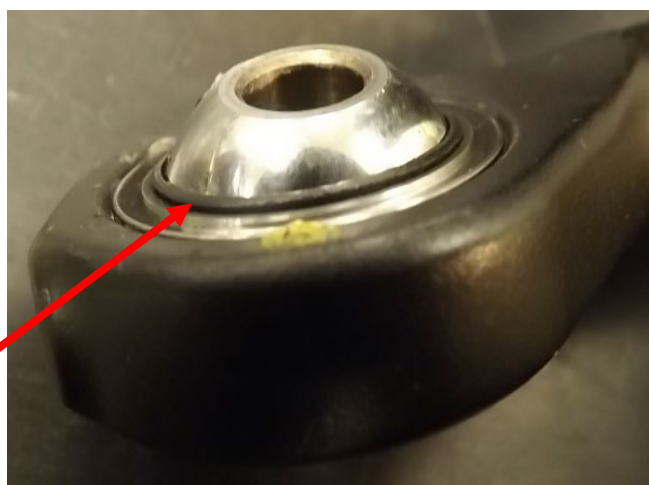
**Bearing Liner  
Extruding**
