# NATIONAL TRANSPORTATION SAFETY BOARD

## MATERIALS LABORATORY FACTUAL REPORT

Report No. 16-048

Place : Stuart, IA  
Date : 9/12/2015  
Vehicle : Baby Bell, N135PA  
NTSB No. : CEN15LA412  
Investigator : Aaron Sauer

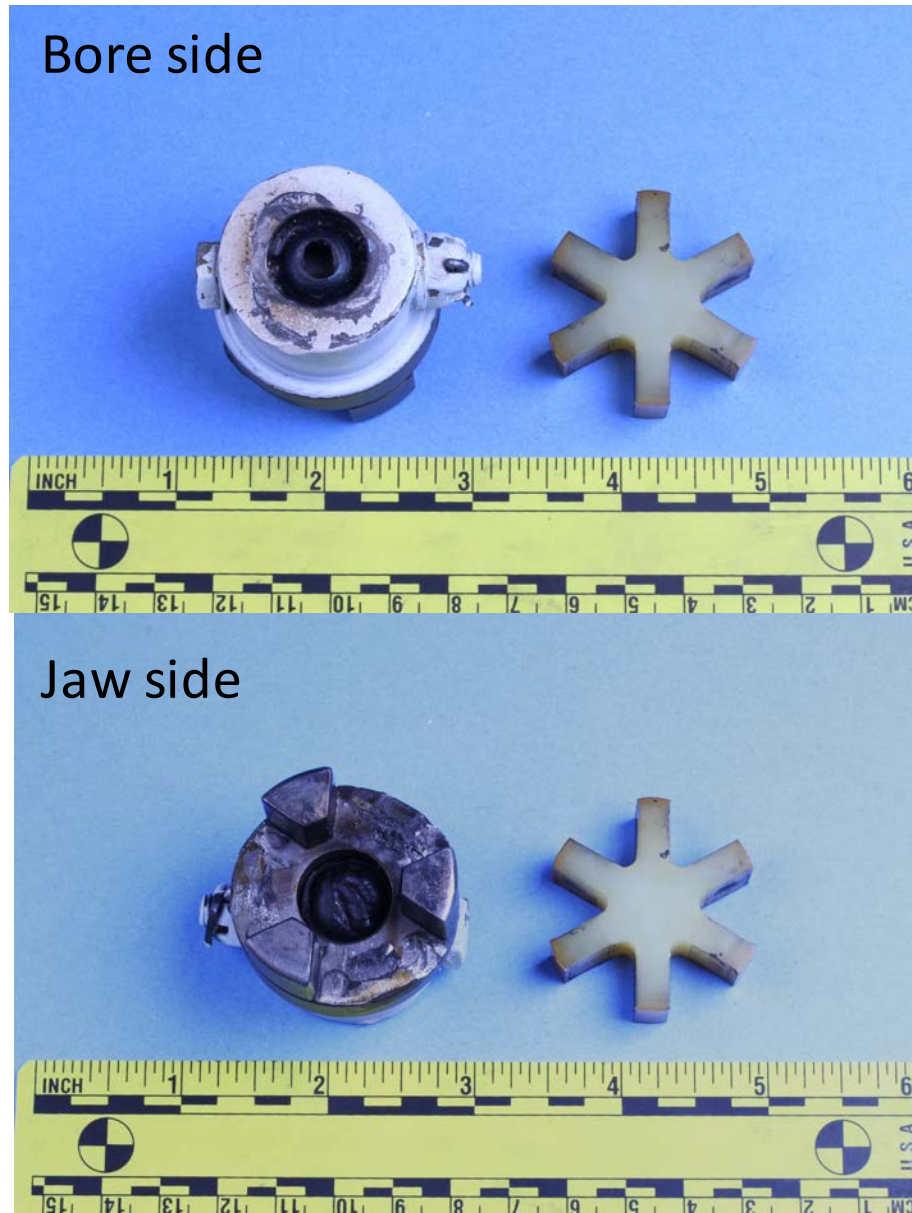
One half of a tail rotor drive shaft flexible coupling assembly, including the flexible elastomeric element, was submitted for examination (figure 1). A portion of the driveshaft remained inside the coupling and was visible from the bore side of the coupling. The through bolt securing the drive shaft in the coupling bore was in place and firmly secured including the cotter pin through the castellated lock nut. The jaw side of the coupling exhibited some gouges and dents in the metal surface (figure 2). The jaws were not damaged and maintained a snug fit with the elastomeric element.

Figure 1: Tail rotor driveshaft coupler as received (both ends shown).

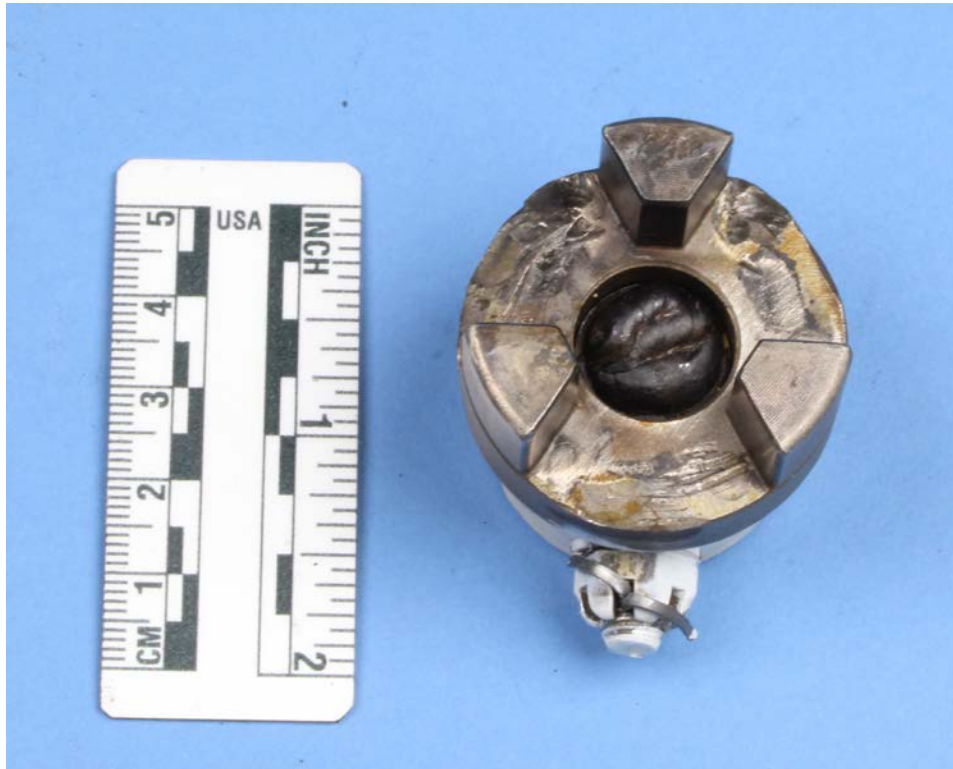
Figure 2: Jaw side of coupling exhibiting dents and gouges.

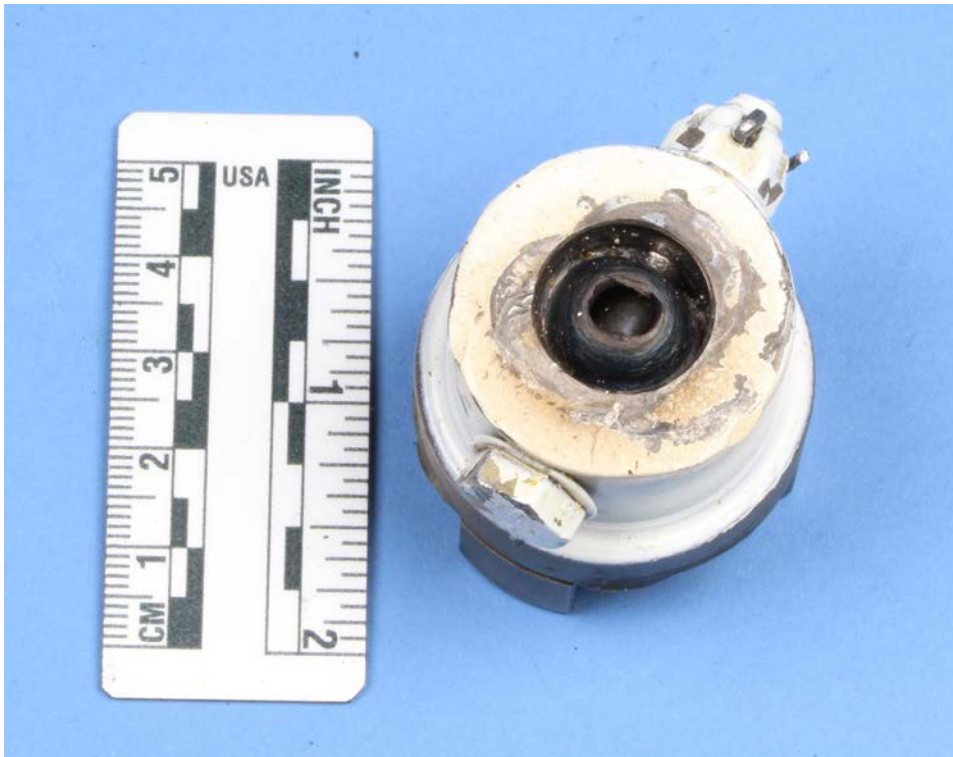
From the bore side of the coupling a portion of the drive shaft was visible and exhibited a smeared fracture surface (figure 3). The through bolt securing the drive shaft was removed and the portion of the driveshaft remaining in the coupling was pressed out pushing from the jaw side of the coupling. The portion of the driveshaft that was removed had a weld bead deposit on the jaw side and appeared necked down on the bore side (figure 4). The outer surface of this portion of driveshaft exhibited file markings and areas with a brass color. Examination with a stereo microscope followed by sectioning in the transverse direction revealed that the drive shaft was sleeved in order to fit the bore of the coupling (figure 5). The drive shaft had an outer diameter of approximately 0.490 inch and an inner diameter of approximately 0.333 inch. The sleeve had an outer diameter of approximately 0.625 inch. The bore of the coupling was approximately 0.625 inch. The fracture surface of the driveshaft was mechanically and thermally deformed and the failure mode could not be established.

Figure 3: Bore side of coupling with a portion of the driveshaft visible.

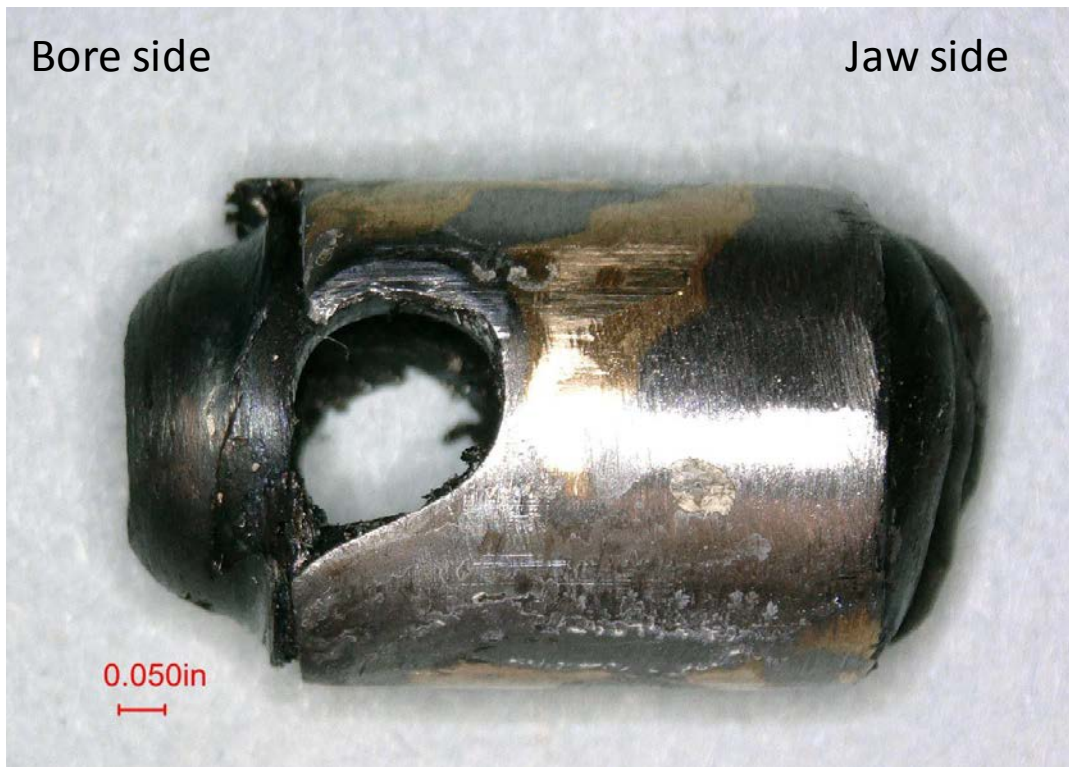
Figure 4: Portion of driveshaft removed from coupling.

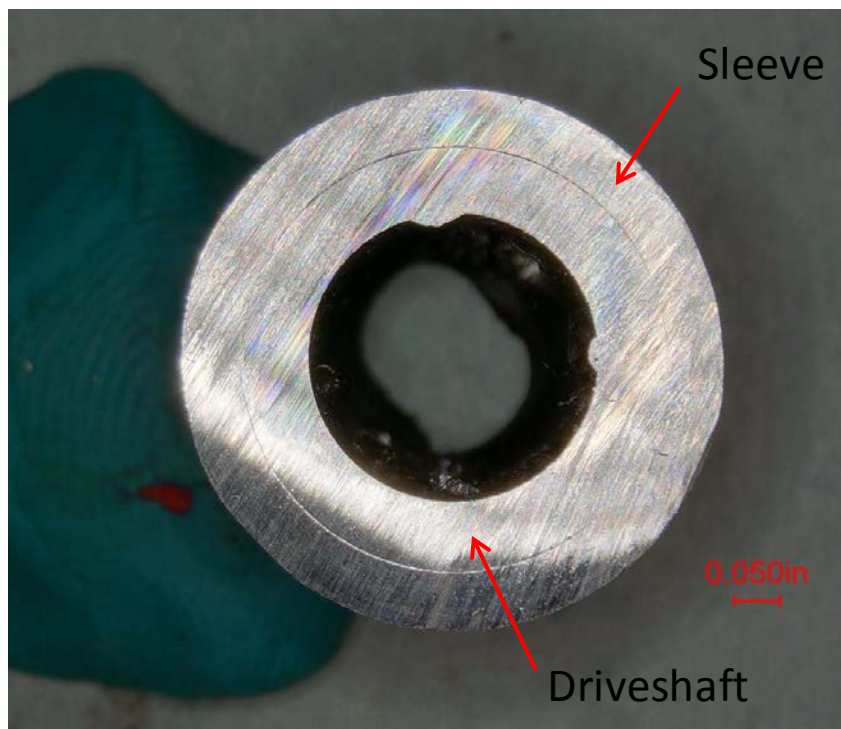
Figure 5: Transverse section through the portion of the driveshaft (near jaw side end).
