**service bulletin**

M86-11

28 May 1986

**SUBJECT: CONNECTING ROD PRODUCT IMPROVEMENT****COMPLIANCE:** At Next Engine Overhaul, Top Overhaul, or Anytime Cylinders are  
Removed For Any Reason

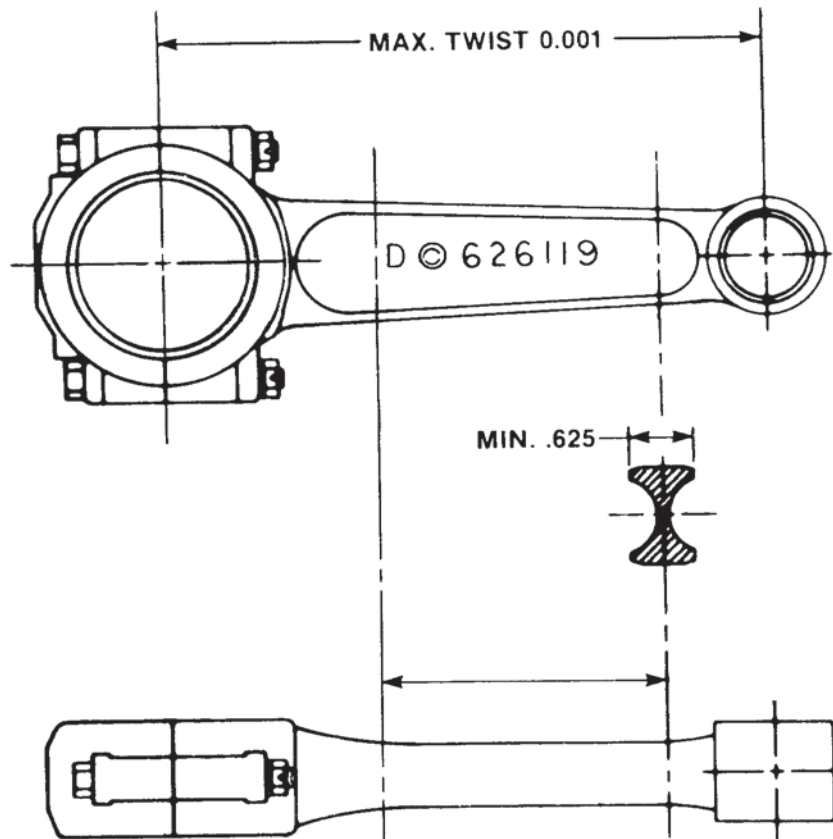
FIGURE 1. CONNECTING ROD.

A potential problem of over stressed connecting rods associated with excessive cylinder pressure which can be caused by lean take-off fuel flows, advanced magneto timing, pre-ignition, overspeed, detonation, overboost, hydrostatic lock, or sudden propeller stop-page may eventually cause connecting rod breakage and resultant engine failure.

We recommend that at any time access is gained to the connecting rods during cylinder removal, the beam section dimension of the connecting rods with forging number 626119 be measured as per illustration Figure 1, and also as found in Overhaul Manual X30030A. Any connecting rod below .625 dimension should be replaced with a new product improvement connecting rod with additional margin of safety, P/N 646321 or P/N 646320, depending on the model affected. In addition, it is recommended that published operating and maintenance procedures be strictly followed to prevent the causes of excessive cylinder pressure as noted in the preceeding paragraph.

A larger number of over stressed connecting rods have been those identified with a forged © on the beam section. These rods were manufactured between June 1976 and September 1981. Particular attention should be paid to these rods.

NOTE: THIS INSPECTION PERTAINS TO THE 626119 FORGING ONLY

If connecting rod replacement is required, new connecting rod bearings of the appropriate part number and new cotter pins P/N 639292 should be installed. Component inspection and reassembly should be in accordance with Overhaul Manual Form X30030A.
