# service bulletin

M86-11 Rev. 1  
Supersedes M86-11Technical Portions Are  
FAA Approved

**SUBJECT: CONNECTING ROD PRODUCT IMPROVEMENT****COMPLIANCE:** At Next Engine Overhaul, Top Overhaul, or Anytime Cylinders are Removed For Any Reason

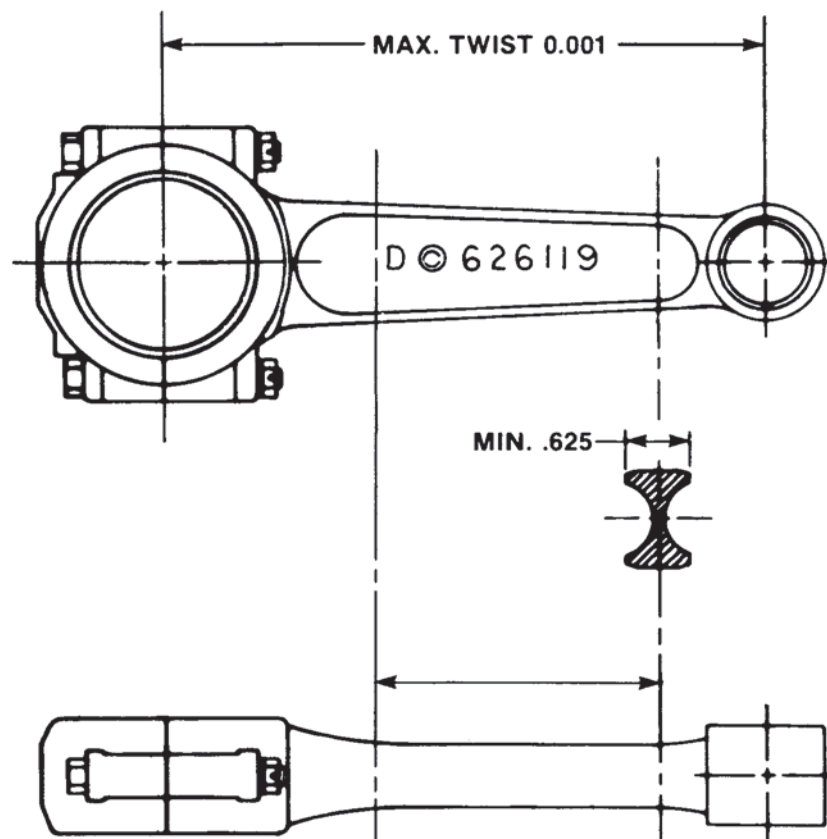
FIGURE 1. CONNECTING ROD.

A potential problem of over stressed connecting rods associated with excessive cylinder pressure which can be caused by lean take-off fuel flows, advanced magneto timing, pre-ignition, overspeed, detonation, overboost, hydrostatic lock, or sudden propeller stoppage may eventually cause connecting rod breakage and resultant engine failure.

A larger number of over stressed connecting rods have been those identified with a forged C on the beam section. These rods were manufactured between June 1976 and September 1981. Particular attention should be paid to these rods.

NOTE: THIS INSPECTION PERTAINS TO THE 626119 FORGING ONLY

We recommend that at any time access is gained to the connecting rods during cylinder removal, the beam section dimension of the connecting rods with forging number 626119 be measured as per illustration Figure 1, and also as found in Overhaul Manual X30030A. Any connecting rod below .625 dimension should be replaced with a new product improvement connecting rod with additional margin of safety, P/N 646321 or P/N 646320, depending on the model affected. In addition, it is recommended that published operating and maintenance procedures be strictly followed to prevent the causes of excessive cylinder pressure as noted in the preceeding paragraph.

If connecting rod replacement is required, new connecting rod bearings of the appropriate part number and new cotter pins P/N 639292 should be installed. Component inspection and reassembly should be in accordance with Overhaul Manual Form X30030A.
