TELEDYNE CONTINENTAL<sup>®</sup> AIRCRAFT ENGINE  
**CRITICAL SERVICE BULLETIN**  
Compliance Necessary To Maintain Safety

**CSB96-13**

**SUBJECT:** IO-360, TSIO-360 AND LTSIO-360 SERIES ENGINE CONNECTING ROD INSPECTION AND REPLACEMENT.

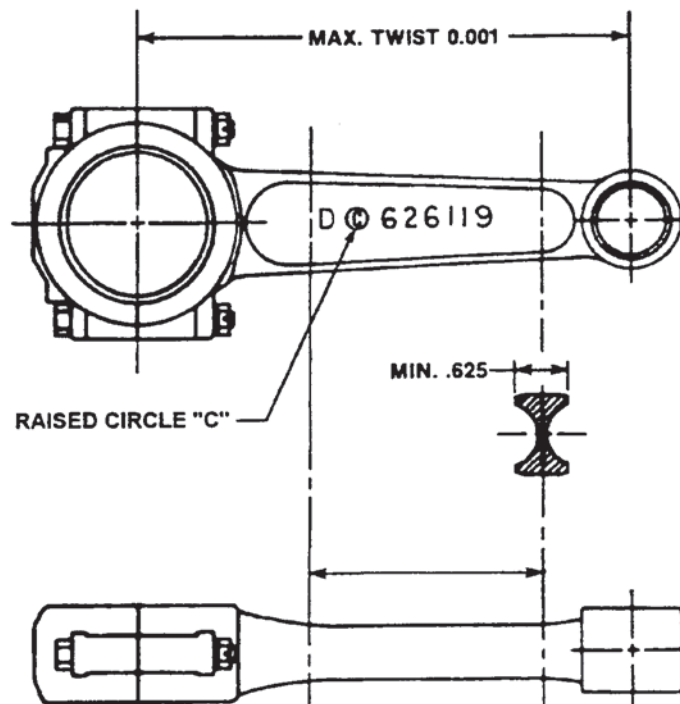
FIGURE 1. CONNECTING ROD.

- Remove all cylinders in accordance with the applicable TCM Overhaul Manual.
  - Inspect each connecting rod while it is positioned at its maximum stroke to allow clearance from the crankcase. Measure the beam width as indicated in Figure 1 and record the forging number.

- Any connecting rod that has a beam width less than .625 inch must be replaced. See Figure 1.
- NOTE: Connecting rods are supplied in pairs due to the maximum weight differential of 14 grams in opposing cylinder bays. Therefore, the opposite cylinder connecting rod will also require replacement. Reference Table 1 for the applicable replacement connecting rod kit.
