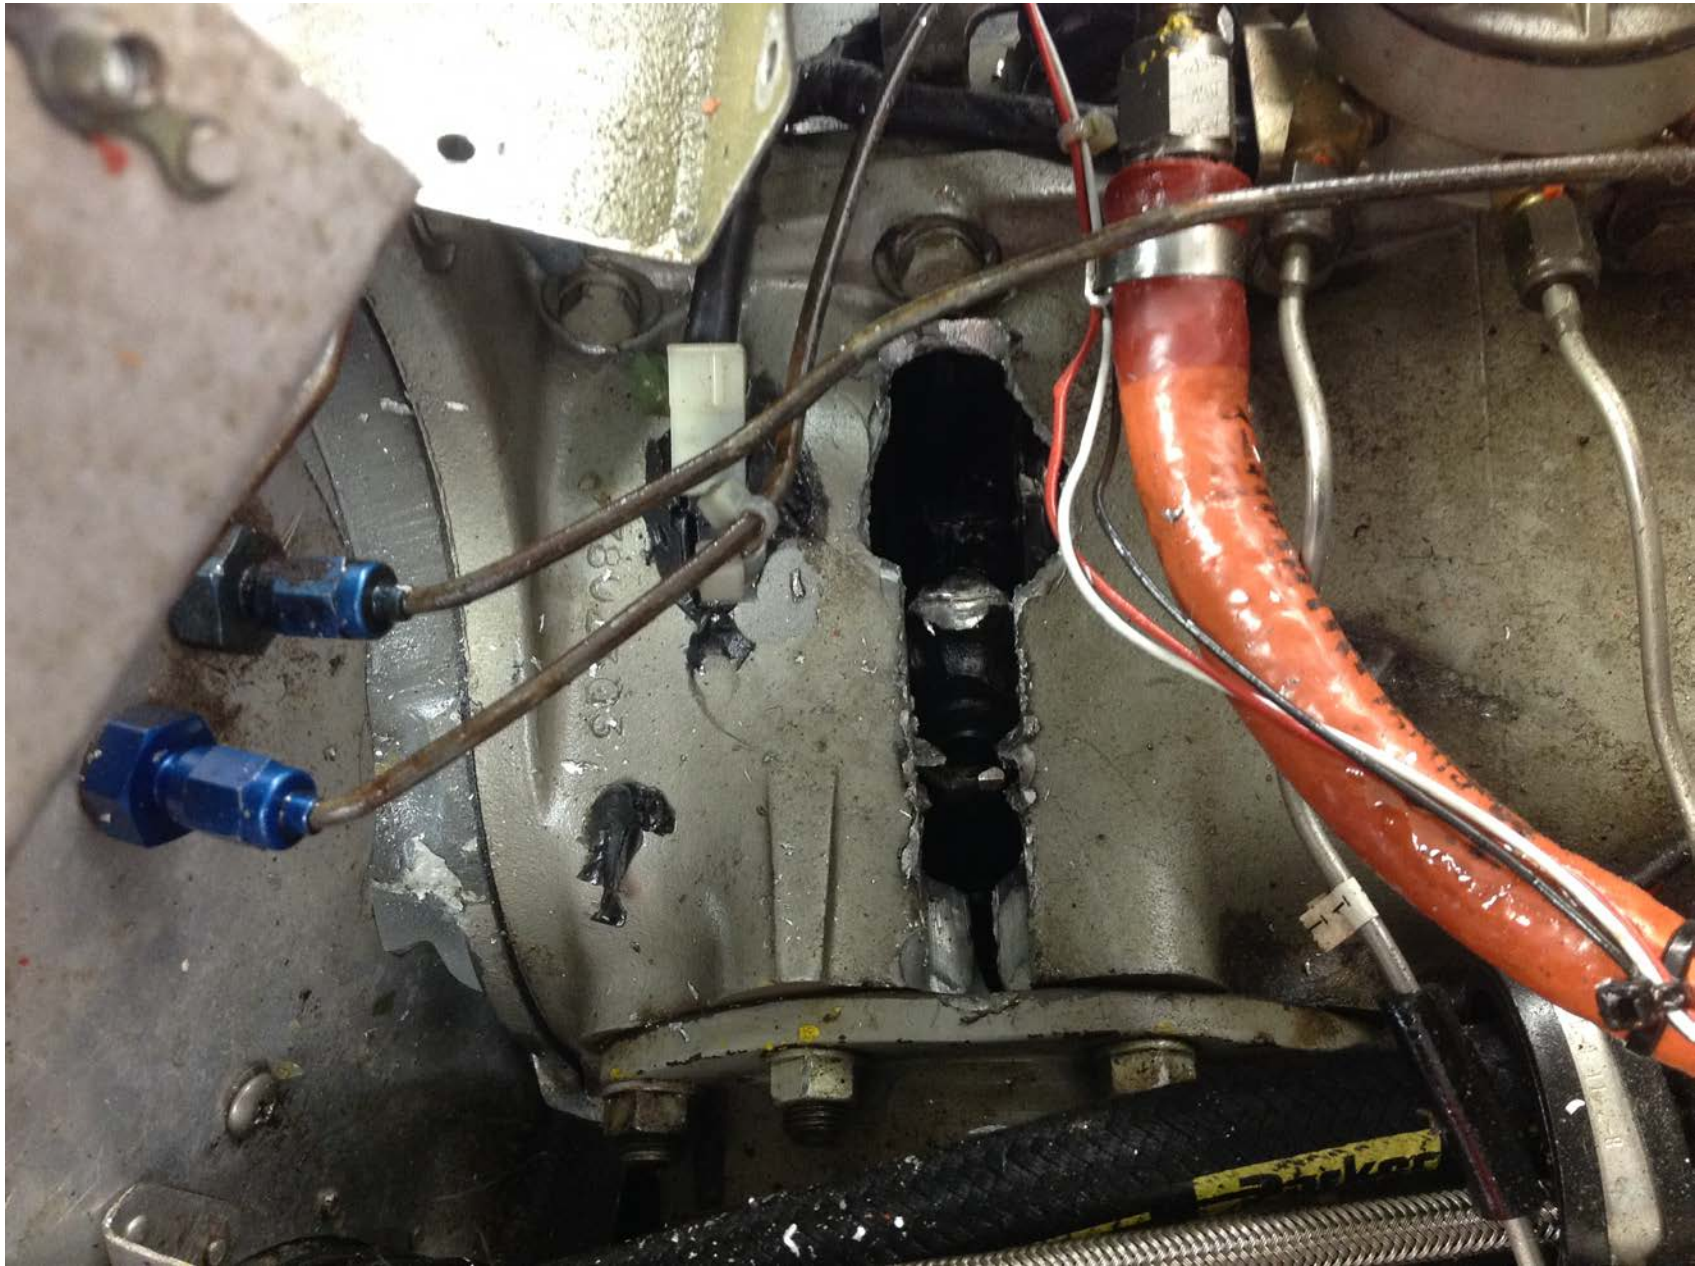
**Photo 1 – Crankcase hole above the #1 cylinder**

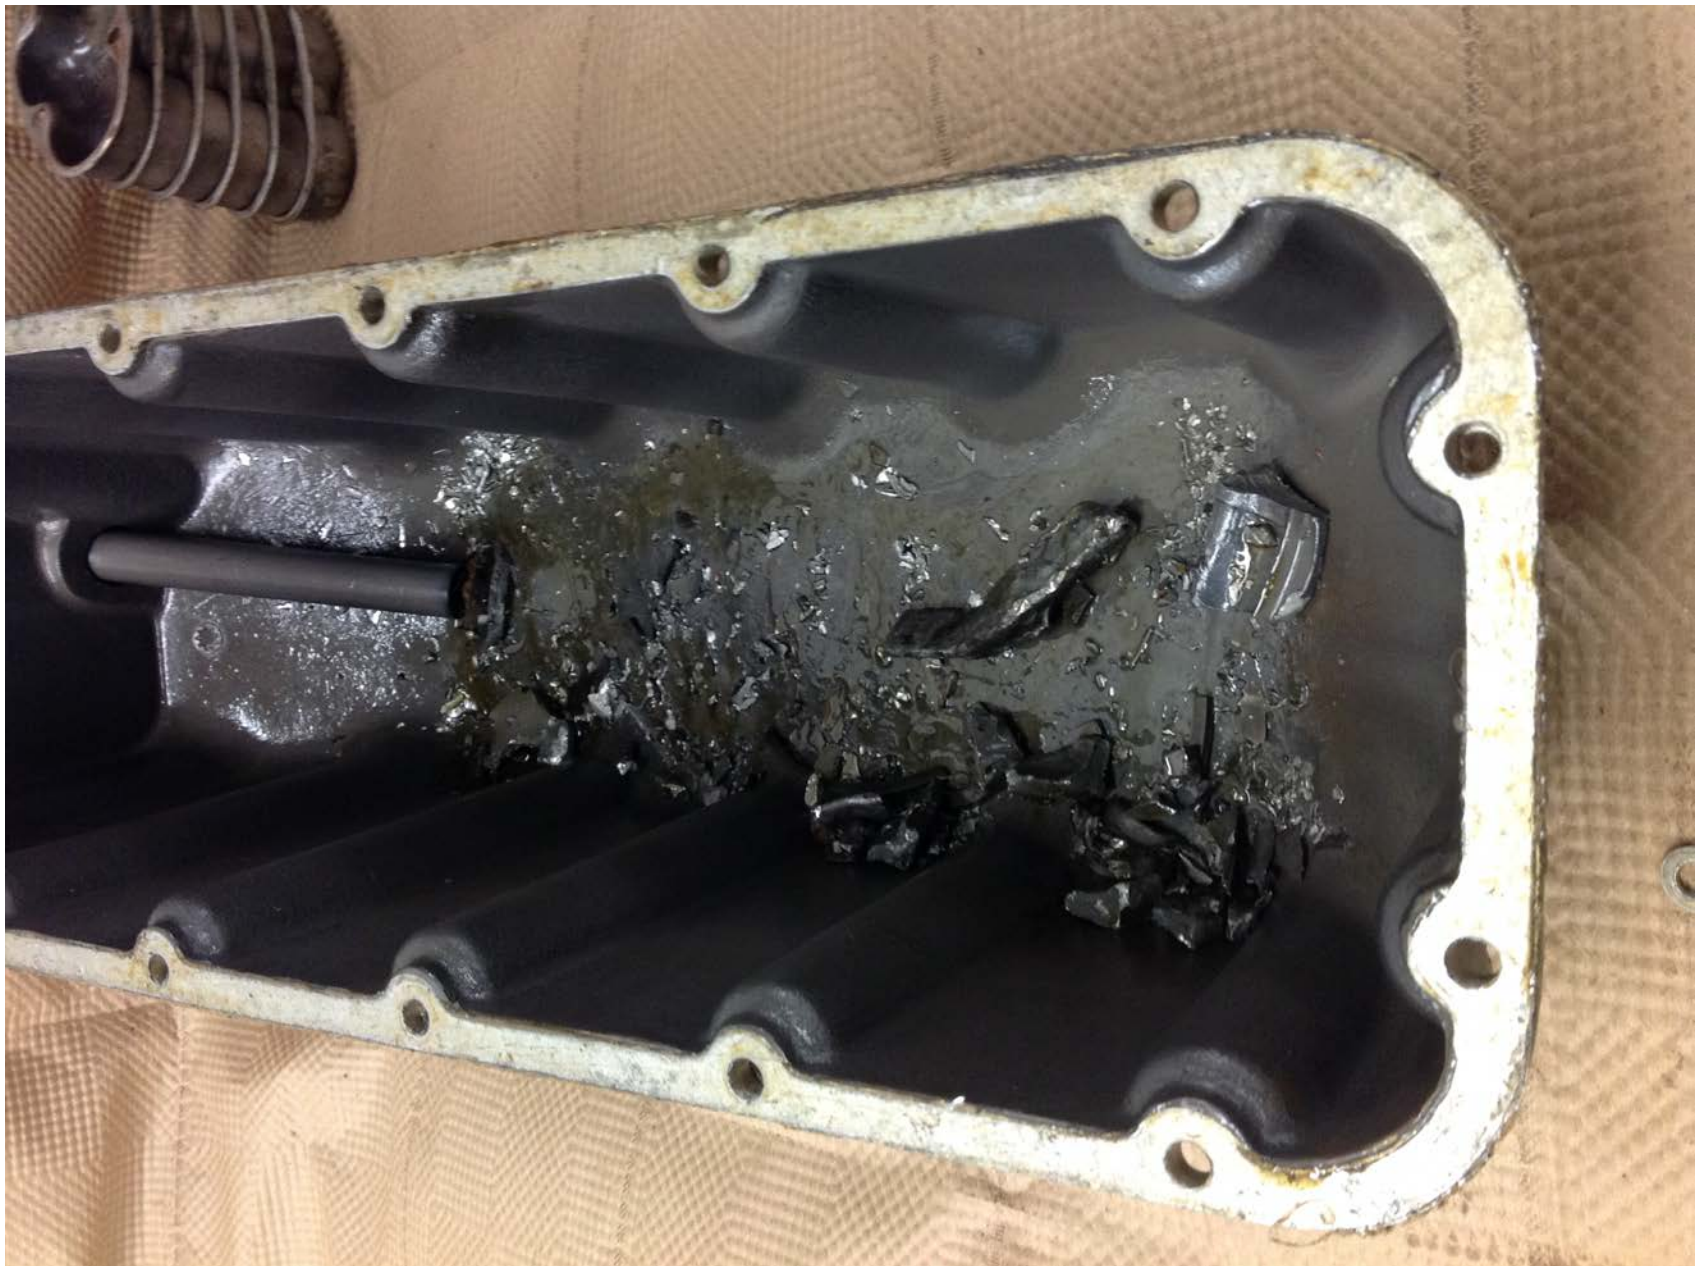
**Photo 2 – Engine oil sump with visible debris**

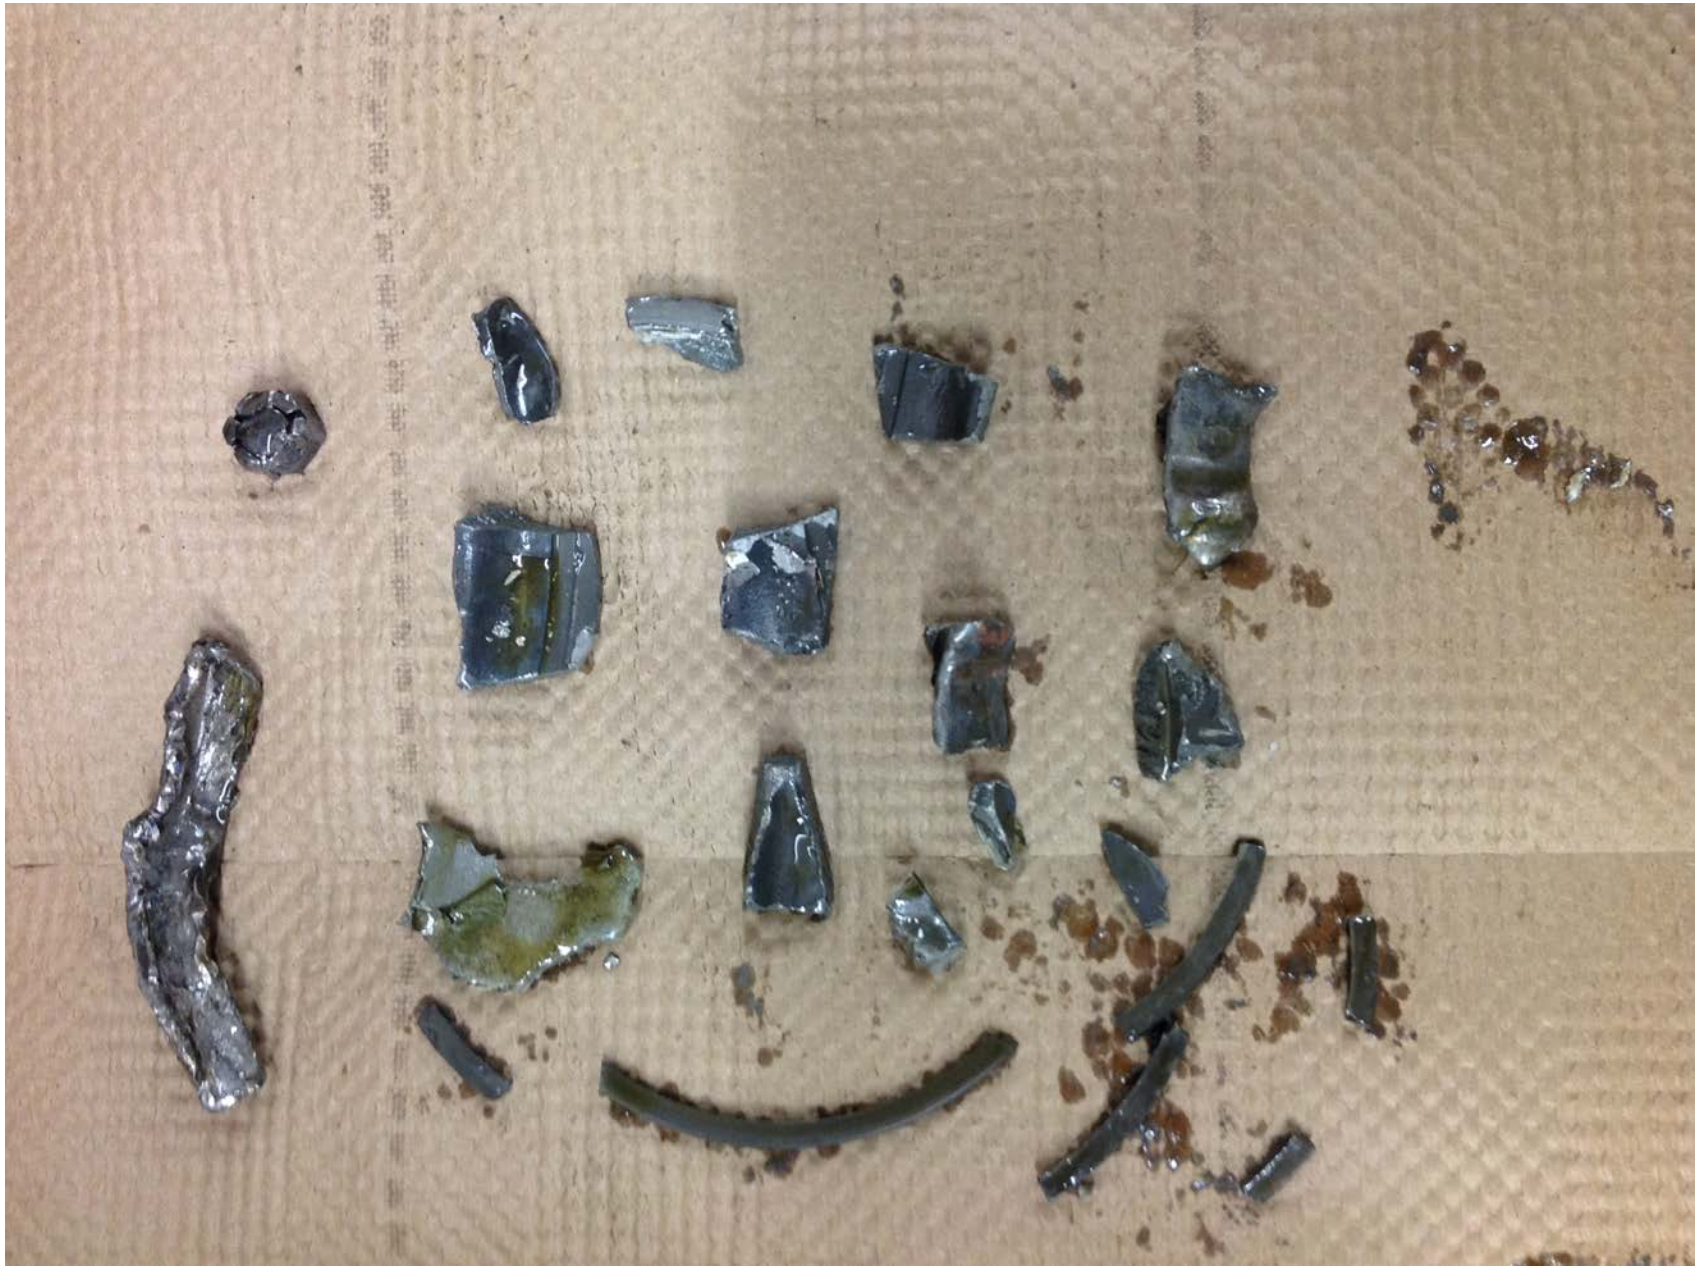
**Photo 3 – Debris contents of the engine oil sump**

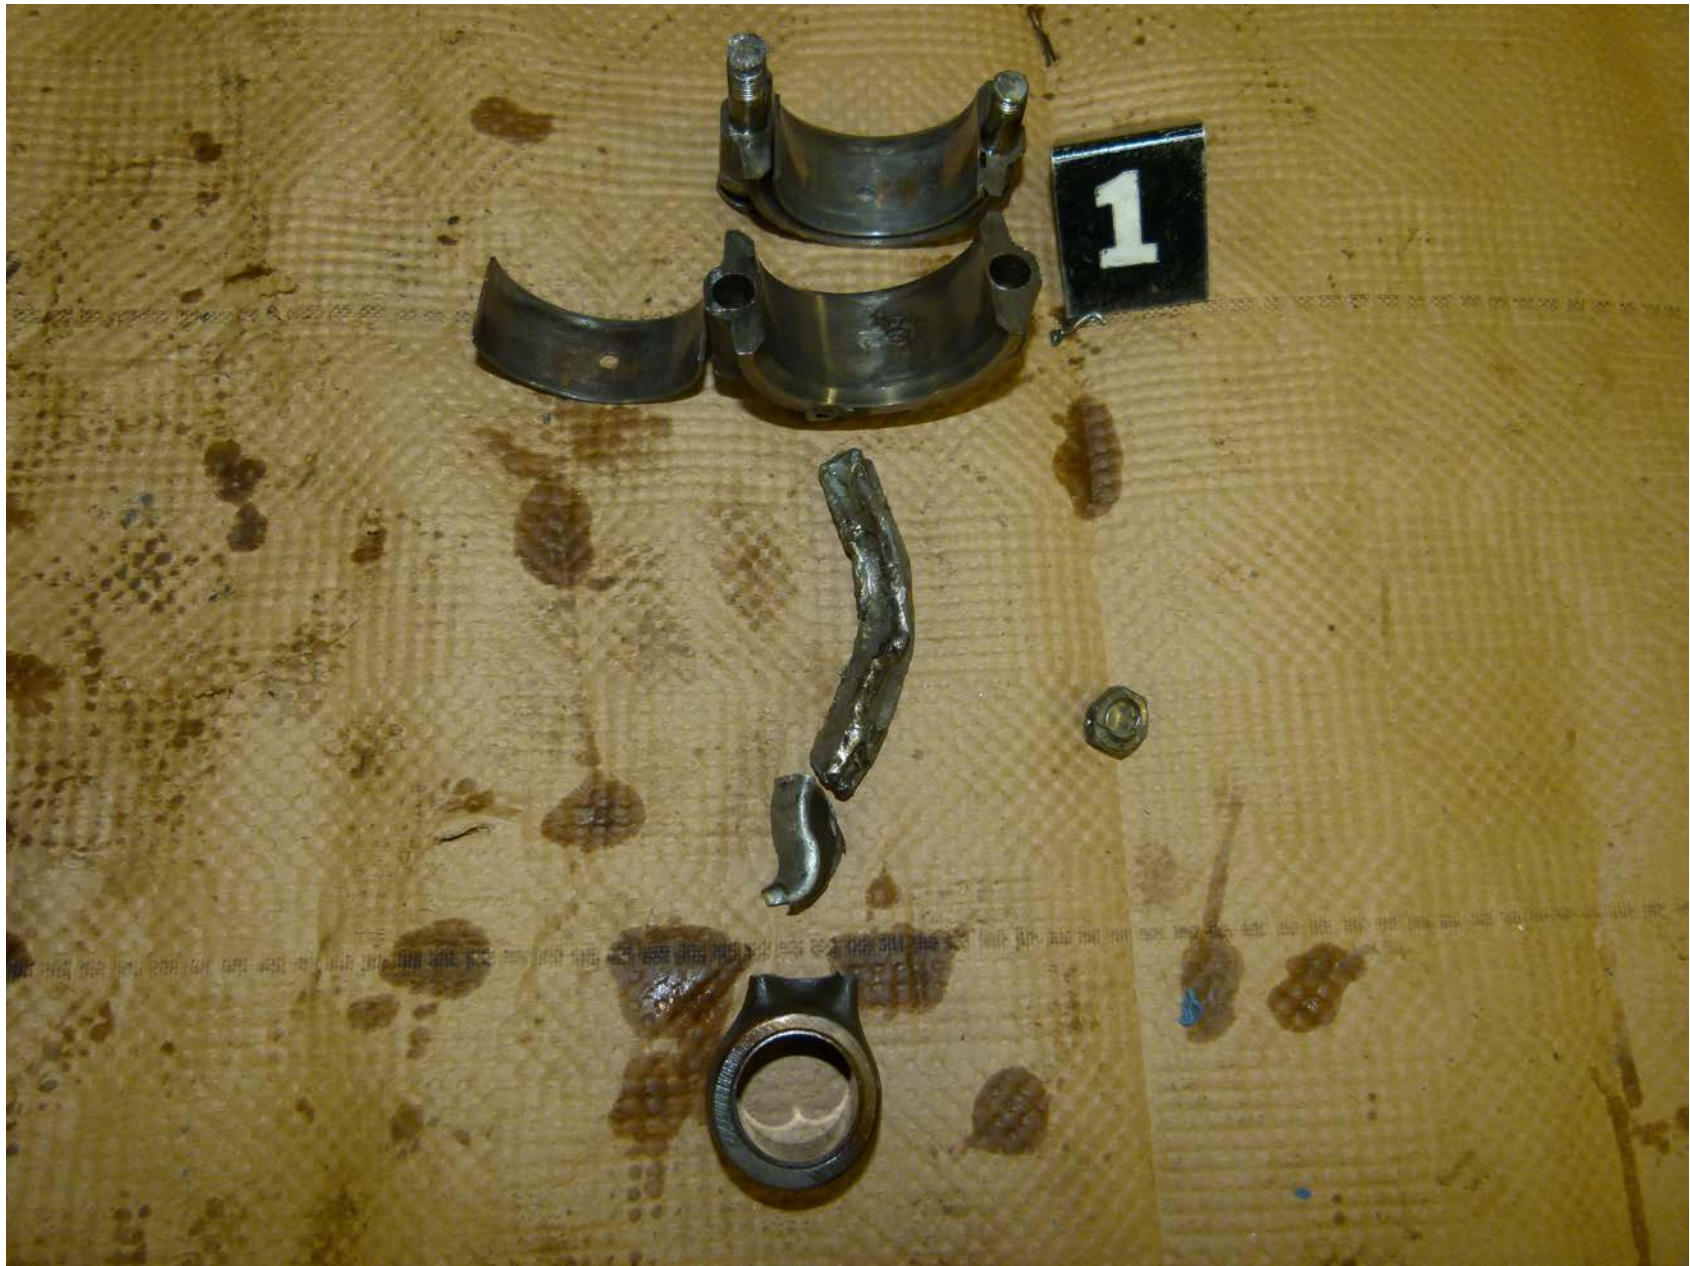
**Photo 4 - #1 Rod Connecting Rod Fragments - Photograph taken by Continental Motors**
