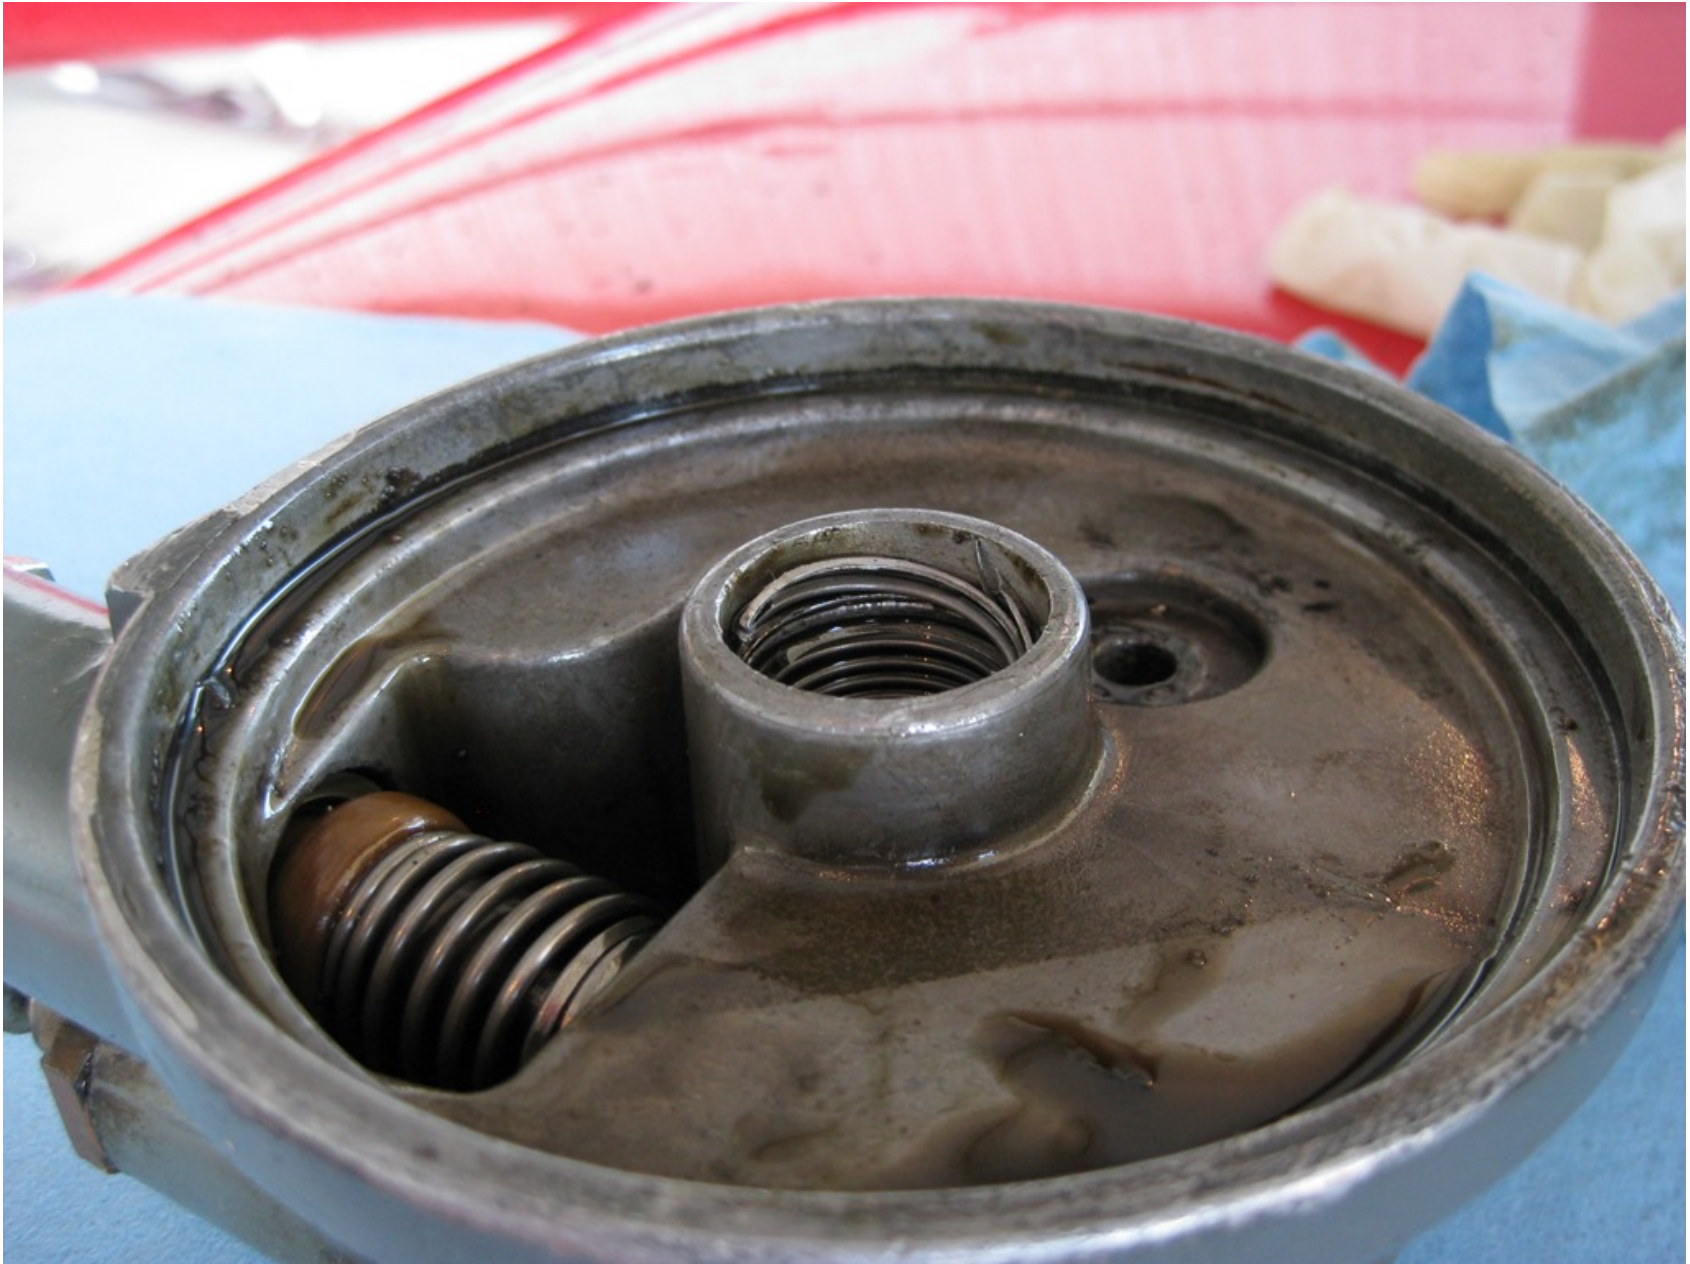
**Photo 2 – Damaged Heli-Coil Insert Threads**
