**Photo 1 – Pre-accident photograph of N2440R on the ramp at Kickapoo Airport (KCWC), Wichita Falls, Texas.**

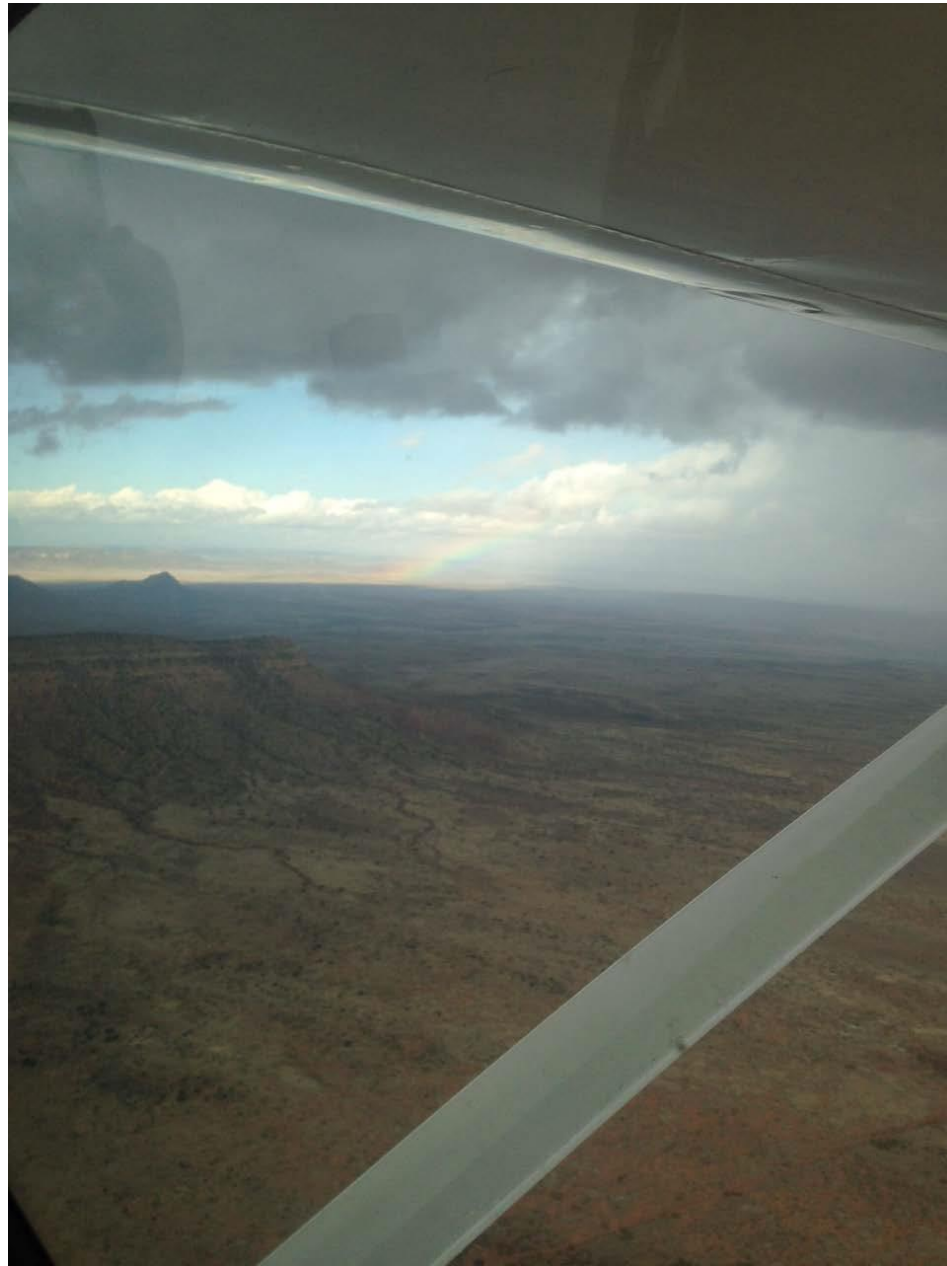
**Photo 2 - En route in VFR conditions (photo taken from passenger's personal cell phone).**

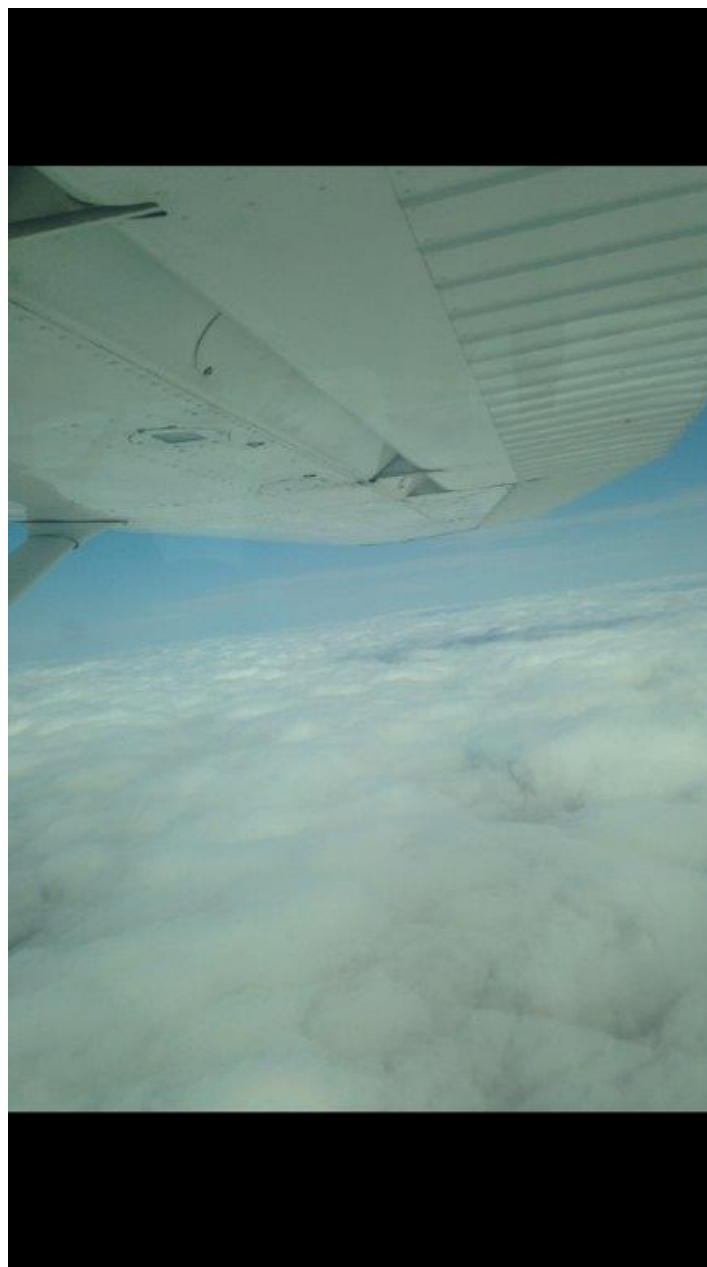
**Photo 3 - En route VFR above a solid overcast (photo taken from passenger's personal cell phone).**

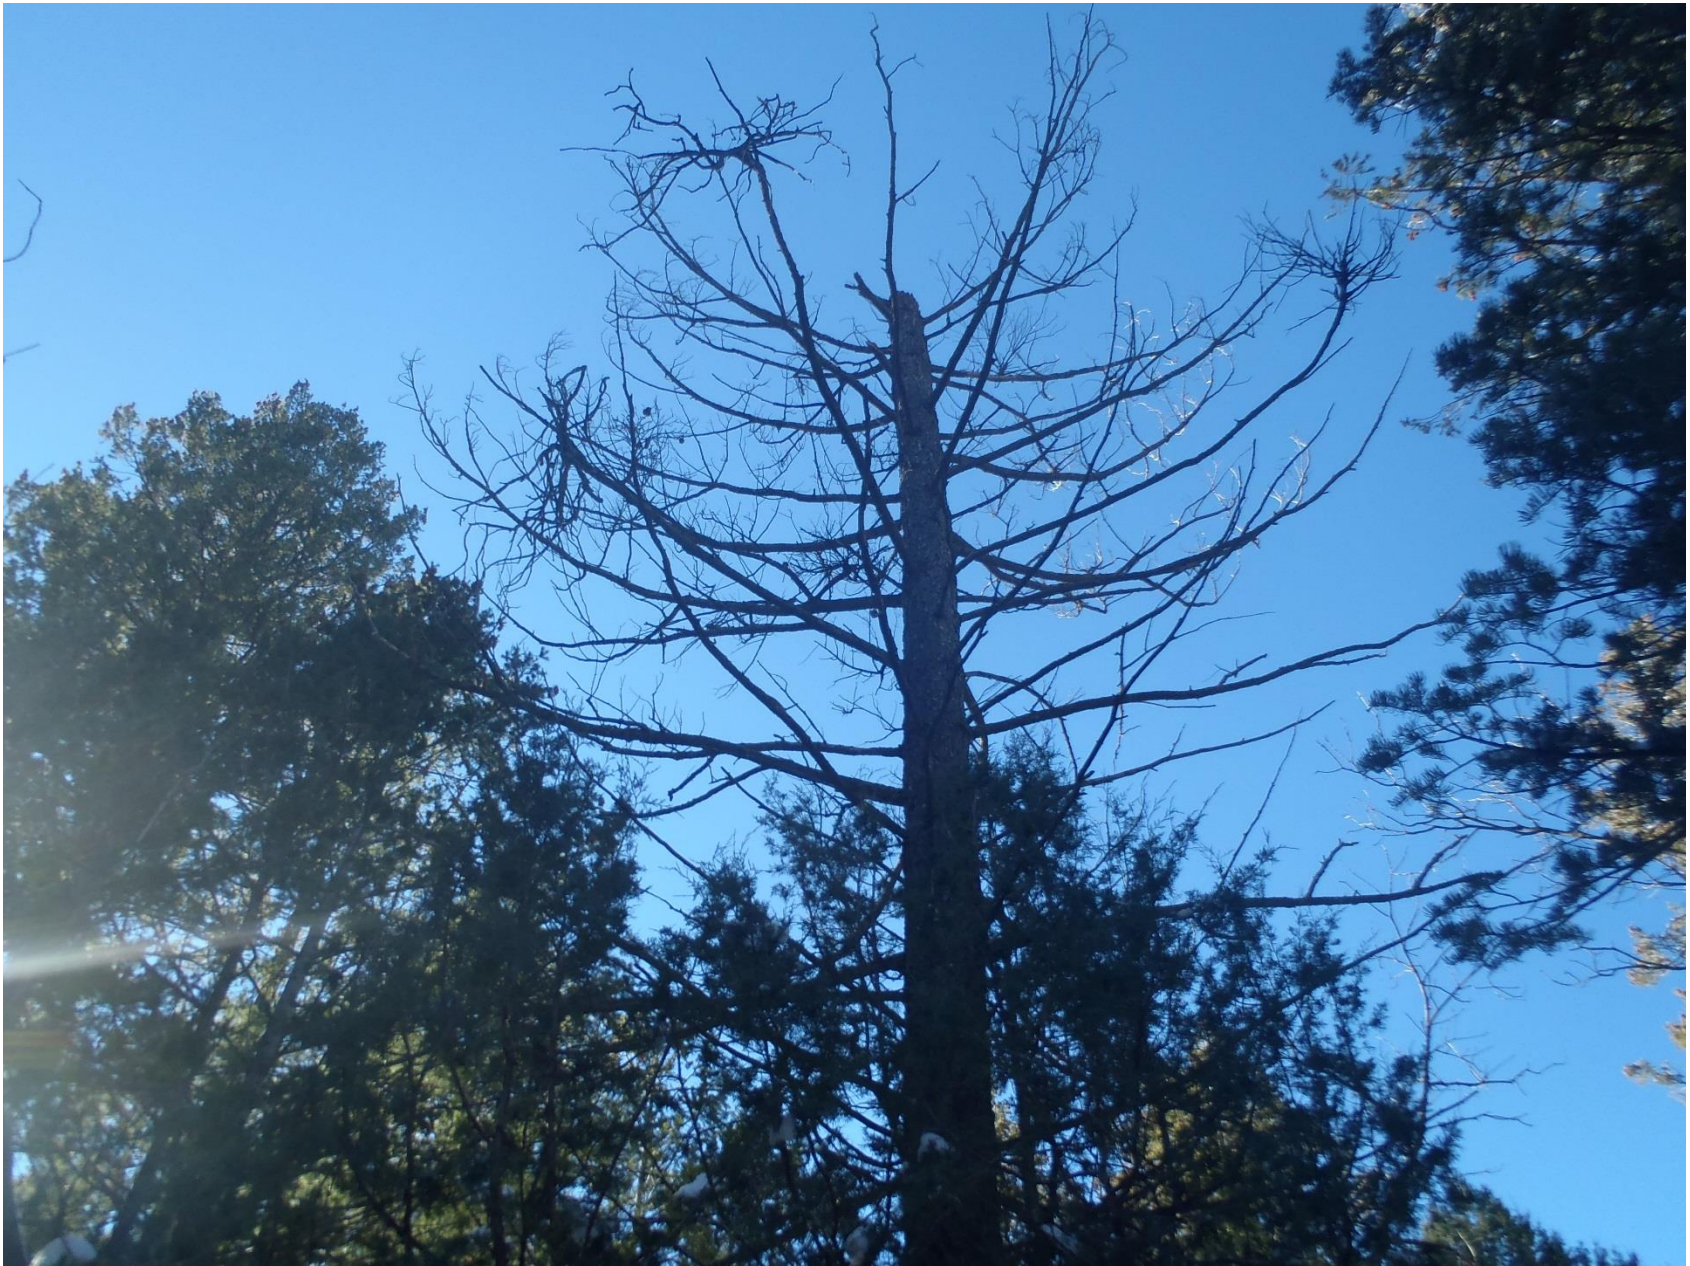
**Photo 4 - Tree struck by N2440R.**

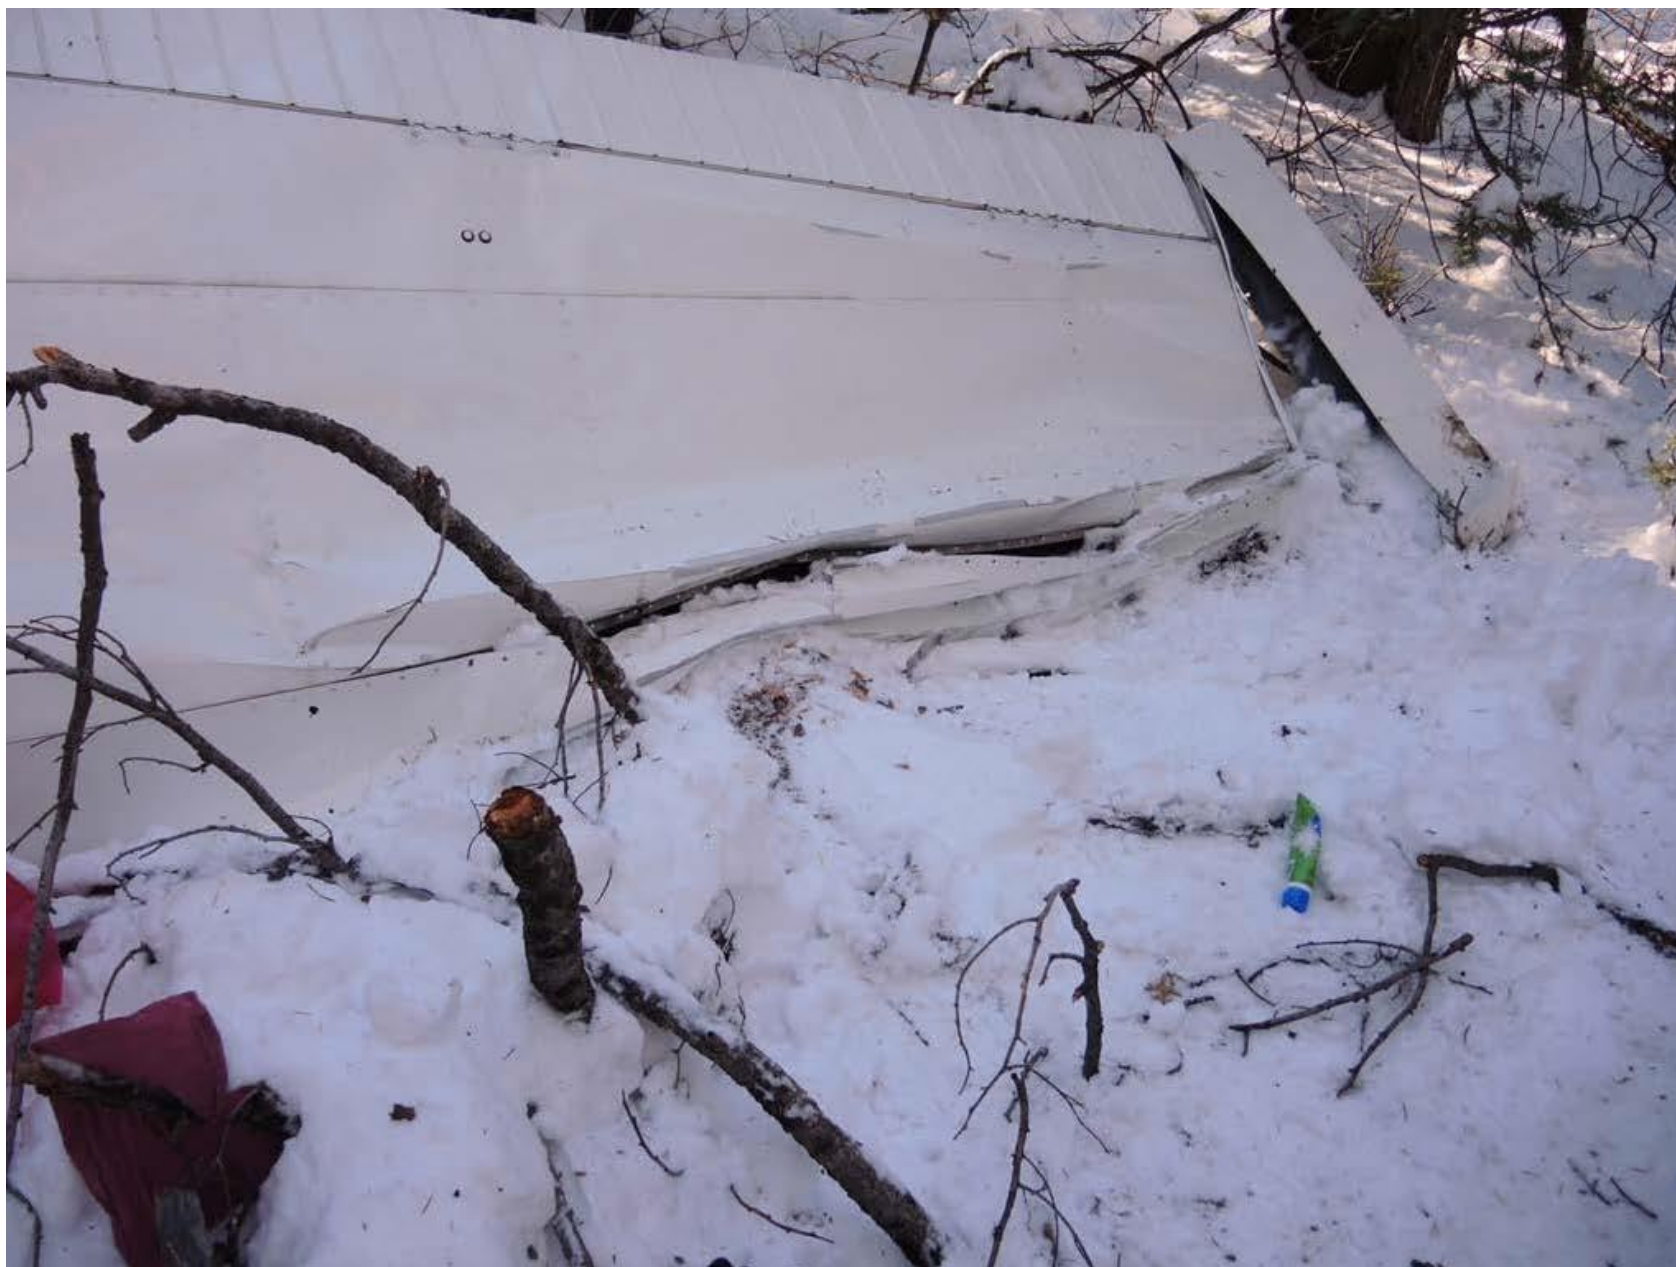
**Photo 5 - Left wing leading edge. Note indentation consistent with a tree strike and scattered branches next to left wing.**

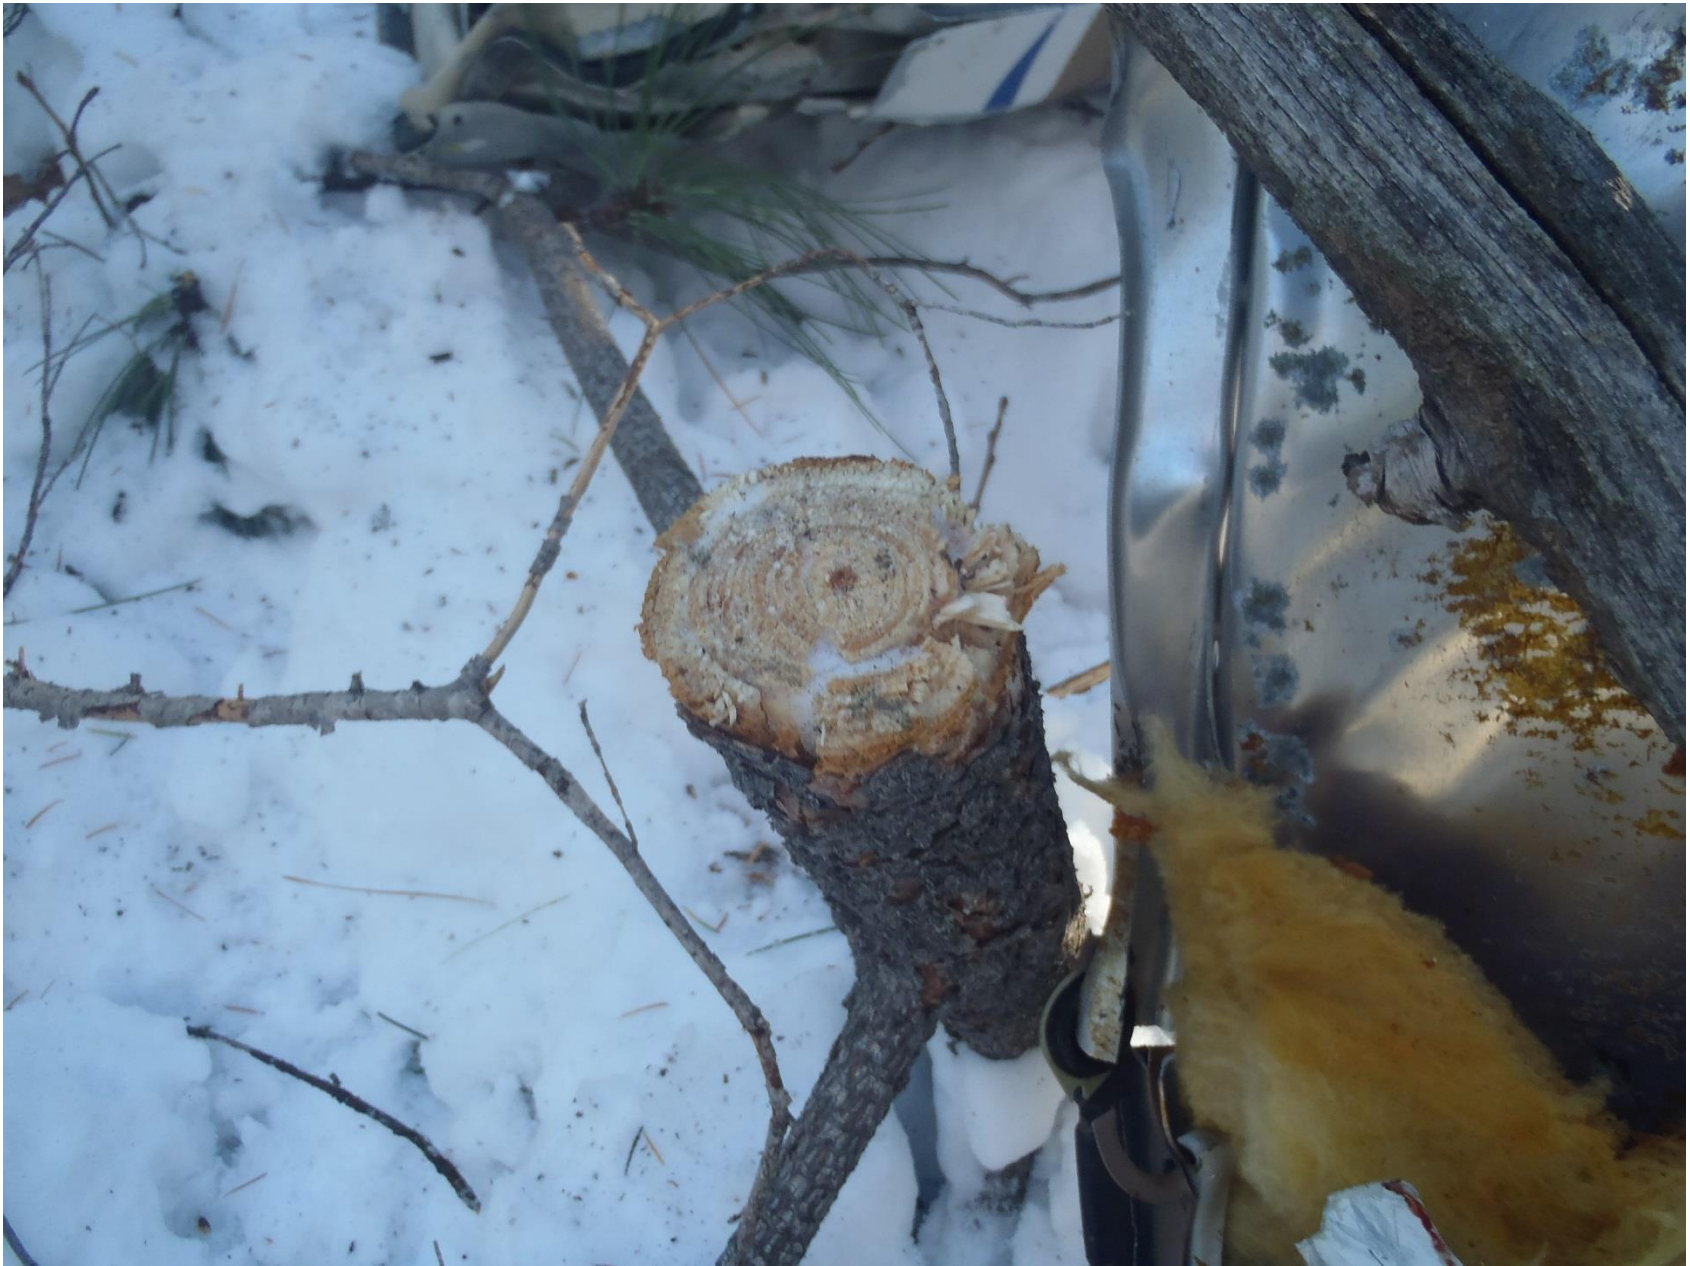
**Photo 6 - Severed branch stump next to left wing.**

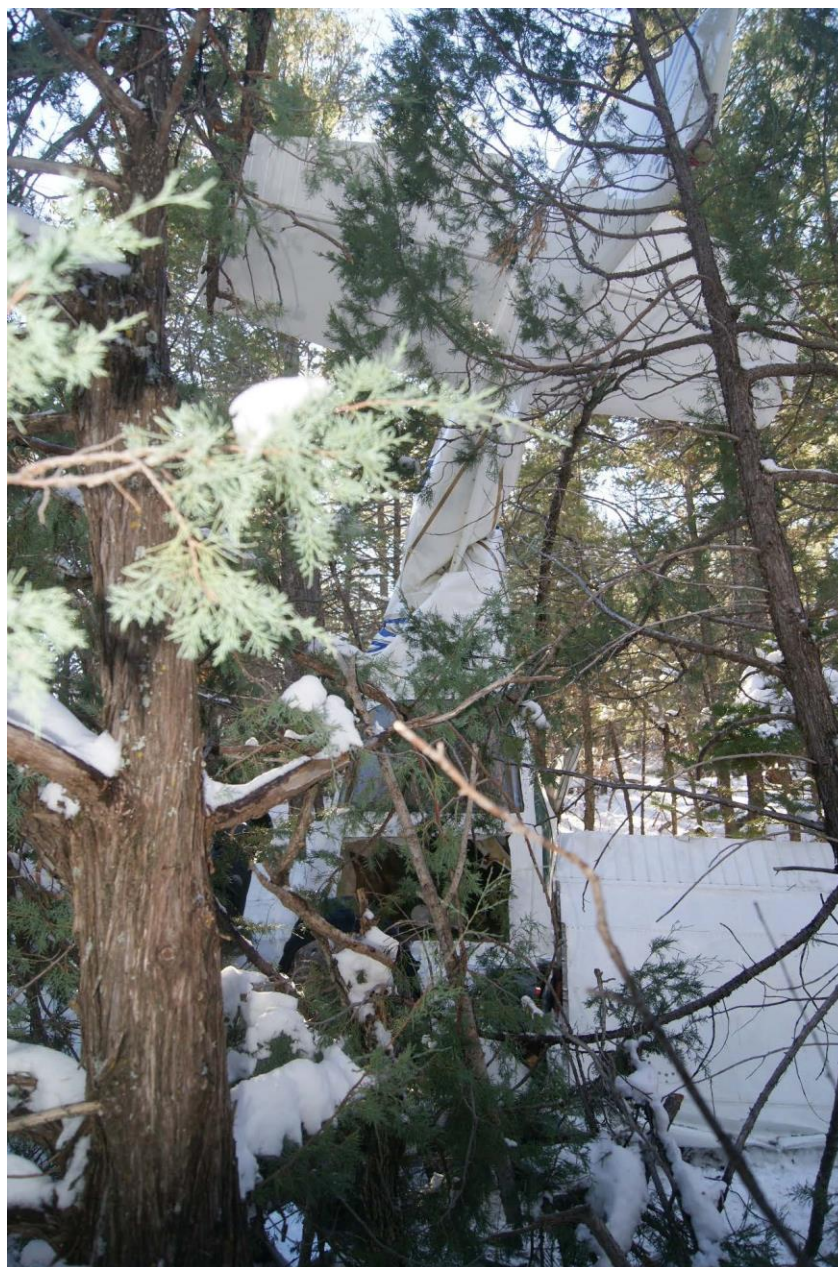
**Photo 7 - Front of airplane at the accident site.**

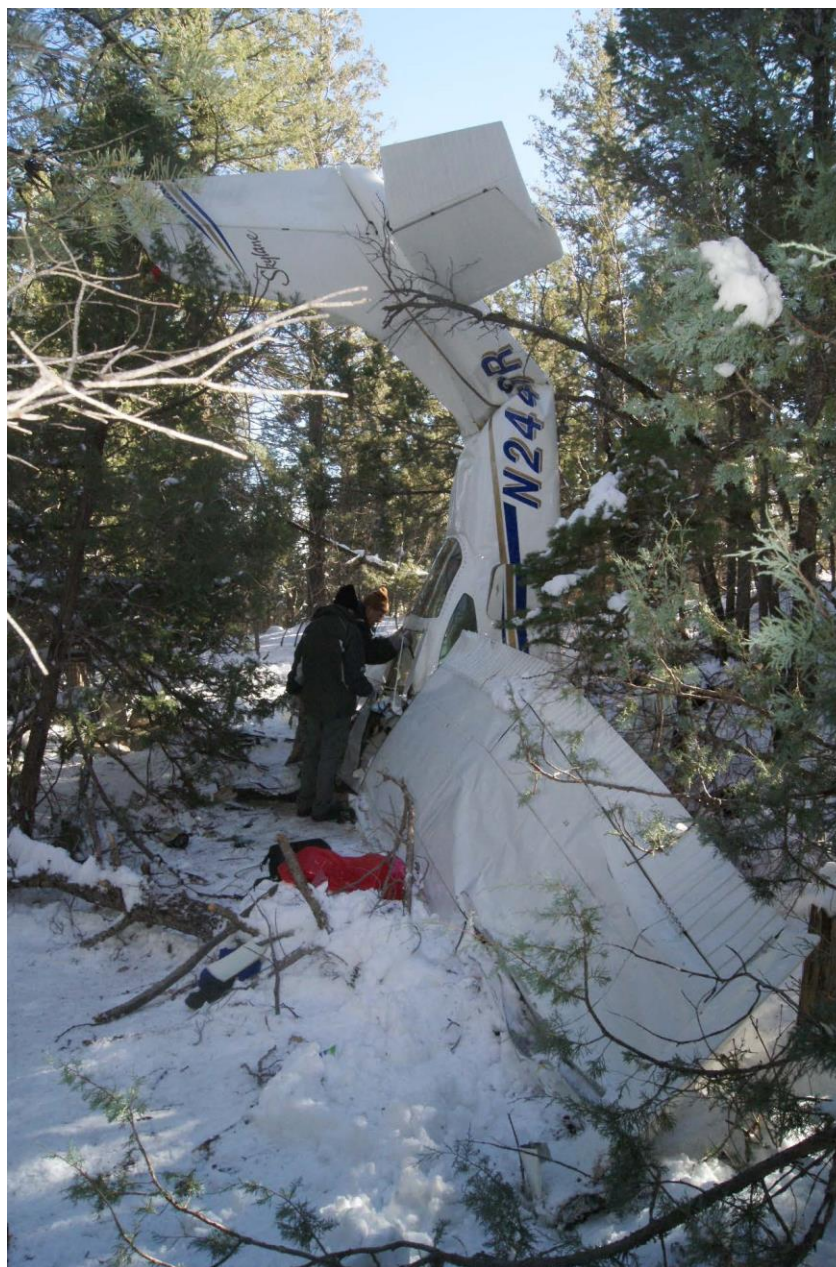
**Photo 8 - Left side of airplane. Note near-horizontal impact with mountainous terrain.**

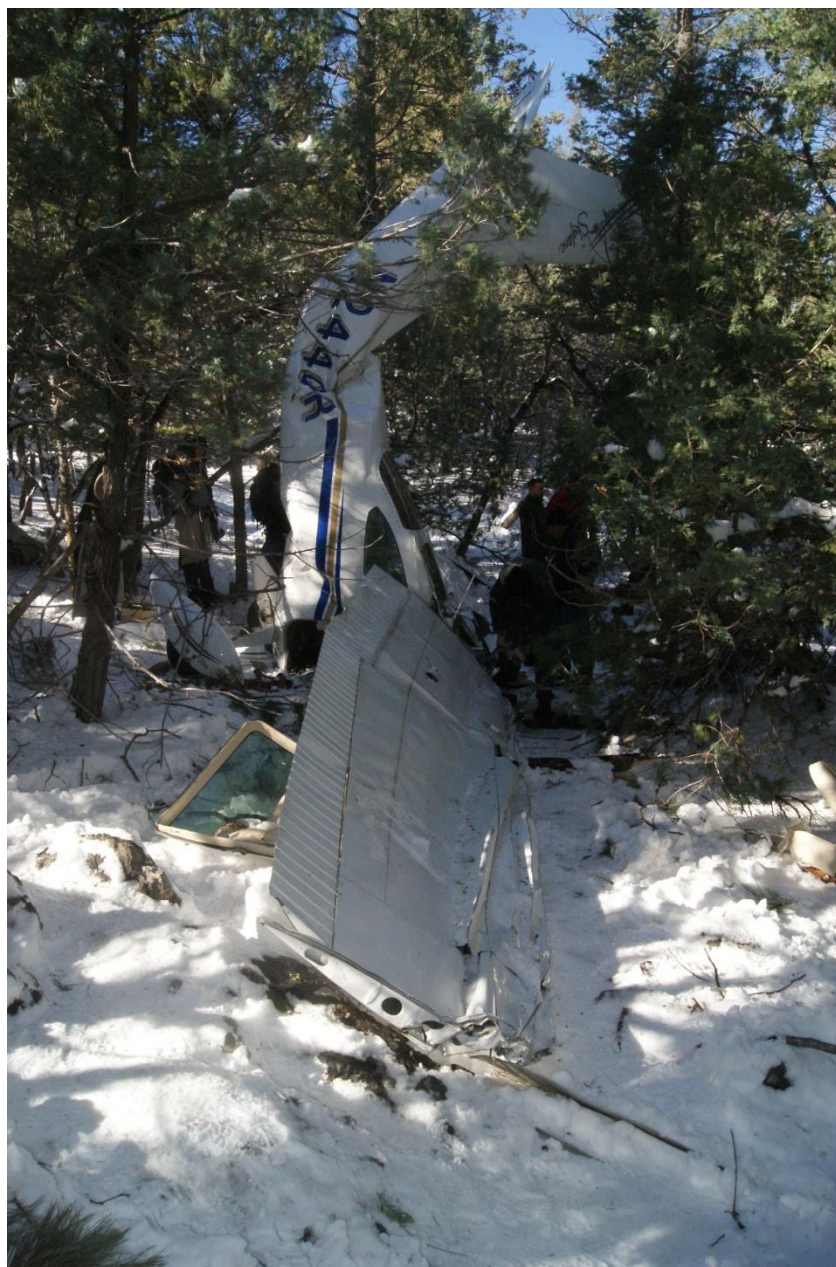
**Photo 9 - Right side of airplane. Note heavily wooded area.**

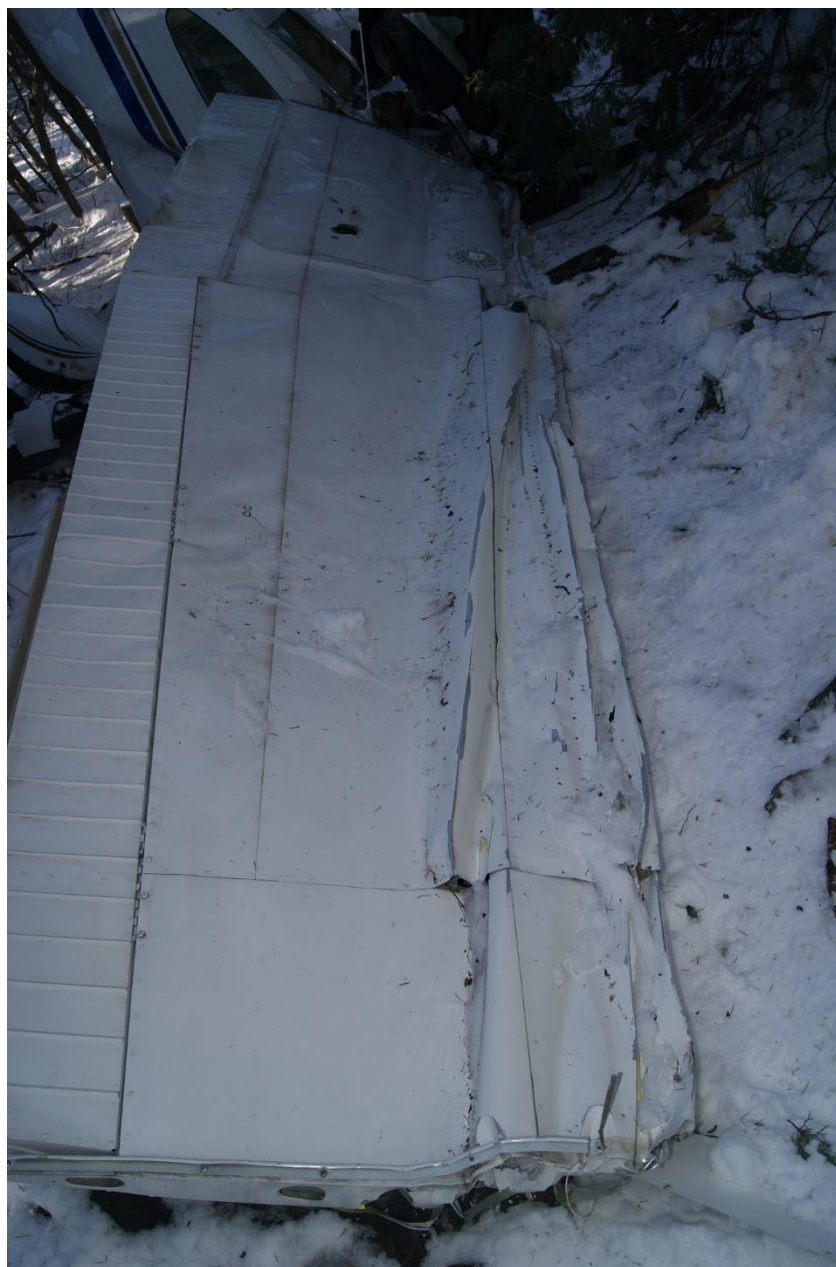
**Photo 10 - Right wing and leading edge accordion-type crush damage.**

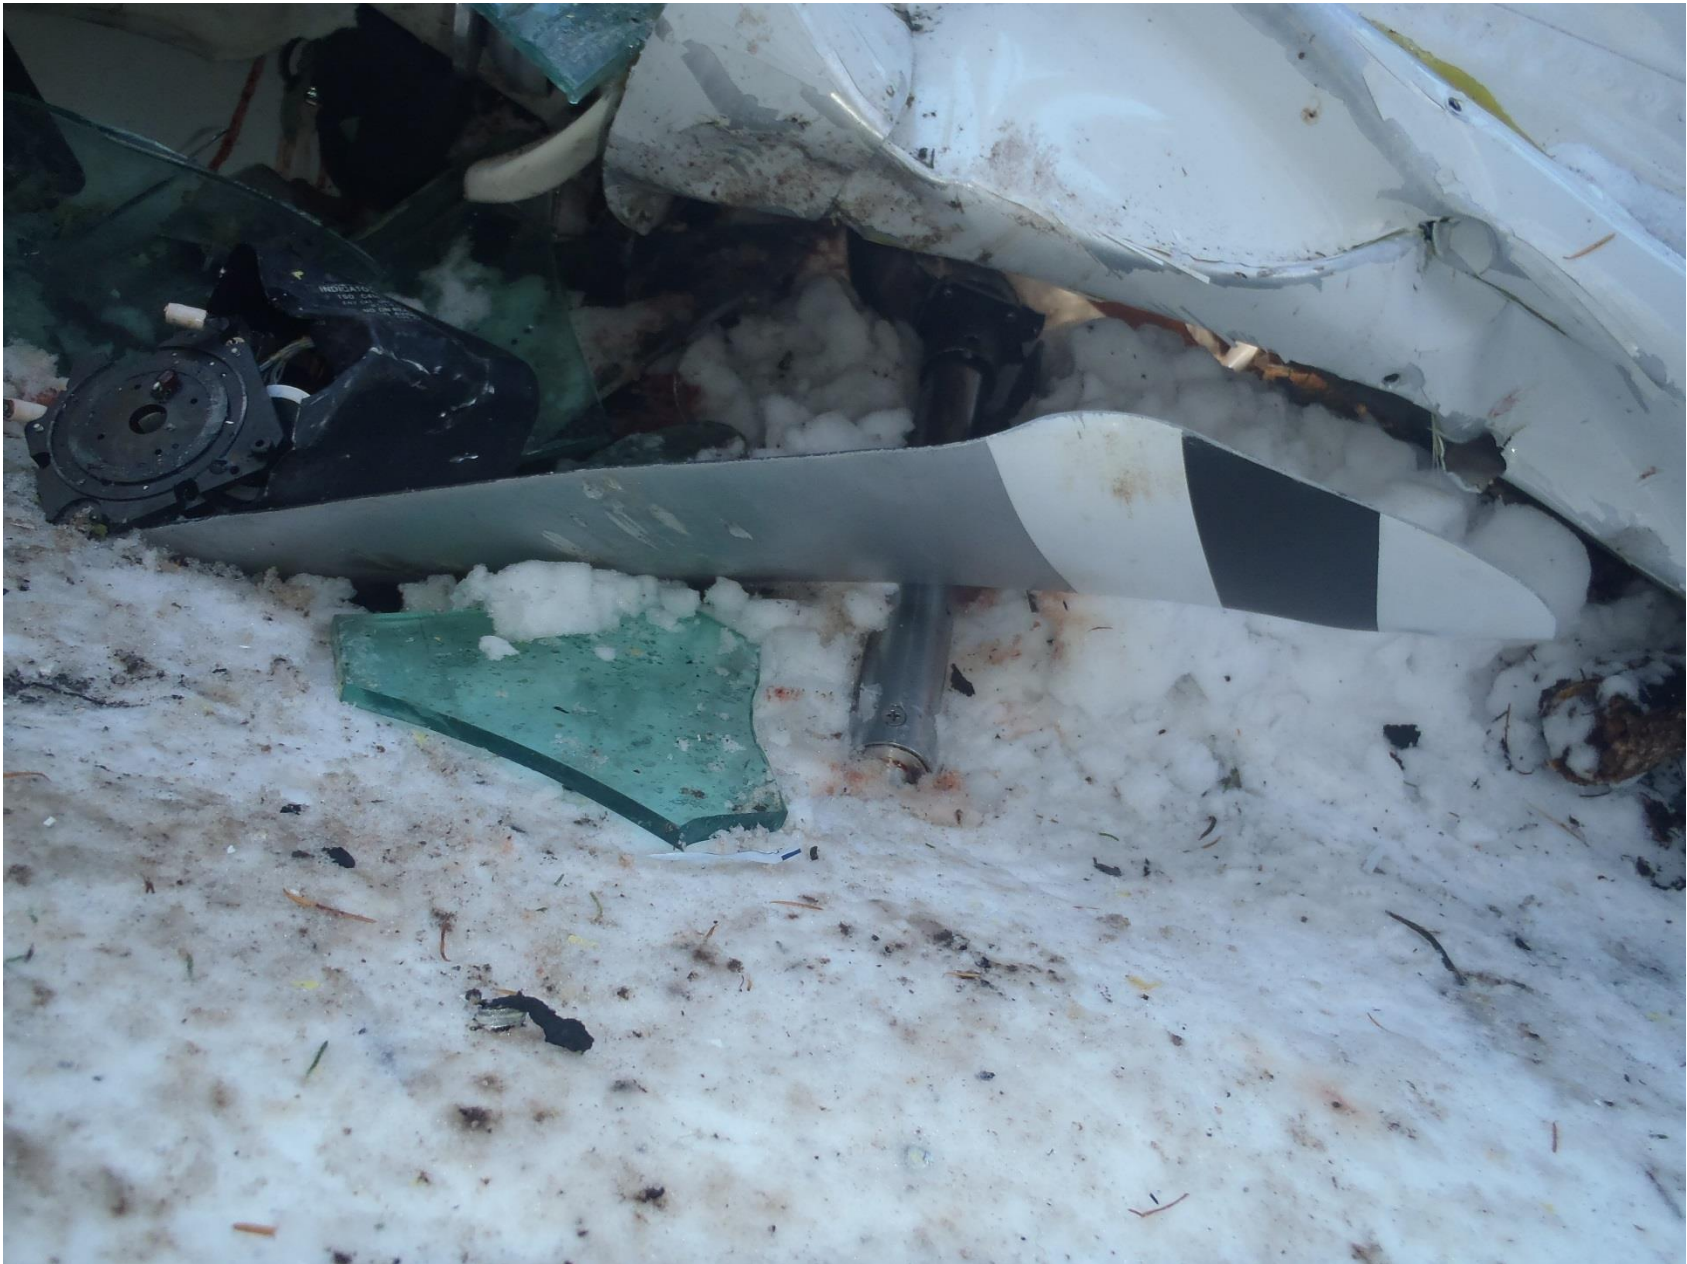
**Photo 11 - Propeller blade A. Note forward bending near the blade tip.**

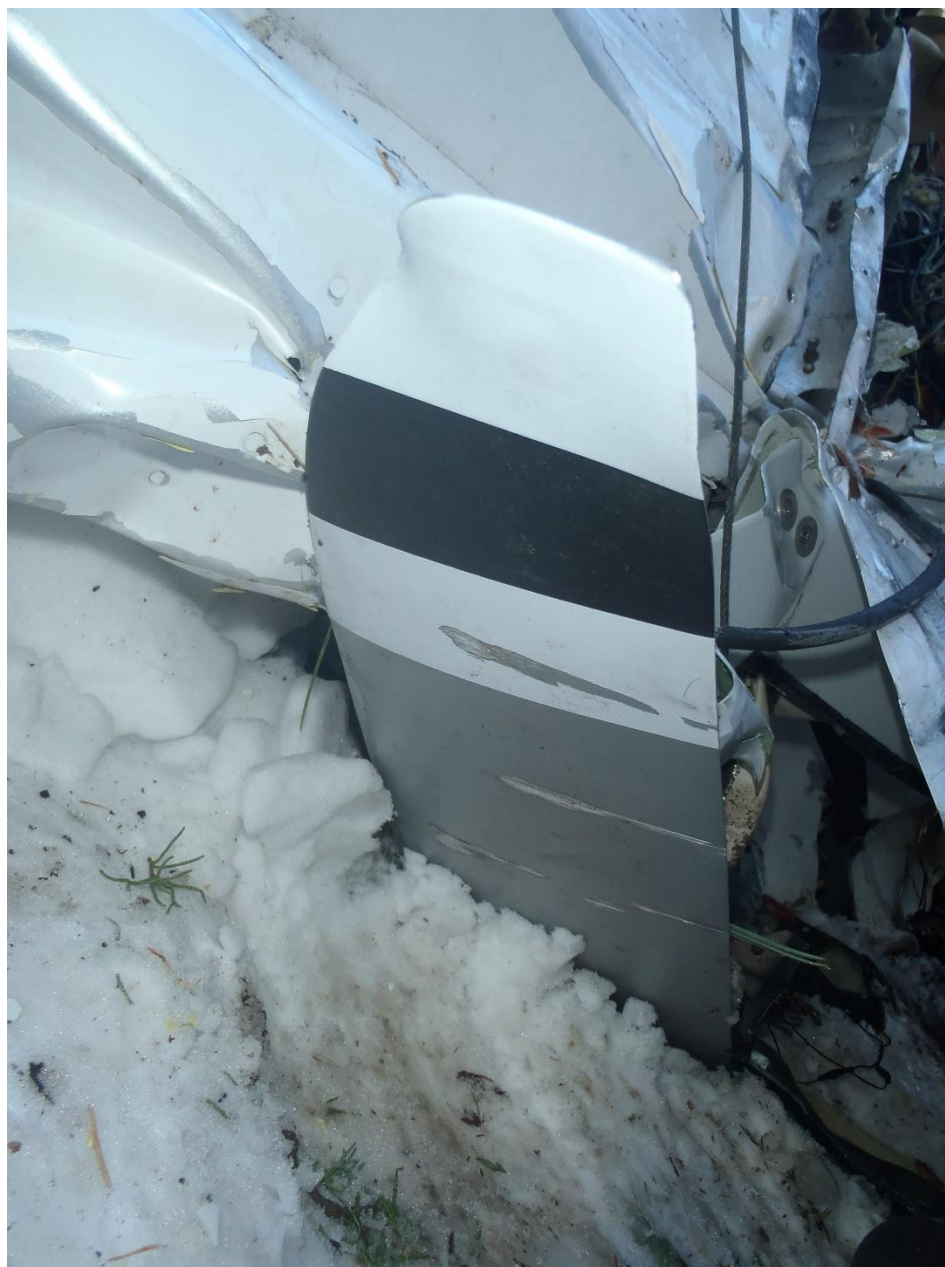
**Photo 12 - Propeller blade B. Note spanwise striations on cambered surface.**
