# Continental Motors

## ENGINE FIELD INSPECTION REPORT

| AIRCRAFT MAKE & MODEL | Cirrus SR22 |
| FILE NUMBER | 15-638 |

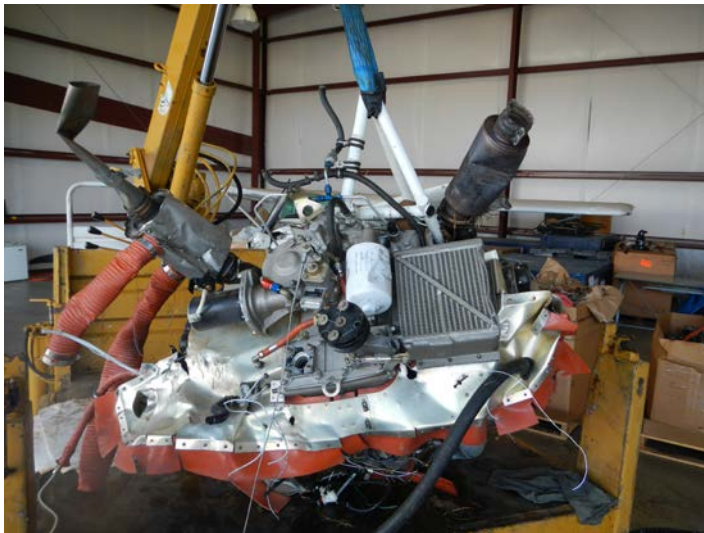
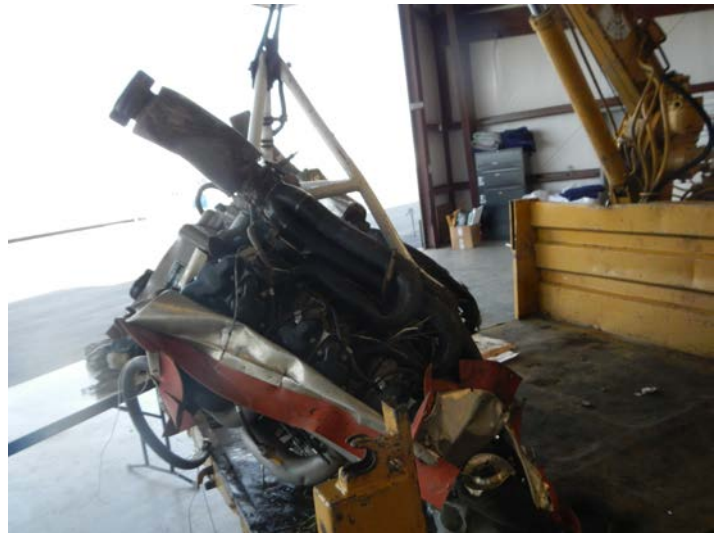
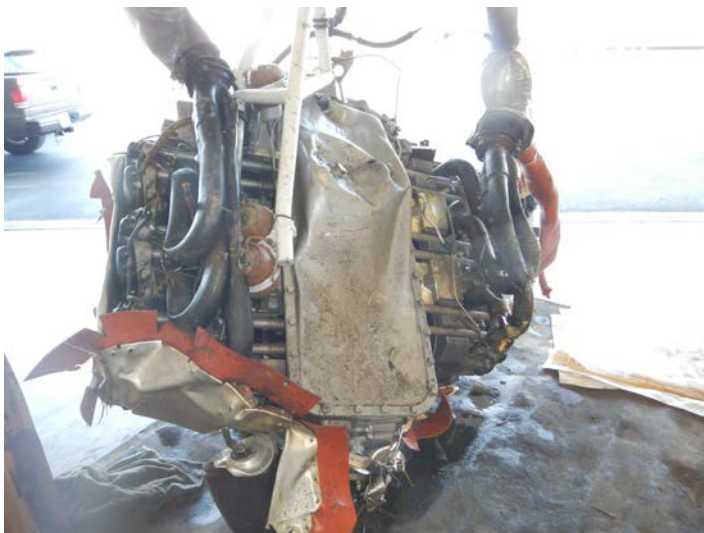
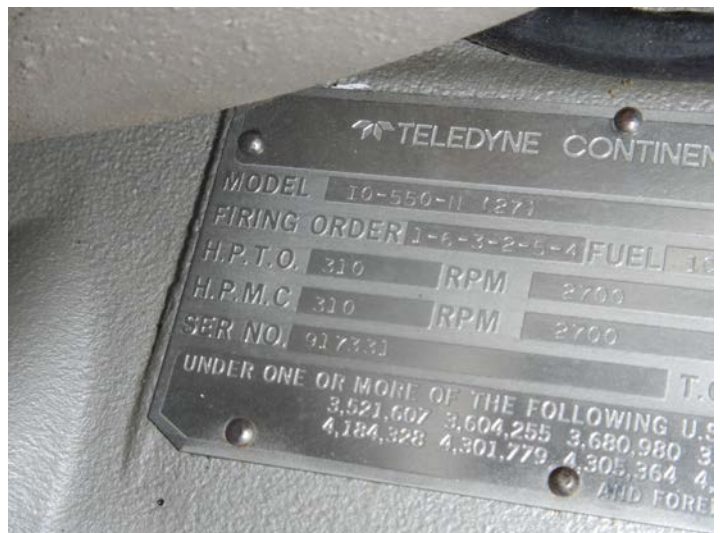
### EXTERNAL INSPECTION OF ENGINE

The engine had separated from the airframe and exhibited impact damage. The oil sump was crushed and two of the four engine mount legs were broken.

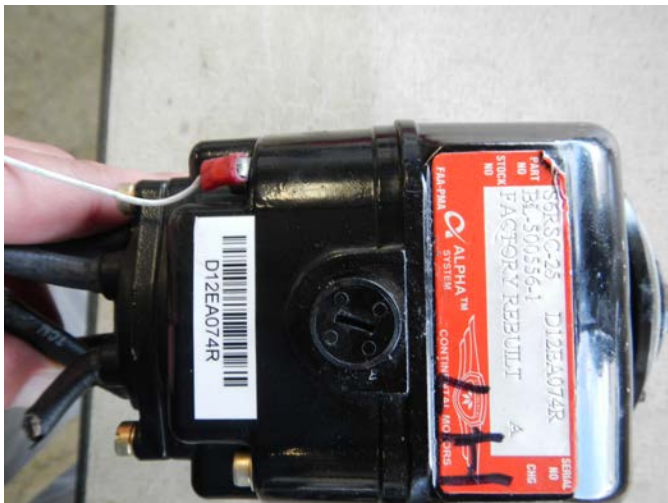
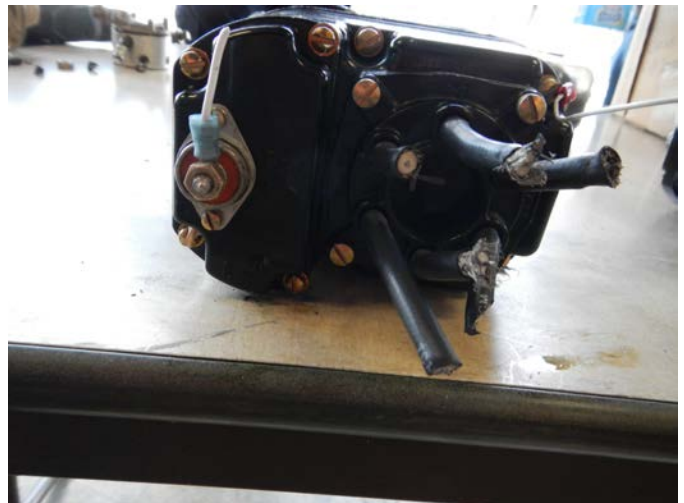
**IGNITION SYSTEM****LEFT  
MAGNETO**

The left magneto was removed from the engine and turn freely by hand with impulse coupling engagement noted. The magneto was placed in a vice and the drive was turned with an electric drill. The magneto produced spark on all six spark plug leads.

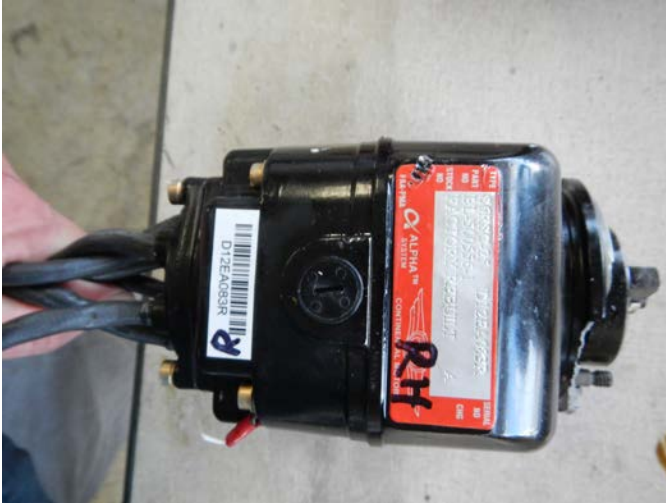
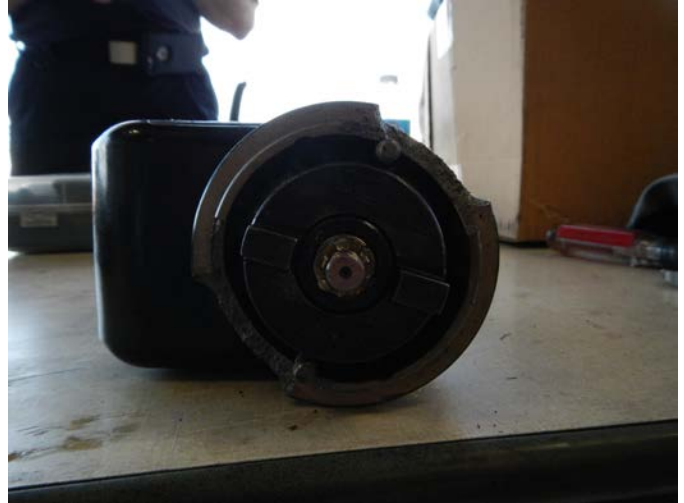
| <b>RIGHT MAGNETO</b> | Manufacturer: CMI | P/N: BL-500556-1 | S/N: D12EA083R |

| Condition: | The right magneto was partially separated from the engine and turn freely by hand with impulse coupling engagement noted. The magneto was placed in a vice and the drive was turned with an electric drill. The magneto produced spark on all six spark plug leads. | | |

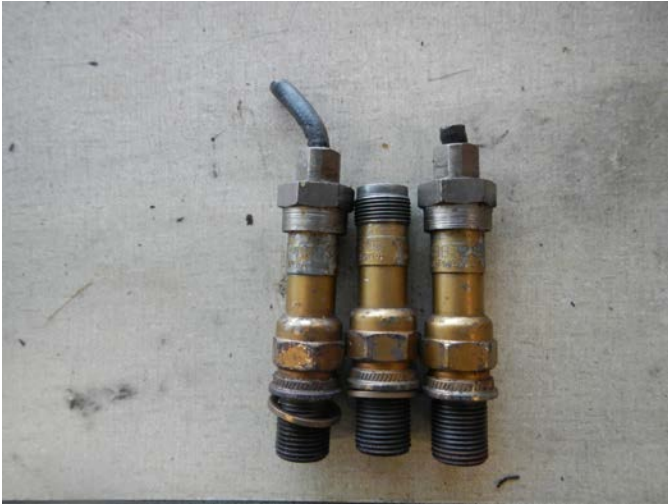
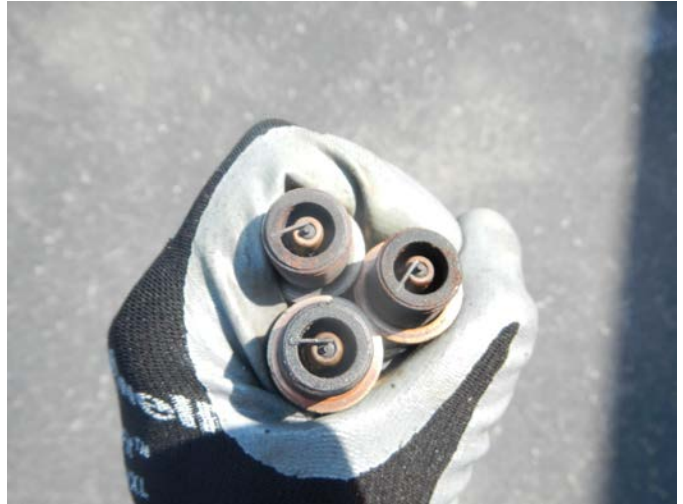
| SPARK PLUGS | Manufacturer: Champion | P/N: RHB32SE |

| Condition: | The top spark plugs had previously been removed by recovery personnel. Three of the top spark plugs were noted during the exam and exhibited normal wear when compared to the Champion Check A Plug chart. | |

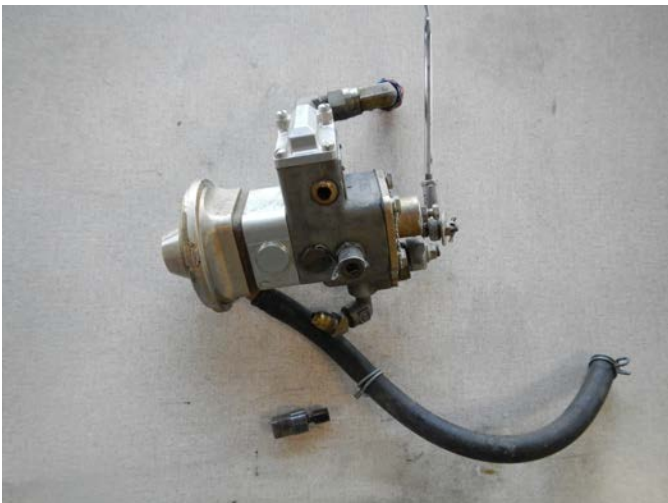
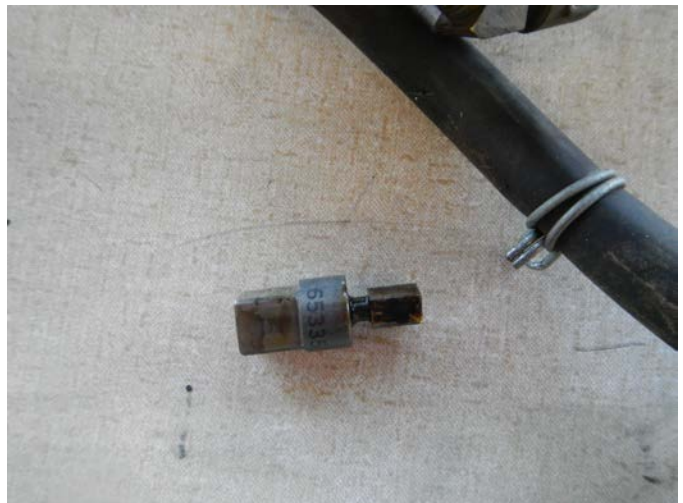
| Condition: | The fuel pump was removed and the drive coupling was intact. The fuel pump drive turned freely by hand and the mixture lever turned freely from stop to stop. Due to fractured fuel line fittings, the pump could not be operationally checked and was disassembled with no anomalies noted. | | |

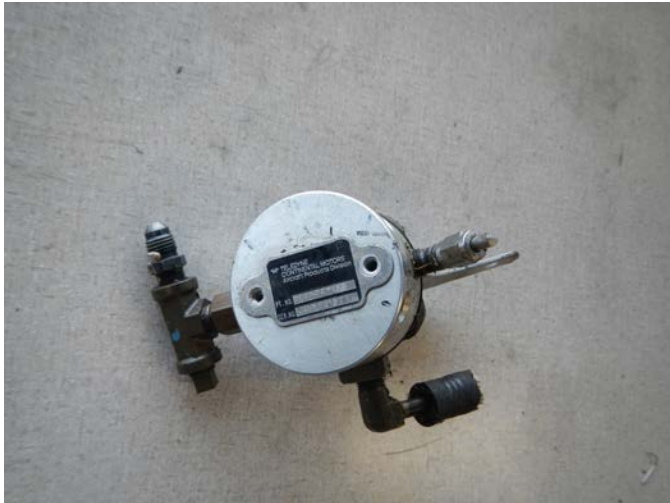
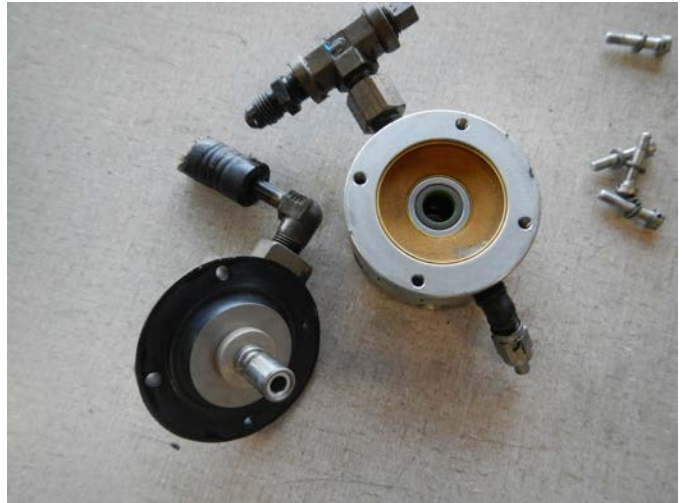
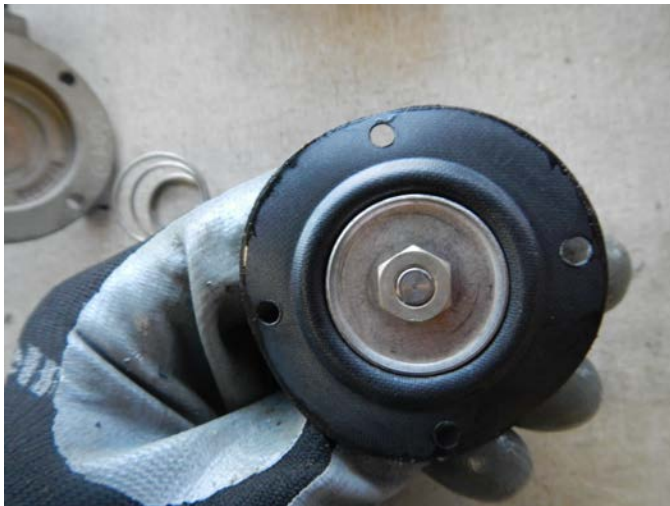
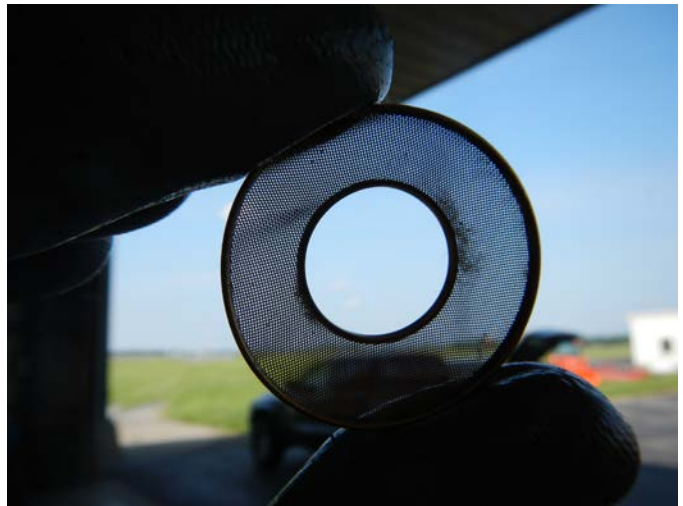
| FUEL MANIFOLD VALVE | Manufacturer: TCM | P/N: 646433-9A1 | S/N: C04FA015 |

| Condition: | The fuel manifold valve had been previously removed and partially disassembled. The diaphragm was intact and the retaining nut was secure. The fuel screen was free of debris. | | |

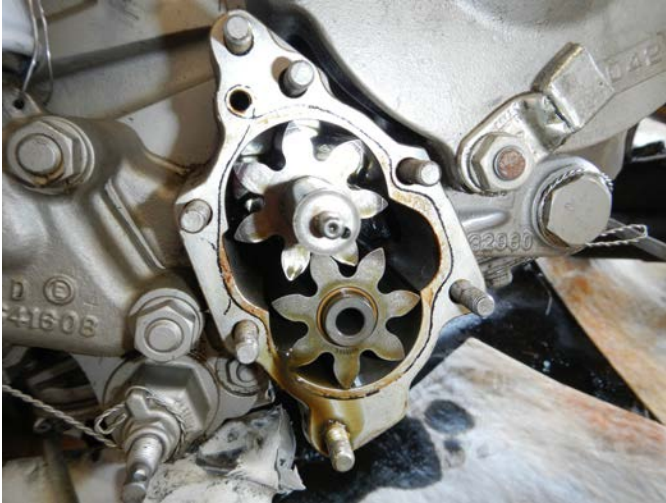
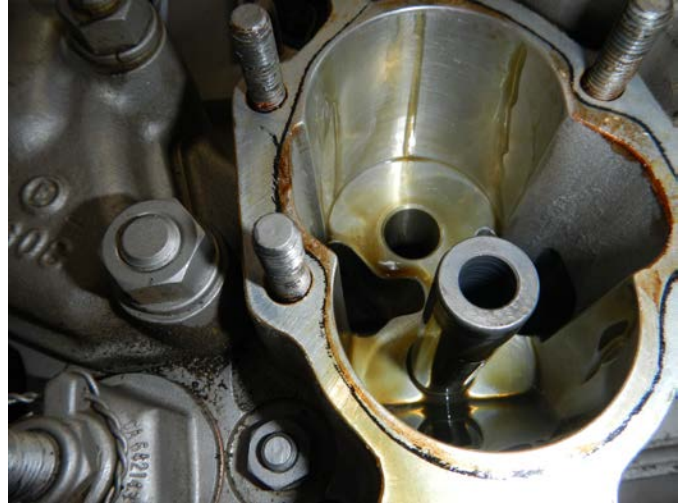
#### OIL PUMP

Condition: The oil pump was disassembled and exhibited no anomalies.

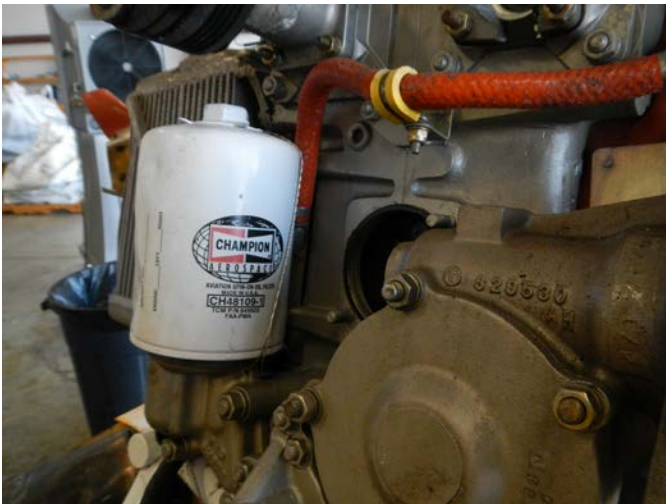
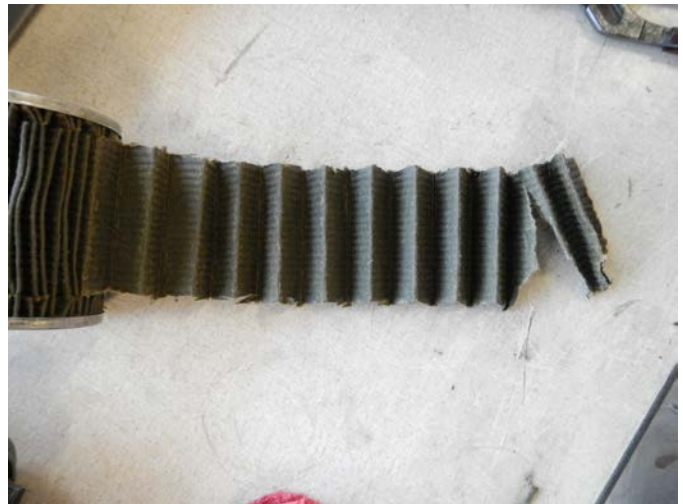
#### OIL FILTER

Condition: The impact damaged oil filter was removed and cut open. No evidence of metal was noted in the oil filter element.

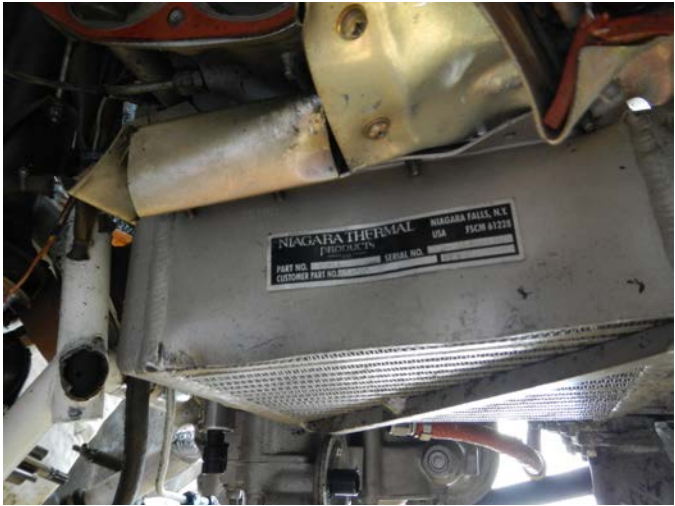
| OIL COOLER | Manufacturer: Niagra | P/N: 10281A | S/N: |

| Condition: | The oil cooler remained attached to the engine and exhibited impact damage. | | |

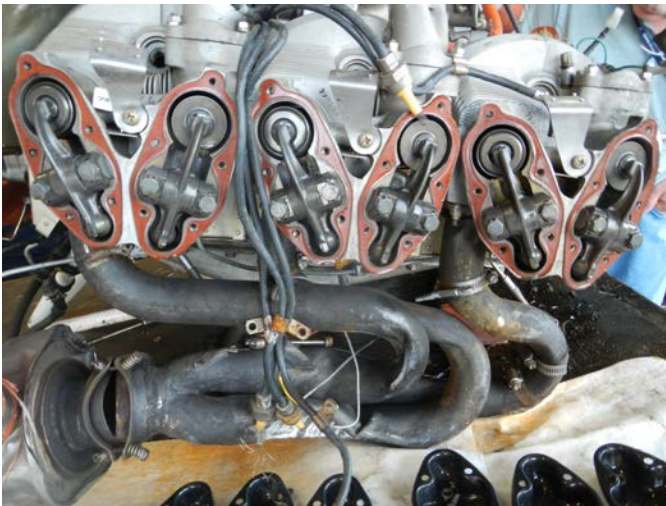
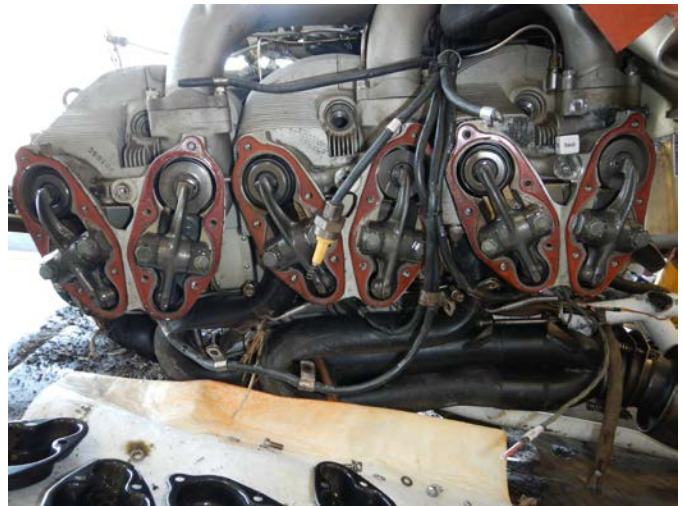
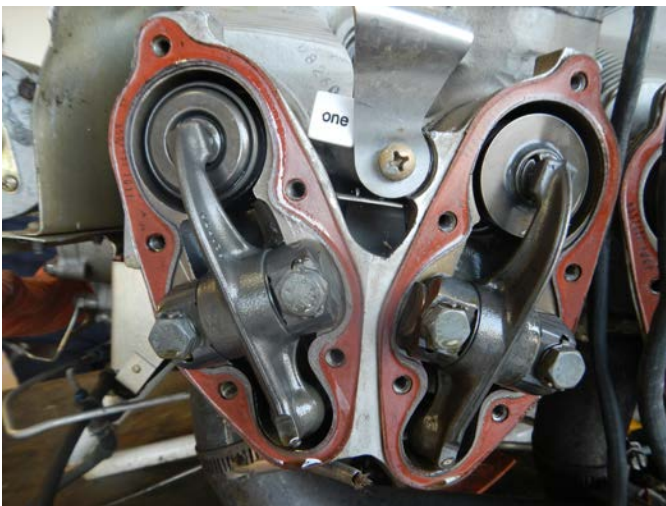
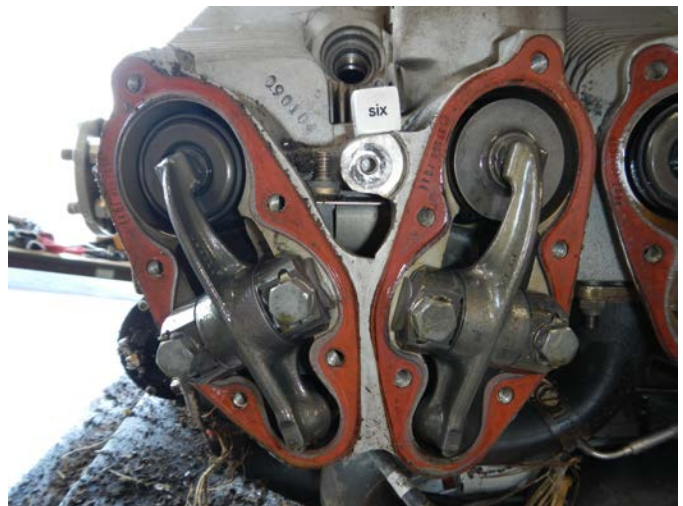
### CYLINDERS

Condition: The cylinders remained attached to the crankcase. The combustion chambers were examined with a lighted bore scope and no anomalies were noted. The crankshaft was rotated by hand using a tool in an accessory gear. Continuity throughout the valve train was noted and thumb compression was obtained on all six cylinders.

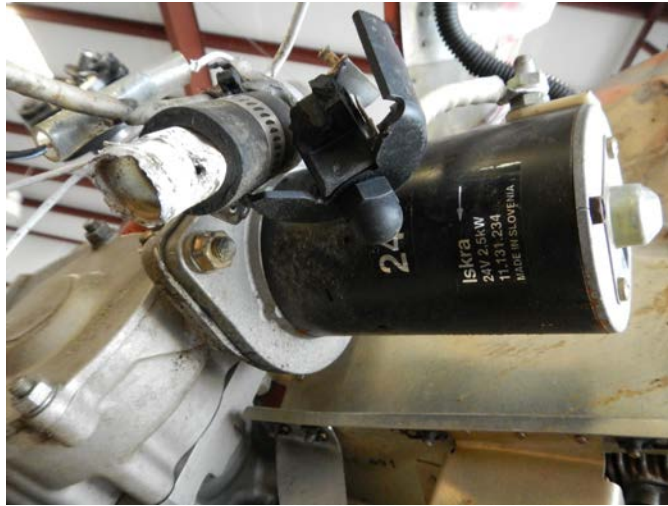
The starter remained attached to the engine and exhibited no anomalies.

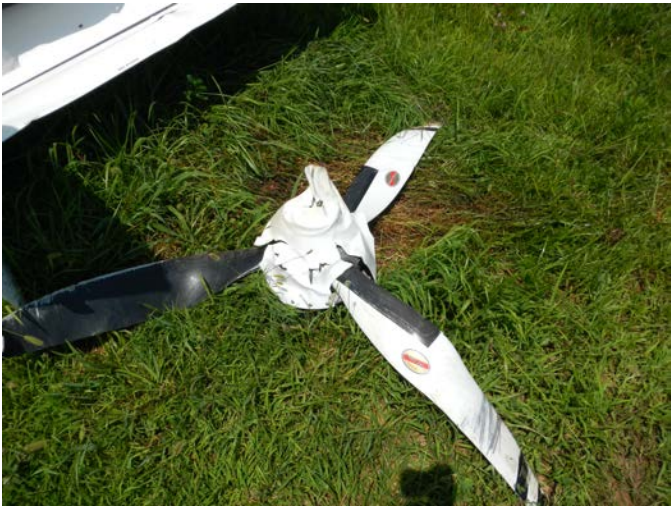
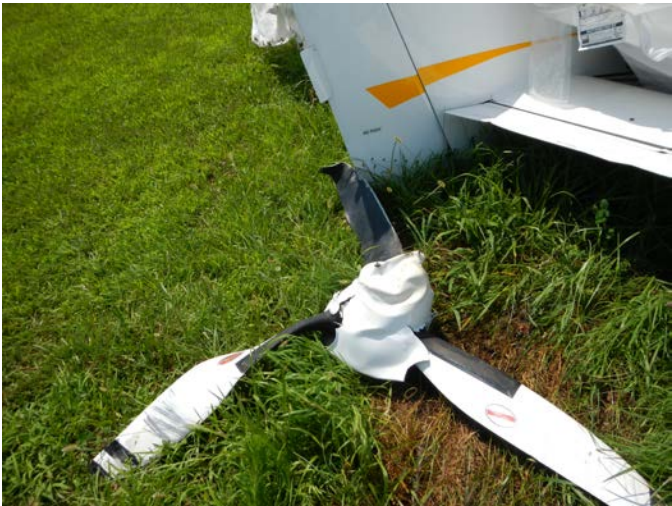
| Condition: | The propeller had separated from the engine. All three blades exhibited chord wise scratches and nicks in the leading edges. Two of the blades were bent and twisted. The propeller governor remained attached to the engine and the control lever was broken from the governor. The governor was removed and the drive turned freely by hand. The gasket screen was free of debris. | | |
