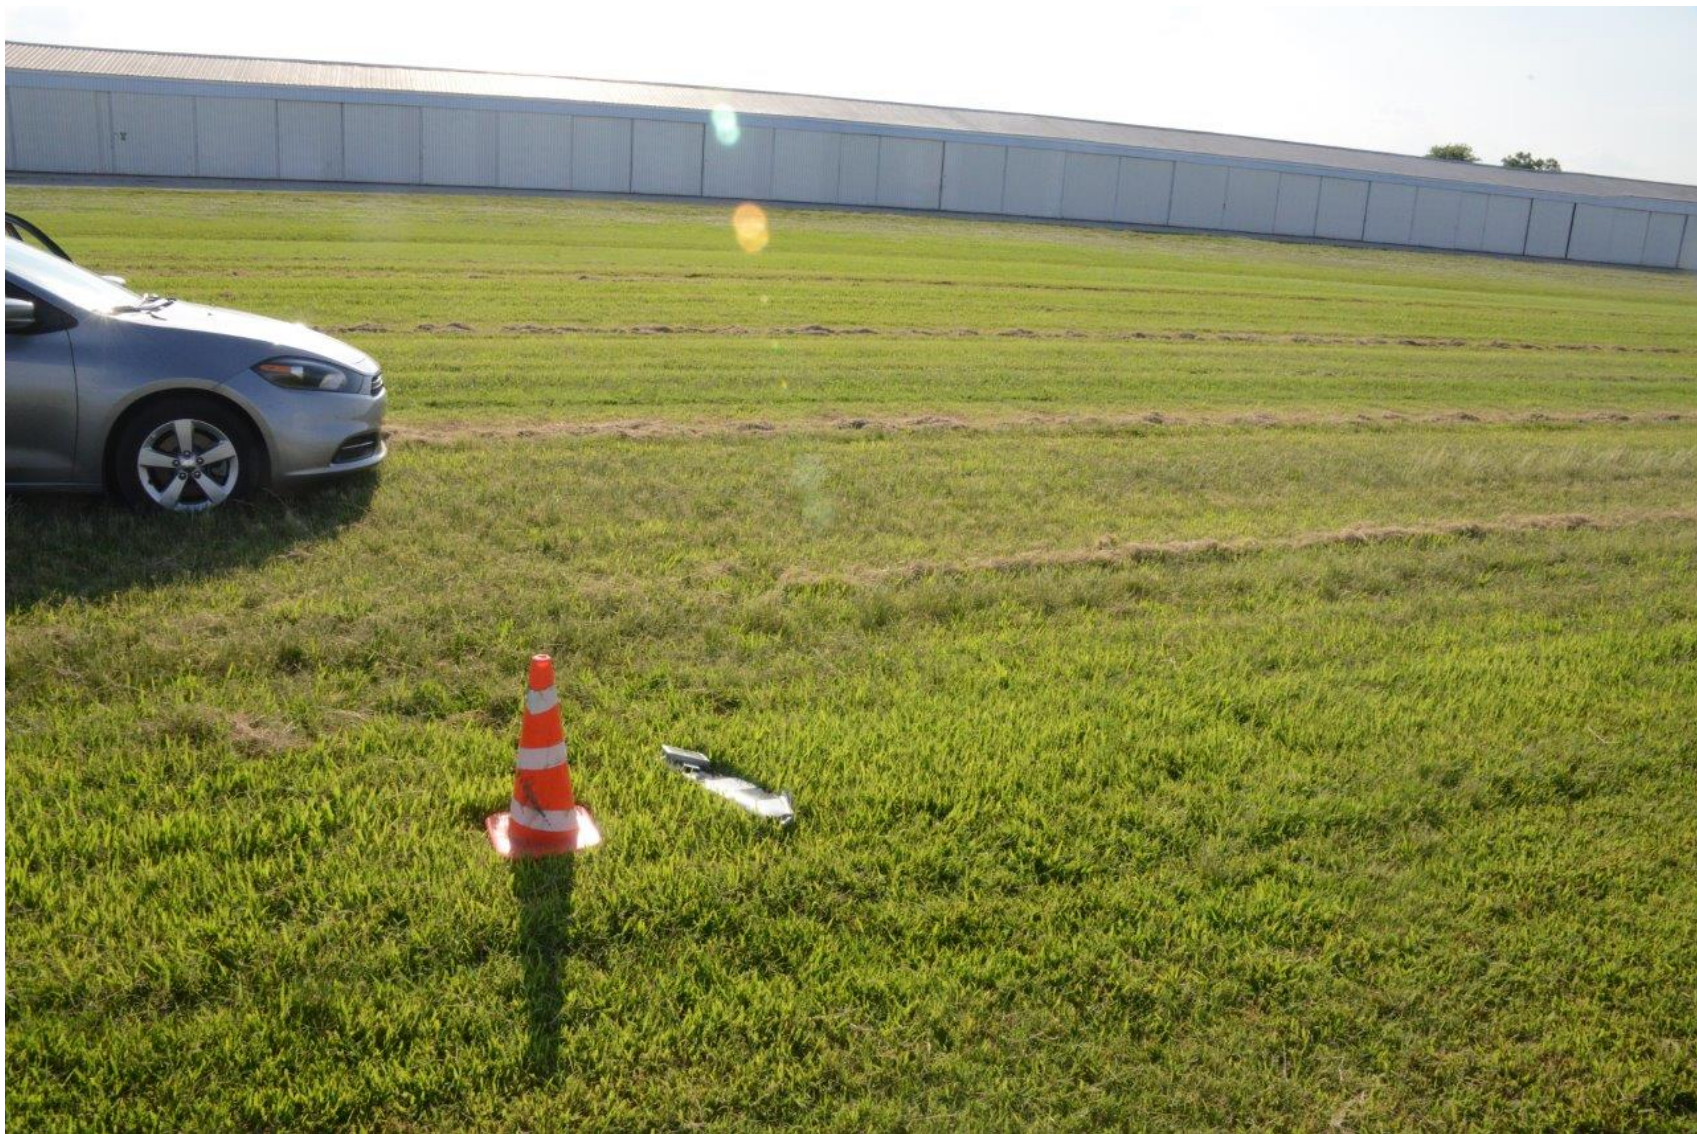
**Photo 2 – View of a separated tail rotor blade on the ground near a hangar.**

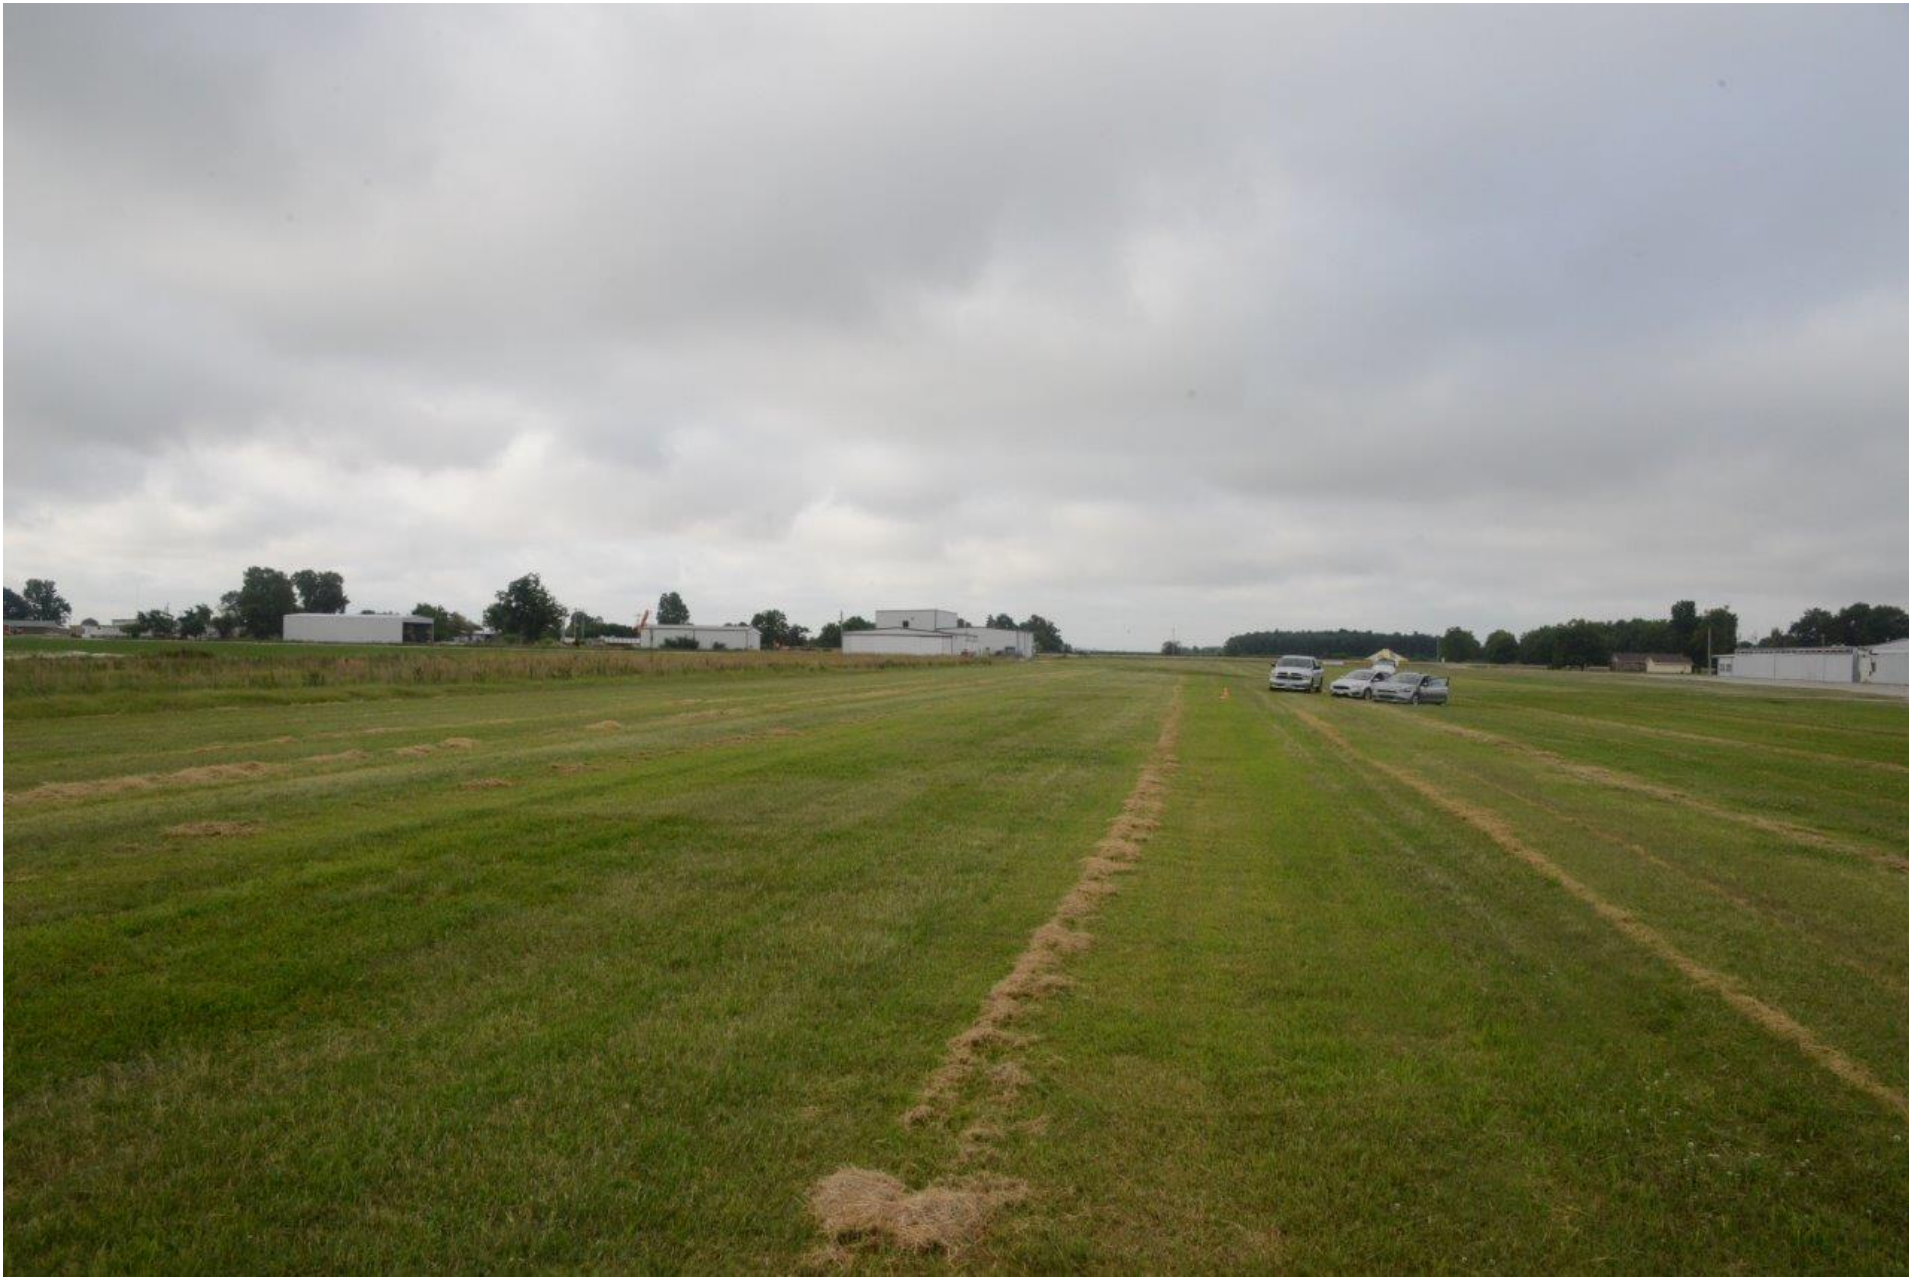
**Photo 3 – View from ground witness marks looking to departure pad.**

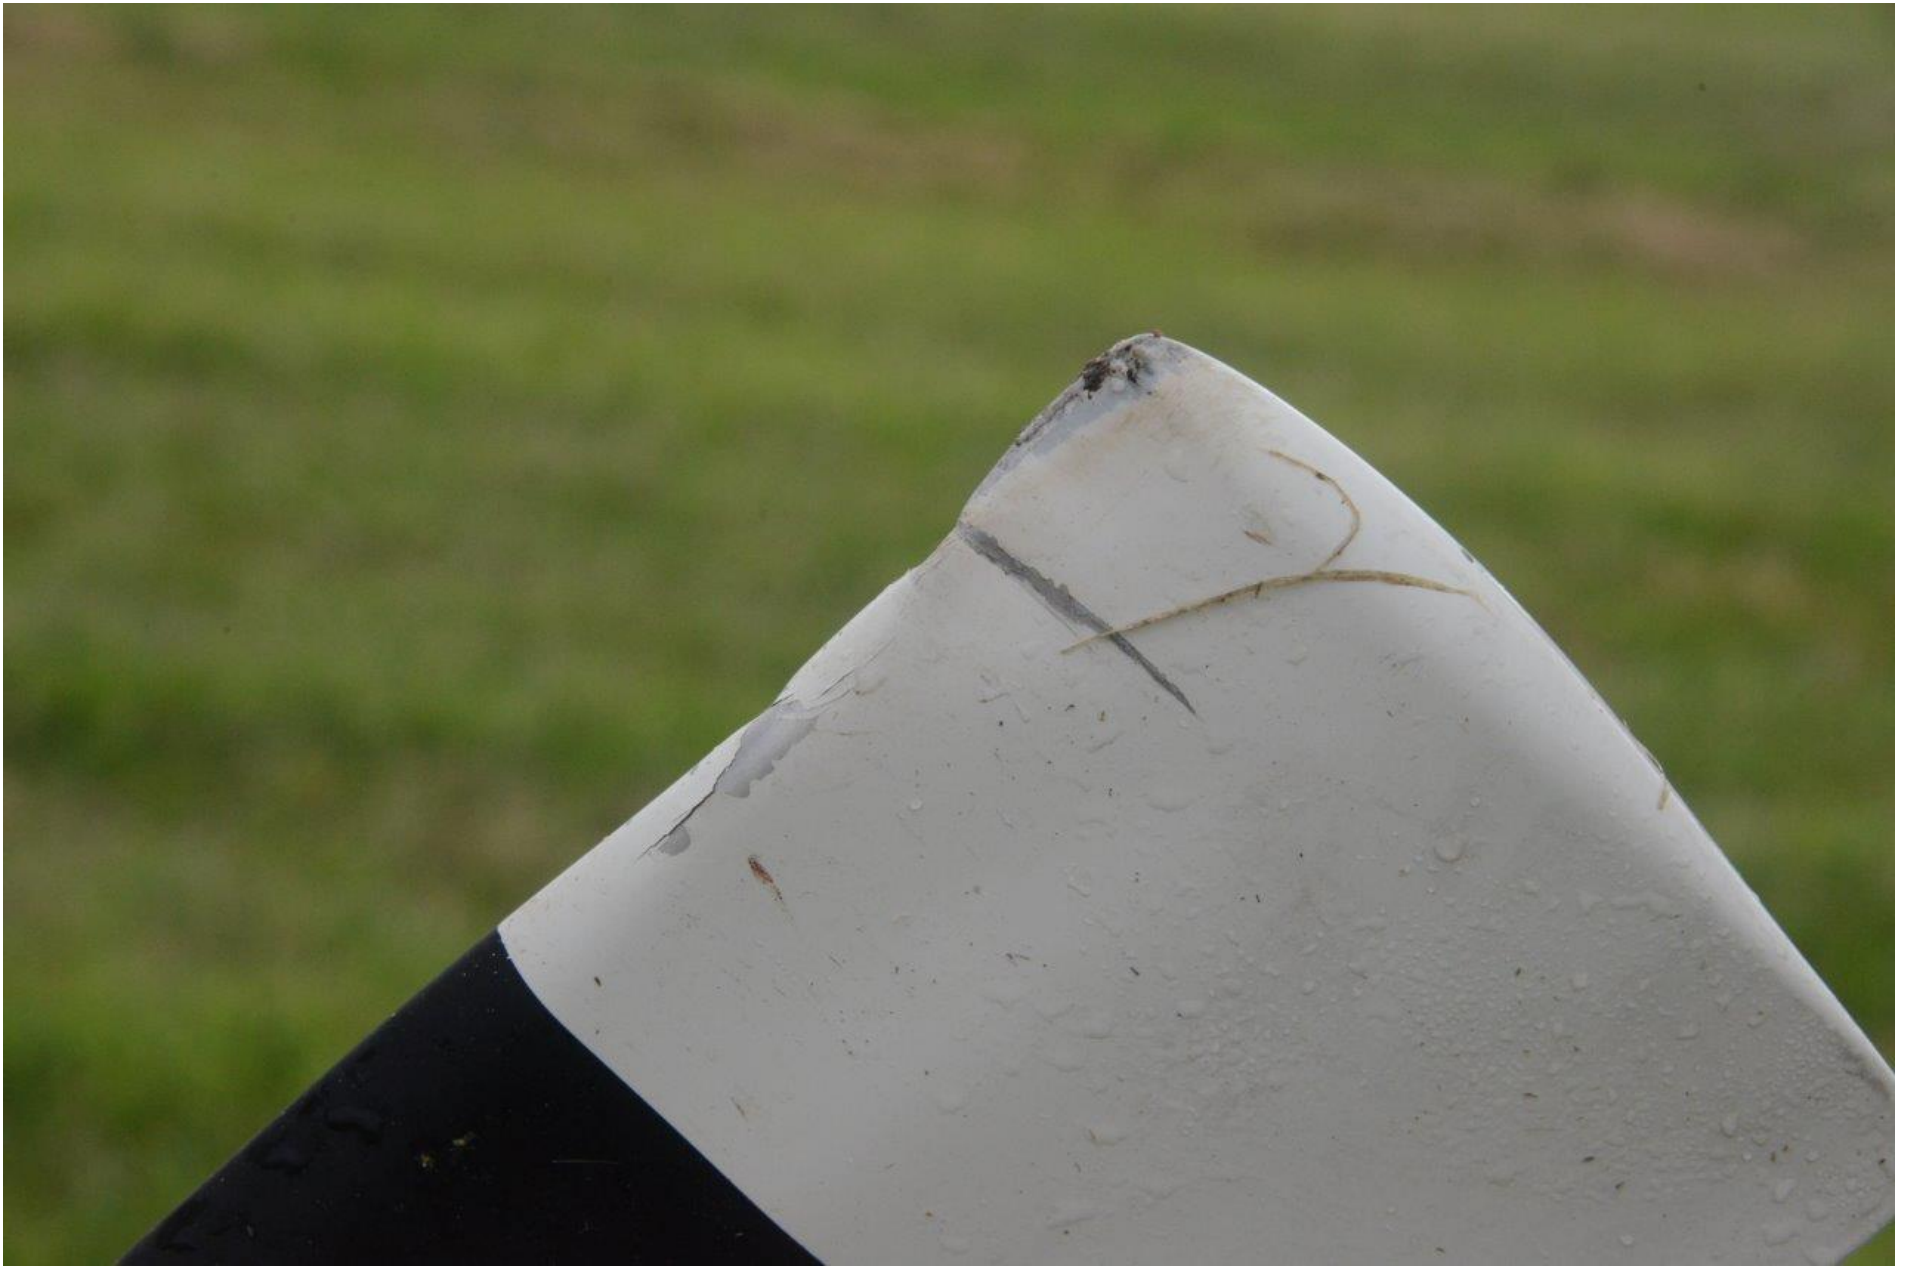
**Photo 4 - View of witness marks on a separated tail rotor blade.**

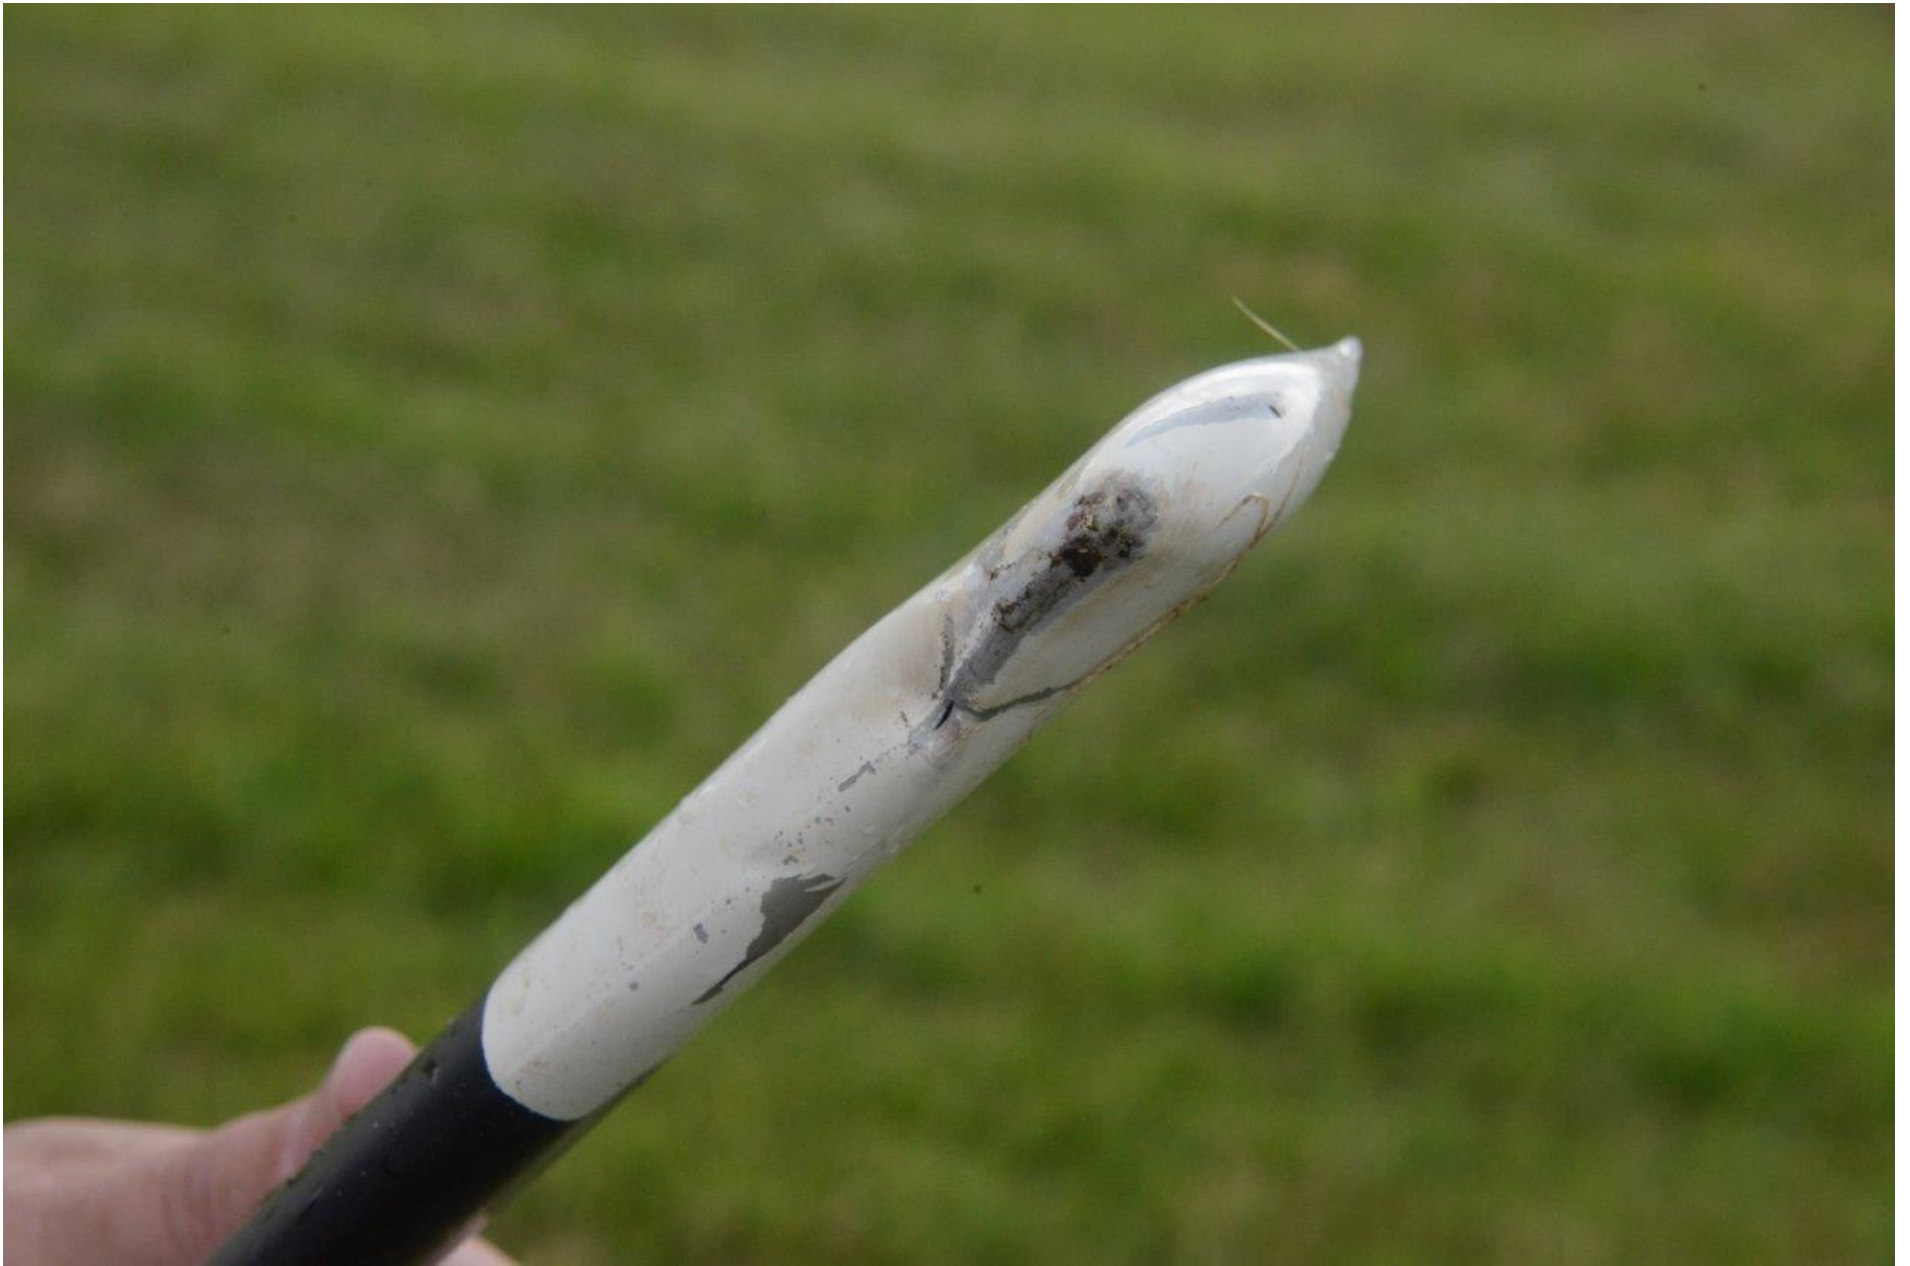
**Photo 5 - View of witness marks on a separated tail rotor blade.**

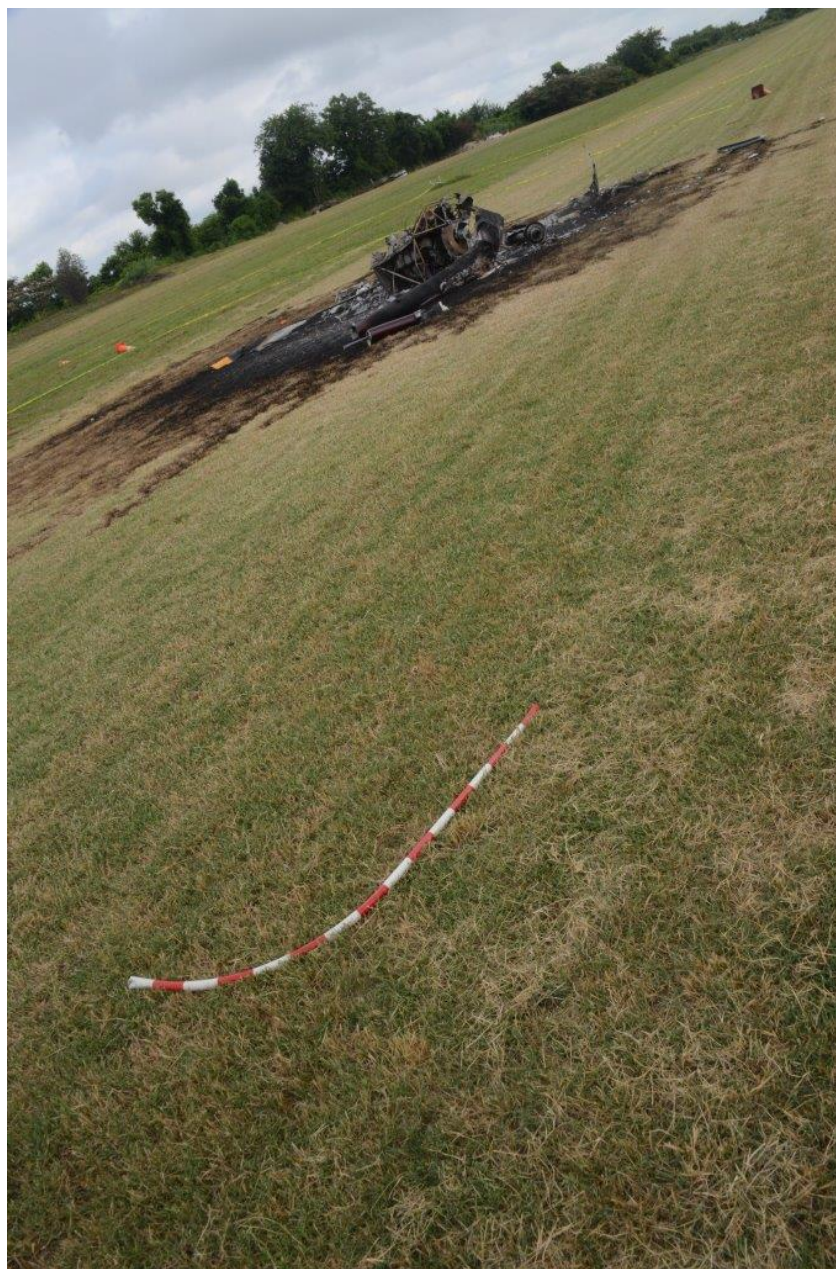
**Photo 11 - View of the main wreckage and tail rotor guard.**

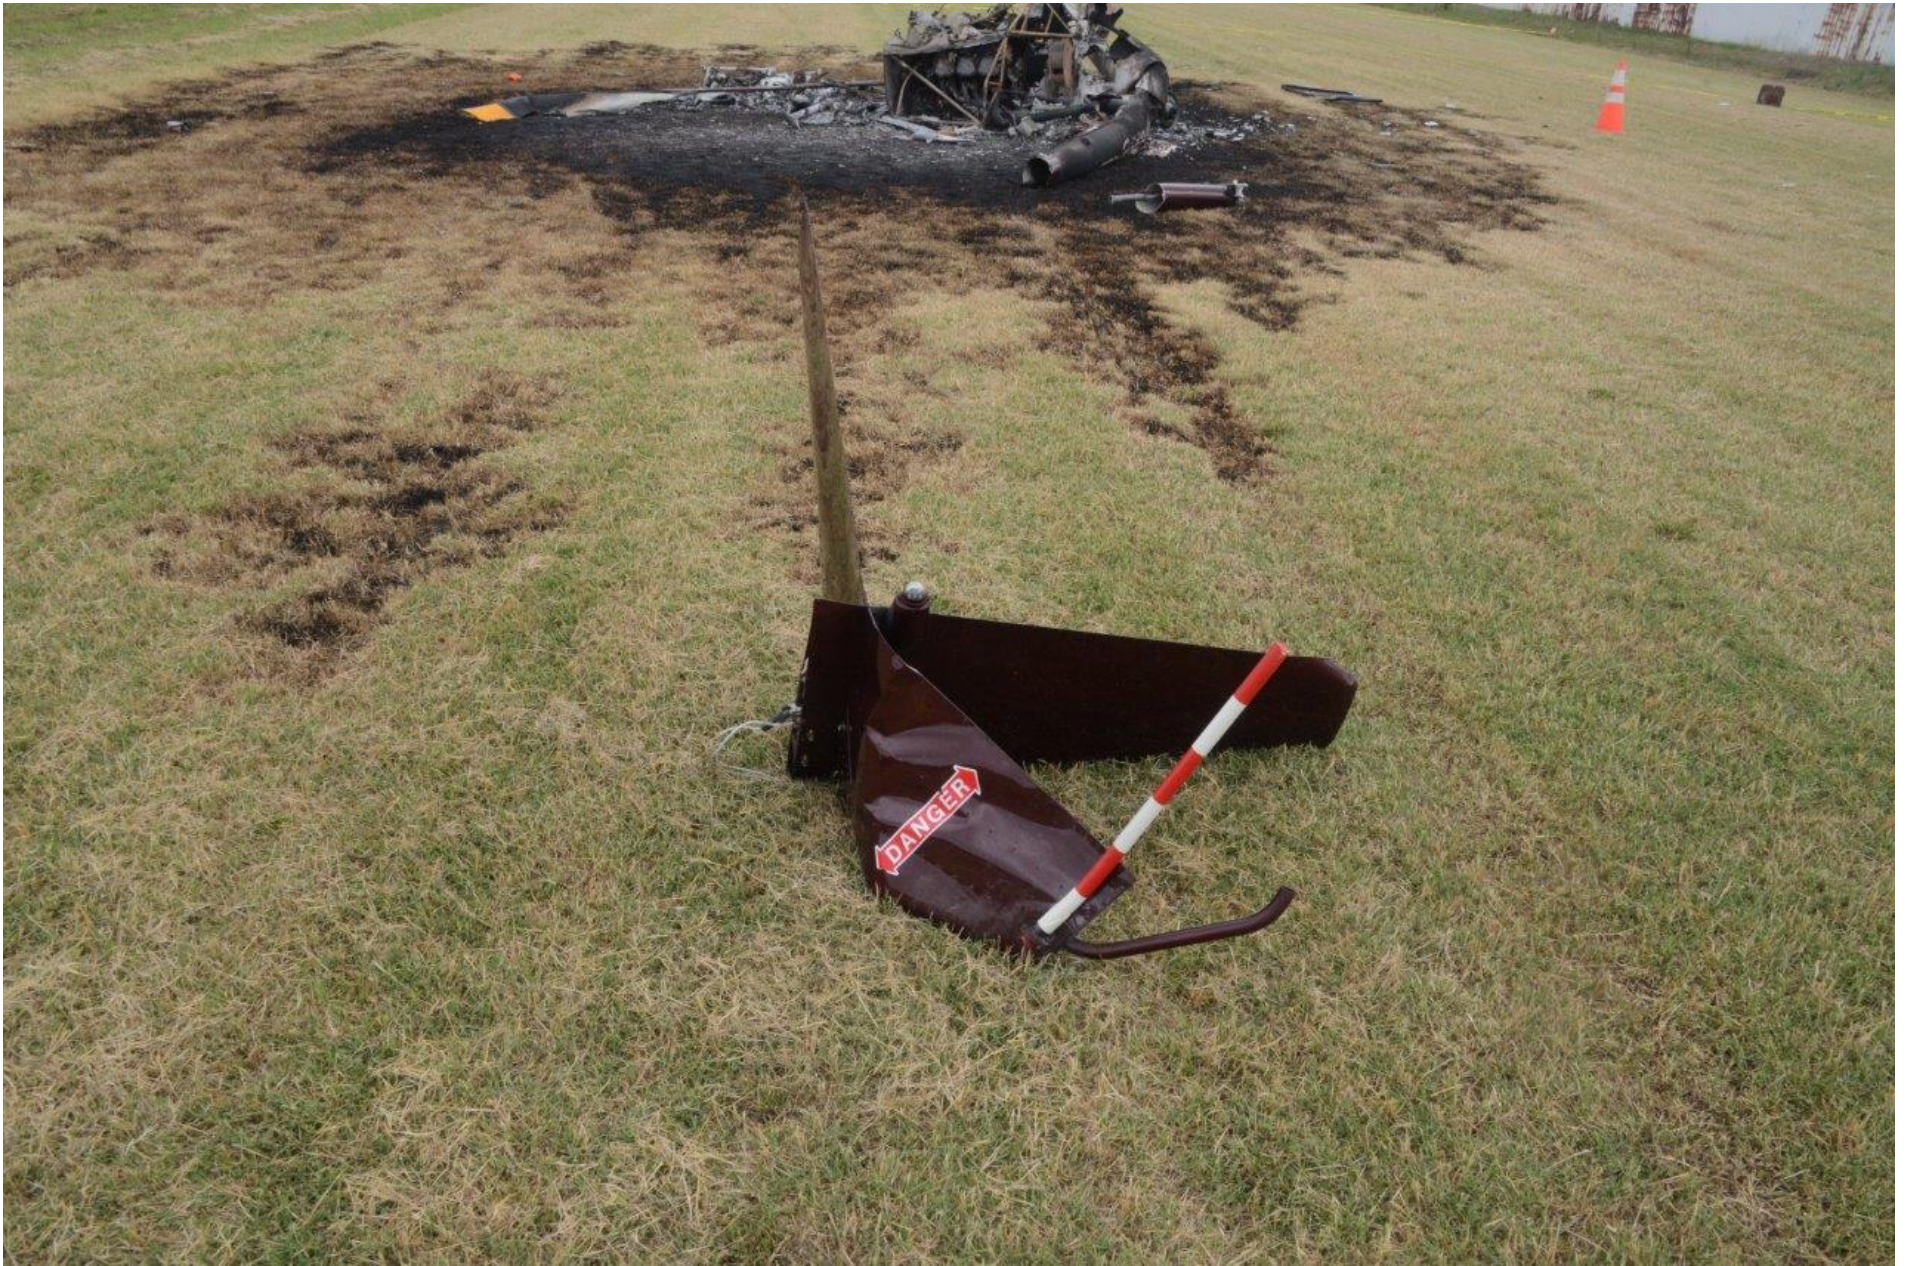
**Photo 12 - View of the main site and separated sections.**

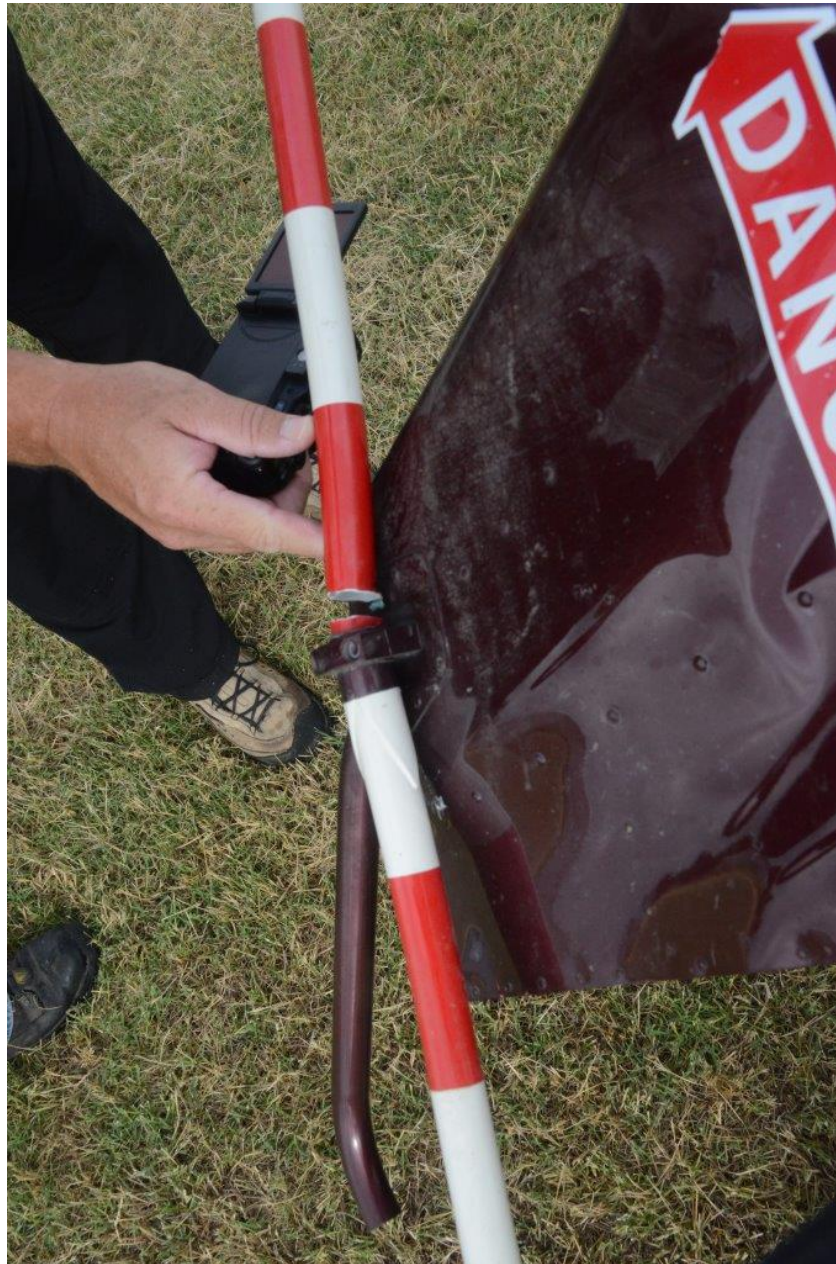
**12BPhoto 13 - View of the tail rotor guard separation.**

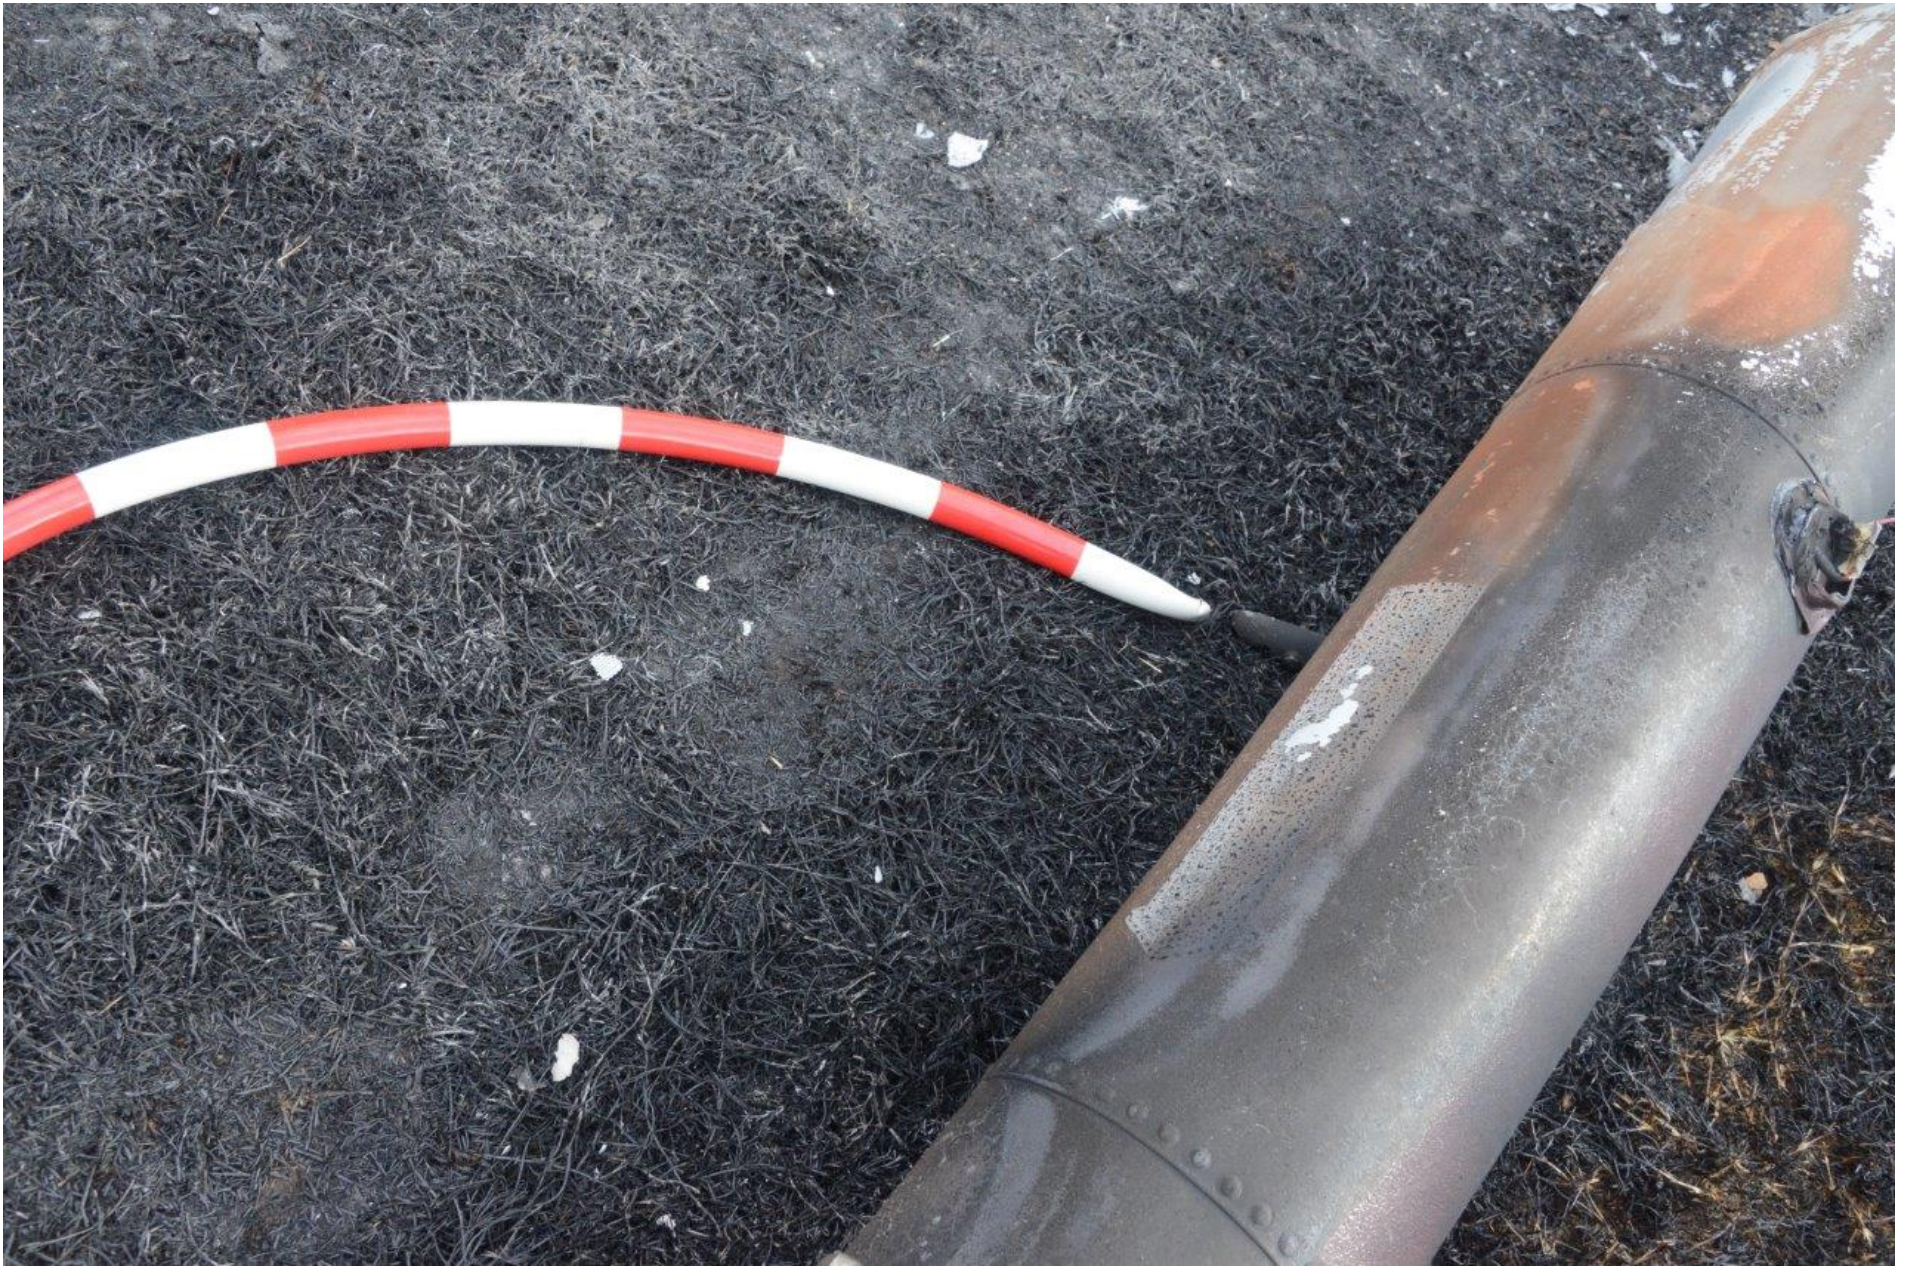
**Photo 14 - View of the tail rotor guard separation.**

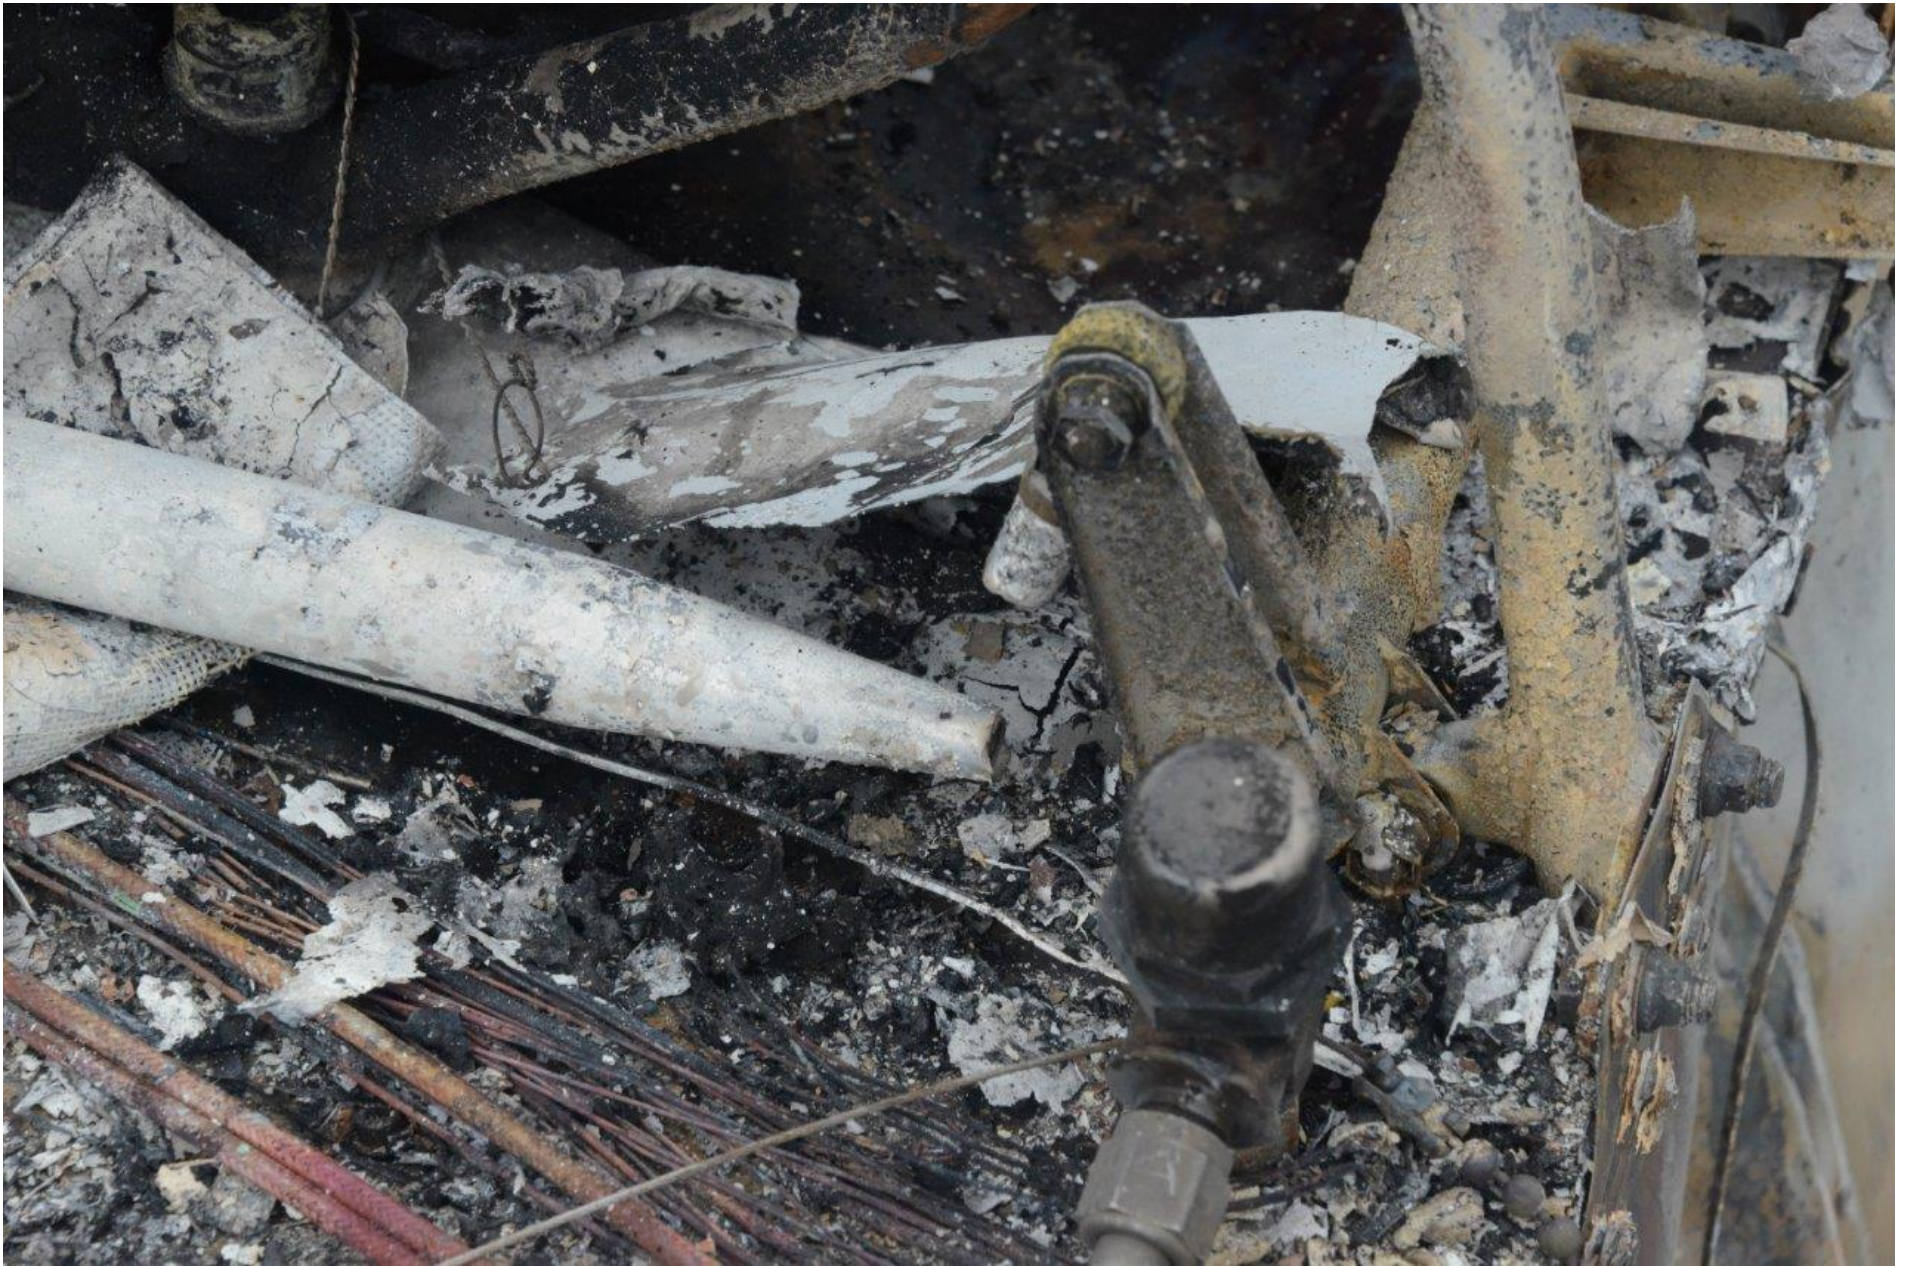
**Photo 16 - View of a control tube separation.**

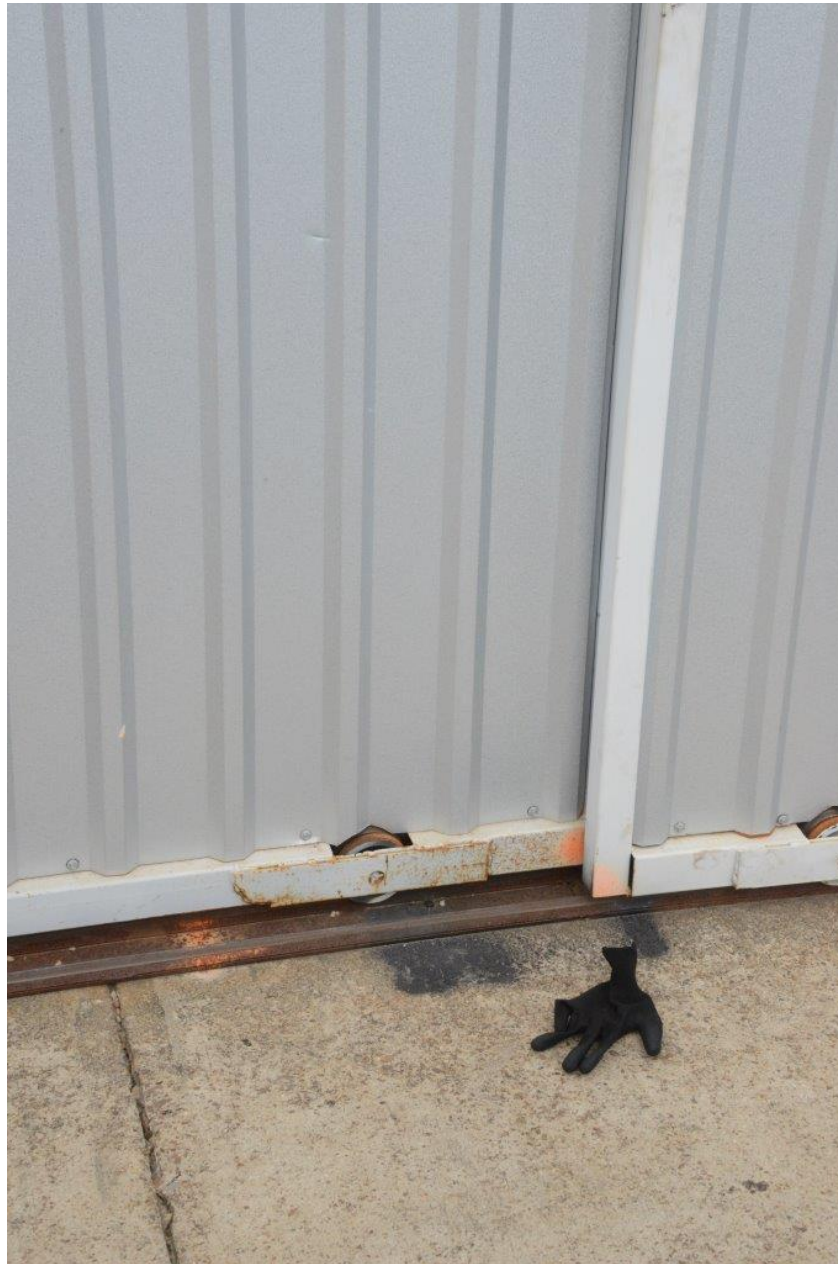
**Photo 17 - View of a hangar door with a witness mark.**

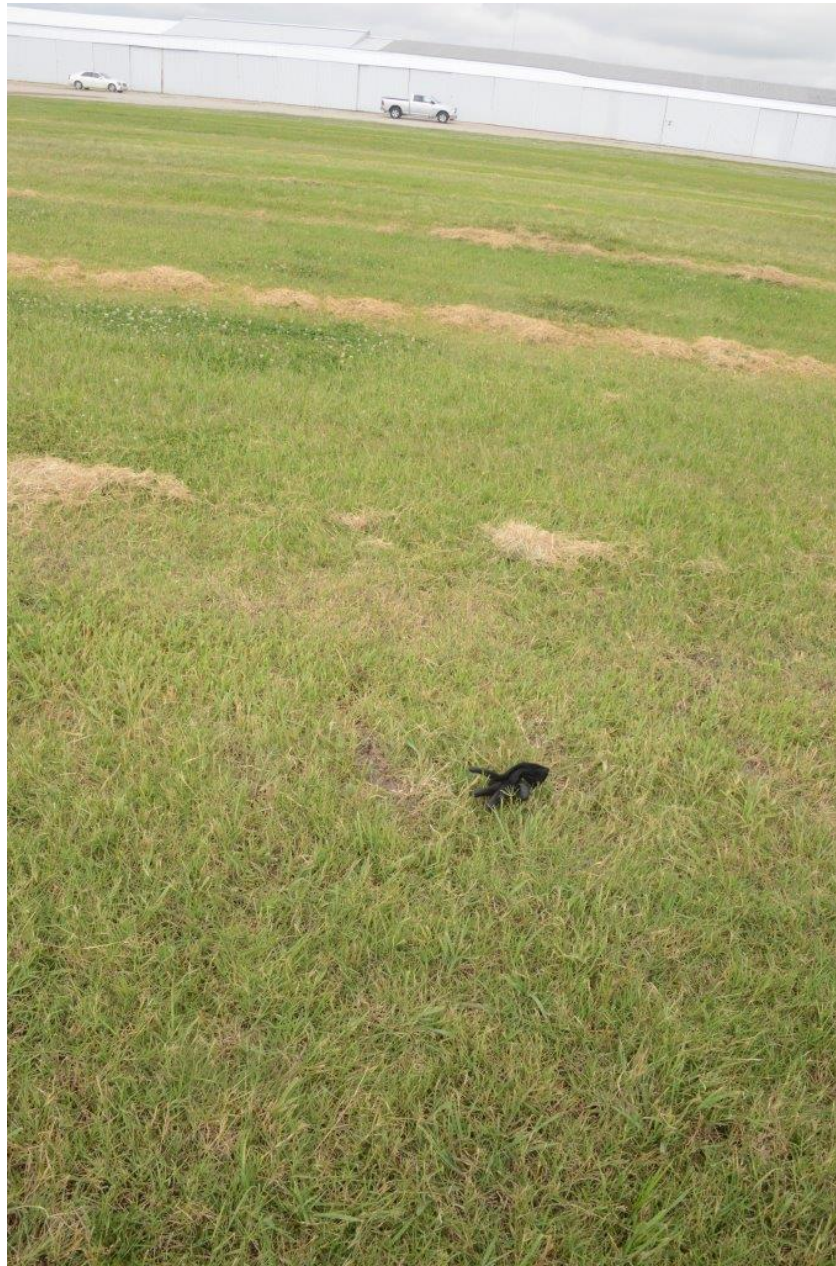
**17BPhoto 18 - View from a set of linear witness marks towards the impacted hangar door.**

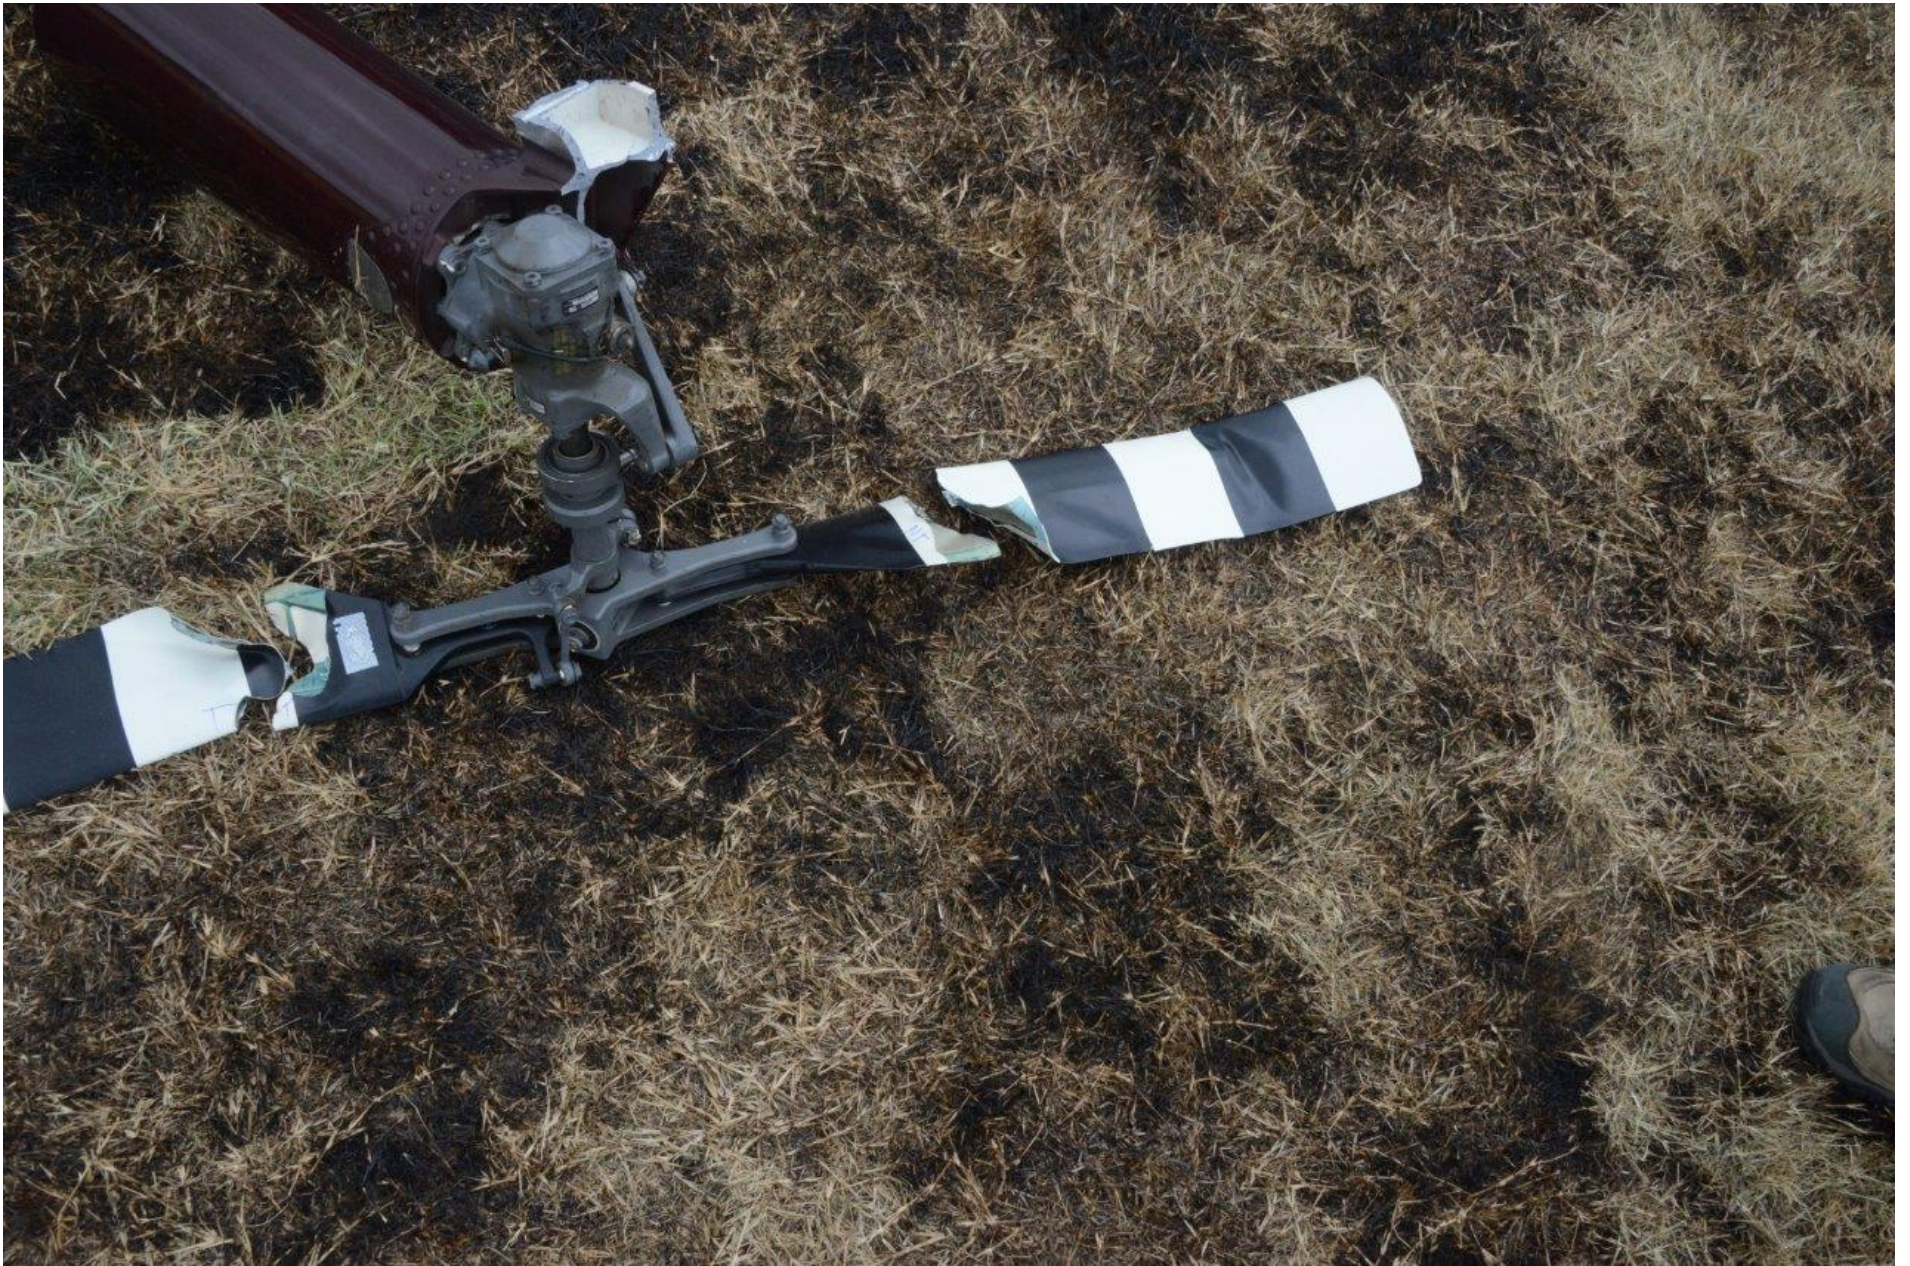
**Photo 19 - View of both tail rotor blade separations.**
