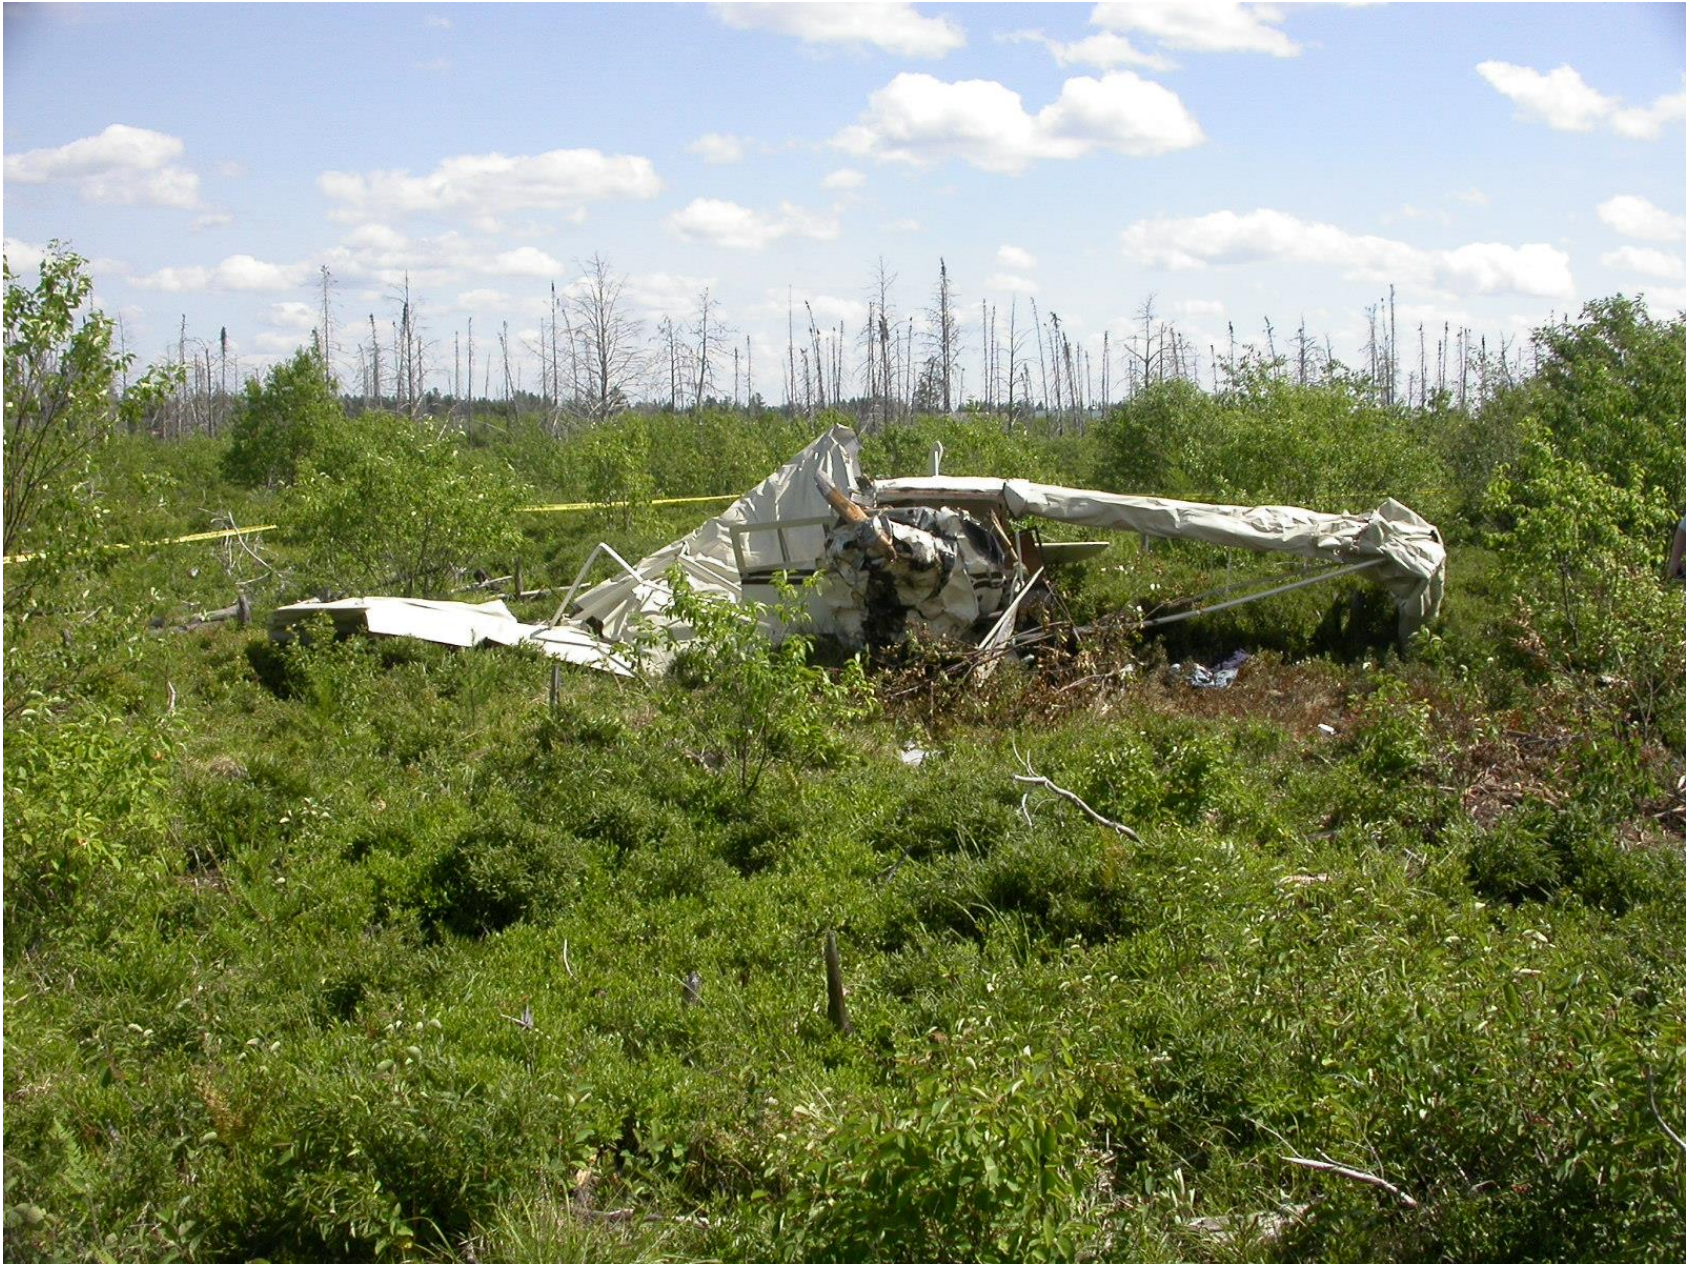
**Photo 1 – Photo of front of the airplane at the accident site**

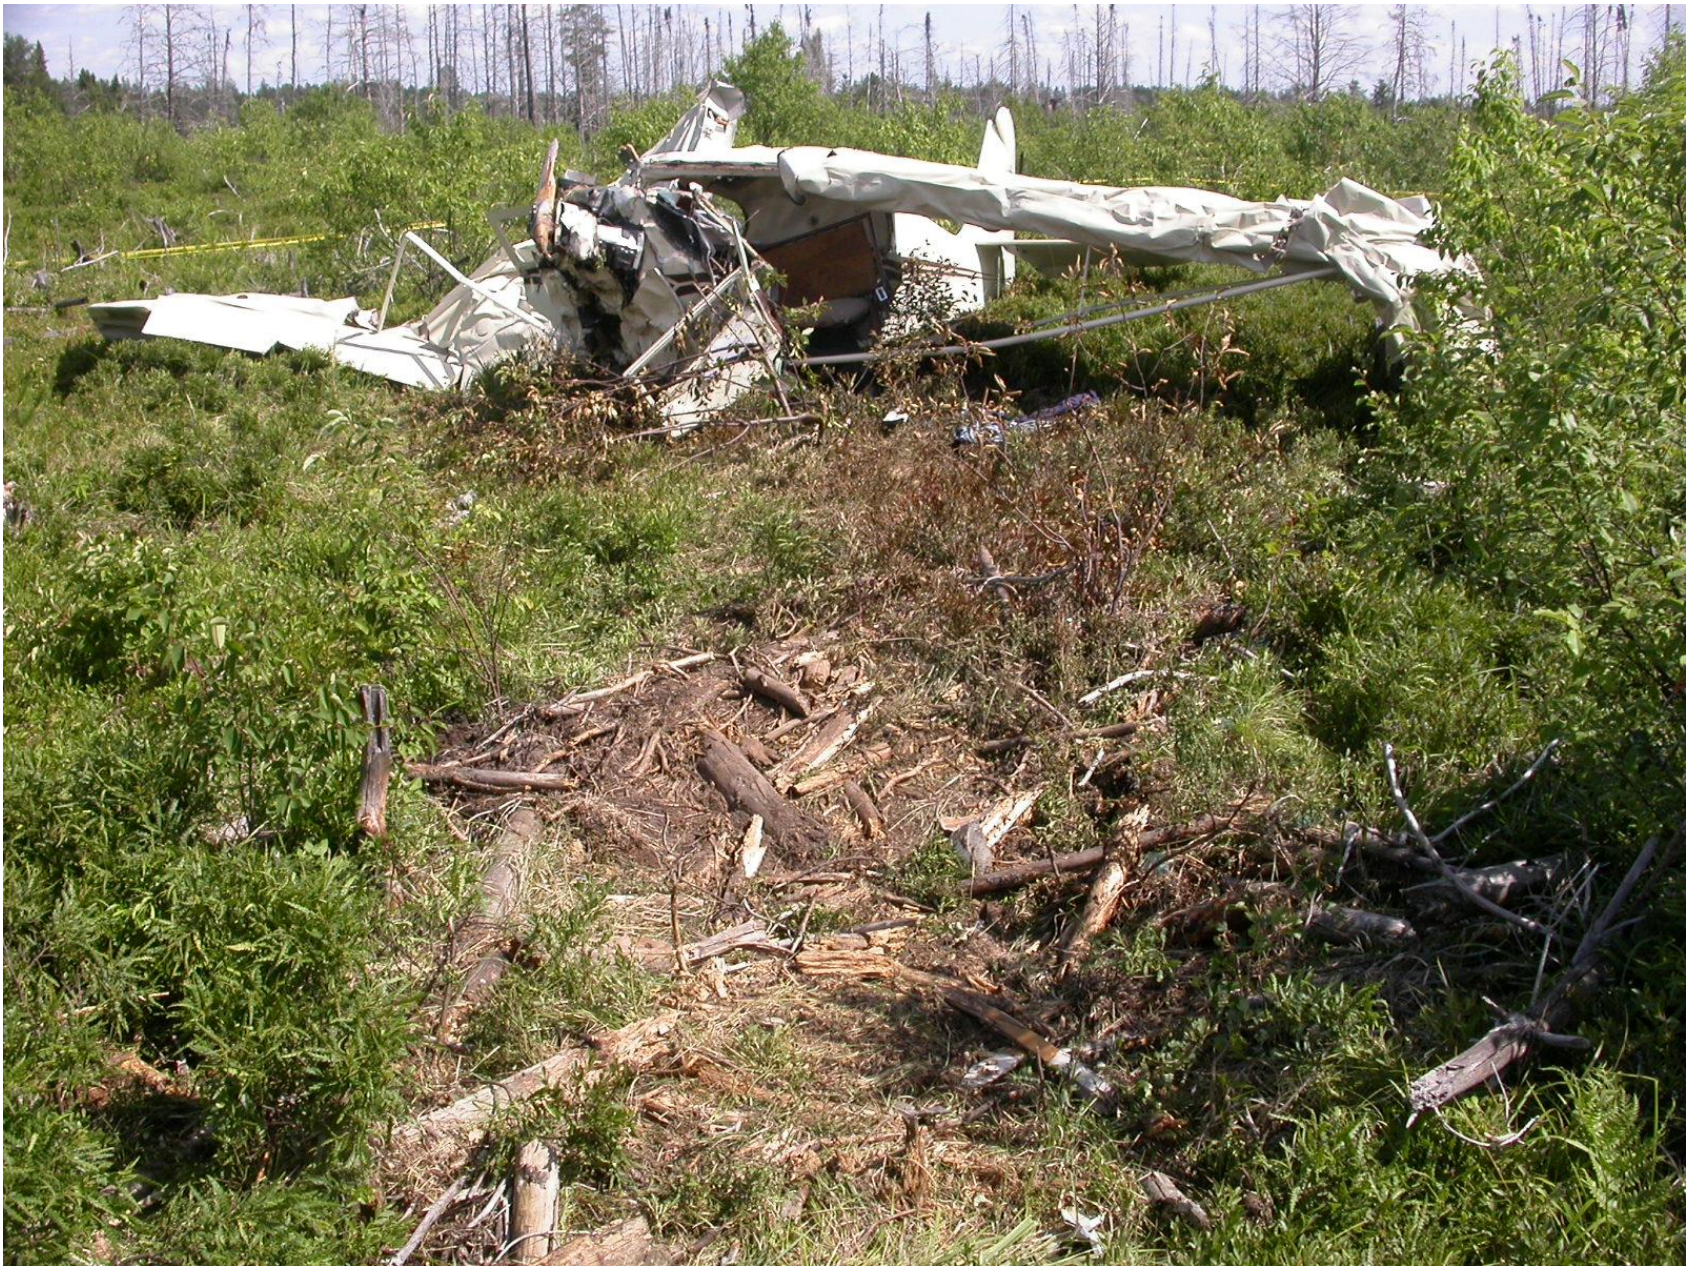
**Photo 2 – View of the initial point of contact**

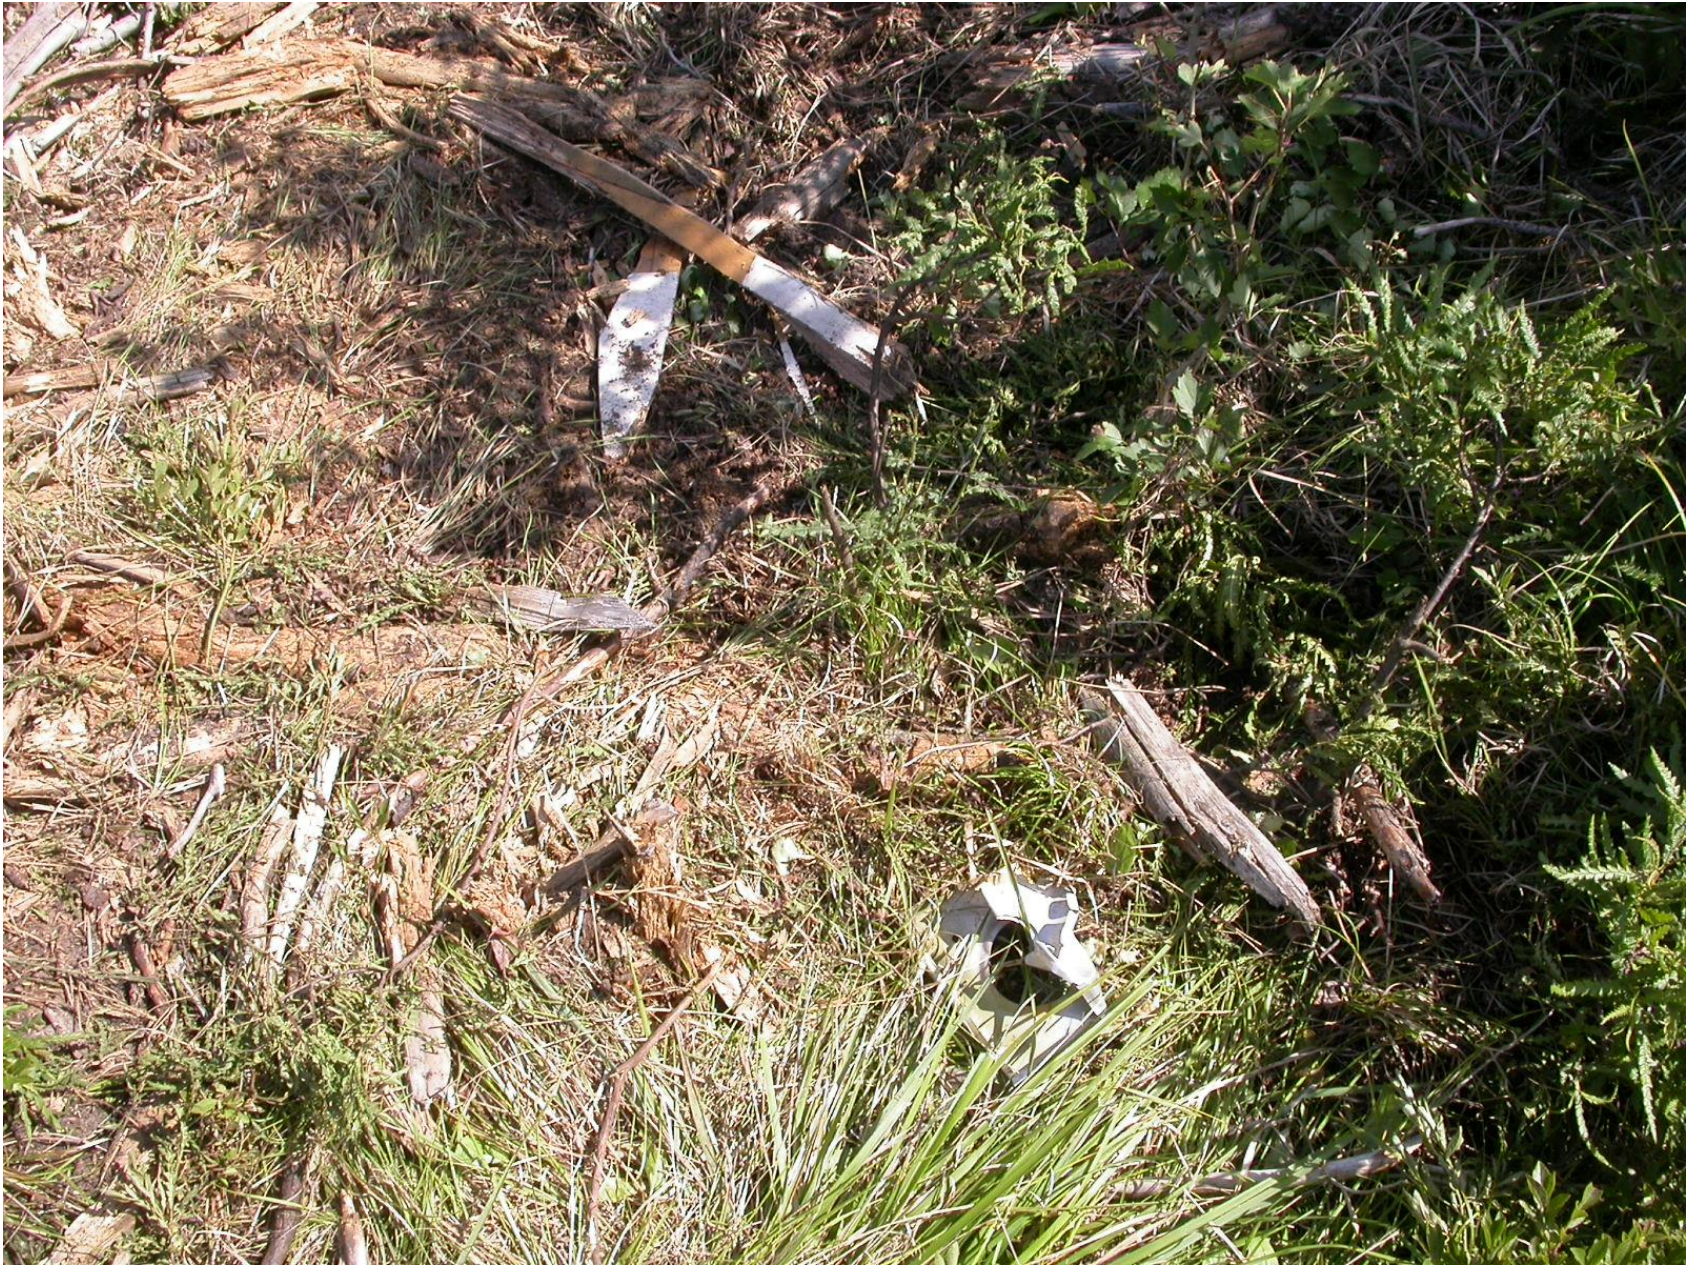
**Photo 3 – View of initial point of contact with pieces of propeller blades**

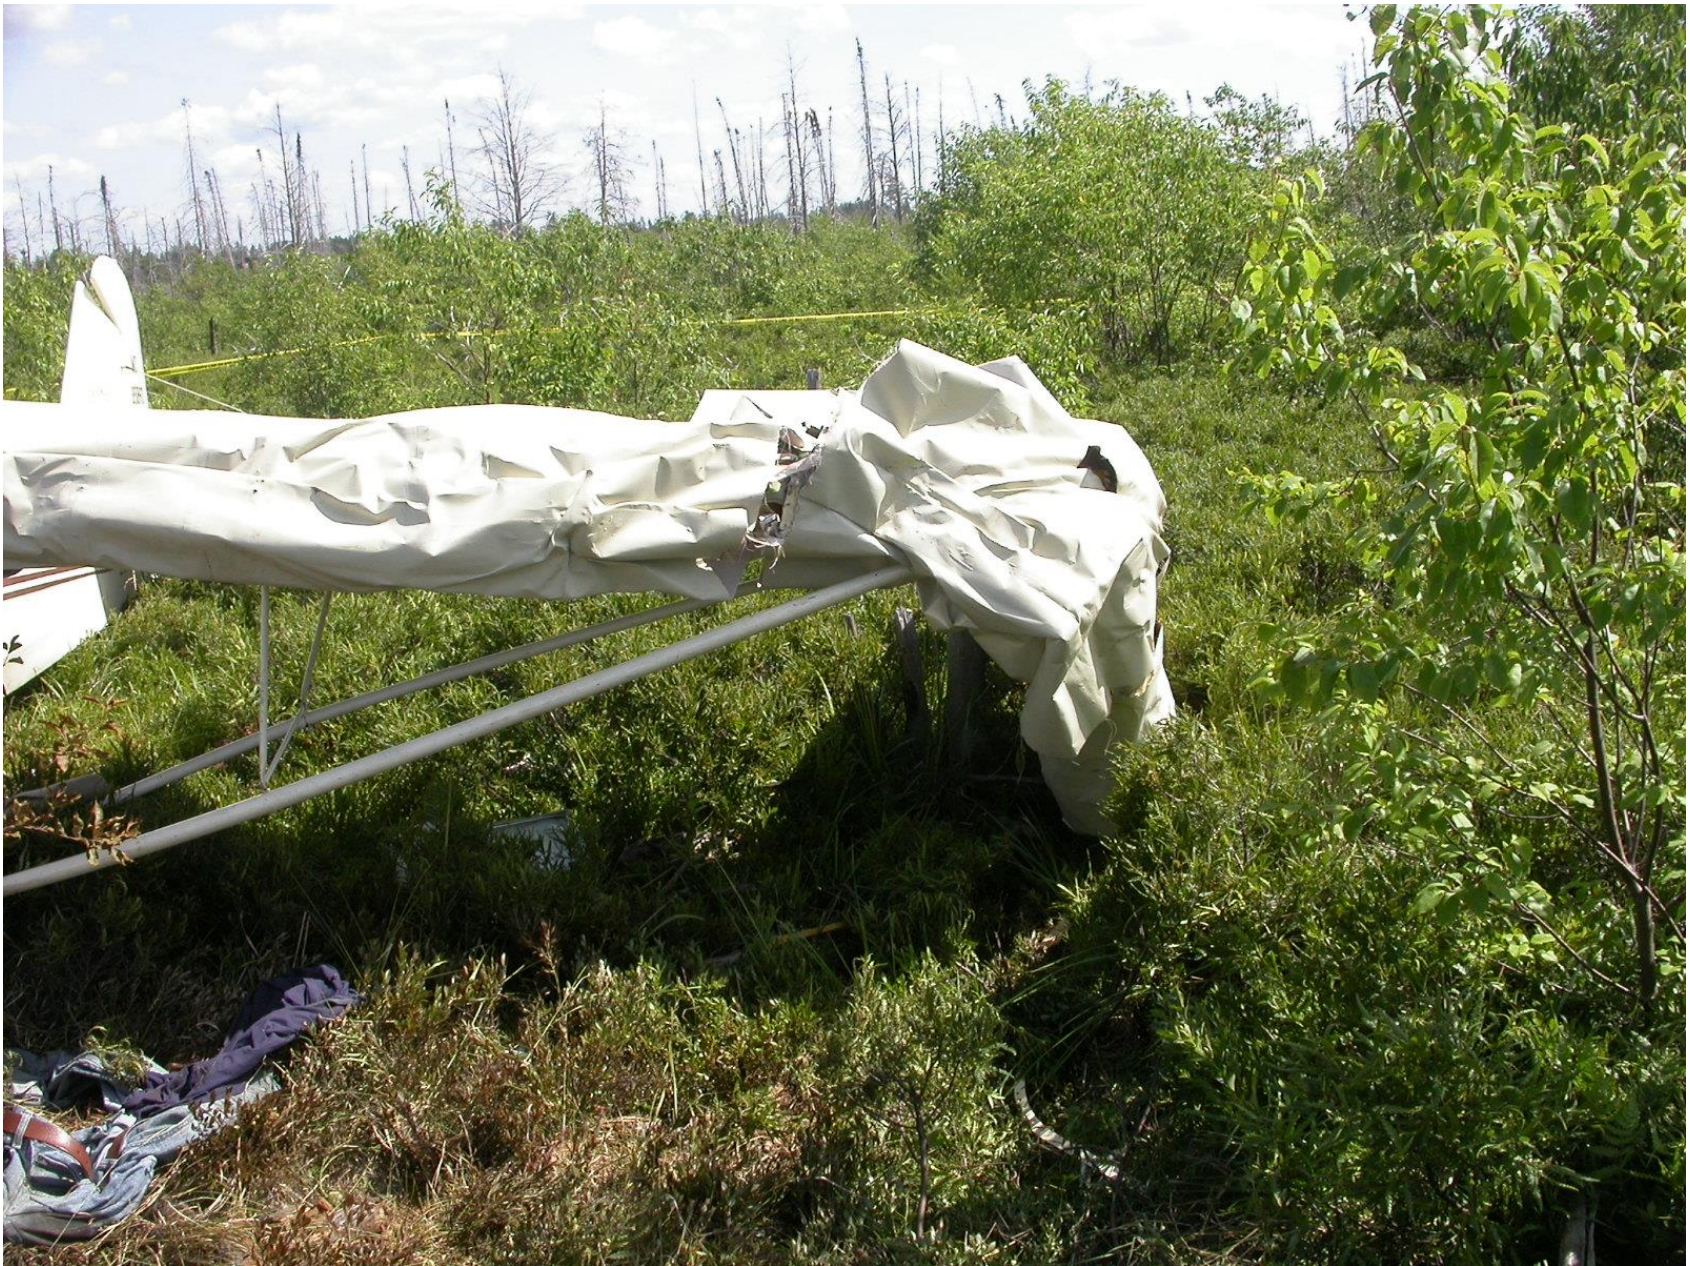
**Photo 4 – View of damage to the left wing**

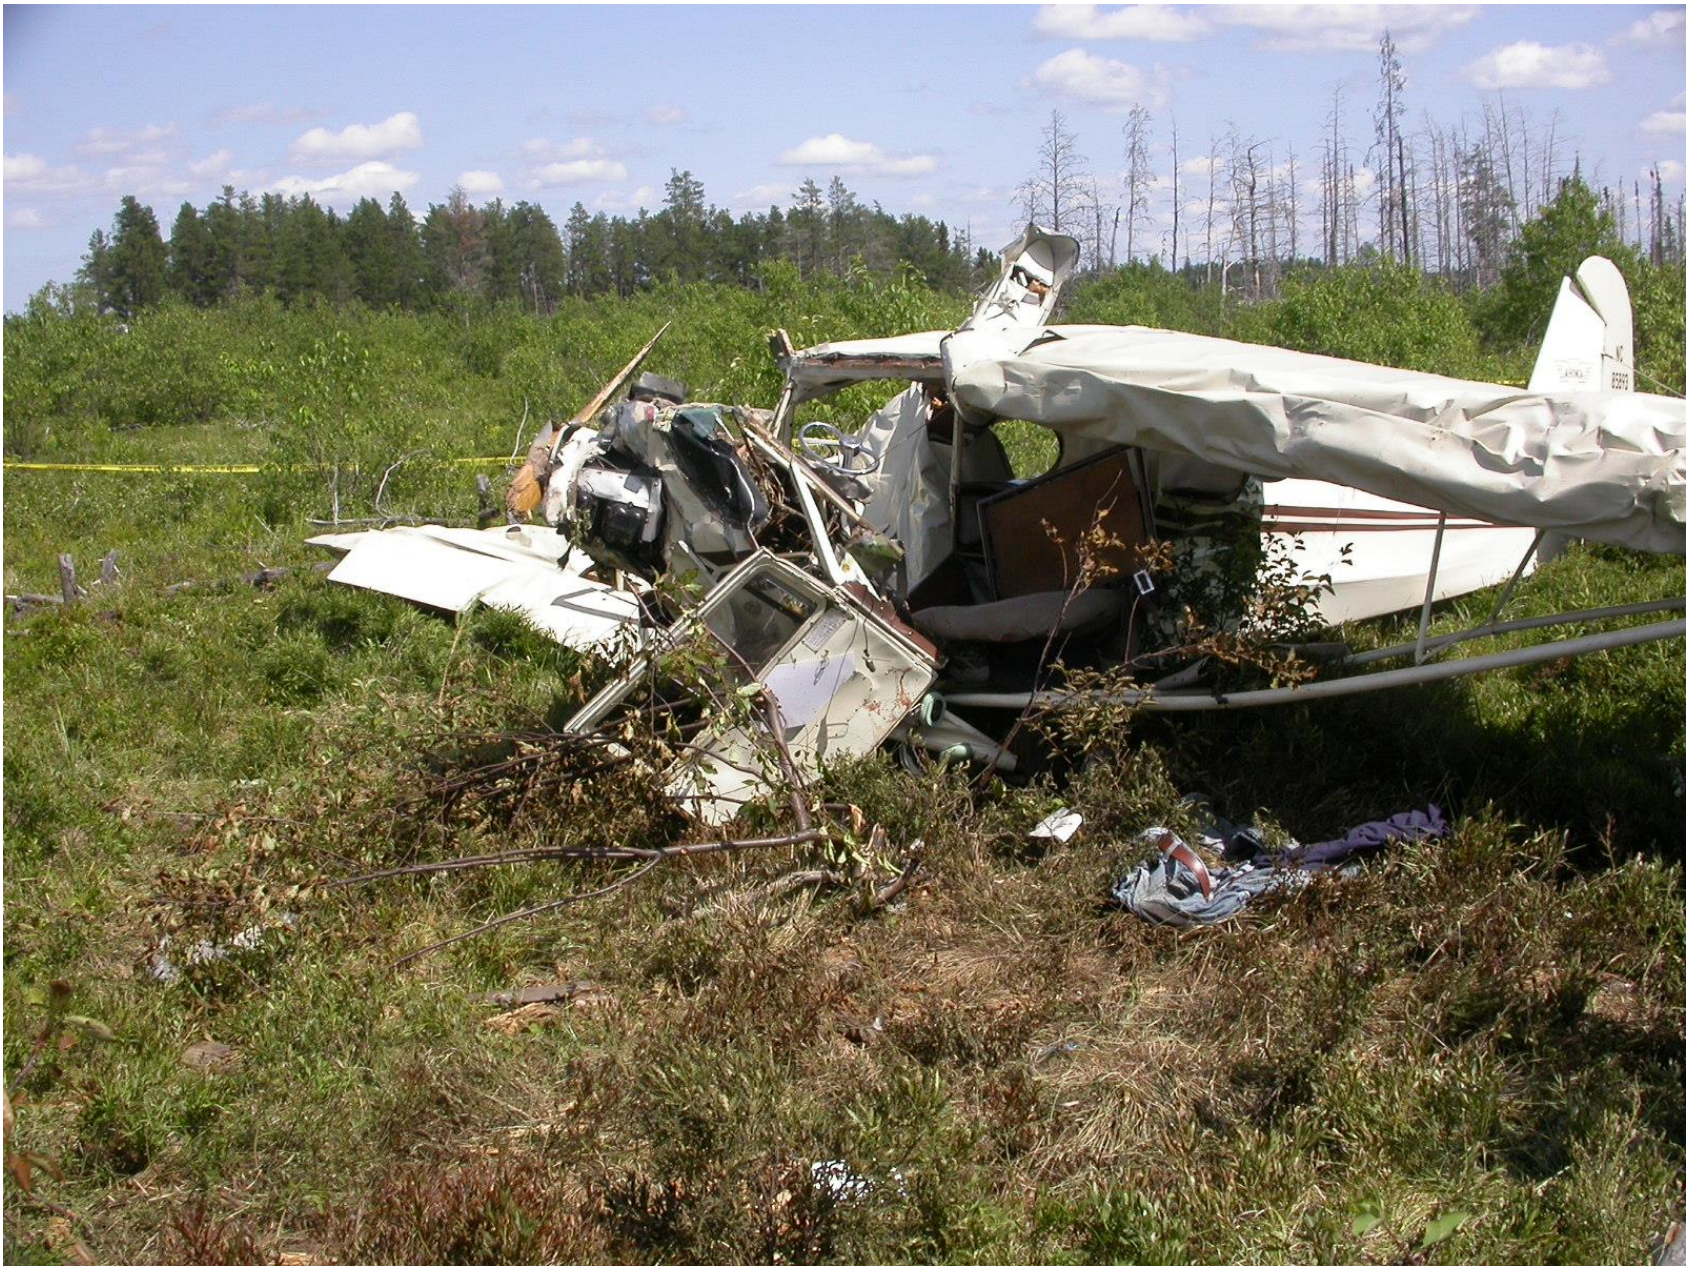
**Photo 5 – View of the damage to the left side of airplane**

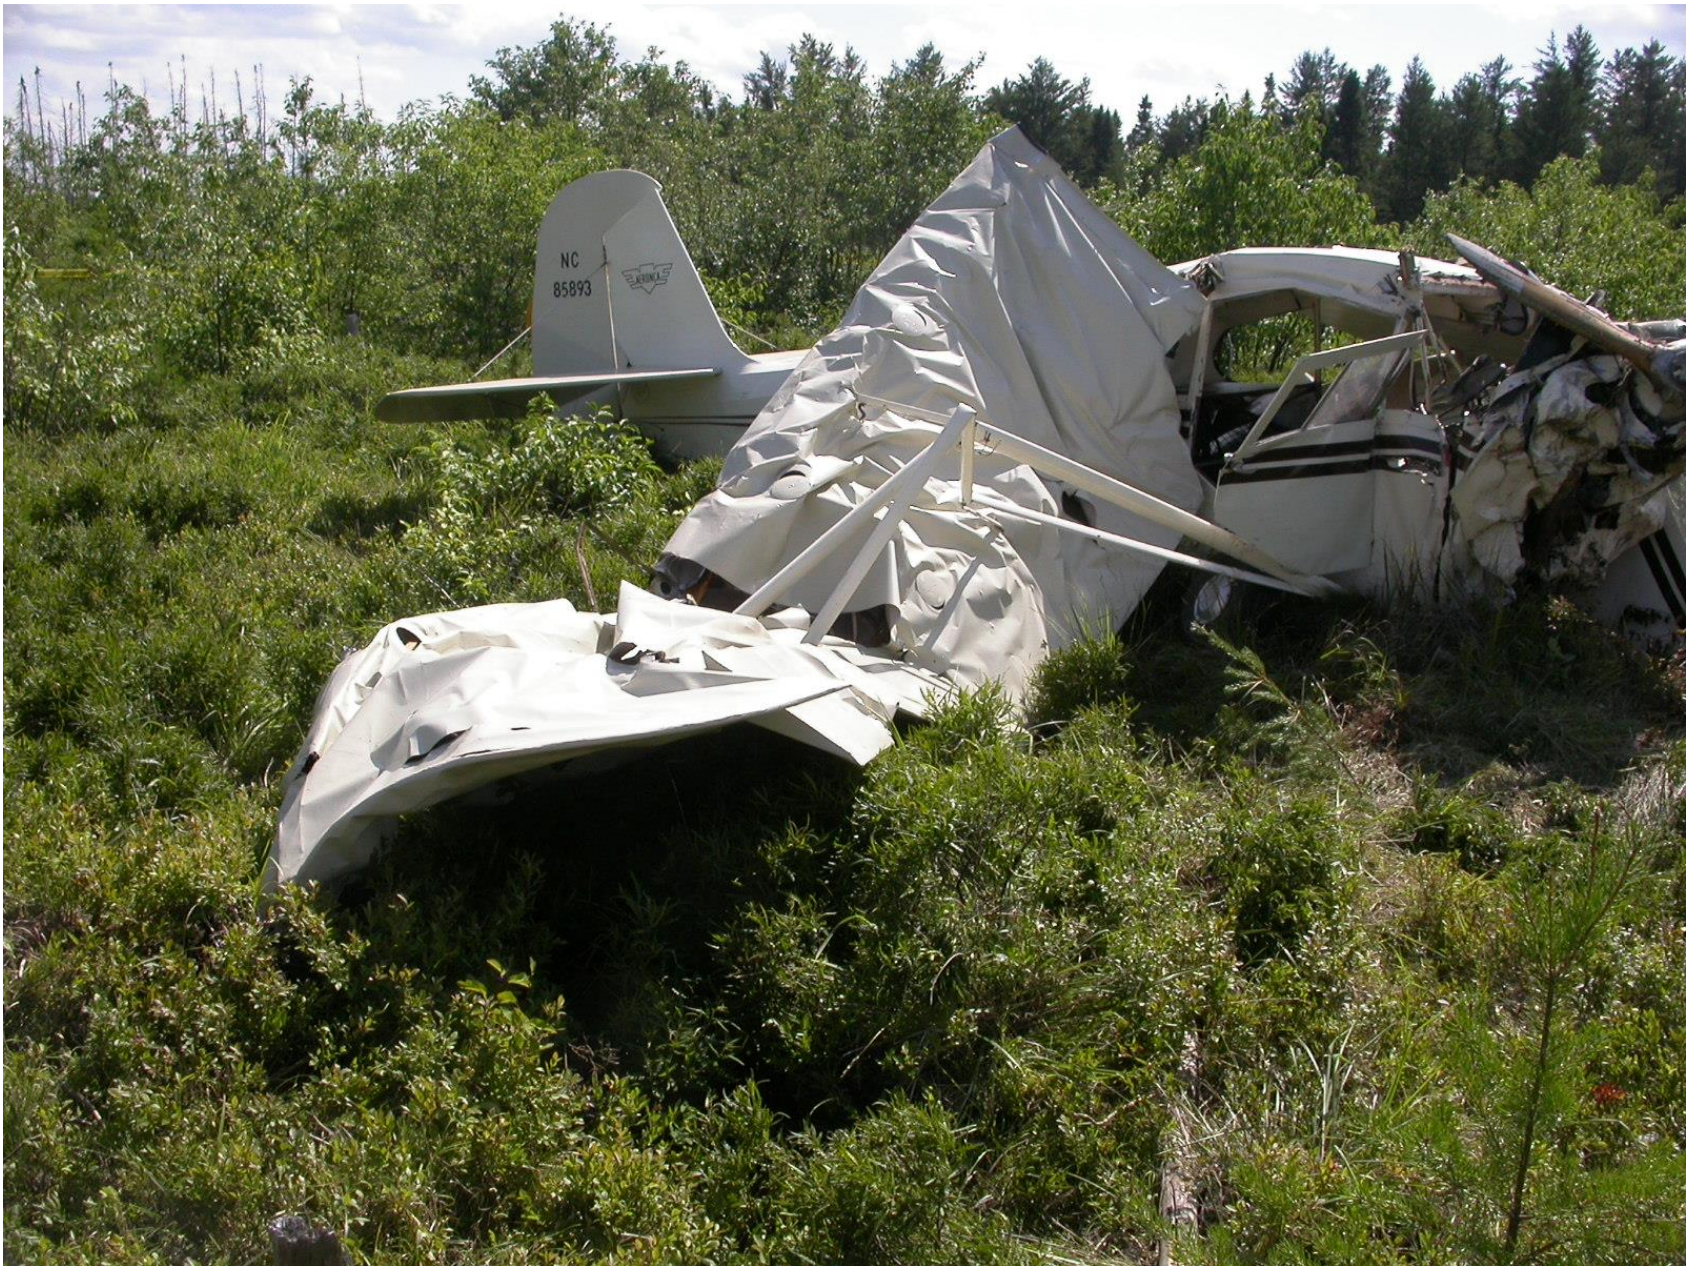
**Photo 6 – View of damage to the right wing**

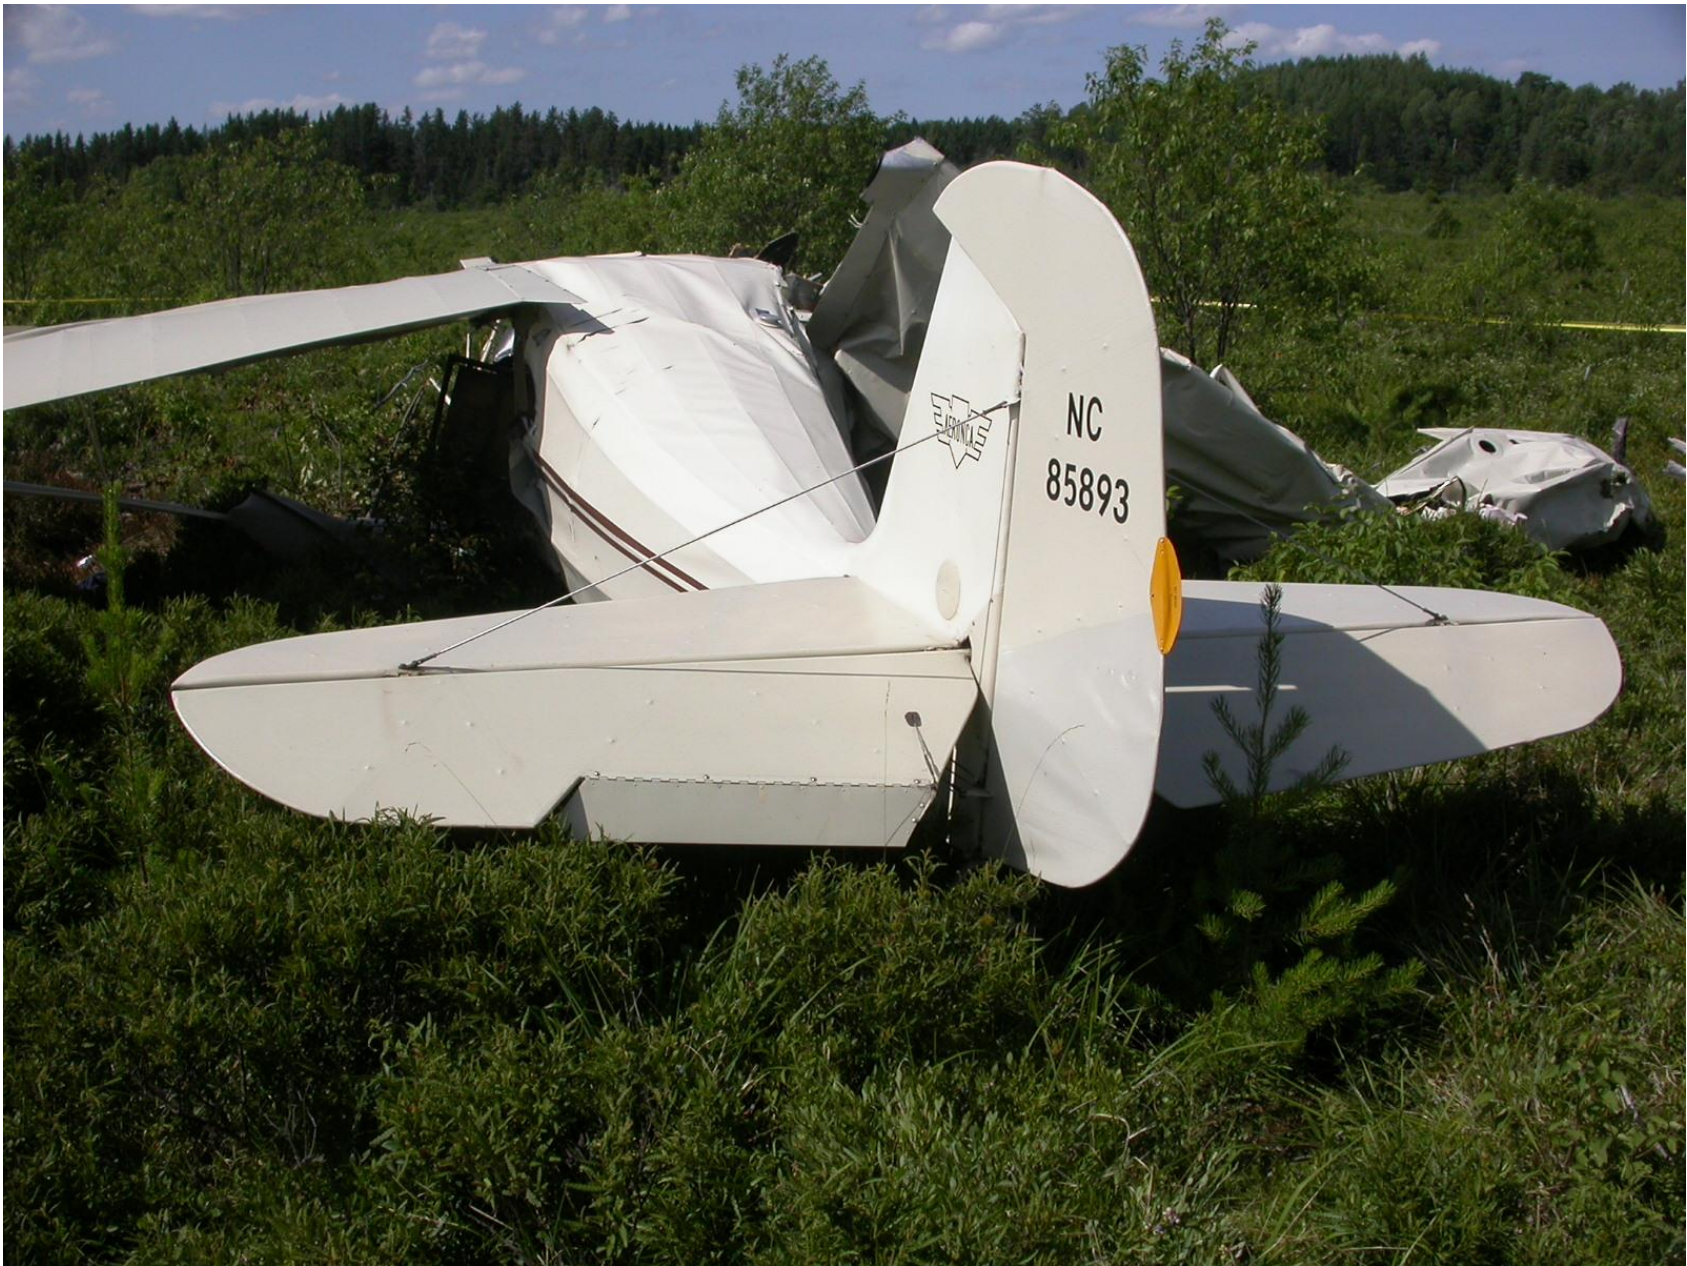
**Photo 7 – View of the empennage**

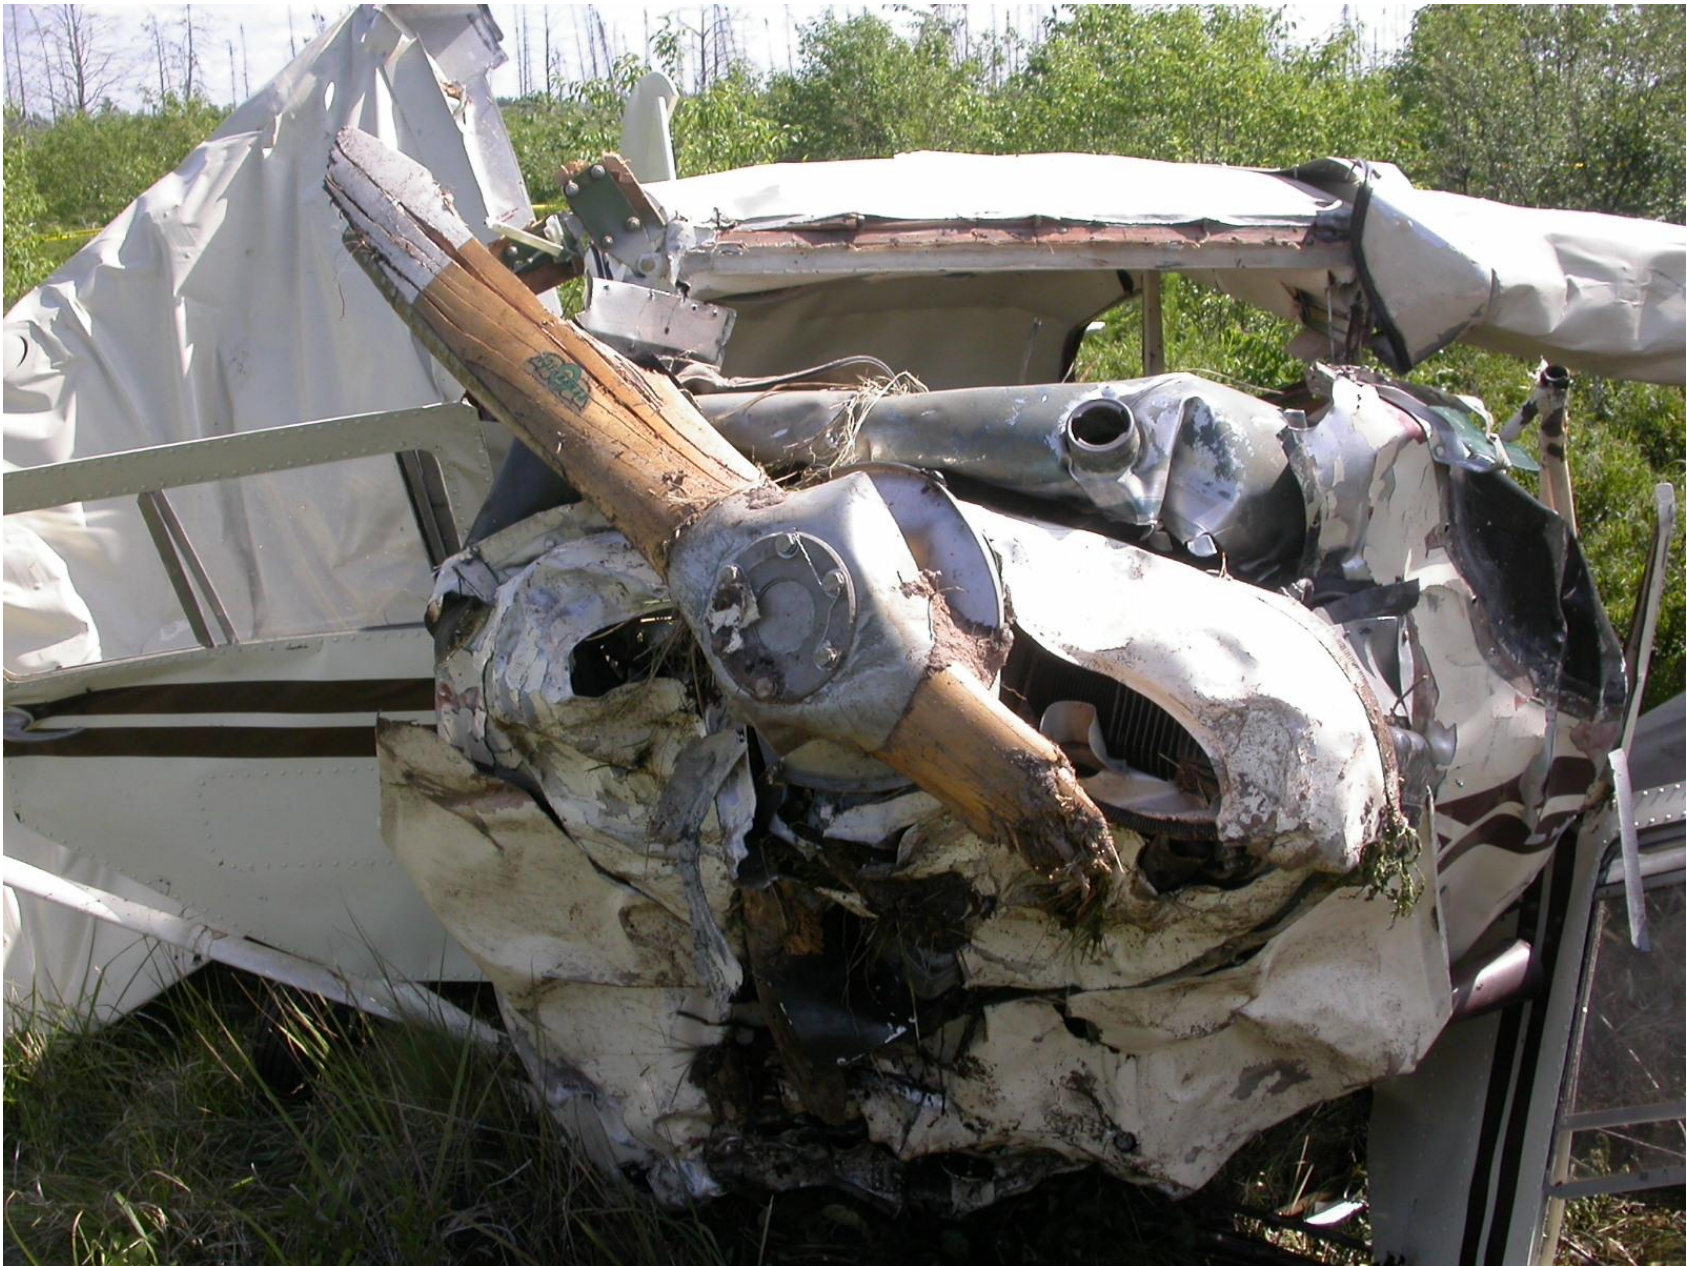
**Photo 8 – View of propeller and nose compartment**

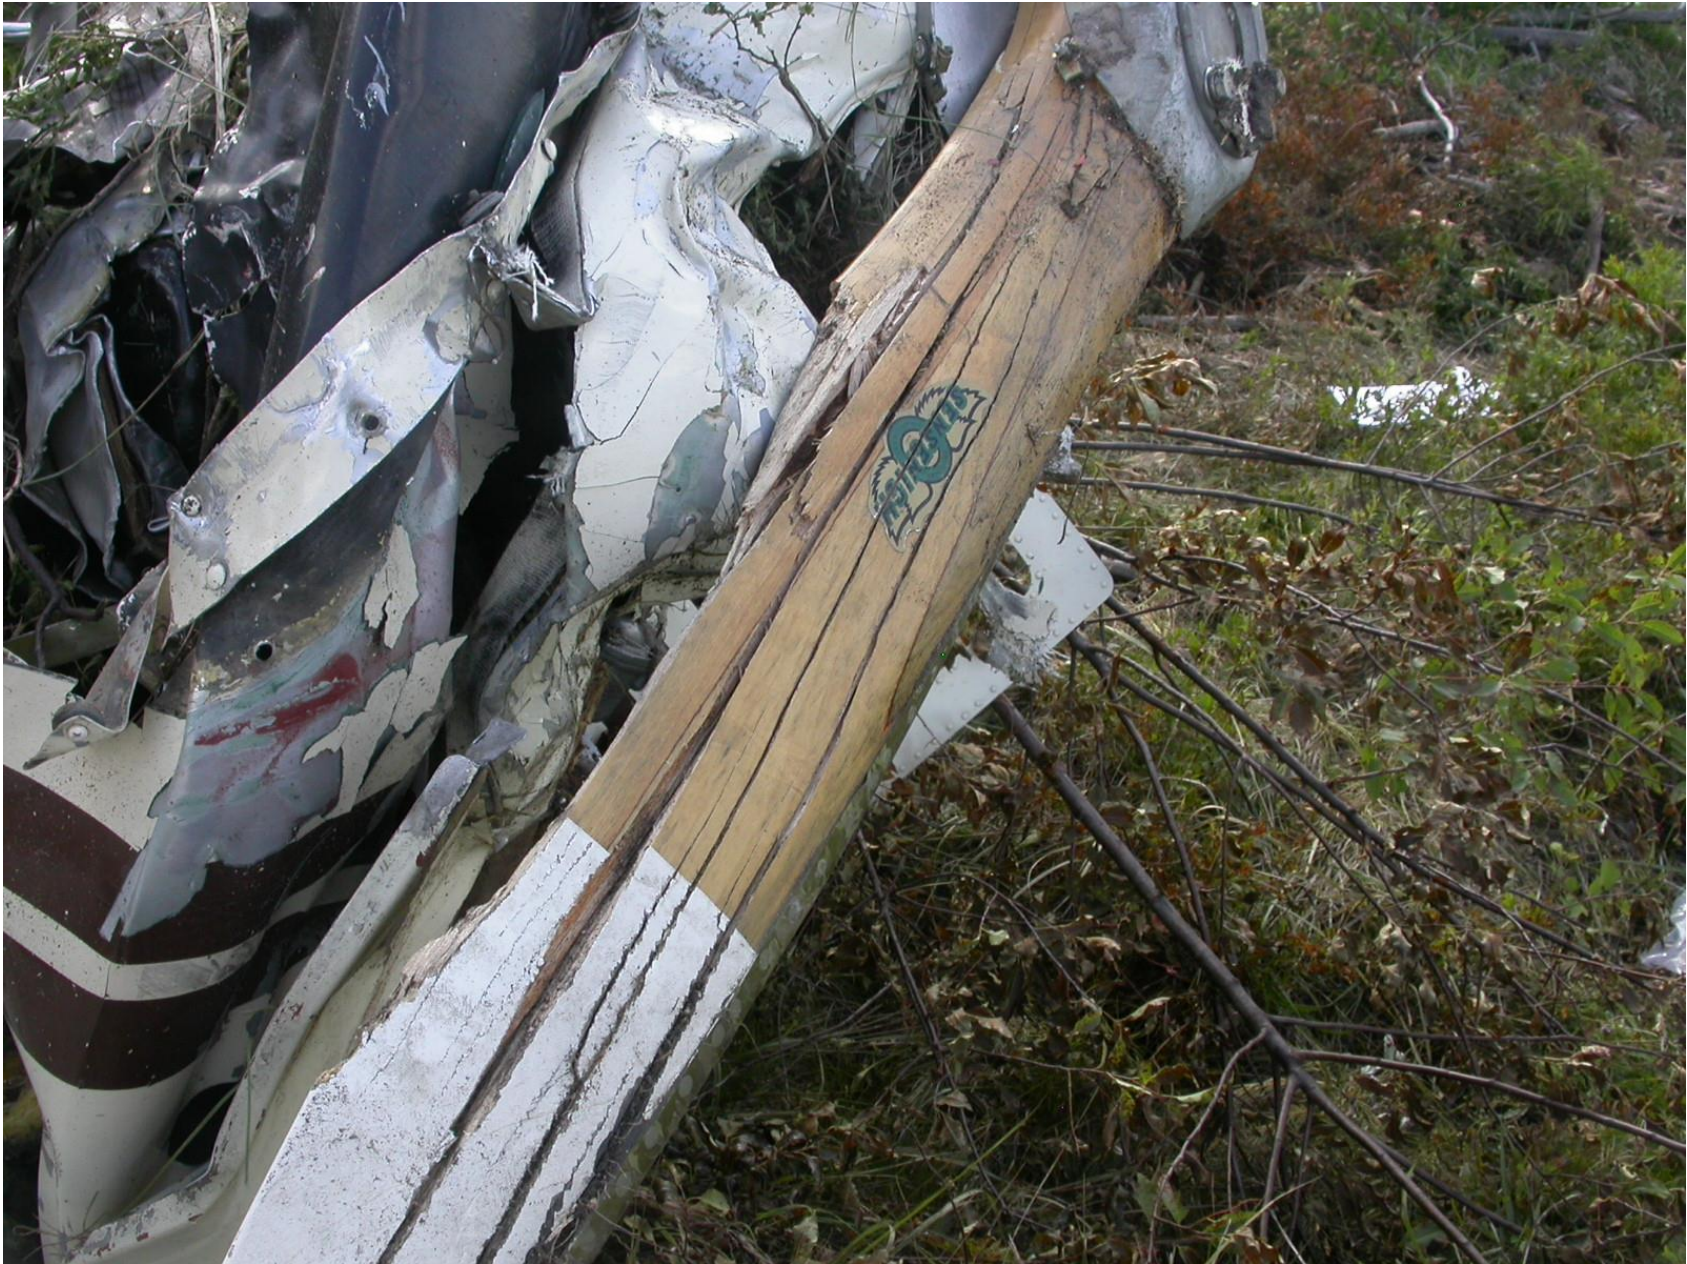
**Photo 9 – View of splintered wooden propeller blade**

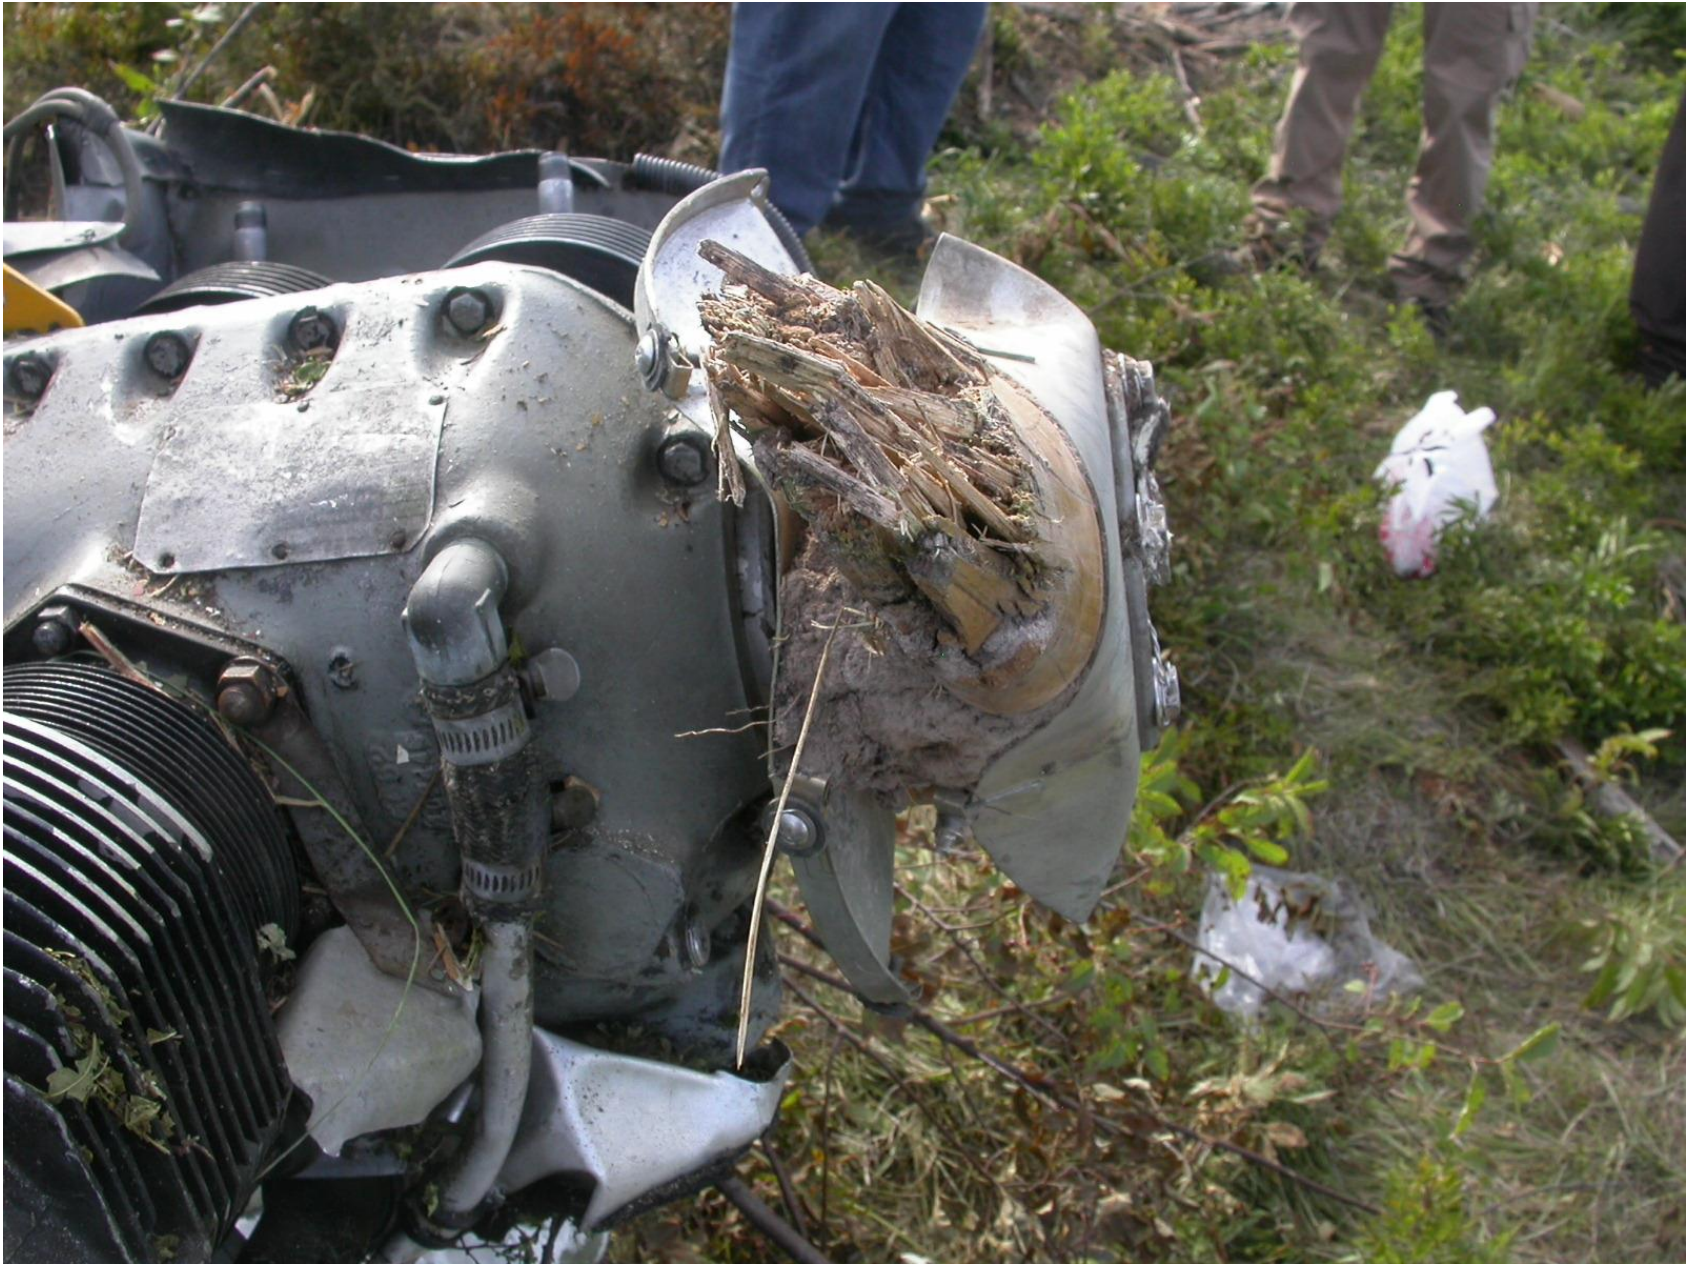
**Photo 10 – View of broken wooden propeller blade**
