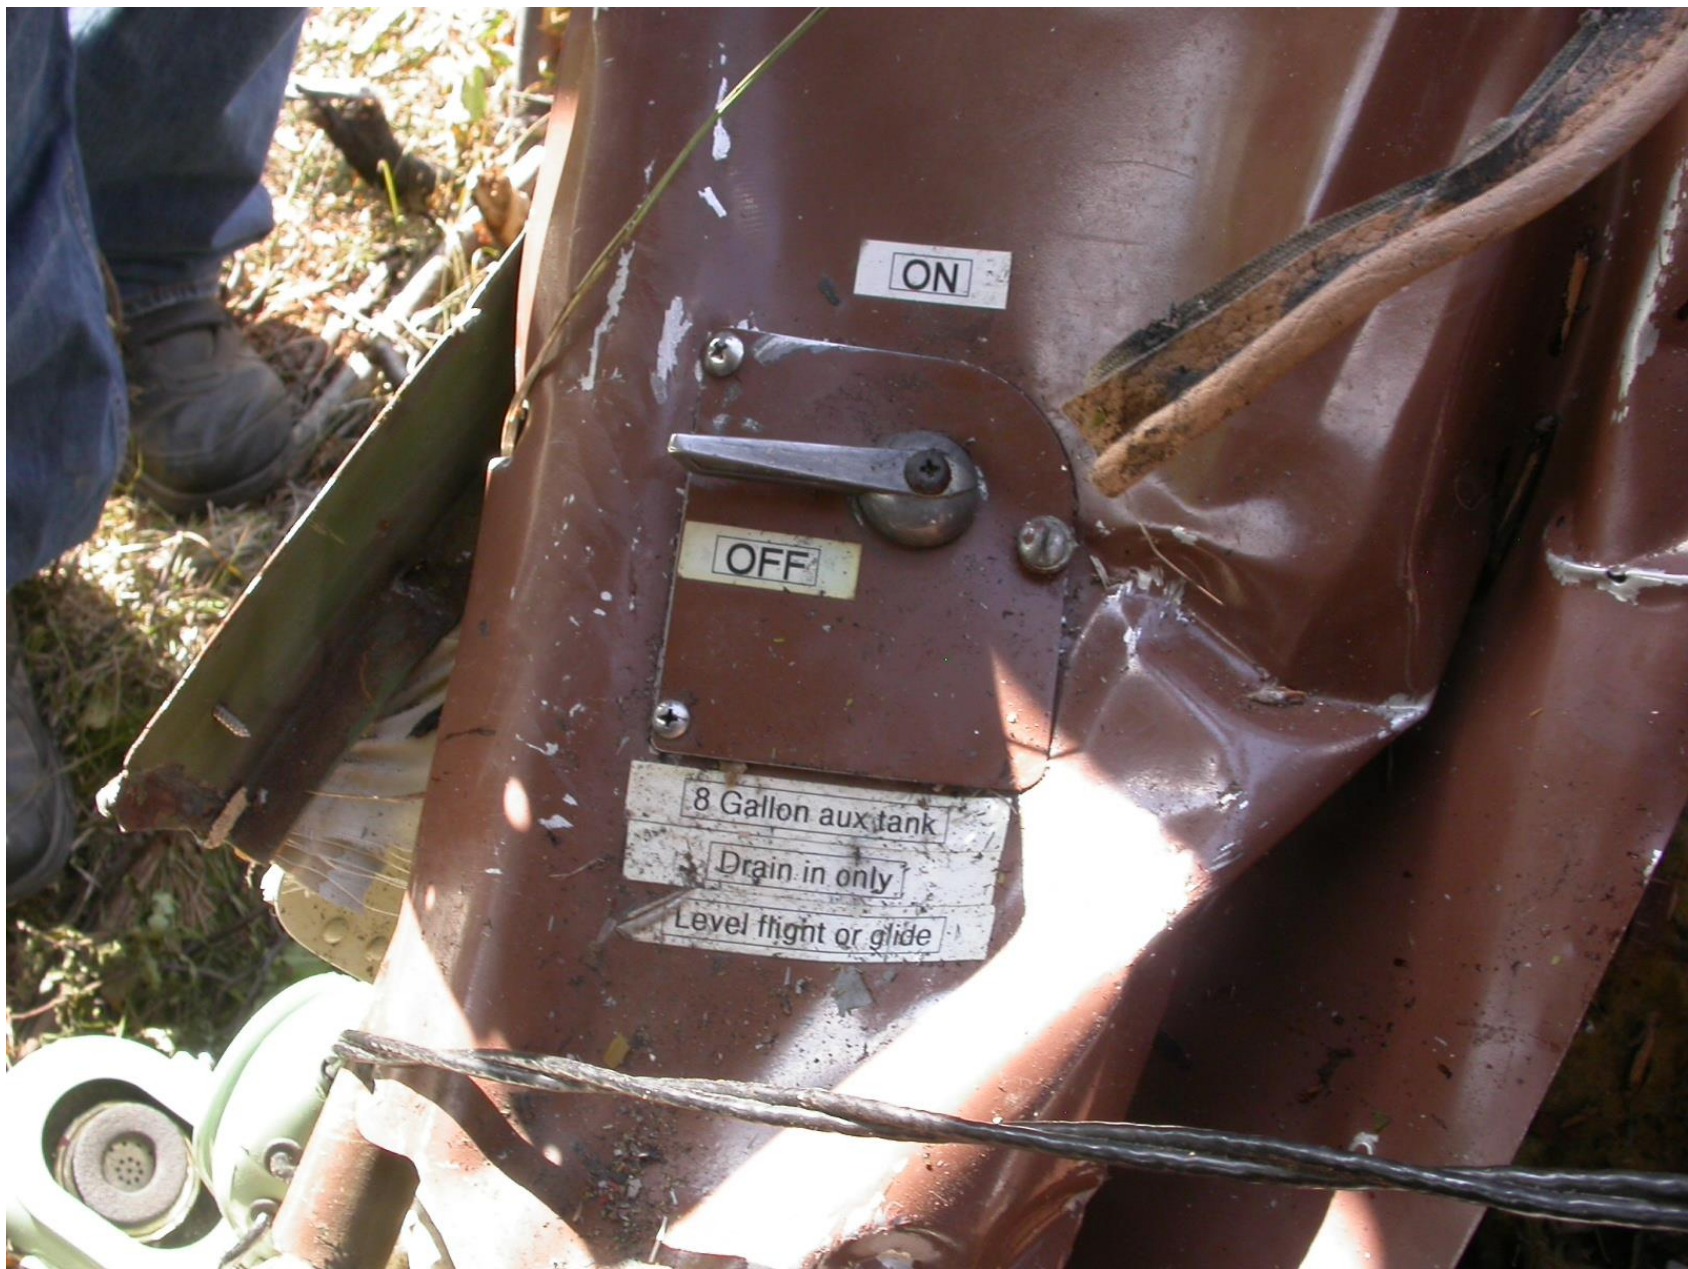
**Photo 11 – View of fuel selector**

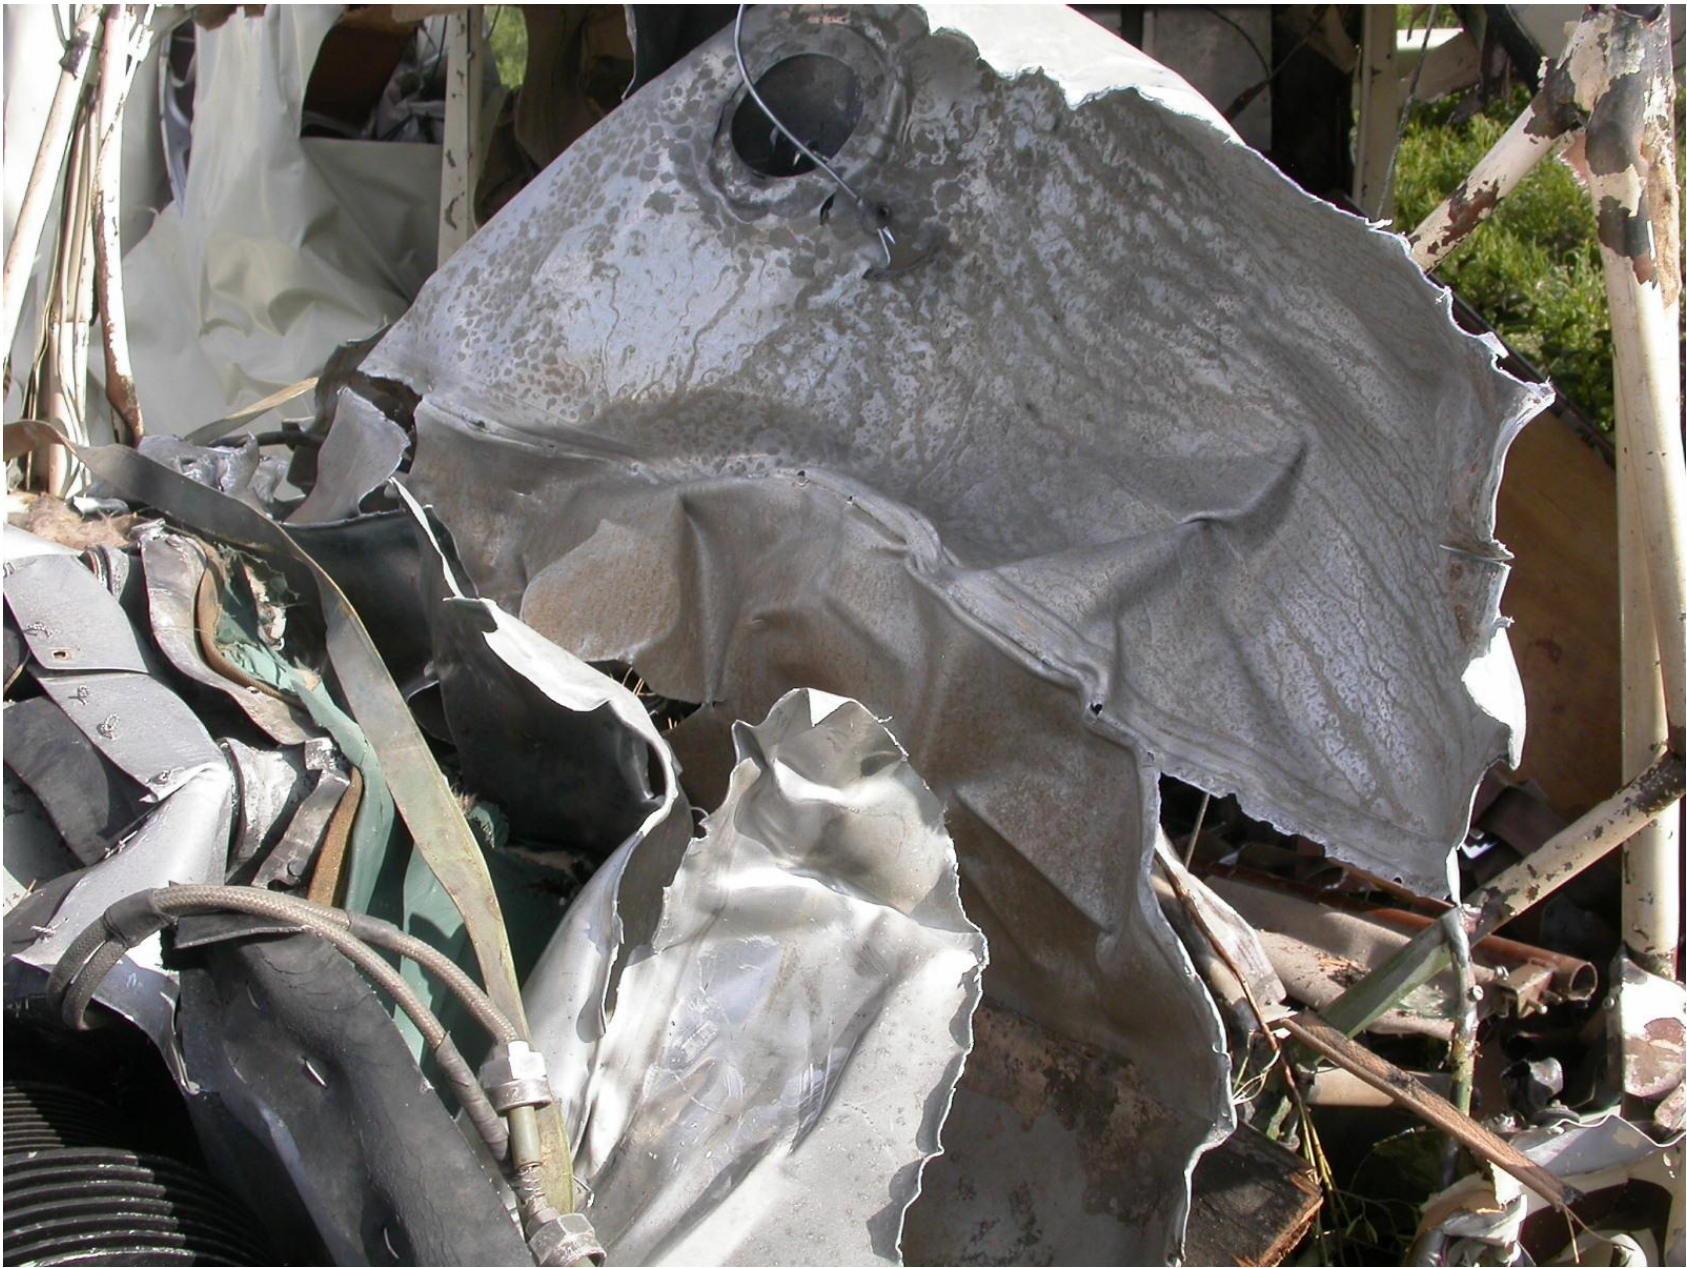
**Photo 12 – View of inside of the main fuel tank**

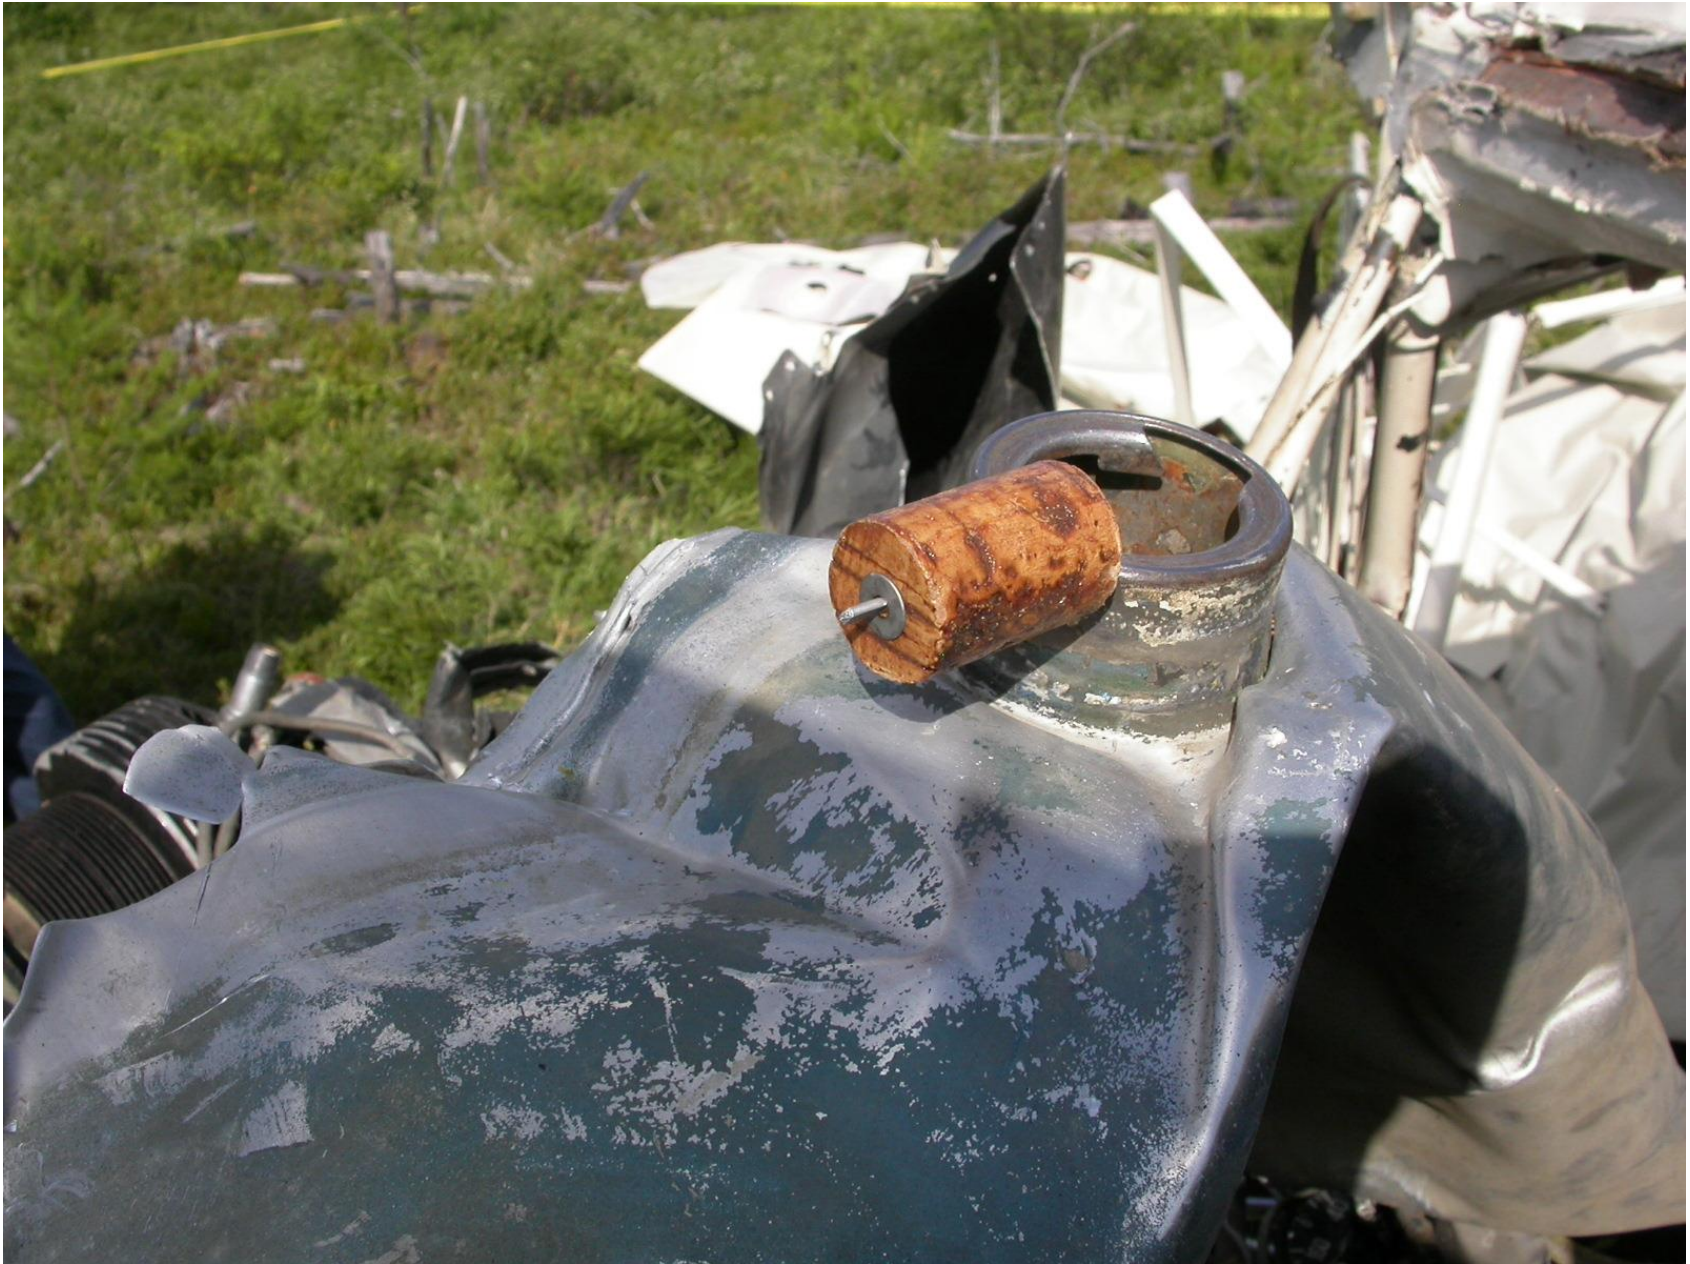
**Photo 13 – View of the main fuel tank cork float**

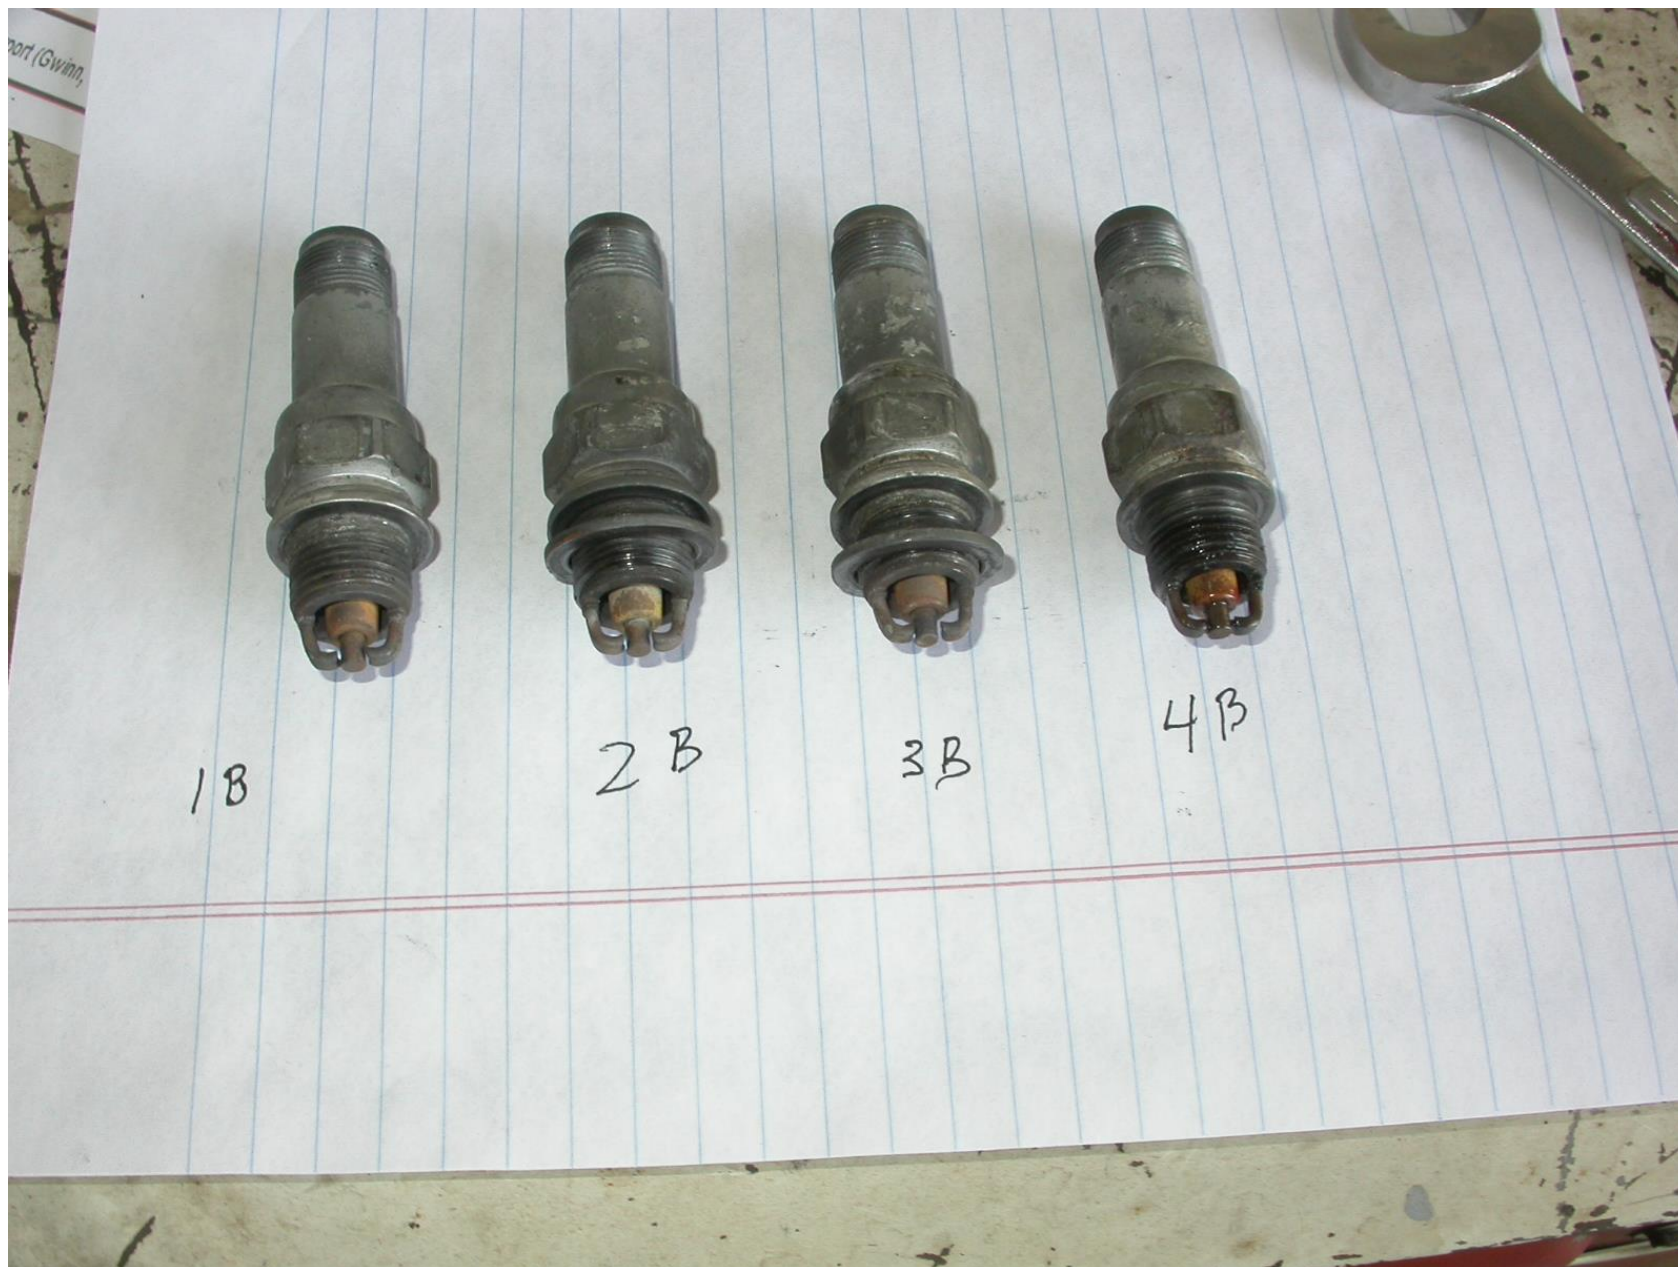
**Photo 14 – View of the bottom spark plugs**

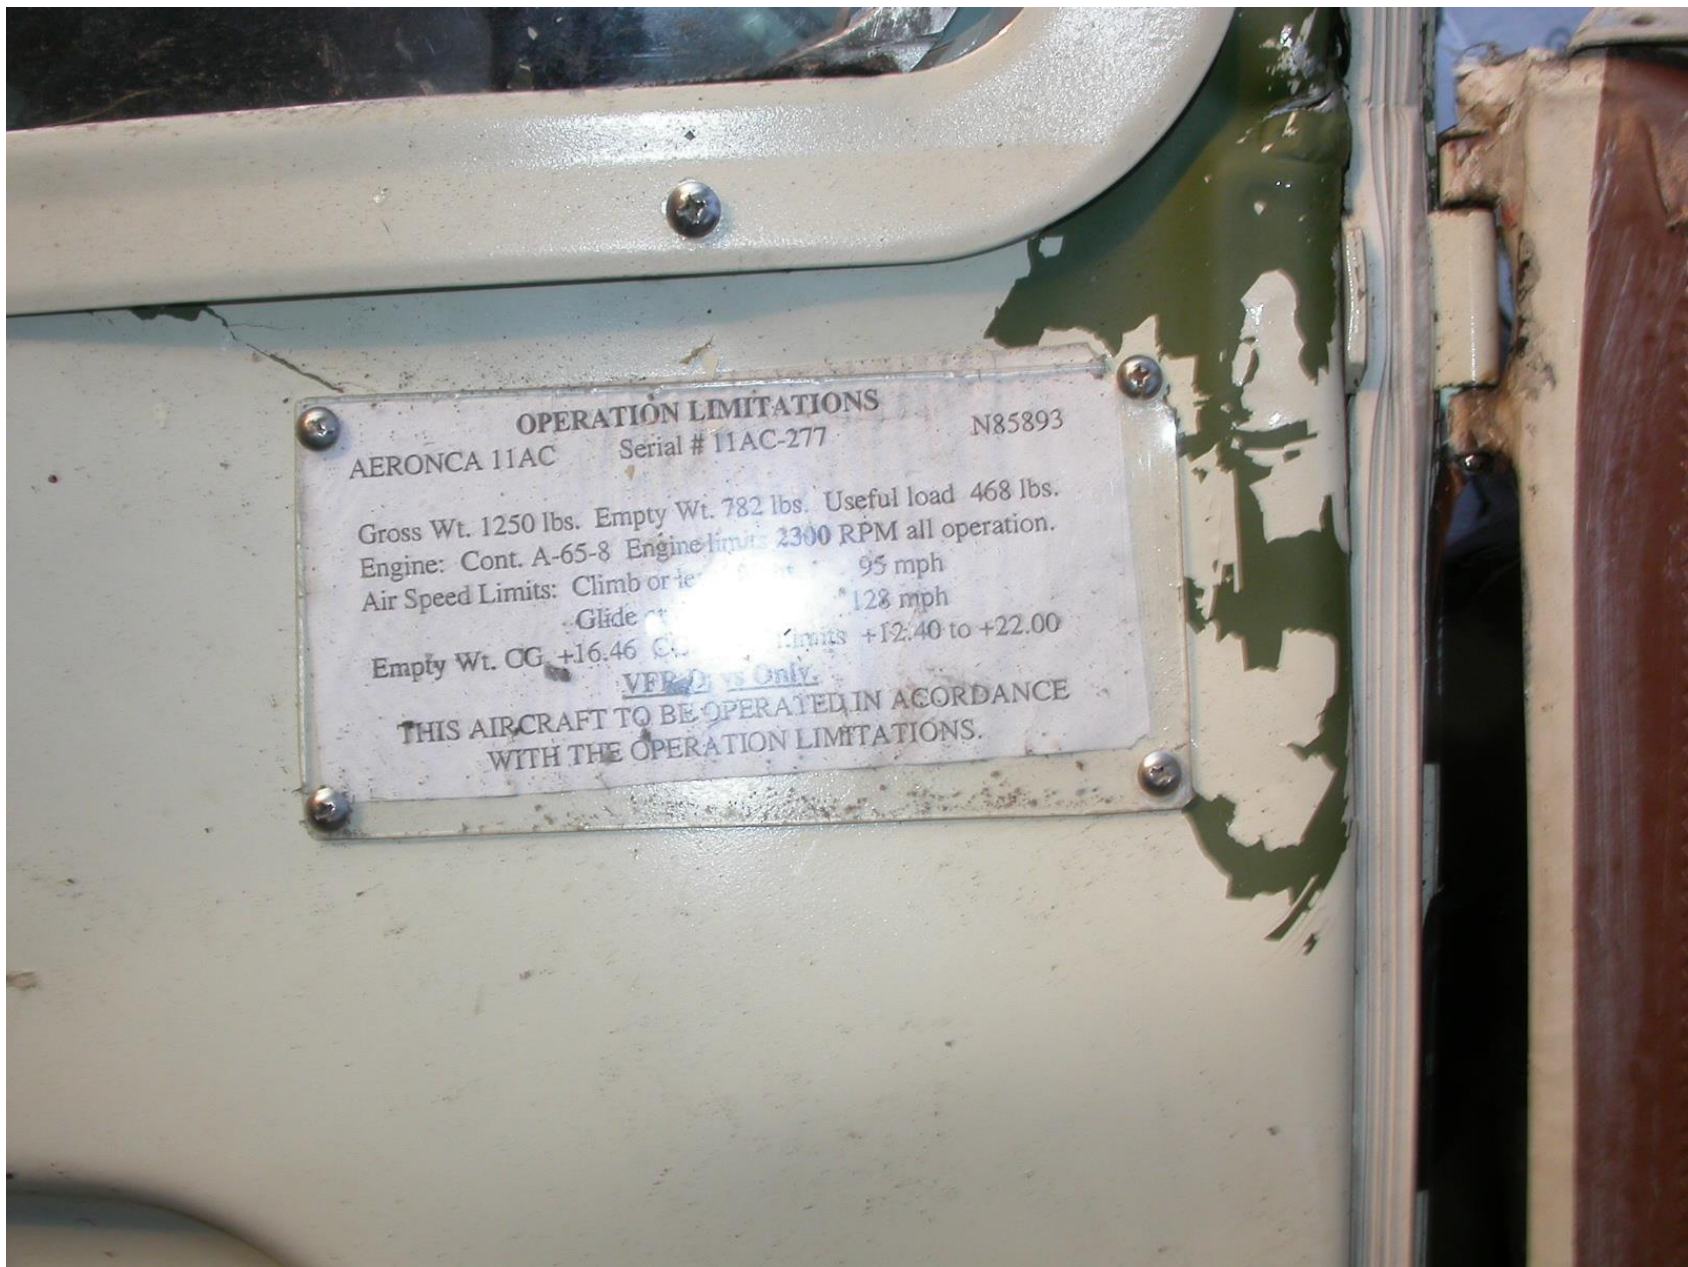
Photo 15 – View of the aircraft weight and balance
