**National Transportation Safety Board**  
Office of Research and Engineering  
Washington, D.C. 20594

**Performance Study**

| Airplane: | Piper PA-30, N7409Y |
| NTSB Number: | CEN16FA276 |

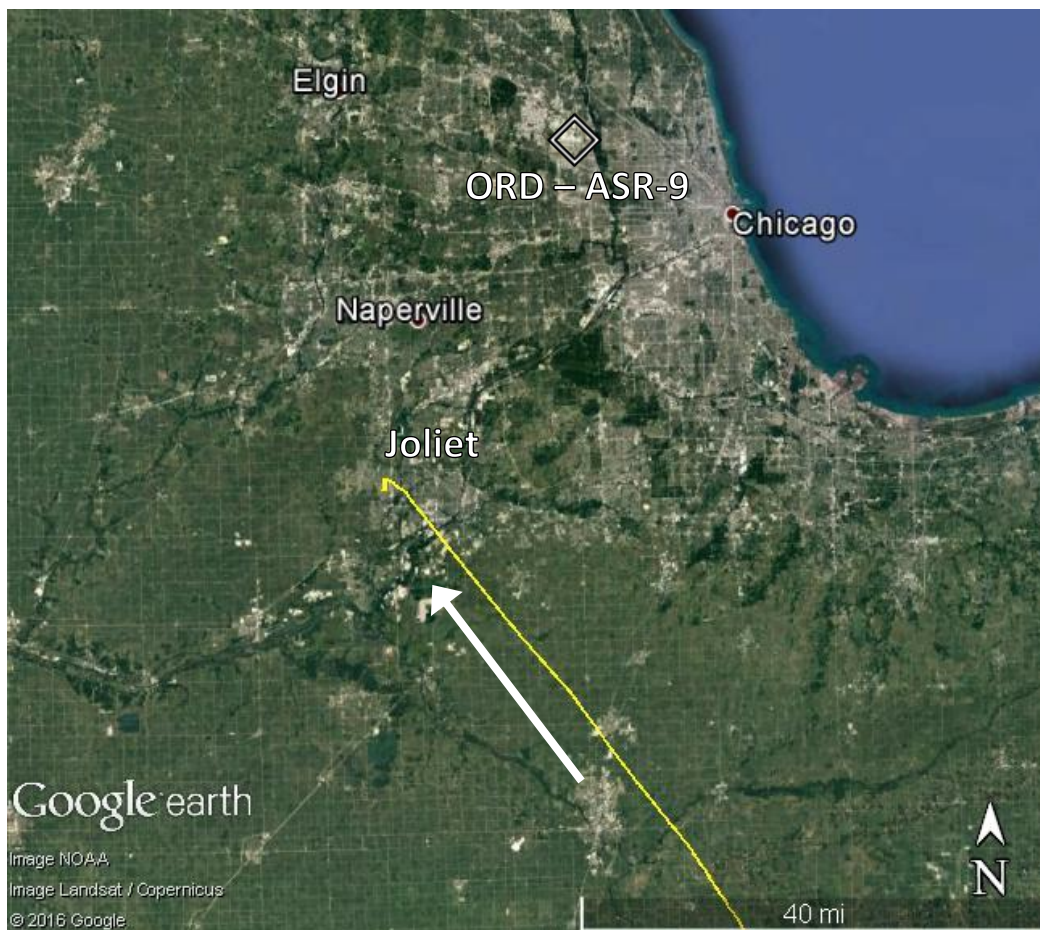
**Figure 1.** Aircraft flight path shown in yellow.

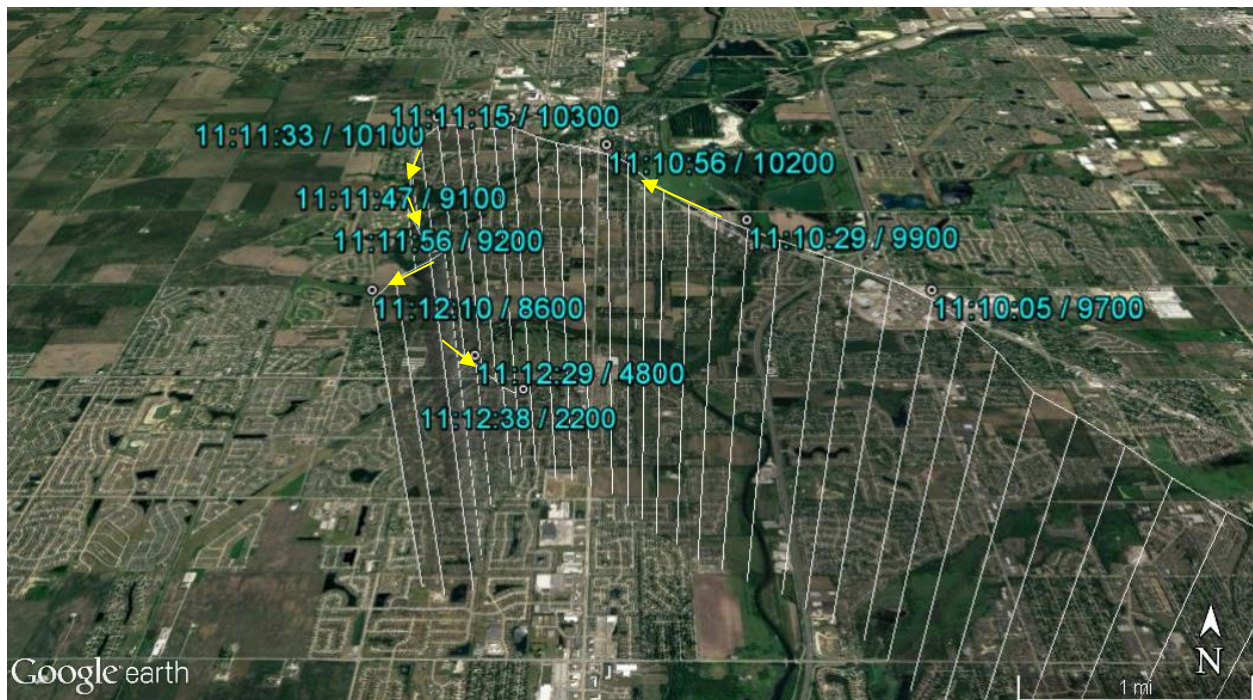
**Figure 2.** End of flight path. Last point is at 11:12:38 and 2200 ft.

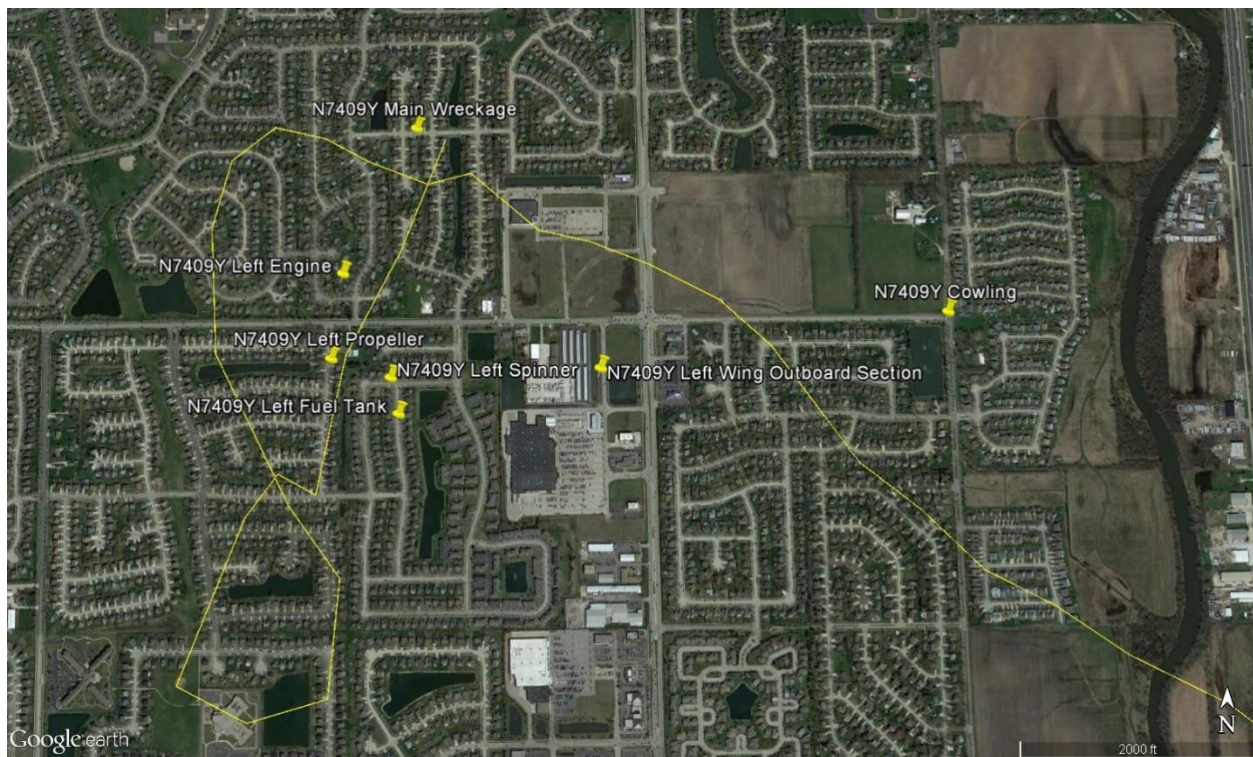
The radar path is shown in Figure 1 and Figure 2. The fuselage, empennage, right engine, right wing, and inboard section of the left wing were found together at the point labeled "Main Wreckage" in Figure 3. Additional pieces of the airplane were found up to a mile away from the main wreckage, indicative of an in-flight breakup.

**Figure 3.** End of flight path and wreckage locations.

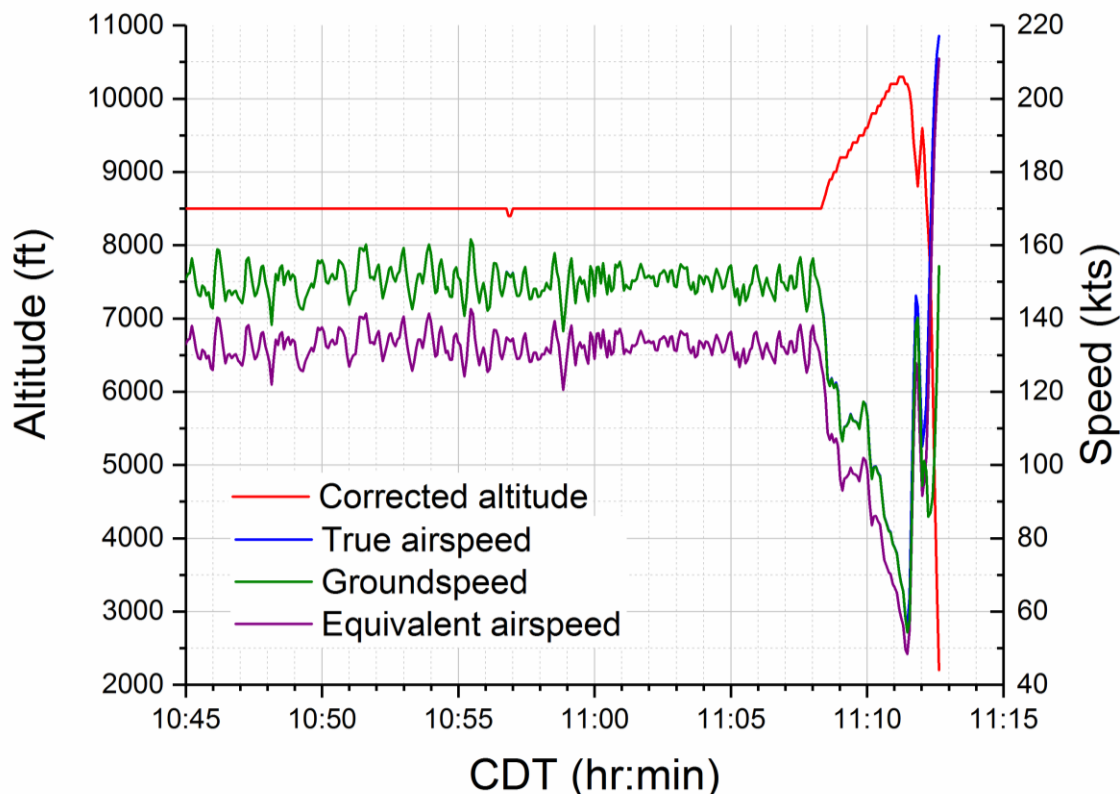
The radar data provided began at about 1044 CDT. From this time until 1108, the airplane was travelling along a path oriented at approximately 320° (true), at an altitude of 8500 ft, and a groundspeed of about 150 kts (airspeed calculations use the weather at the time and location of the accident and may not accurately reflect the winds at the start of the radar track, 60 NM away and 30 minutes earlier). At 1108:23 the airplane began to gain altitude while losing speed until 1111:10 when it reached an altitude of 10300 ft (Figure 4 and Figure 5). The airplane held 10300 ft until 1111:23 when it began to descend and gain speed. At 1111:28 the airplane reached its lowest calculated equivalent airspeed of 48 kts. The final radar point was at 1112:37.78 when the altitude was recorded at 2200 ft and the calculated equivalent airspeed was 211 kts.

**Figure 4.** Altitude and calculated speeds versus time.

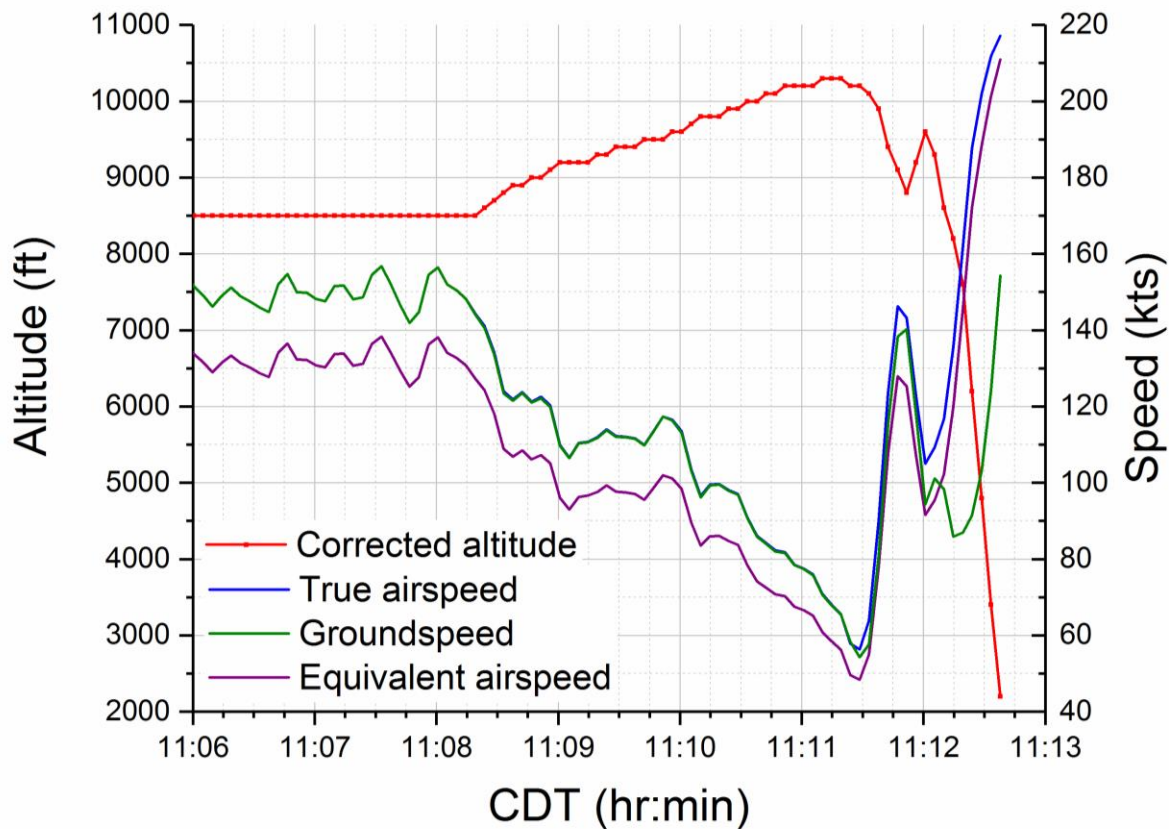
**Figure 5.** End of flight path. Last point is at 11:12:37.78 and 2200 ft.

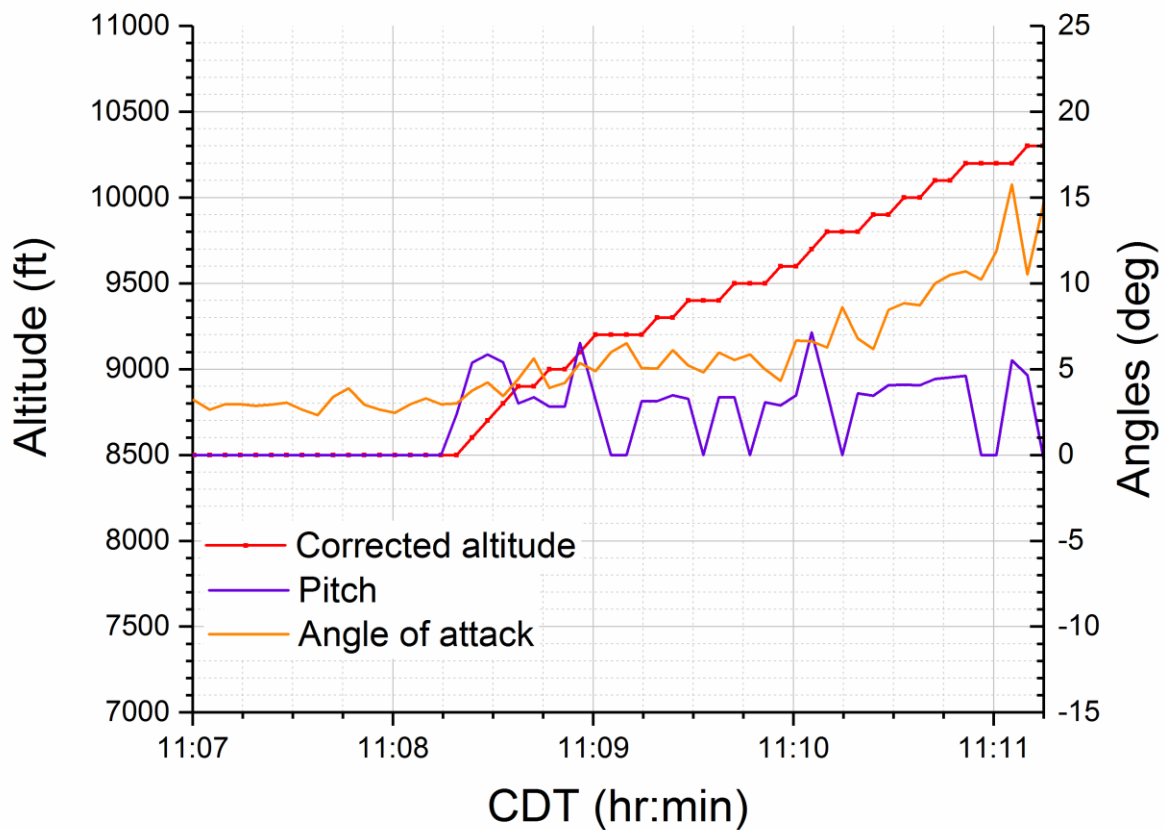
Figure 6 shows the calculated pitch and angle of attack for the final climb. These angles are calculated using a simplified aerodynamic model. While the airplane gained altitude but lost airspeed, the angle of attack increased to nearly 20°. The high angle of attack and low airspeed put the airplane at risk of aerodynamic stall.

**Figure 6.** Calculated pitch and angle of attack for climb from 8500 ft to 10300 ft.

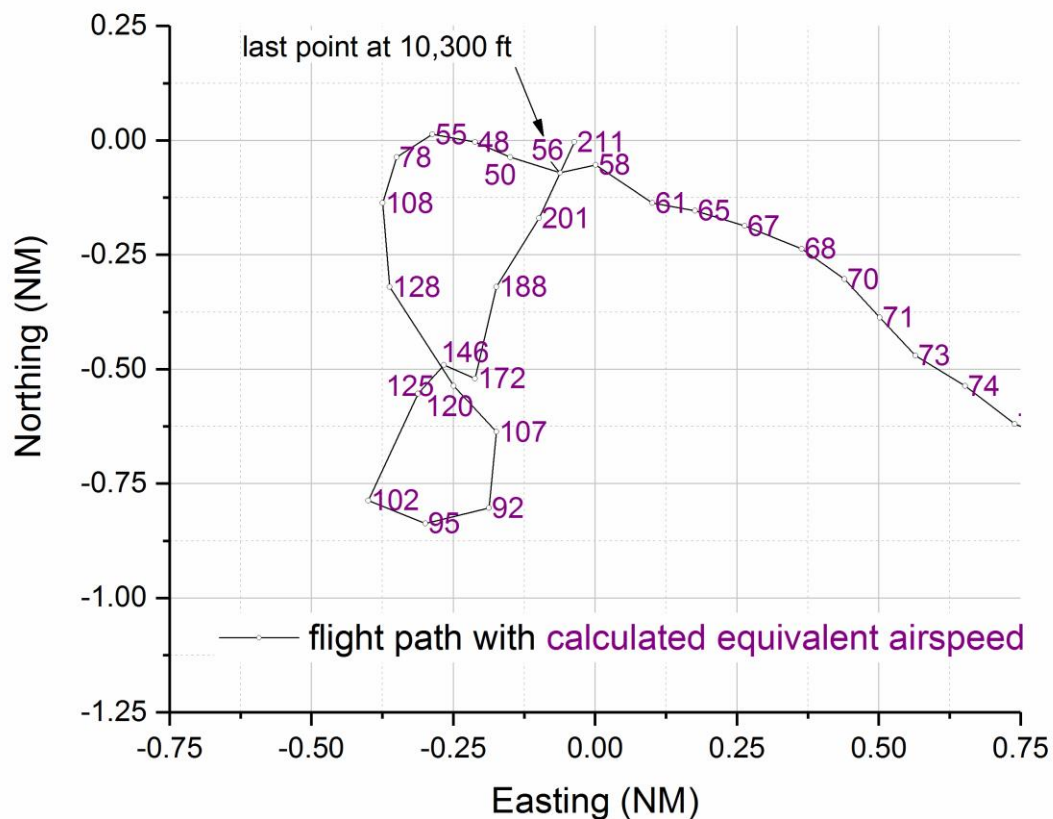
The POH reported the gear and flaps up stall speed to be between 76 mph (66 kts) at 3,600 lbs gross weight and 67 mph (58 kts) at 2,600 lbs gross weight<sup>1</sup>. The loss of altitude and left turn corresponded with the airplane's calculated airspeeds dropping below the reported stall speed. Figure 7 shows that the airplane lost altitude and began a series of turns, the first to the left, after the equivalent airspeed dropped below 60 kts (last radar point at an altitude of 10,300 ft is noted).

**Figure 7.** End of flight path in Northing versus Easting with equivalent airspeed for each point.
