NATIONAL TRANSPORTATION SAFETY BOARD  
Office of Aviation Safety  
Washington, D.C. 20594  
October 17, 2017

## Group Chairman's Factual Report

# STRUCTURES

CEN16FA276

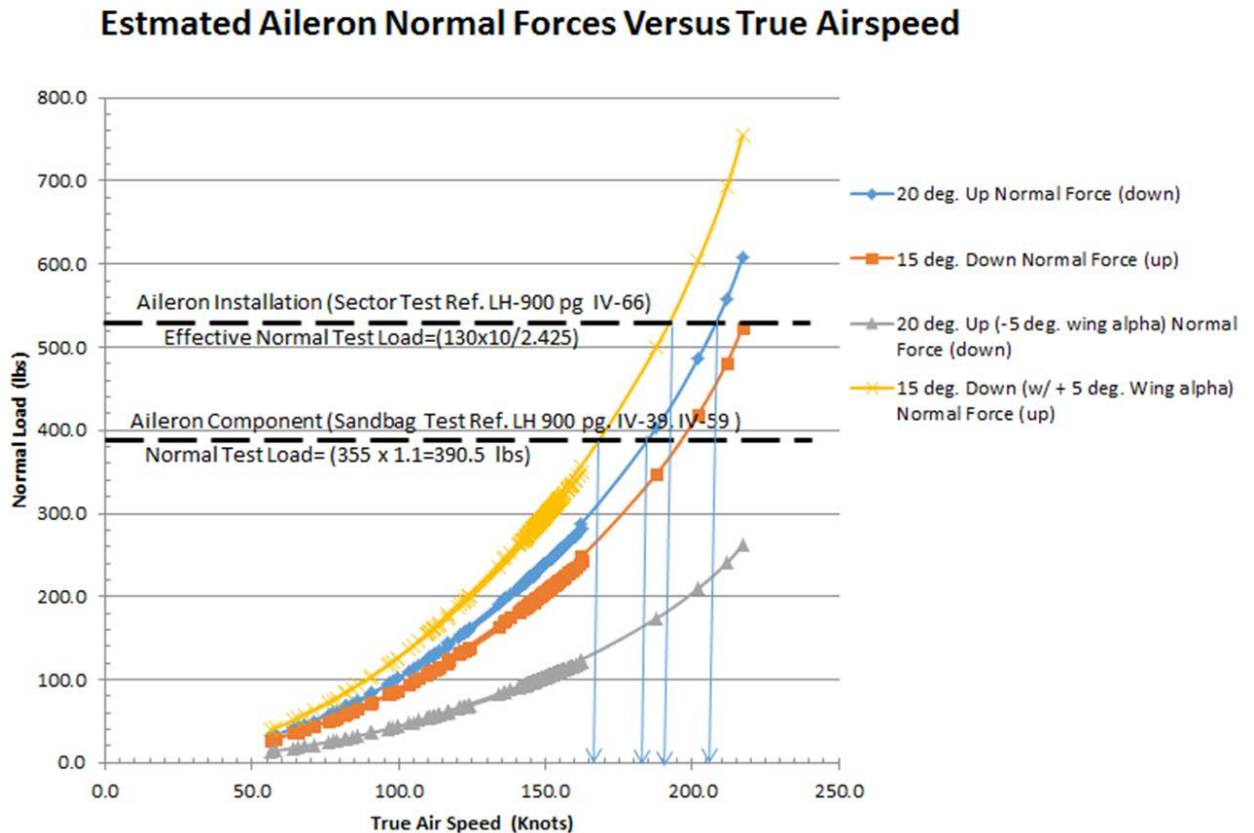
Piper performed a loads analysis for the loads achieved during the descending spiral and determined that at the maximum airspeed achieved the loads on the aileron and its installation would have exceeded the loads that the aileron was tested to during the certification.

The plot demonstrates that for the accident aircraft, the aileron components per type design, at a minimum, should have been structurally capable up to full deflections (down to up) between 166 to 183 knots true, and the aileron installation per type design, should have been structurally capable for full deflection (down to up) between 190 to 206 knots true.

This analytical demonstration is considered adequate given the calculated minimum failure speeds are above the published aircraft usage limits for maximum maneuvering at 135 MPH (117.3 knots) at min. weight and 162 MPH (140.8 knots) at maximum weight as stated in the pilots operating handbook, Report 1269.

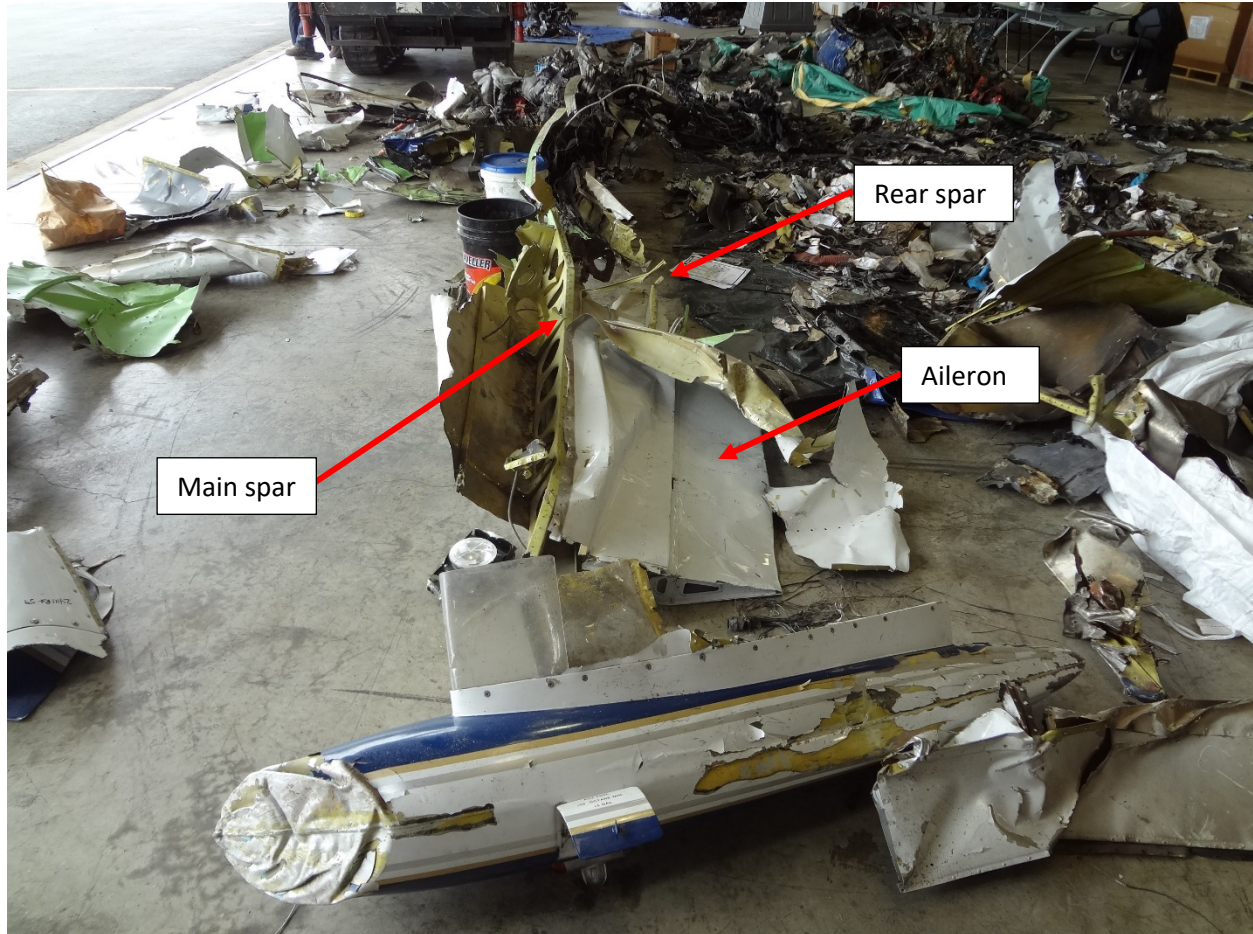
Approximately 83 inches of the outboard wing was separated and found approximately 0.44 nautical miles from the main wreckage. Leading edge skin separations were noted to the separated section of wing. The outboard approximate 68 inches of the left aileron remained attached to the separated section of wing with the aileron balance weight still secured to the aileron. The inboard section of the aileron was separated from the remainder of the structure and was not located within any of the recovered wreckage. No evidence of fire or fire damage was noted to the separated section of wing or aileron. The left tip tank was separated from the outboard section of the wing and was found approximately 0.41 nautical miles from the main wreckage. The tip tank was found breached from impact damage to the leading edge.

Figure 1 – Left wing looking inboard.

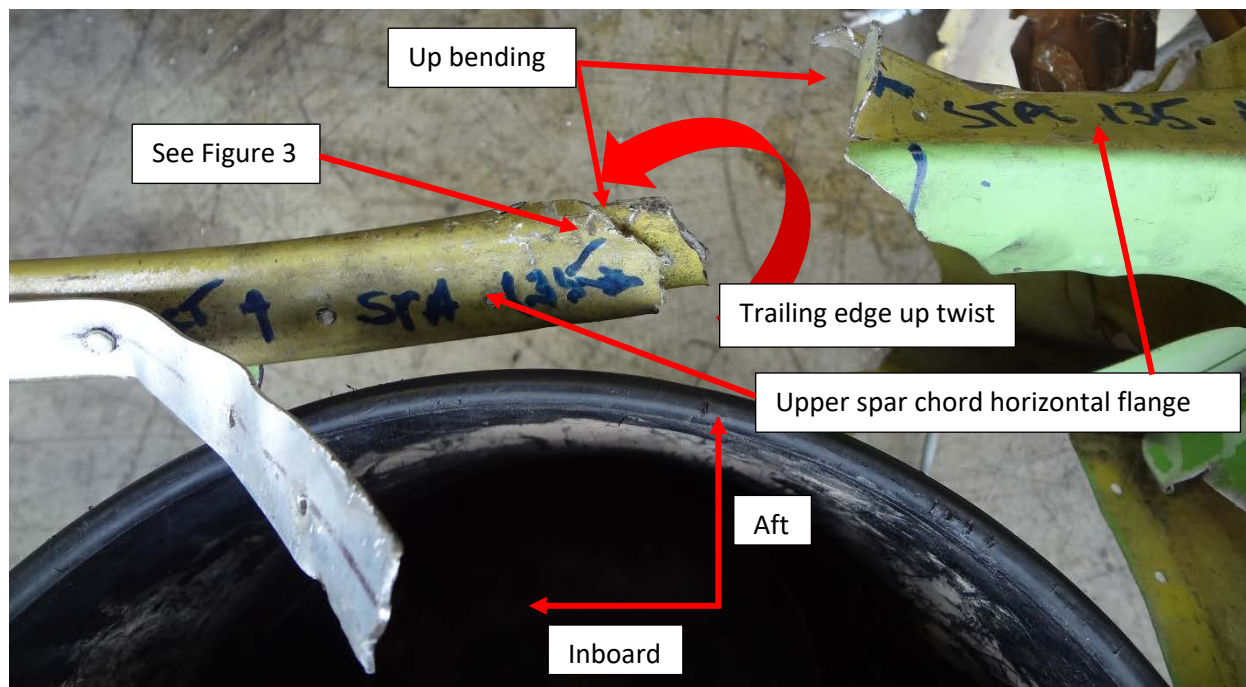
The upper main spar chords fractured at about wing station 135/136 (reference Figures 2 thru 4 and 7) and lower spar chord at about station 125/126 (reference Figure 5 and 7) and both exhibited evidence of upward and aft bending. An examination of the shear lips on the horizontal legs of the spar chord at each of the fracture locations confirmed the upward bending along with the fractured ends of the horizontal legs of the spar chords deforming in an upward direction. The compression buckling (reference Figure 6), crippling, or aft bending of the horizontal legs of the upper spar chord from about station 95 to 122 and from about station 104 to 122 on the horizontal lower spar chord. The spar chords also exhibited evidence of trailing edge up twisting deformation consistent with the outboard wing rotating counter clockwise about the main the spar when looking inboard (reference Figures 2 and 5). The main spar web was missing from about station 122 to 143 in the area of the aileron bell crank assembly. The rear spar was missing (reference Figures 8 and 9) from about station 130 to 143 in the area of the rear spar aileron hinge fitting. Neither the inboard aileron nor inboard rear spar aileron hinge fitting were recovered. The bell cranks outboard support rib (reference Figures 9 and 10) fractured vertically about six inches aft the main spar attachment and the inboard support was not recovered. The bell crank, the assembly, and the remaining outboard support rib were recovered at the main wreckage site. The inboard 20 inches of the aileron spar in the area of the aileron hinge fitting attachment was not recovered and the inboard twenty inches of the aileron skin panel was recovered separate from both the main wreckage and the outboard wing section. The aileron exhibited evidence of up bending reference Figures 12 and 13). The aileron balance weight cutout exhibited evidence of impact damage from about the 5 o'clock to 12 o'clock positions (reference Figure 14). The rear upper spar chord exhibited evidence aileron cable contact from station 117 inboard to about station 85. The upper wing skin along the rear spar had evidence of a cable cut from about station 116, the aileron hinge location, inboard to about station 92 (reference Figure 15).

**Figure 2 – Left wing main spar upper chord at about station 135.**

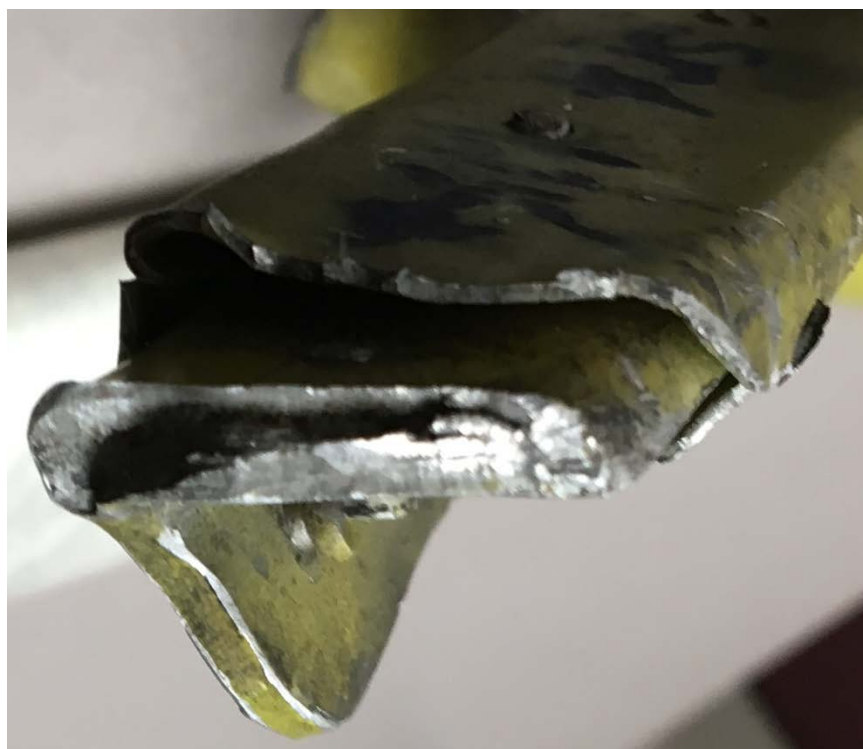
**Figure 3 – Inboard side of left wing upper spar chord fracture at station 135 exhibiting evidence of up bending.**

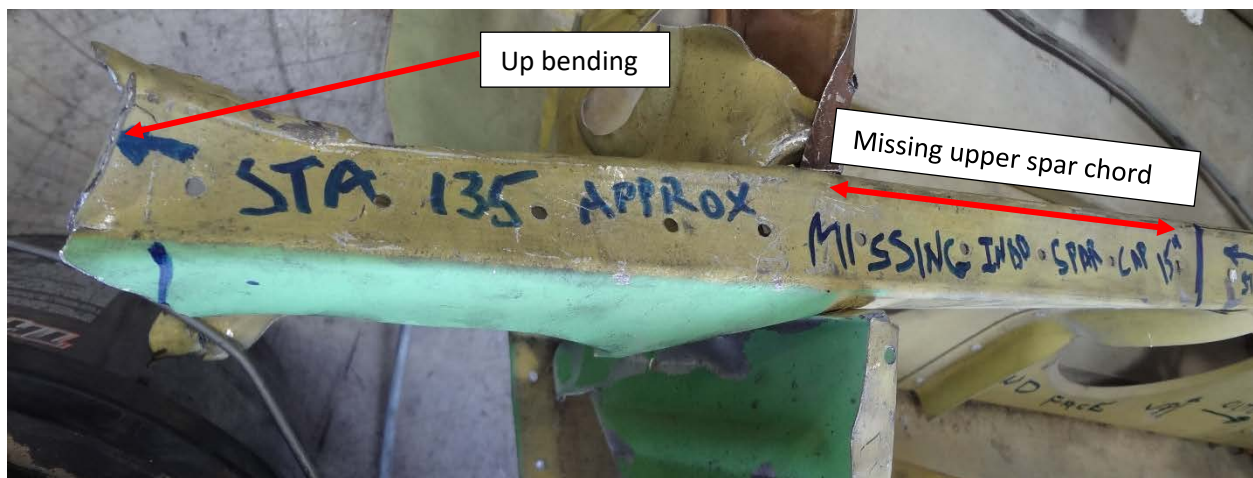
Figure 4 – Outboard section of left wing main spar fracture at station 135.

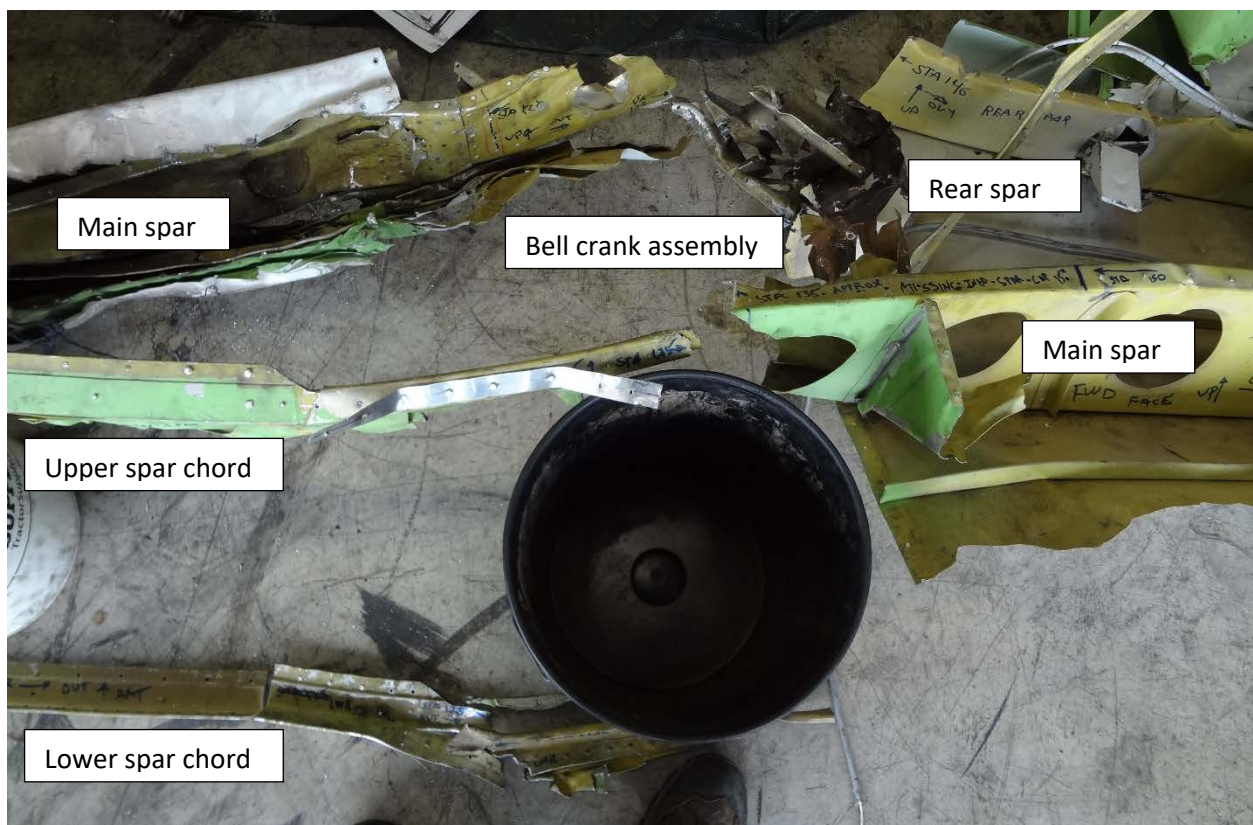
Figure 5 - Overhead view of the left-wing failure area.

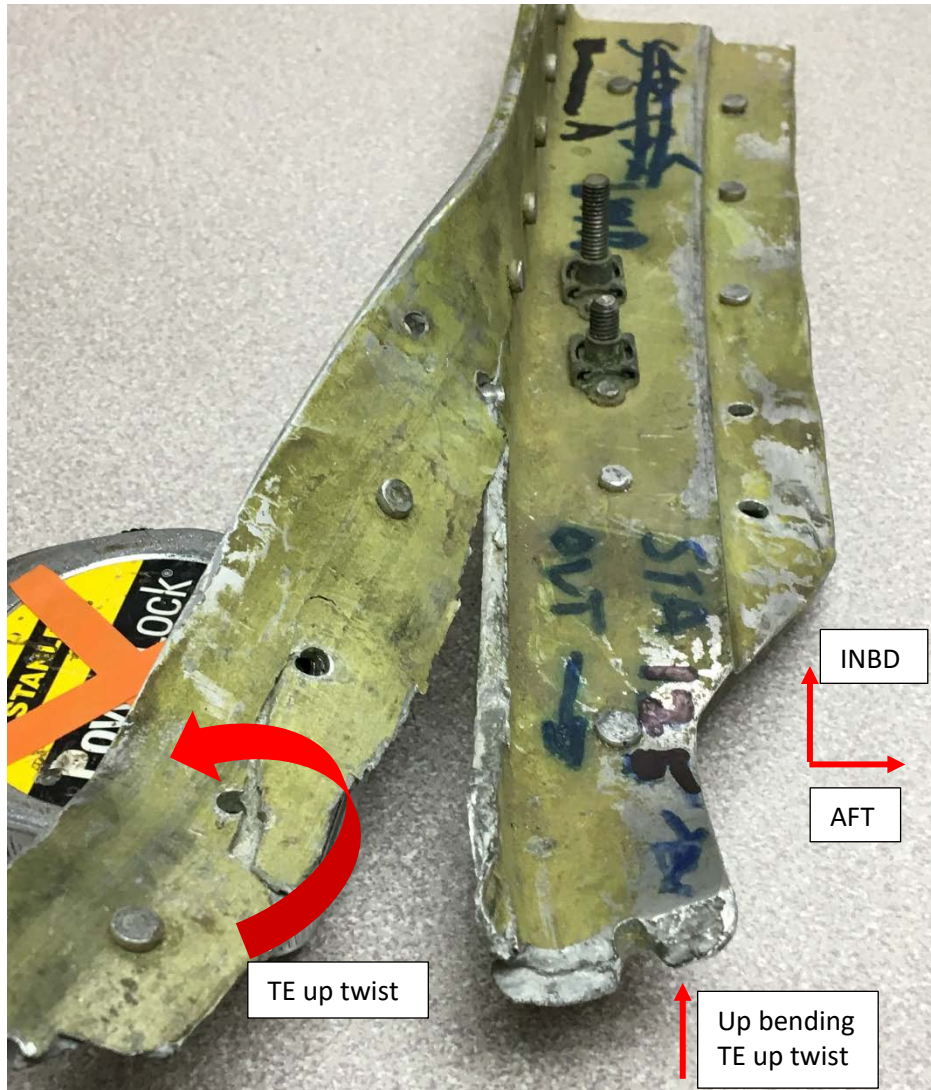
Figure 6 – Left wing lower main spar chord fracture at station 125.

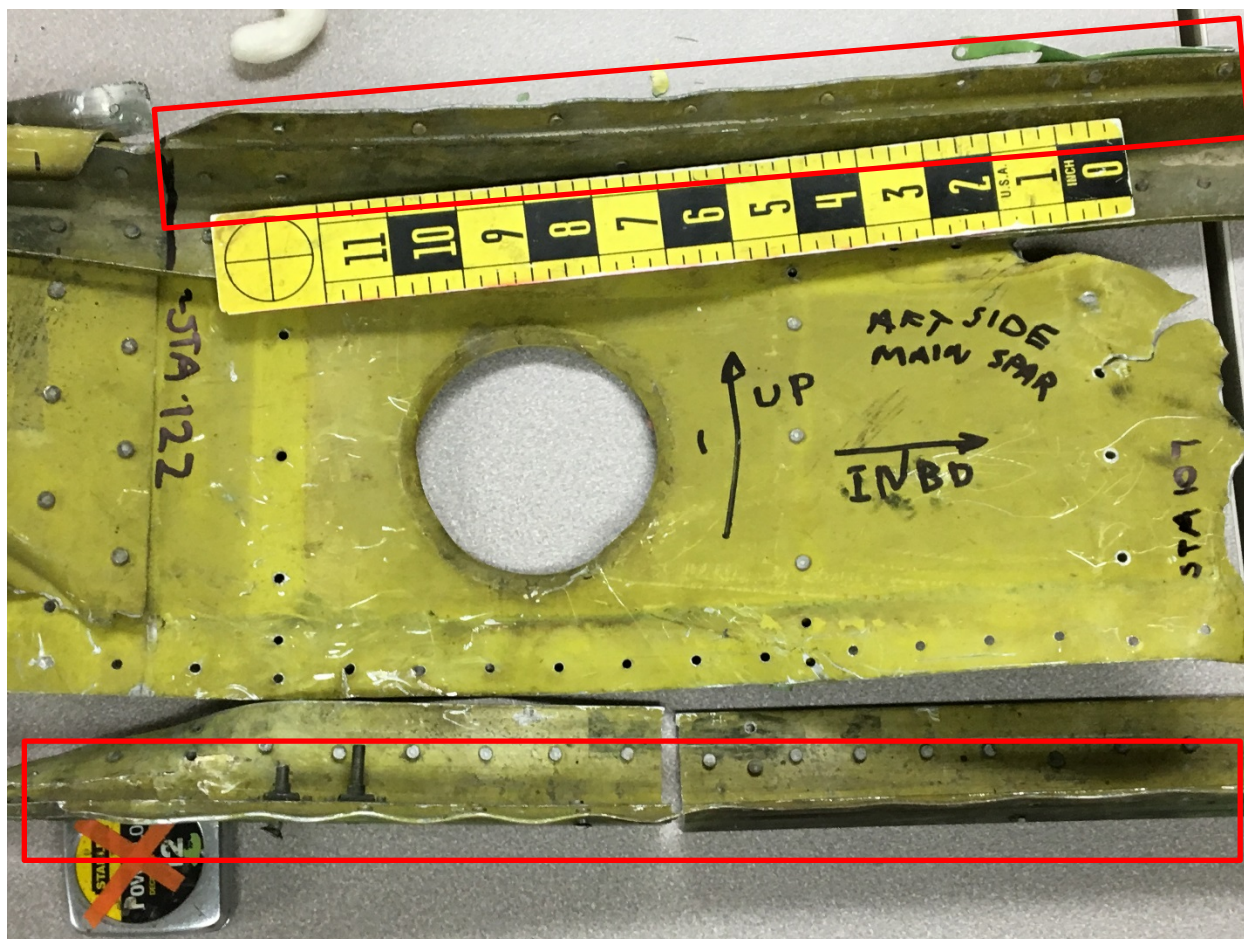
Figure 7 – Left wing upper and lower spar chord compression buckling (crippling) due to aft bending.

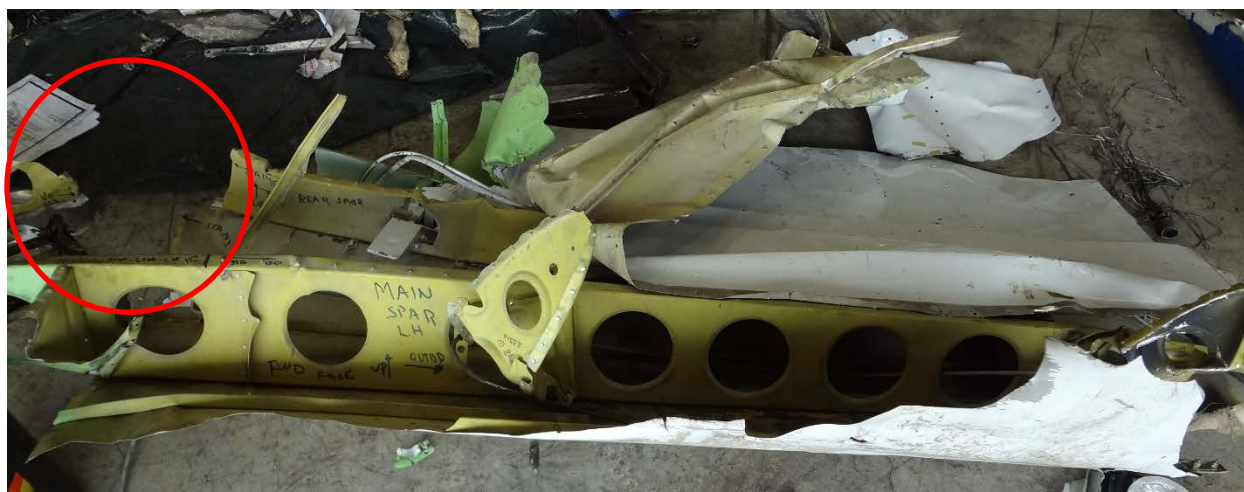
Figure 8 – Missing left-wing rear spar and aileron hinge fitting.

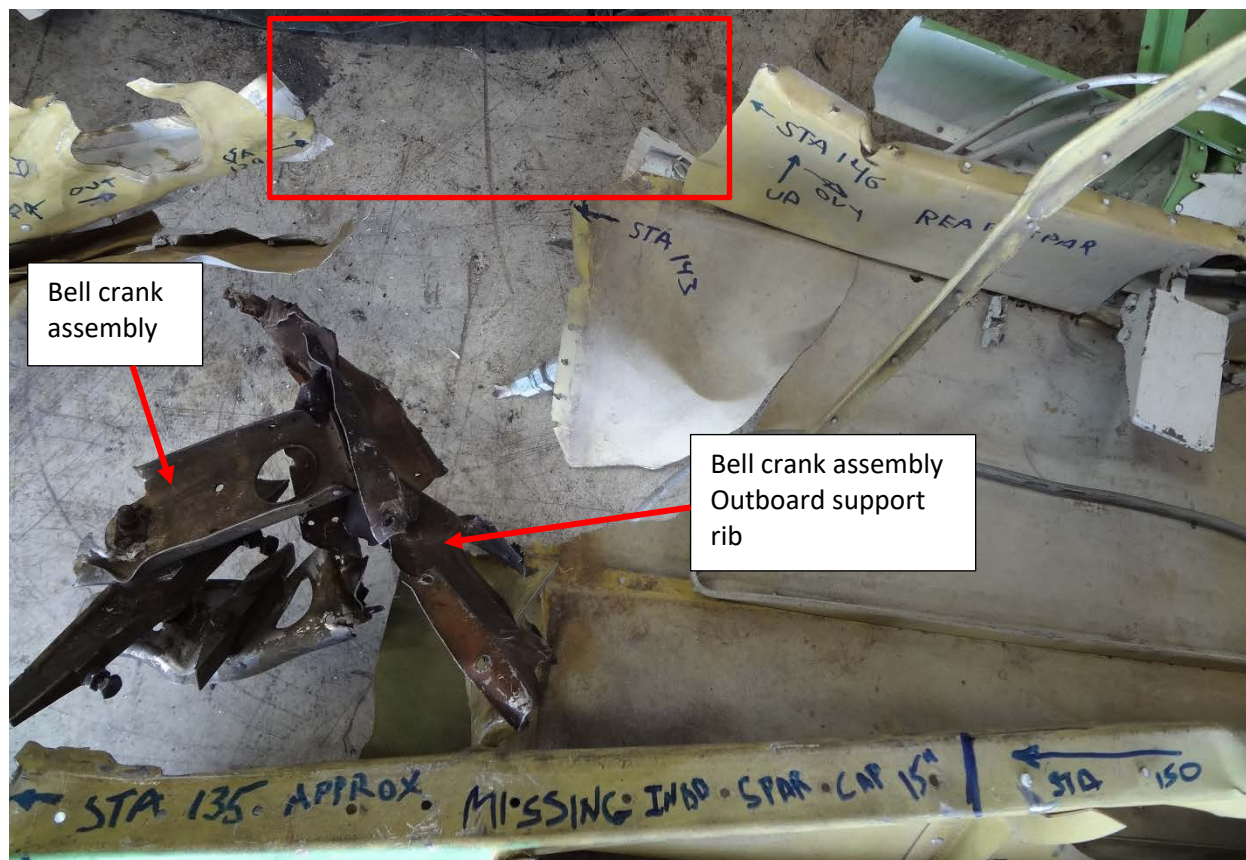
Figure 9 – Missing left-wing rear spar in the area of the inboard aileron hinge fitting.

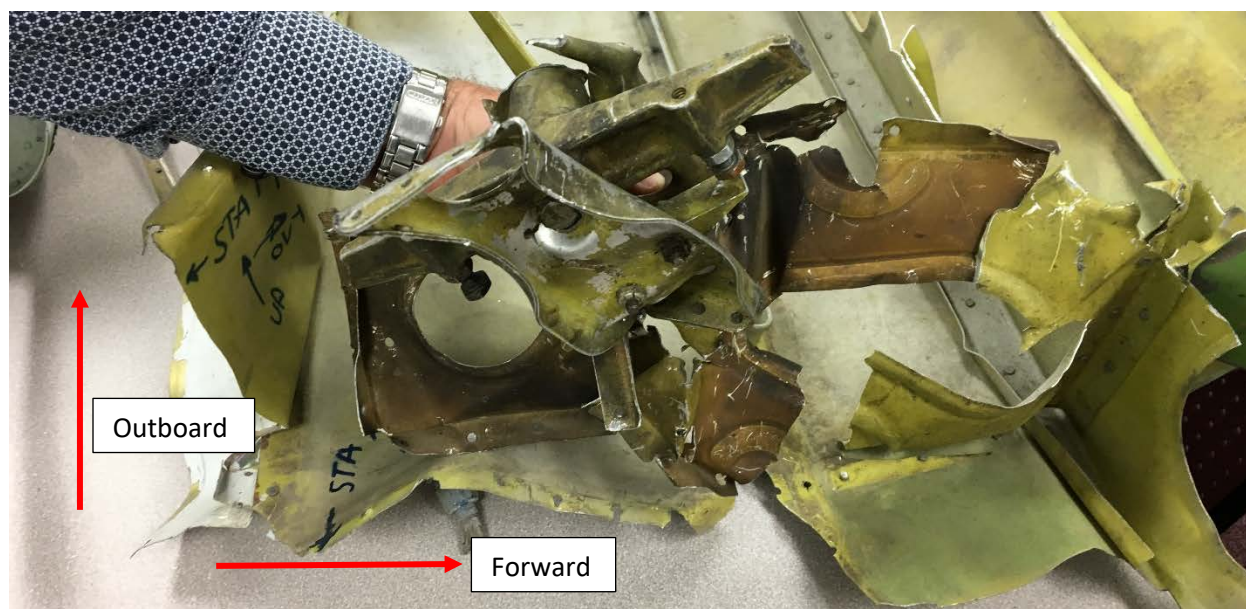
Figure 10 – Left wing bell crank assembly and outboard support rib at about station 143/146.

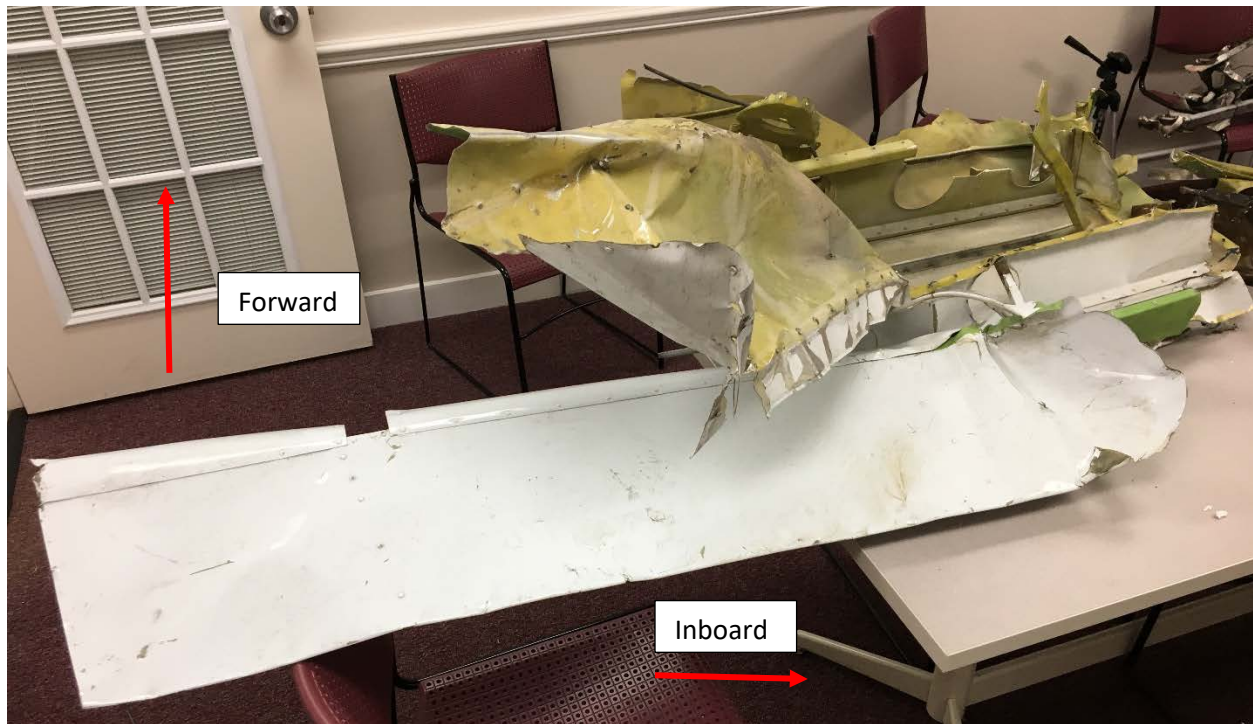
Figure 11 – Left aileron.

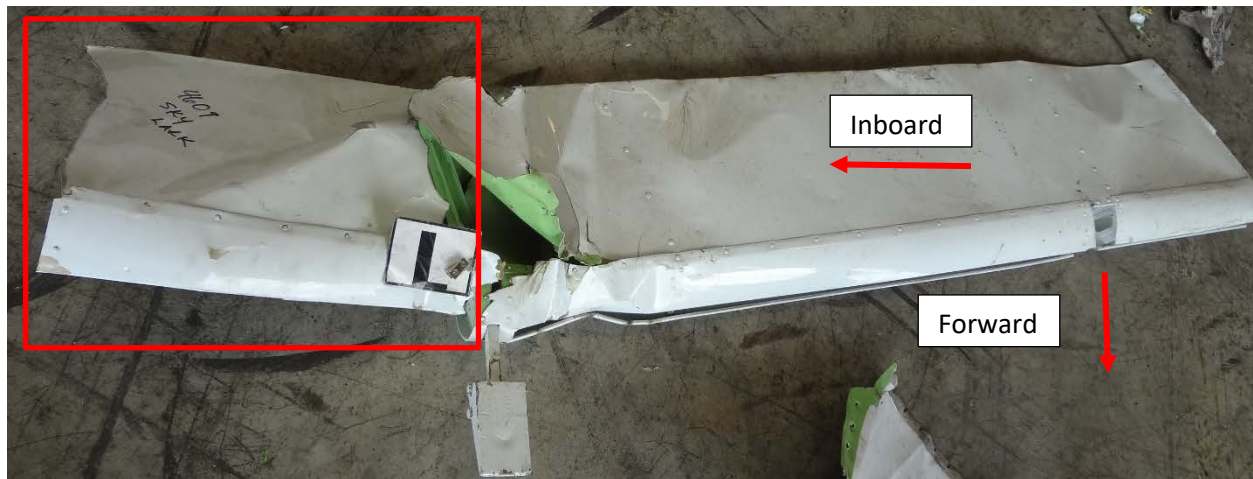
Figure 12 – Left aileron with additional skin panel recovered away from the main wreckage and left outboard wing.

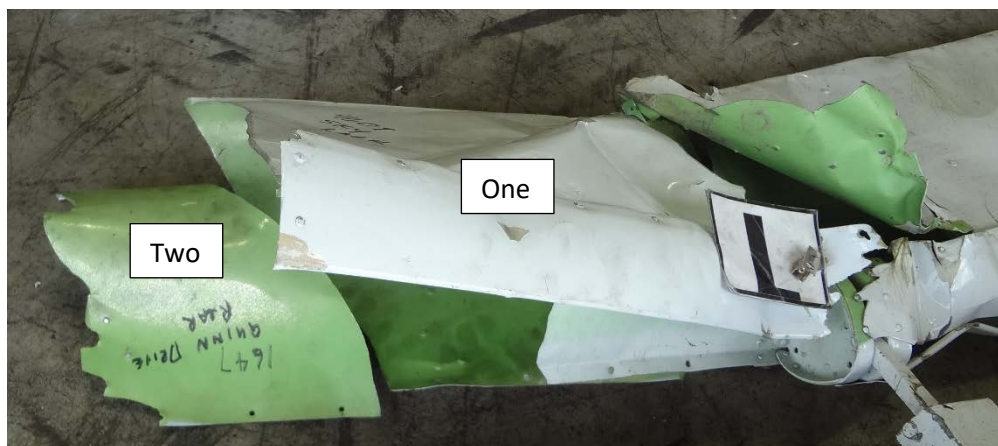
**Figure 13 - Two additional aileron skin pieces recovered away from main wreckage and outboard left-wing section.**

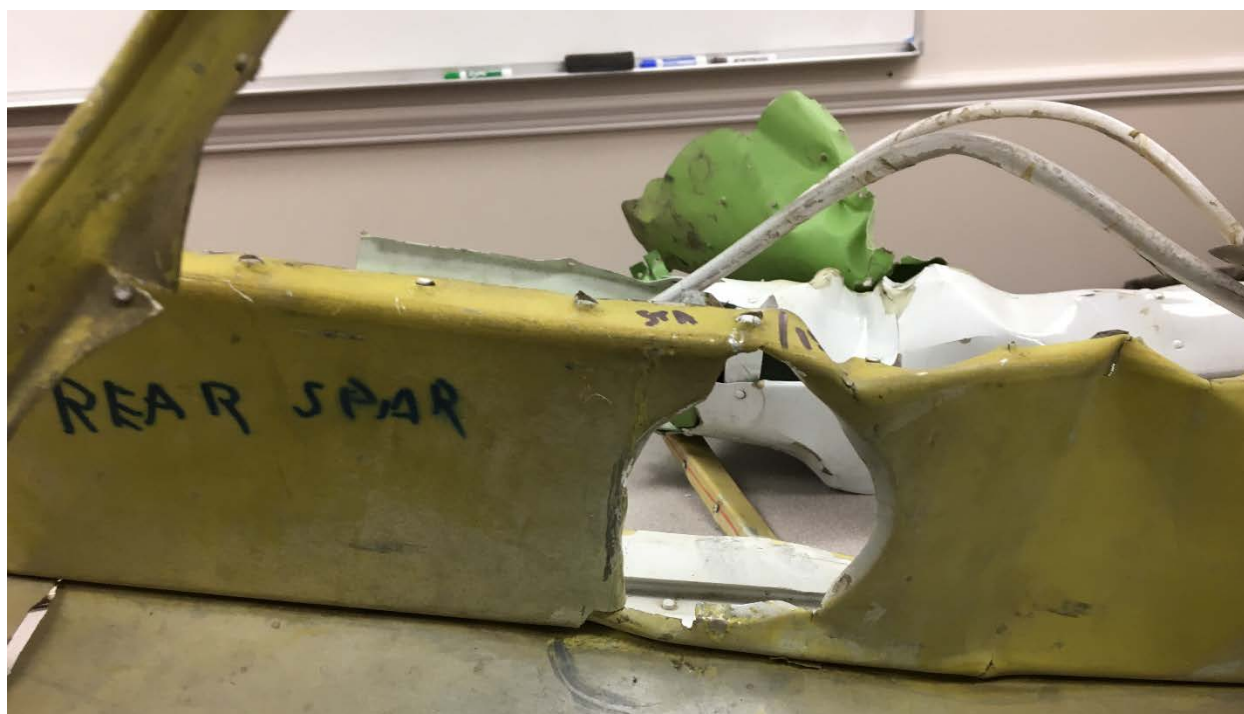
**Figure 14 – left wing balance weight cut out damage in rear spar.**

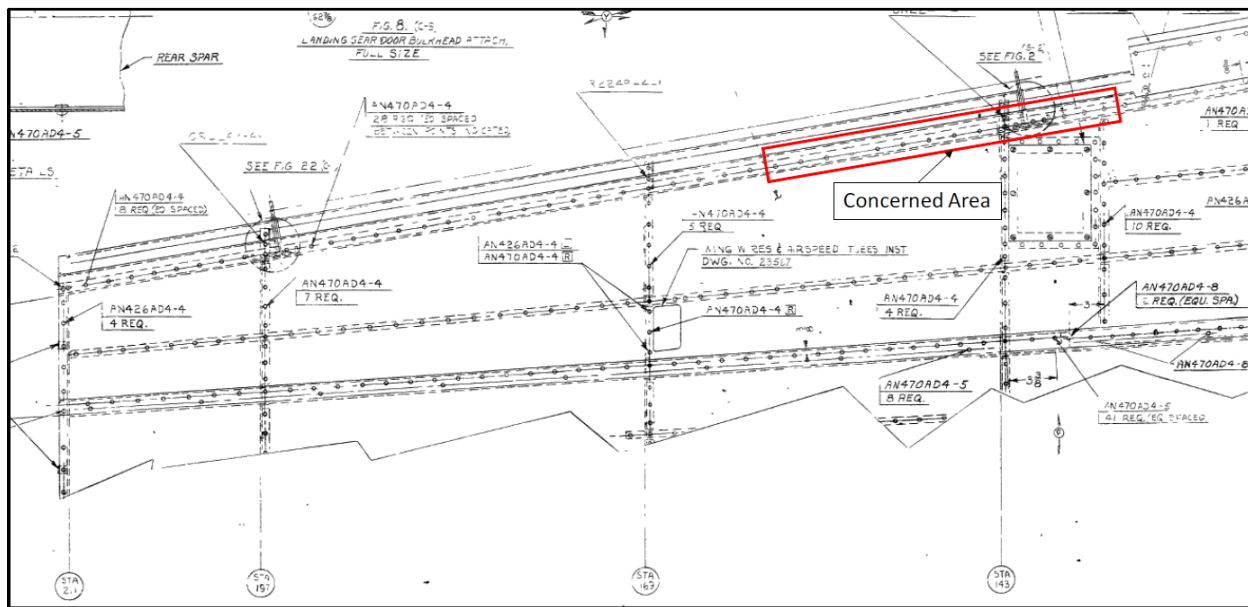
Figure 17 - Overlay of concerned area on drawing 23560

Per the 23560 drawing (reference Figure 17), the fasteners intended to be installed in the concerned holes are AN470AD4-4 rivets, which are classified as solid-shank rivets. Correct installation of these rivets in the assembly is accomplished by slightly expanding the shank while being driven (reference Figure 19).

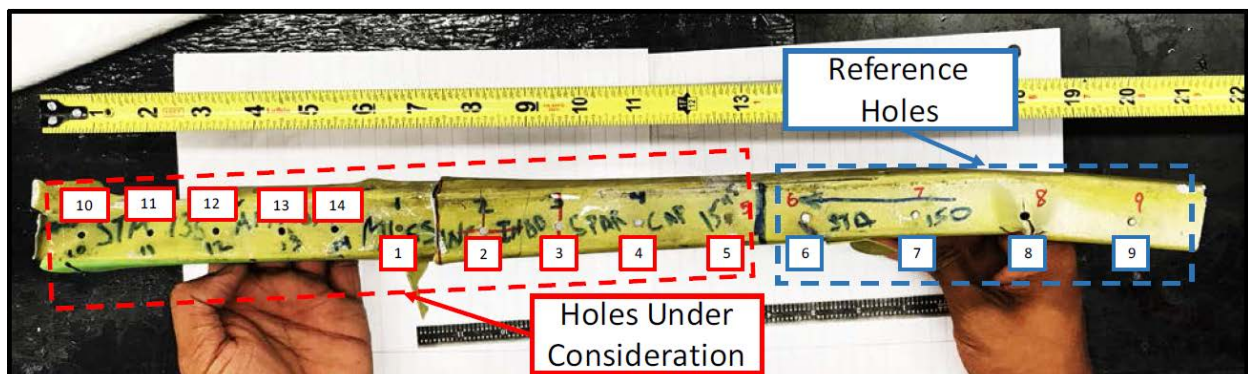
Figure 18 - Destructively separated section under consideration with hole ID

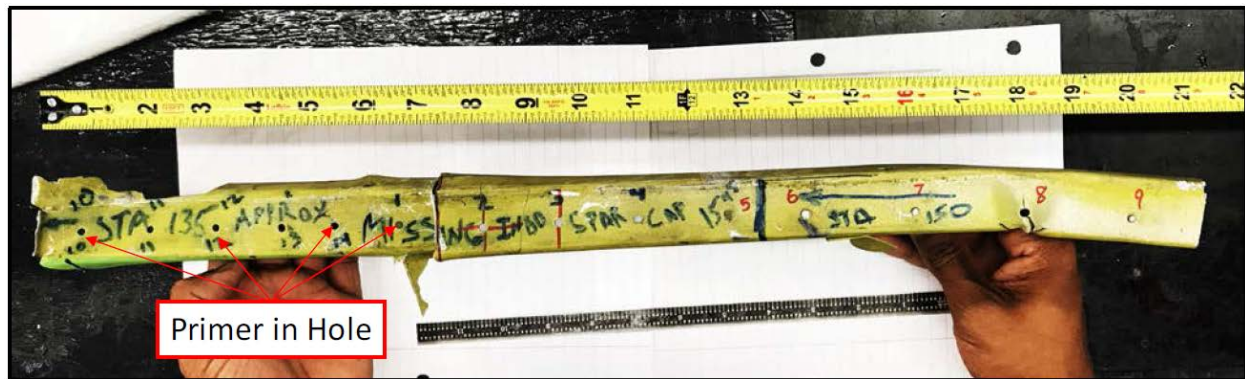
During normal operation of the aircraft and considering the extreme conditions experienced, primer should have been present in the rivet holes had the rivets been installed correctly, the (reference Figure 20), if present, would have worn off. Since in these holes, it can be said that the rivets in these holes may not have been installed in these holes correctly. A pictorial description of these findings is shown in Figure 22.

Figure 20 – Fastener holes with primer.

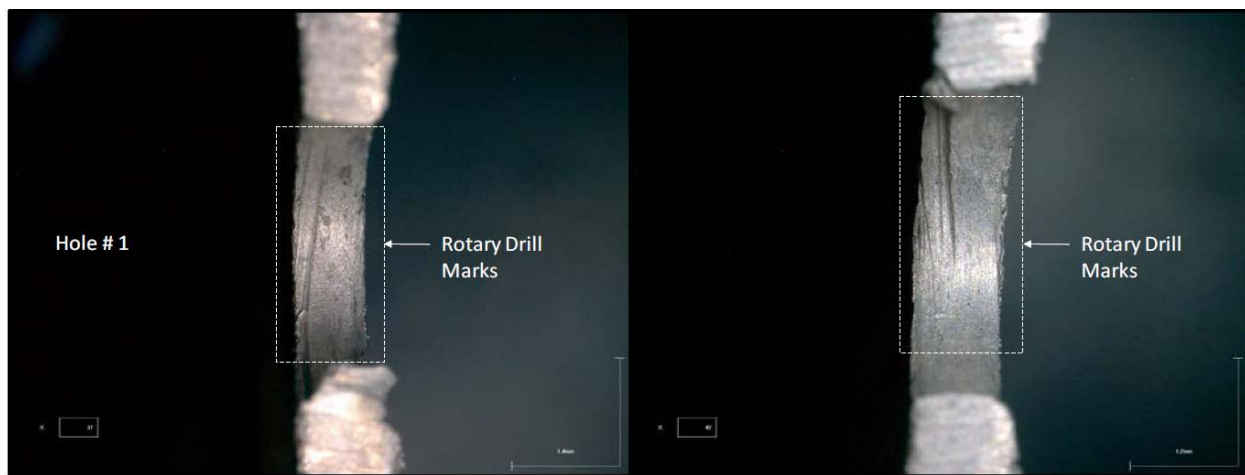
Following the stripping and etching rotary drill marks were observed in holes, (# 1, # 3, # 4, # 5, # 9, # 10 and # 11) created by a drill bit rotating in the hole. The type design rivets in the holes are solid-shank rivets share the load during normal operation. During installation of these rivets and normal operation the rotary marks created by the drill bit should be disturbed. Since the above-mentioned holes showed clear indications of rotary marks from a drill bit, consistent with the rivets not participating in the load sharing.

Figure 21 – Typical rotary drill marks after etching in hole #1.

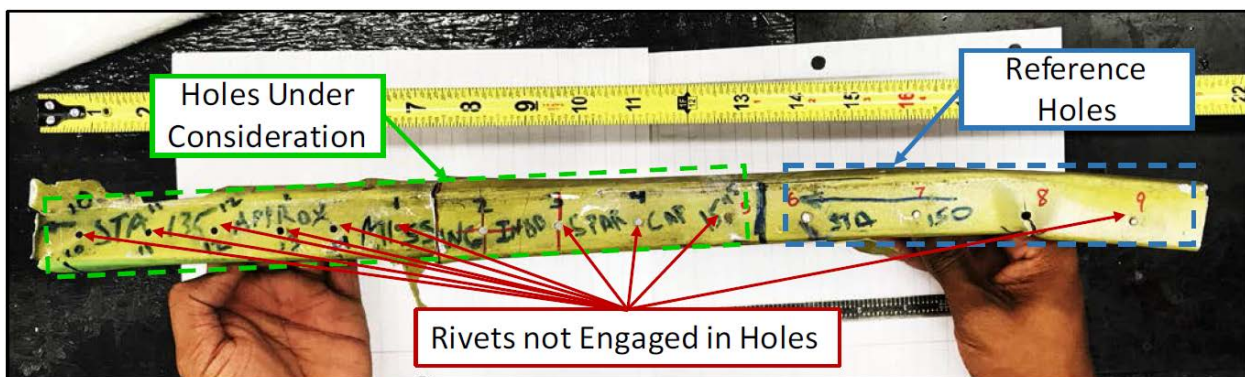
A summary of the pre-etched and post-etched microscopy findings is as shown in Figure 21 and Table 1.

Figure 22 - Pre-etched and post-etched microscopy summary of findings.
