**From:** [Kramer Donald](#)  
**To:** [Malinowski Edward](#)  
**Subject:** Materials Laboratory Factual Report - CEN16FA276 - Plainfield, IL - Piper PA-30, N7409Y - July 21, 2016  
**Date:** Wednesday, August 31, 2016 11:13:29  
**Attachments:** [IMG 0161.JPG](#)  
[Forward crankshaft piece.JPG](#)

Vehicle: Piper PA-30, N7409Y

NTSB No.: CEN16FA276

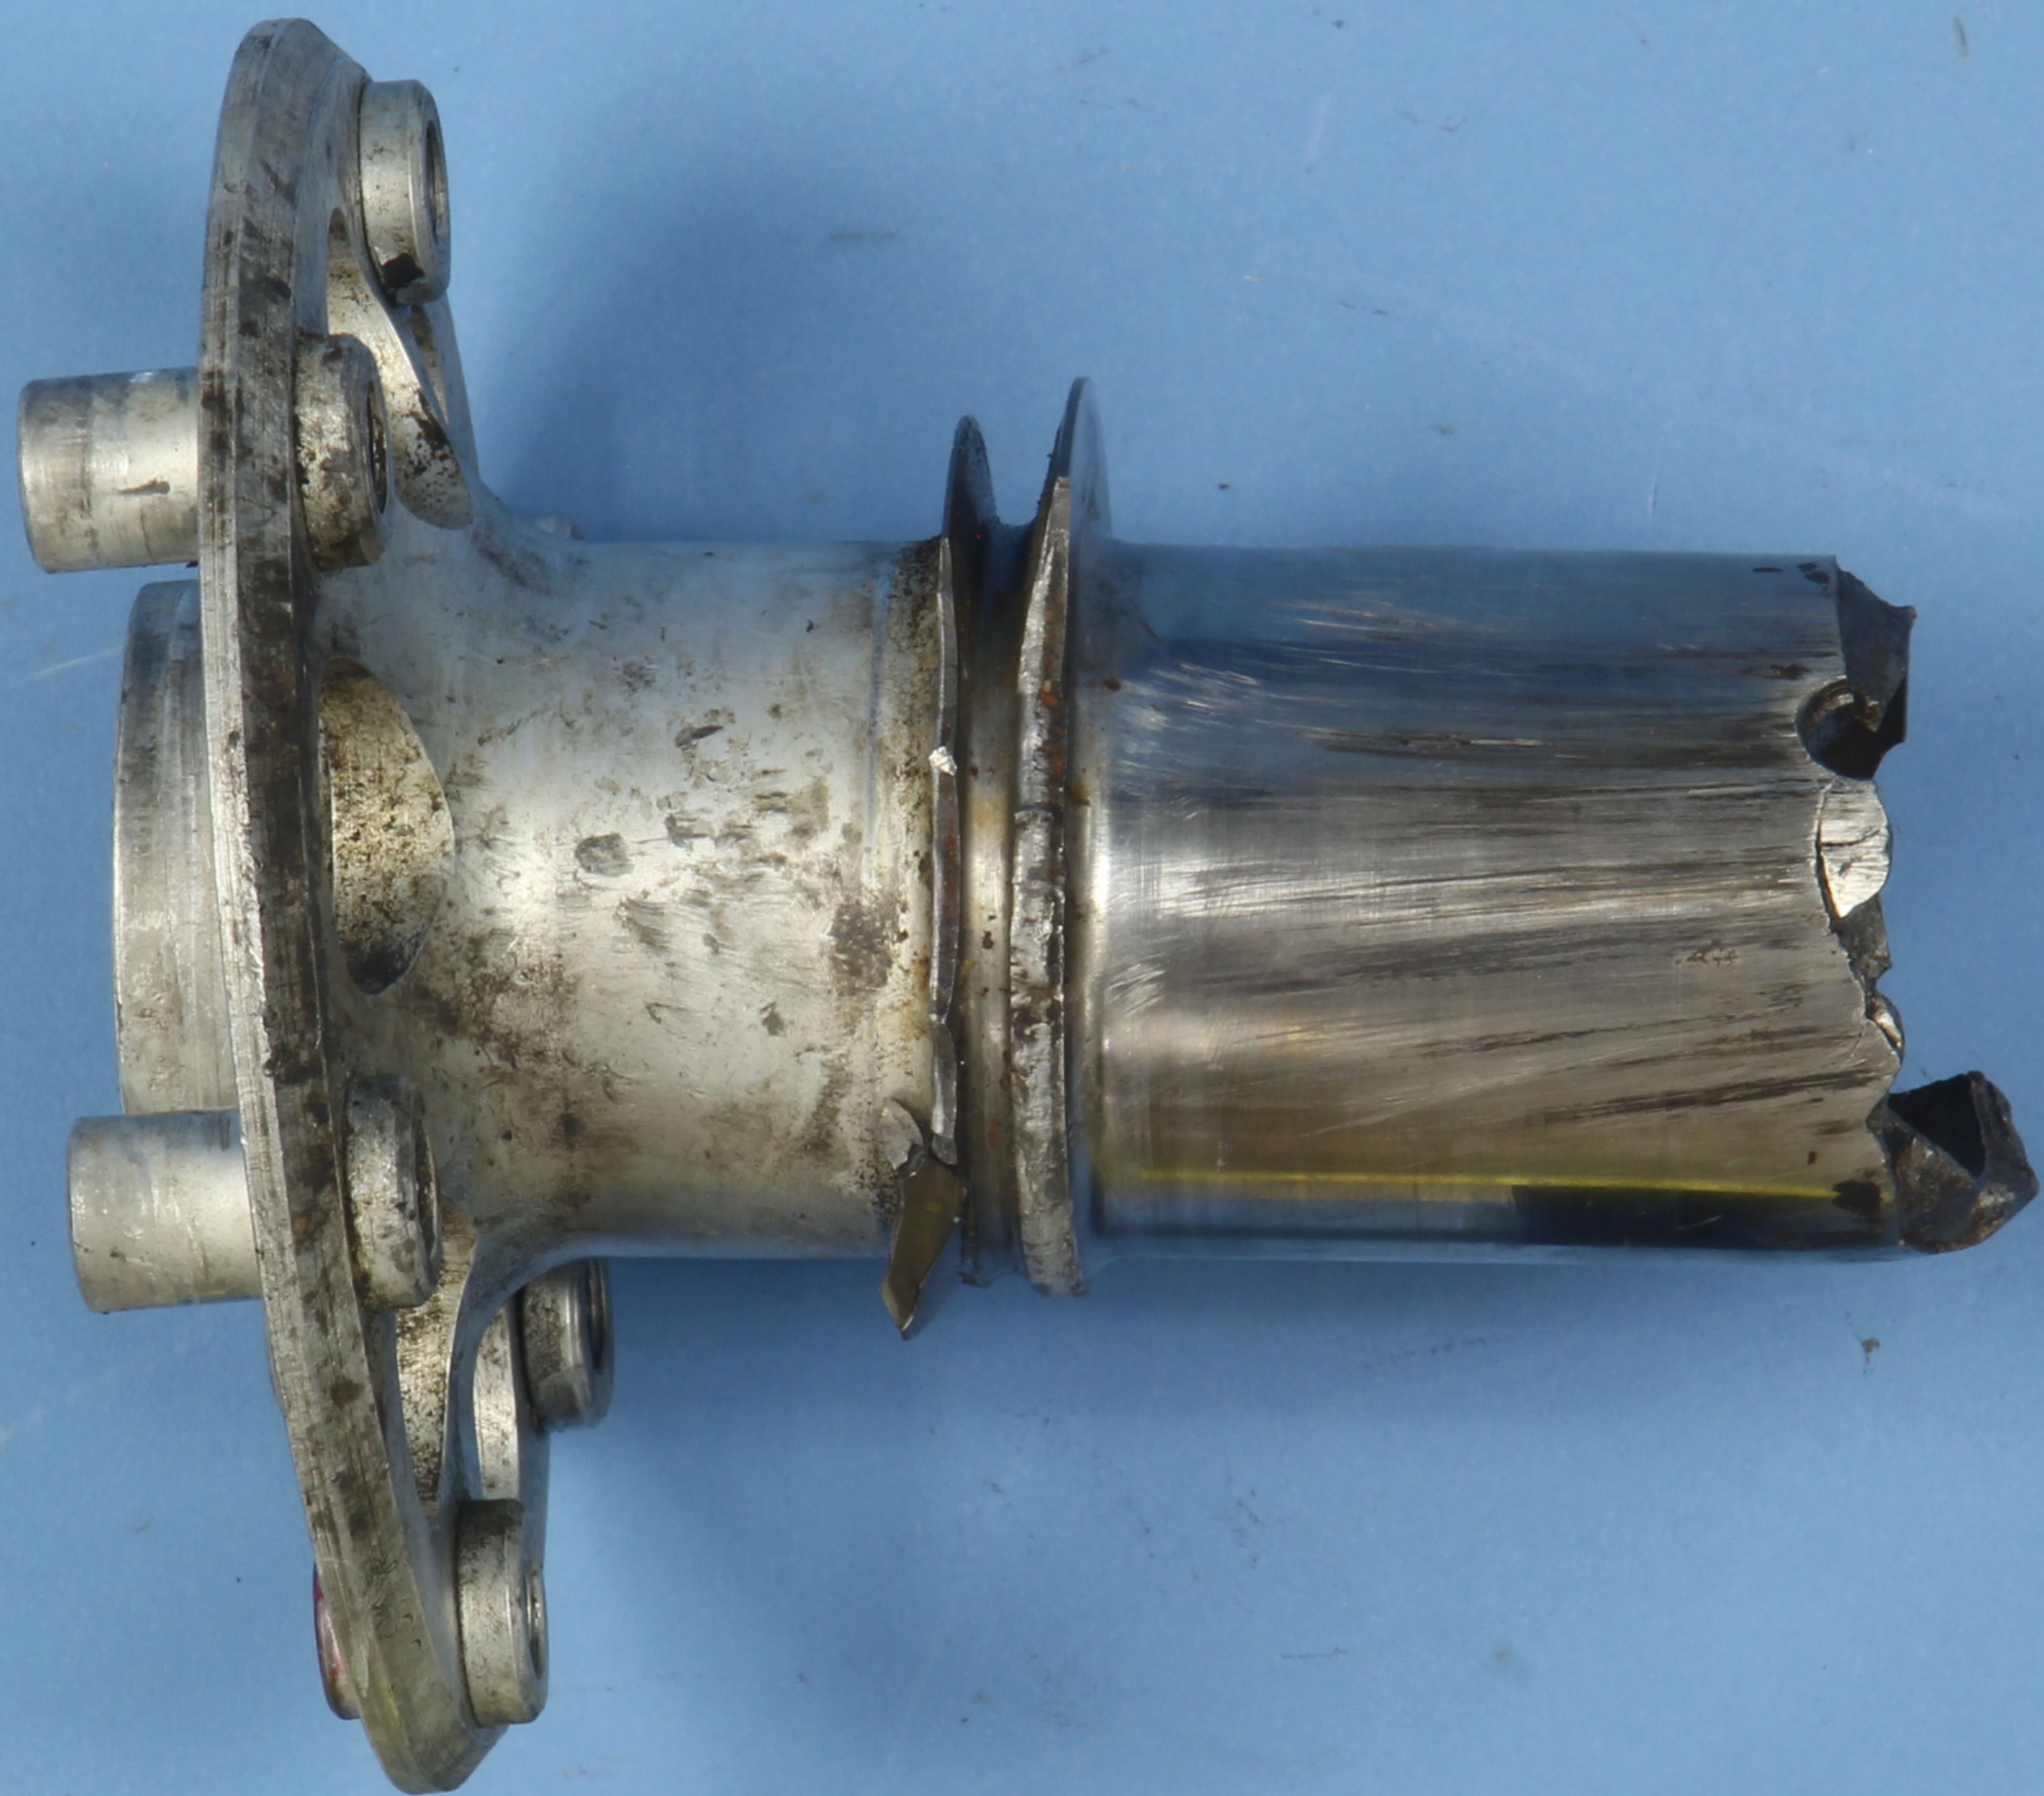
Two pieces from forward end of crankshaft: First piece from propeller flange to a fracture through the oil tube hole in the first main bearing journal; second piece from the fracture to a cut through the second connecting rod journal.

The two pieces of the crankshaft and the bearing shells were sent to the NTSB Materials Laboratory for examination. The propeller flange on the crankshaft exhibited bending deformation, with one region bent forward and the opposite region 180 degrees around the shaft bent aft. A portion of the oil flinger flange was fractured leaving an approximately 120 degree region intact. The crankshaft was fractured in the circumferential direction at the oil tube hole in the first (forward) main bearing journal. The fracture surfaces had a comparatively rough appearance and were inclined approximately 45 degrees to the bearing surface. Taken together, the features were consistent with a bending overstress fracture.
