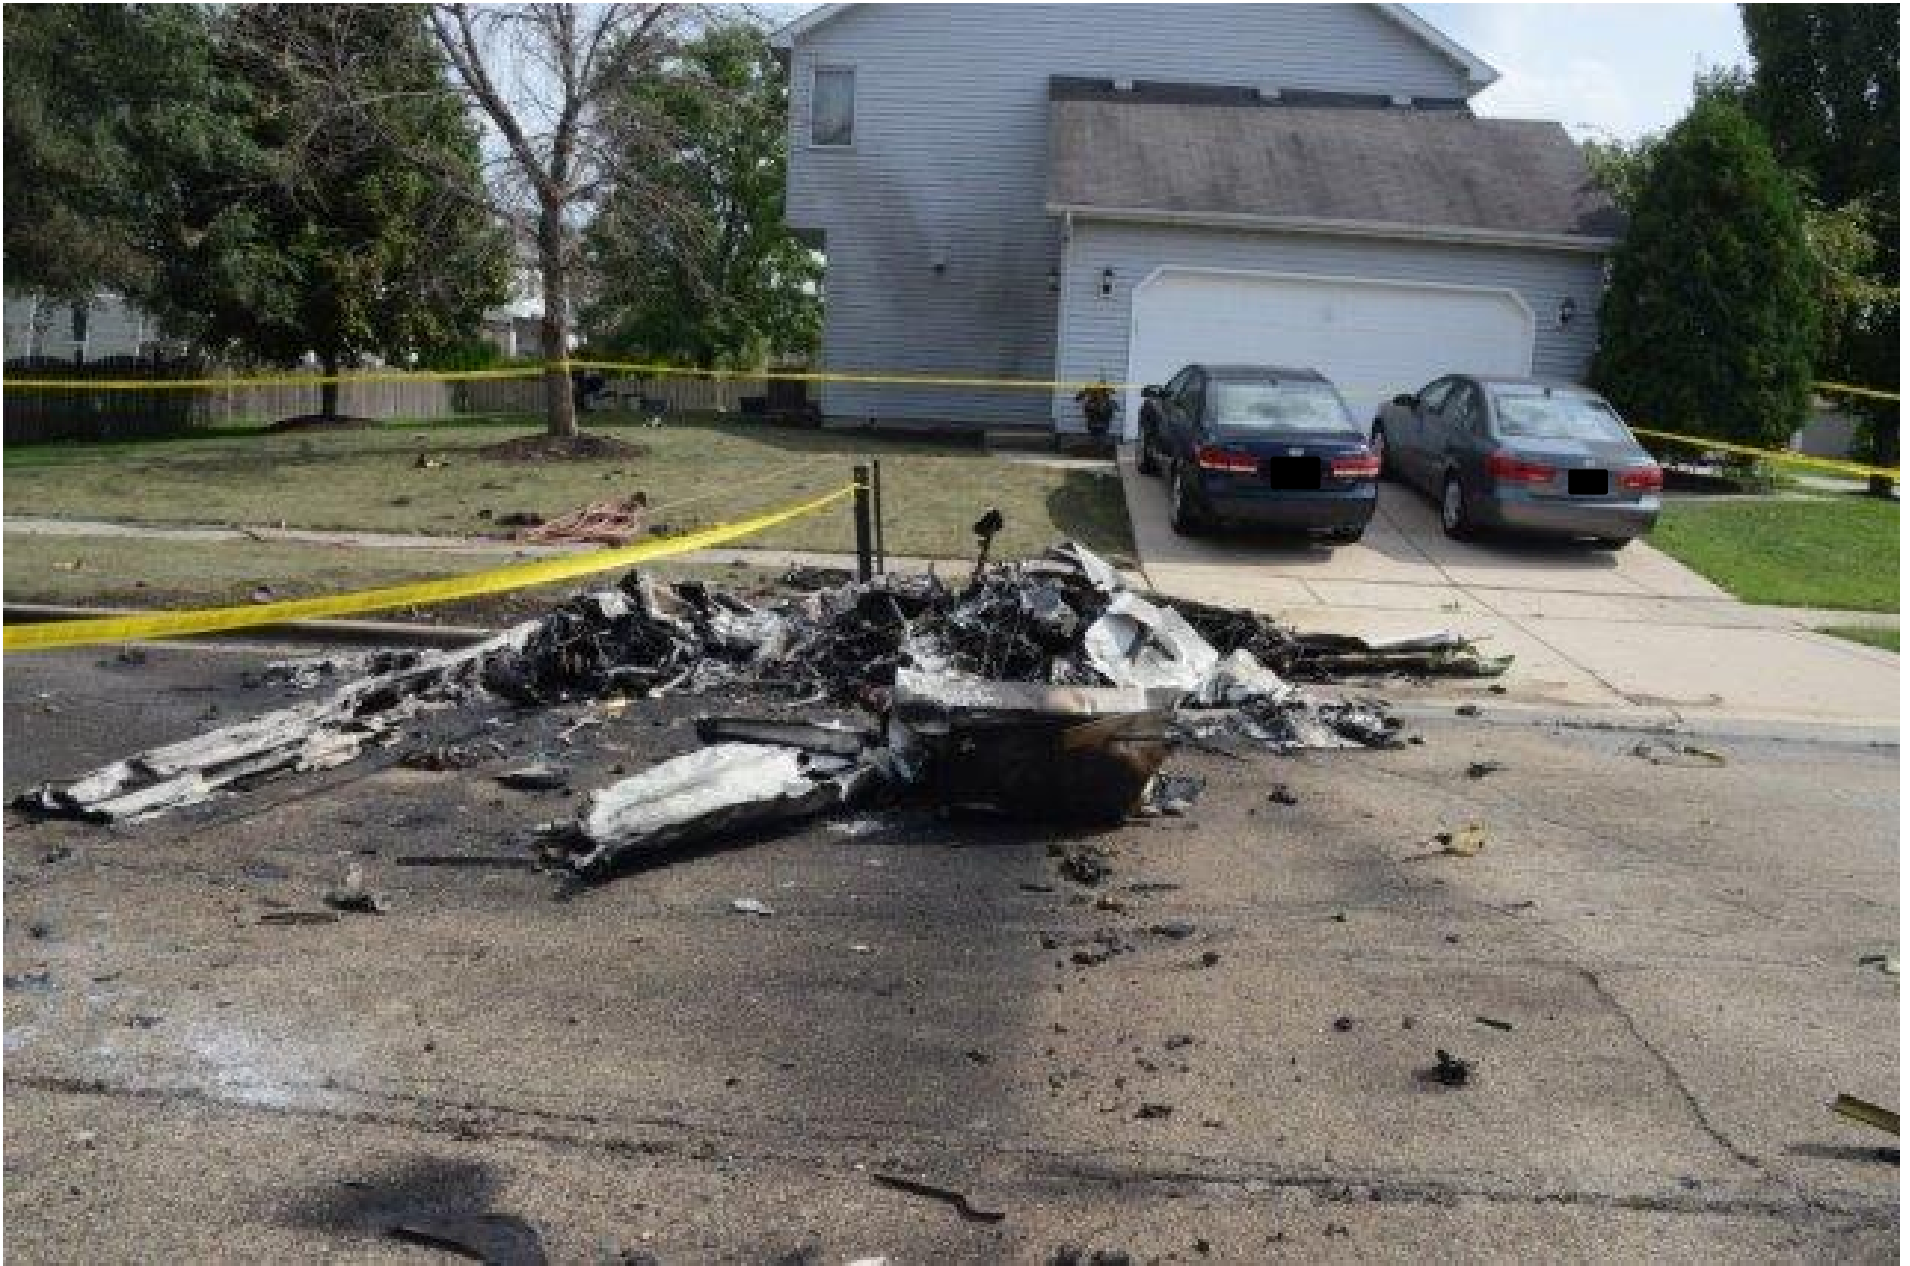
**Photo 1 – View of the main wreckage.**

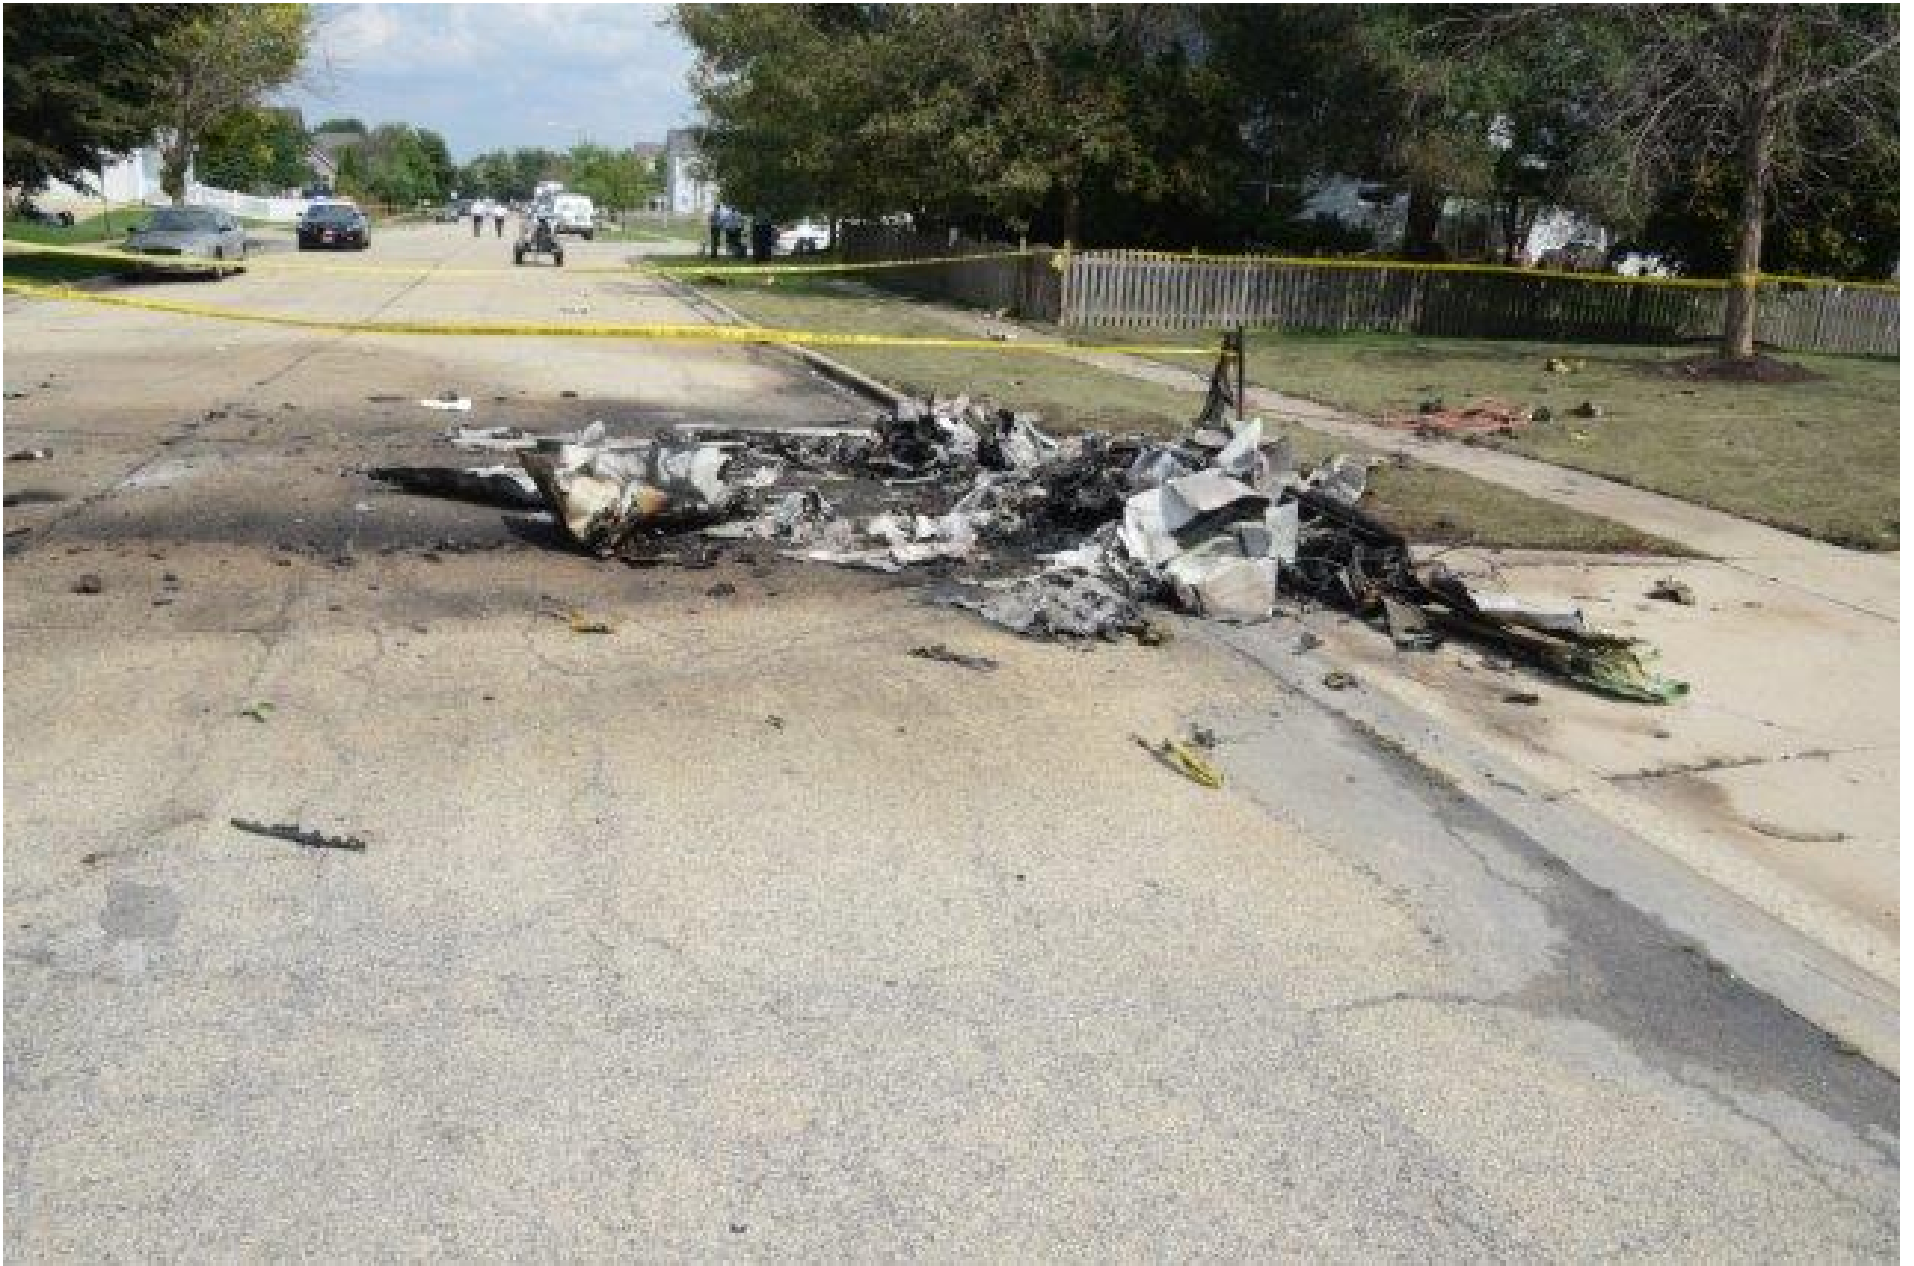
**Photo 2 - View of the main wreckage.**

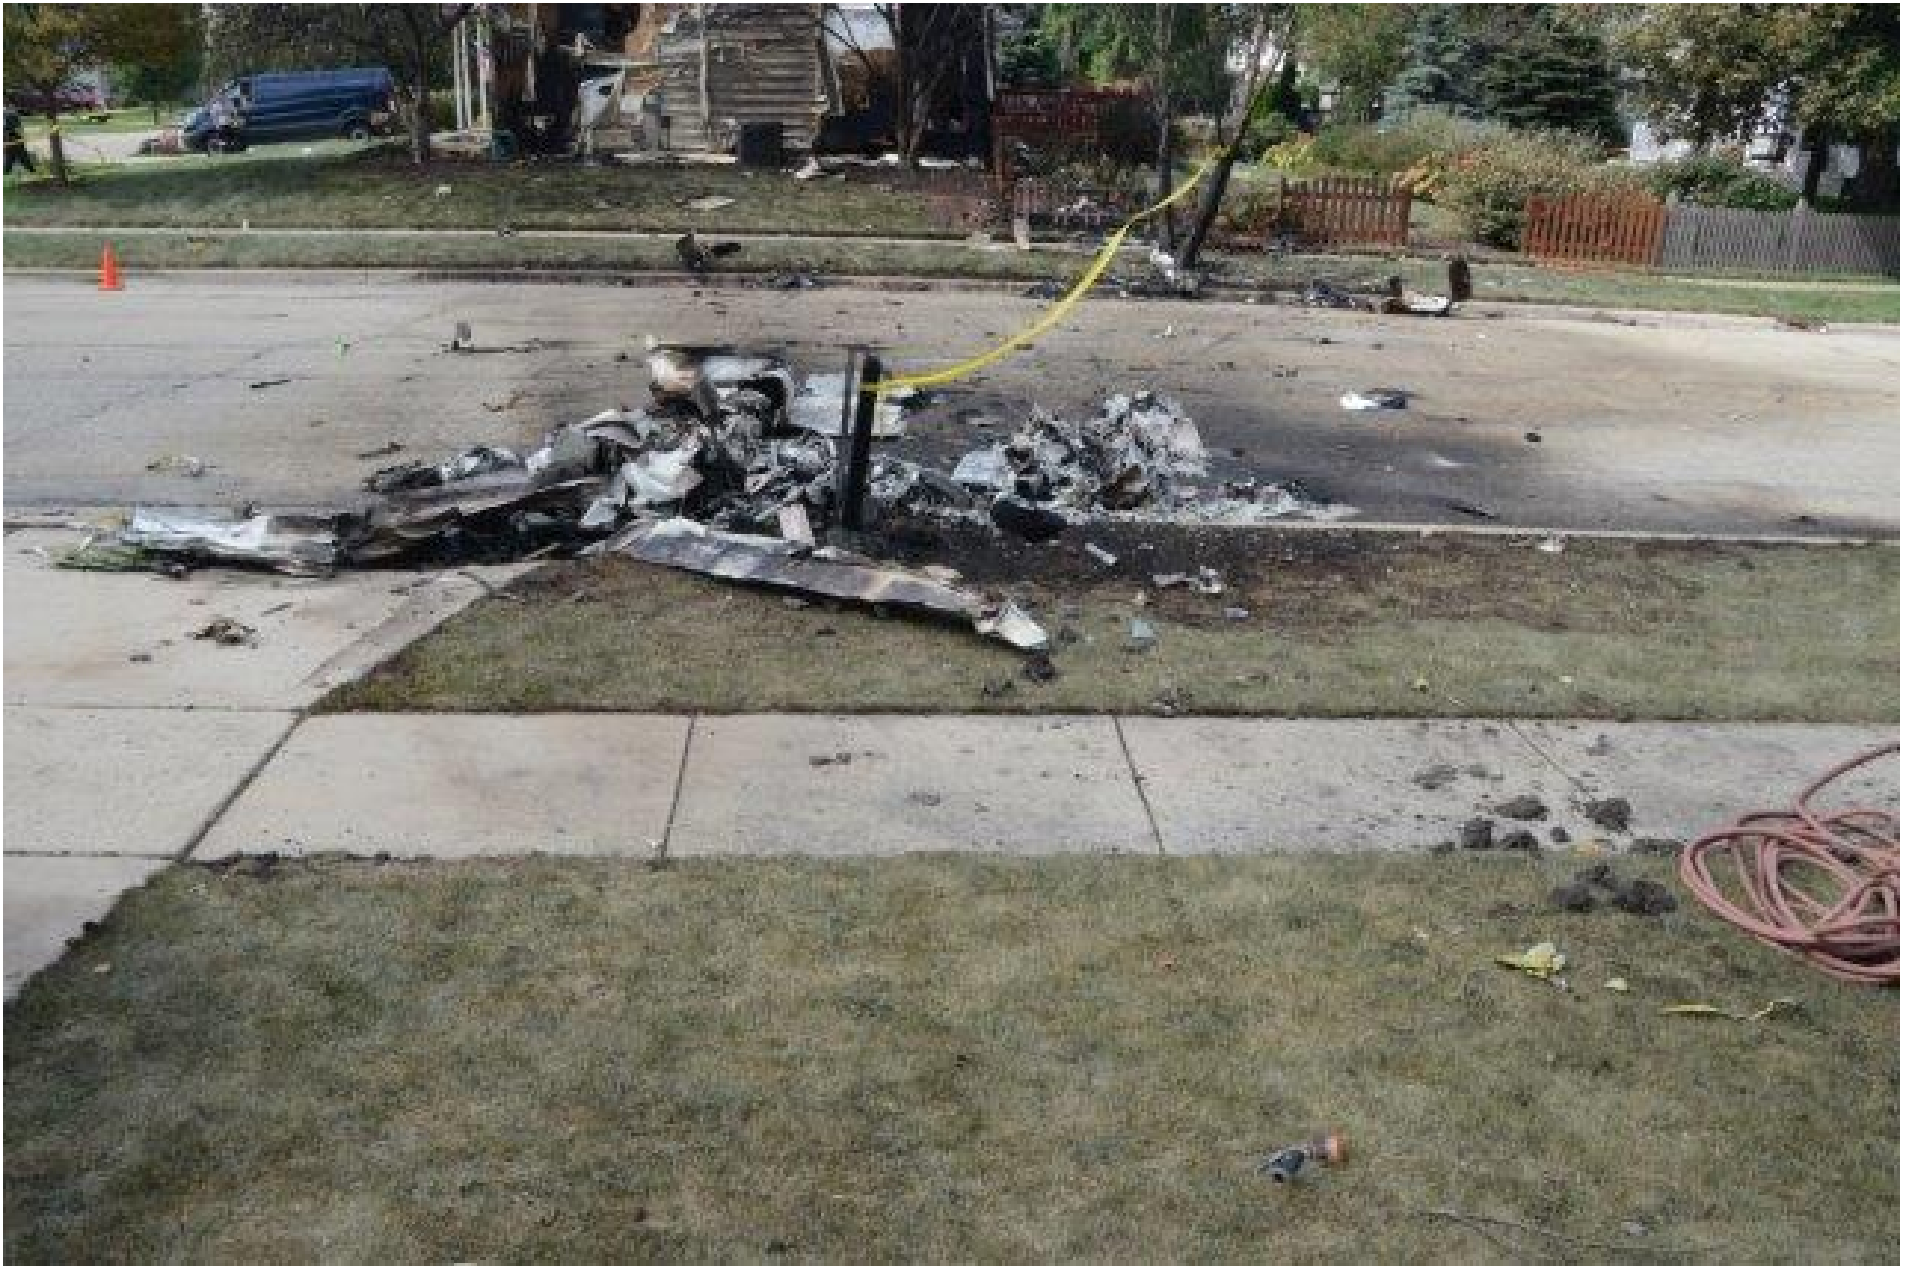
**Photo 3 - View of the main wreckage.**

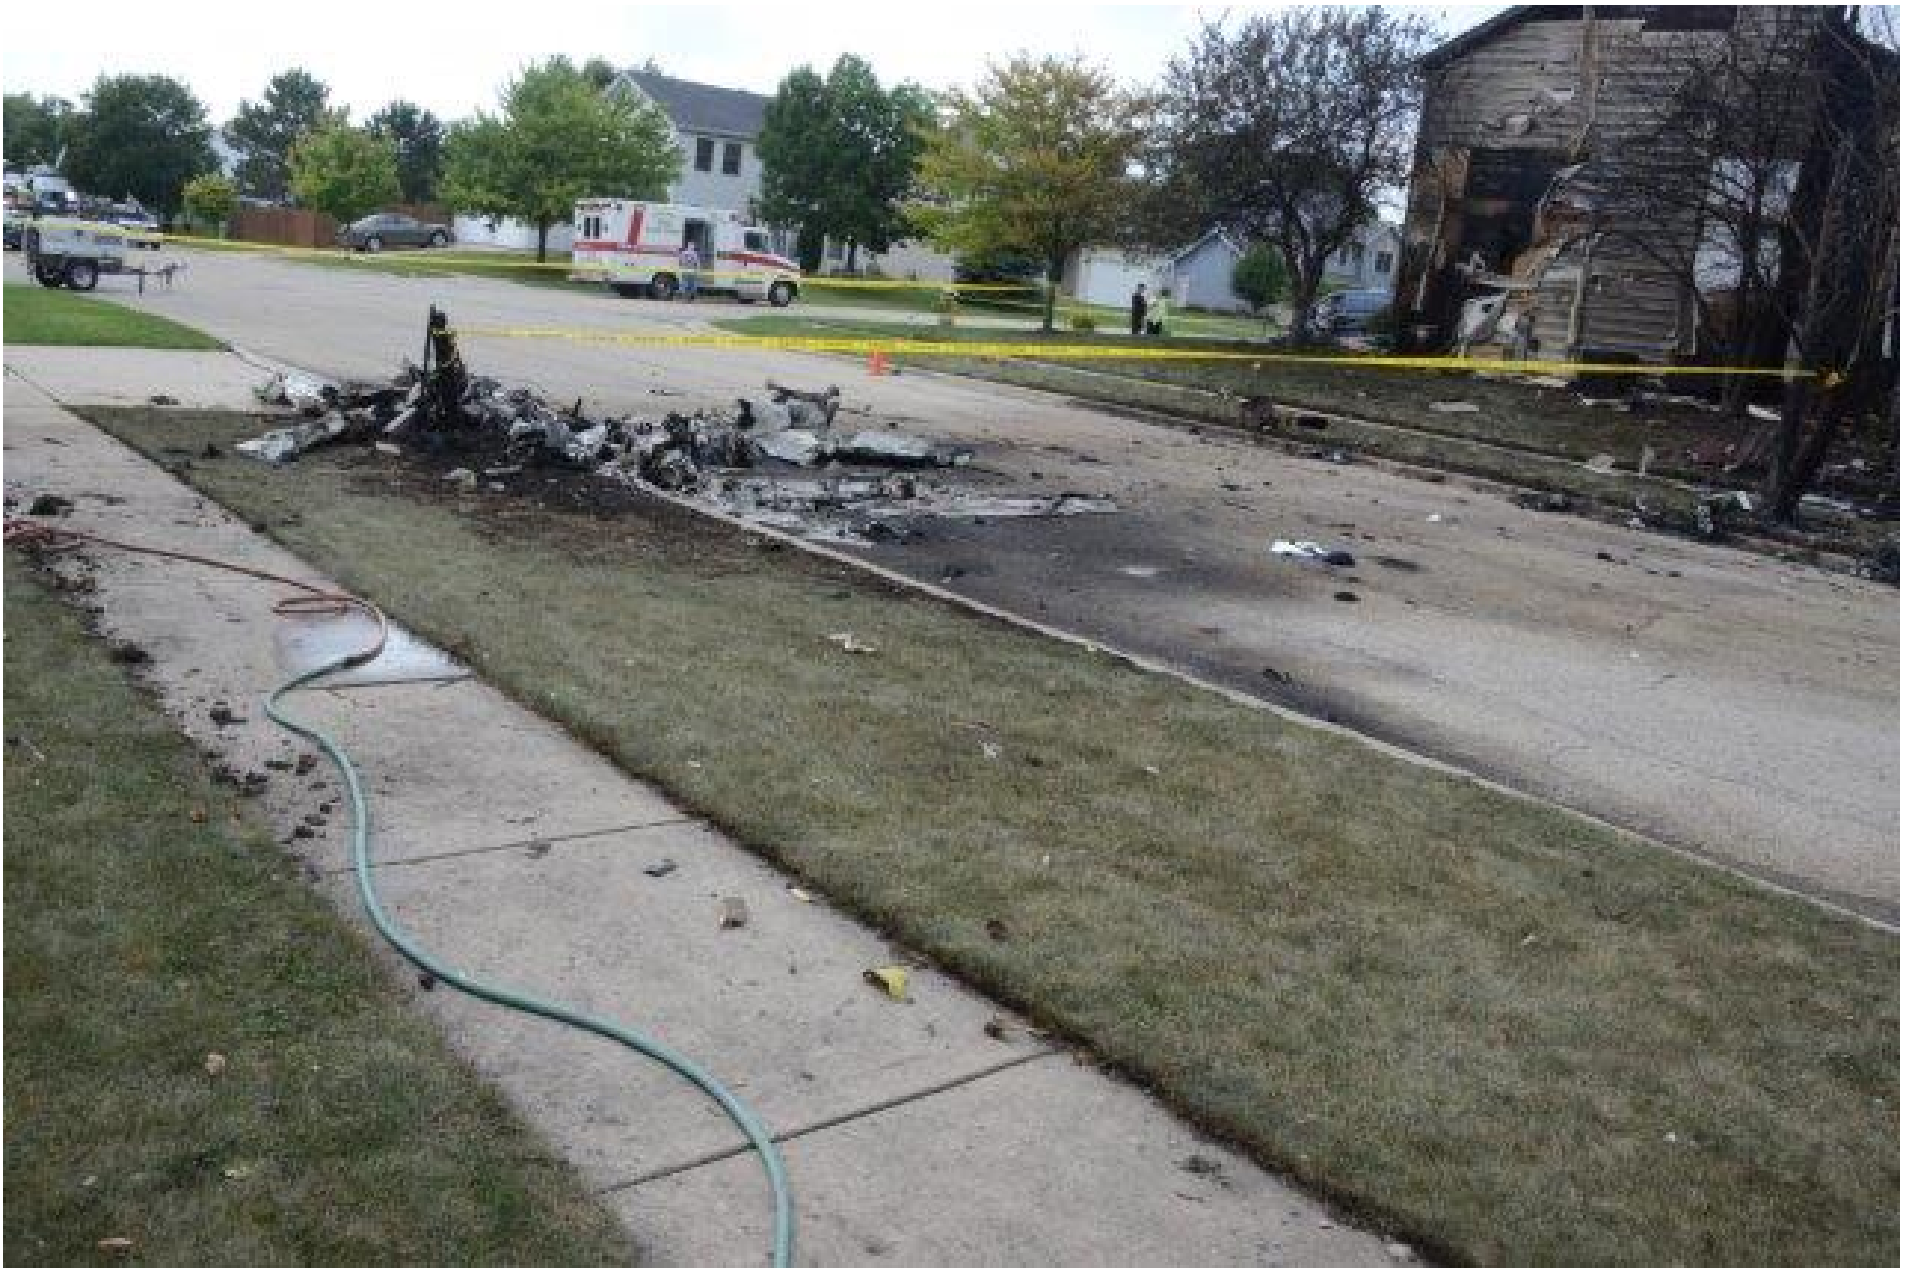
**Photo 4 - View of the main wreckage.**

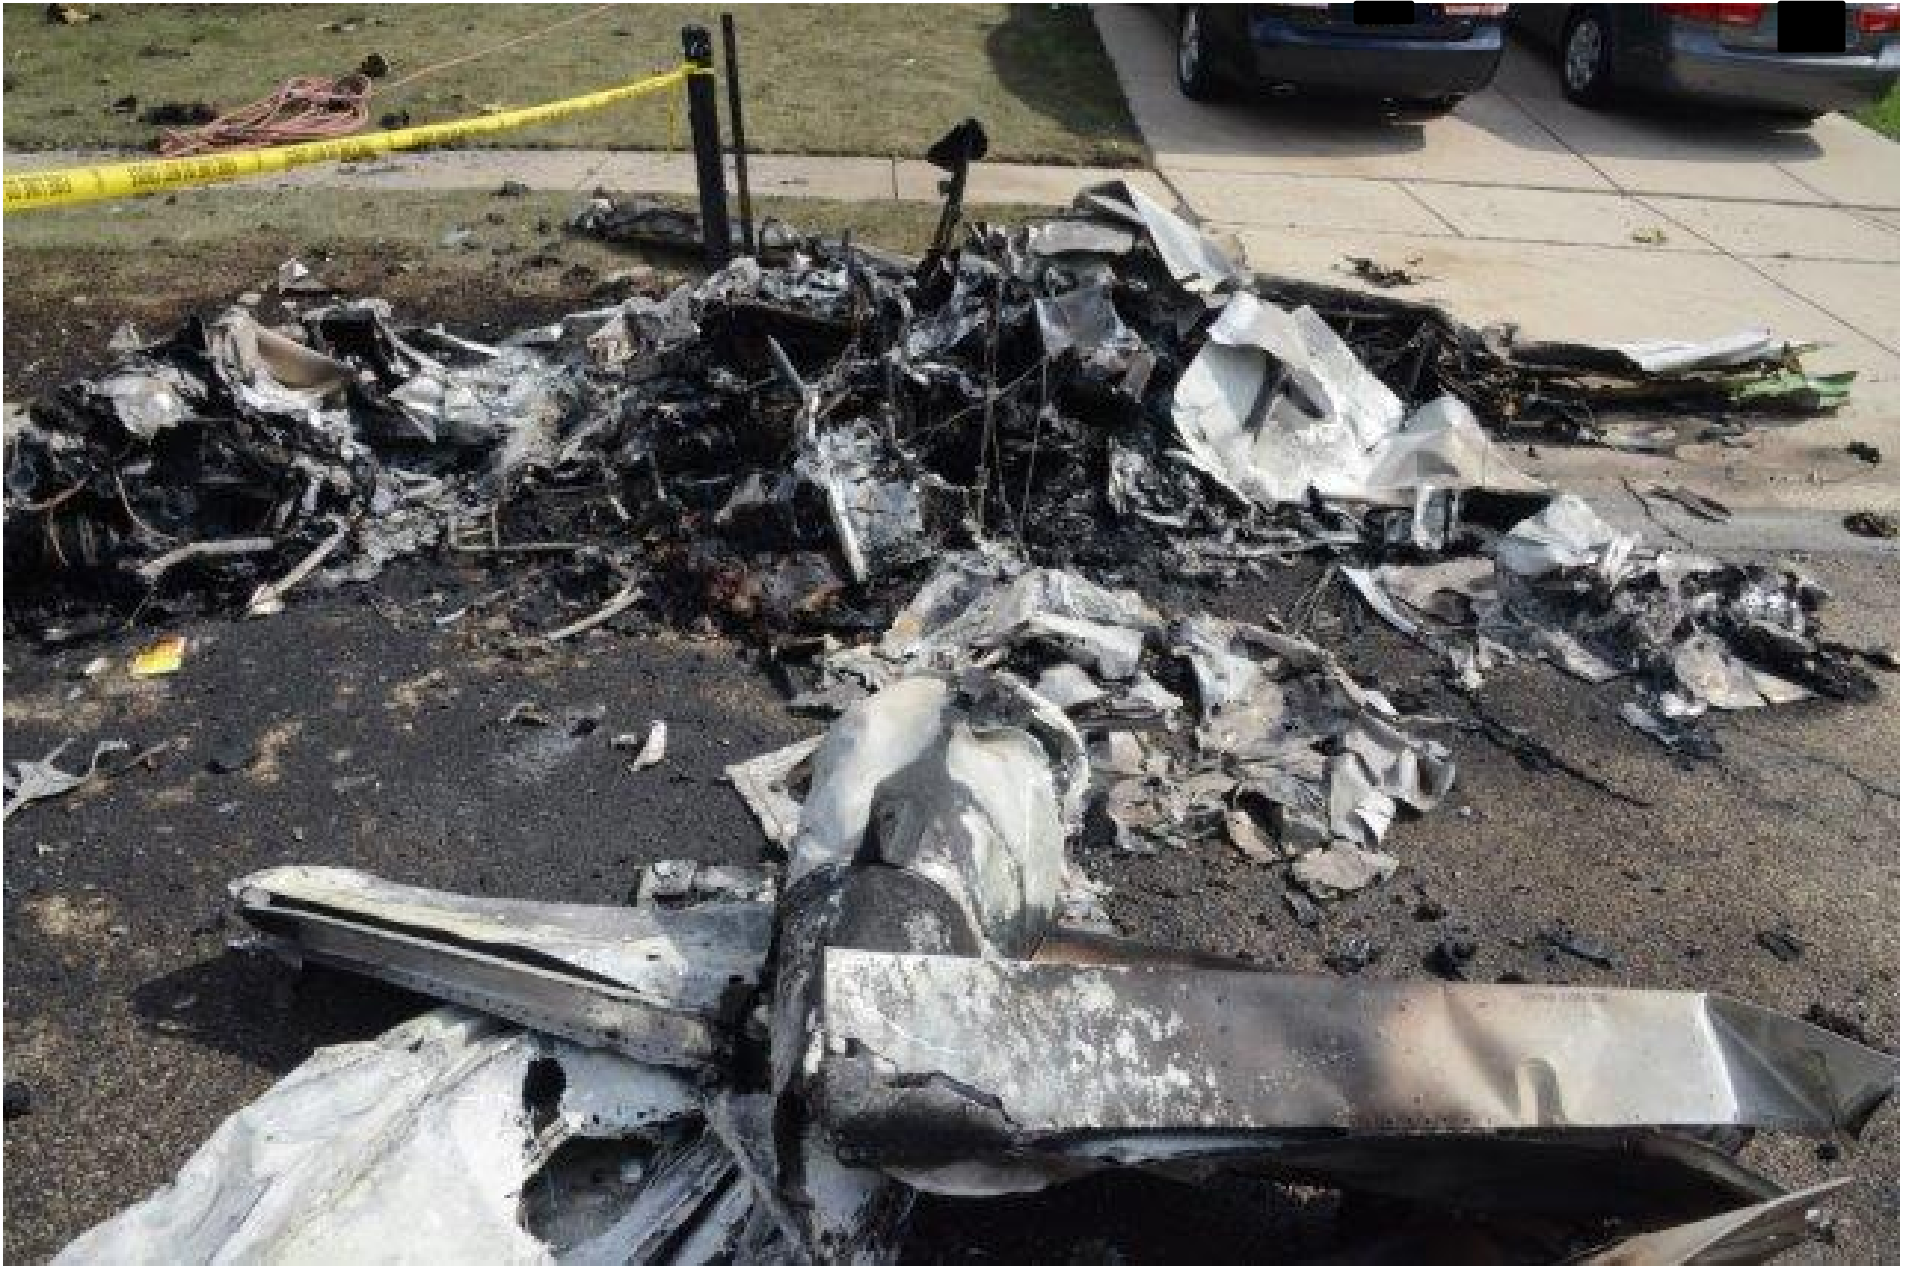
**Photo 5 - Close up view of the main wreckage.**

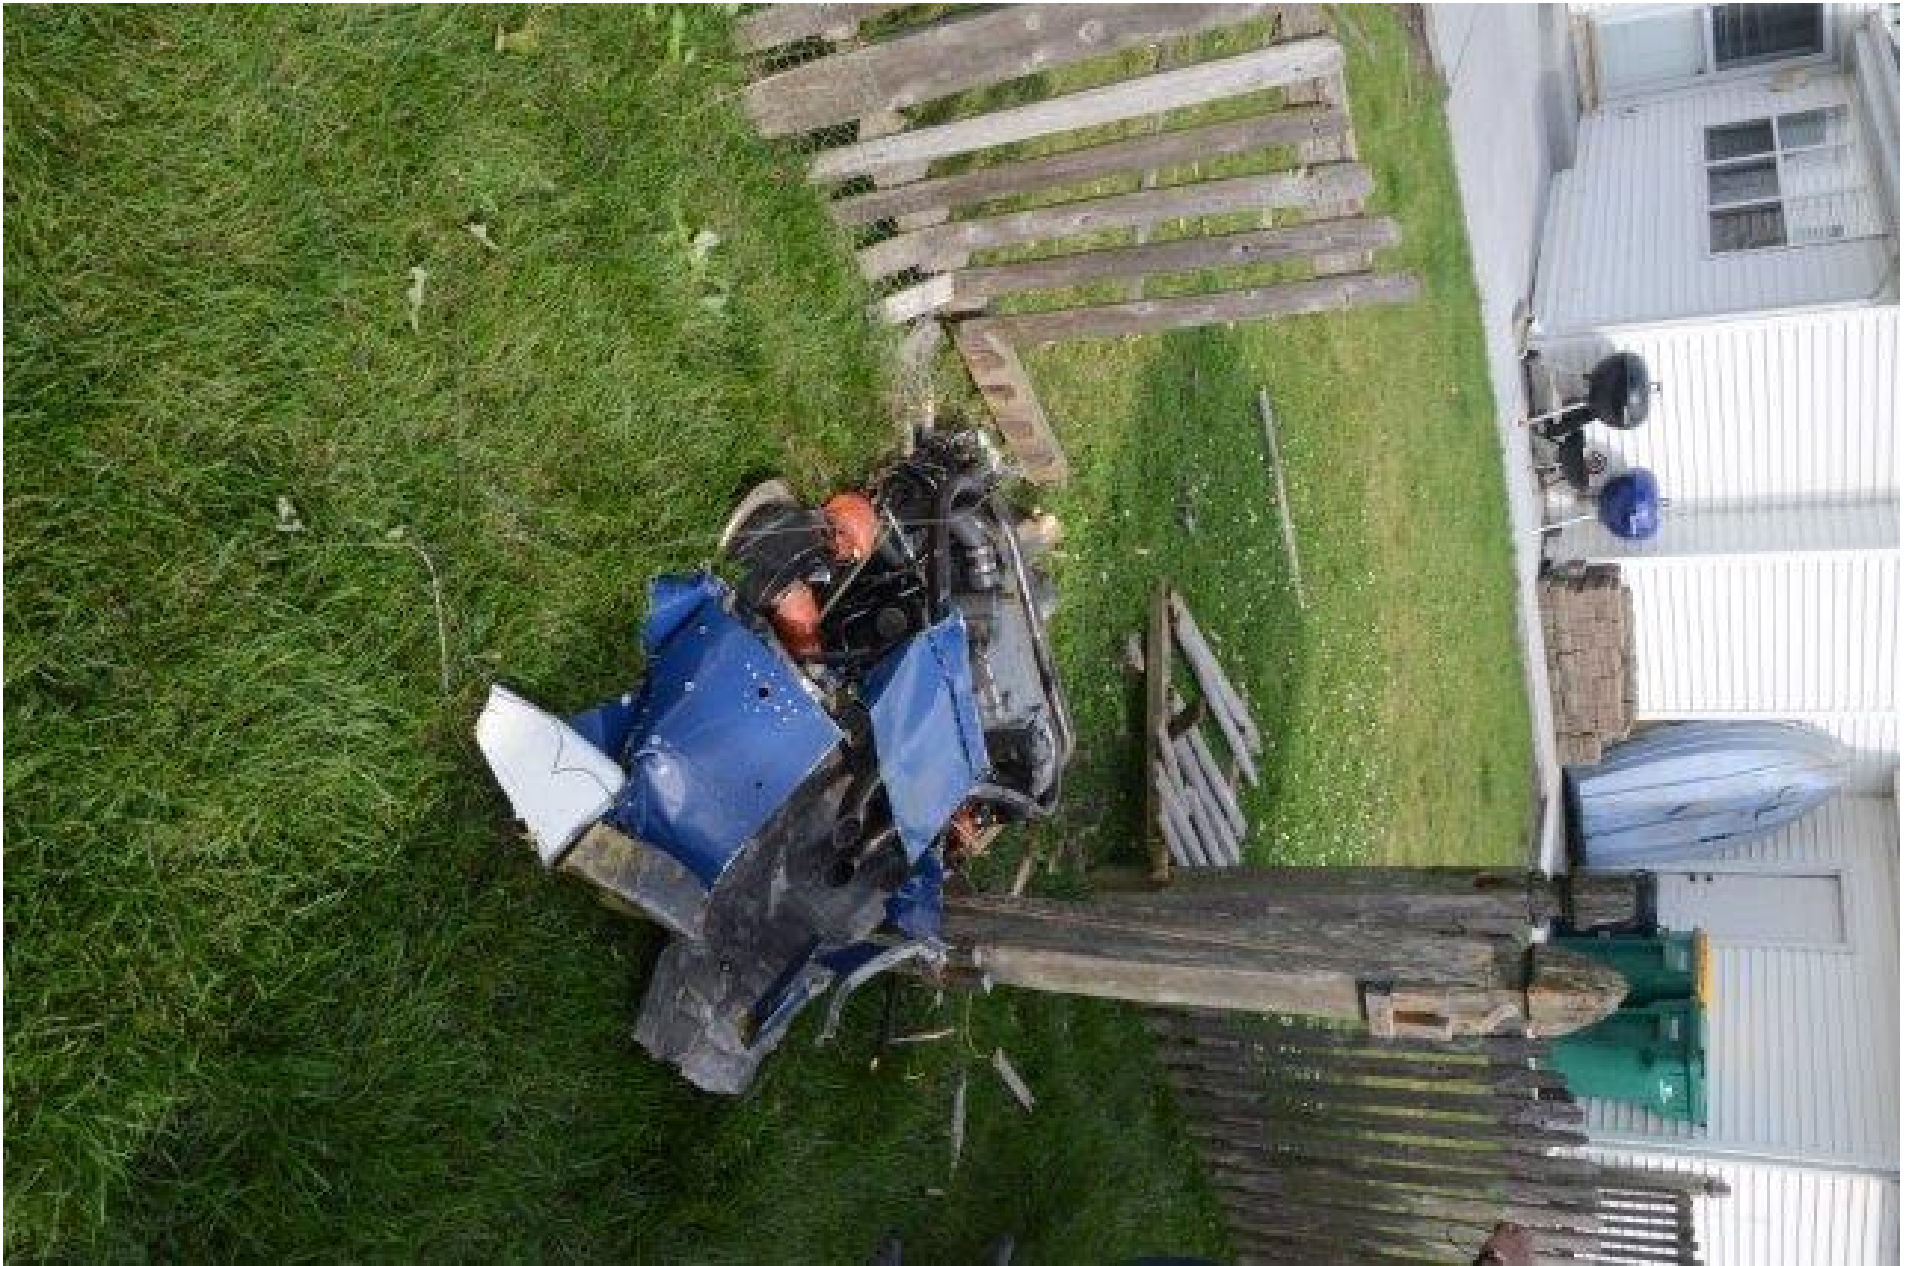
**Photo 6 - View of the left engine.**

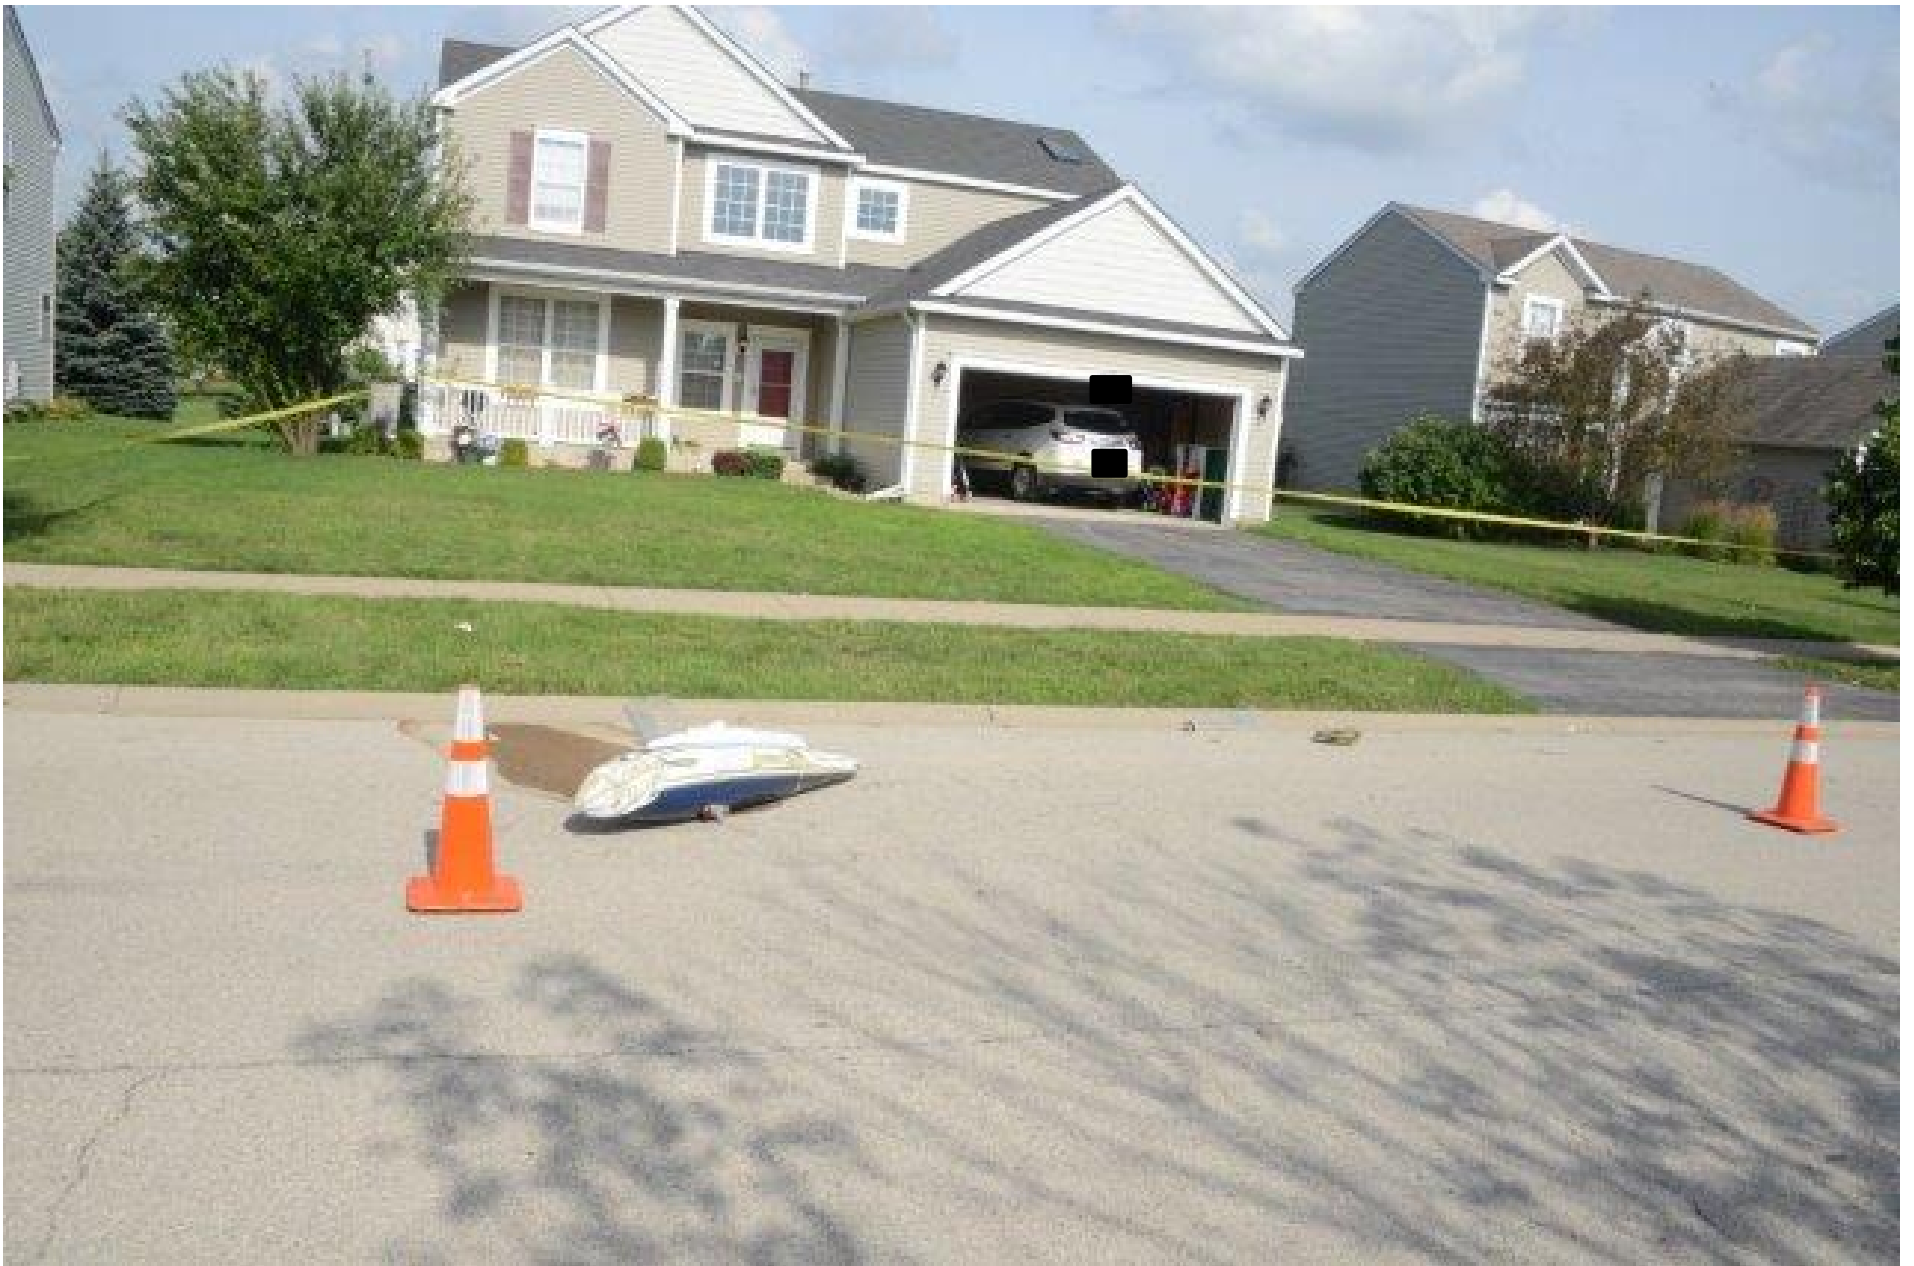
**Photo 7 - View of the left tip tank.**

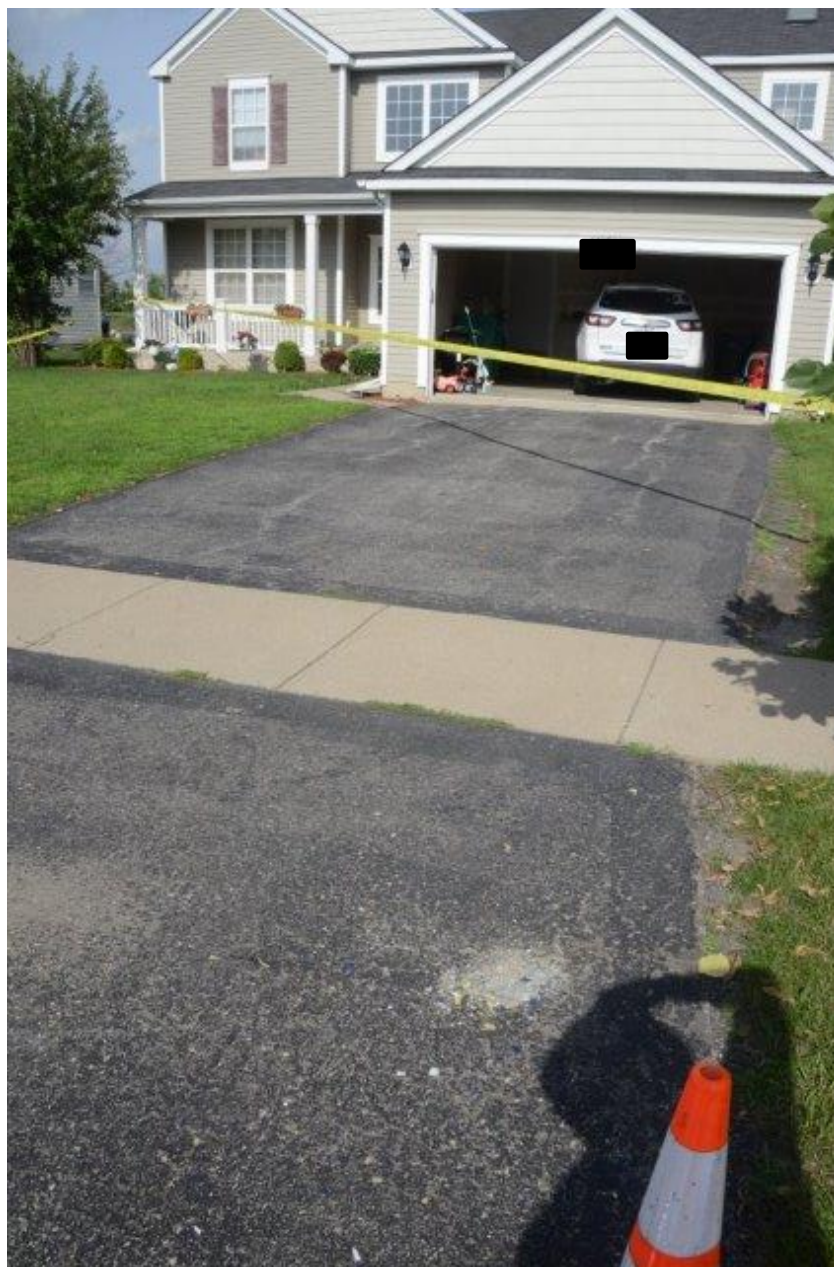
**Photo 8 - View of a witness mark near the left tip tank.**

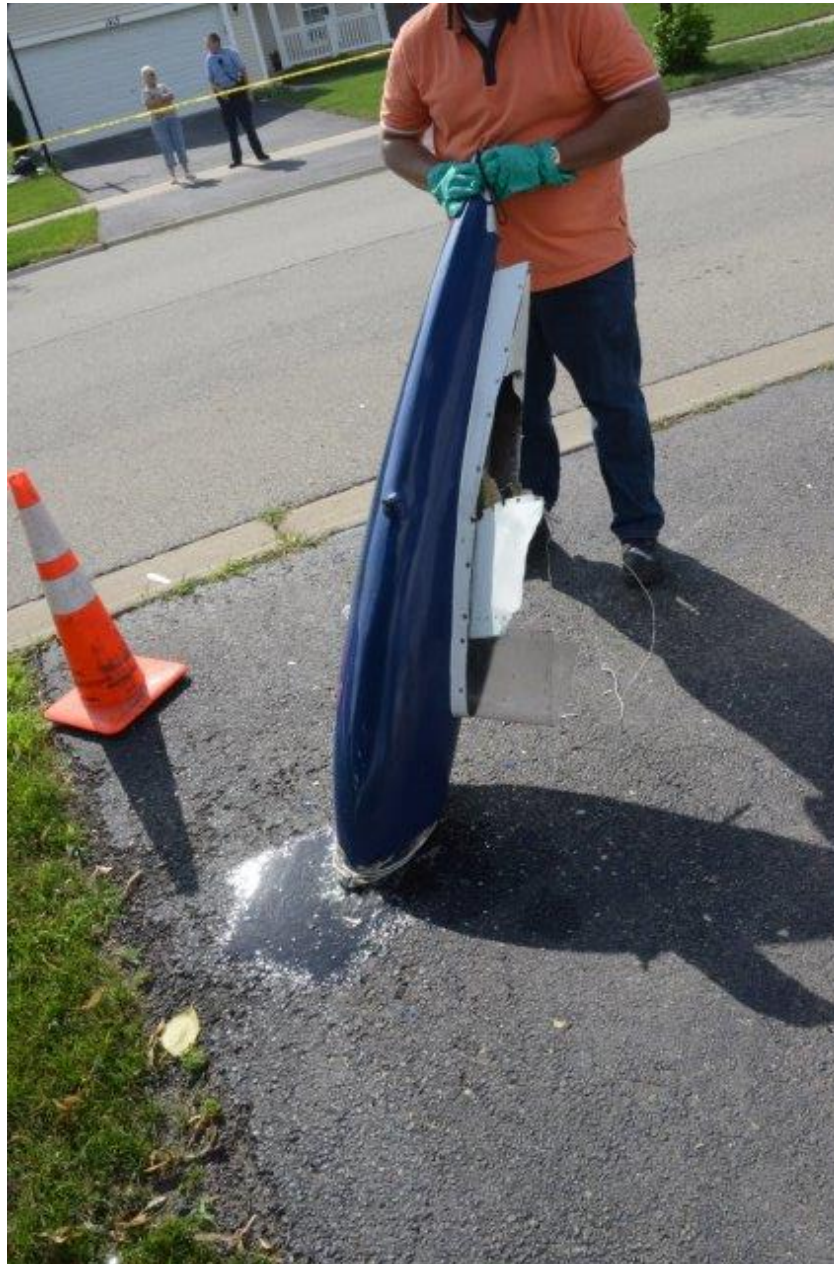
**Photo 9 - View of a witness mark consistent with the shape of the tip tank.**

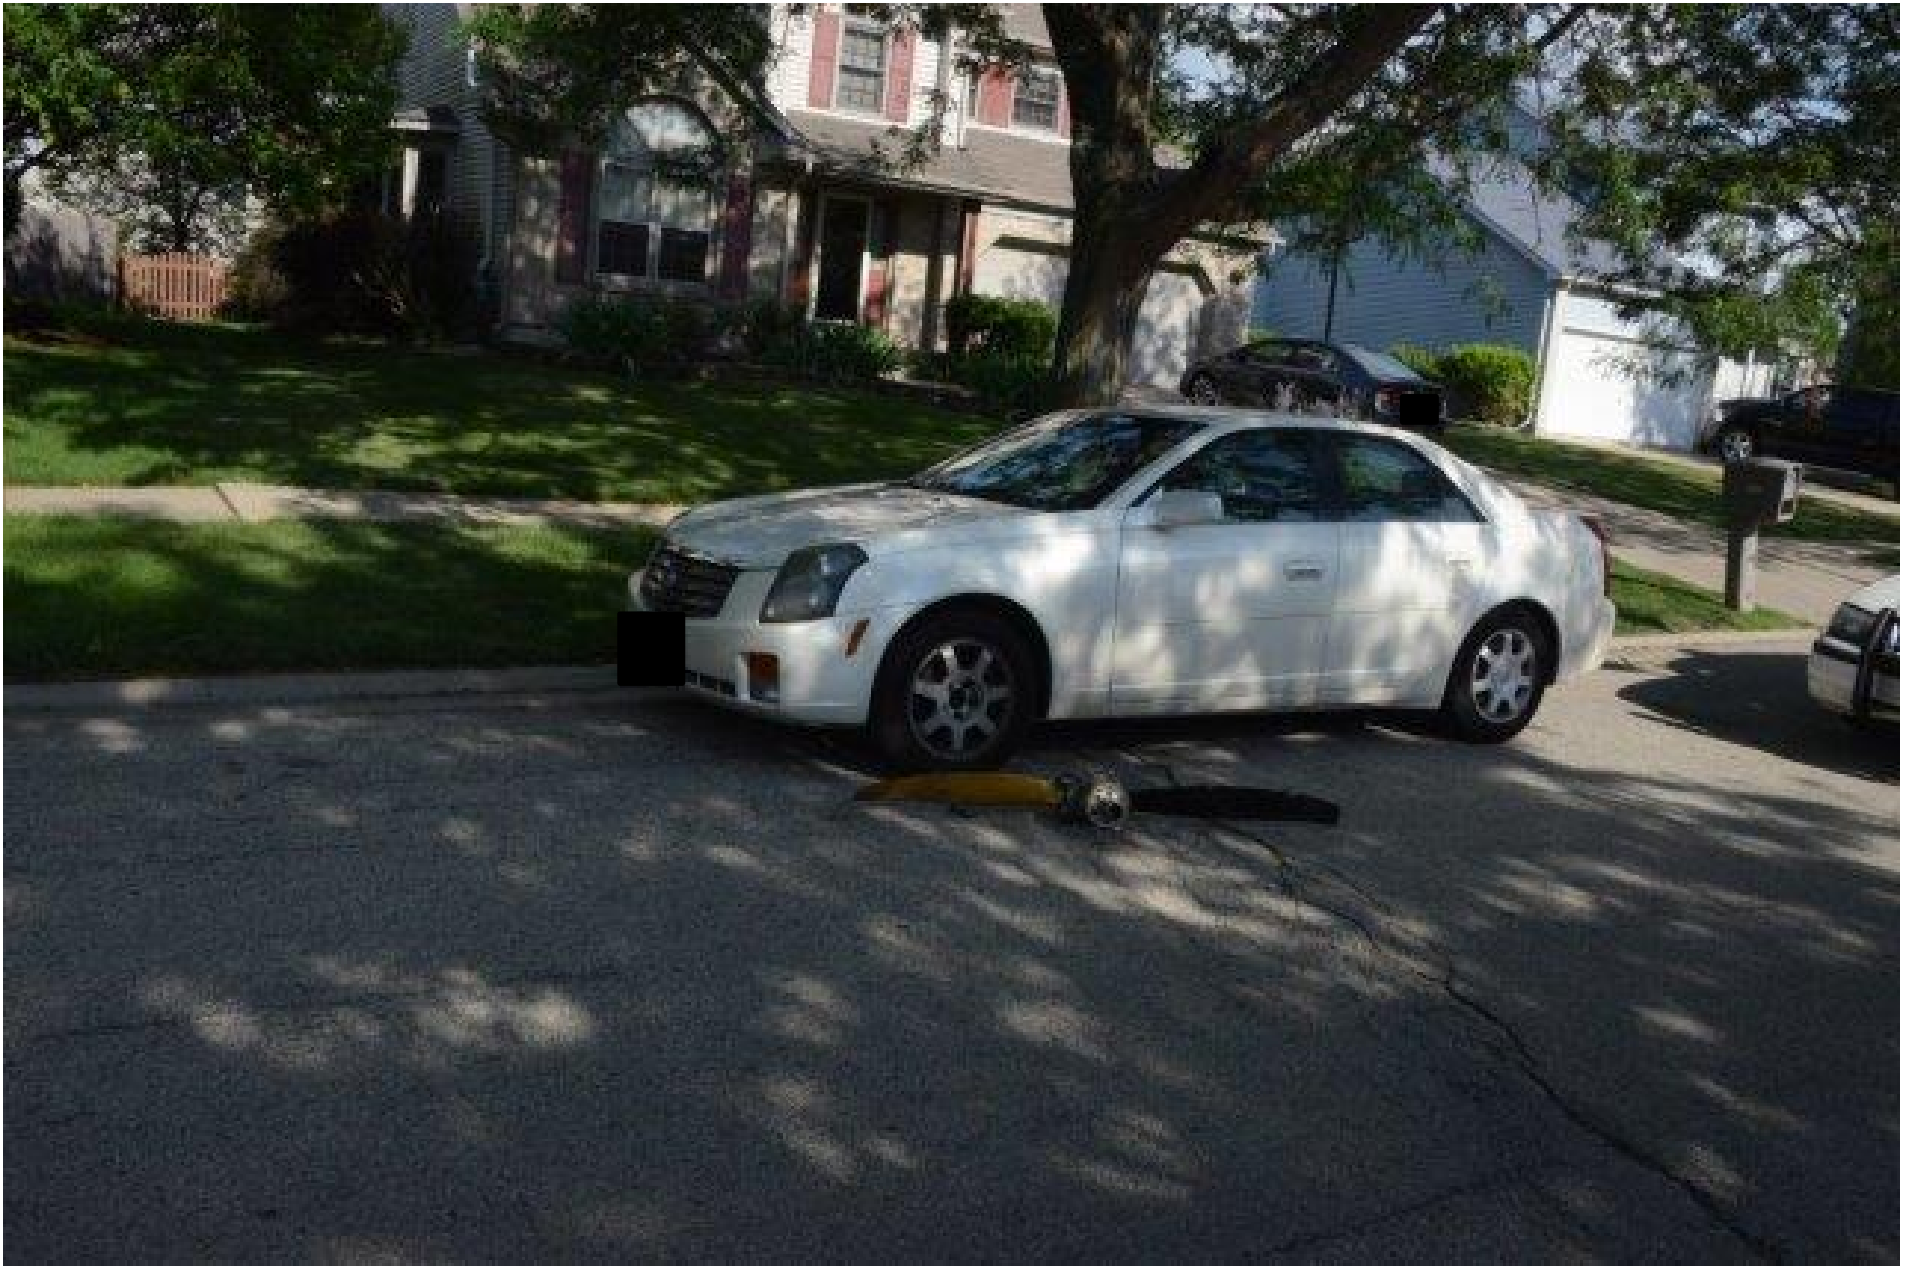
**Photo 10 - View of the left propeller.**
