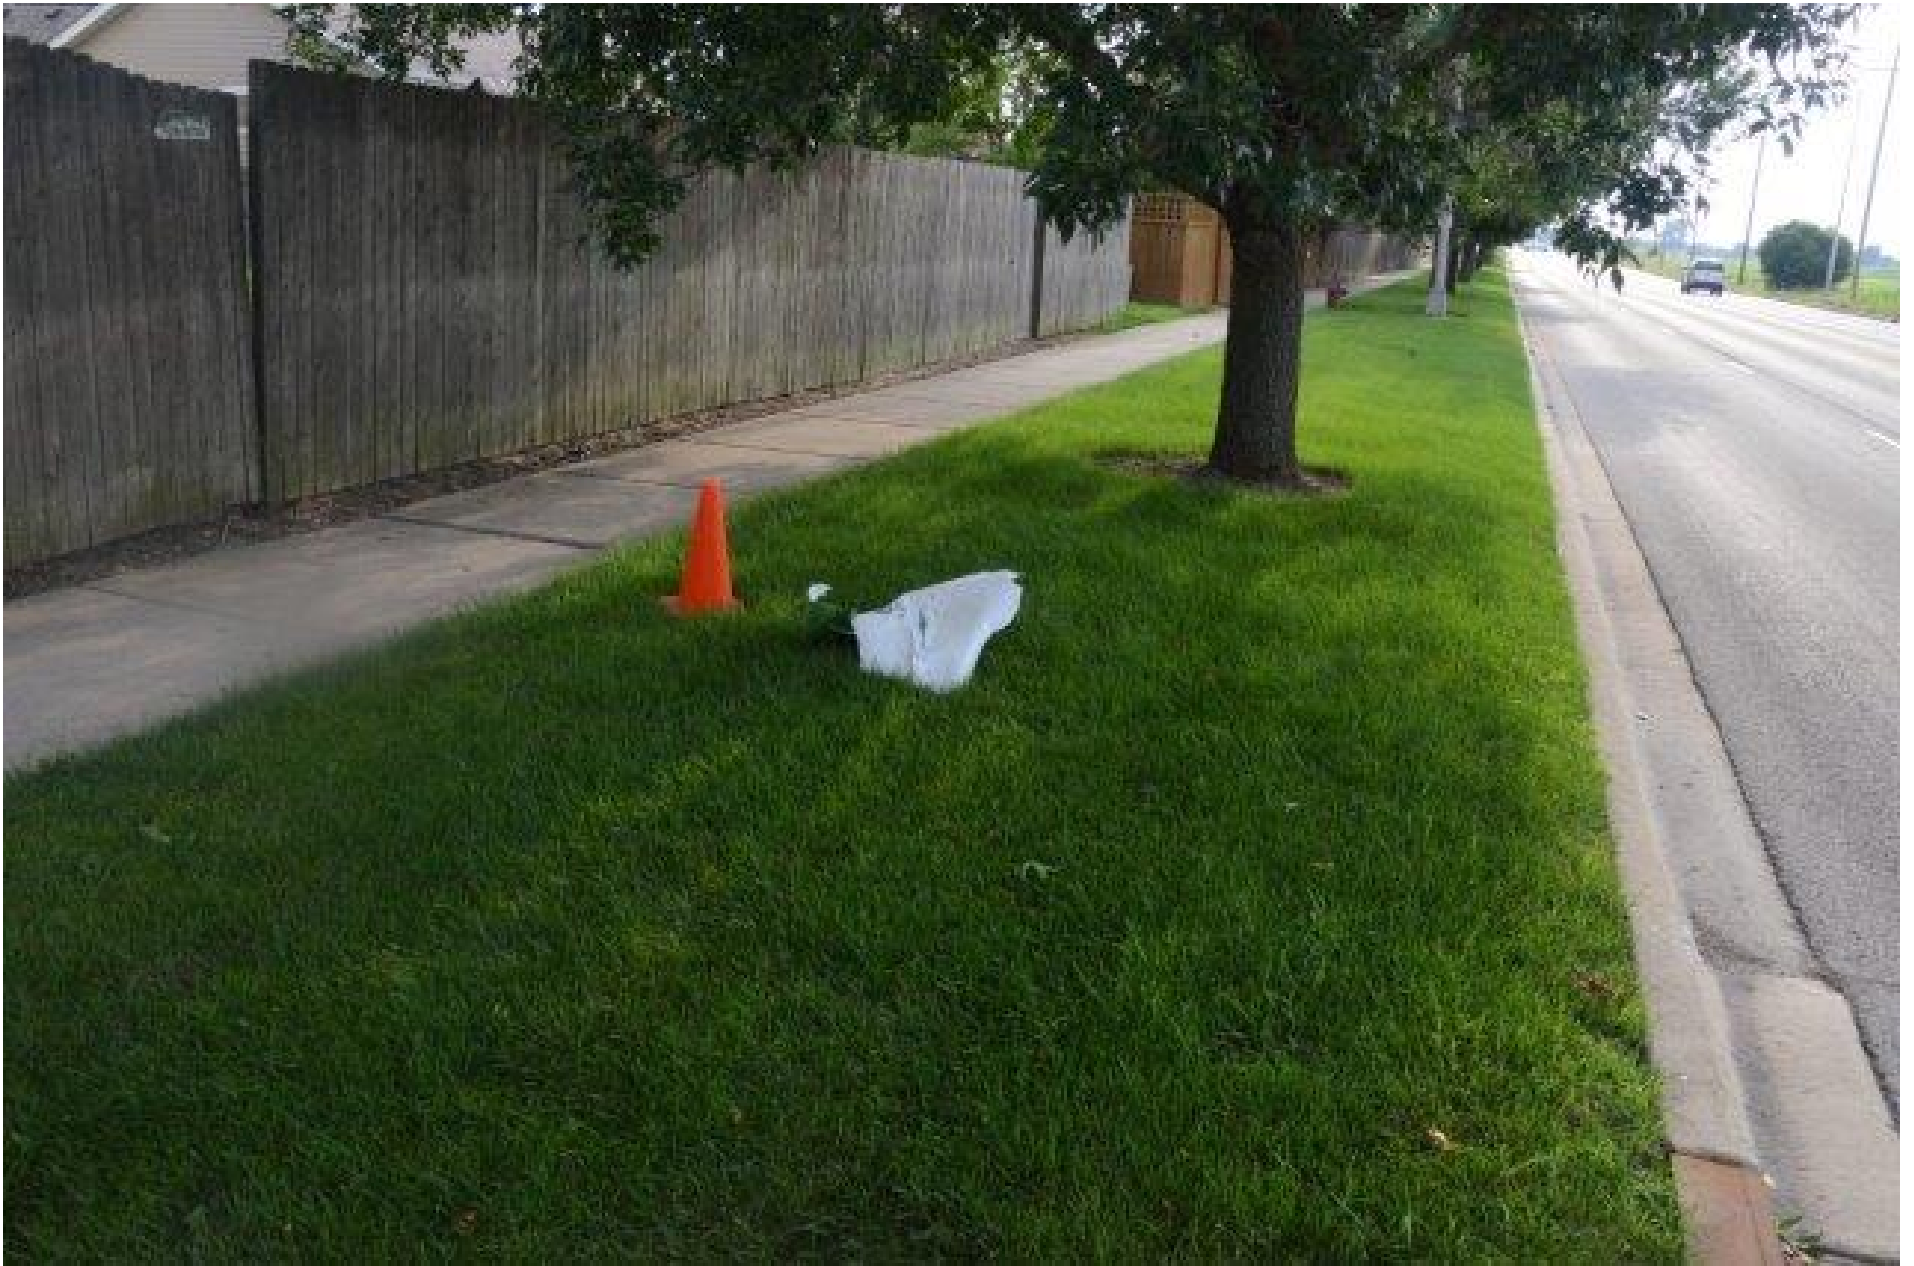
**Photo 11 - View of separated airplane skin along a parkway.**

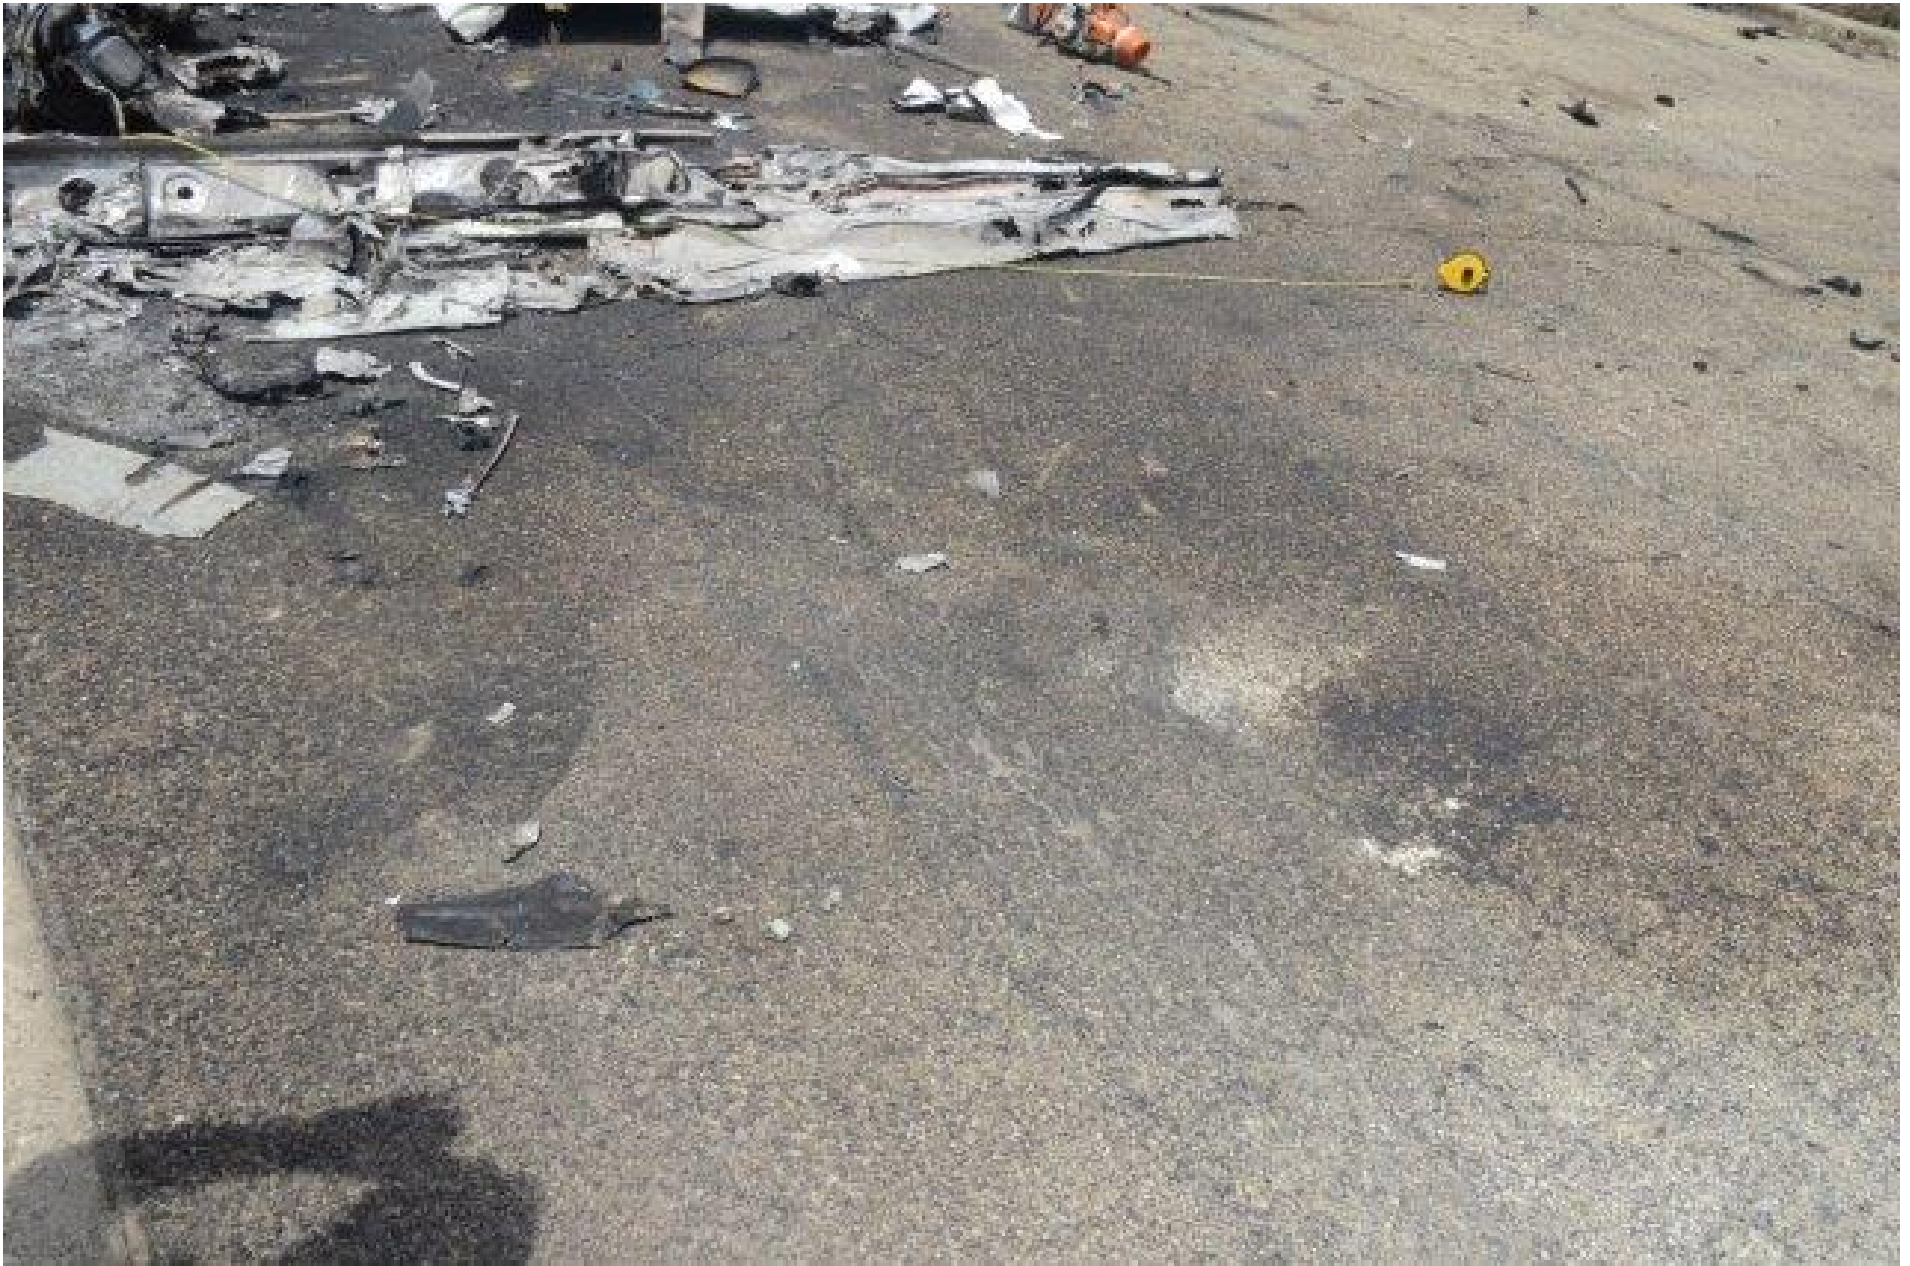
**Photo 12 - View of the right wing.**

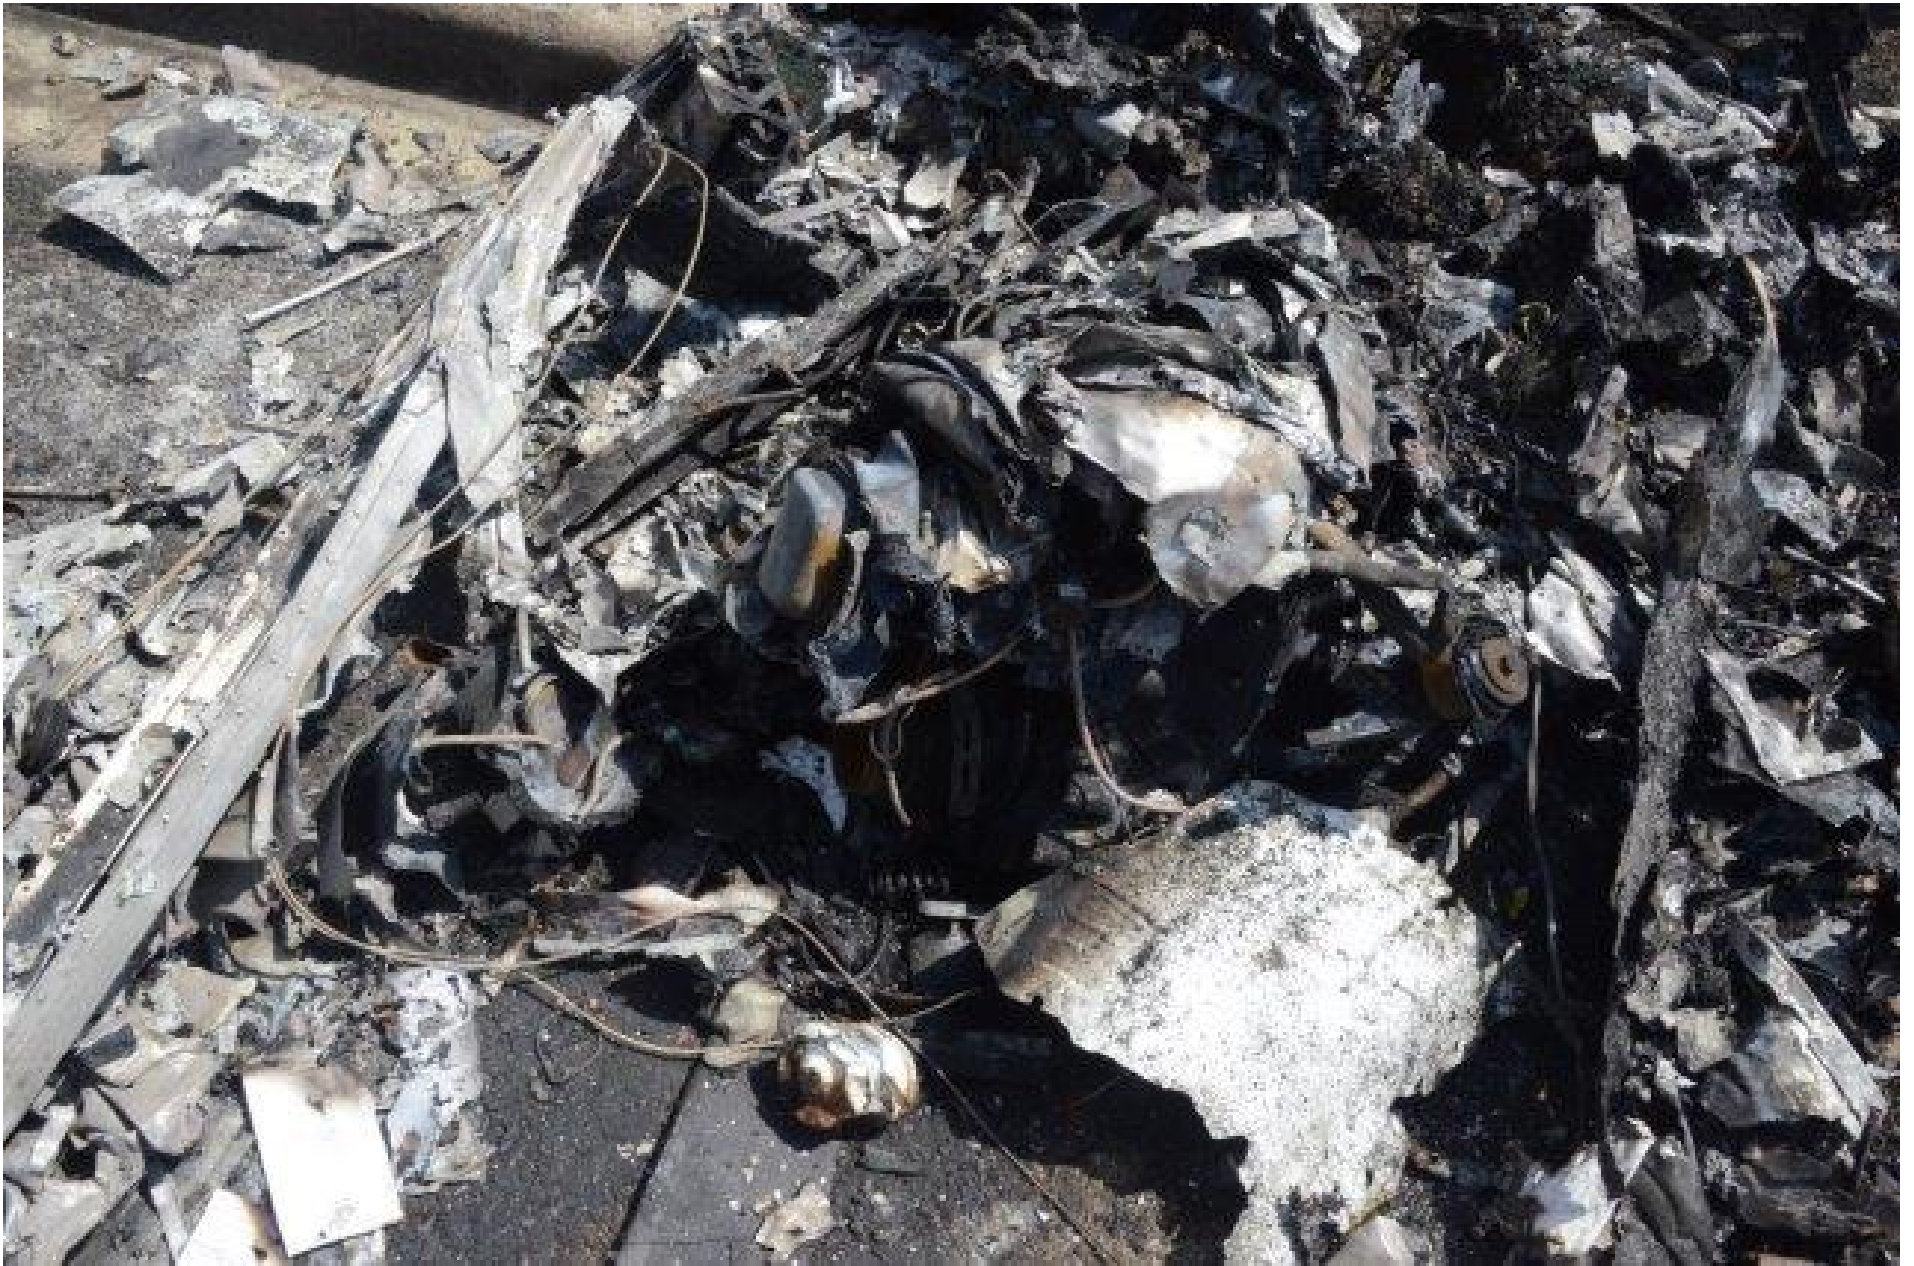
**Photo 13 - View of the right engine within the main wreckage site.**

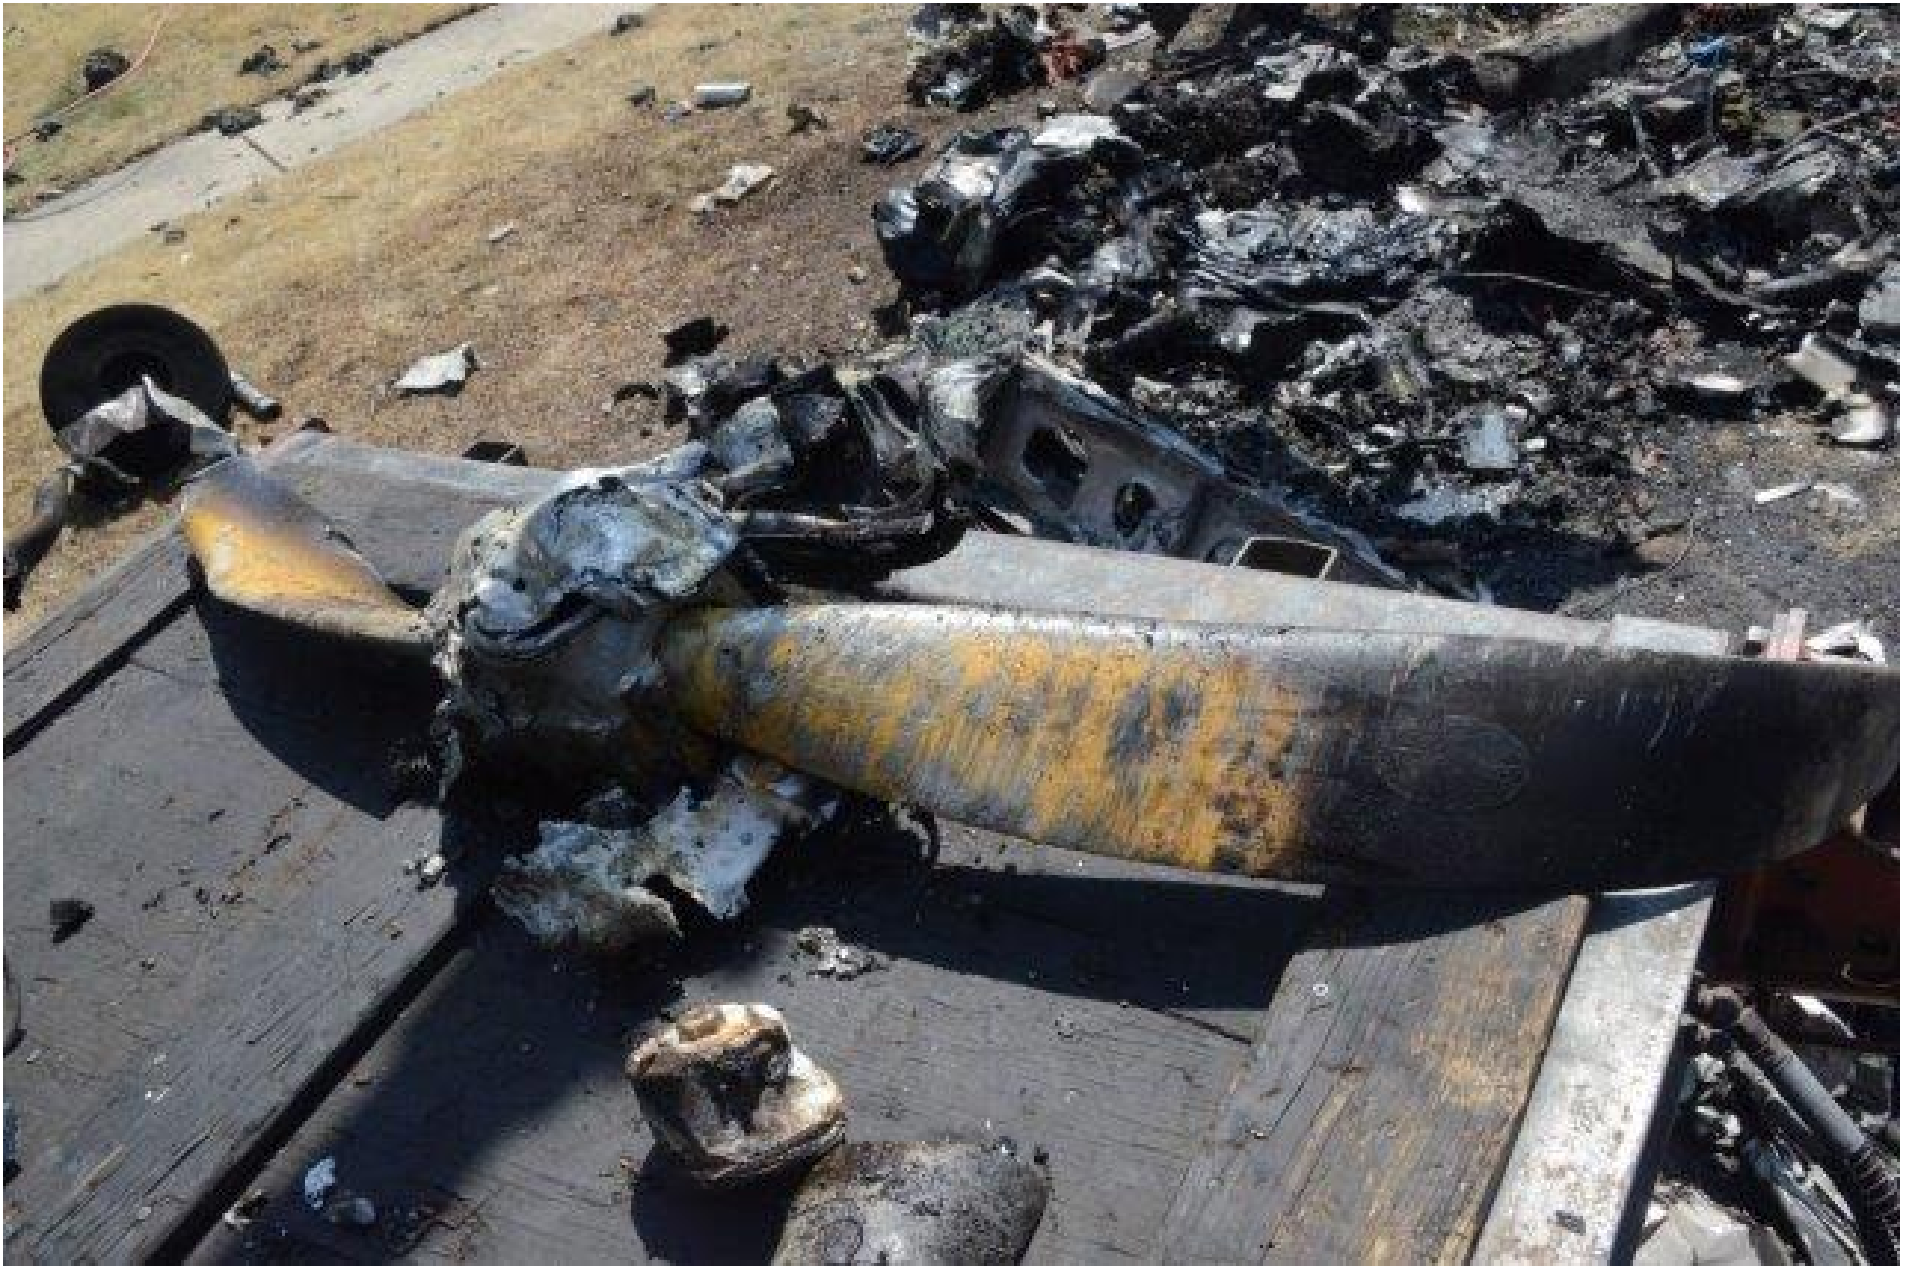
**Photo 14 - View of the recovered right propeller.**

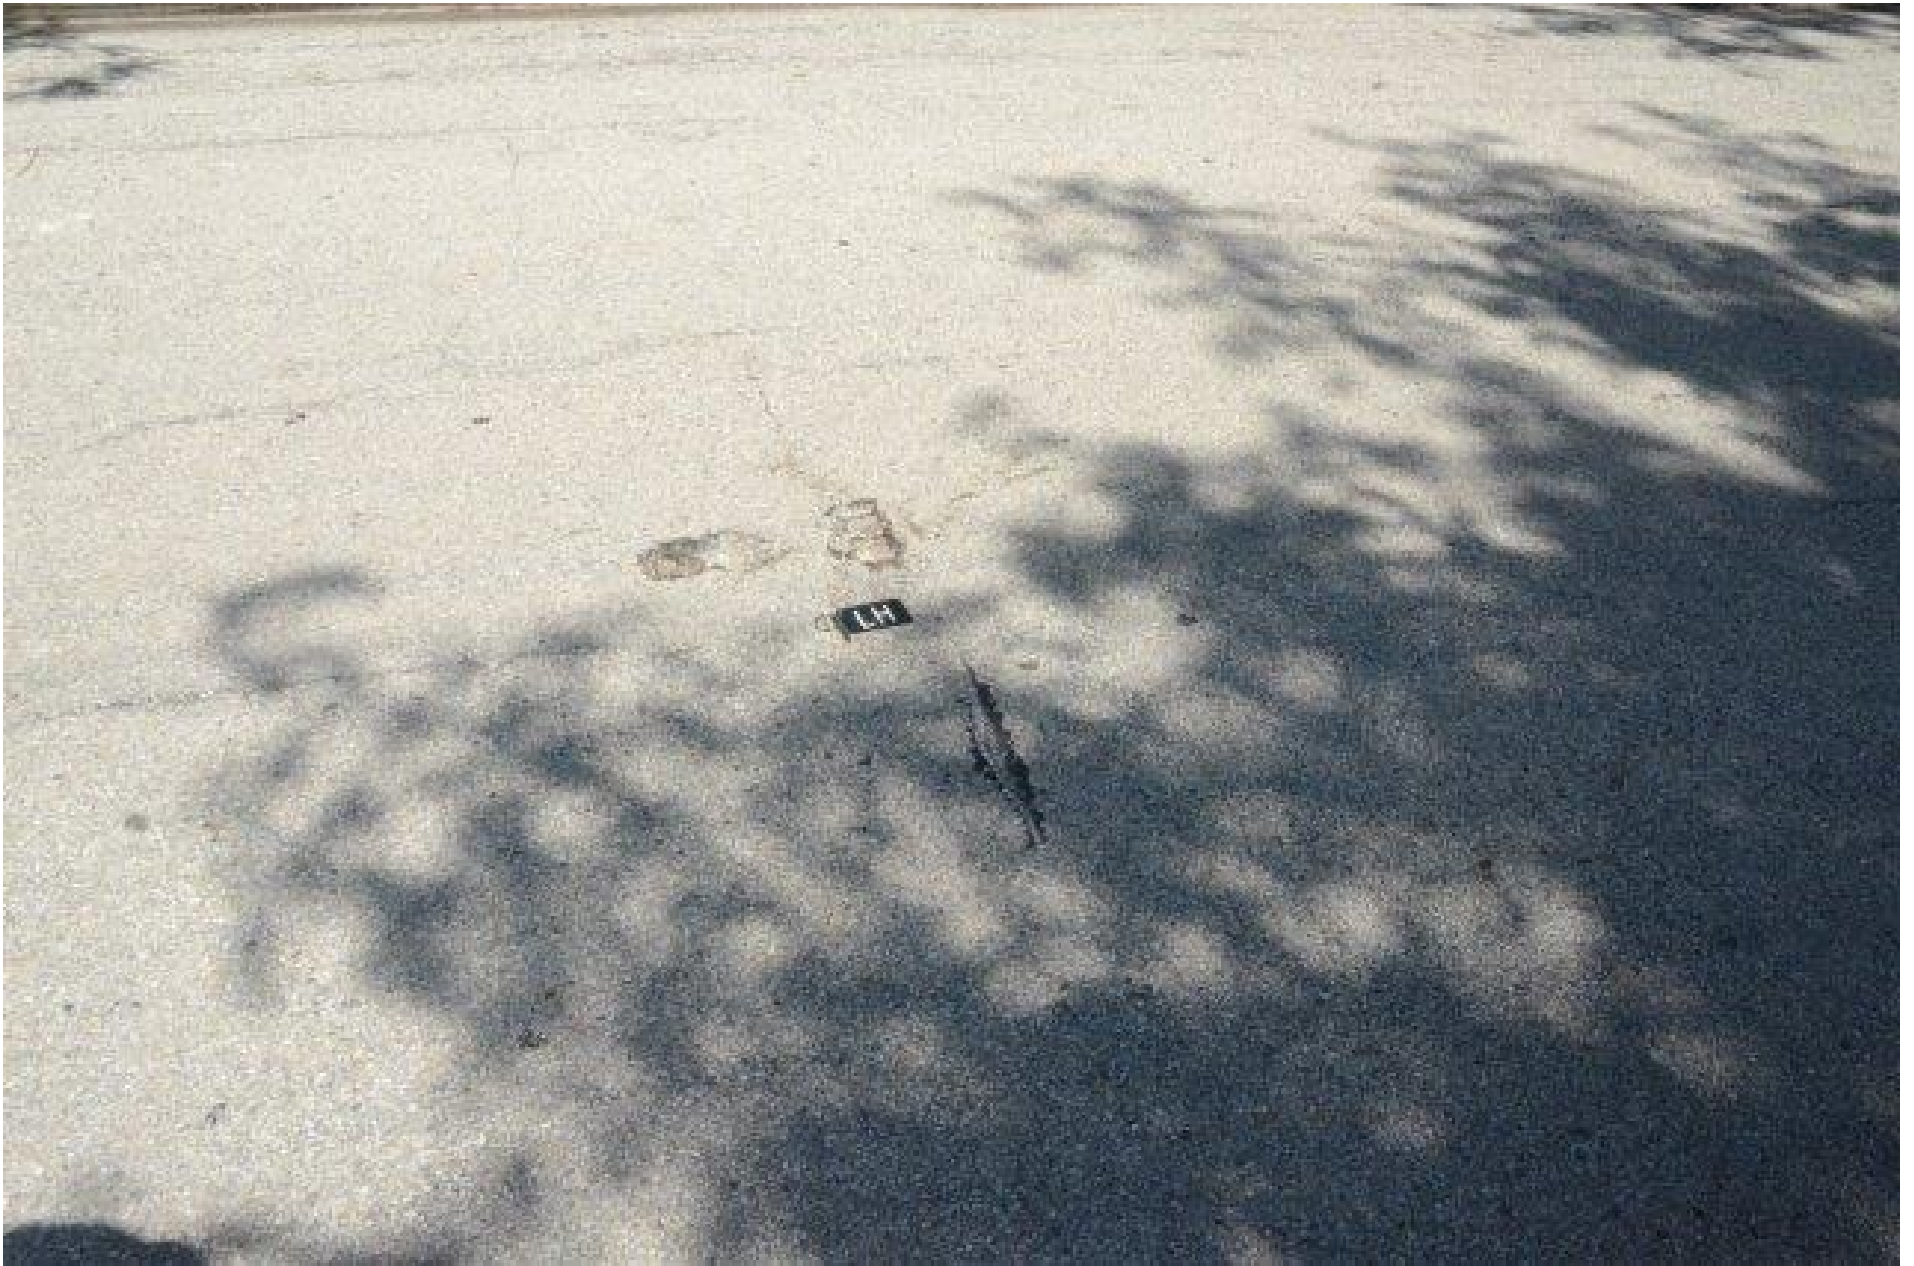
**Photo 15 - View of a witness mark near the left propeller.**

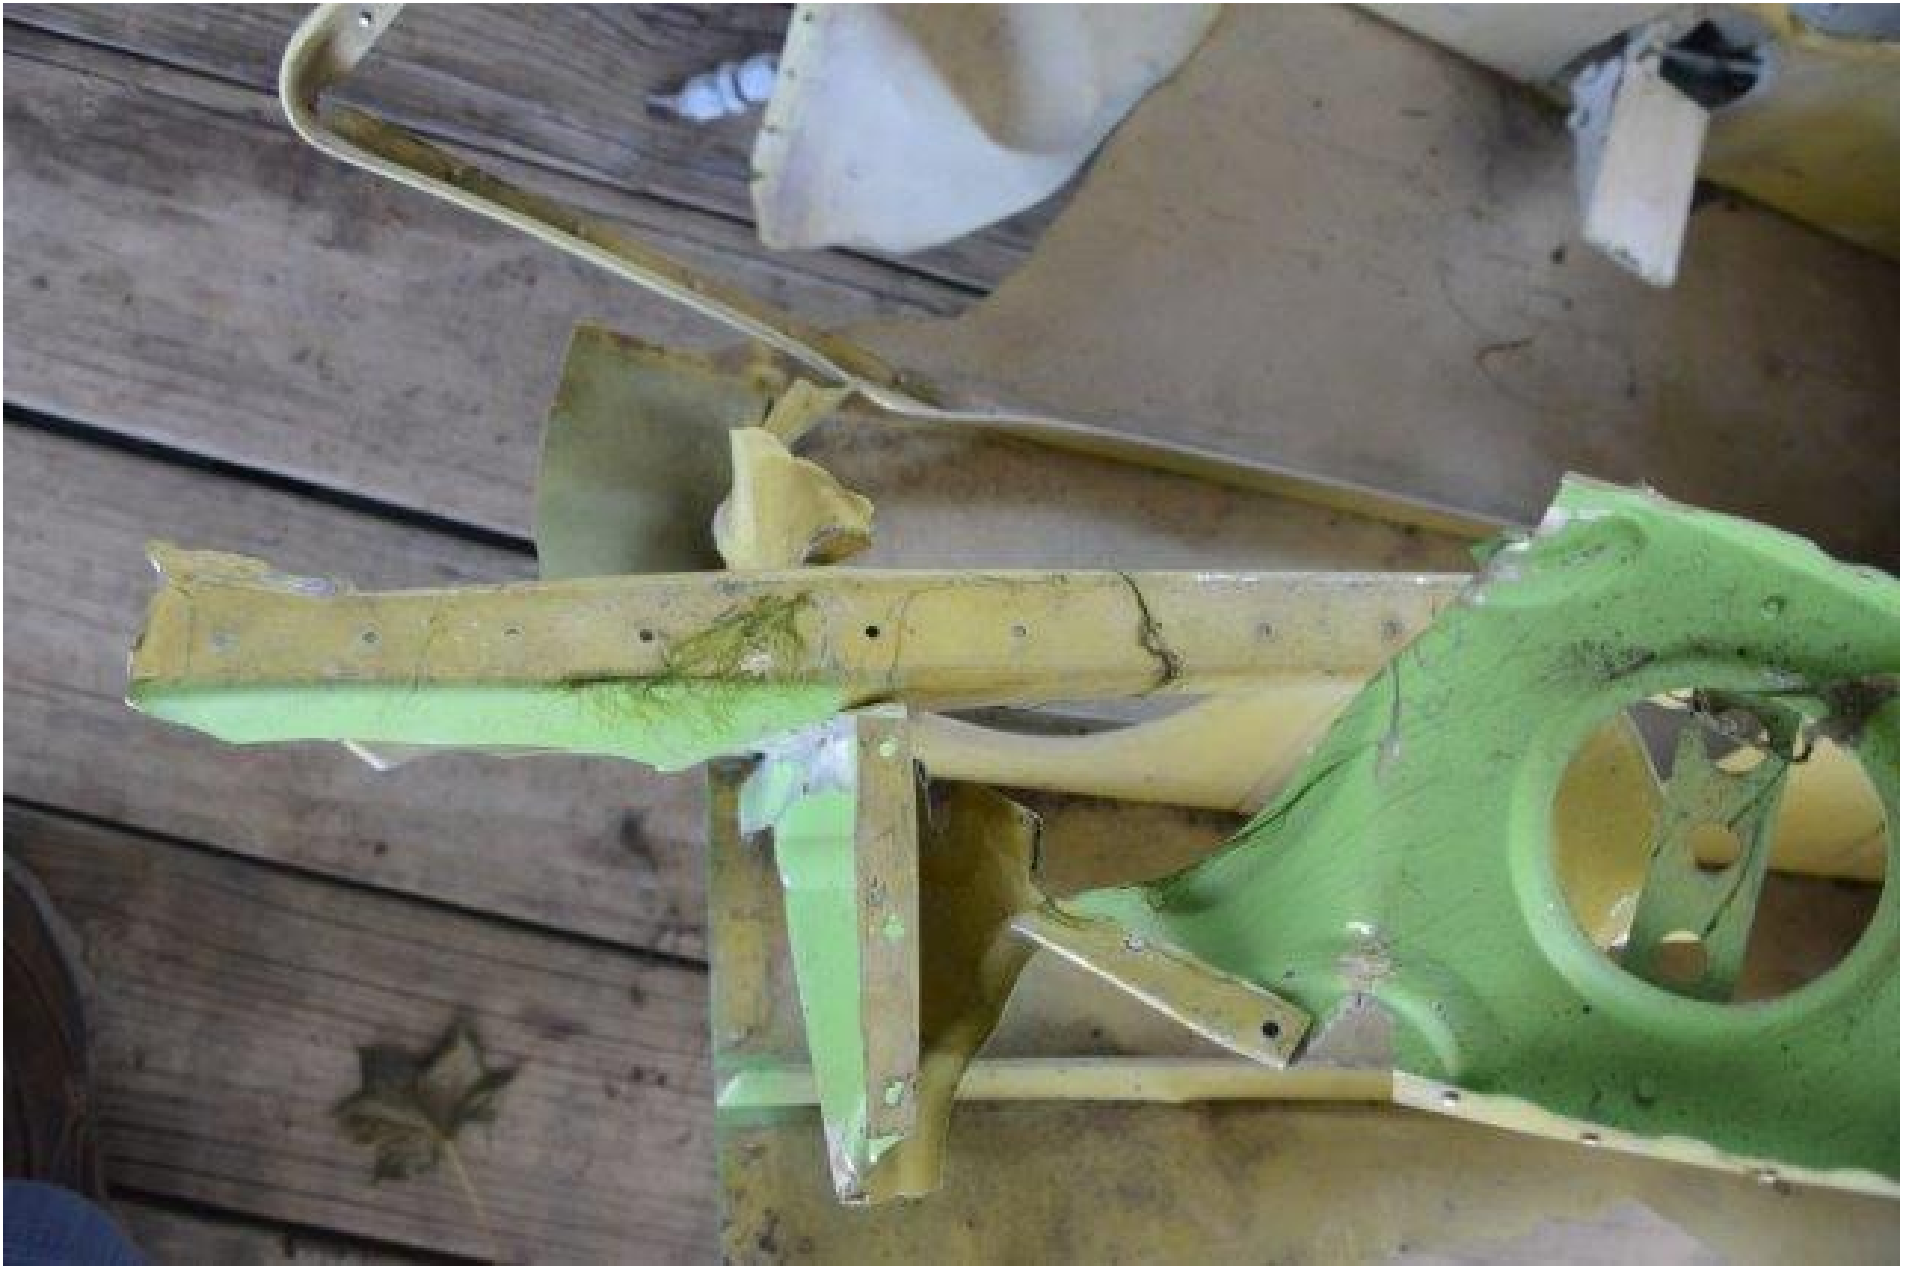
**Photo 16 - View of a left wing spar.**

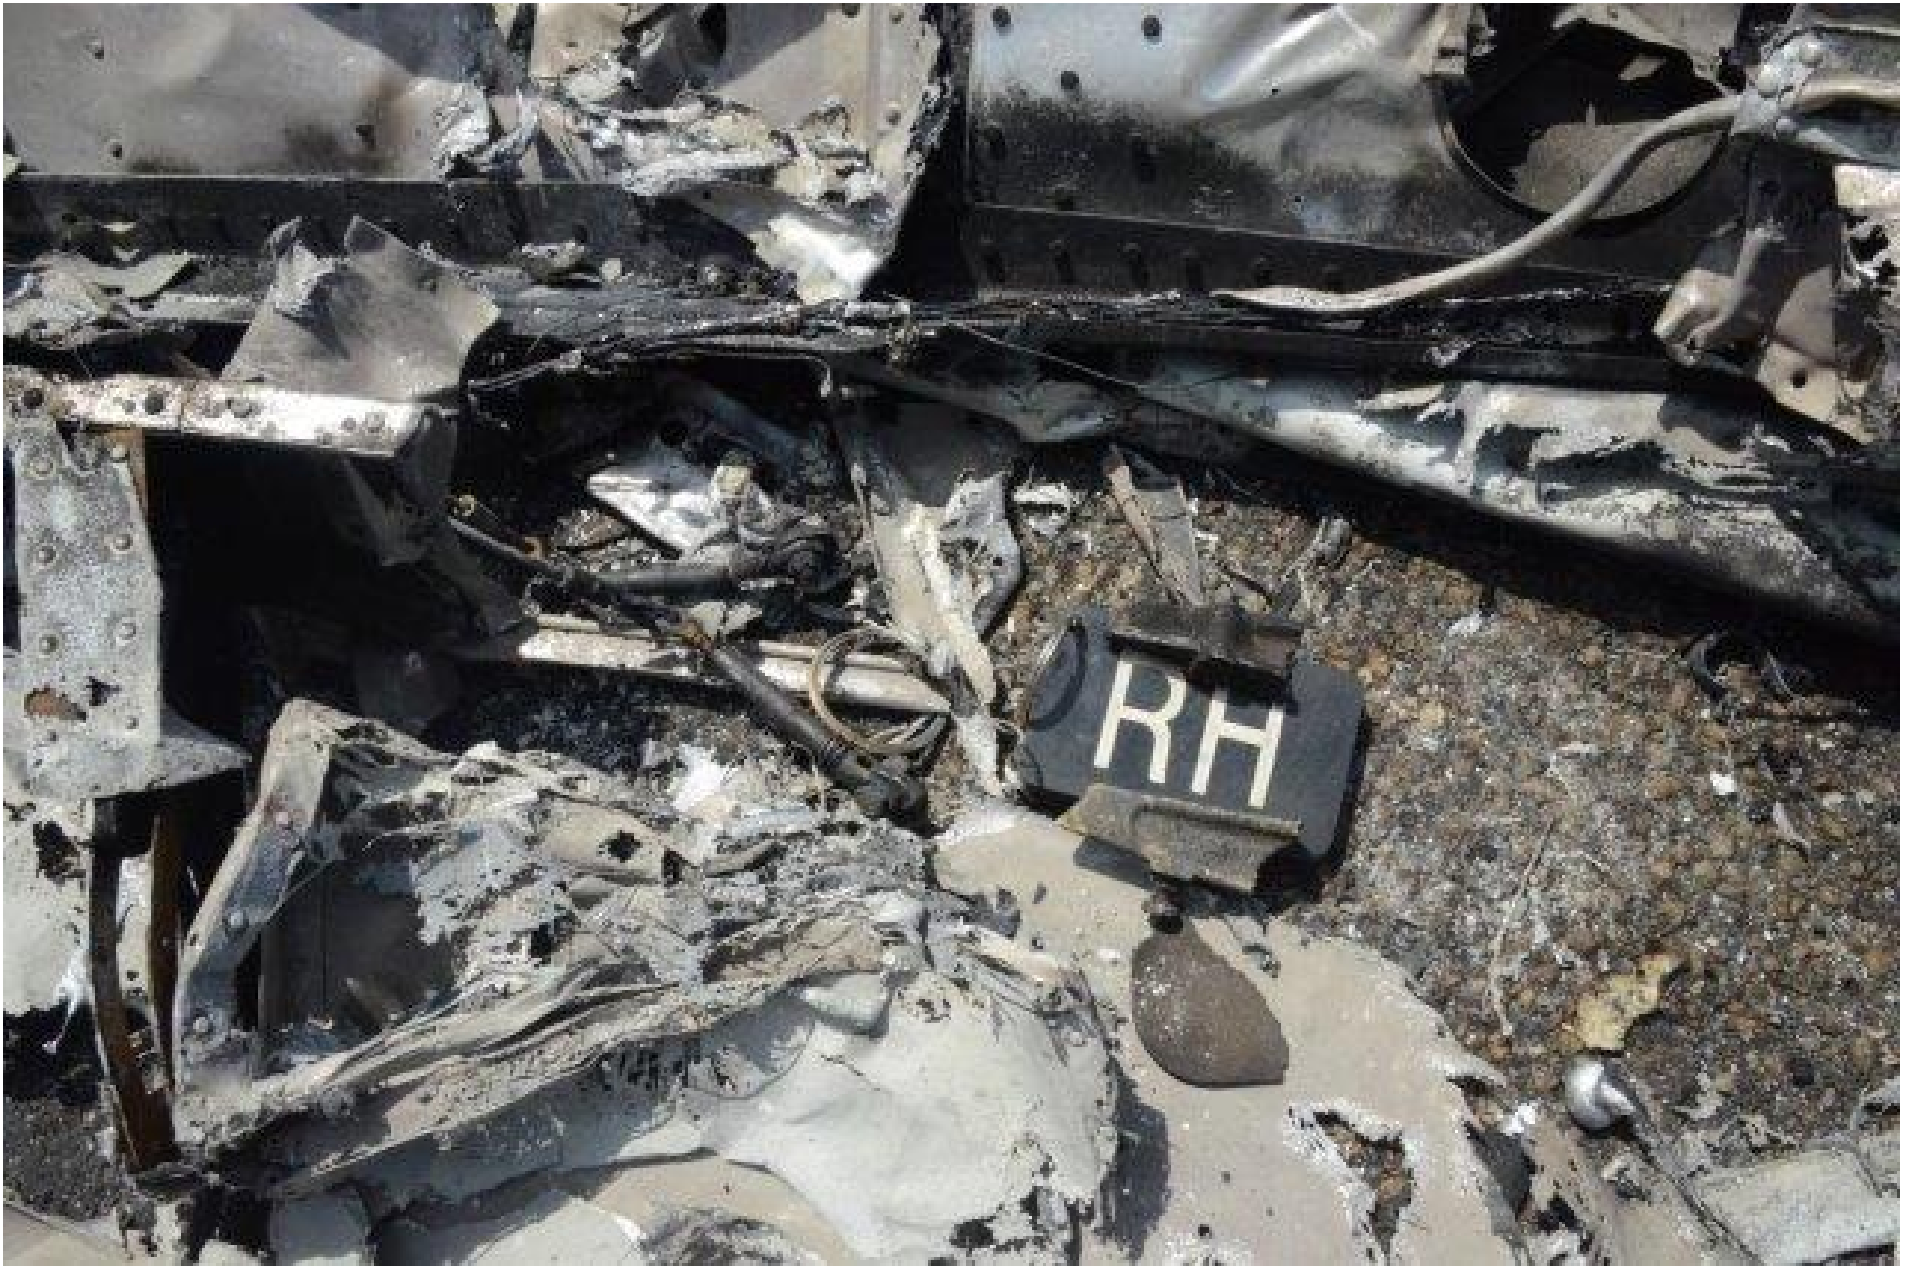
**Photo 17 - View of right wing control cables within the main wreckage.**

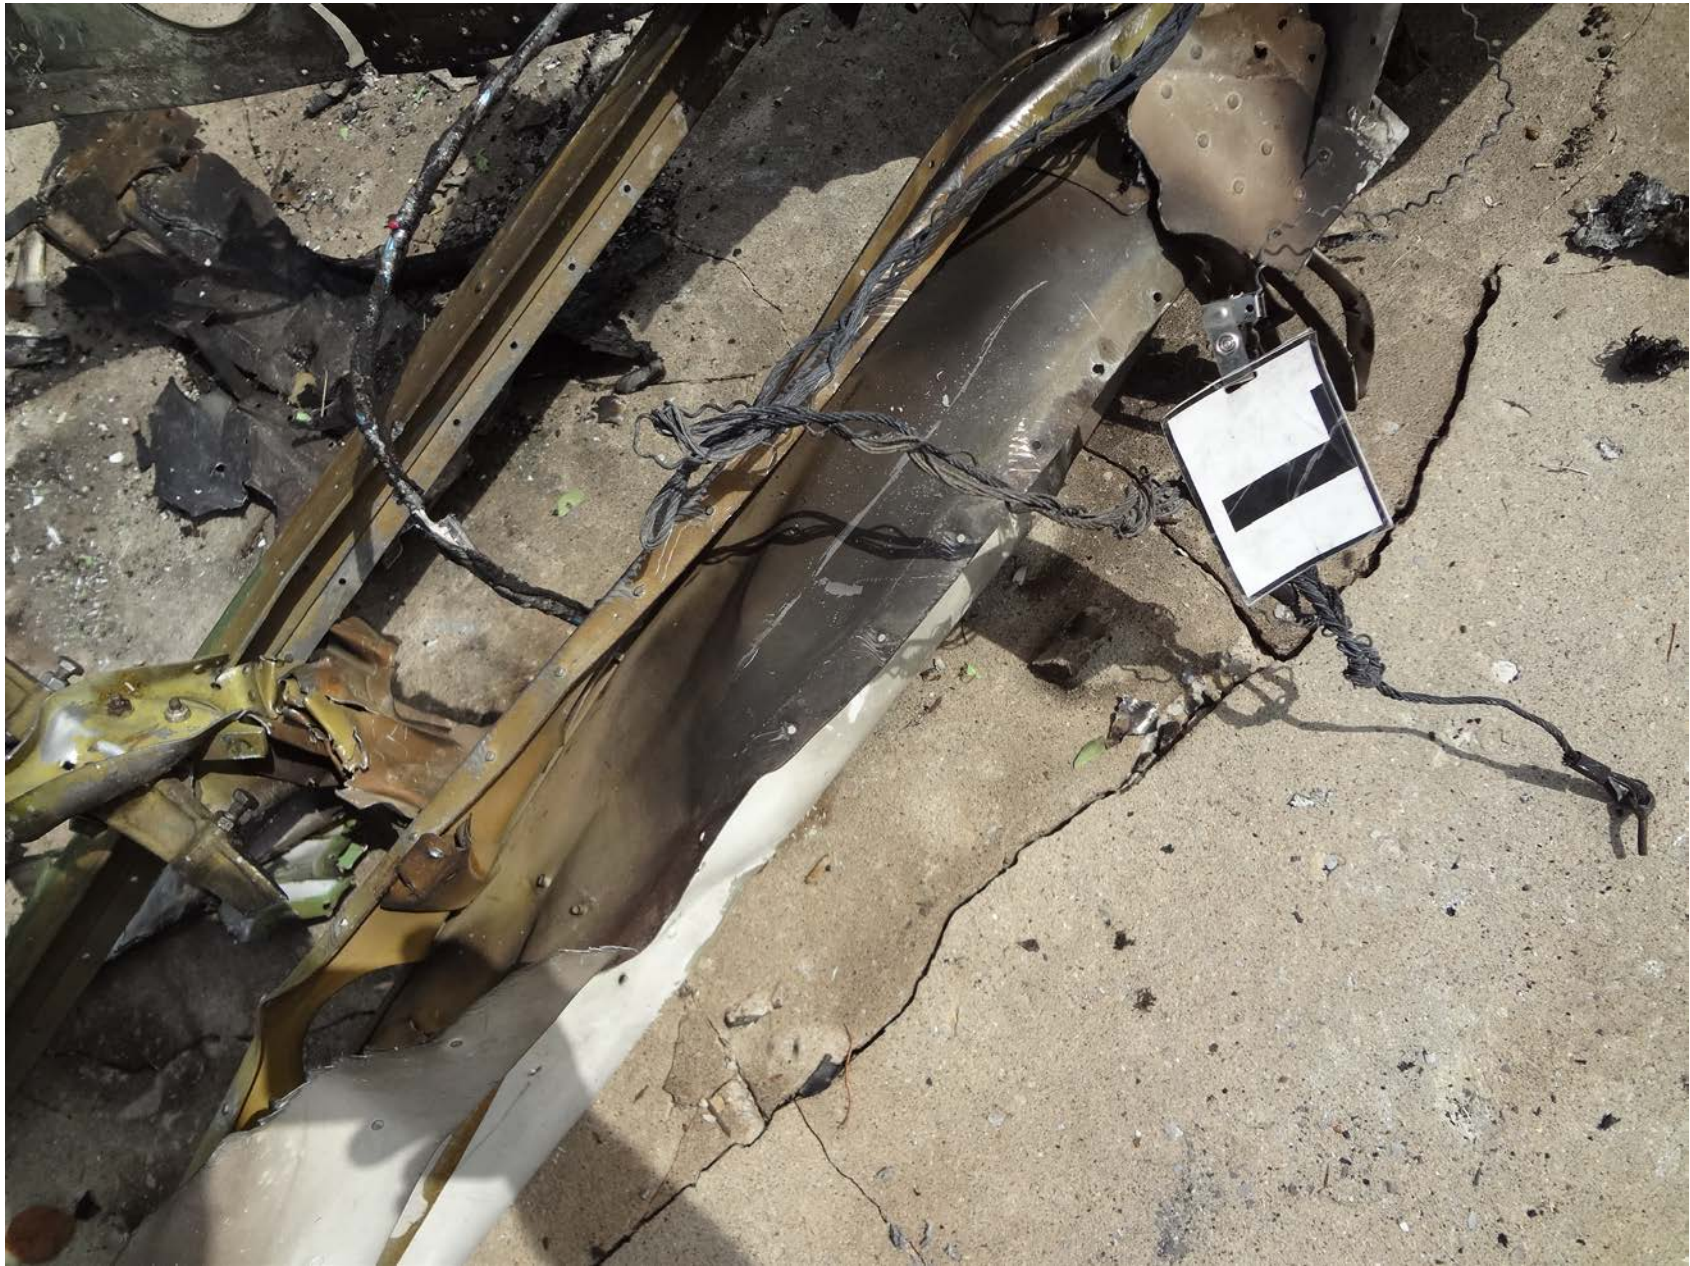
**Photo 18 - View of left wing control cables within the main wreckage.**

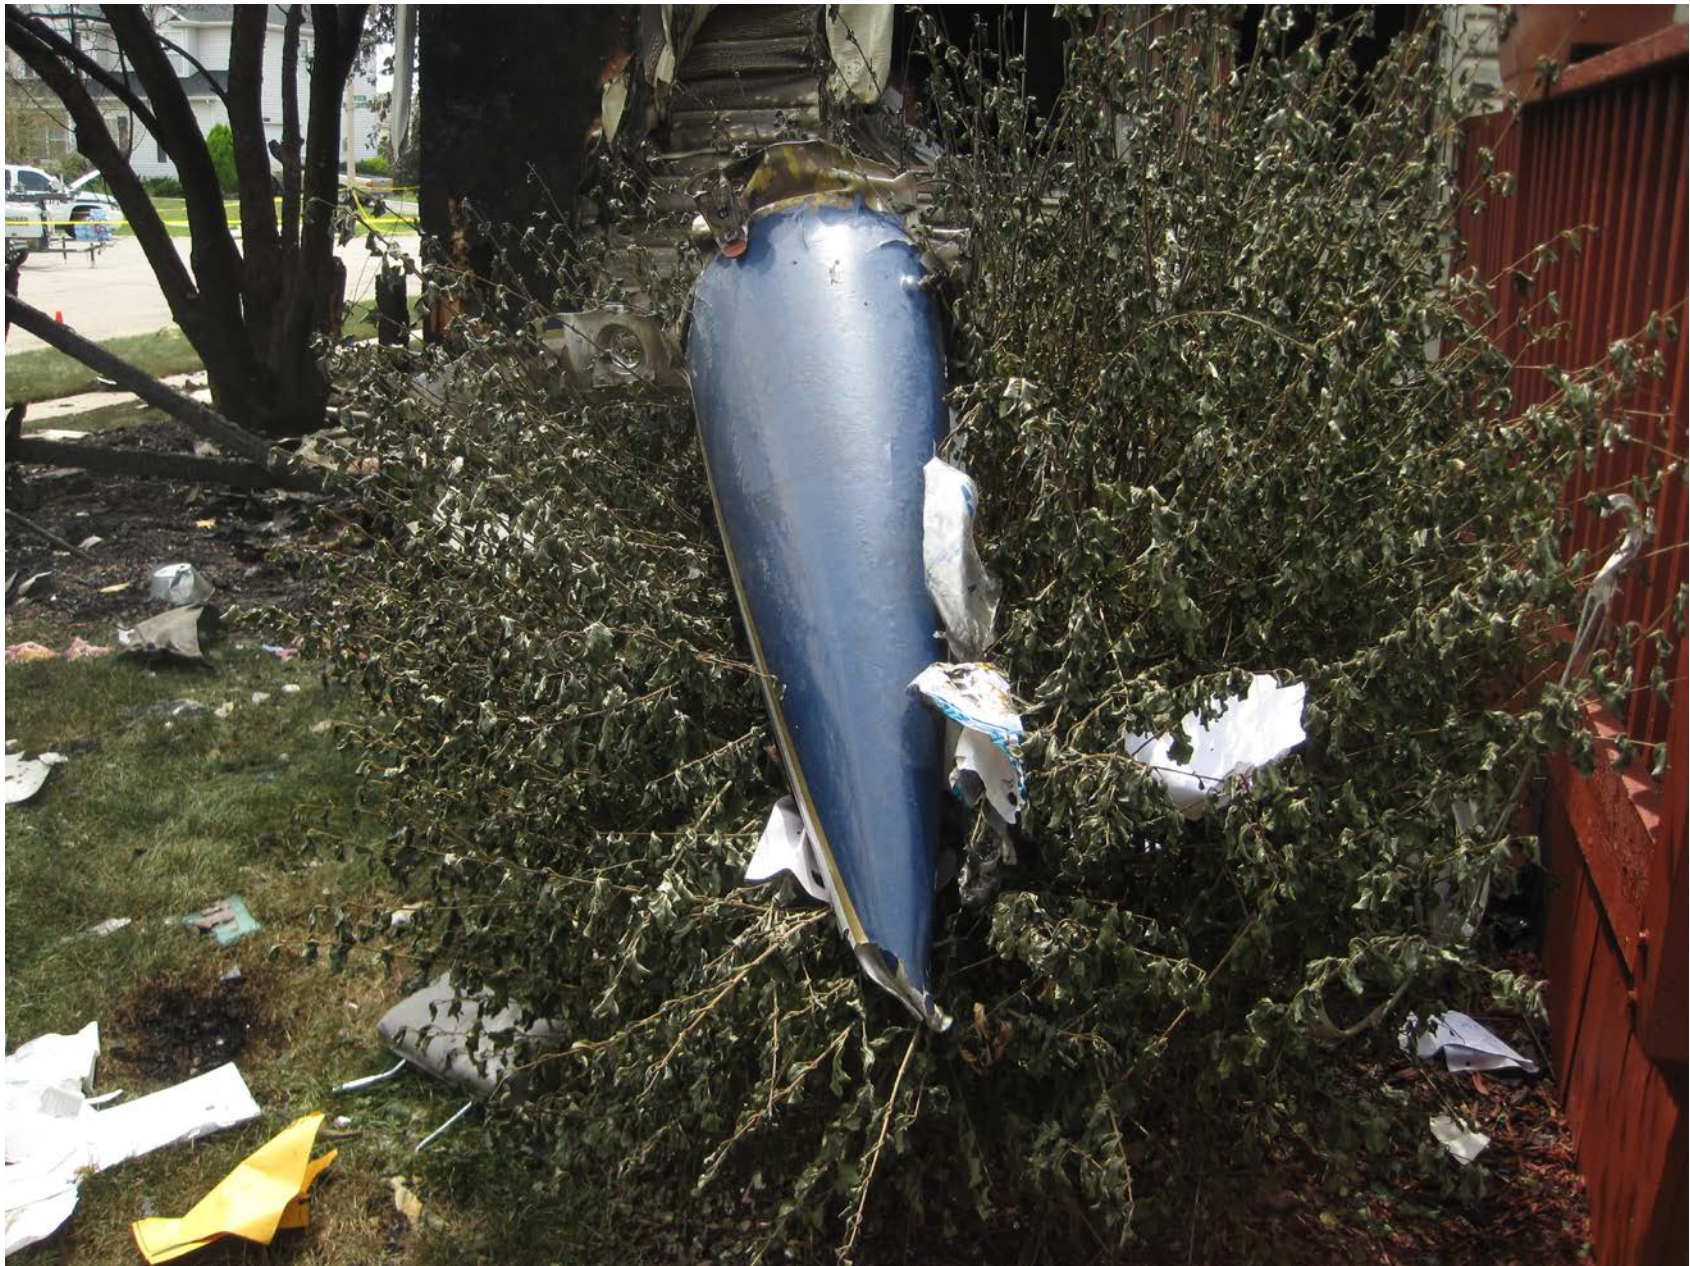
**Photo 19 - View of the right tip tank near the main wreckage.**
