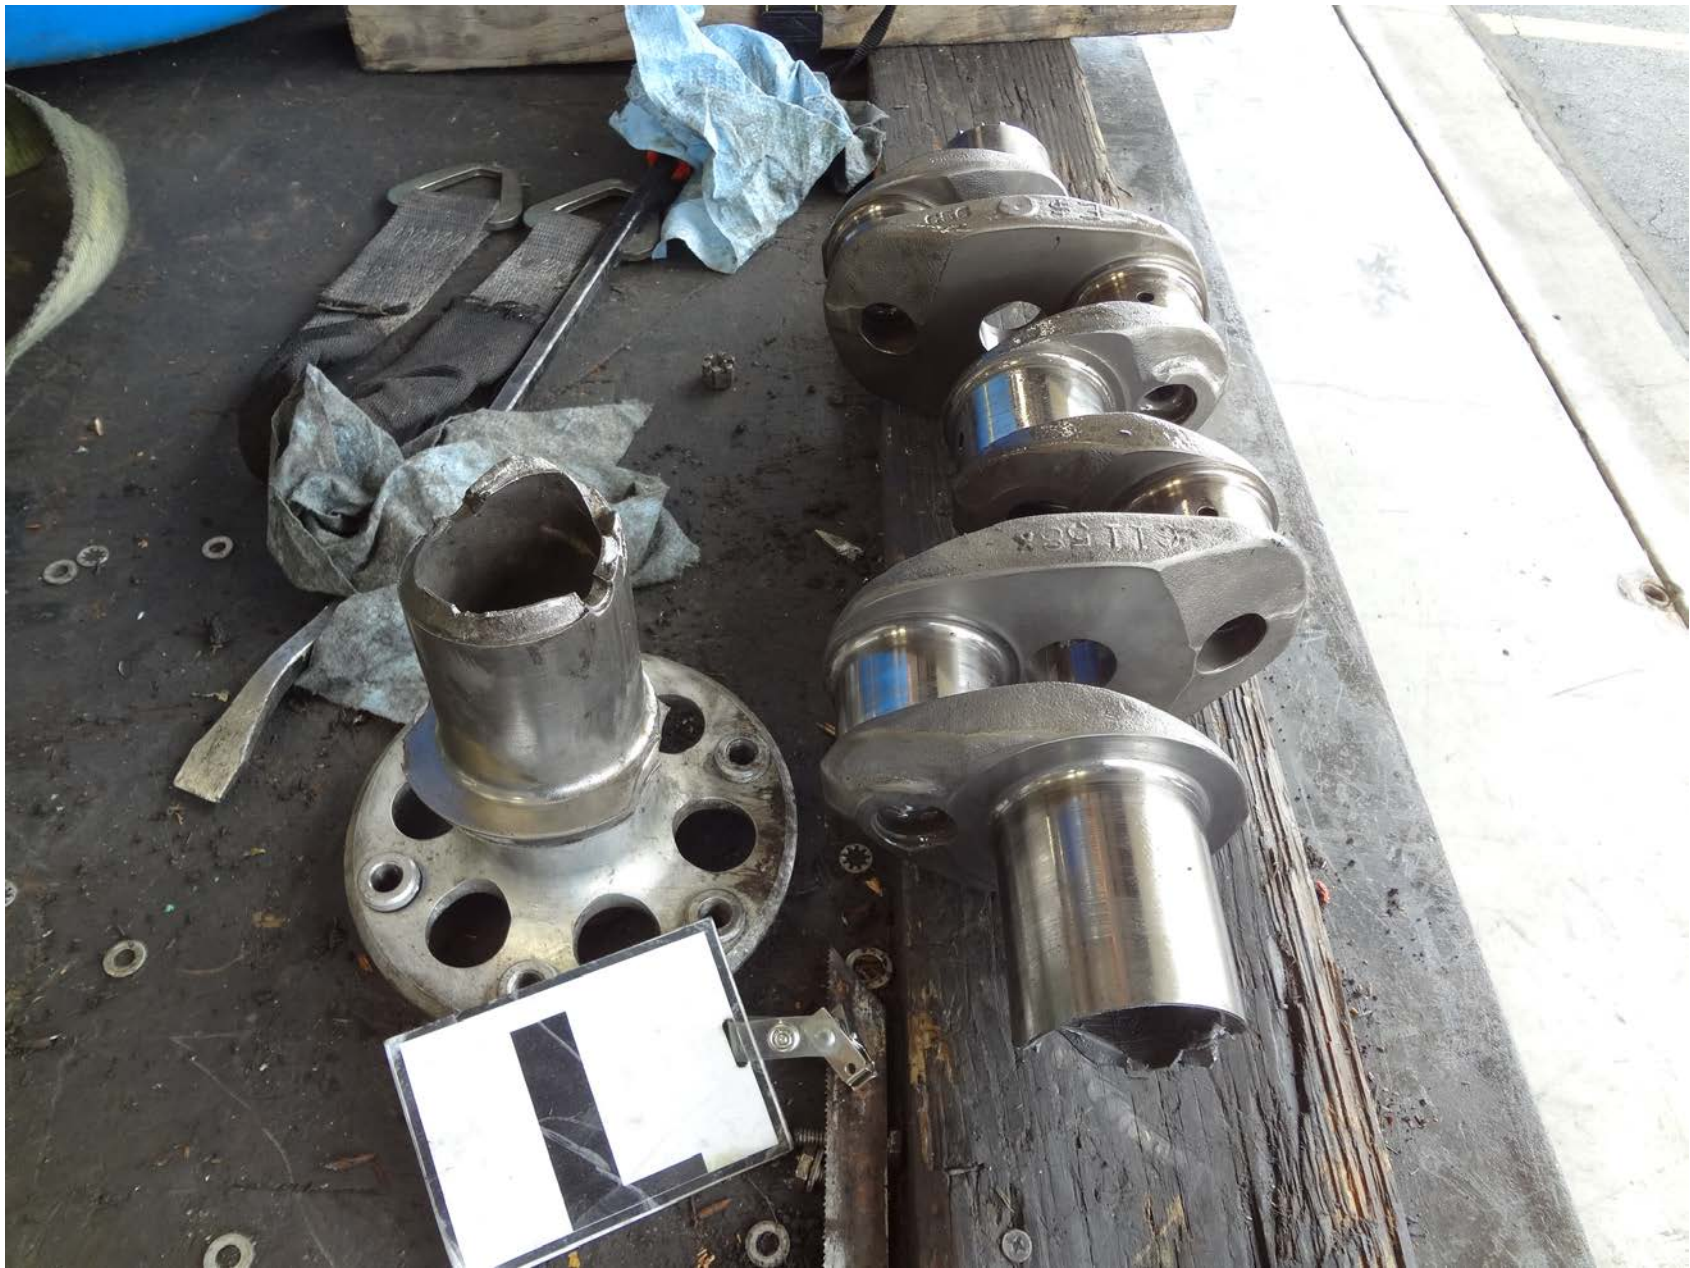
**Photo 20 - View of the left engine crankshaft.**
