**From:** McAtee Nancy  
**To:** [Aguilera Jason](#)  
**Cc:** [Budinski Michael](#)  
**Subject:** CEN16FA282-Stall Switch  
**Date:** Friday, March 9, 2018 4:46:00 PM  
**Attachments:** [Contact for CEN16FA282 switch.jpg](#)  
[CEN16FA282 Stall Switch.JPG](#)  
[close up of contacts neutral.jpg](#)  
[close up of contacts switch down.jpg](#)  
[close up of contacts switch up.jpg](#)

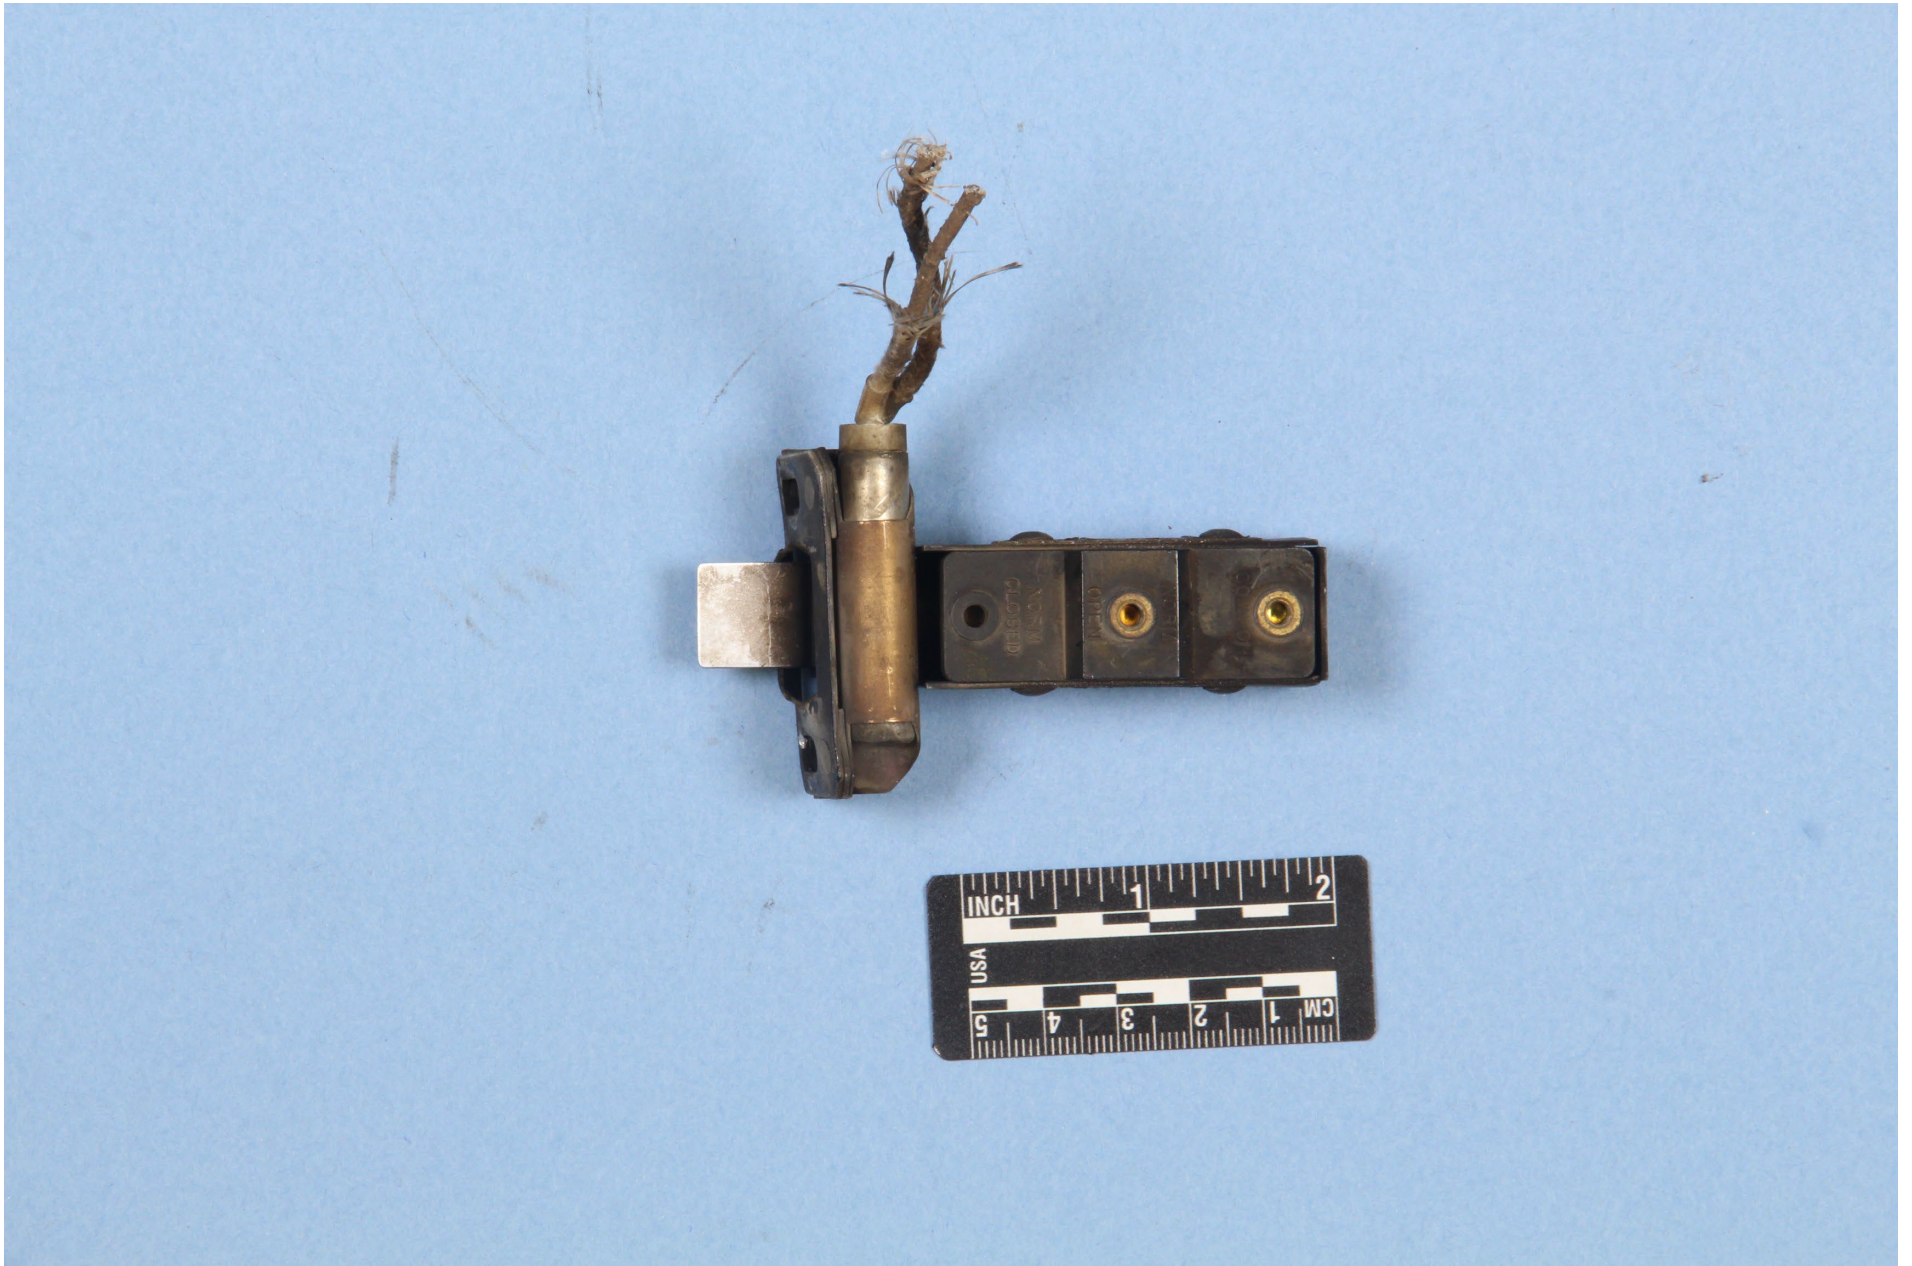
**Photo 1 – Stall Warning Switch**

A stall switch from the accident aircraft was submitted to the Materials Lab for examination. The switch continuity was tested upon receipt of the switch. The continuity for the NORMALLY CLOSED to GROUND did not change with switch position indicating that the switch was not closing the circuit for an unknown reason. The switch was x-rayed in all three switch positions (UP, NEUTRAL and DOWN) to determine the contact position at each switch position. The contact did not appear to move despite switch position. The radiographs are attached to this email.

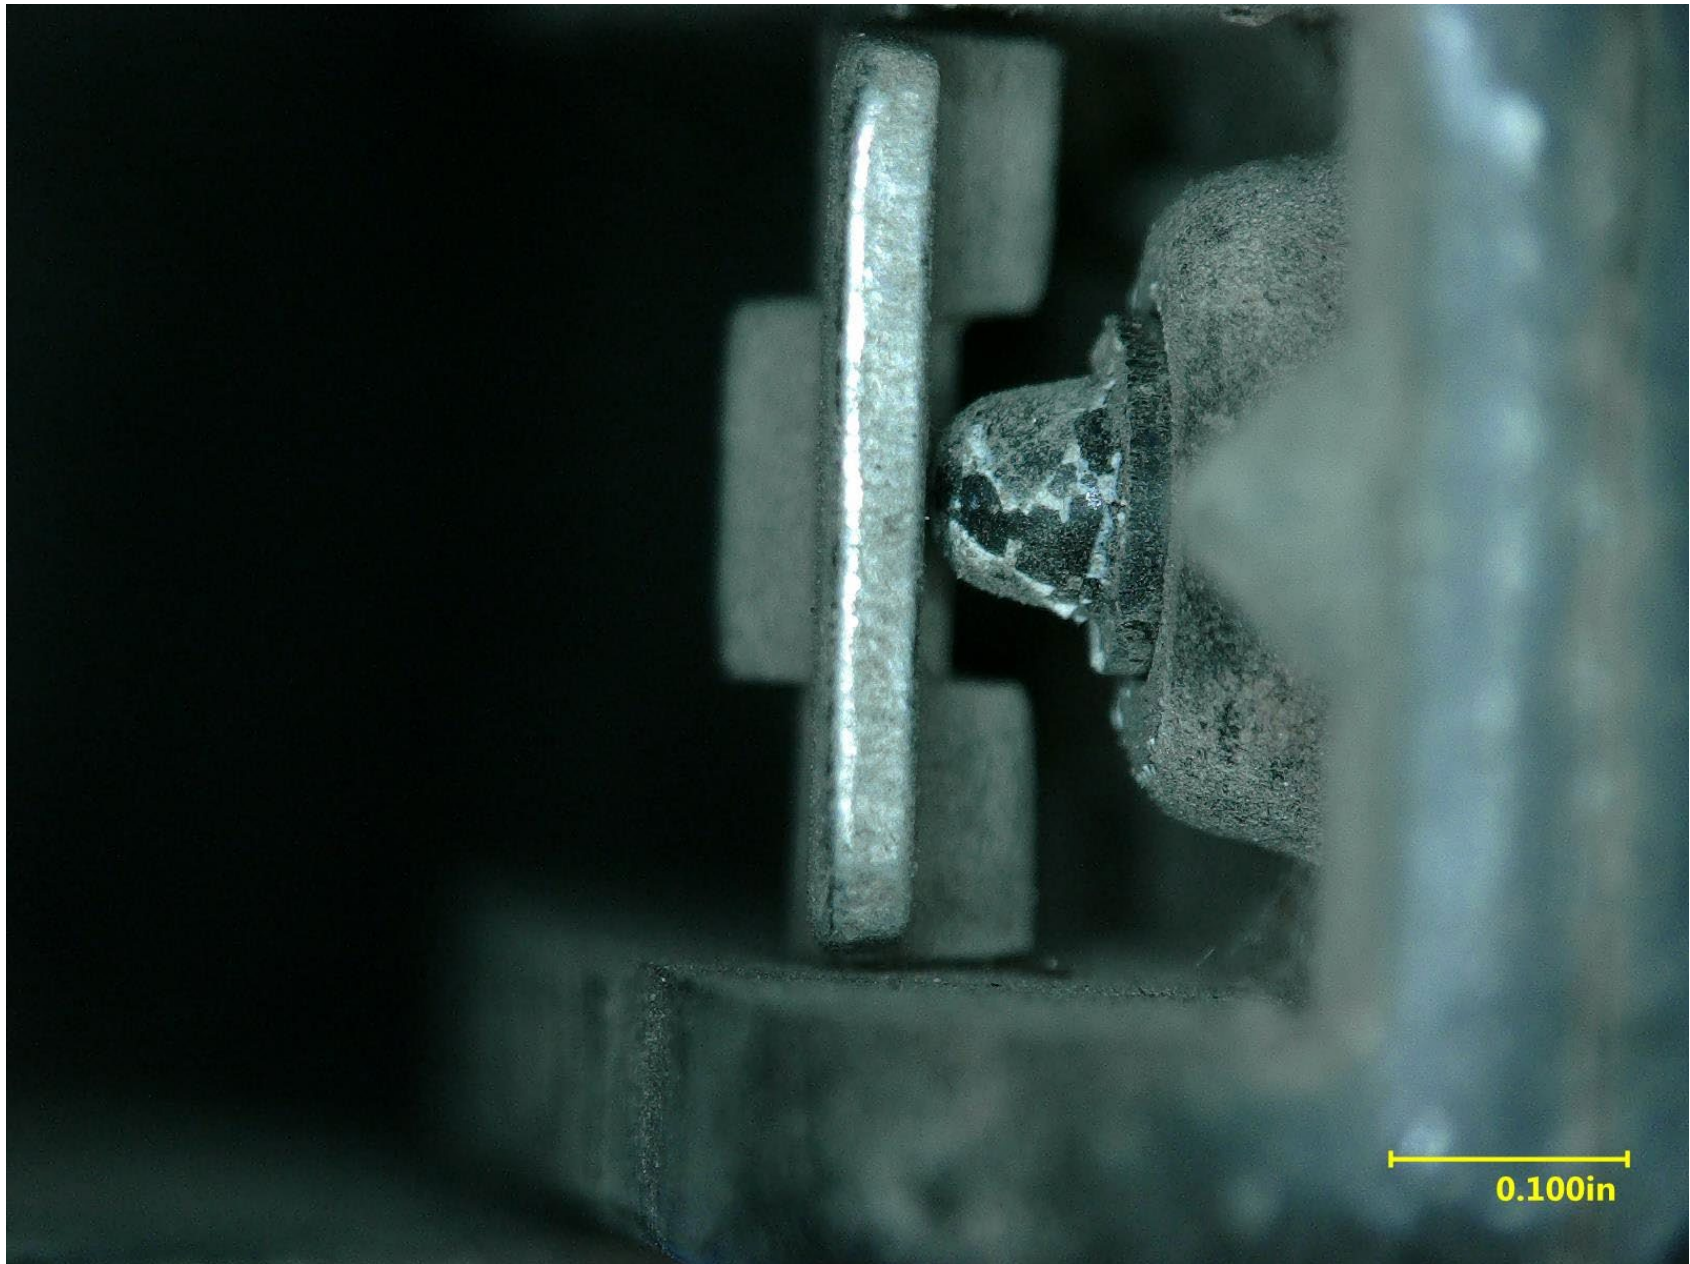
**Photo 5 – Switch Contact**

The case of the switch was removed to determine the cause of the lack of contact movement. The contact was examined. The contact surface was dirty and showed some signs of corrosion but there was no obvious cause for the binding of the contact. A close-up photograph is attached to this email. Once the case was removed, the continuity for the NORMALLY CLOSED to GROUND tested appropriately-circuit closed when the switch was in the UP position. The cause of the original continuity failure and lack of contact movement could not be determined.
