**NATIONAL TRANSPORTATION SAFETY BOARD**  
Vehicle Recorder Division  
Washington, D.C. 20594

## **Engine Data Monitor (EDM)**

**Specialist's Factual Report**  
**By Joe Gregor**

Location: Leshara, Nebraska  
Date: July 24, 2016  
Aircraft: Beech 95-B55  
Registration: N55NE  
Operator: LeMay Aero Club  
NTSB Number: CEN16FA282

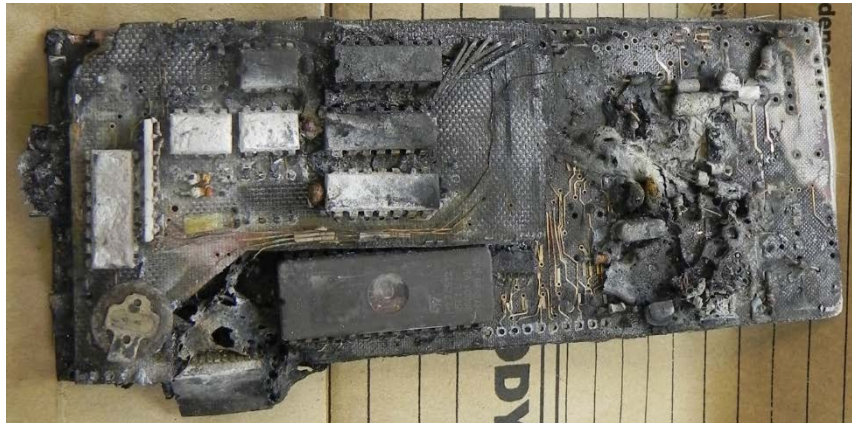
The recorder was catastrophically damaged due to fire (see figure 1). X-ray examination of the integrated circuit memory 'chips' used to store parametric data recorded by the unit showed evidence of catastrophic heat damage including melting of the gold wire-bond

**Figure 1. Image of the main printed circuit board showing effects of catastrophic fire damage.**

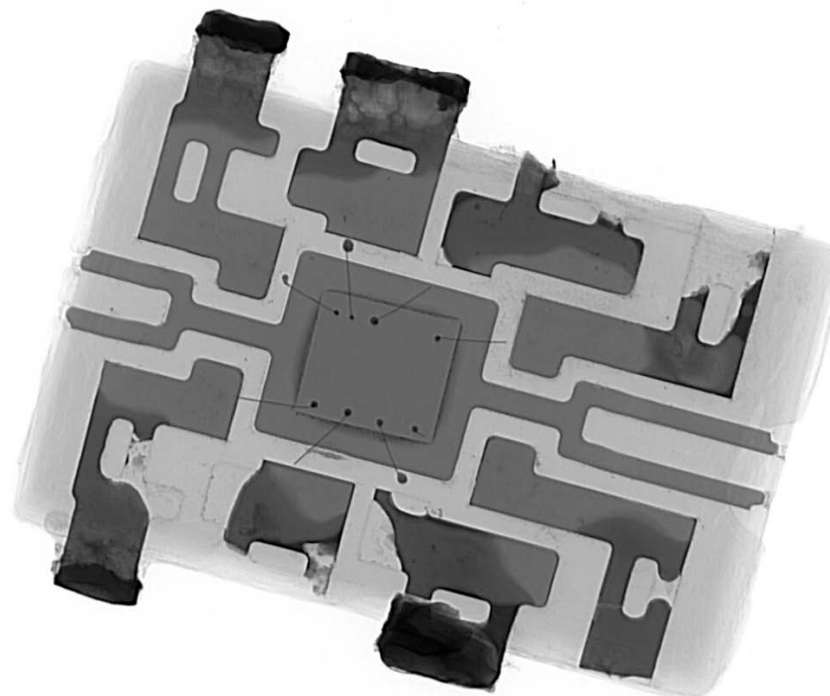
connections between the internal silicon die and the pins of the integrated circuit packaging (see figure 2). The packaging itself was rendered extremely friable and portions of many of the pins used to interface the integrated circuit to the external circuitry were consumed by fire (see figure 3).

**Figure 2. X-ray image of FLASH memory integrated circuit showing melting of the gold bond wires.**

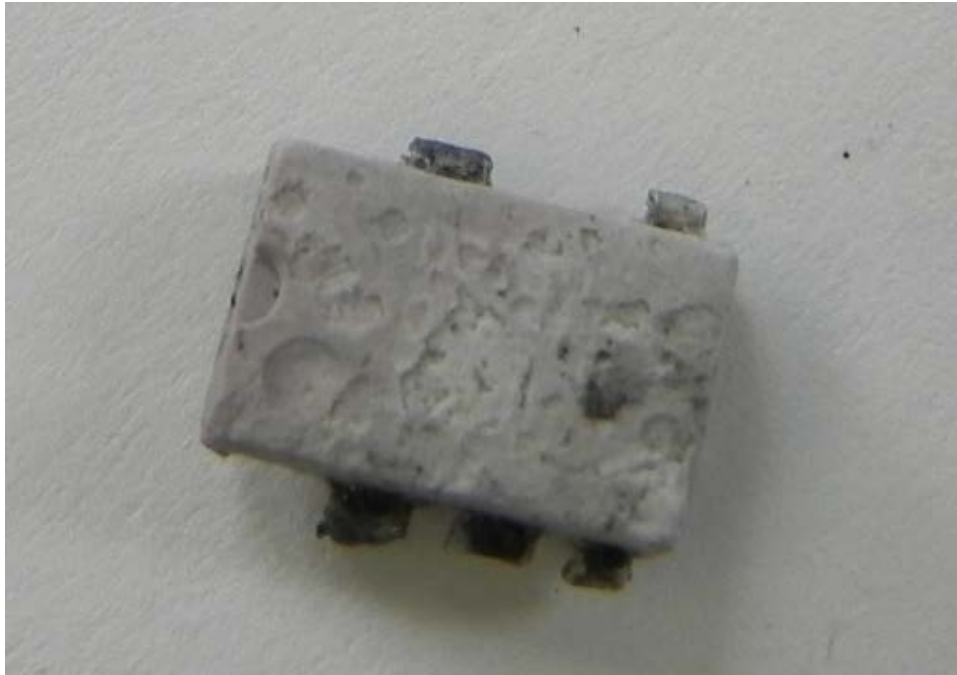
**Figure 3. Image of FLASH memory integrated circuit showing fire damage to leads and packaging**
