# **GROUP CHAIRMAN'S FACTUAL REPORT OF INVESTIGATION**

**CEN16FA307**

## Onboard Image Recorder

Location: Burns Flat, Oklahoma  
Date: August 6, 2016  
Aircraft: Bugatti-Demonge 100P  
Registration: N110PX  
Operator: Private  
NTSB Number: CEN16FA307

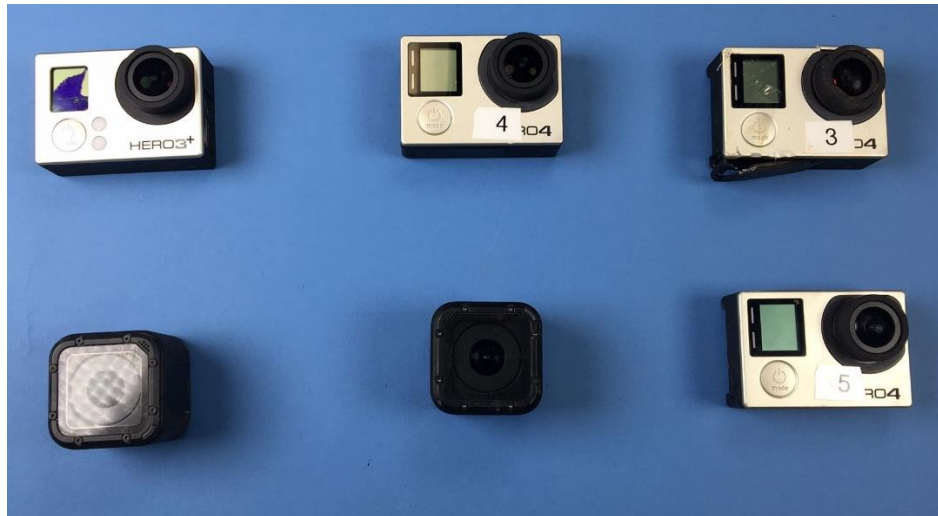
**Figure 1. The condition of the GoPro Cameras**

Figure 1 shows the condition of the six GoPro cameras upon receipt by the NTSB Vehicle Recorders laboratory. The six cameras had various states of mechanical damage ranging from light, to an entirely displaced rear camera frame (top right). The cameras were shipped with their associated microSD cards seated in the camera's chassis. All microSD cards were present and appeared undamaged.

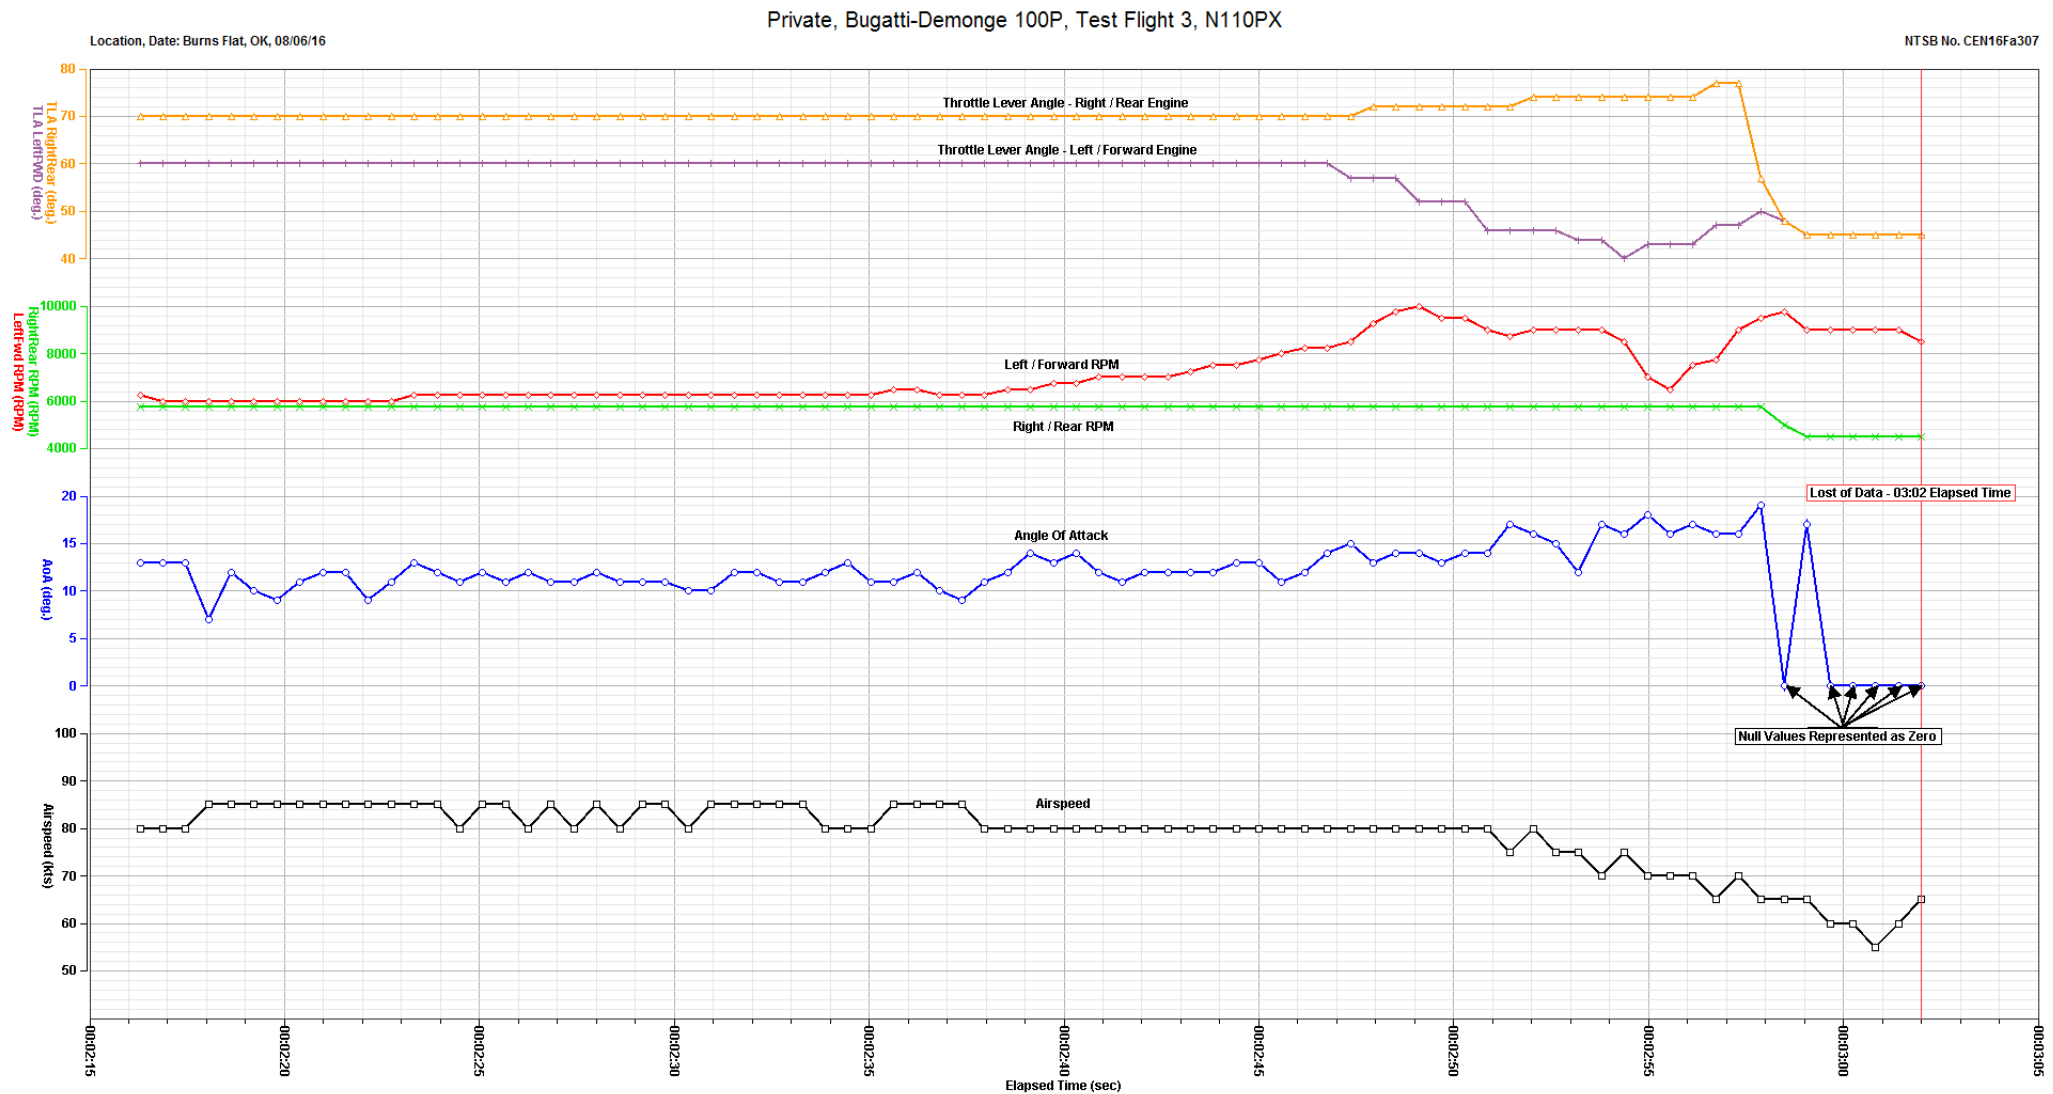
Figure 2. A plot of relevant flight data created from information captured on the GoPro Cameras.

Around 02:39, there was a noticeable pitch change in the ambient engine noise. The pilot did not appear to change the throttle settings. The RPM indicator for the left/forward engine began to climb, the RPM indicator for the right/rear engine appeared to remain at a stabilized setting. At 02:42, the pilot looked downward and to his right correlating to the area of the hydraulic valve lever within the cockpit. The end of runway 35L became visible under the aircraft. The aircraft was significantly left of runway centerline. At 02:44, the pilot appeared to reach with his right arm toward the location of the hydraulic valve lever. The throttles were visible as the pilot removed his left hand from that area and began to fly using his left hand on the control stick. The left/forward engine throttle lever, then appeared to be a knob and half width distance from the right/rear

engine throttle lever. The RPM indicator for the left/forward engine was around 7,750 RPM and trending upward. The AoA indicator began climbing above its previously indicated range of +11 and +13 degrees to about + 15 degrees. About two seconds later at 02:46, the pilot replaced his right hand on the stick and the left hand on the throttle levers. The aircraft entered an uncommanded slight left roll. The left/front engine RPM indicator approached around 8250 RPM, and the engine was heard surging. At 02:48, the left/forward engine RPM reached about 10,000 RPM. Almost immediately thereafter, at 02:49, the pilot used his left hand to pull back the left/forward engine throttle lever. At 02:54, the left/forward RPM lever was almost in the closed position, the ambient engine noise decreased slightly, and the RPM indicator for the left/forward engine rolled back to about 7,000 RPM around 02:55. At the same moment, the airspeed was noted as being around the start of the green arc (70 knots).

At 02:56, the ambient sound of an engine appeared to surge once more. The pilot appeared to have pushed the right/rear engine throttle lever forward. The left/fwd engine RPM then indicated a surge took place to about 9,500 RPM (redline) at 02:58. The position of the left/forward throttle lever was still nearly at the closed position. The aircraft rolled right. The right roll appeared uncommanded. Some flutter was on the aircraft's left aileron. As the aircraft slowed, aileron flutter on the left aileron was seen up until nearly the moment of impact. The airspeed indicator appeared to be slightly below the green arc at around 65 knots.

The pilot regained control of the right roll and the aircraft was once again briefly level. One second later at 02:59 the aircraft began a uncommanded left roll, the airspeed indicated about 65 knots. The AoA indicator showed +18 degrees. The stick appeared to be in a mostly neutral position. The left/forward engine RPM remained around 9,000 RPM and the right/rear RPM was around 4,500 RPM. As the aircraft rolled 90 degrees to the left, the pilot placed both hands on the control stick. The pilot's input to the control stick was commanding a right roll and a positive pitch attitude. The aircraft continued to roll left and the nose dropped significantly, a green bean field came into view out of the front windscreen. The AoA indicator indicated two dashes as the aircraft rolled inverted.

The aircraft impacted the ground around 03:02. At the time of impact, airspeed was indicated just above 65 knots. The left/forward engine showed an indicated RPM of about 9,000. The right/rear engine remained about 4,250 RPM.

Figure 2 is a plot of the flight data obtained from the data logging exercise. The time interval displayed is between 02:15 to 03:05 elapsed time.
