**National Transportation Safety Board**  
Office of Research and Engineering  
Washington, D.C. 20594

## Airplane Performance Study

| Airplane: | Experimental Amateur-Built Wilson Bugatti-DeMonge 100P, N110PX |
| NTSB Number: | CEN16FA307 |

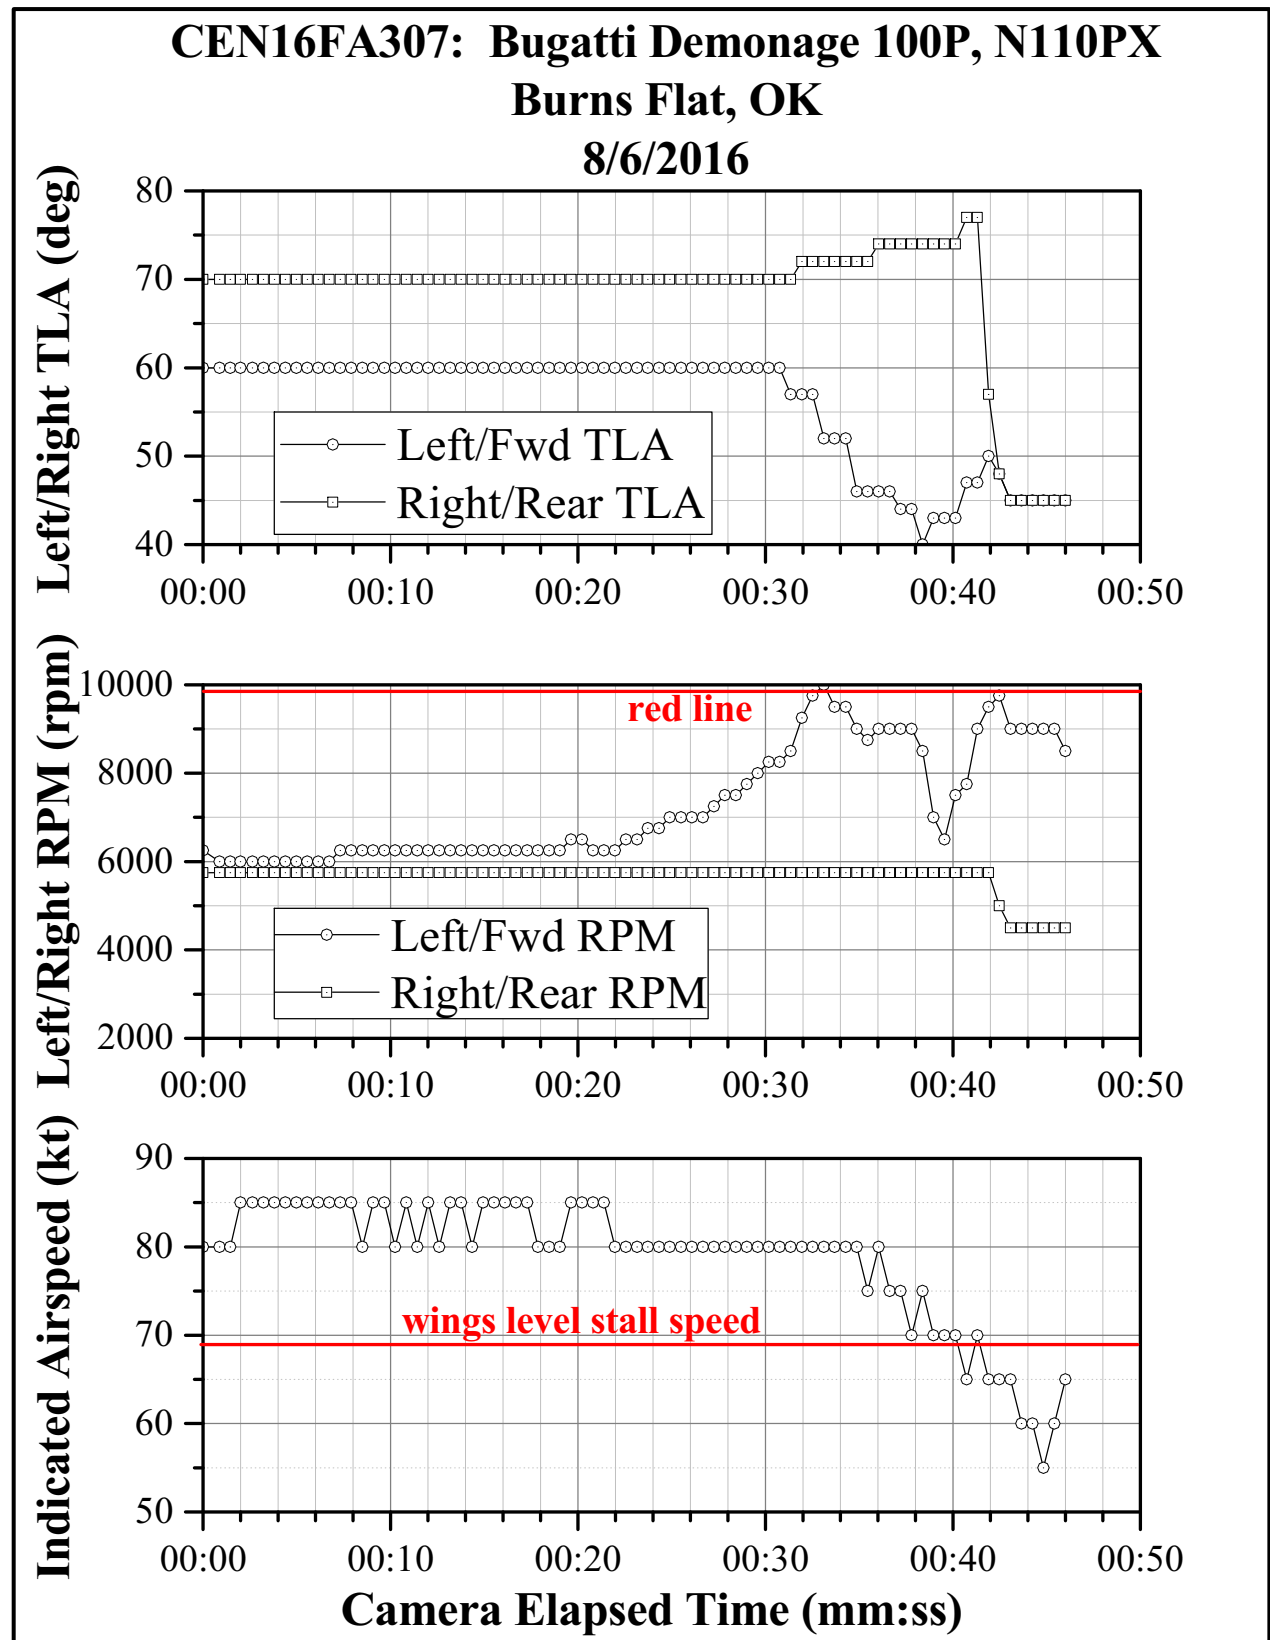
Figure 4: Throttle Lever Angle, Engine RPM, and Speed Based on Cockpit Video

Figure 4 is a plot of the tabulated TLA’s, RPM’s, and VIAS’s as a function of camera elapsed time. The data show that the engine speed for the forward engine began increasing from 6,000 RPM about seven seconds into the recording without any apparent TLA input from the pilot. The pilot responded by reducing TLA for the forward engine at 31 seconds into the recording, about two seconds before the forward engine reached its red line of 9,500 RPM.

The pilot continued to reduce TLA to a minimum of about 40° for the forward engine until, at about 38 seconds elapsed time, he increased the forward TLA by 10°. This was likely in response to the airplane’s decaying airspeed. The forward engine reached red line for a second time at about 42 seconds elapsed time.

The input TLA and engine RPM for the right/rear engine appear more consistent than for the left/forward engine; however, it too has an anomaly. The RPM for the rear engine remained at approximately 5,800 RPM<sup>2</sup> for most of the recording until, at 31 seconds elapsed time, the pilot began increasing the rear engine TLA by 7° over about ten seconds. During this time, the rear engine RPM remained constant despite the 7° increase in TLA. The RPM on the right engine reduced to about 4,500 RPM after the pilot pulled the TLA back to 45° at 41 seconds elapsed time<sup>3</sup>.

The airspeed plot in Figure 4 shows that the airplane decelerated below the published stall speed of 70 KEAS (based on a gross weight of 2,850 lb and a normal load factor of 1.0<sup>4</sup>) about 41 seconds elapsed time and remained below the stall speed for the remainder of the recording. An aerodynamic stall is also consistent with the witness statement.

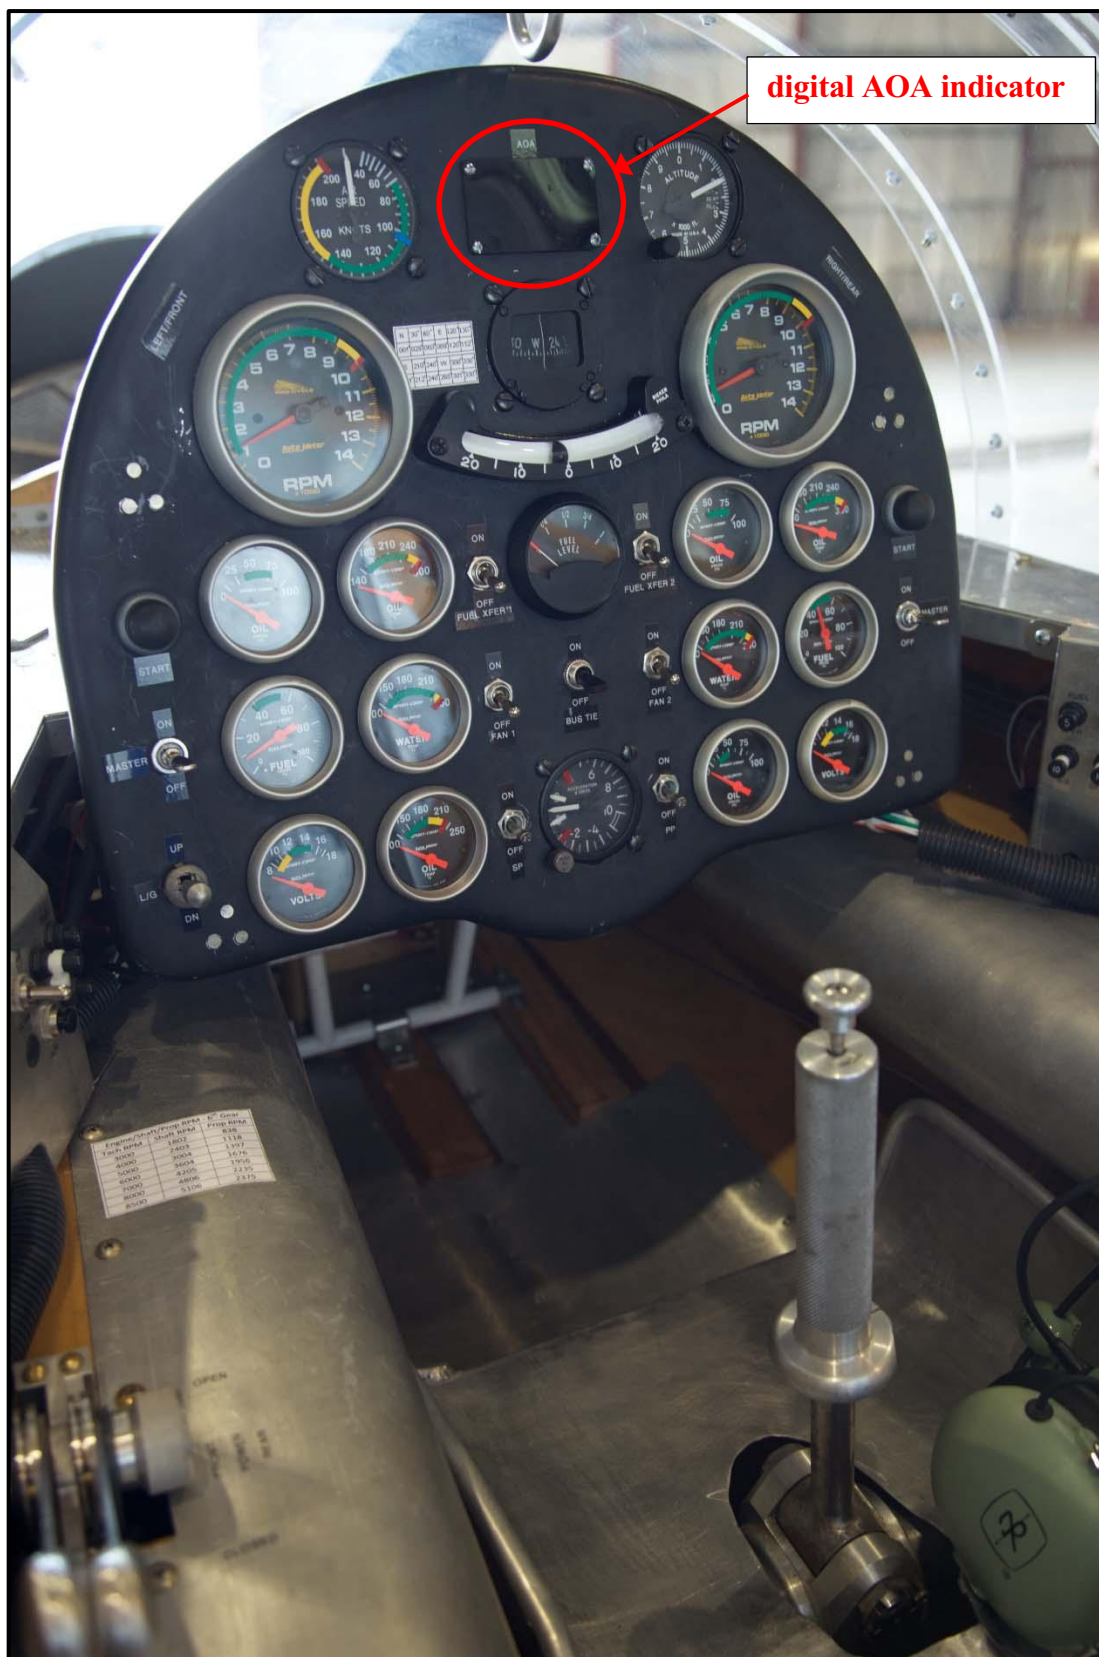
Figure 5: Instrument Panel of Accident Airplane

Using the tabulated airspeed (VIAS) and an approximate gross weight of 2,650 lb, the airplane lift coefficient ( $C_L$ ) for the Bugatti-DeMonge 100P was extracted from the data as a function of indicated angle-of-attack. (Figure 5 highlights the location of the digital angle-of-attack indicator in the cockpit.)

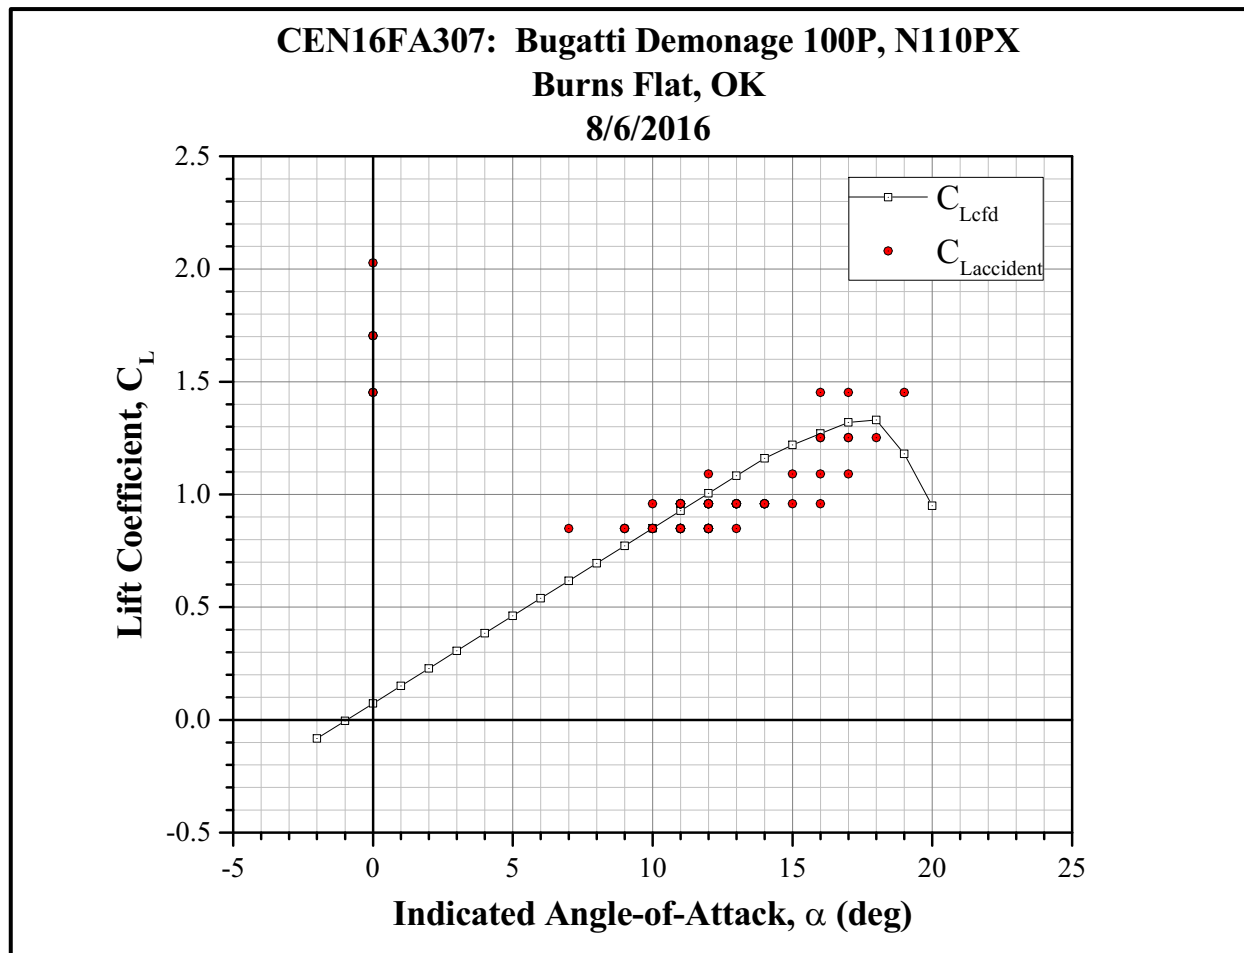
Figure 6: Lift Coefficient Based on Accident Data

Figure 6 shows the lift coefficient as a function of angle-of-attack that was extracted from the accident data as well as the lift derived by the Le Reve Bleu team using computational fluid dynamic methods. Despite a few outliers at the end of the flight (where indicated angle-of-attack was unavailable), the lift from the accident compares well with design estimates.

Lift data extracted from the accident data compares well with engineering estimates for the airplane. This lends some credibility to the stall speeds published for the Bugatti airplane.

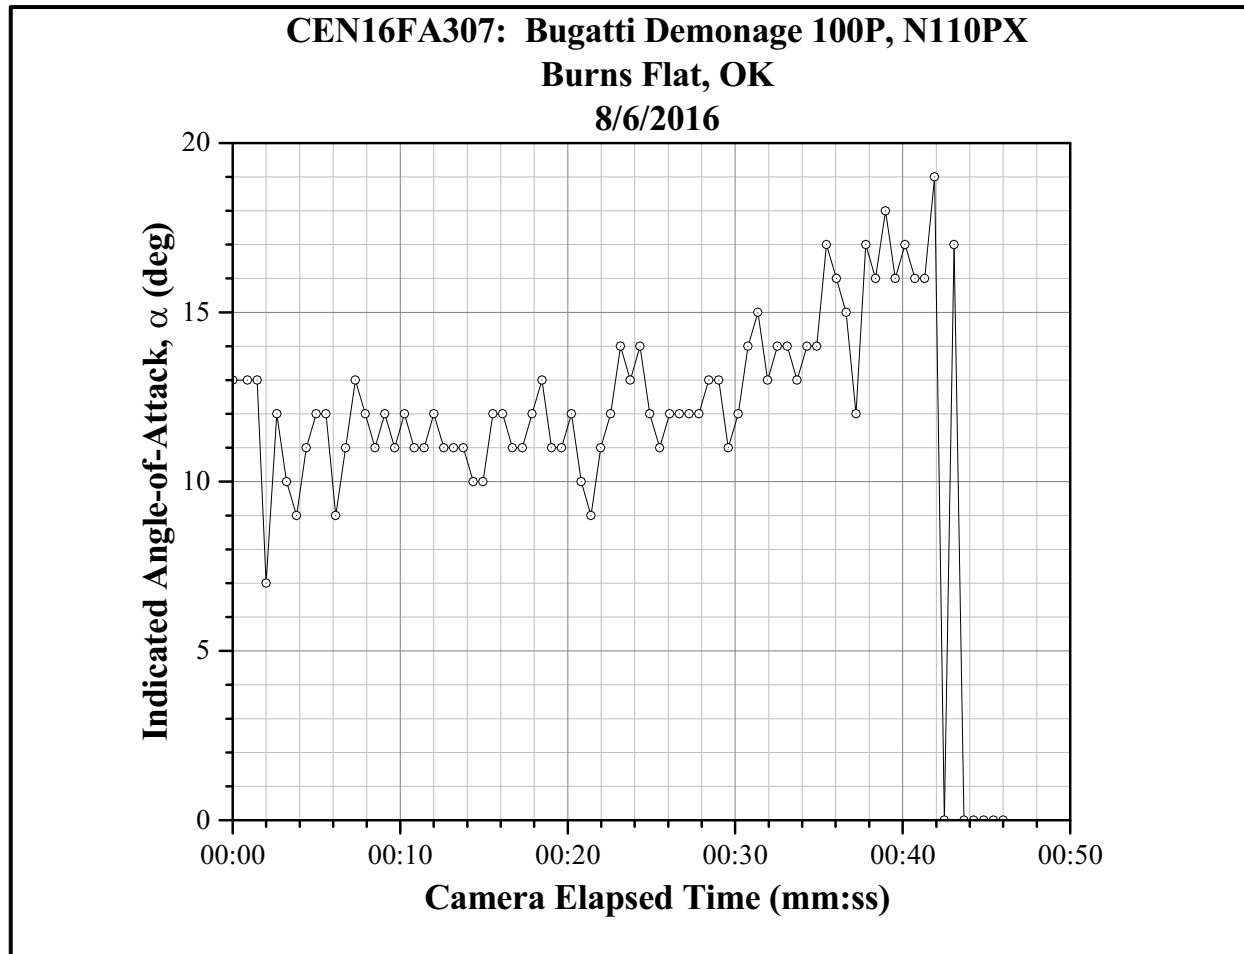
**Figure 7: Angle-of-Attack from Digital Instrument in Cockpit**

Figure 7 is a plot of the indicated angle-of-attack from the image recorders.
