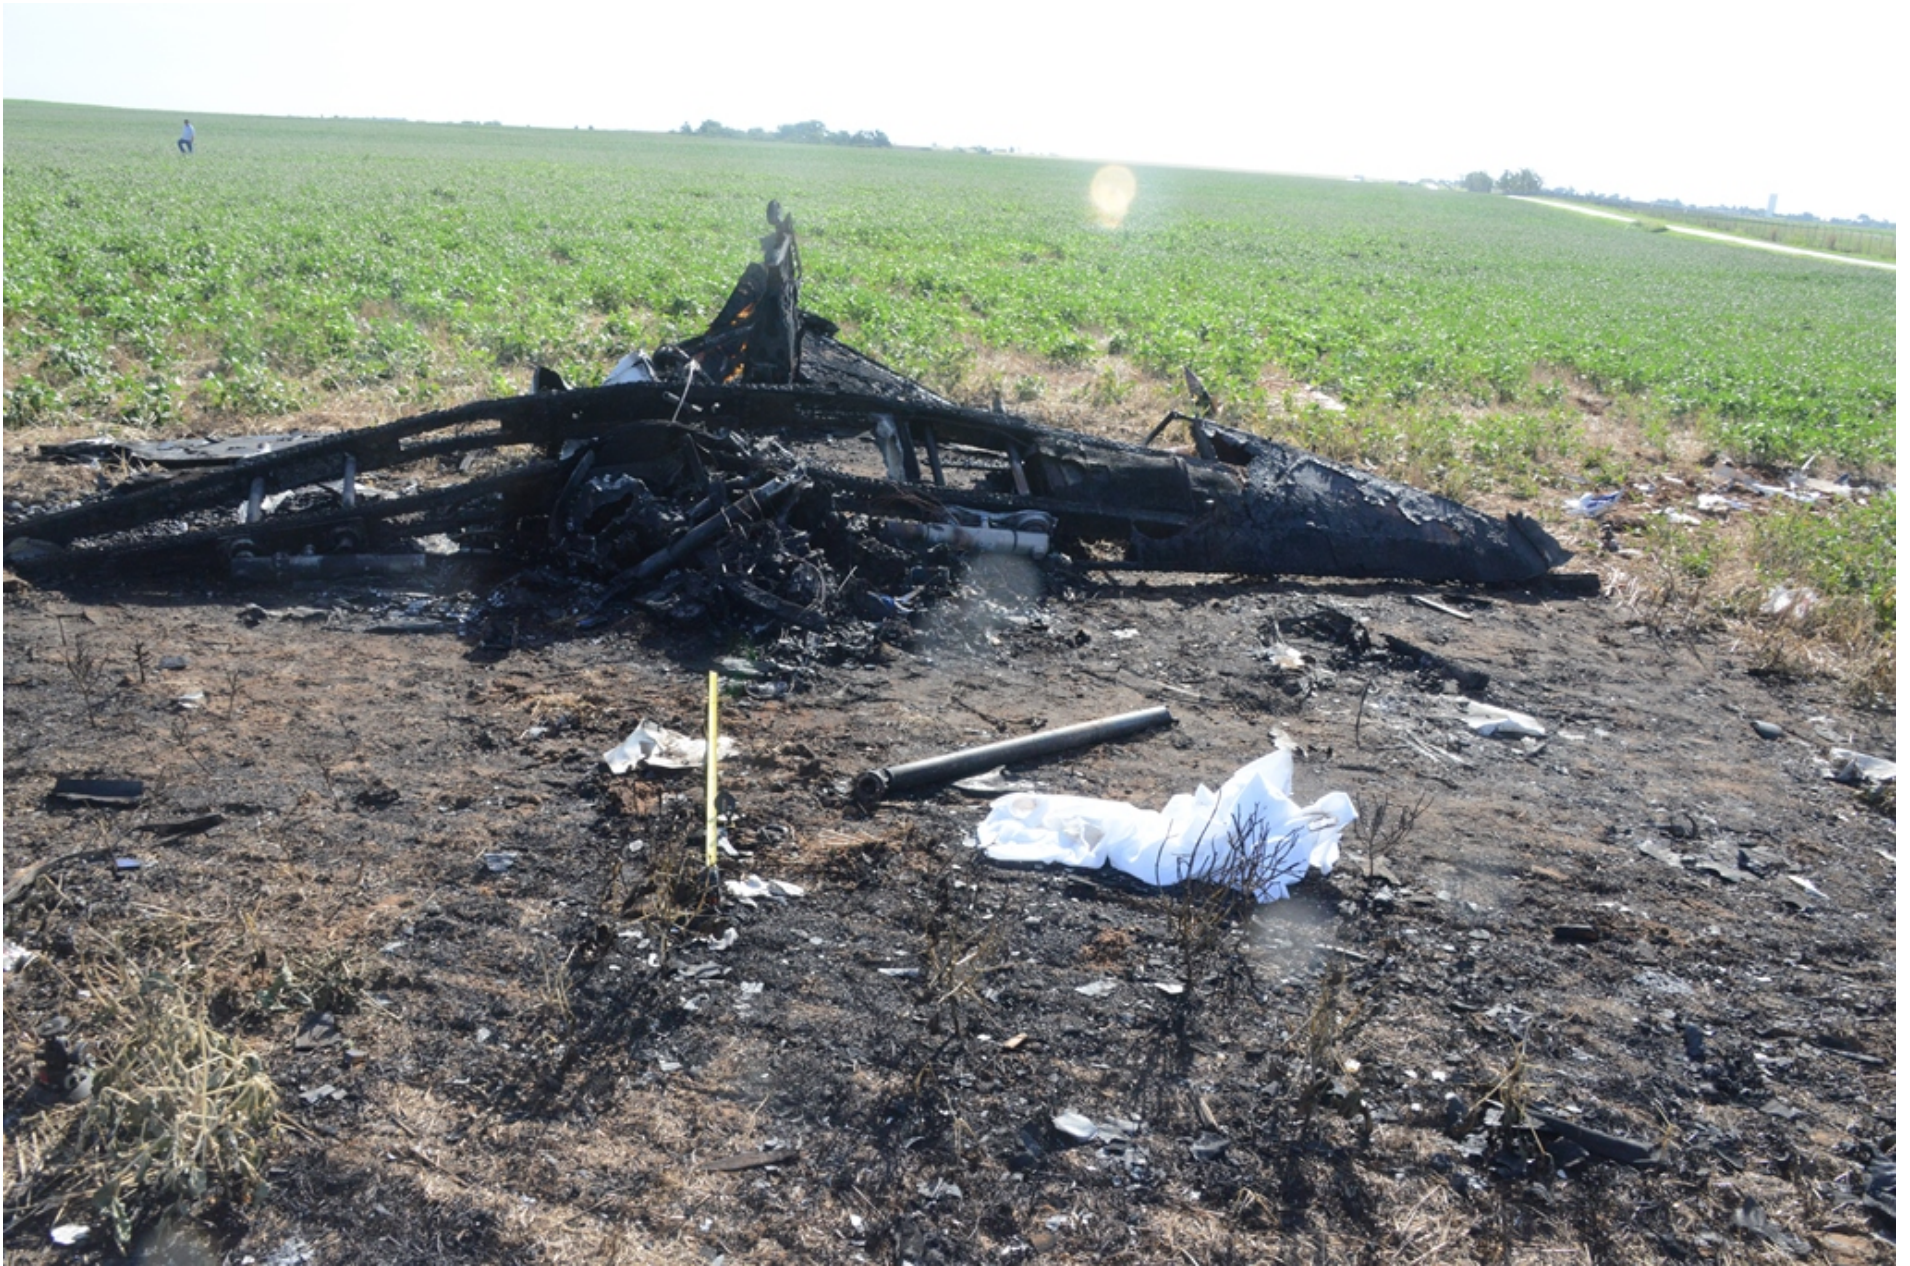
**Photo 1 – View of the front of the inverted airplane at the accident site.**

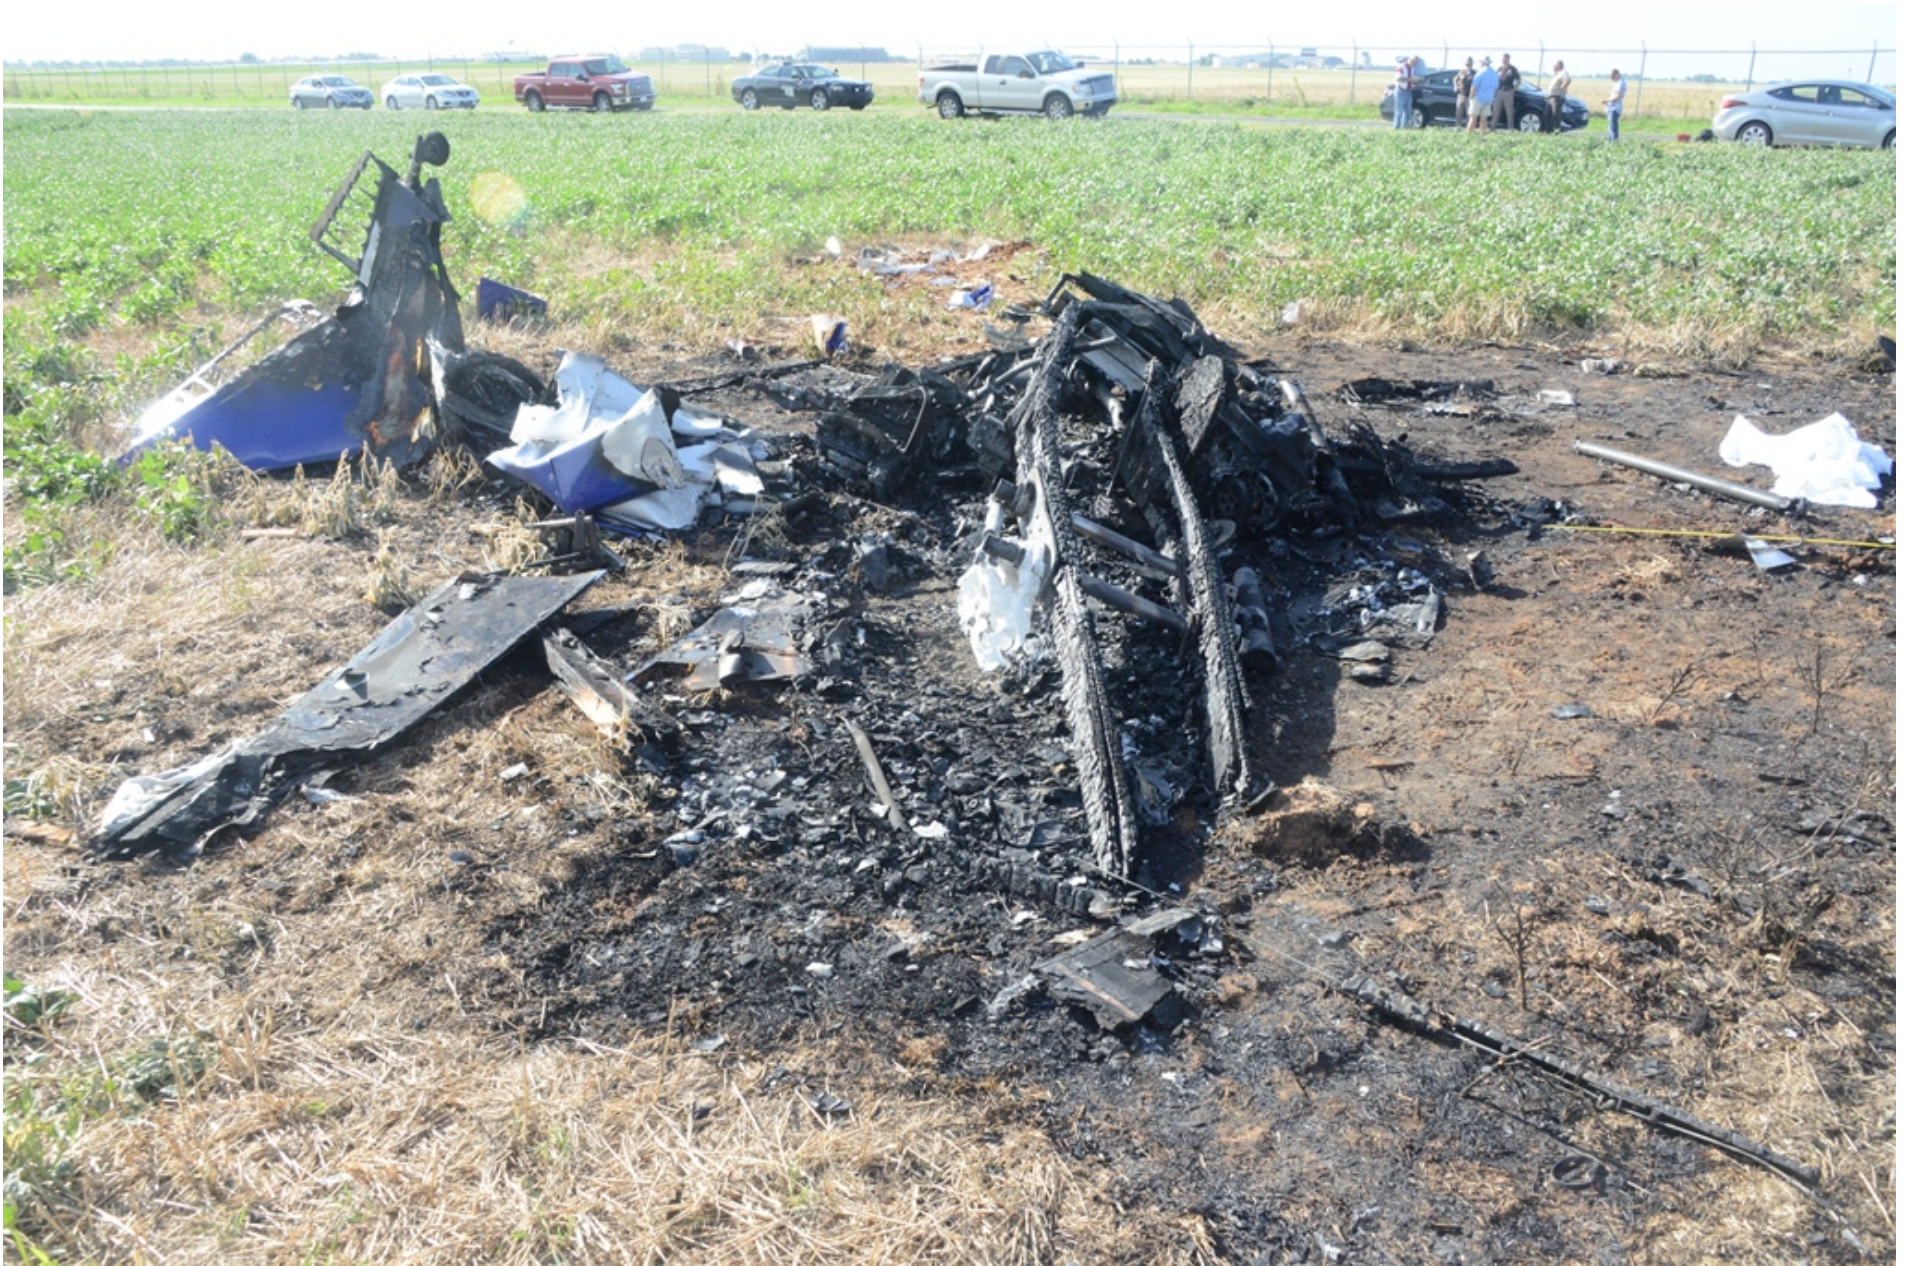
**Photo 2 - View of the left side of the inverted airplane at the accident site.**

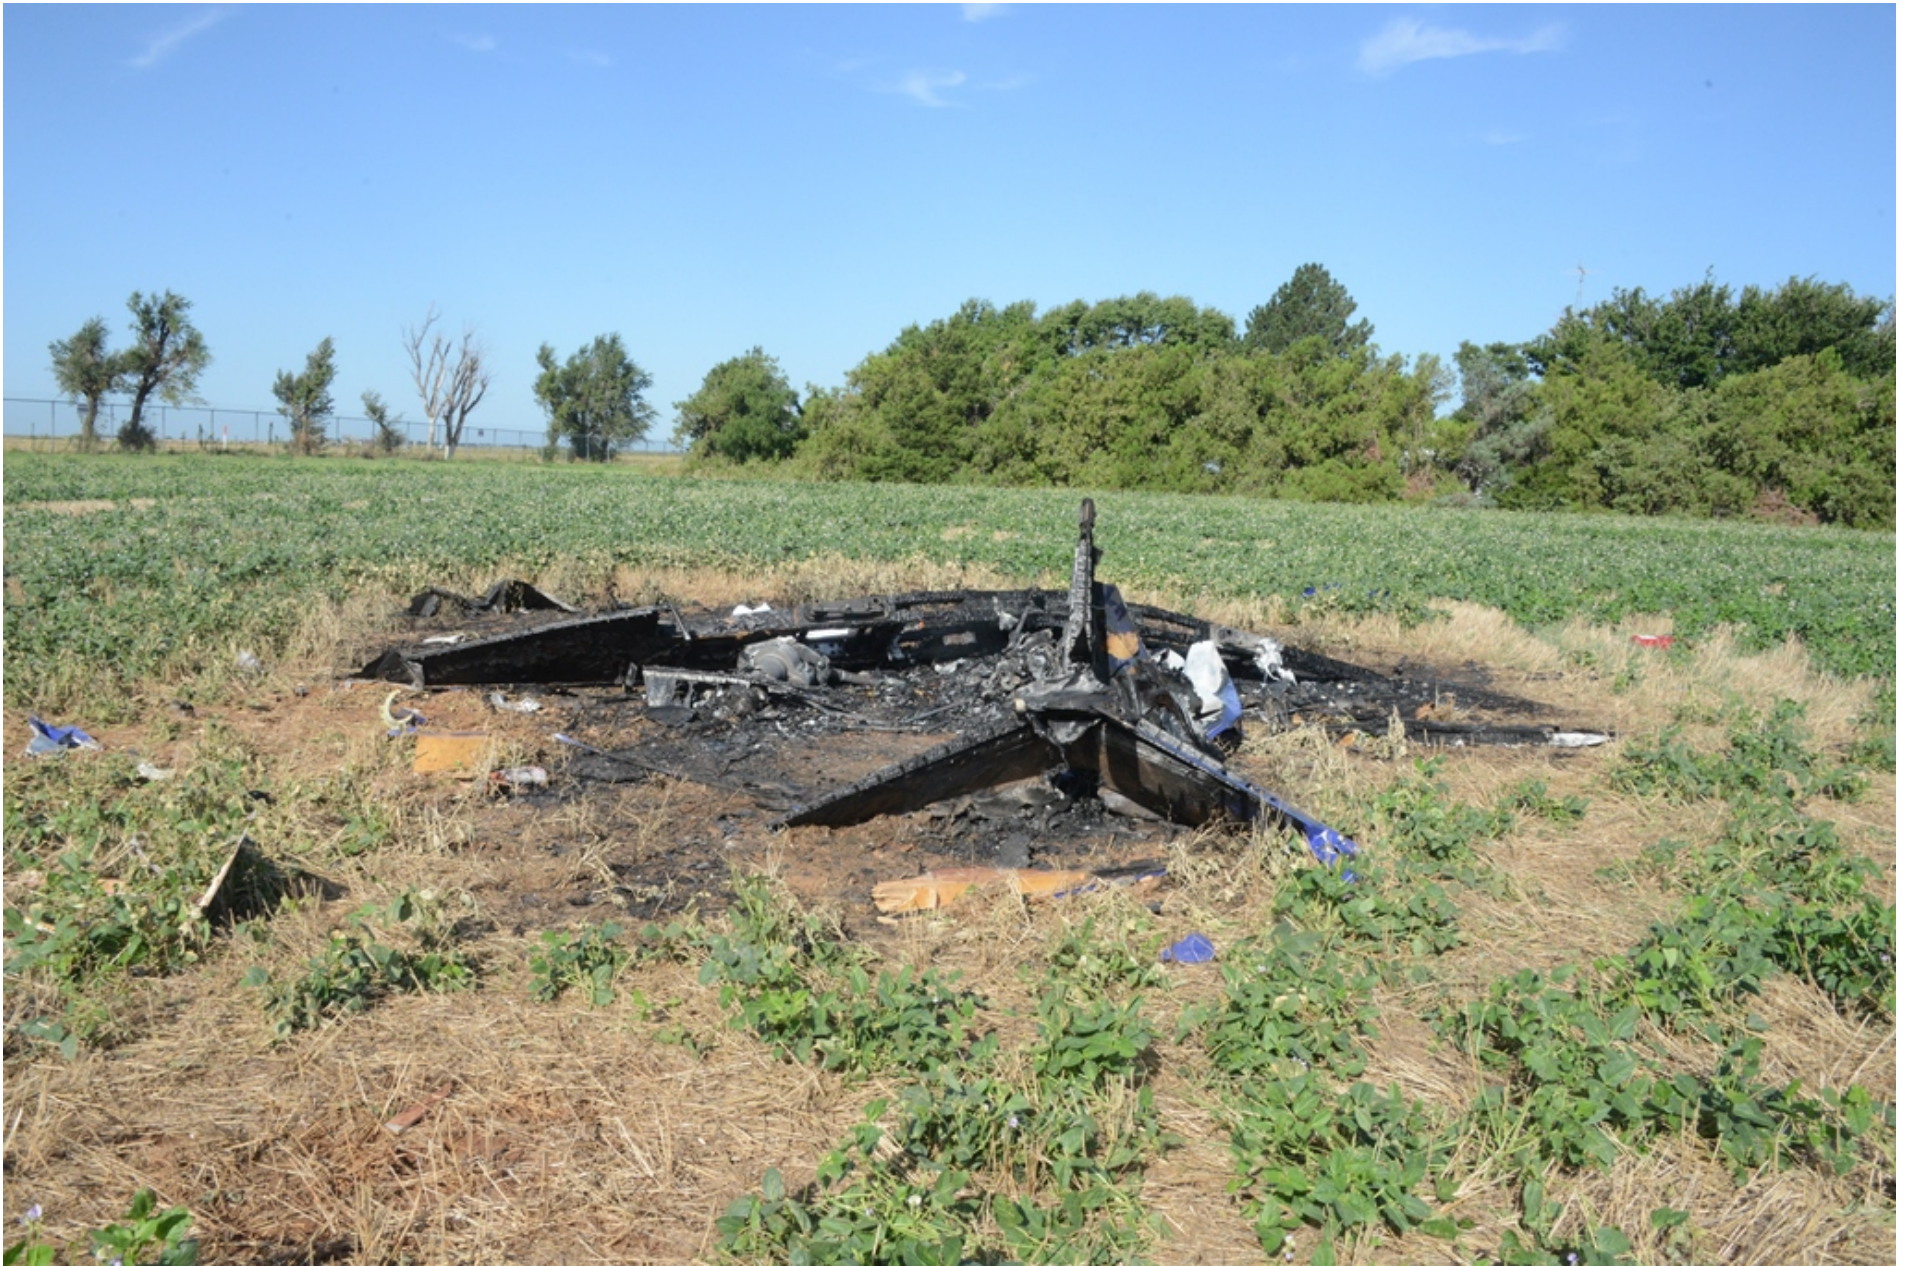
**Photo 3 - View of the aft side of the inverted airplane at the accident site.**

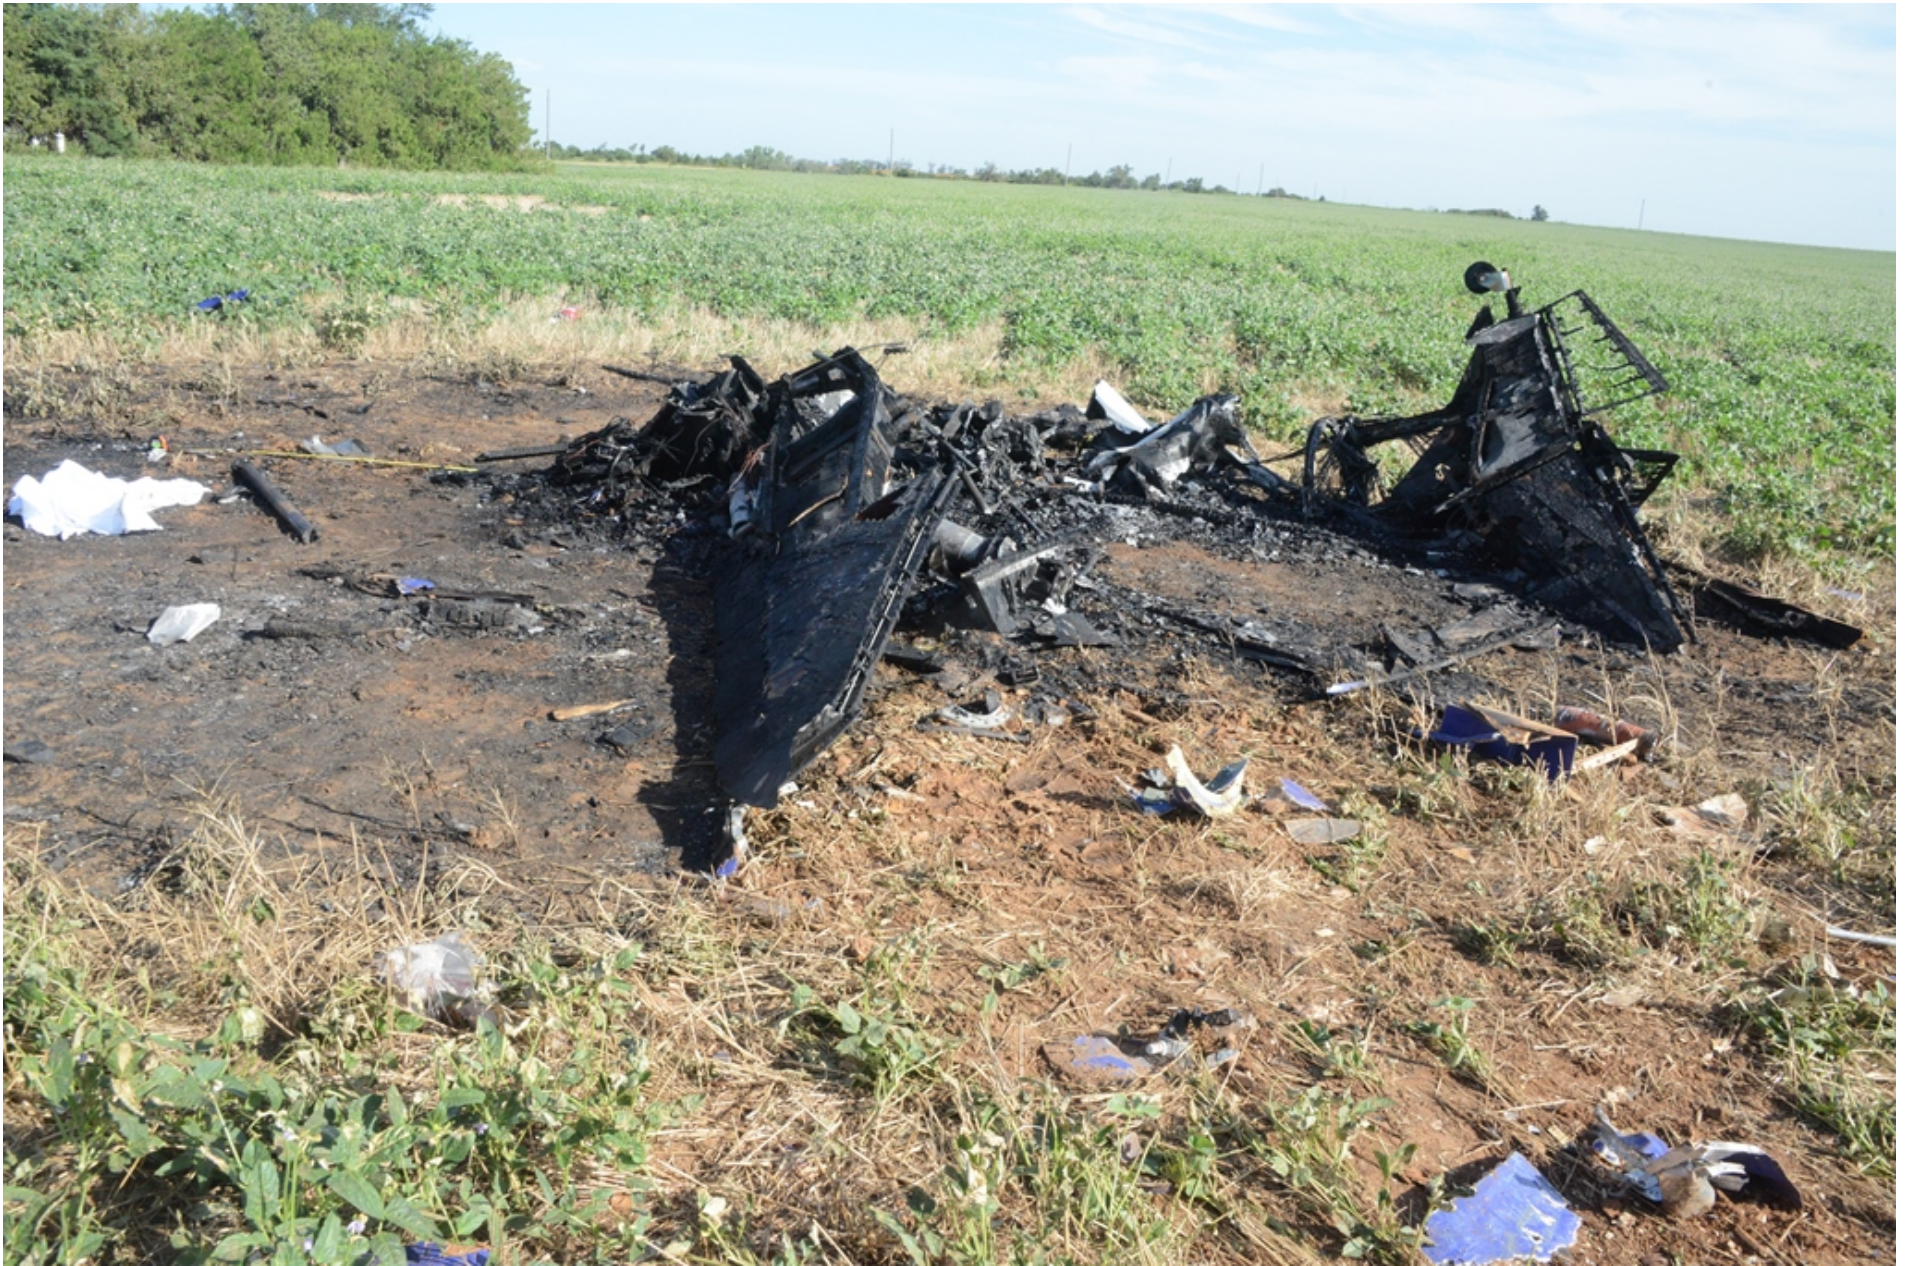
**Photo 4 - View of the right side of the inverted airplane at the accident site.**

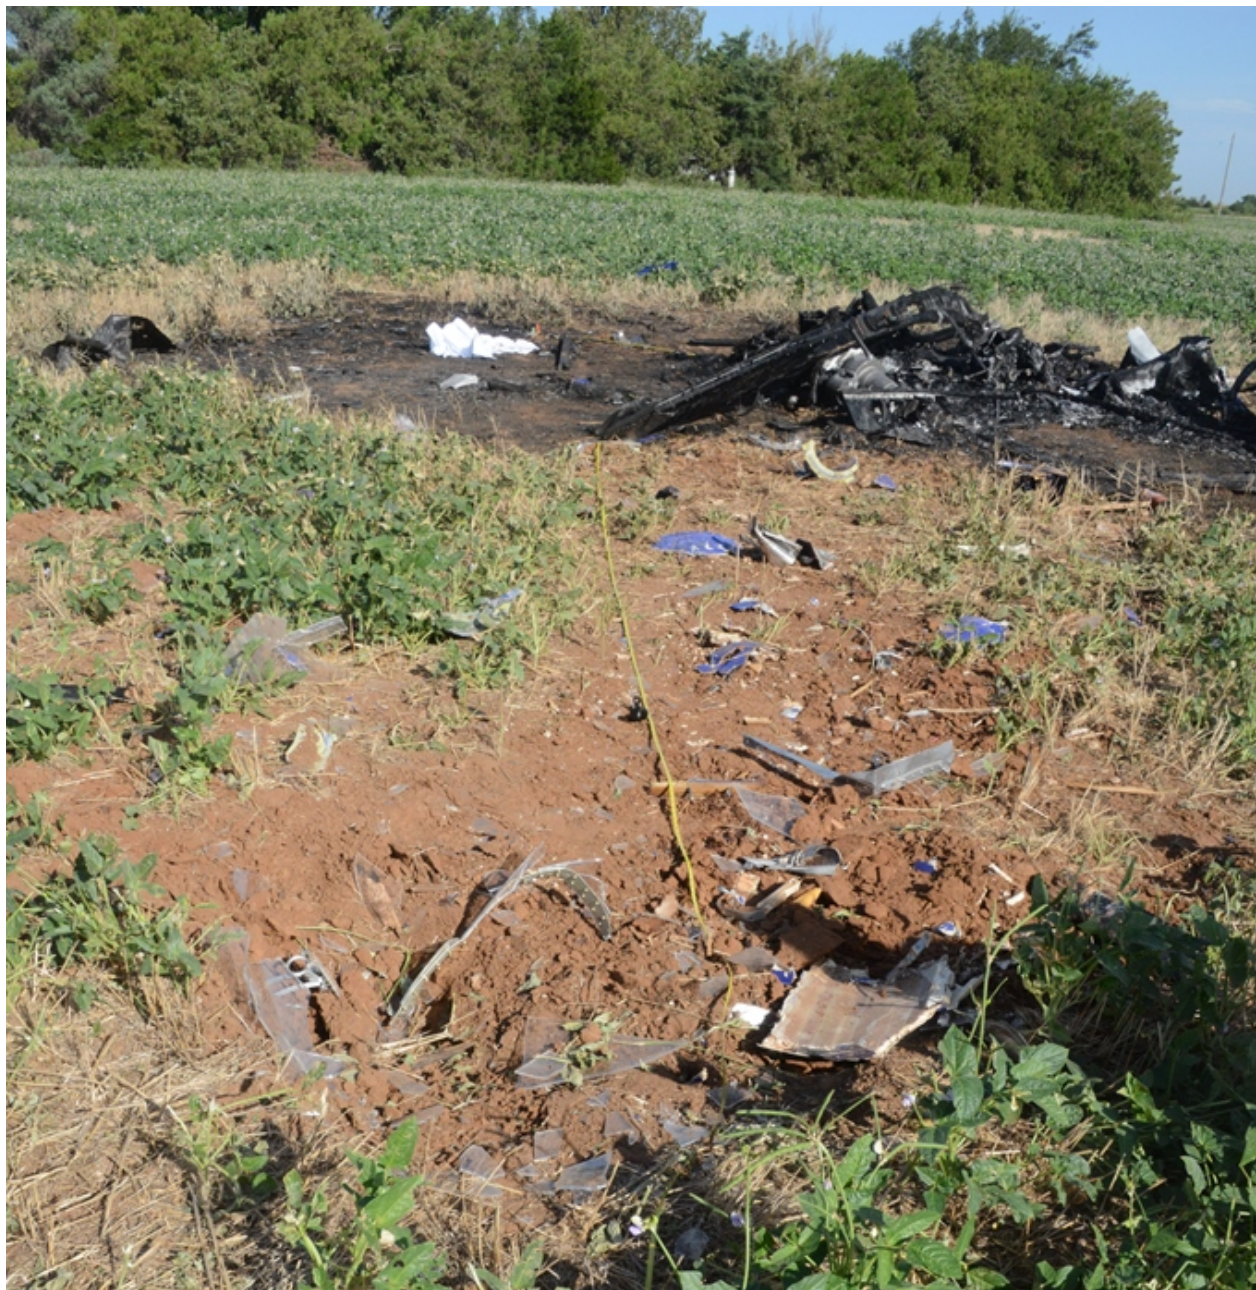
**Photo 5 - View of the right side of the inverted airplane and debris path at the accident site.**

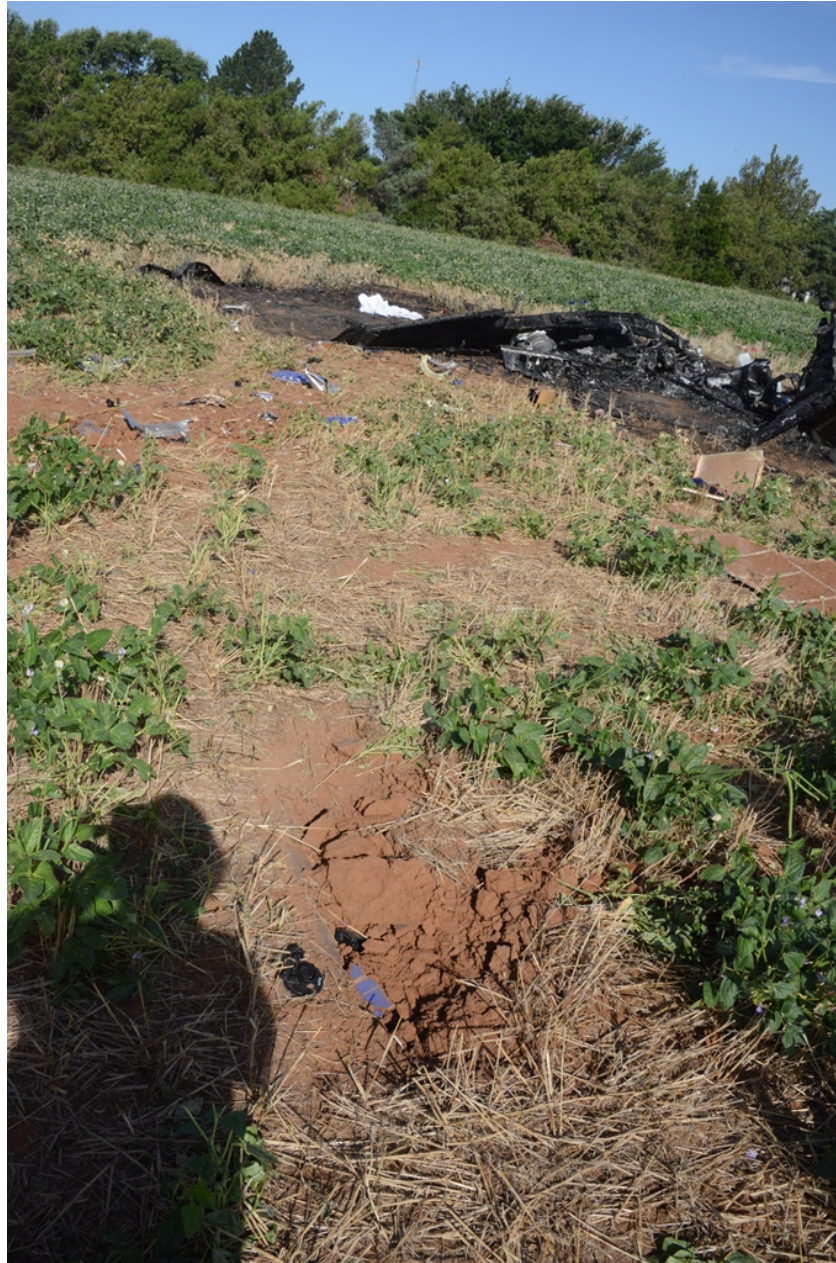
**Photo 6 - View of the right side of the inverted airplane and ground scar at the accident site.**

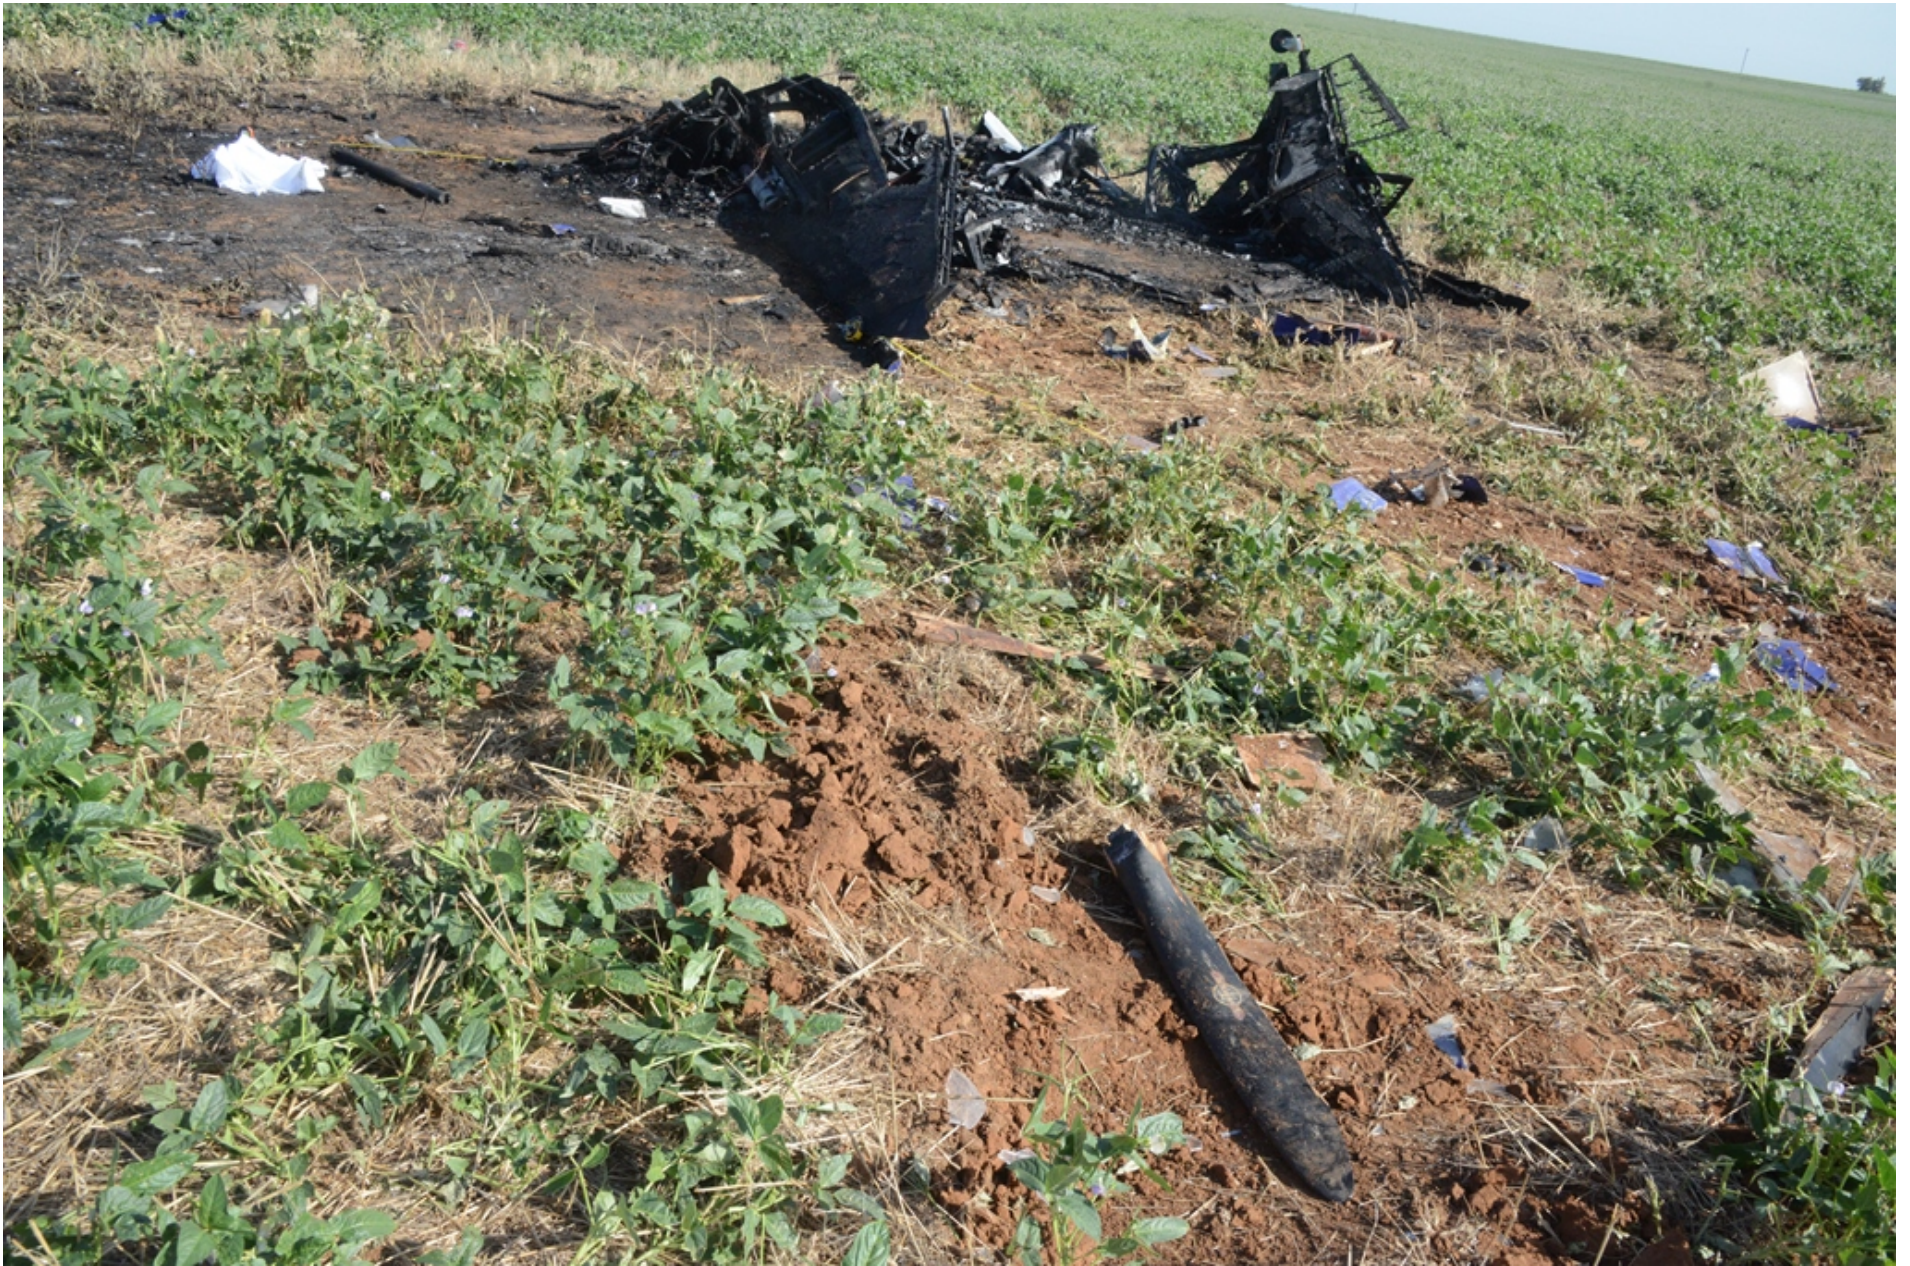
**Photo 7 - View of the right side of the inverted airplane and a separated propeller blade at the accident site.**
