# Continental Motors

## ENGINE FIELD INSPECTION REPORT

| ENGINE MODEL | IO-550-B |
| FILE NUMBER | 16-149 |

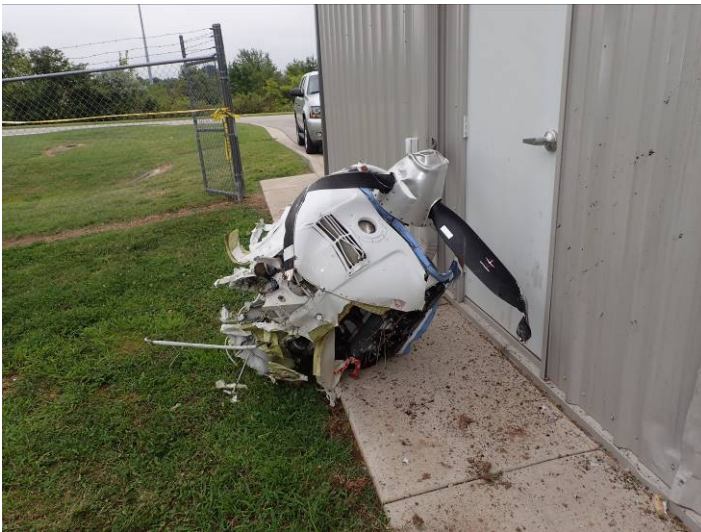
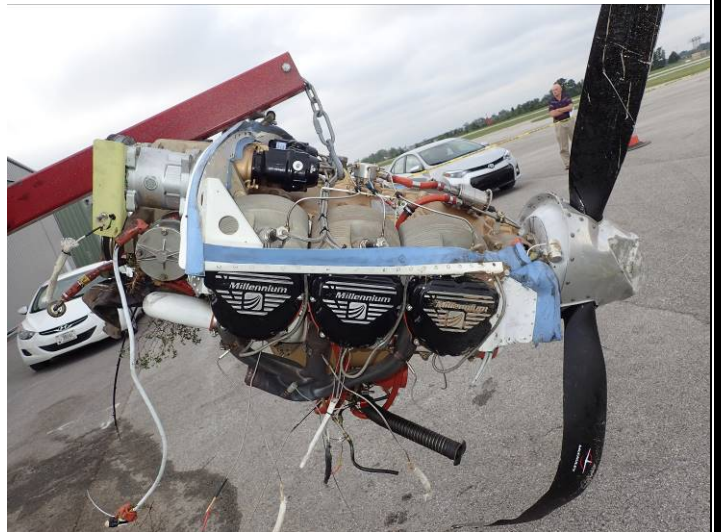
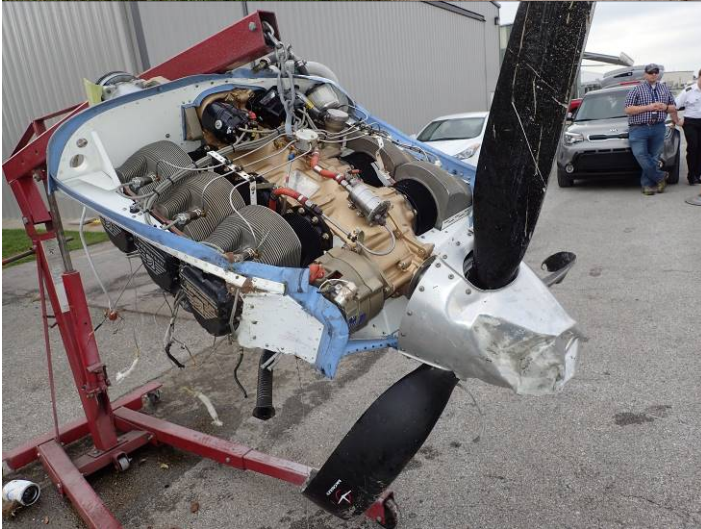
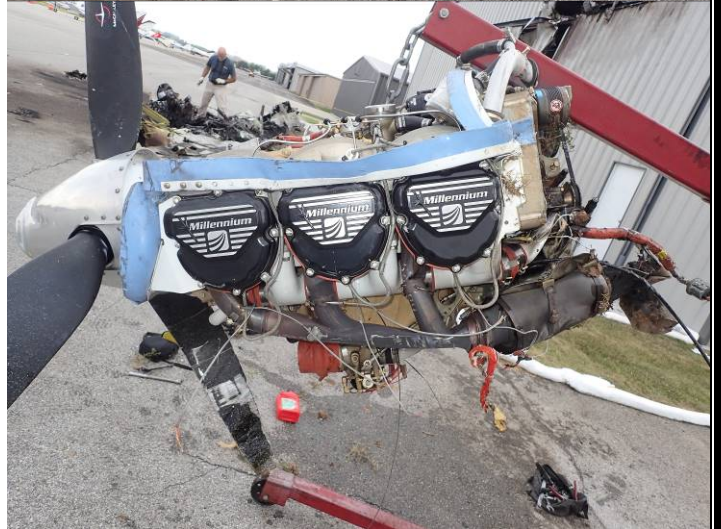
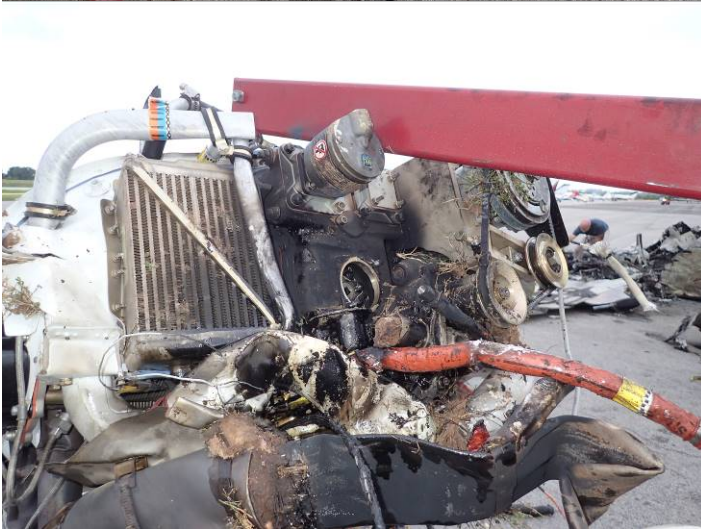
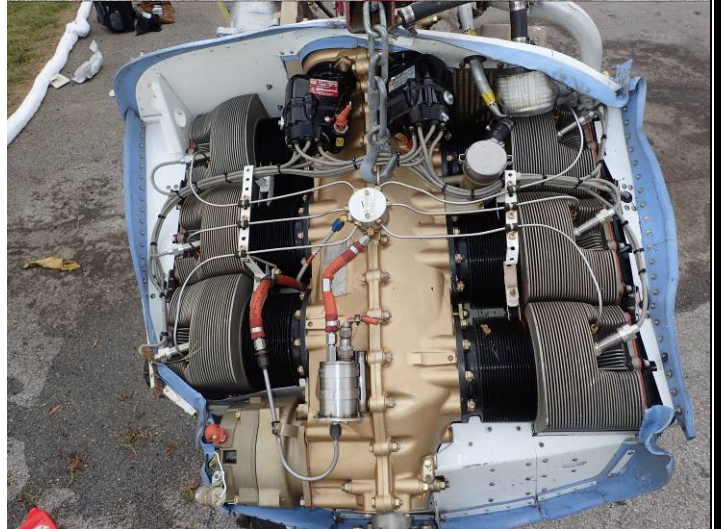
The engine and a portion of the airframe had broken free from the rest of the airframe and was found resting against a hangar adjacent to the hangar that was impacted by the aircraft. The engine displayed impact damage signatures concentrated to the bottom of the engine. There were some thermal damage signatures at the rear of the engine that were concentrated around the fuel pump. The crankcase remained intact and displayed thermal damage signatures at the rear of the crankcase. All of the cylinders remained attached to their cylinder bays and displayed minor impact damage signatures. The three blade, constant speed propeller remained attached to the crankshaft and displayed impact damage signatures. All three propeller blades remained within the propeller hub and displayed impact damage signatures. One blade displayed leading edge gouging, aft bending deformation. Another blade displayed a significant leading edge gouge and a portion of the blade tip had broken free from the rest of the blade; the blade also displayed minor twisting deformation. The last blade displayed a significant amount of twisting deformation of the blade tip and a significant amount of blade polishing at the tip.

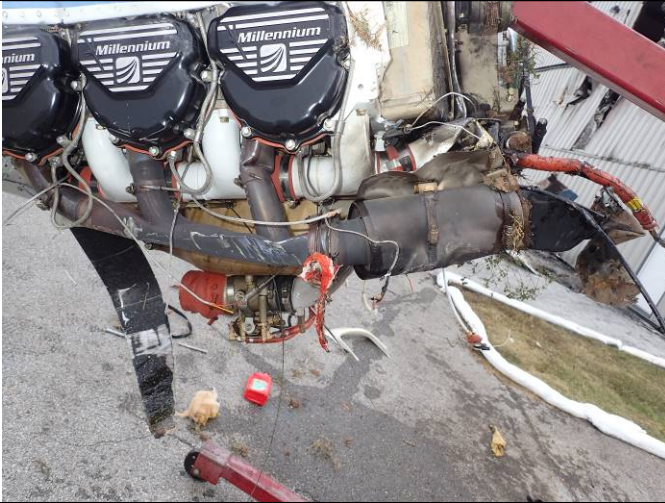
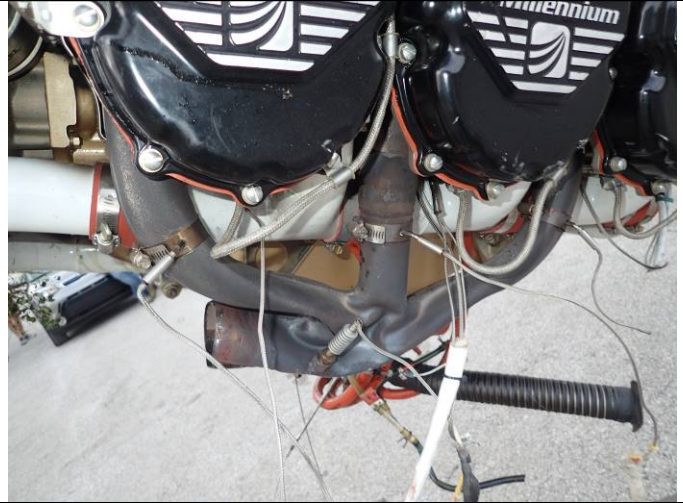
#### EXHAUST SYSTEM

**Condition:** The exhaust system displayed impact damage signatures. The right heat exchanger and tailpipe had broken free from the rest of the exhaust system; the tailpipe was crushed and the heat exchanger displayed impact damage. The rest of the exhaust system remained attached to the engine and displayed impact damage signatures in the forms of bending and crushing. There were no anomalies noted with the exhaust system.

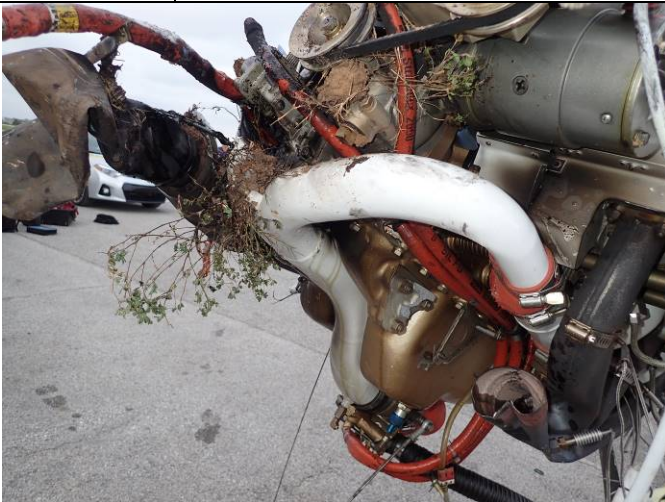
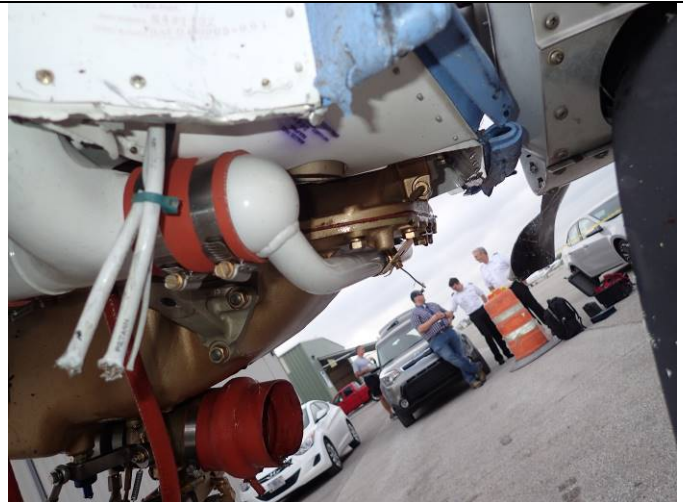
#### INDUCTION SYSTEM

**Condition:** The induction system displayed impact and thermal damage signatures concentrated to the rear induction components. There were no anomalies noted with the induction system.

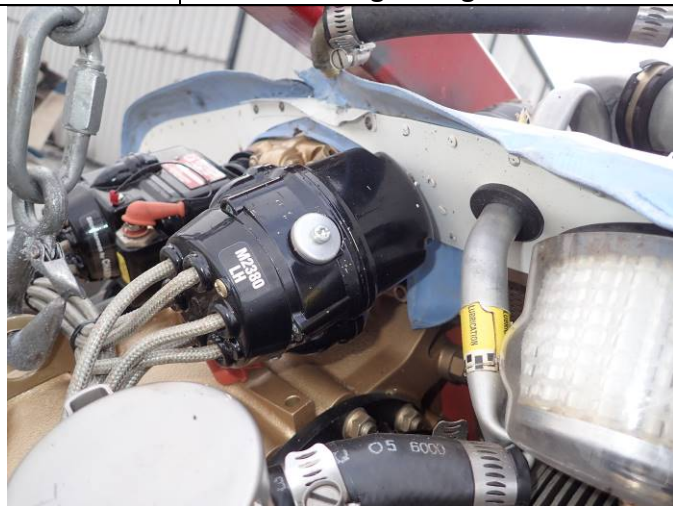
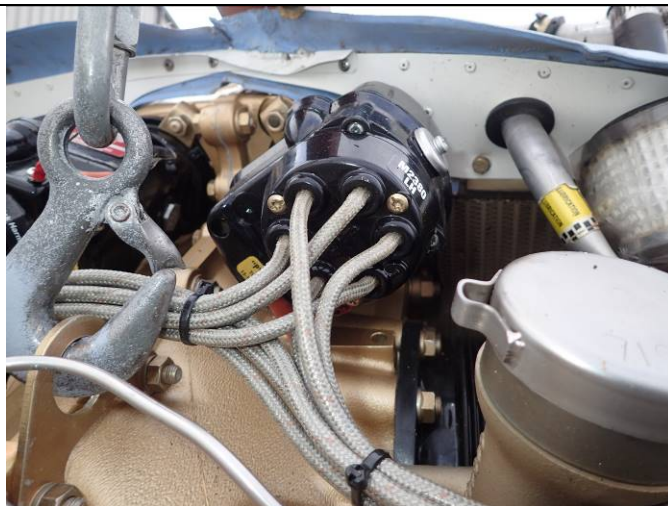
## LEFT MAGNETO

The magneto remained attached to its installation point and was undamaged. It was noted that during crankshaft rotation the impulse coupling would operate normally. During impulse coupling operation the magneto was observed to be capable of producing a spark to the end of each of the ignition lead in the proper order and at approximately the same time as the right magneto.

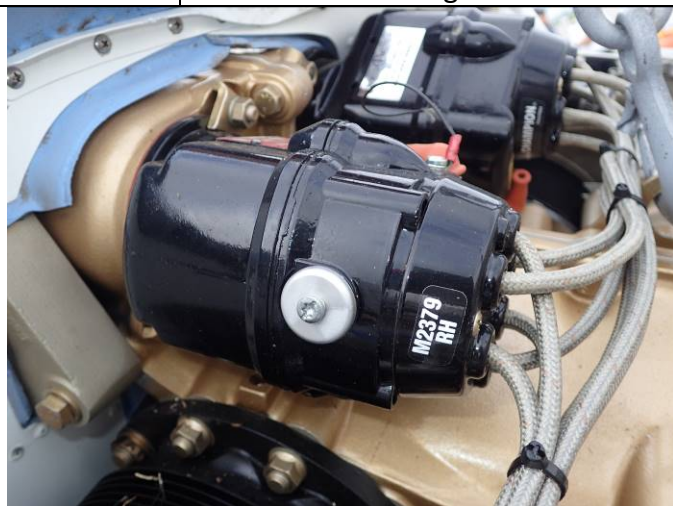
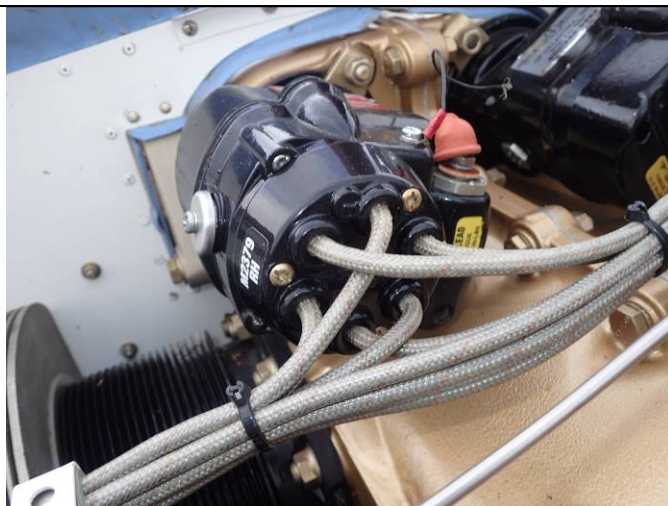
## RIGHT MAGNETO

The magneto remained attached to its installation point and was undamaged. It was noted that during crankshaft rotation the impulse coupling would operate normally. During impulse coupling operation the magneto was observed to be capable of producing a spark to the end of each of the ignition lead in the proper order and at approximately the same time as the left magneto.

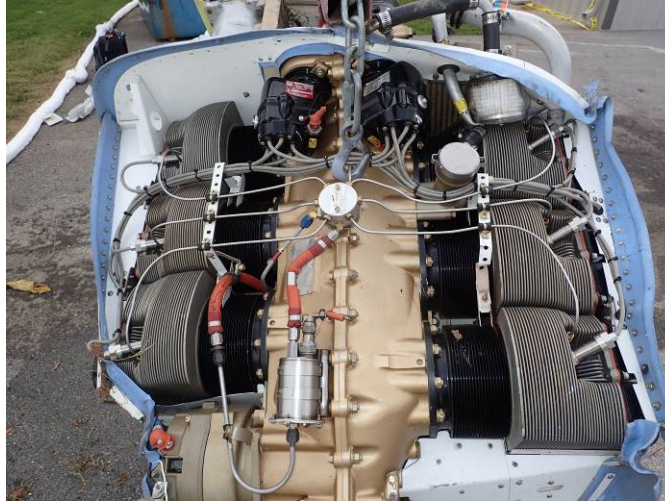
## IGNITION HARNESS

The ignition harness remained secured to both of the magnetos and to each of the spark plugs. The ignition harness displayed minor impact damage signatures to some of the leads. It was noted that during magneto impulse coupling operation that each of the ignition leads was capable of conducting a spark from the magneto to the spark plug.

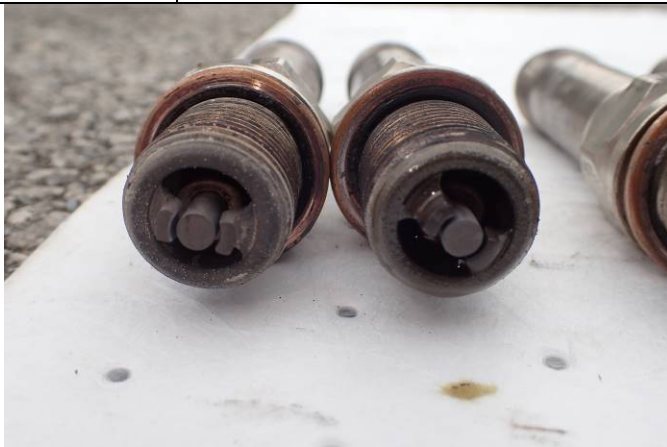
#1 Top and Bottom Spark Plugs

All of the spark plugs remained installed in their cylinders and the ignition leads were secured to each of the spark plugs. The spark plugs were removed and the electrodes were visually inspected. The #1, #2, #4, and the #6 bottom spark plugs were oil soaks which was consistent with post-accident accumulation. All of the spark plugs displayed normal operating and wear signatures. The spark plugs were reinstalled on their ignition leads and it was noted that all of the spark plugs were capable of conducting a spark between the center and ground electrodes during impulse coupling operation.

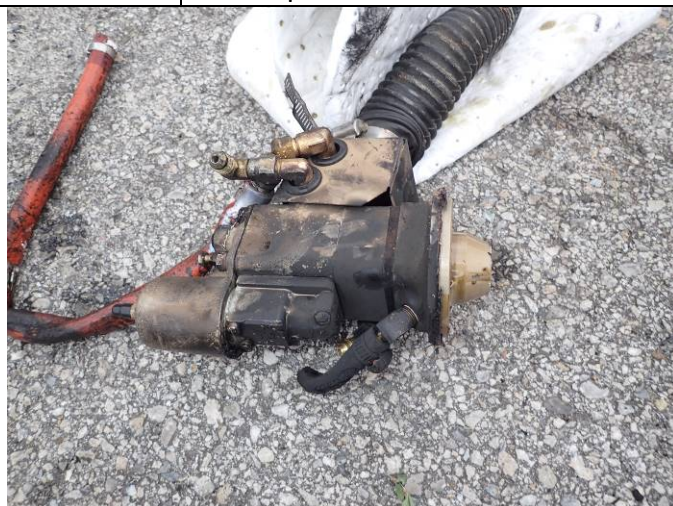
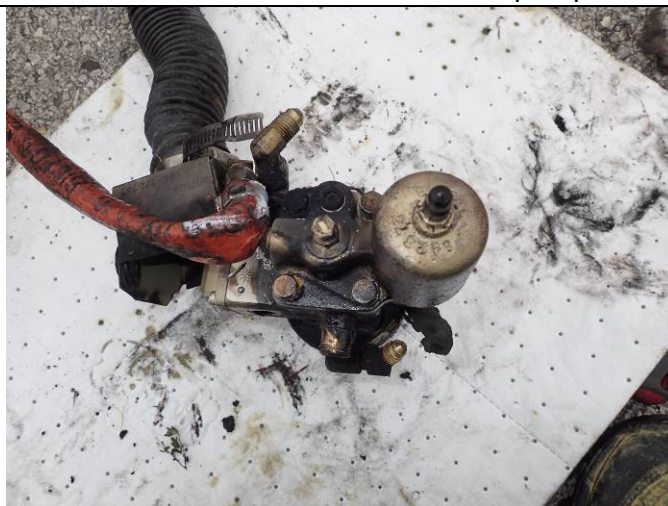
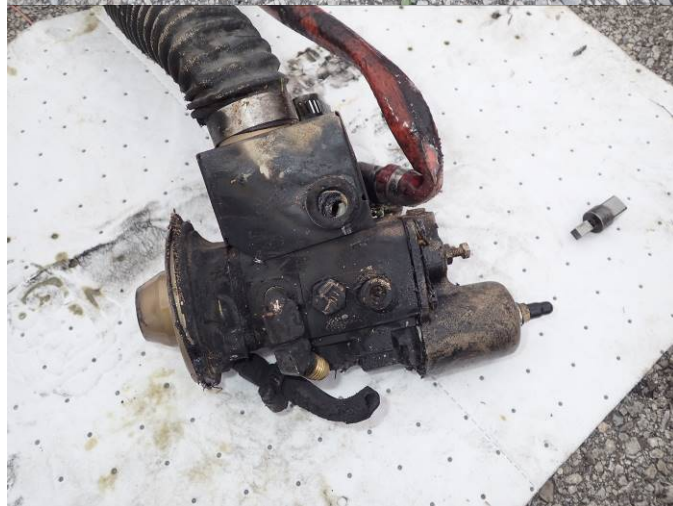
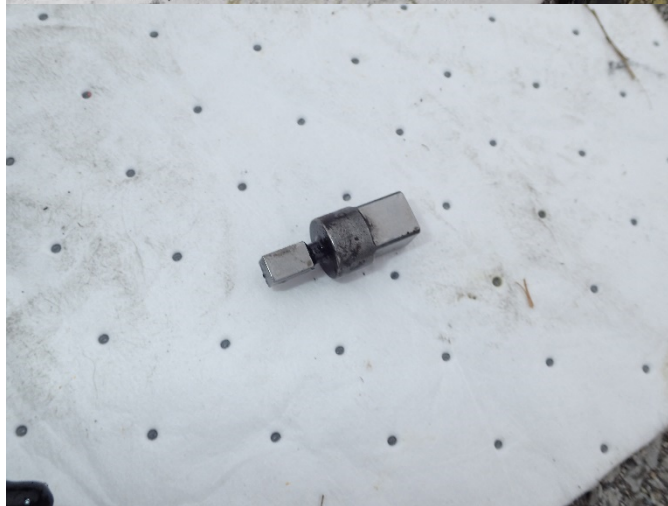
### FUEL PUMP

The fuel pump remained attached to its installation point and displayed thermal damage signatures. The fuel pump was removed and it was noted that the fuel pump drive coupling remained intact. The fuel pump drive was rotated by hand; the fuel pump drive was capable of normal rotation. There were no anomalies noted with the fuel pump.

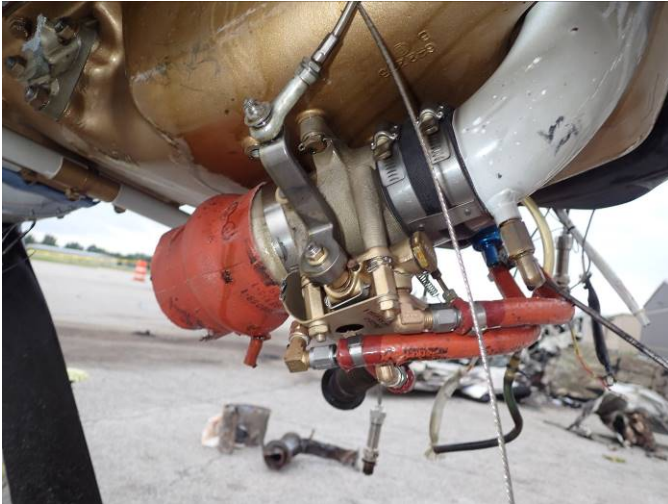
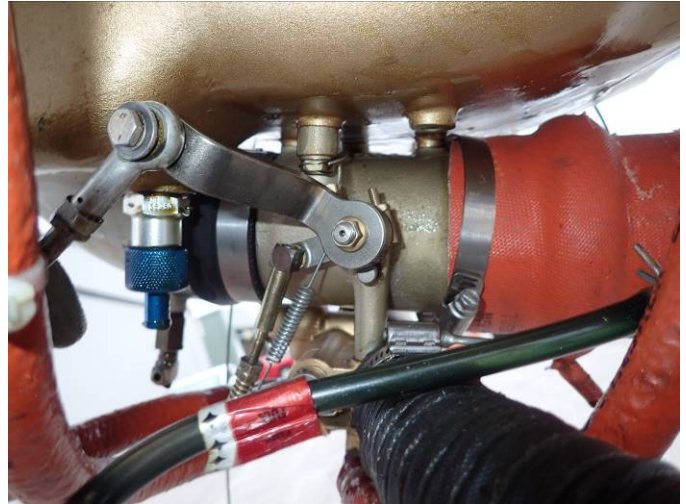
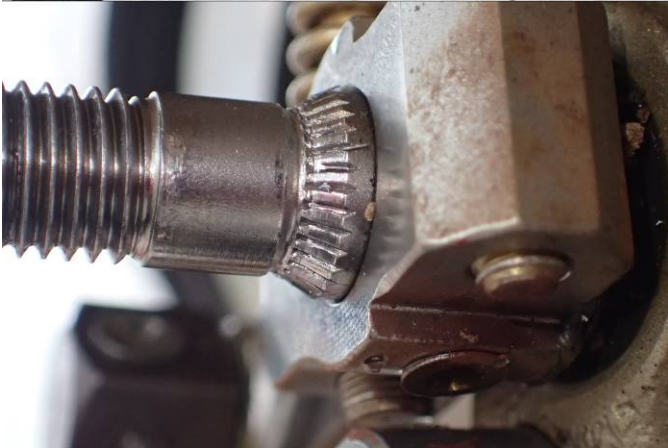
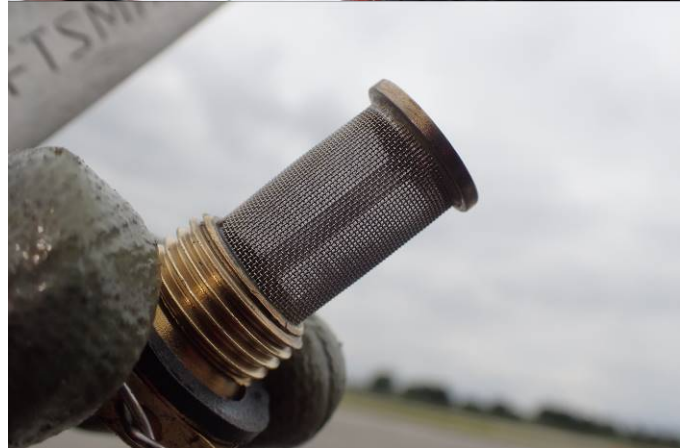
### THROTTLE BODY METERING UNIT

The throttle and fuel metering unit remained attached to its installation point and displayed impact damage signatures. It was noted that the throttle control arm was able to turn freely around the throttle control shaft. The throttle control arm was removed and it was noted that the knurls were smeared consistent with impact damage. The mixture control arm was secure on the mixture control shaft and was capable of normal movement. The fuel inlet screen was removed and there were no contaminants noted.

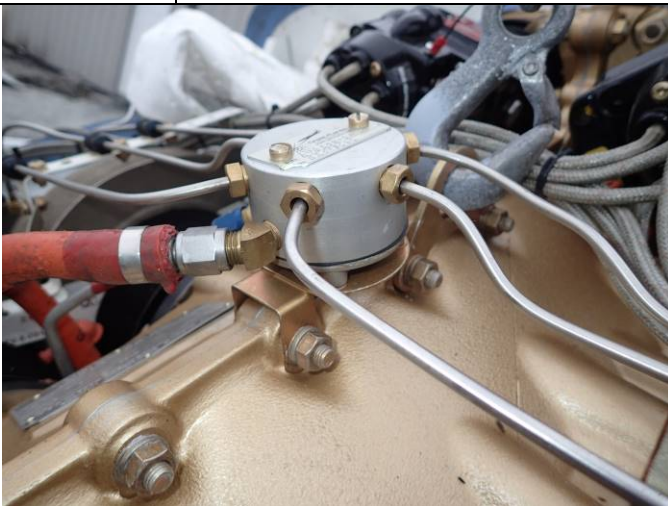
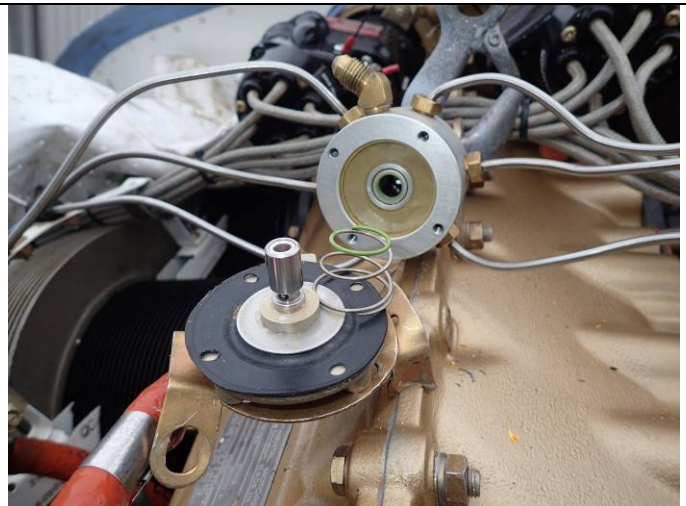
## FUEL MANIFOLD VALVE

The fuel manifold valve remained attached to its installation point and was undamaged. The manifold valve was disassembled and the internal components were visually inspected. There were no anomalies noted with the manifold valve.

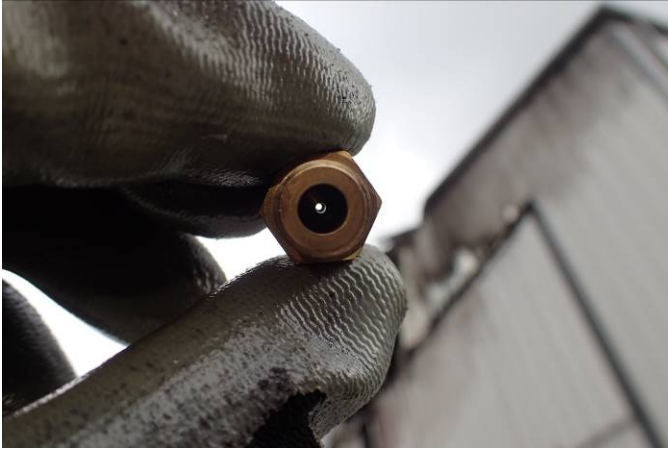
#1 Fuel Nozzle

| Position | #1 | #3 | #5 | #2 | #4 | #6 |
|---|---|---|---|---|---|---|
| Condition: | All of the fuel nozzles remained installed in their cylinders and all of the fuel lines were secured to the nozzles. The fuel nozzles were removed and checked for blockages; all of the fuel nozzles were clear. There were no anomalies noted with the nozzles. | | | | | |

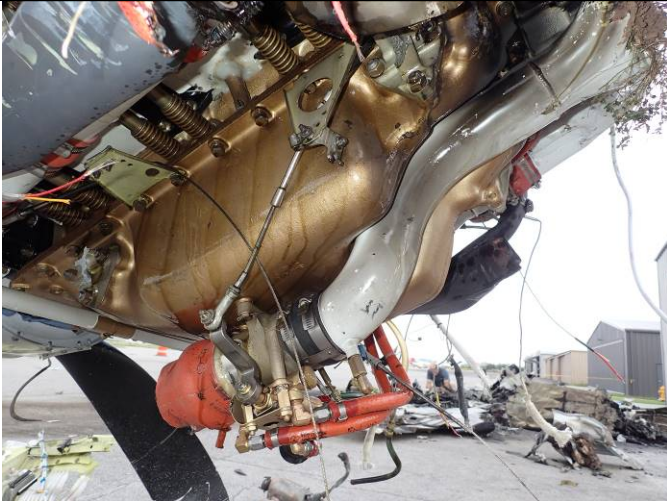
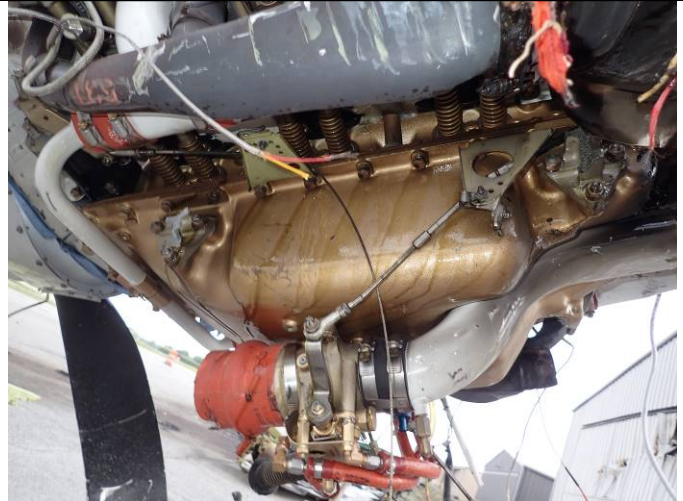
### OIL SUMP

The oil sump remained intact and there were no breaches in the sump. There were no anomalies noted with the oil sump.

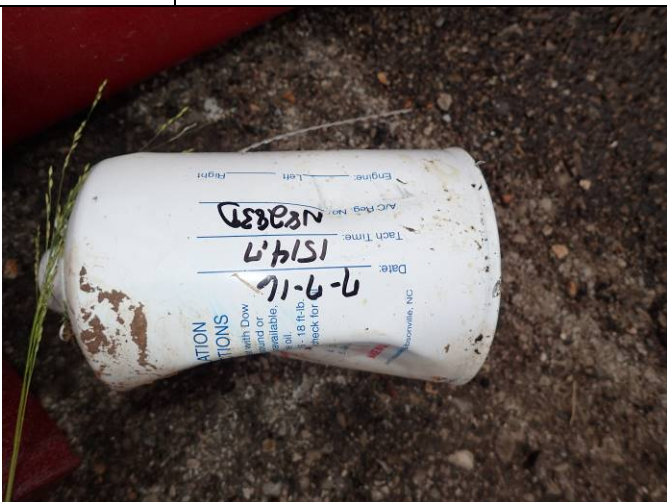
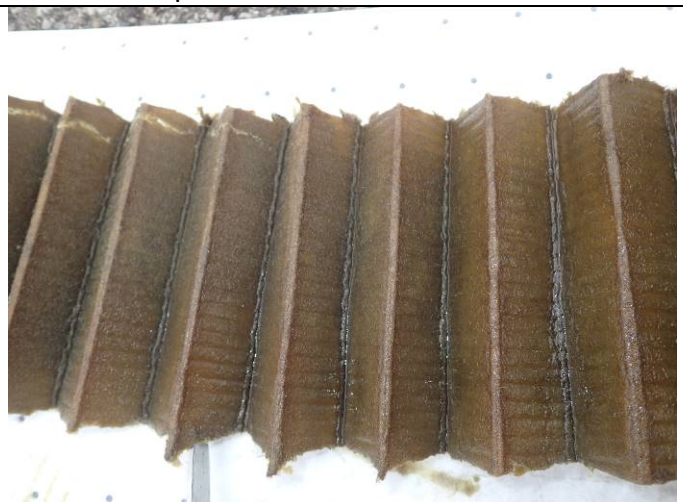
### OIL FILTER

The oil filter had broken free from the oil filter adapter and was located along the wreckage path. The oil filter housing was cut open and the filter pleats were inspected. There were no anomalies noted with the oil filter inspection.

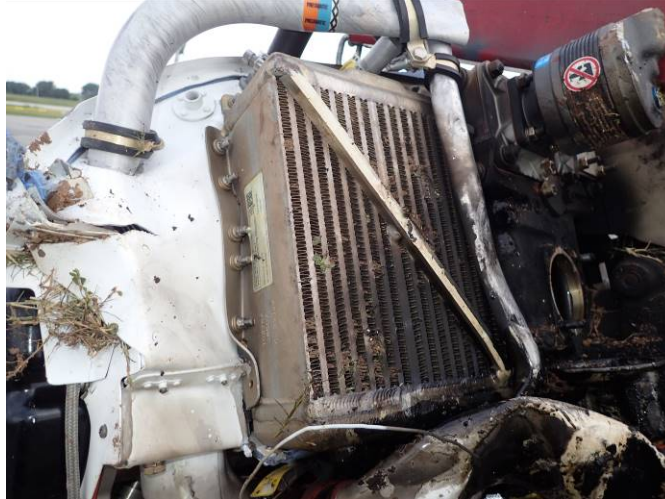
## OIL COOLER

The oil cooler remained attached to its installation point and displayed some impact and thermal damage signatures. There were no anomalies noted with the oil cooler.

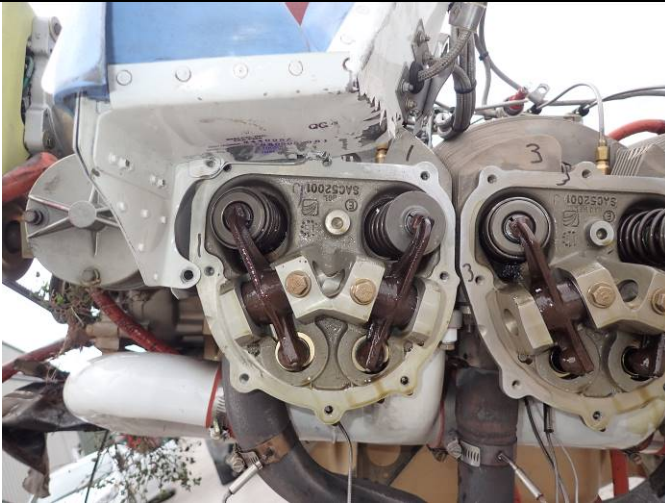
#1 Cylinder

| CYLINDERS | P/N: No observed | S/N: Not observed |
|---|---|---|
| Condition: | All of the cylinders remained attached to their cylinder bays and displayed very minor impact damage signatures. All of the cylinders were inspected using a lighted borescope. The cylinder bores, piston faces, and valve heads displayed normal operating and combustion signatures. All of the overhead components (valves, springs, and rocker arms) displayed normal operating and lubrication signatures. The crankshaft was rotated by hand and it was noted that all of the cylinders displayed good thumb compression and suction. There were no anomalies noted with the cylinders. | |

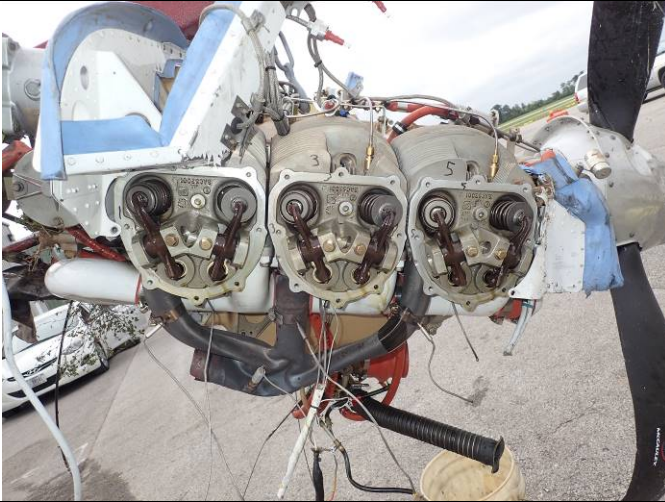
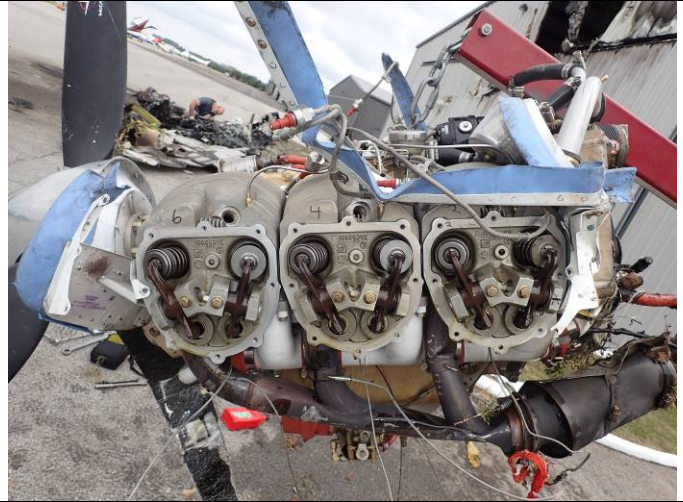
## ROCKER ARMS AND SHAFTS

Condition: All of the rocker arms displayed normal operating and lubrication signatures. During crankshaft rotation all of the rocker arms operated normally. There were no anomalies noted.

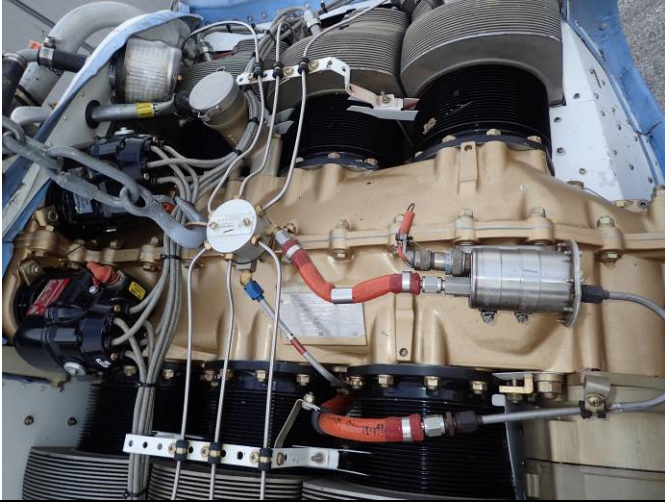
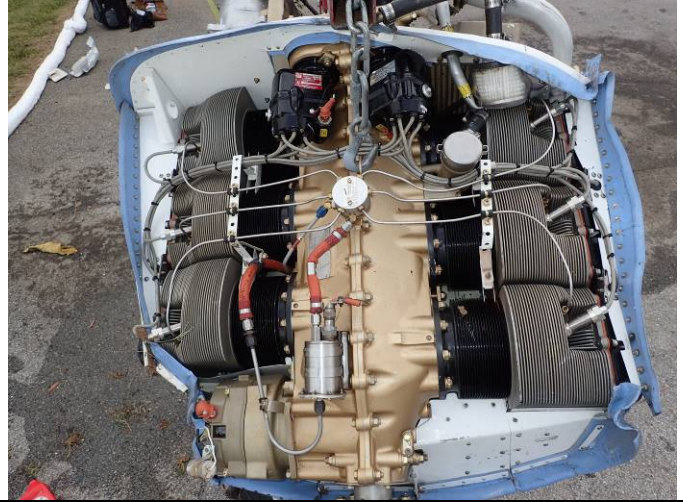
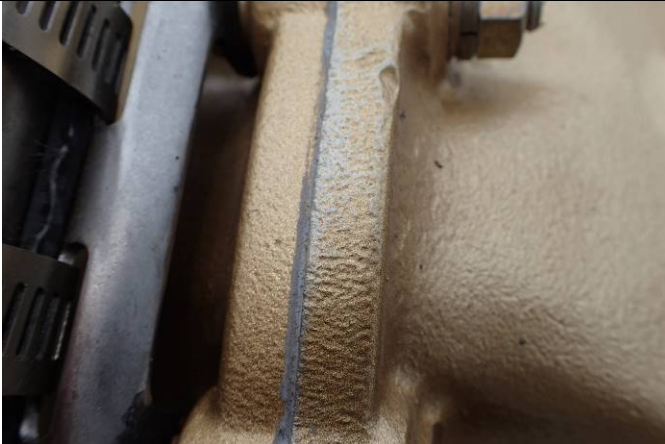
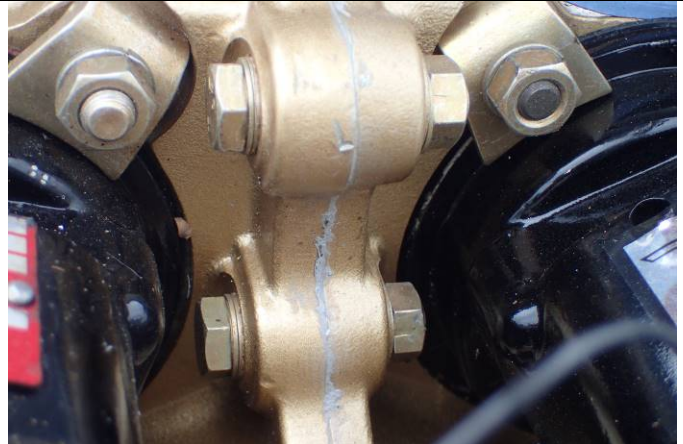
#### CRANKCASE

The crankcase remained intact and was undamaged. It was noted that there was a grey colored sealant between the two crankcase halves that could not be identified.

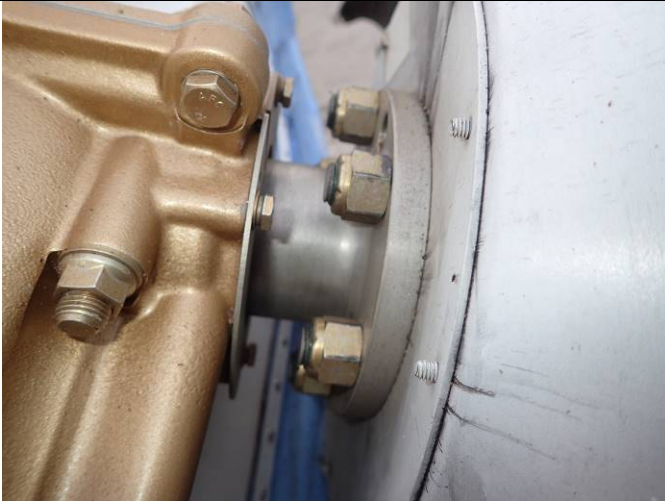
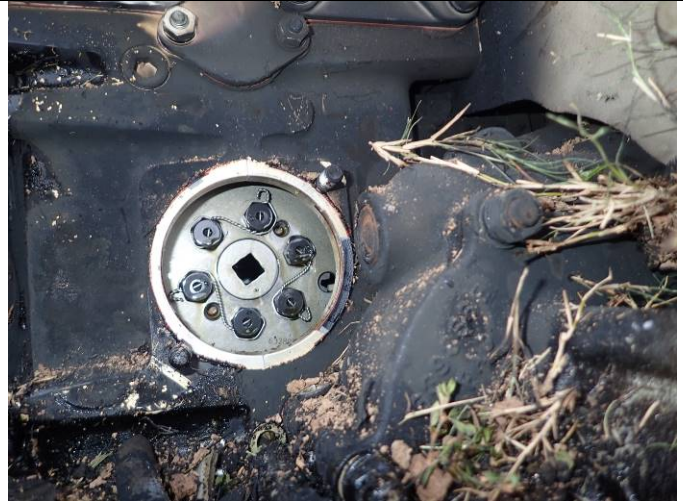
| <b>CRANKSHAFT</b> | Forging Number:<br>Inaccessible | S/N: Not observed | Heat code: Inaccessible |
|---|---|---|---|
| Condition: | The propeller flange remained attached to the crankshaft and there were no signs of damage to the visible portion of the crankshaft. The crankshaft was rotated by hand and continuity was established between the crankshaft, camshaft, connecting rods, and associated components. The crankshaft gear was noted to be secured to the crankshaft and the bolts were properly safety wired. There were no anomalies noted with the crankshaft. | | |

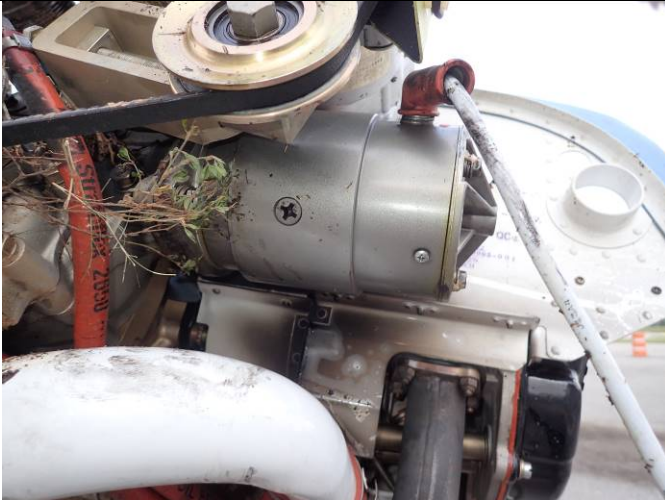
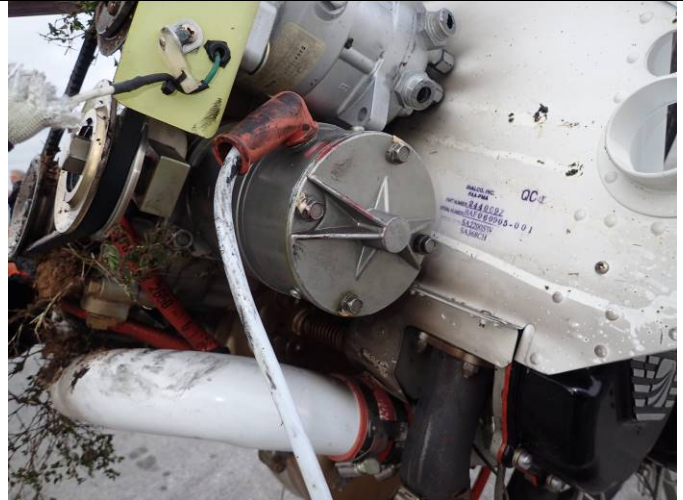
### STARTER

The starter remained attached to the starter adapter and was undamaged. There were no anomalies noted with the starter.

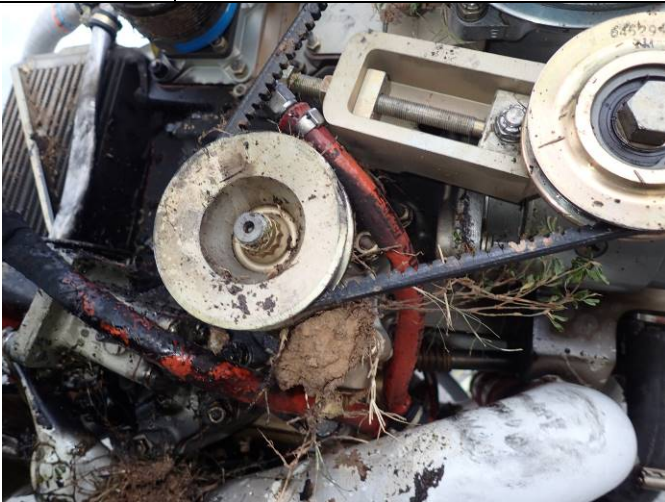
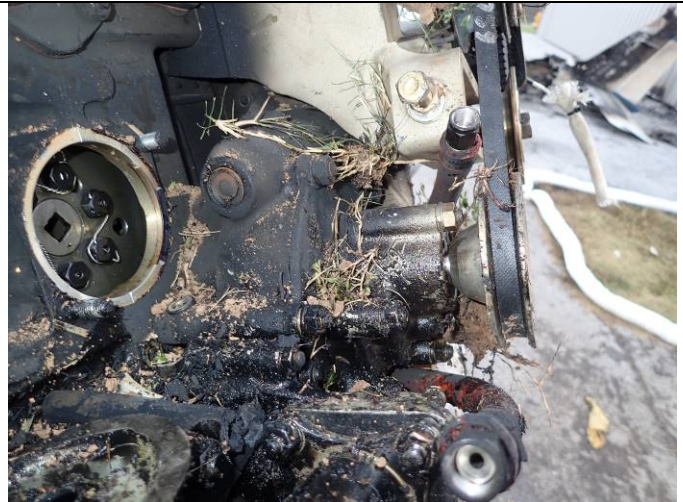
### STARTER ADAPTER

The starter adapter remained attached to its installation point and displayed thermal damage signatures. There were no anomalies noted with the adapter.

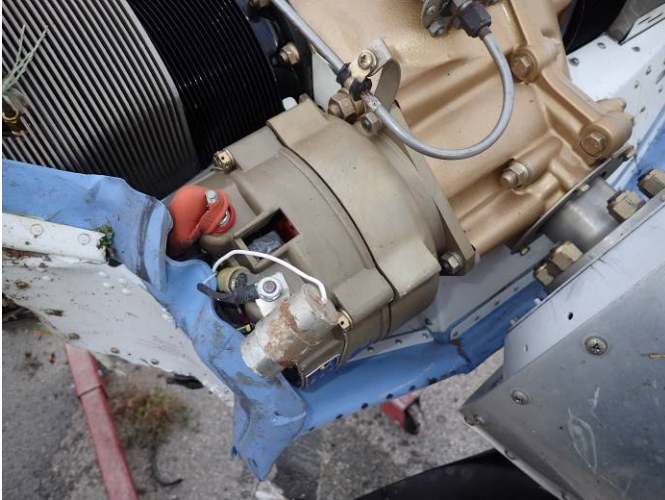
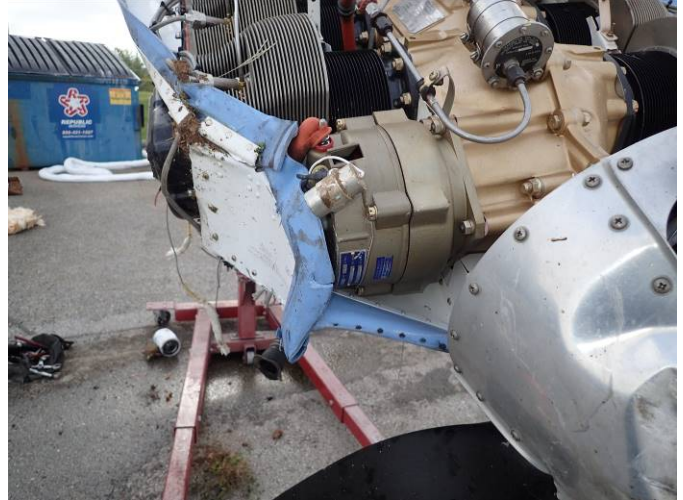
## ALTERNATOR

The alternator remained attached to its installation point and displayed minor impact damage signatures. There were no anomalies noted with the alternator.

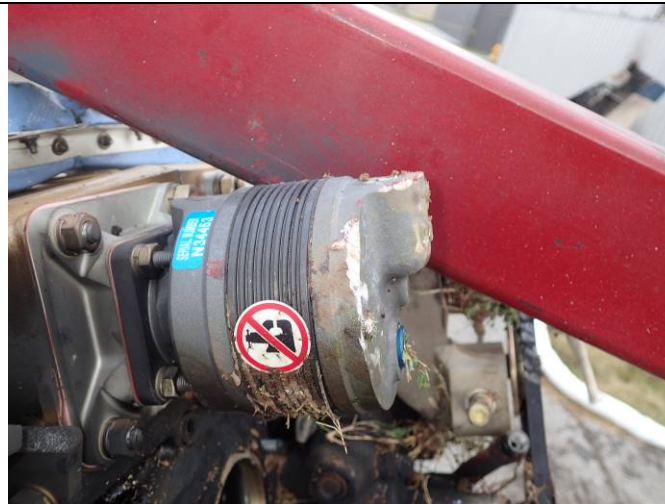
## VACUUM PUMP

The vacuum pump remained attached to its installation point and displayed impact damage signatures. There were no anomalies noted with the vacuum pump.

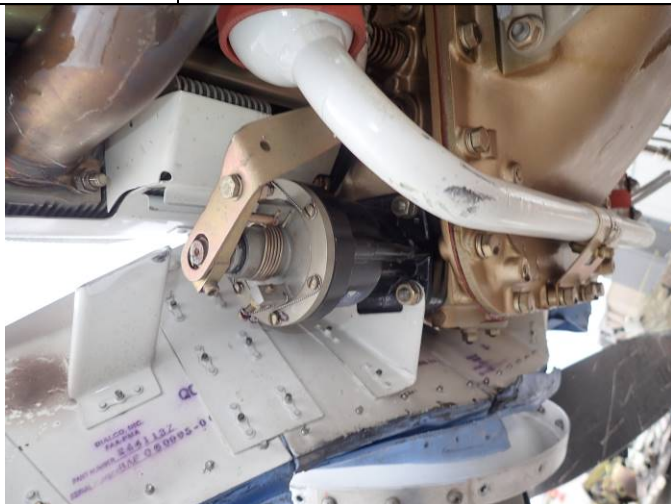
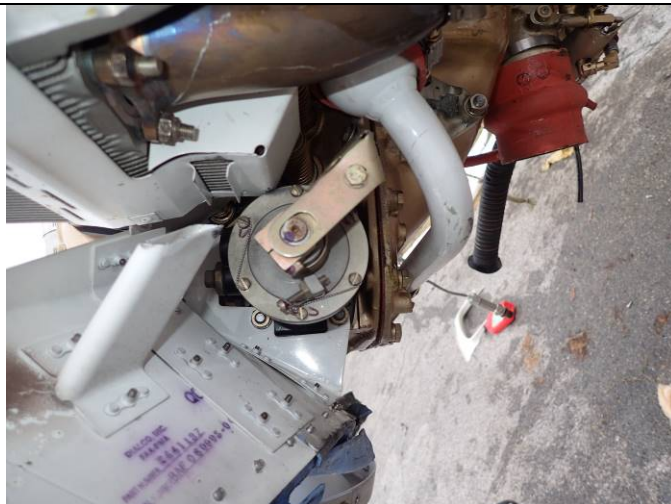
| PROPELLER GOVERNOR | Manufacturer: Not observed | P/N: Not observed | S/N: Not observed |
|---|---|---|---|
| Condition: | The propeller governor remained attached to its installation point and displayed minor impact damage signatures. The propeller control rod end remained secure to the propeller control arm. There were no anomalies noted. | | |

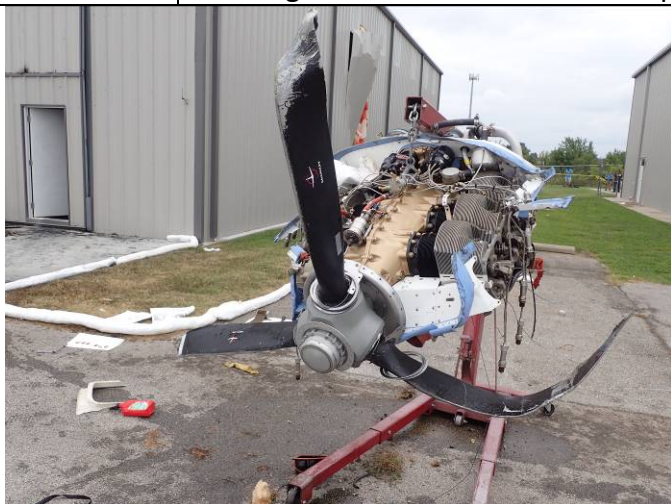
Propeller

| PROPELLER | Manufacturer: McCauley | P/N: D3A32C409-C | S/N: 912714 |
|---|---|---|---|
| Condition: | The three blade, constant speed propeller remained attached to the crankshaft and displayed impact damage signatures. All three propeller blades remained within the propeller hub and displayed impact damage signatures. The propeller blade marked "A" displayed leading edge gouging, aft bending deformation and twisting deformation. The blade marked "B" displayed a significant leading edge gouge and a portion of the blade tip had broken free from the rest of the blade; the blade also displayed minor twisting deformation. The blade marked "C" displayed leading edge gouges, a significant amount of twisting deformation of the blade tip, and a significant amount of blade polishing at the tip. | | |
