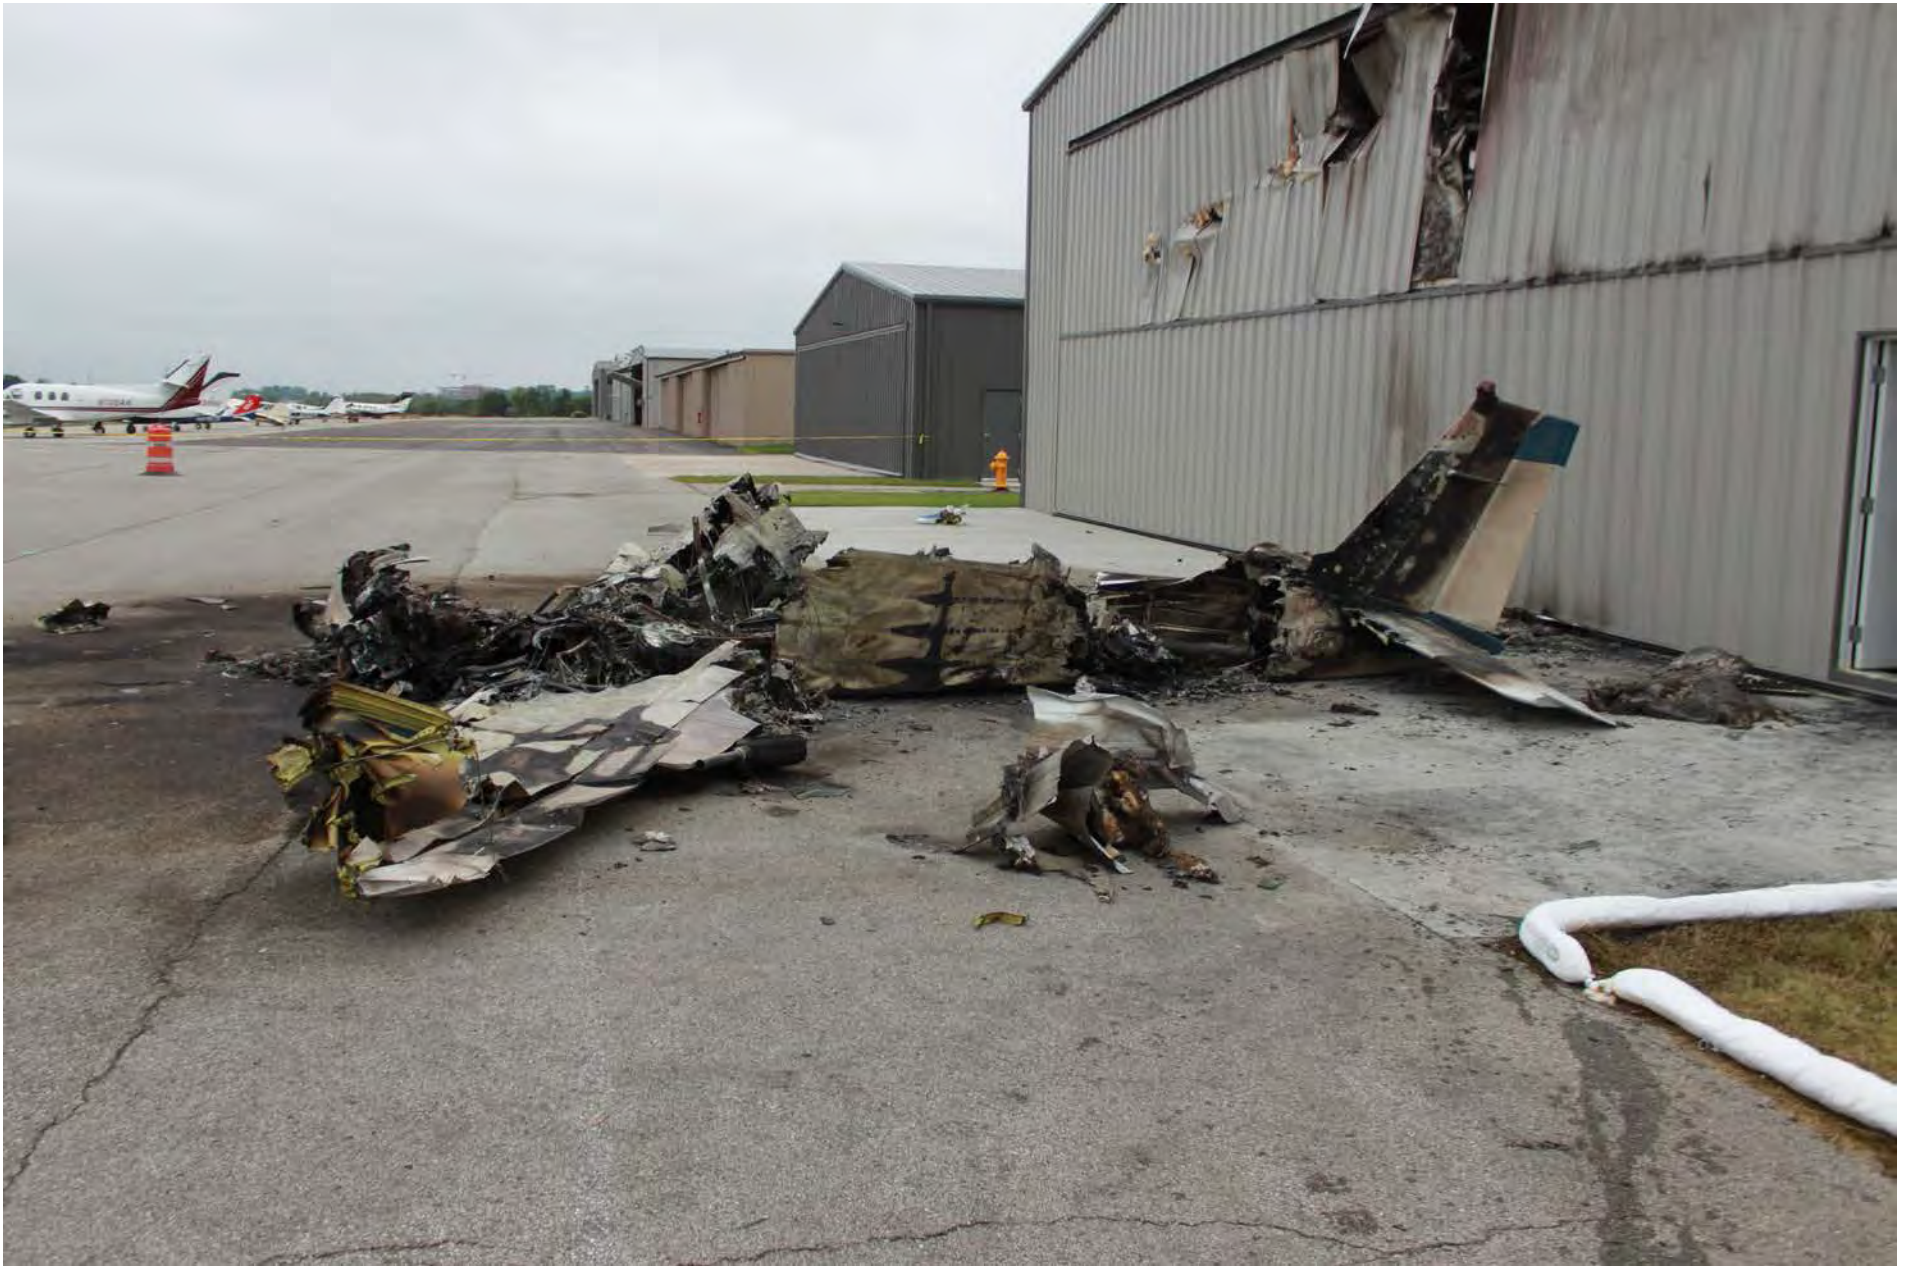
**Photo 1 – Left side view of wreckage**

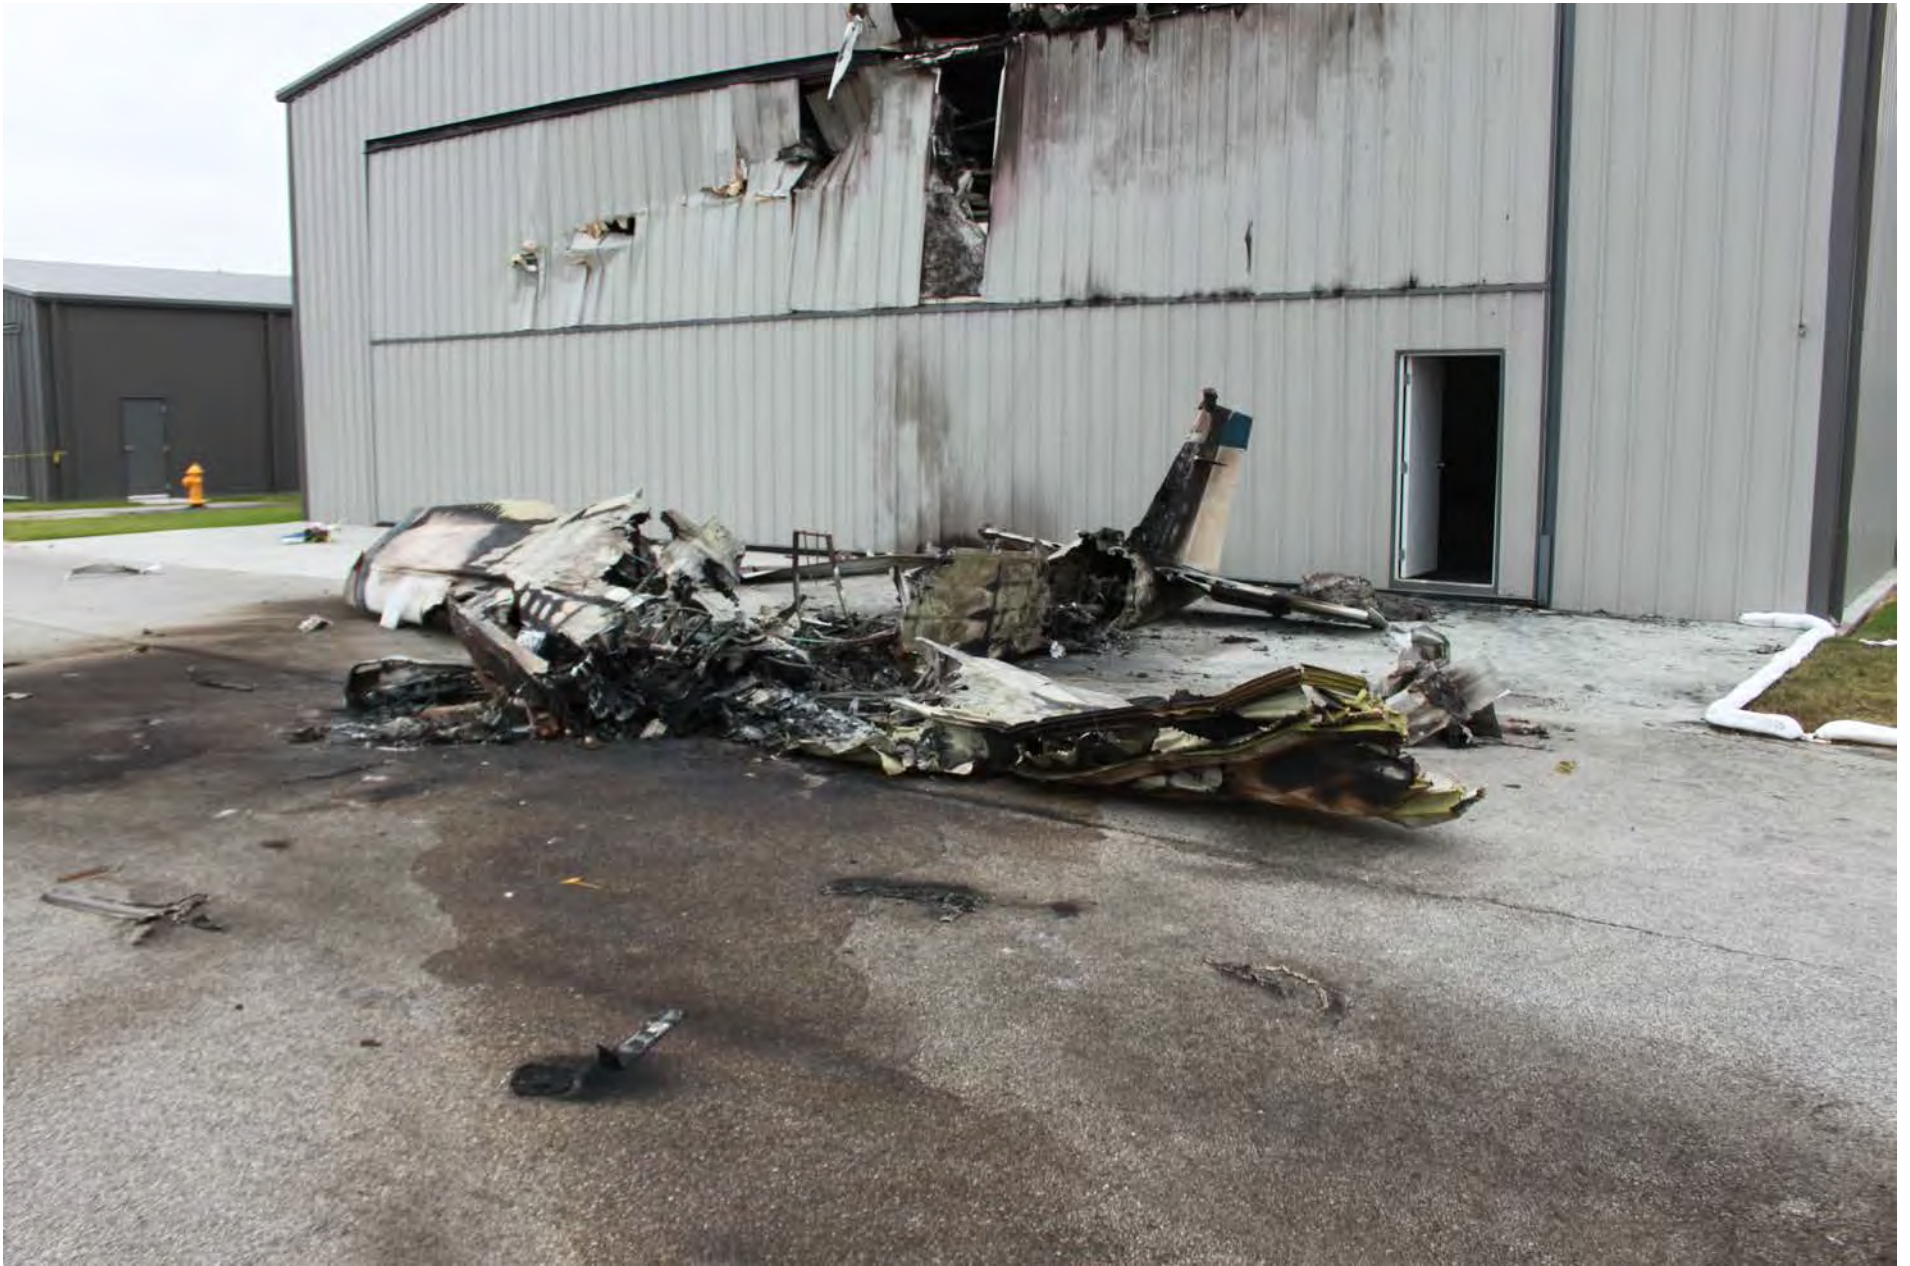
**Photo 2 – Front left side view of wreckage**

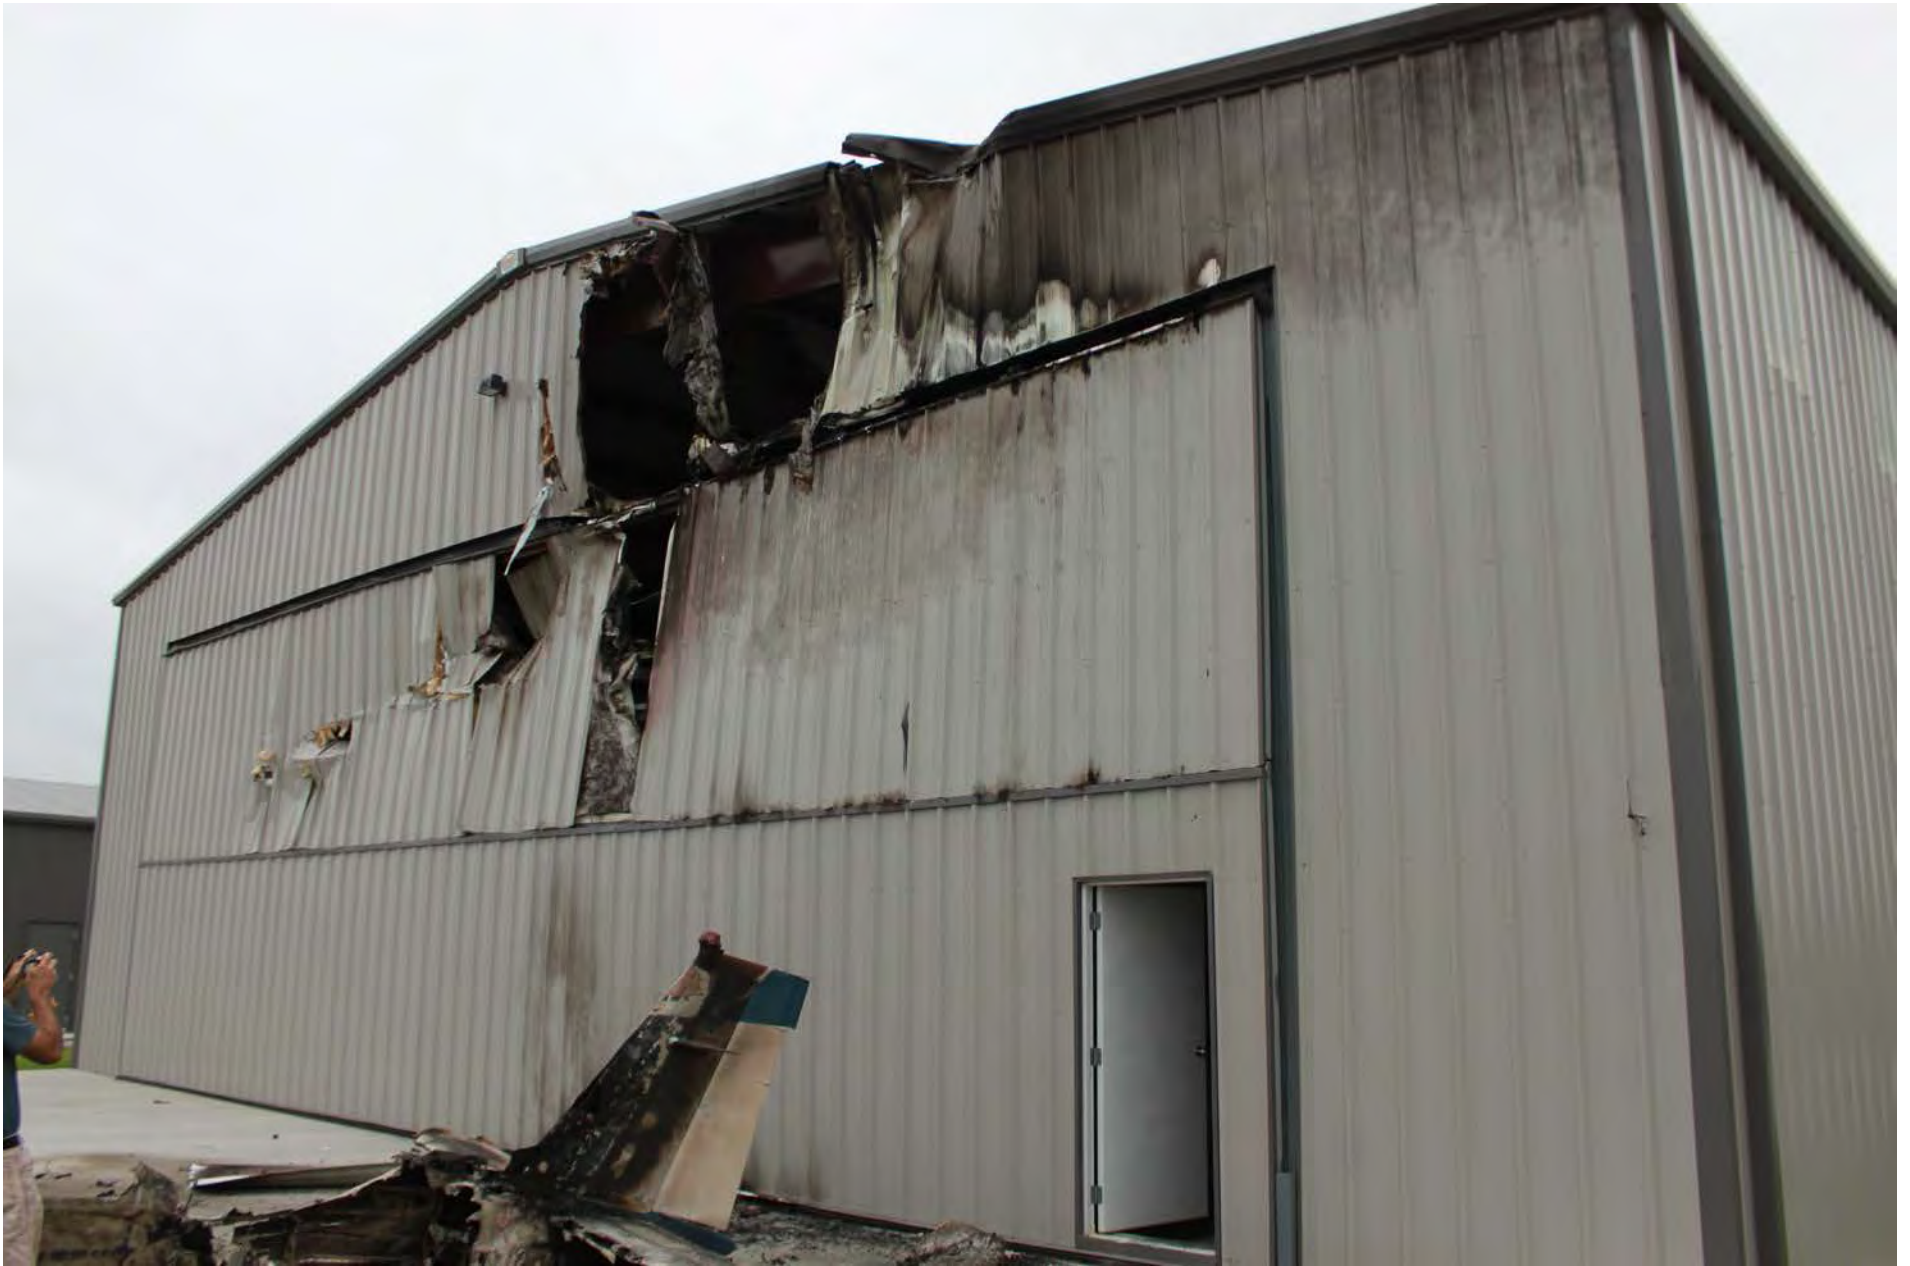
**Photo 3 – View of hangar that was struck**

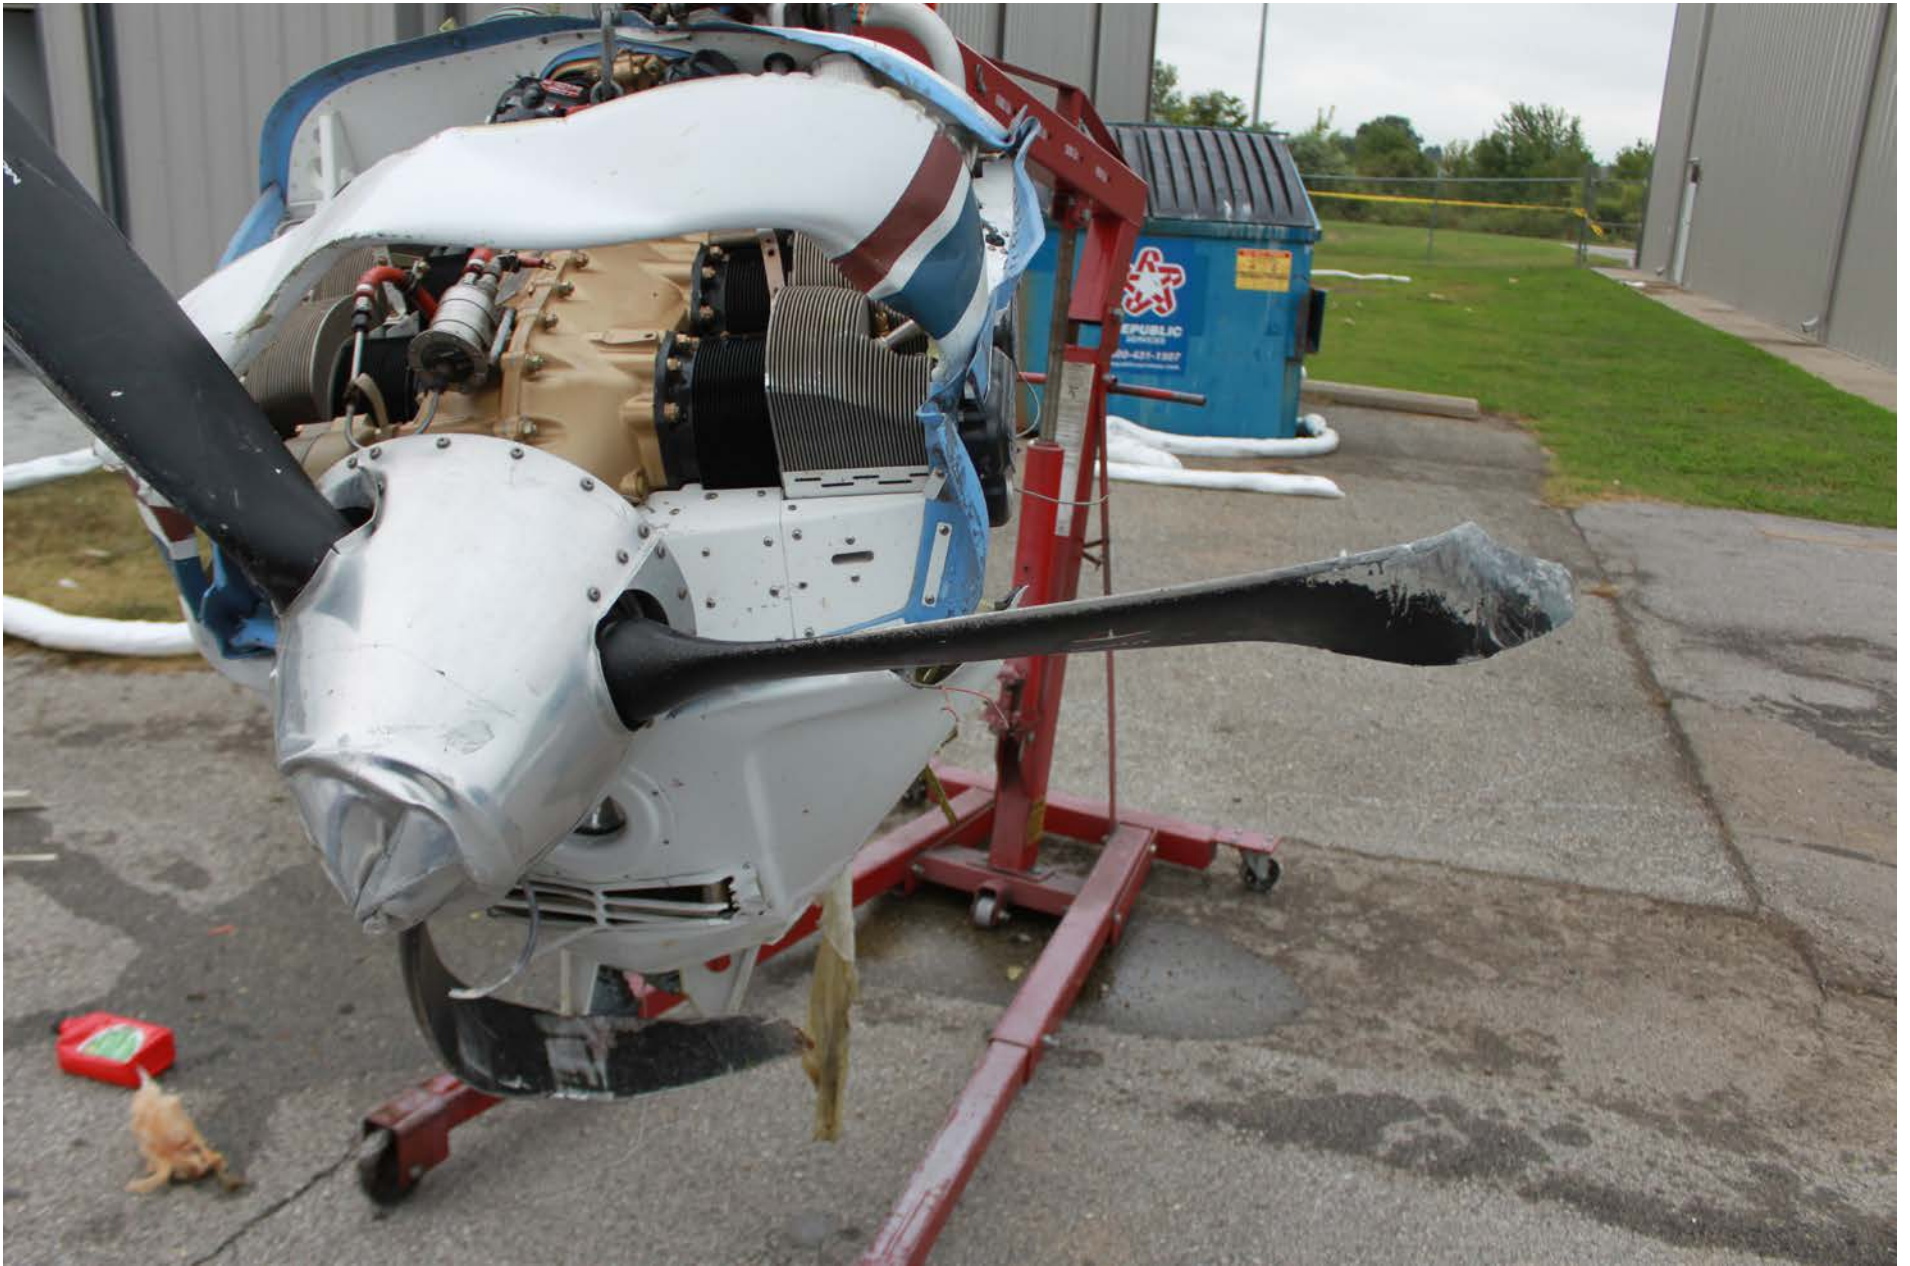
**Photo 4 – View of engine during examination**
