**NATIONAL TRANSPORTATION SAFETY BOARD**

**System's Group Chairman's Factual Report**

**NTSB ID No.: CEN16FA372**

Location: Alexandria, Minnesota  
Date: September 17, 2017  
Time: 0207 Central Daylight Time  
Aircraft: Agusta S.p.A A109S helicopter, N91NM

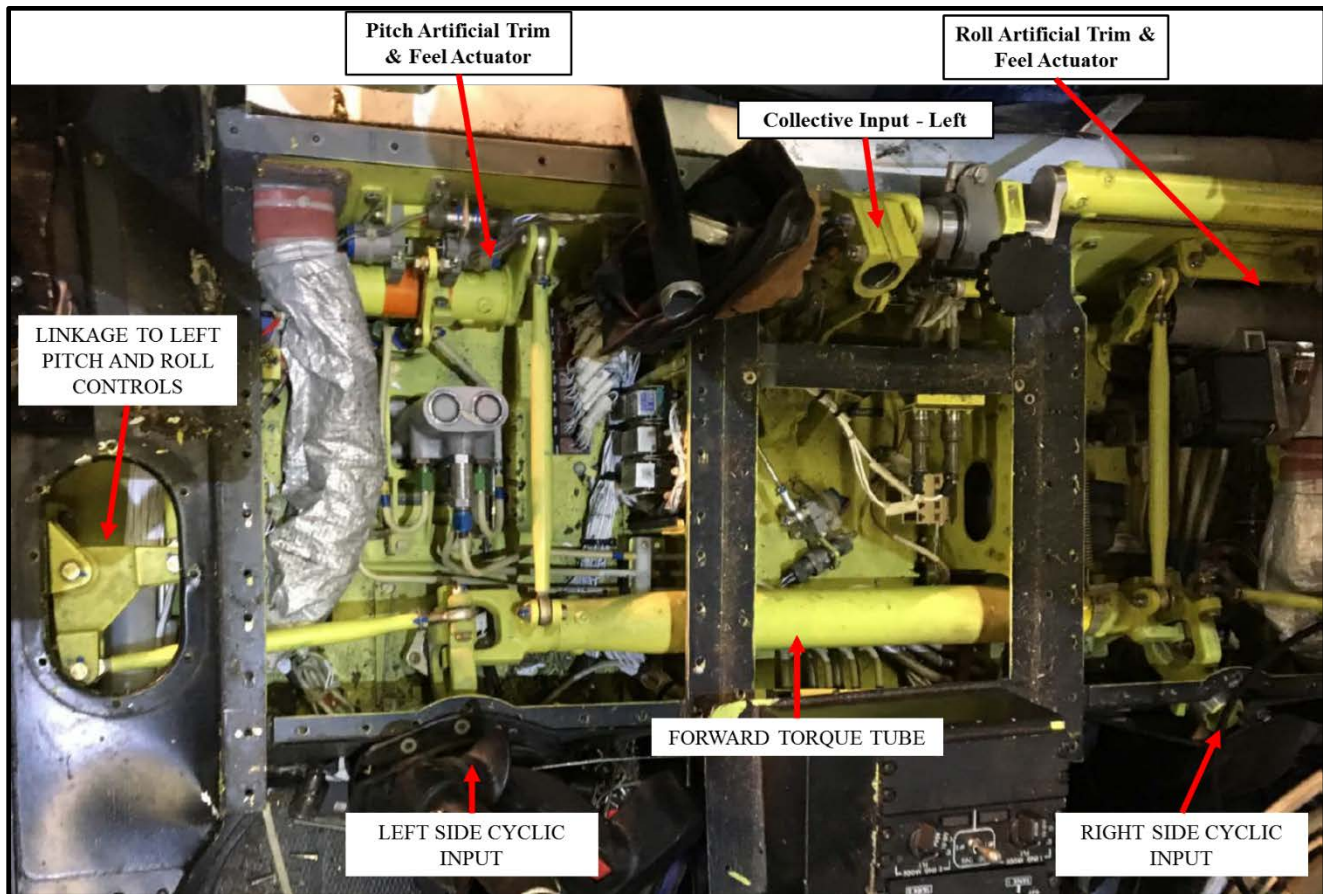
**Figure 2 Photograph of flight controls located beneath cockpit floor**

As shown in Figure 2, the main and tail rotor flight control system components (pushrods, torque tubes, attachment hardware, etc.) located beneath the cockpit floor were found in place and remained properly connected via their attachment hardware. The artificial feel & trim actuator, P/N 109-0021-18-1, S/N 11687 was removed from the helicopter and retained for functional testing at Thales Italia Avionics. Reference section D.7.4 of this report.

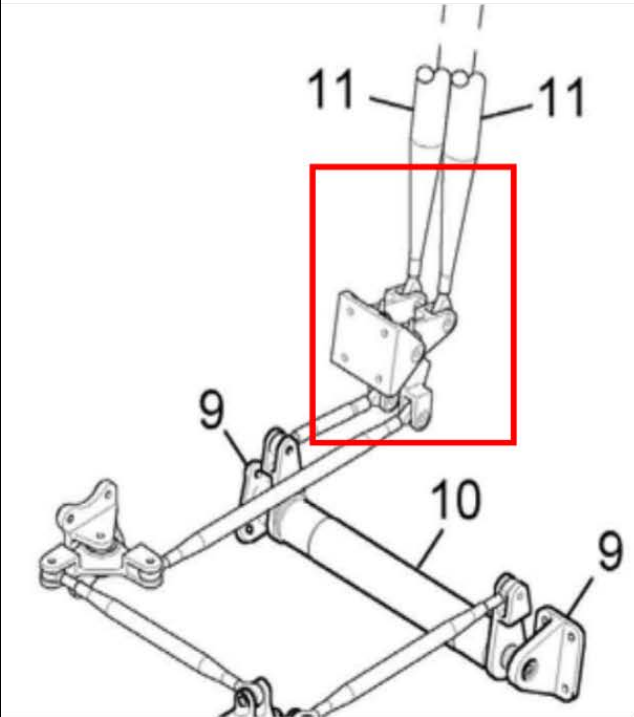
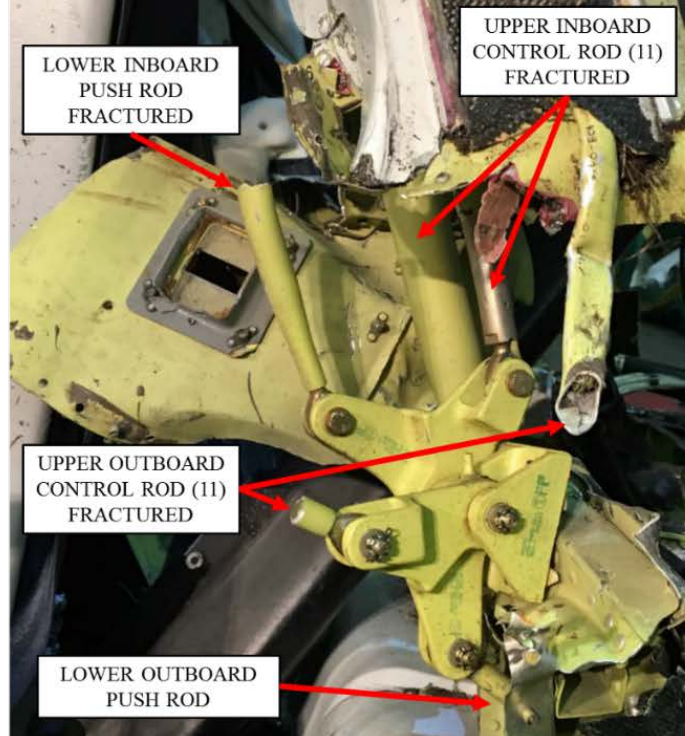
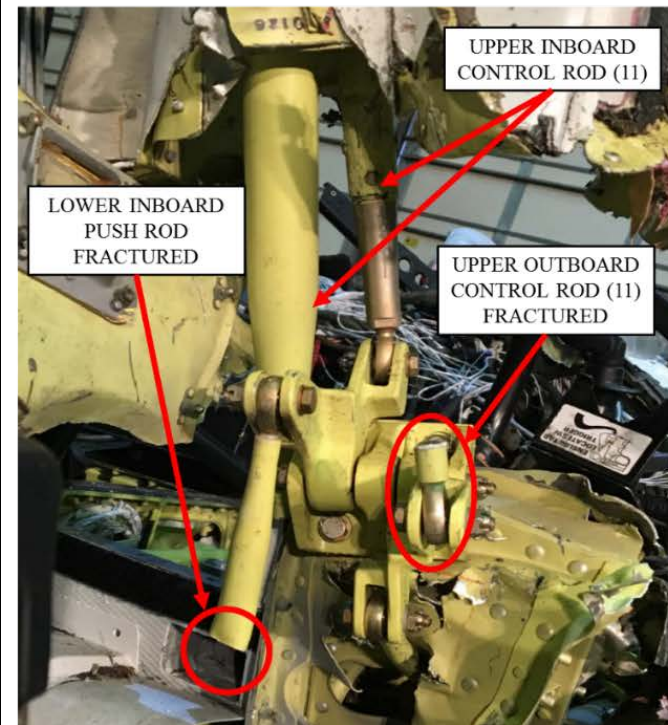
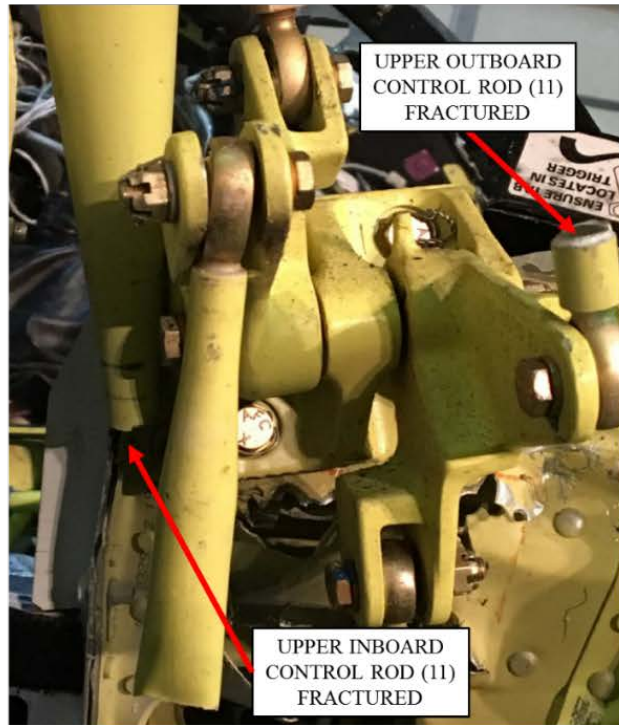
**Figure 3 Left bellcrank assembly**

As shown in Figure 3, both cyclic (pitch and roll) pushrods and control tubes were found fractured near their respective lower bellcrank assemblies. Inspection found that the rod ends for both pushrods and both control tubes remained properly connected via their attachment hardware to their respective bellcrank assembly. The upper end of the control tubes remained intact and properly connected to their respective bellcrank assembly with their attachment hardware.

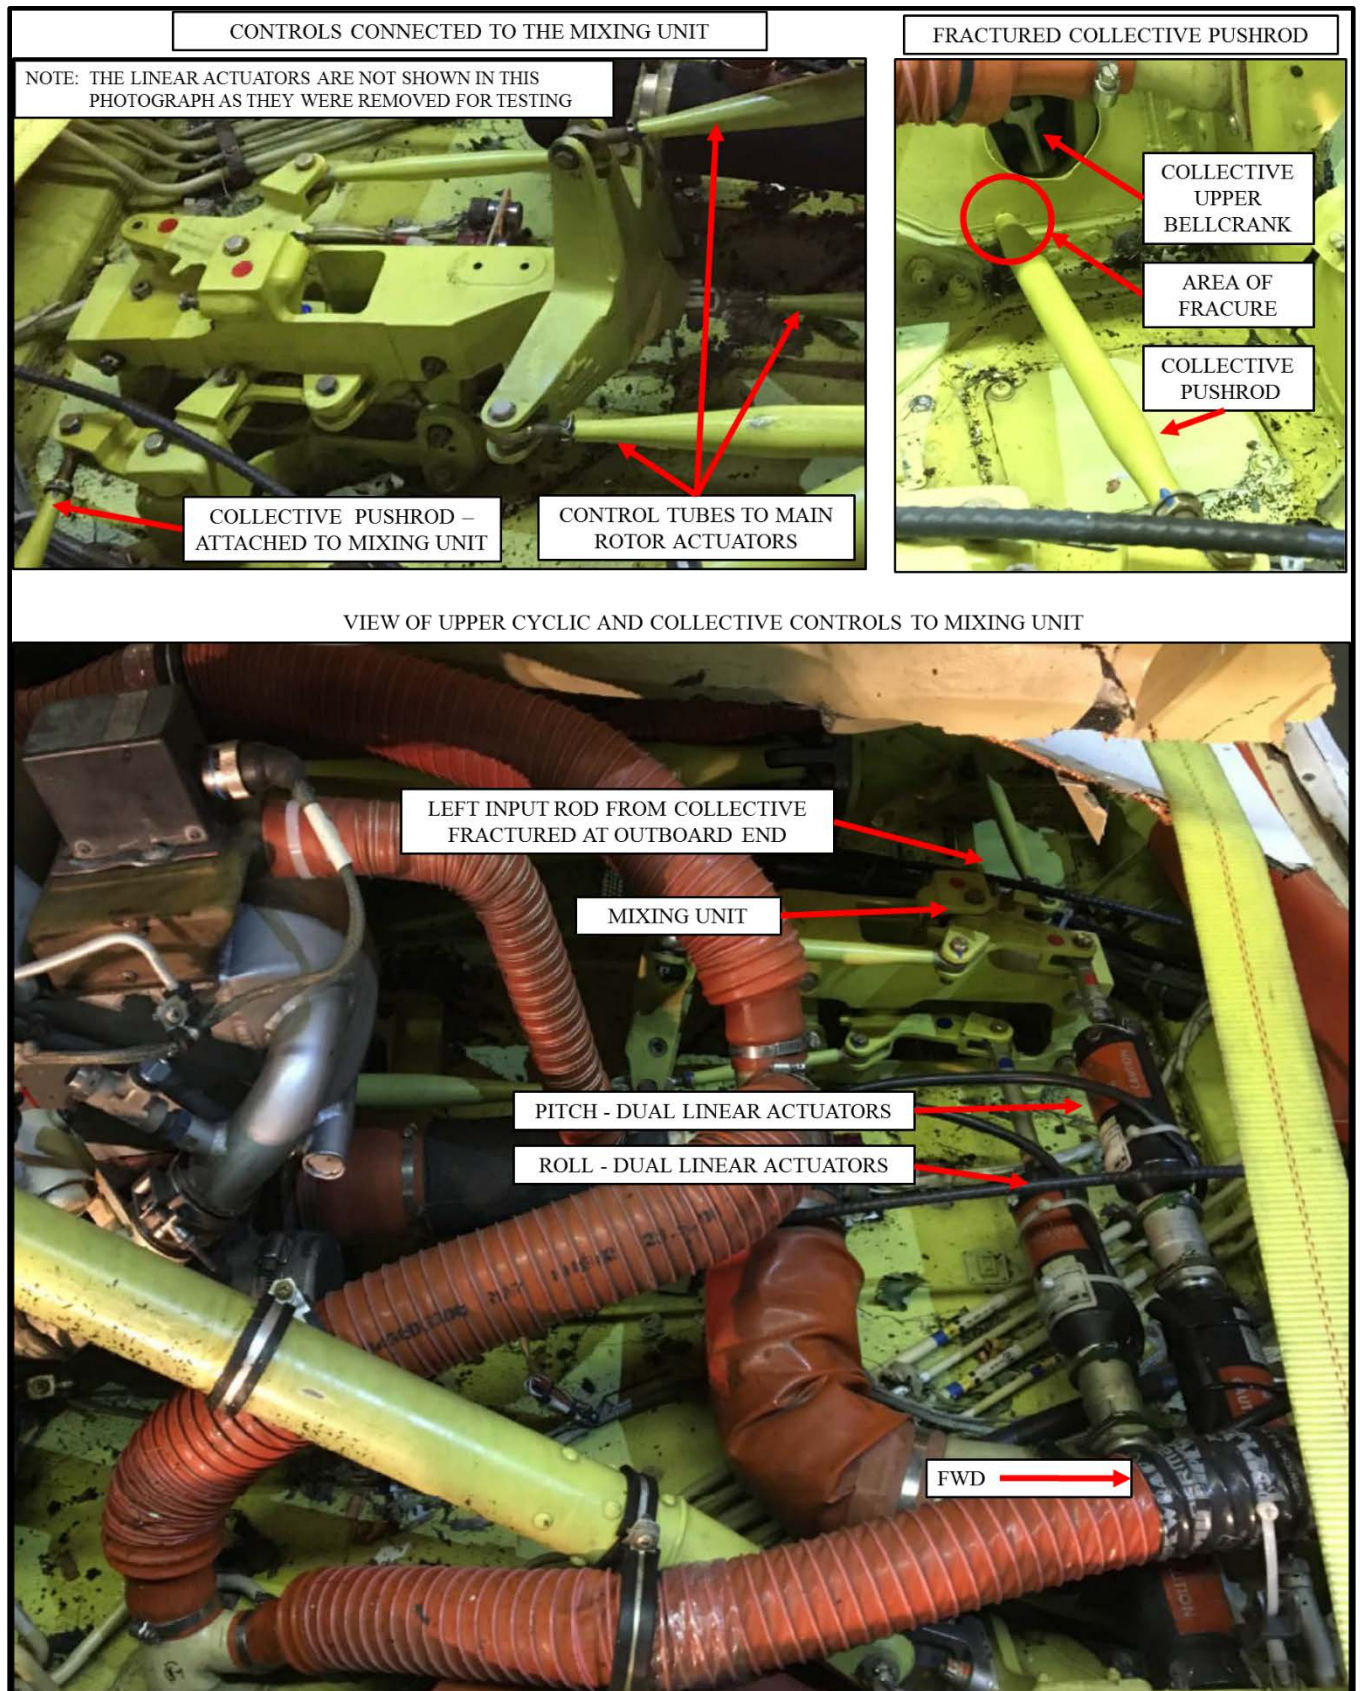
**Figure 4 Flight Controls located in compartment above the cockpit**

The lower end of the collective control tube was found fractured just above its rod end; which remained intact and properly connected to the lower bellcrank with its attachment hardware. The upper end of the control tube remained intact and properly connected to the upper bellcrank with its attachment hardware.

Figure 4 also shows that the pushrod, connecting the collective control tubes upper bellcrank to the mixing unit, was found separated in the area near the upper bellcrank.

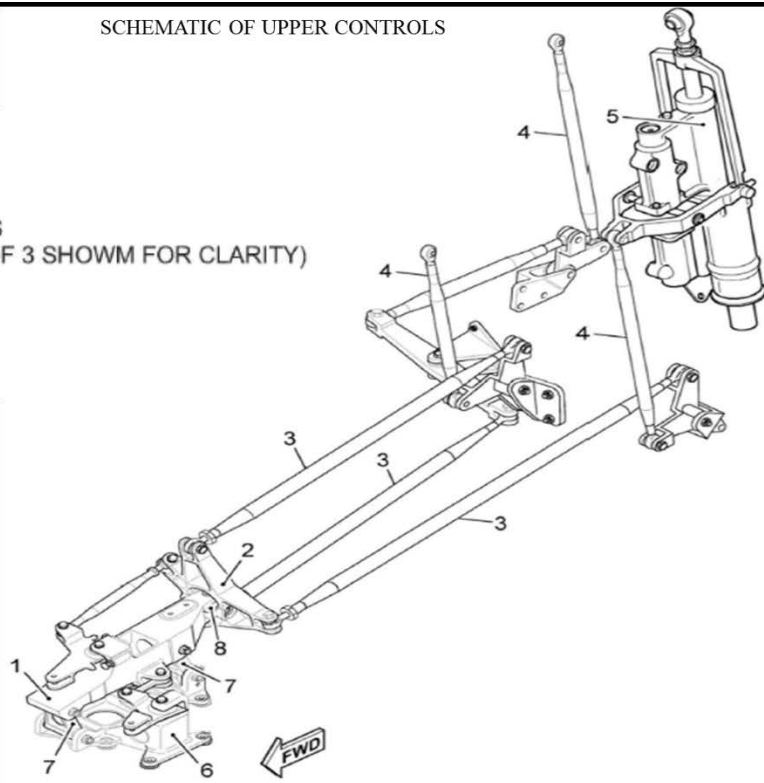
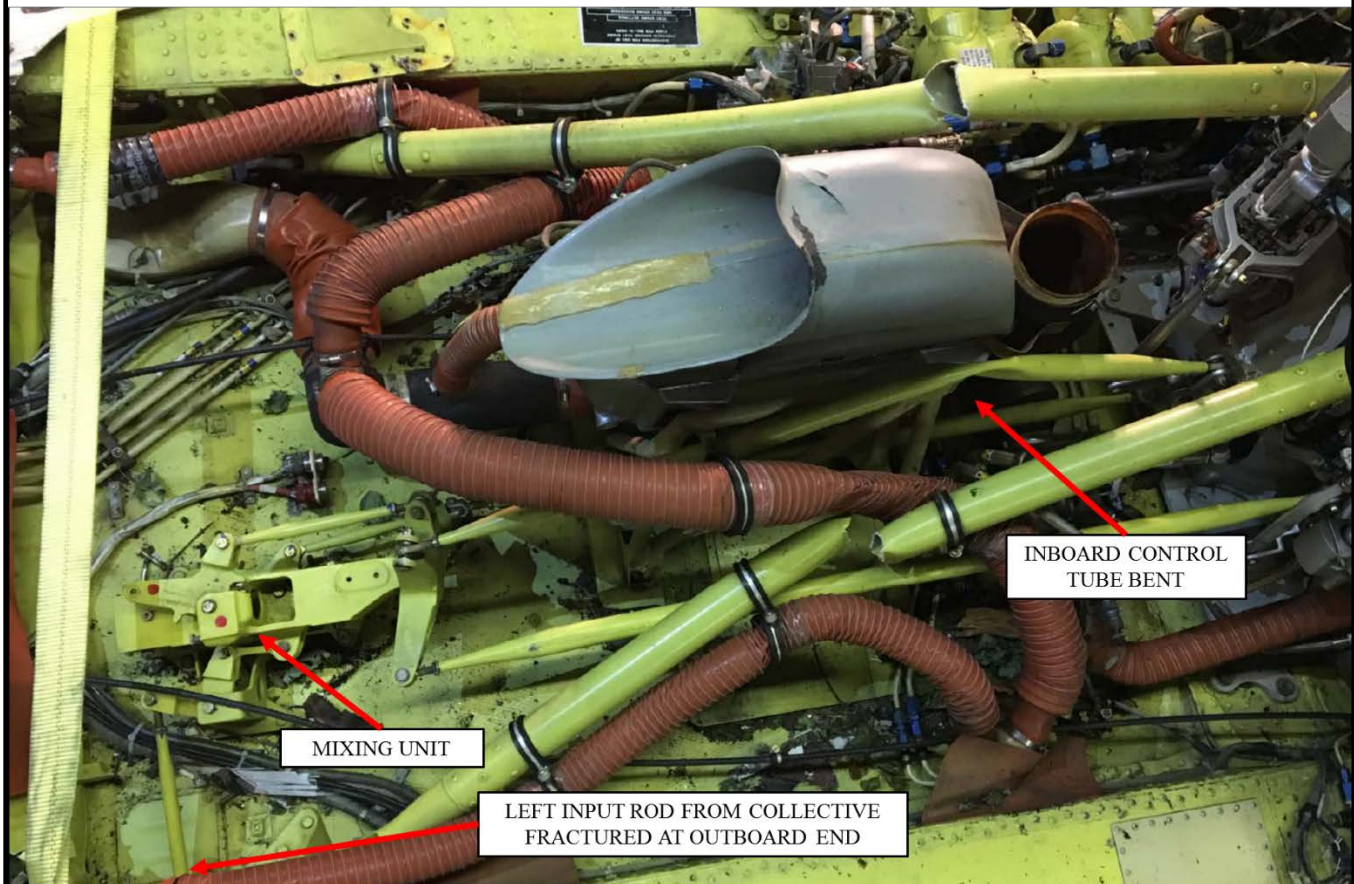
**Figure 5 Controls to main rotor actuator**

Continuity was established between the mixing unit and each of the three main rotor actuators. As shown in Figure 5, the controls (control tubes, bellcranks, etc.) from the mixing unit to the three-main rotor actuator input levers remained properly connected to their respective linkages and all attachment hardware remained intact and in place. Some structural deformation/damage was observed on the control tubes and bellcranks.

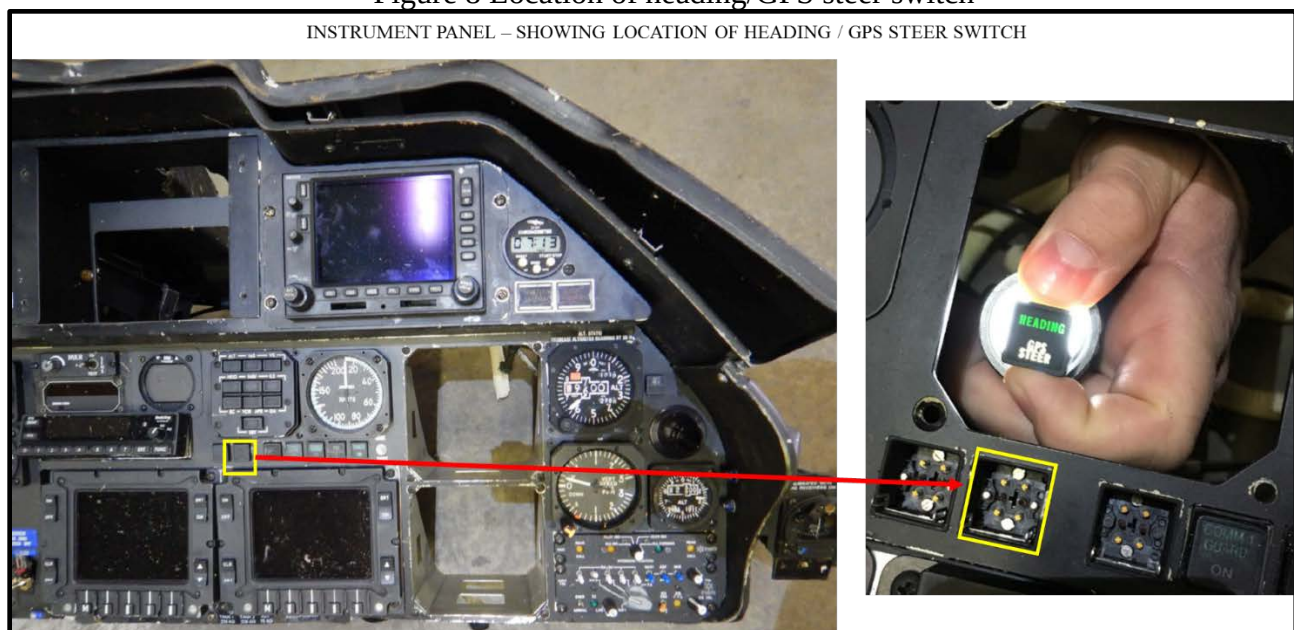
Figure 8 Location of heading/GPS steer switch

On April 24, 2017, the systems group examined and tested the HDG/GPS STEER Switch at the Wentworth Aircraft hangar at Airlake Airport (LVN), Lakeville, MN. A visual inspection of the switch found that its pushbutton remained in an extended “HEADING” position. According to the MSP Aero roll steering modification drawing, when continuity exists between pins A3 and A2, the HDG/GPS STEER Switch is positioned to “HEADING” and when continuity exists between pins A3 and A1, the HDG/GPS STEER Switch is positioned to “GPS STEER”. Using a multimeter, a check of the “as found” switch position was conducted and the following results were measured<sup>2</sup>:

- A2 to A3 – No Continuity
- A1 to A3 – Continuity

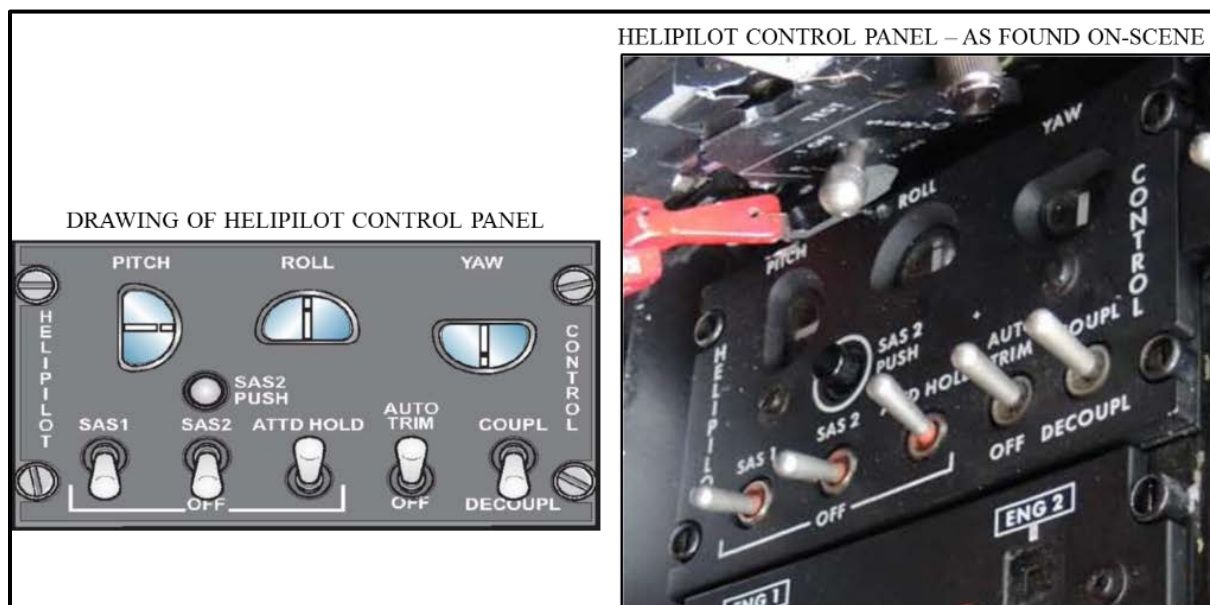
**Figure 9 Helipilot control panel**

During the on-scene activities, a photograph of the Helipilot control panel was taken (Reference Figure 9). A review of the photograph shows that its switches were found positioned as indicated in Table 5.

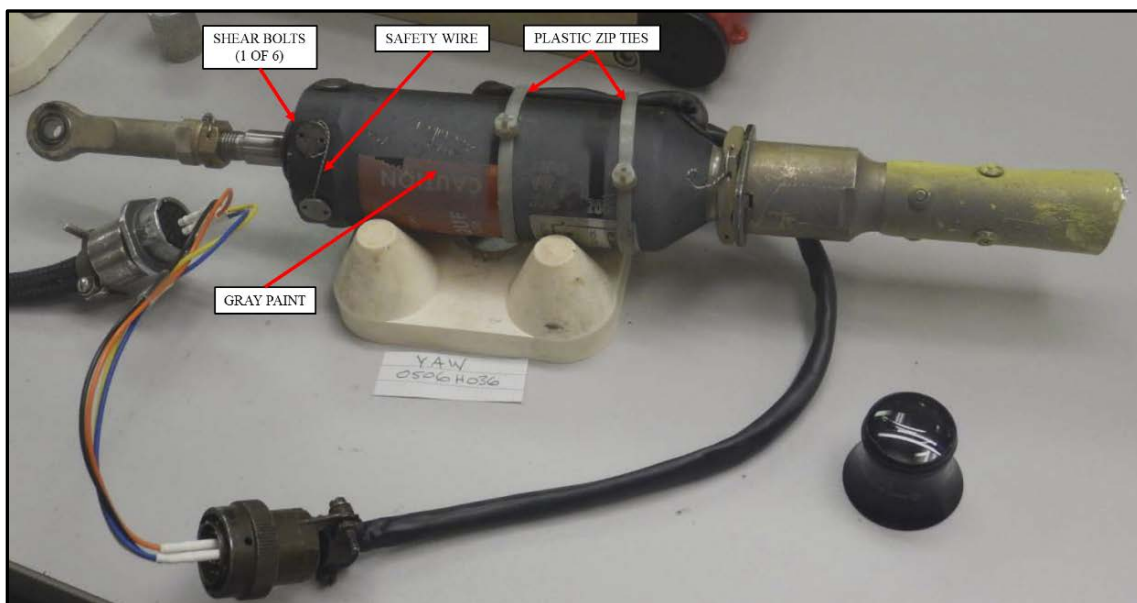
**Figure 13 Yaw actuator**

The visual inspections revealed that the yaw actuator, P/N 4012373-905, S/N 0506H036, was intact, three plastic zip ties (white) were observed attached to the outside of the unit, all safety wire remained present and intact, a “Honeywell” quality seal remained intact and covering the safety wire between the shear bolts in one location, the grommet for the wiring harness was cracked, gray paint was observed on a portion of the unit and no corrosion or bent pins was observed on the electrical connector. All shear bolts (6) appeared to be undamaged; there was no visual evidence of a fracture.

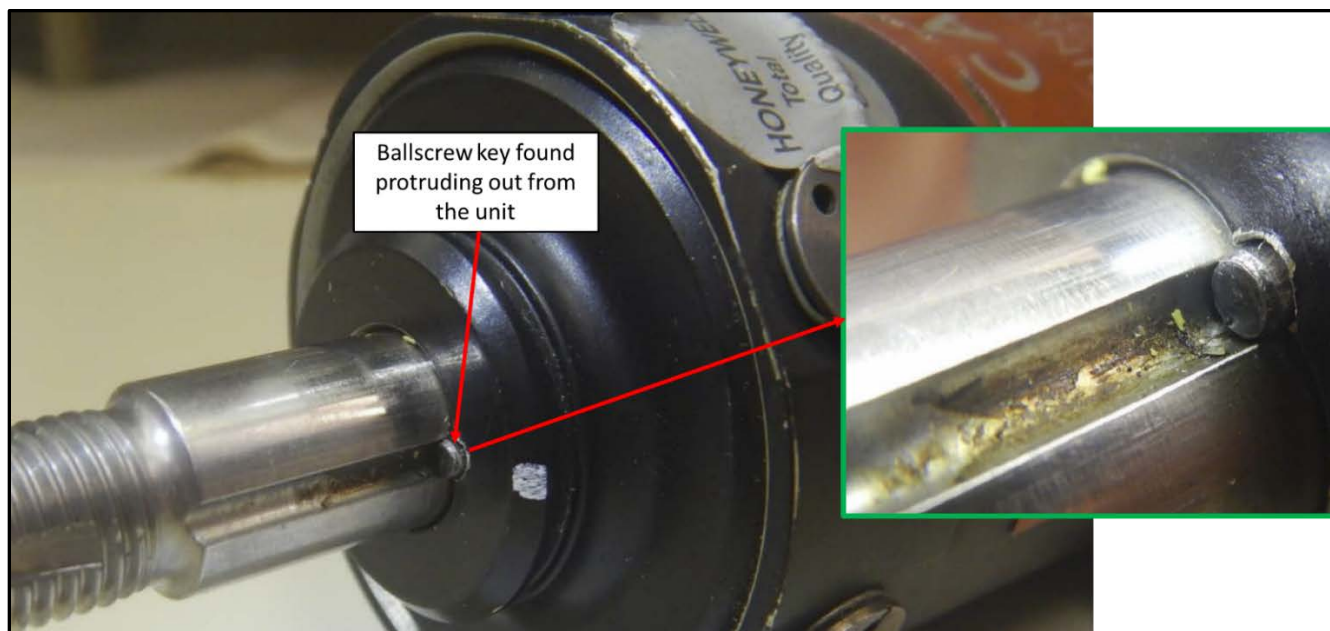
**Figure 14 Photograph of ballscrew key**

It was noted that the rear housing to ballscrew key for ballscrew anti-rotation, key P/N MS16555-618 was found protruding out from the unit. The housing material holding the pin in its location exhibited shearing and overload deformation, allowing the pin to protrude from the end of the housing by 0.050”.

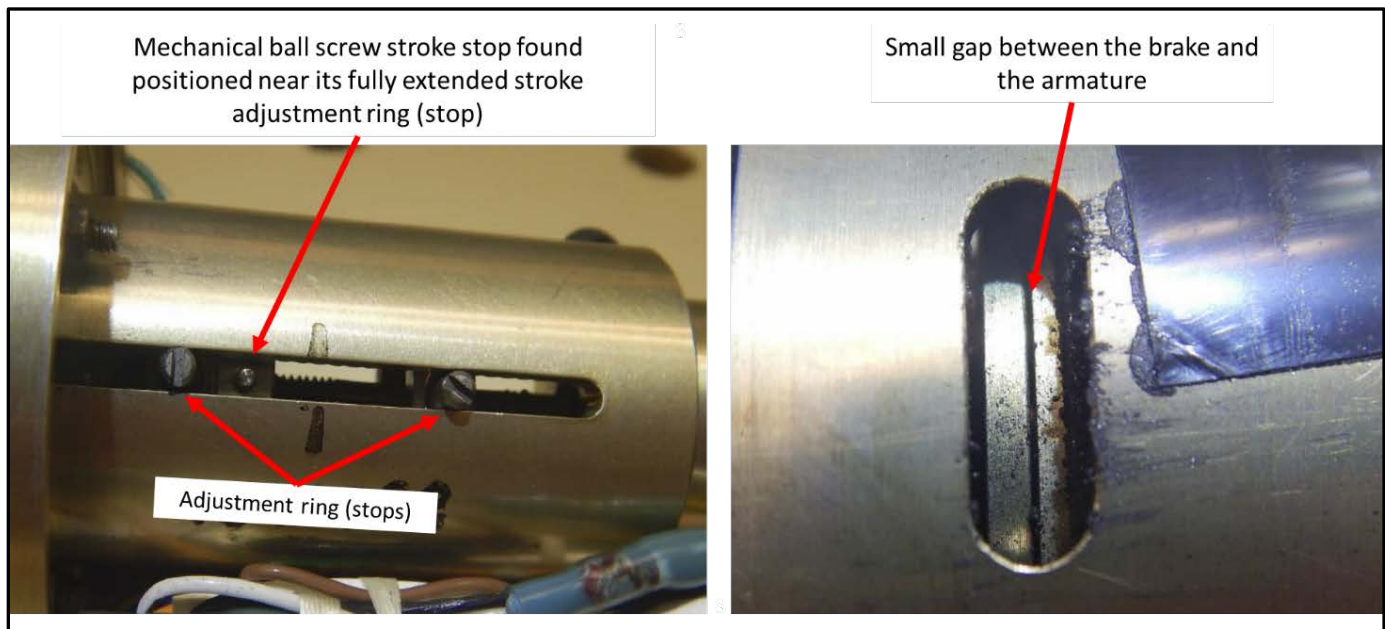
**Figure 15 Ballscrew and brake position**

As shown in Figure 15, after removing the actuators housing, the mechanical ball screw stroke stop was found positioned near its fully extended stroke adjustment ring (stop). A small gap between the brake and the armature was observed, however, a minimum shim gap tool (0.025) could not be inserted between them.

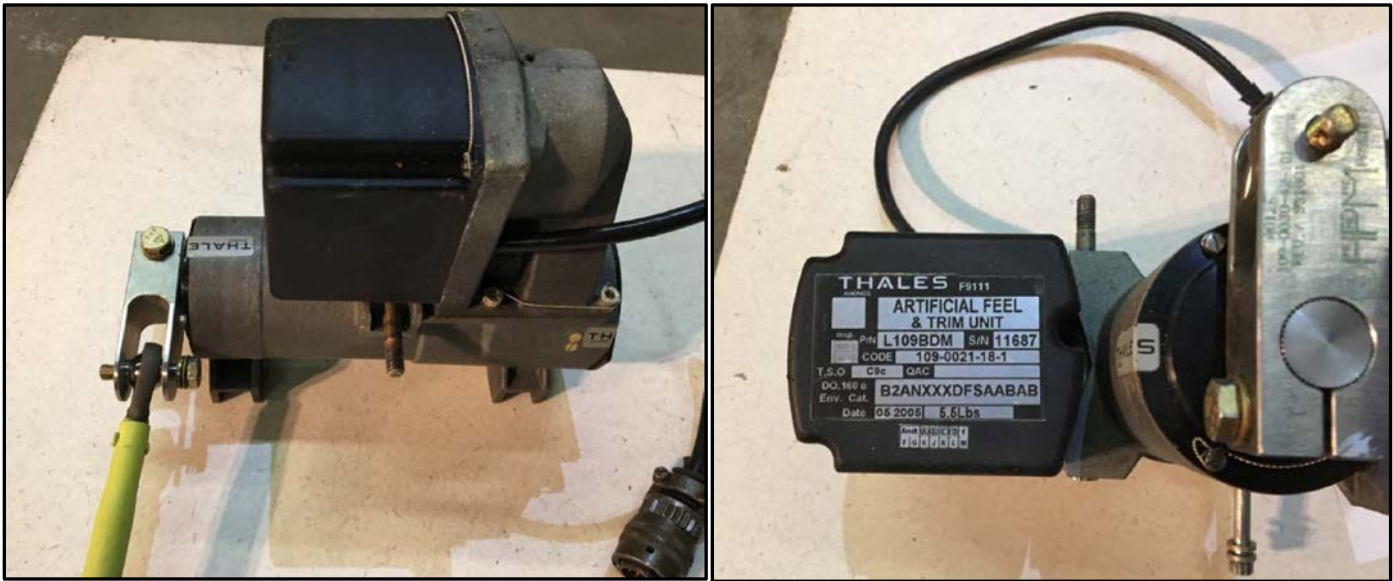
**Figure 16 Artificial feel & trim unit as photographed at the wreckage facility**

On July 14, 2017, visual examination and functional testing were conducted on the actuator by Thales in the presence of a representative from Leonardo Helicopters. Results of the examination showed that there were no mechanical or electrical malfunctions with the actuator and that it passed its acceptance testing.

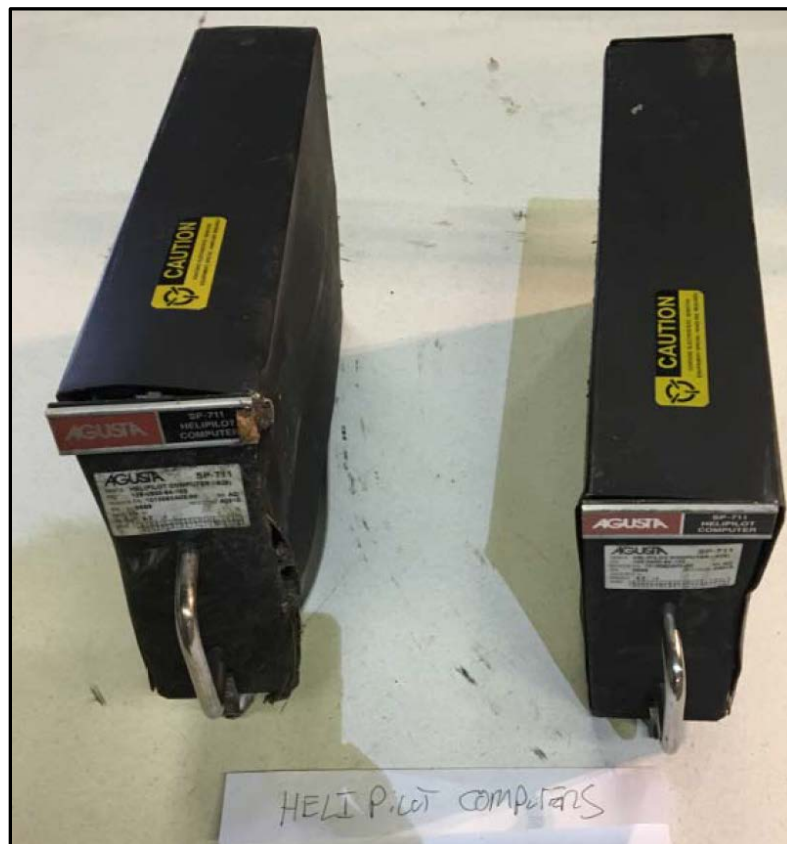
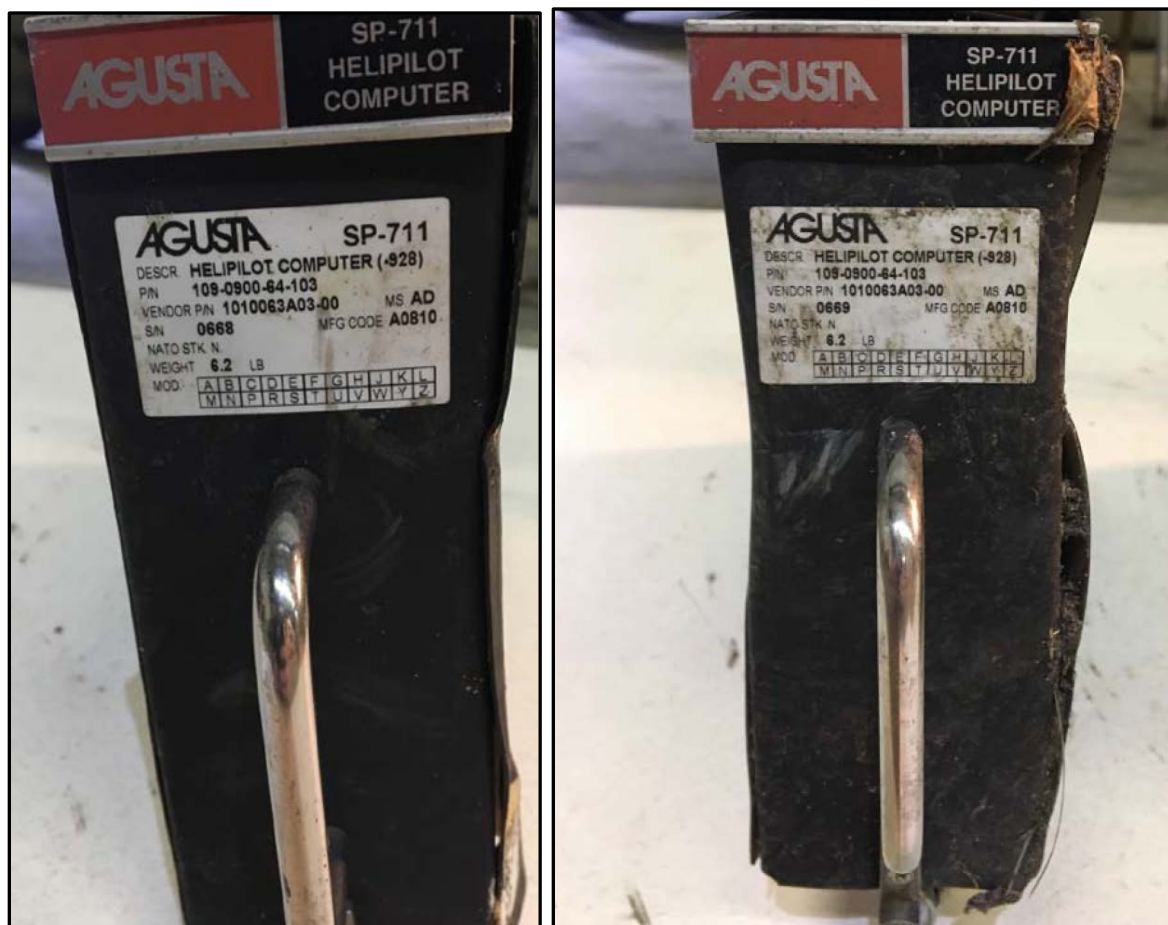
The helicopter was equipped with two Helipilot computers having part number 1010063A03-00AD and serial numbers 0668 and 0669. Reference Figure 17 and 18. Both computers were removed from the helicopter on April 24, 2017 at the Wentworth Aircraft hangar. The units were then shipped to Leonardo Airborne and Space Systems located in Nerviano (MI), Italy for examination.

**Figure 17 Helipilot computers as photographed at the wreckage facility**

**Figure 18 Photograph of the front of the Helipilot computers showing their identification tags**

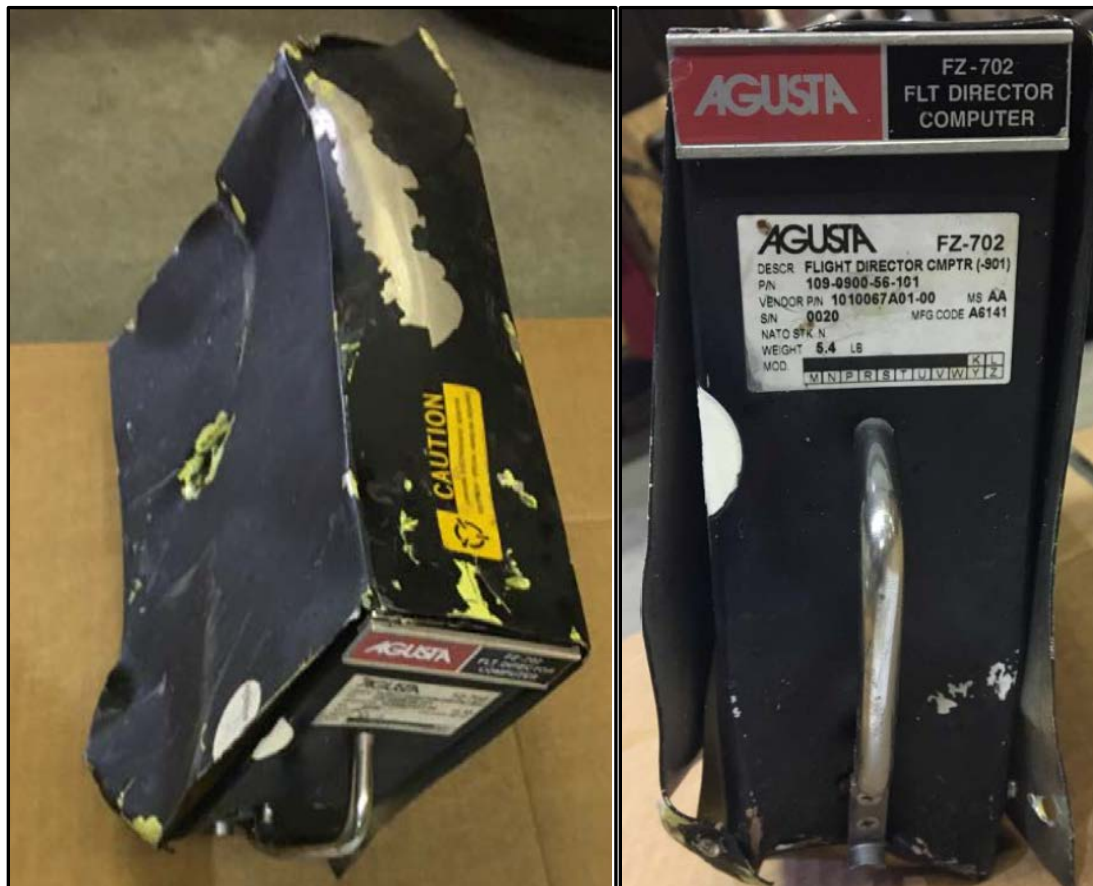
**Figure 19 Flight director computer as photographed at the wreckage examination**

An external visual inspection of the exterior of the unit revealed that the cover assembly and chassis were heavily damaged and deformed. The removal of the cover was particularly difficult; it had to be opened with some force (also by using a shear to cut the heads of the attachment screws). Once removed, a visual inspection of the interior of the unit revealed the circuit cards were also damaged.

The circuit cards were removed from the unit and placed on a table to perform a more detailed visual inspection: the inspection showed considerable mechanical damage to the components located on all of the circuit cards. However, none of the circuit cards had evidence of electrical or burn damage on their components.

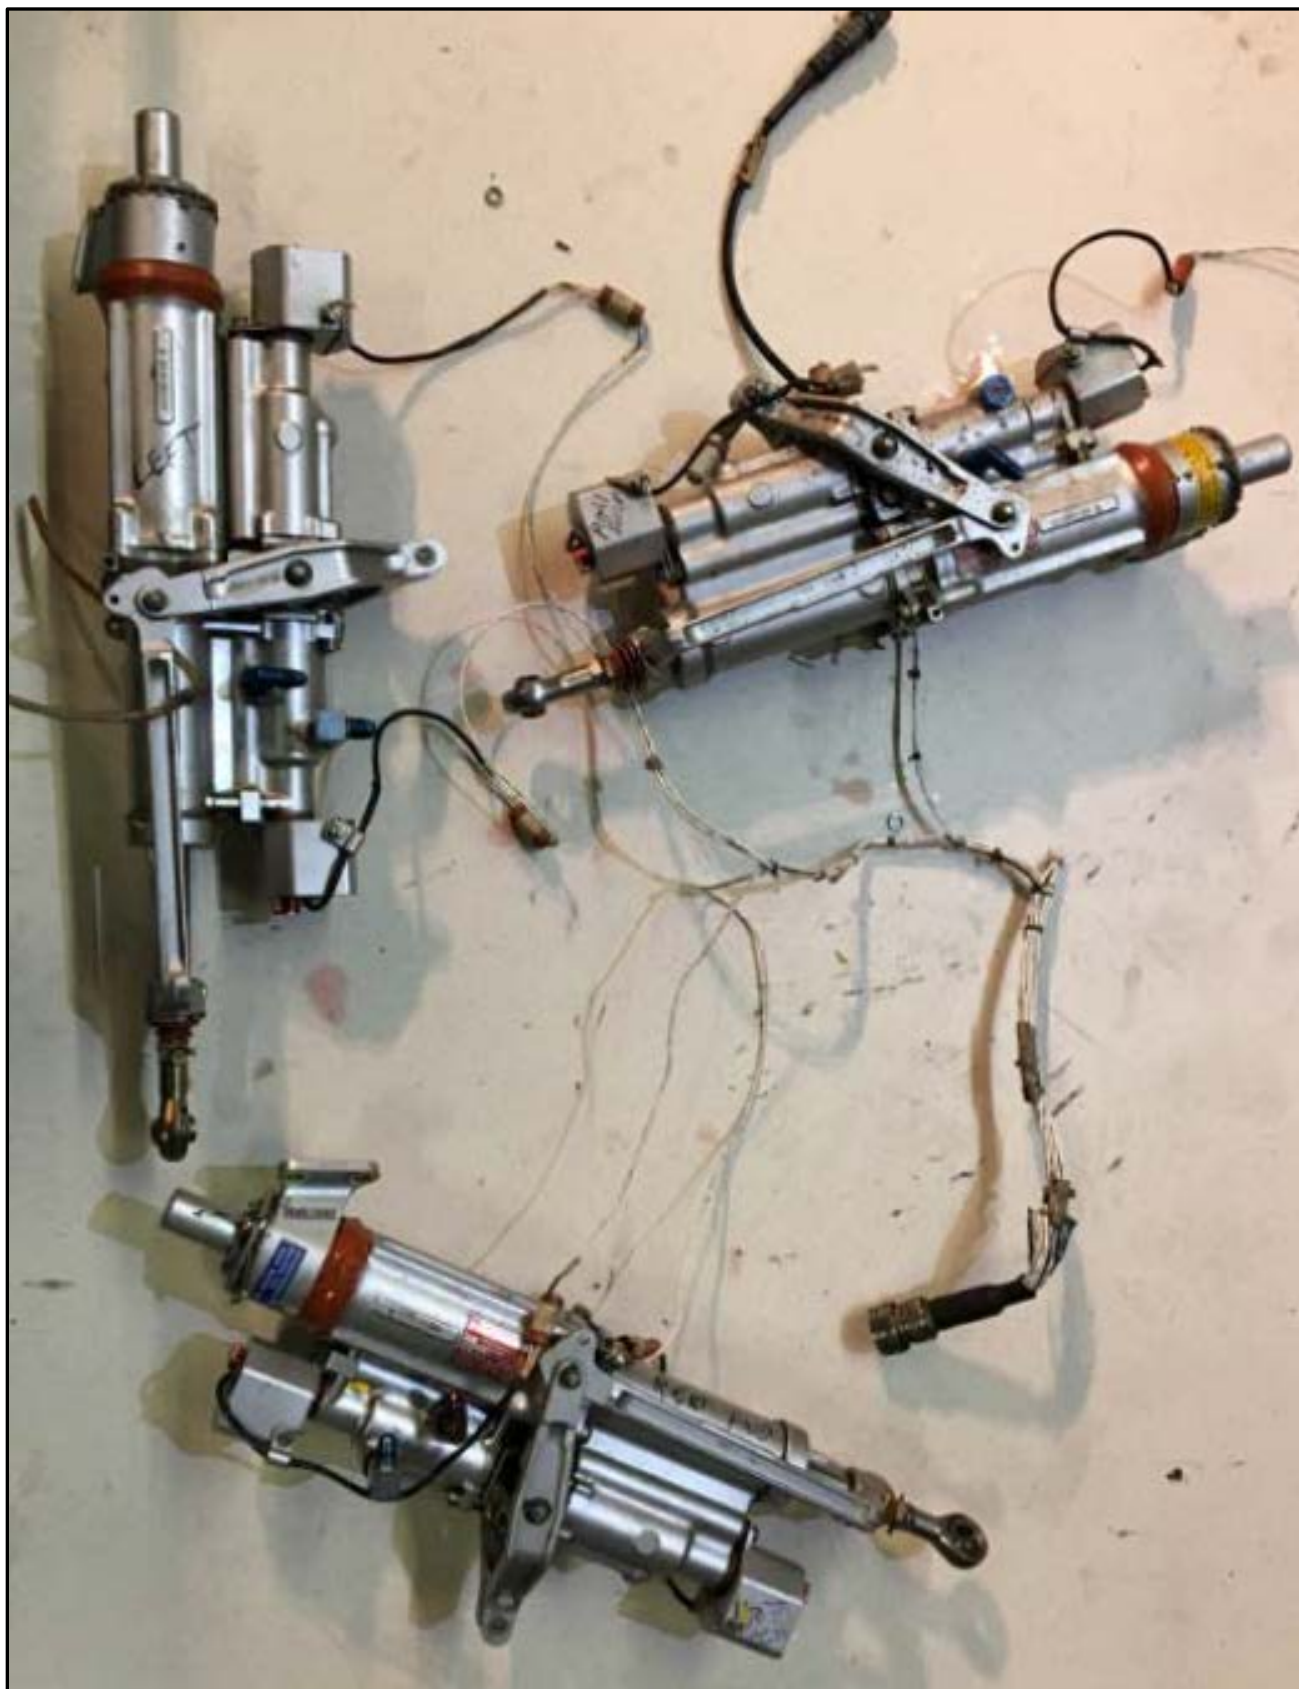
**Figure 21 Main rotor actuators - at the wreckage examination**

Examination of the three actuators found that the forward right actuator (blue) remained attached to the upper case of the transmission by its jointed support assembly. The left (red) and right (yellow) actuators were found not attached to the upper case of the transmission; their jointed support assemblies were found fractured.

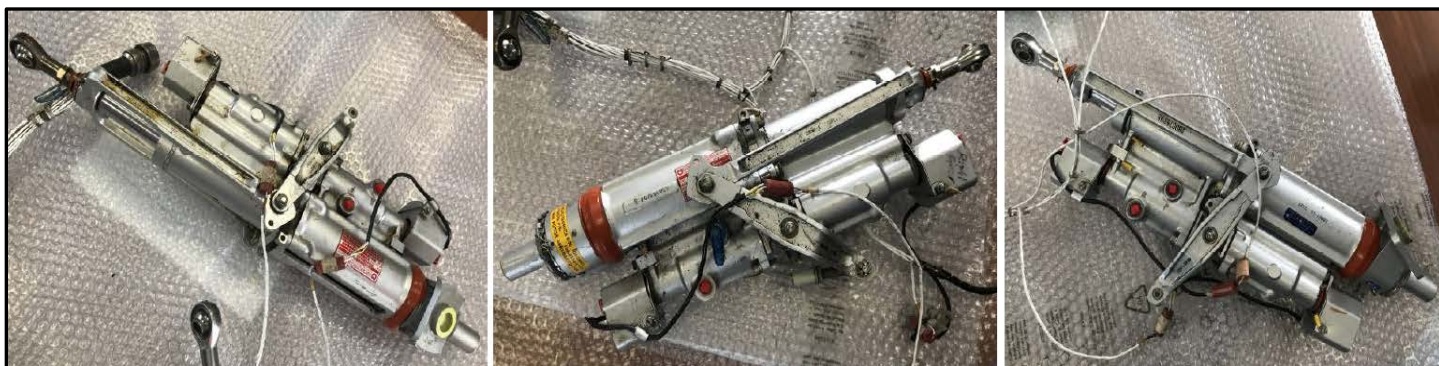
Figure 23 Visual inspection of the unit's S/N 4006 (left image), 6021 (center image) and 8011 (right image).

| | Left actuator<br>(red position)<br>P/N 304-28007-00<br>S/N 4006 | Right actuator<br>(yellow position)<br>P/N 305-28007-00<br>S/N 6021 | Forward actuator<br>(blue position)<br>P/N 306-28007-00<br>S/N 8011 |
|---|---|---|---|
| <b>Missing parts</b> | No missing parts were detected, apart from the red support identification label. | No missing parts. | No missing parts. |
| <b>External damage</b> | Two deep scrapes on the cap and a clear bending deformation of both Microswitch carters were observed. The eye-end was also contacting the spool end | Two deep scrapes on the fixed-end valve body were observed. In addition, a plastic deformation of the fixed end Microswitch carter was clearly visible | No external damages, apart from a clear bending deformation of the fixed-end Microswitch carter, which was contacting the spool end |
| <b>Support conditions</b> | Broken (support side lugs were missing). | Broken (support side lugs were missing). Also, the bent teeth of the lock washer were either clearly deformed or broken due to a sudden over torque and rotation between the locked parts | No significant damage observed. |
| <b>Ram</b> | No deformations of The eye end, ram, cylinder or outer glands were observed.<br>Piston position: approximately <b>67%</b> (72.9 mm) of the stroke. | No deformations of The eye end, ram, cylinder or outer glands were observed.<br>Piston position: fully <b>retracted</b> . | No deformations of The eye end, ram, cylinder or outer glands were observed.<br>Piston position: approximately <b>30%</b> (34.4 mm) of the stroke. |

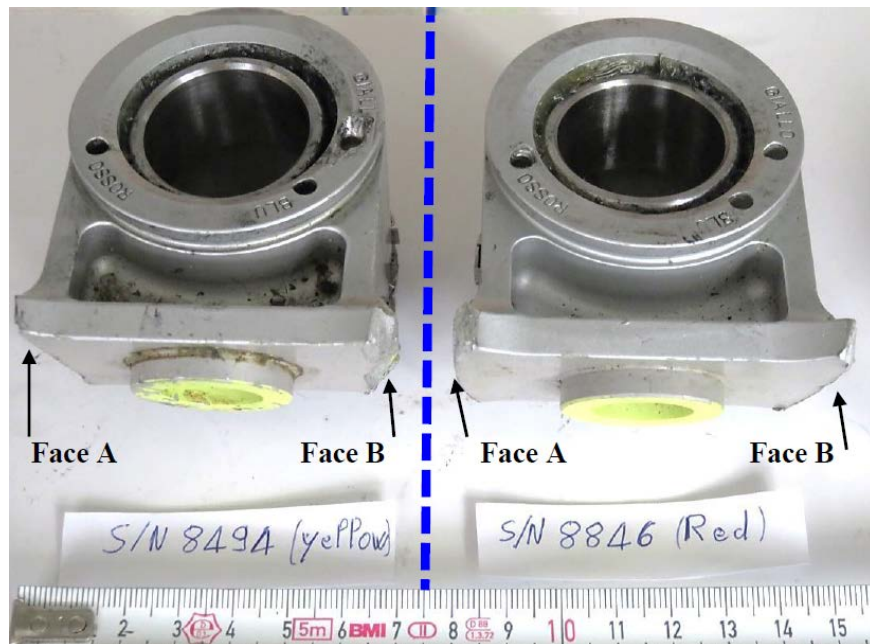
**Figure 24 View of the two main rotor actuator attachments as arrived in Leonardo's laboratory**

A visual examination of the broken support assemblies (Red and Yellow actuators) revealed that the surface of the fractures had the appearance of a static failure due to a sudden overload.

According to a report, dated 9/26/2017, from Leonardo Helicopter, the scope of their investigation was to determine the type of fracture morphology (fatigue or overload) that was present on the fracture surfaces of the wings that were found broken on the Yellow (S/N 8494 with 609.3 flight hours) and Red (S/N 8846 with 113.6 flight hours) main rotor servo actuator attachments removed from the A109S S/N 22014 R/M N91NM. Reference Figure 24.

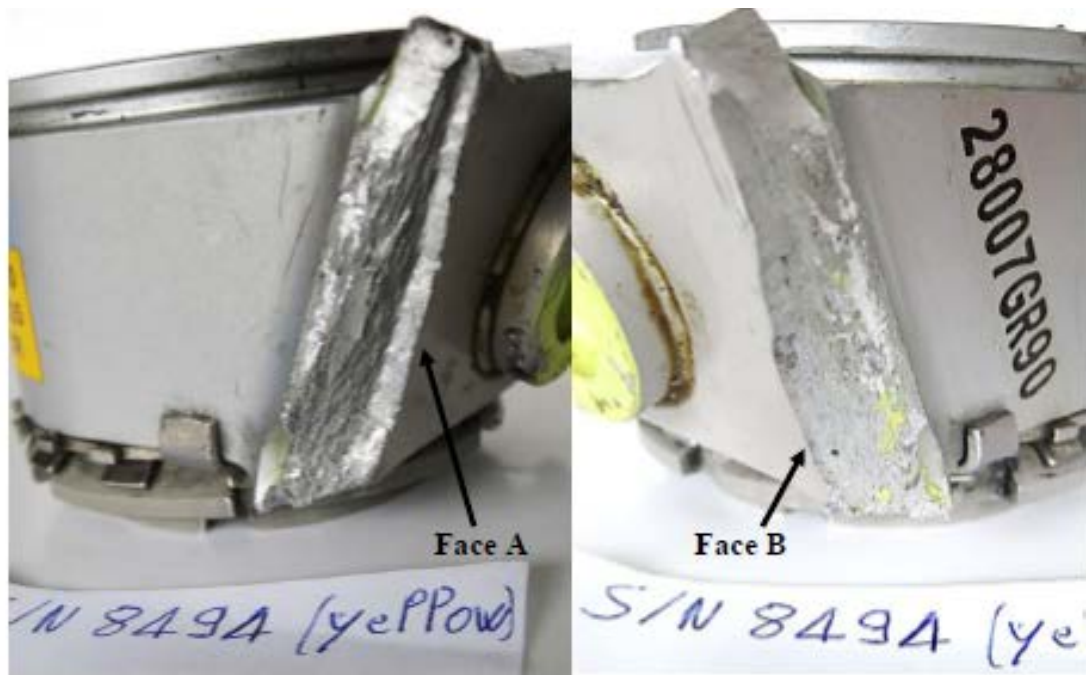
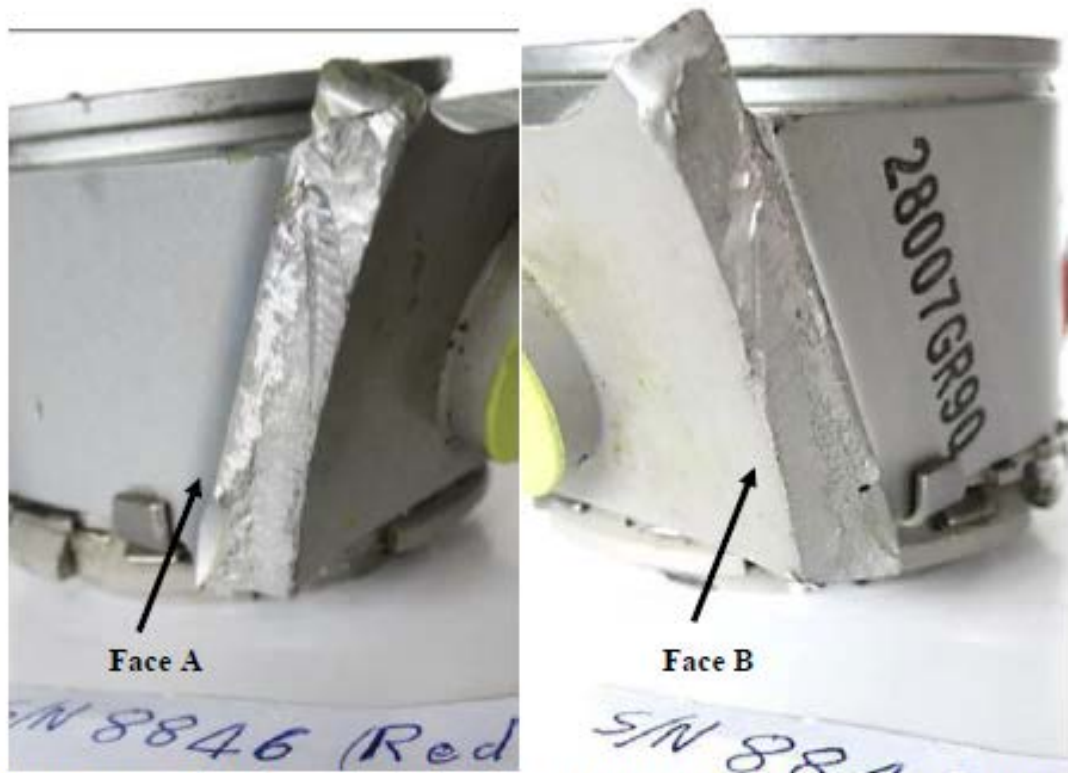
Figure 25 photos of yellow and red support surfaces

The macroscopic aspect of the four fracture surfaces were characterized by sliding of the material with significant roughness aspect of the same fracture surfaces. Reference Figure 25. The S.E.M. investigations conducted in a central zone for every fracture surface, evidenced that the modality of the cracks is by overload as indicated by the presence of dimples. Reference Figure 26.

Picture n°2 S/N 8494 (Yellow) View of the Face A and B (named in laboratory for identification)

Picture n°3 S/N 8846 (Red) View of the Face A and B (named in laboratory for identification).

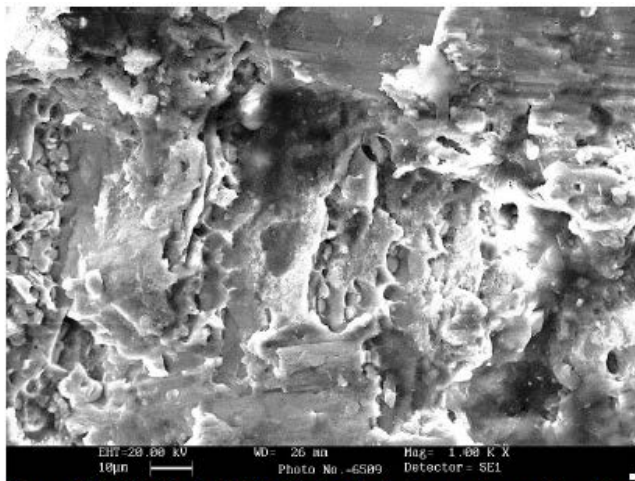
Picture n°4 1000X SEM S/N 8494 (Yellow) - Dimples in a central zone of Face A fracture.

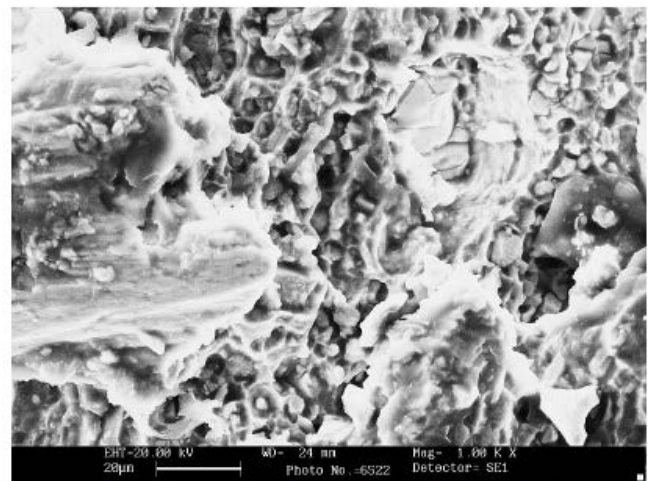
Picture n°6 1000X SEM S/N 8846 (Red) - Dimples in a central zone of Face A fracture.
