**NATIONAL TRANSPORTATION SAFETY BOARD**

**System's Group Chairman's Factual Report**

**NTSB ID No.: CEN16FA372**

Location: Alexandria, Minnesota  
Date: September 17, 2017  
Time: 0207 Central Daylight Time  
Aircraft: Agusta S.p.A A109S helicopter, N91NM

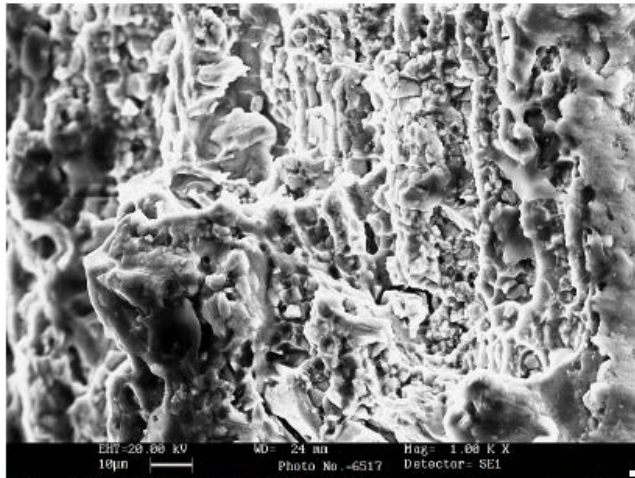
Picture n°5 1000X SEM S/N 8494 (Yellow) - Dimples in a central zone of Face B fracture.

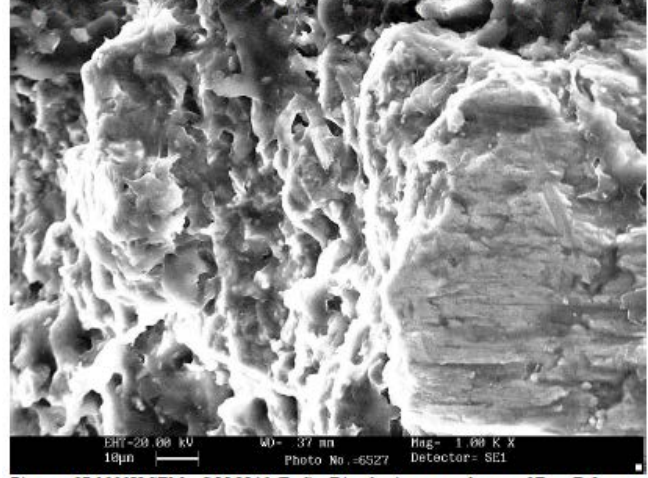
Picture n°7 1000X SEM S/N 8846 (Red) - Dimples in a central zone of Face B fracture.
