**NATIONAL TRANSPORTATION SAFETY BOARD**

**Computed Tomography Specialist's Factual Report**

CEN-16-FA-372

Location: near Chandler Field Airport (AXN), Alexandria, Minnesota  
Date: September 17, 2016  
Time: 0207 central daylight time  
Airplane: Agusta S.p.A A109S helicopter, N91NM

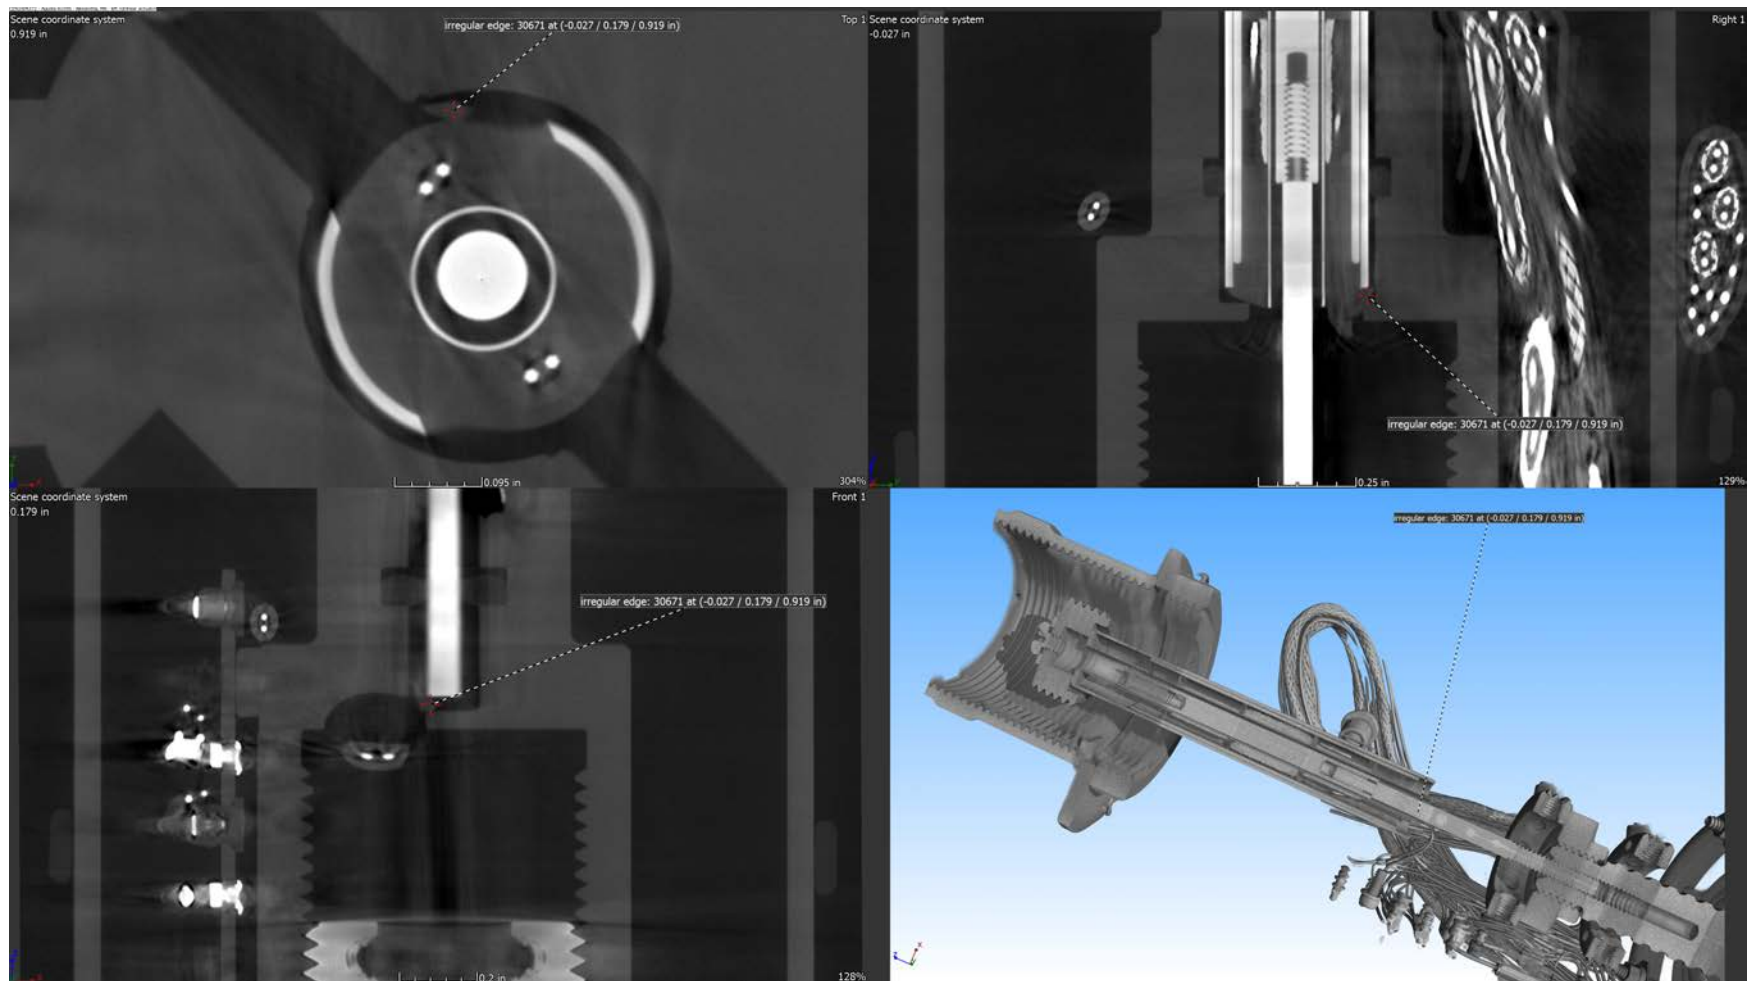
- there was an irregular material edge noted in the area of the LVDT;
- there was medium density material noted in two places within the left roll linear actuator LVDT;
- there were cracks noted in the grommet;

Figure 36  
Left roll linear actuator – LVDT – irregular edge

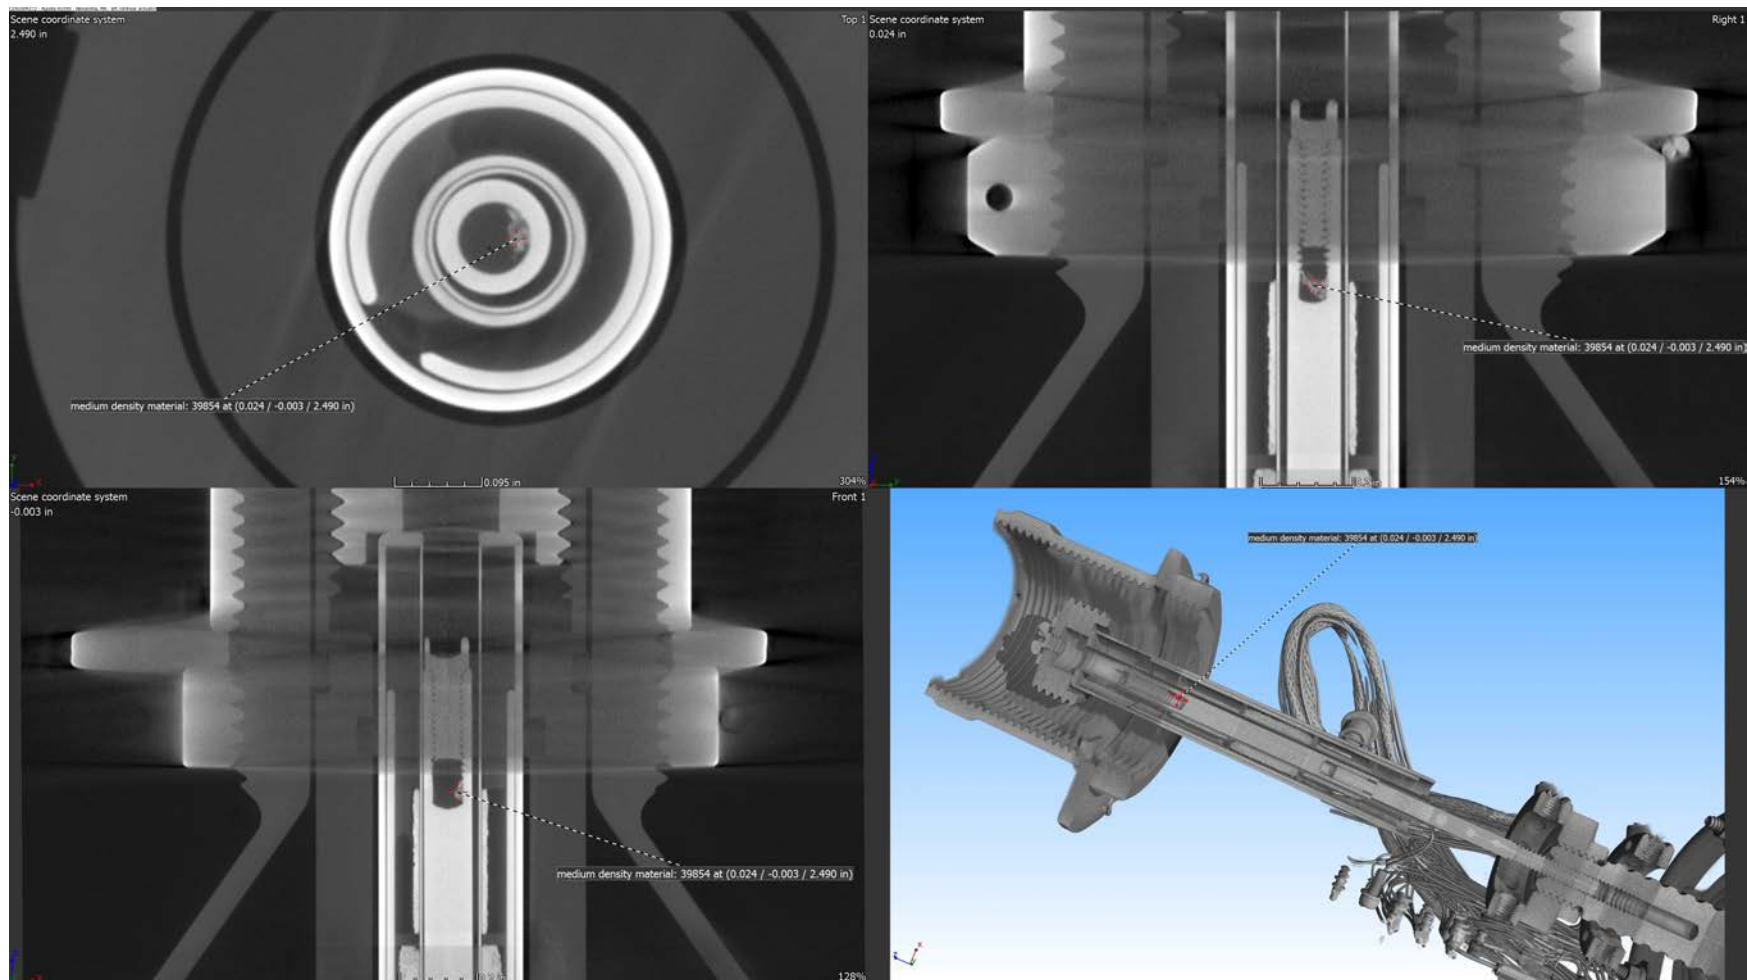
Figure 37  
Left roll linear actuator – medium density material in LVDT

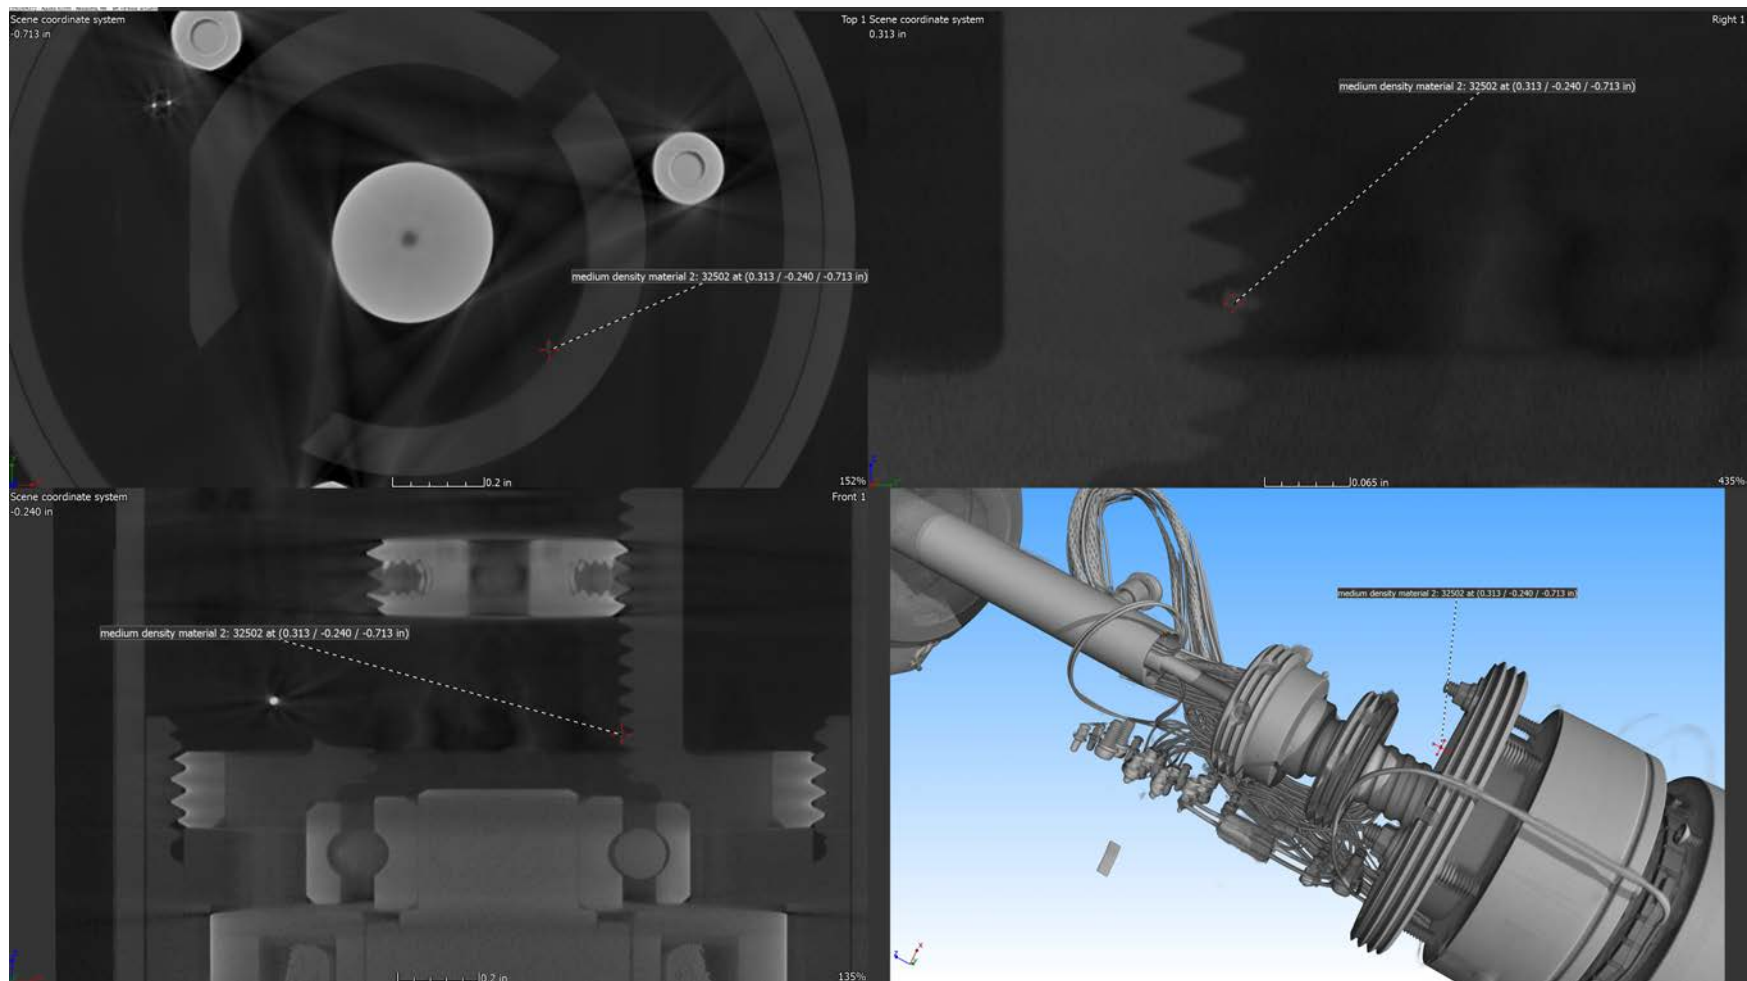
Figure 38  
Left roll linear actuator – medium density material in LVDT – second location

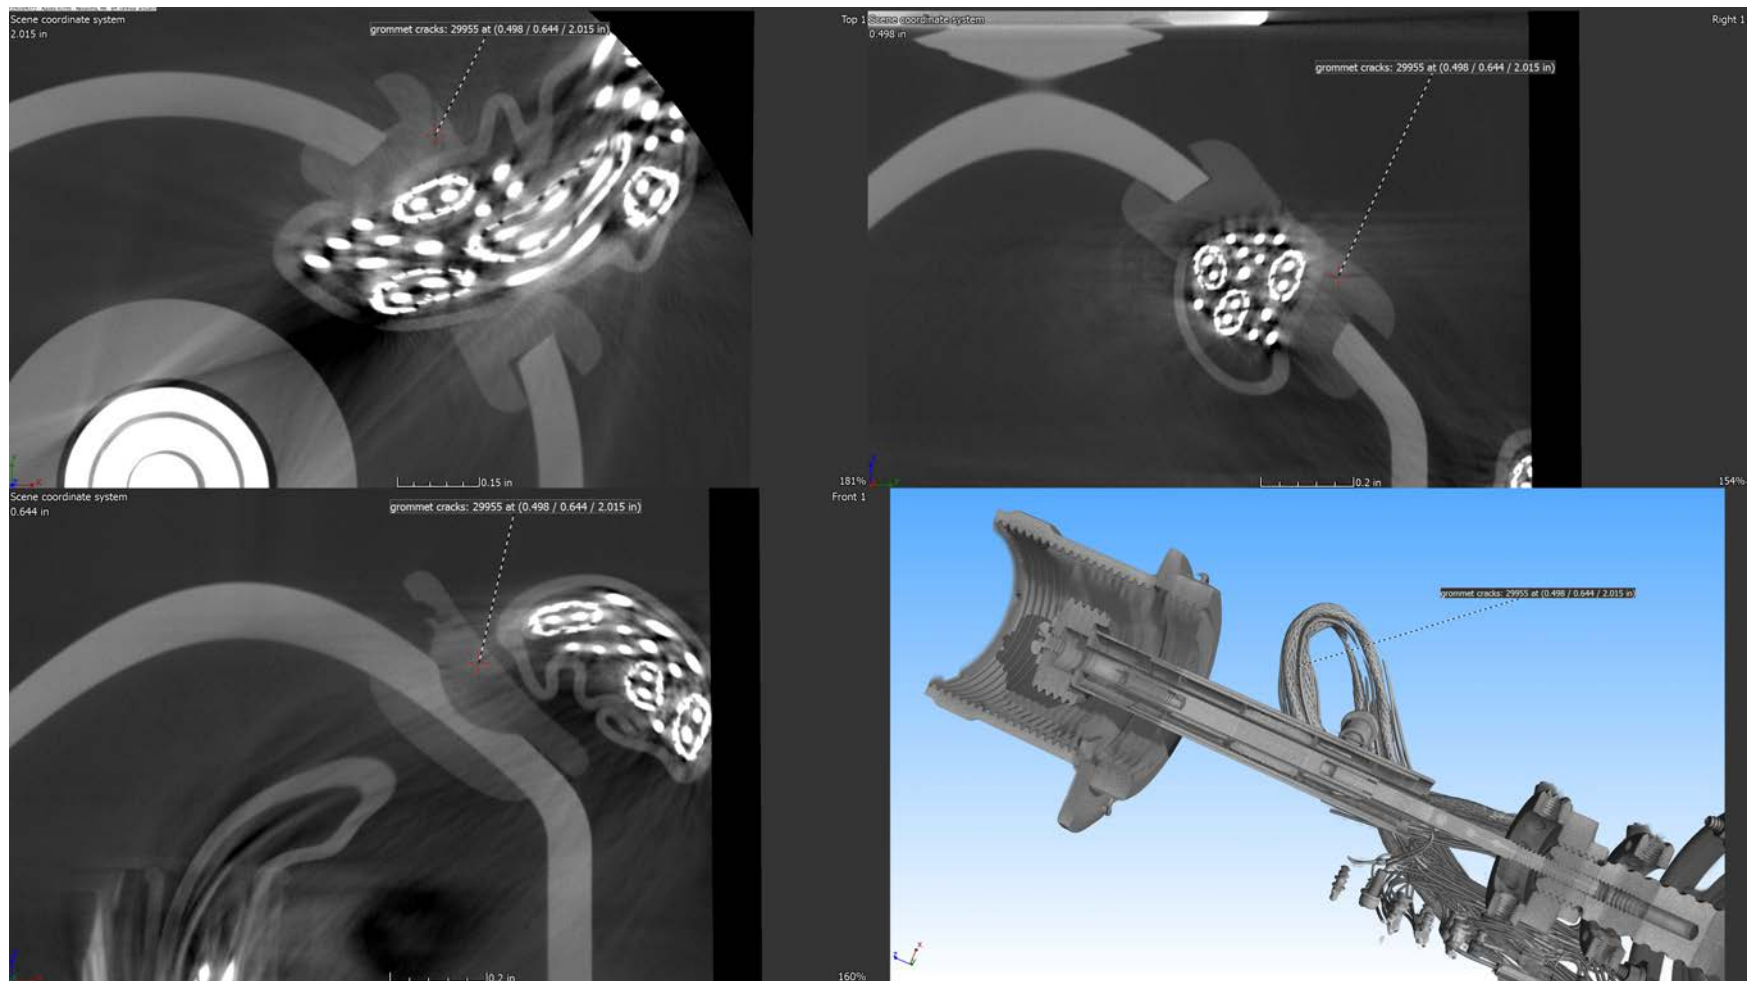
Figure 39  
Left roll linear actuator – grommet cracks

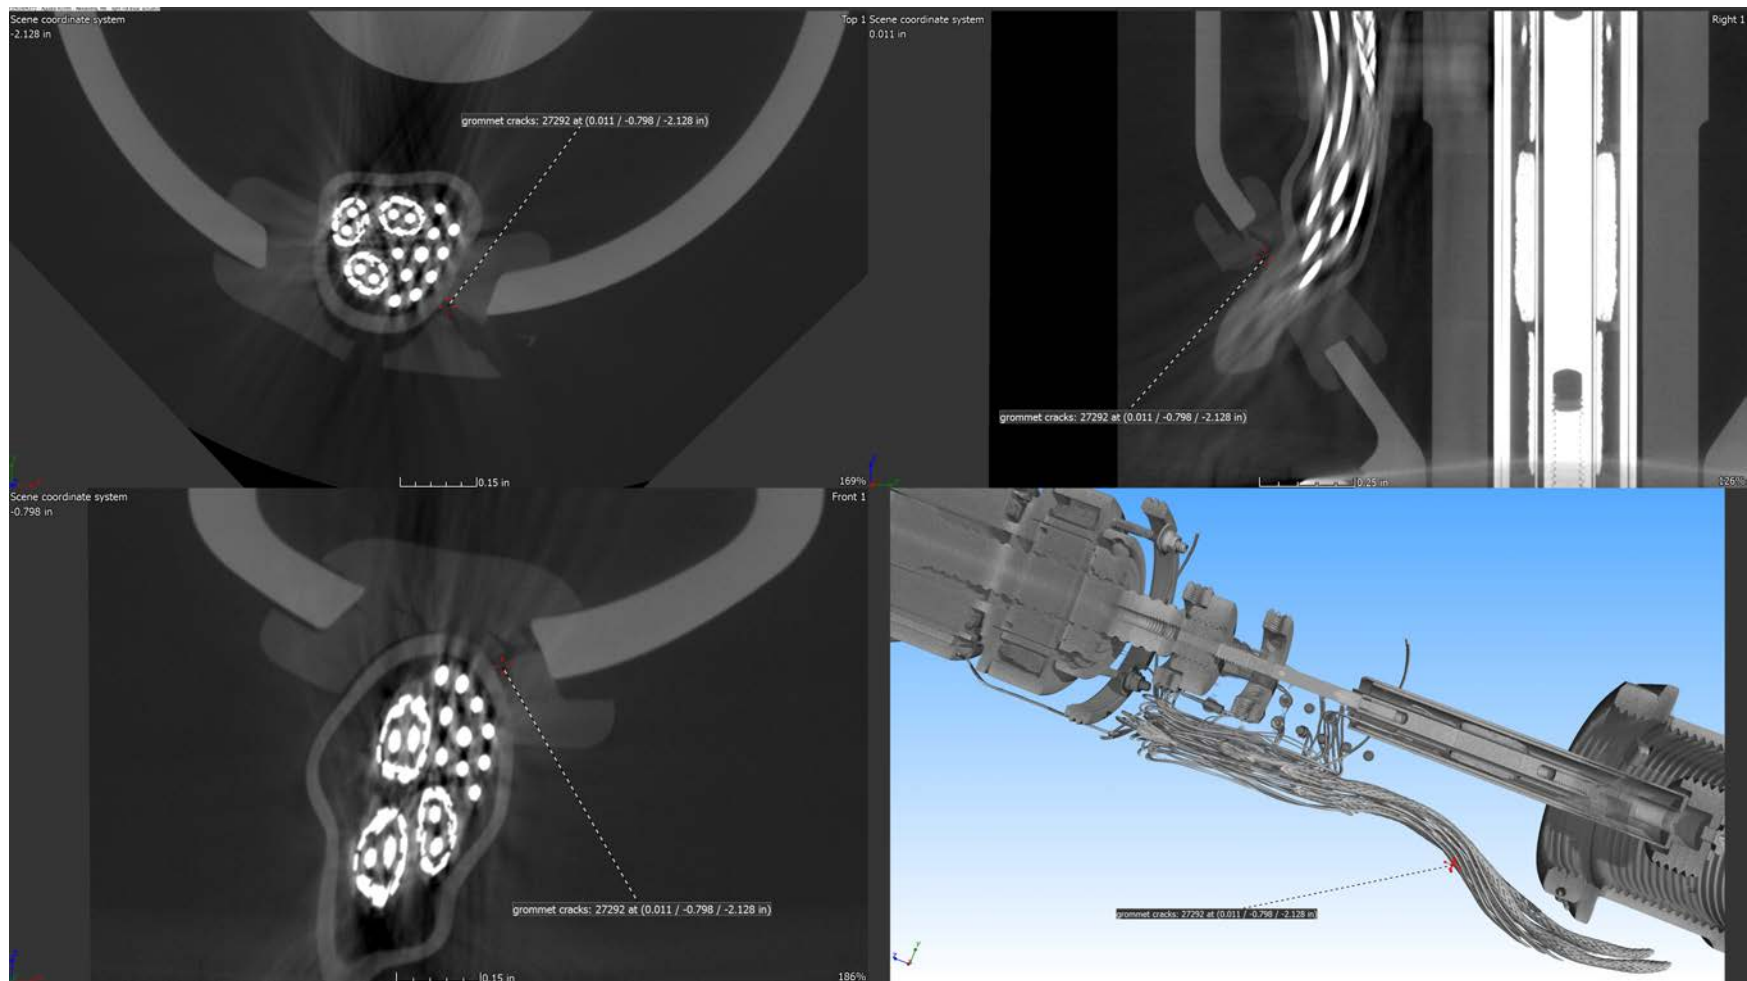
- there were cracks noted in two locations within the grommet;
- there was a ring of material at one end of the motor cavity within the actuator;
- there was medium density material noted in the retract stop, the extend stop, the LVDT, and near the brake;

Figure 56  
Right roll linear actuator – grommet cracks

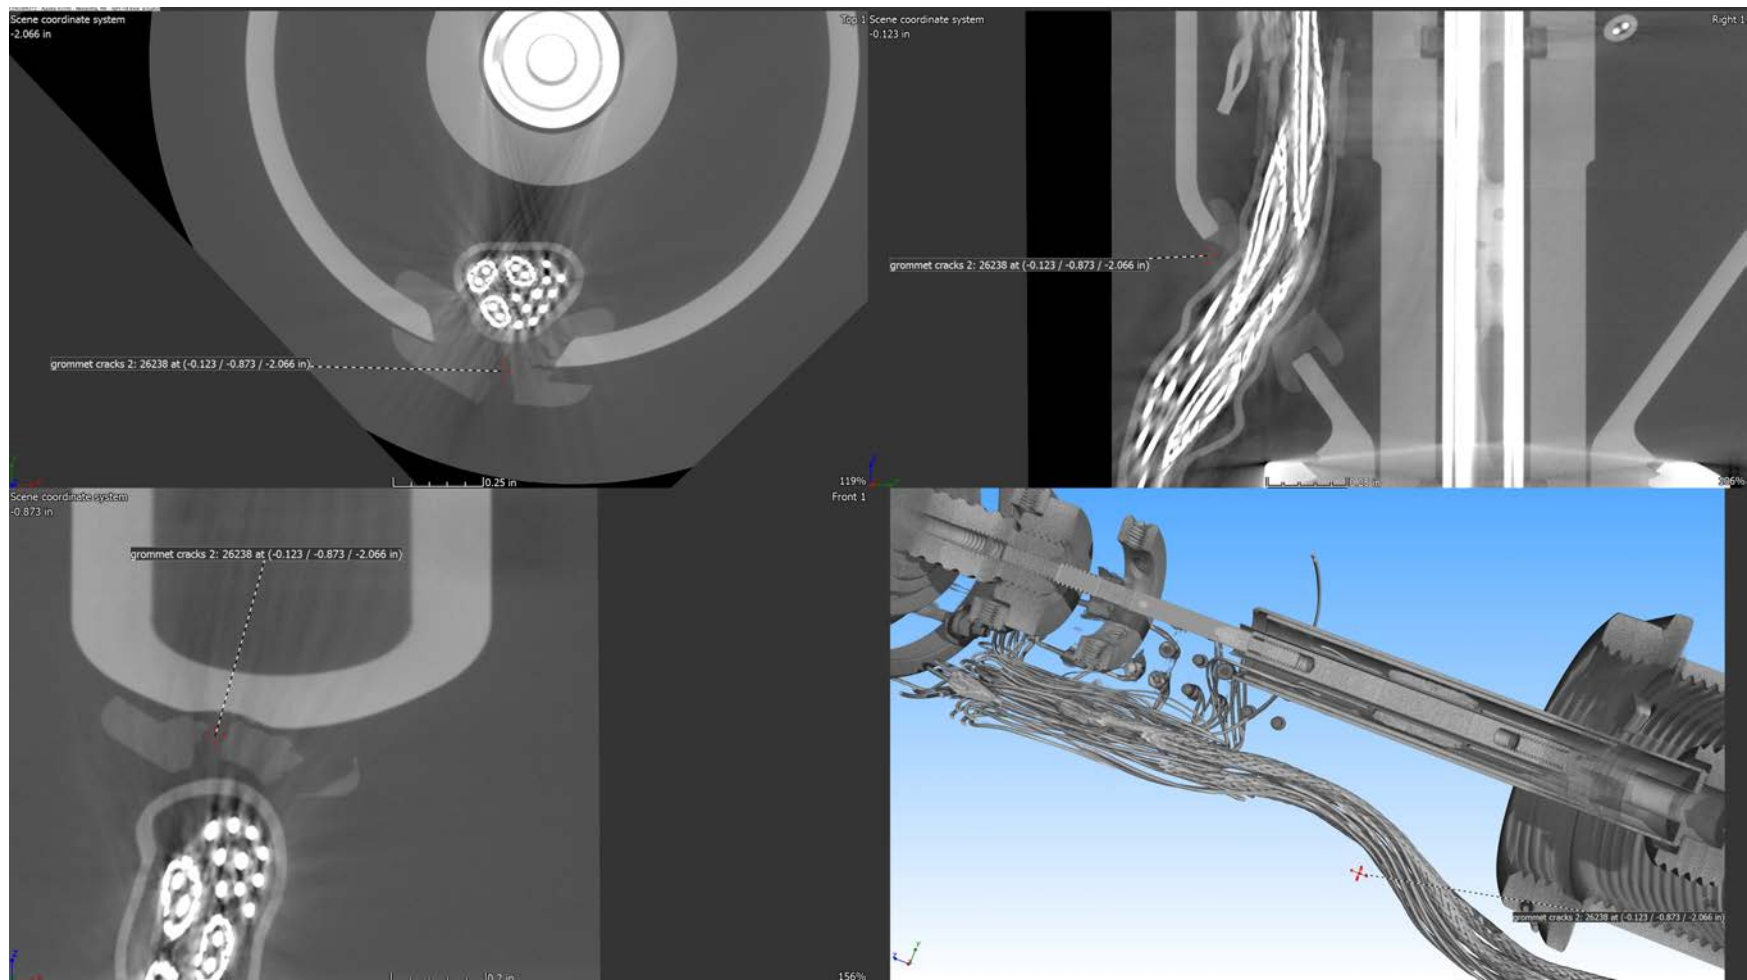
Figure 57  
Right roll linear actuator – grogmet cracks – location 2

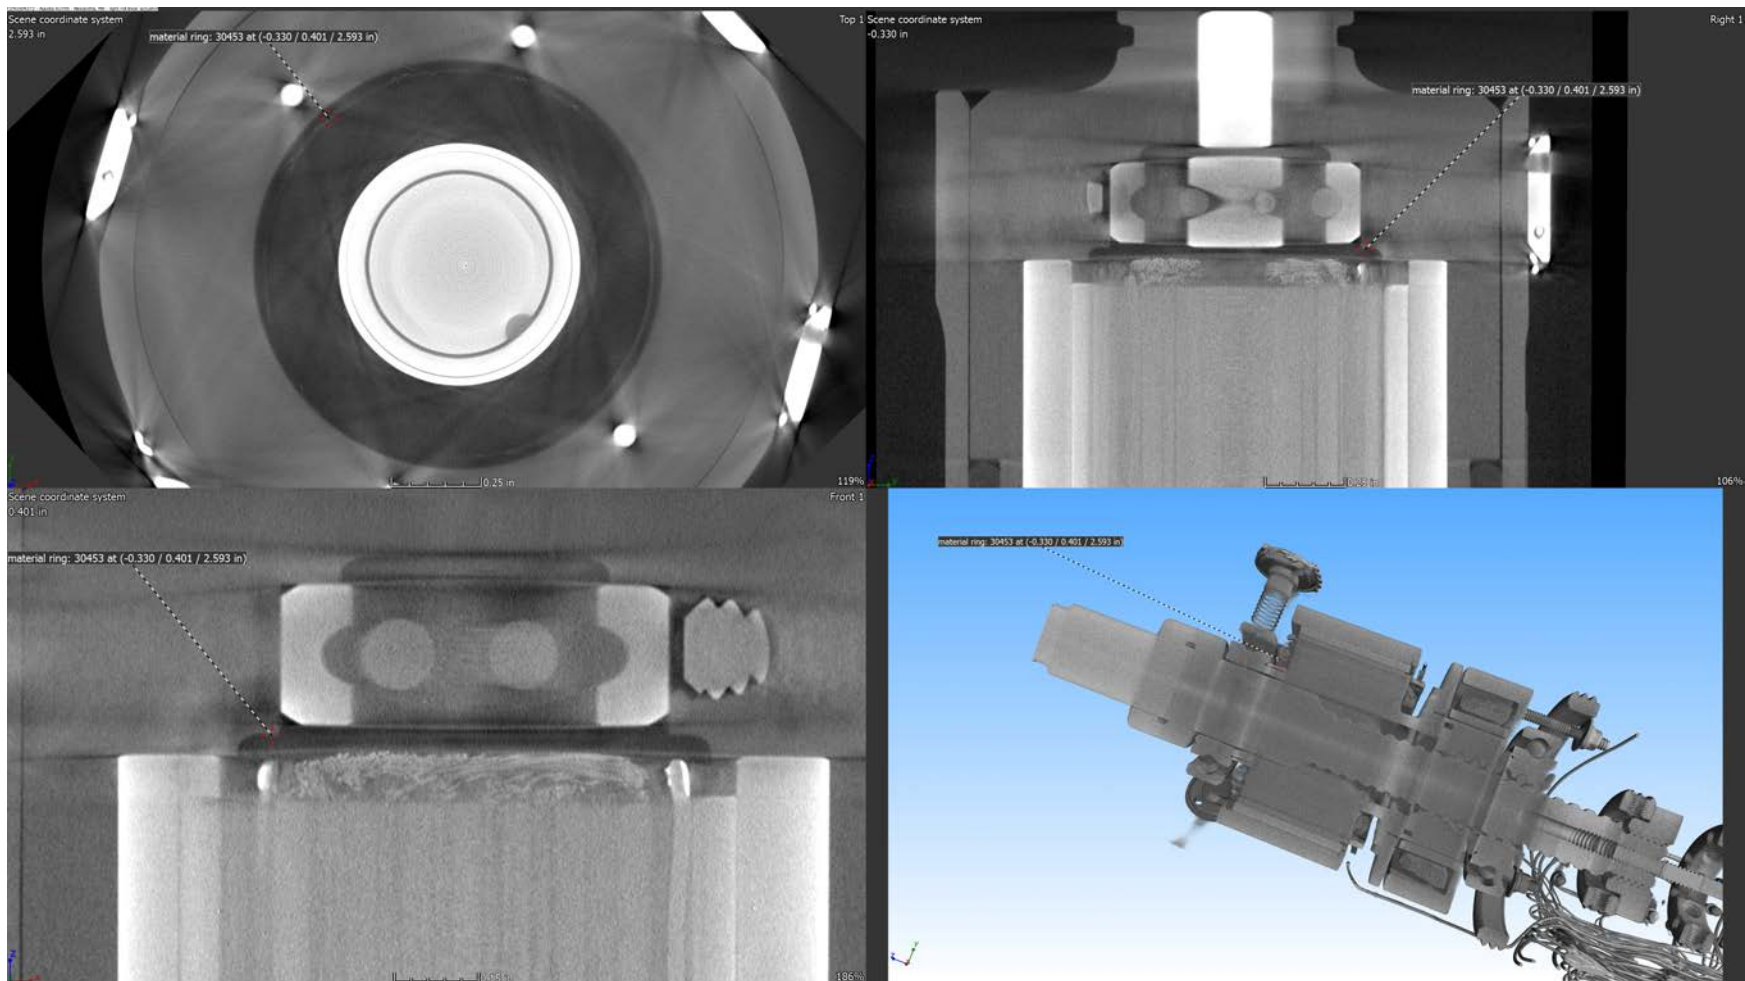
Figure 58  
Right roll linear actuator – material ring near motor

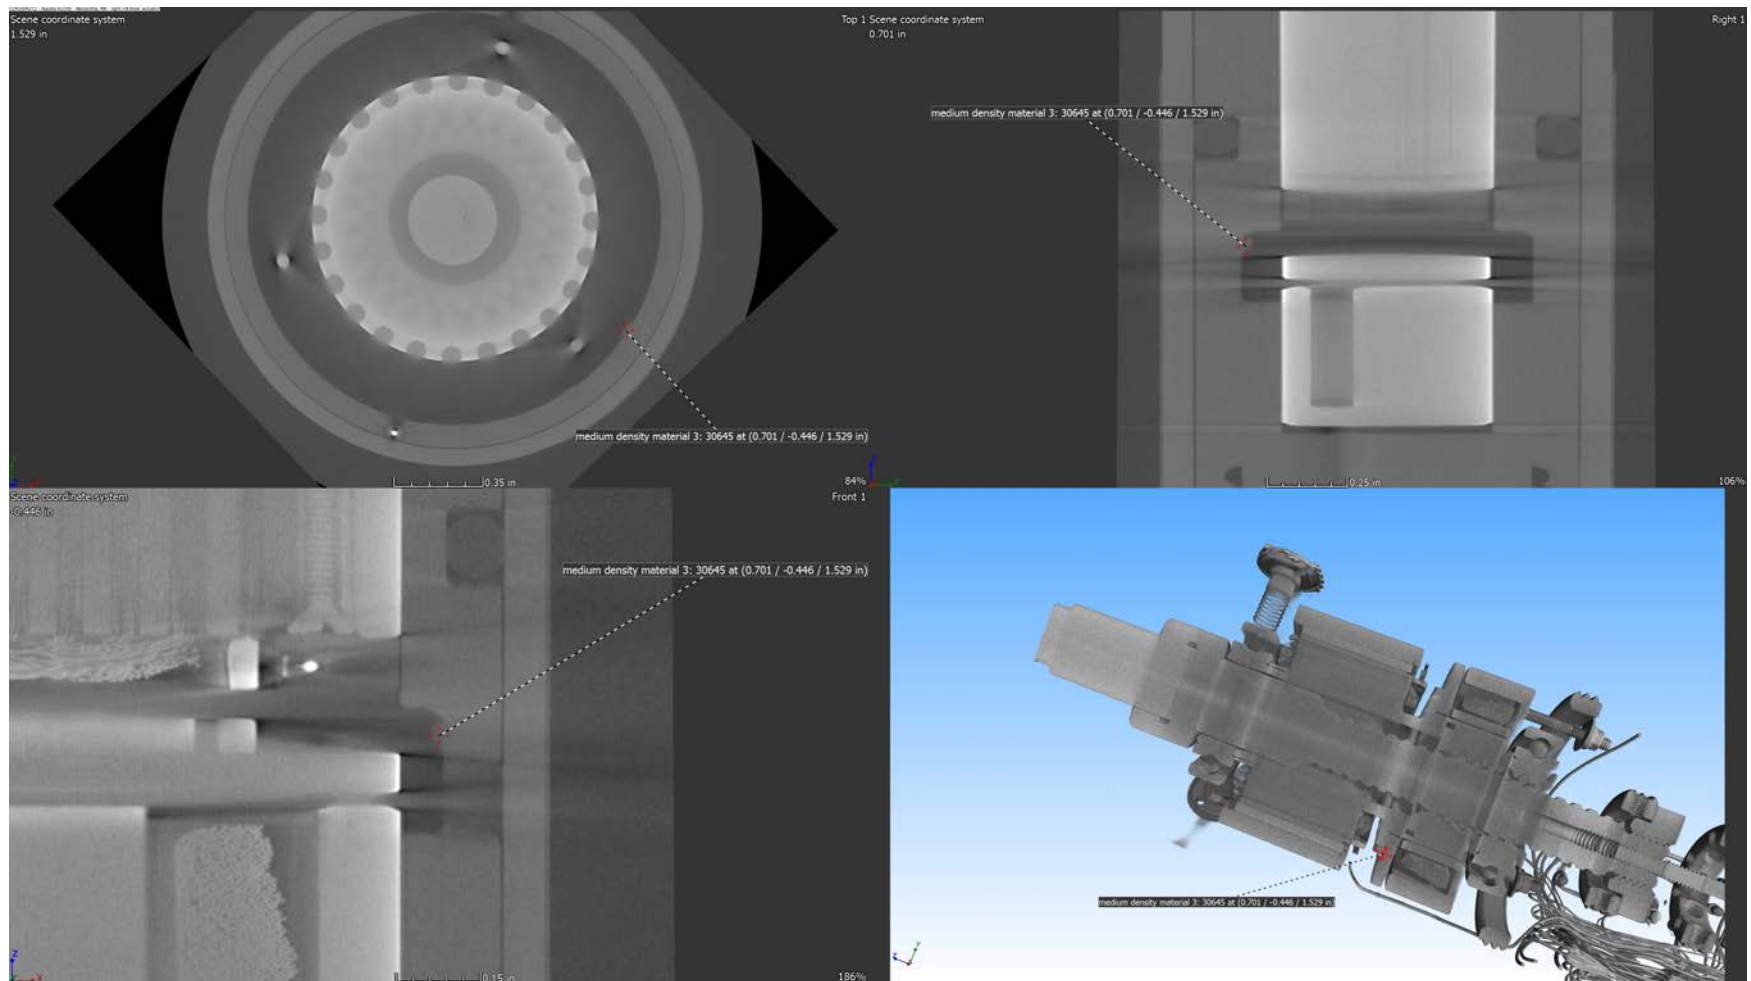
Figure 60  
Right roll linear actuator – medium density material near brake

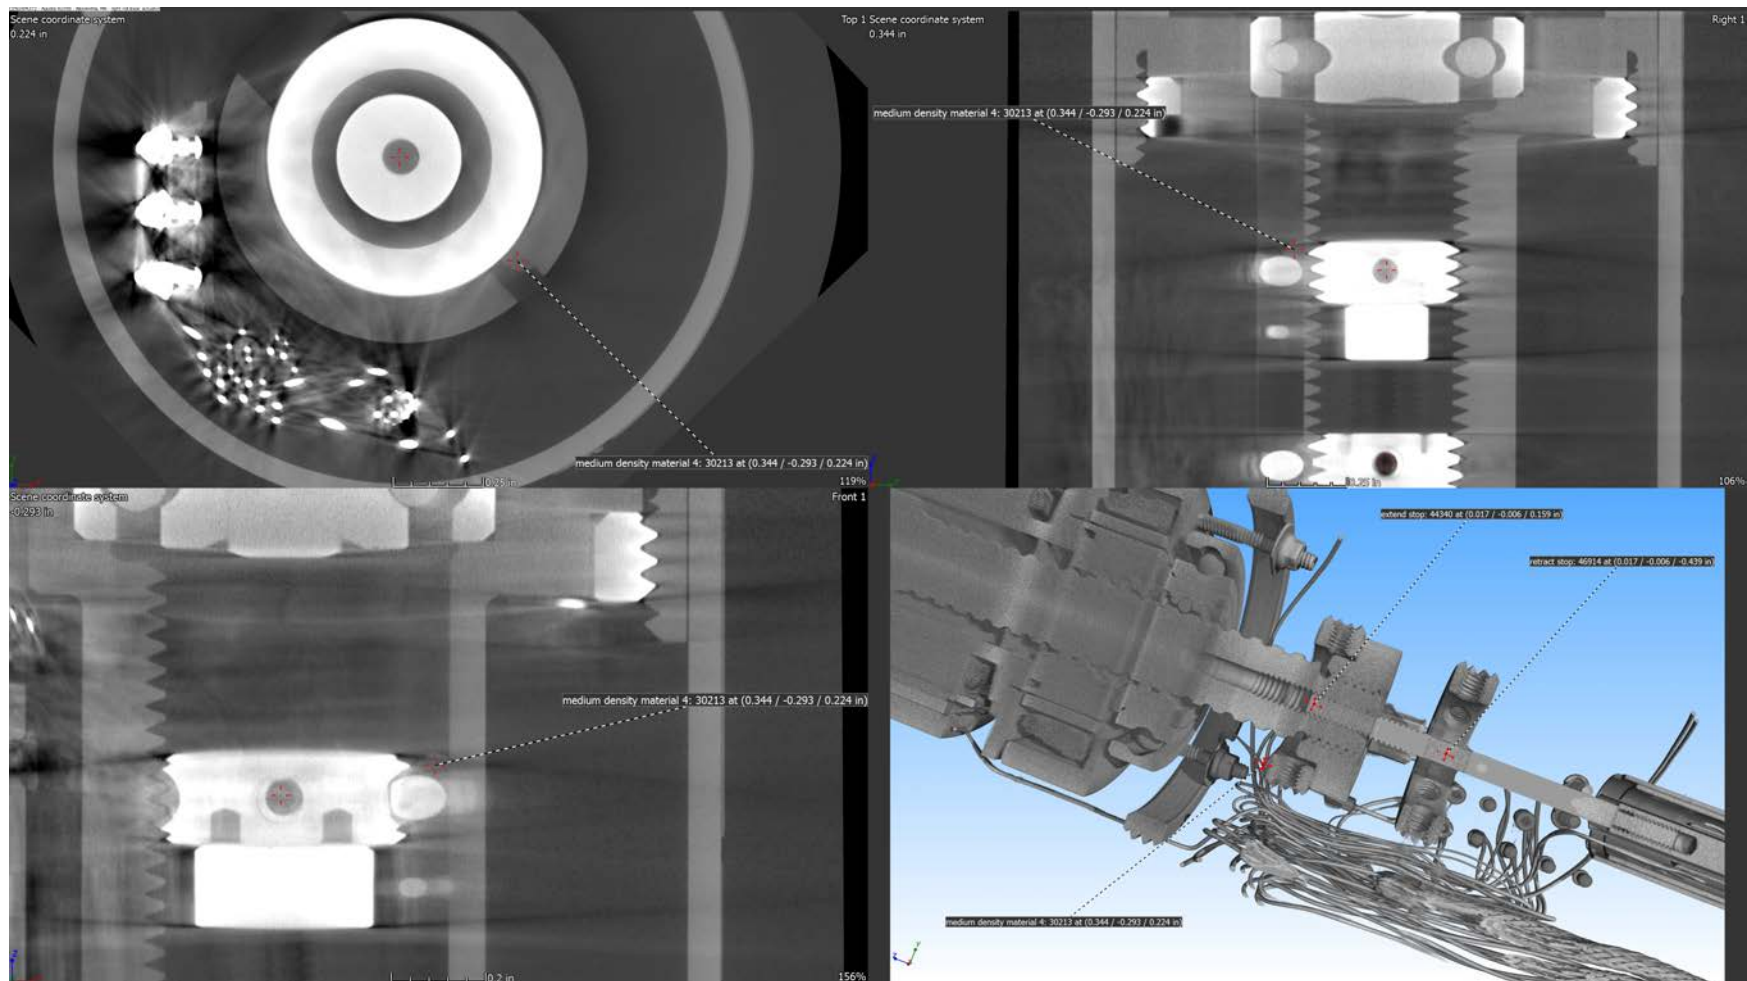
Figure 61  
Right roll linear actuator – medium density material near extend stop

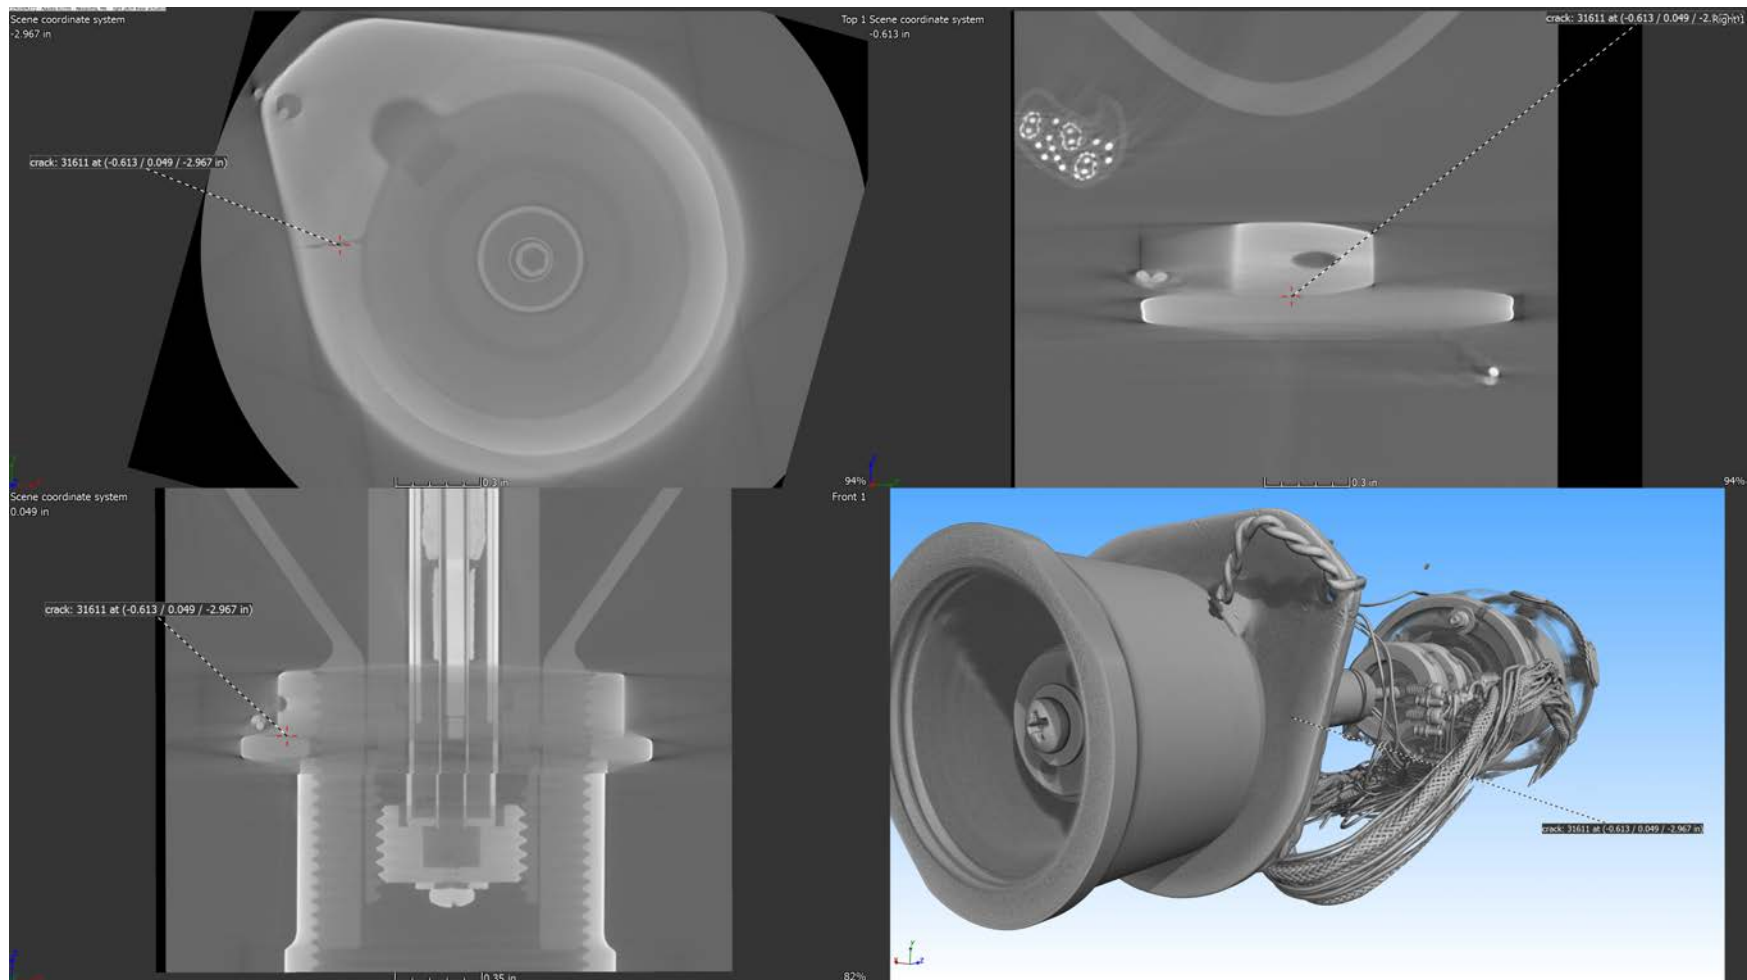
- there was a crack noted in the exterior flange of the actuator body;
- there were high density particles noted in four locations in the actuator;
- there were medium density particles noted in three locations in the actuator.

Figure 80  
Right pitch linear actuator – crack in flange

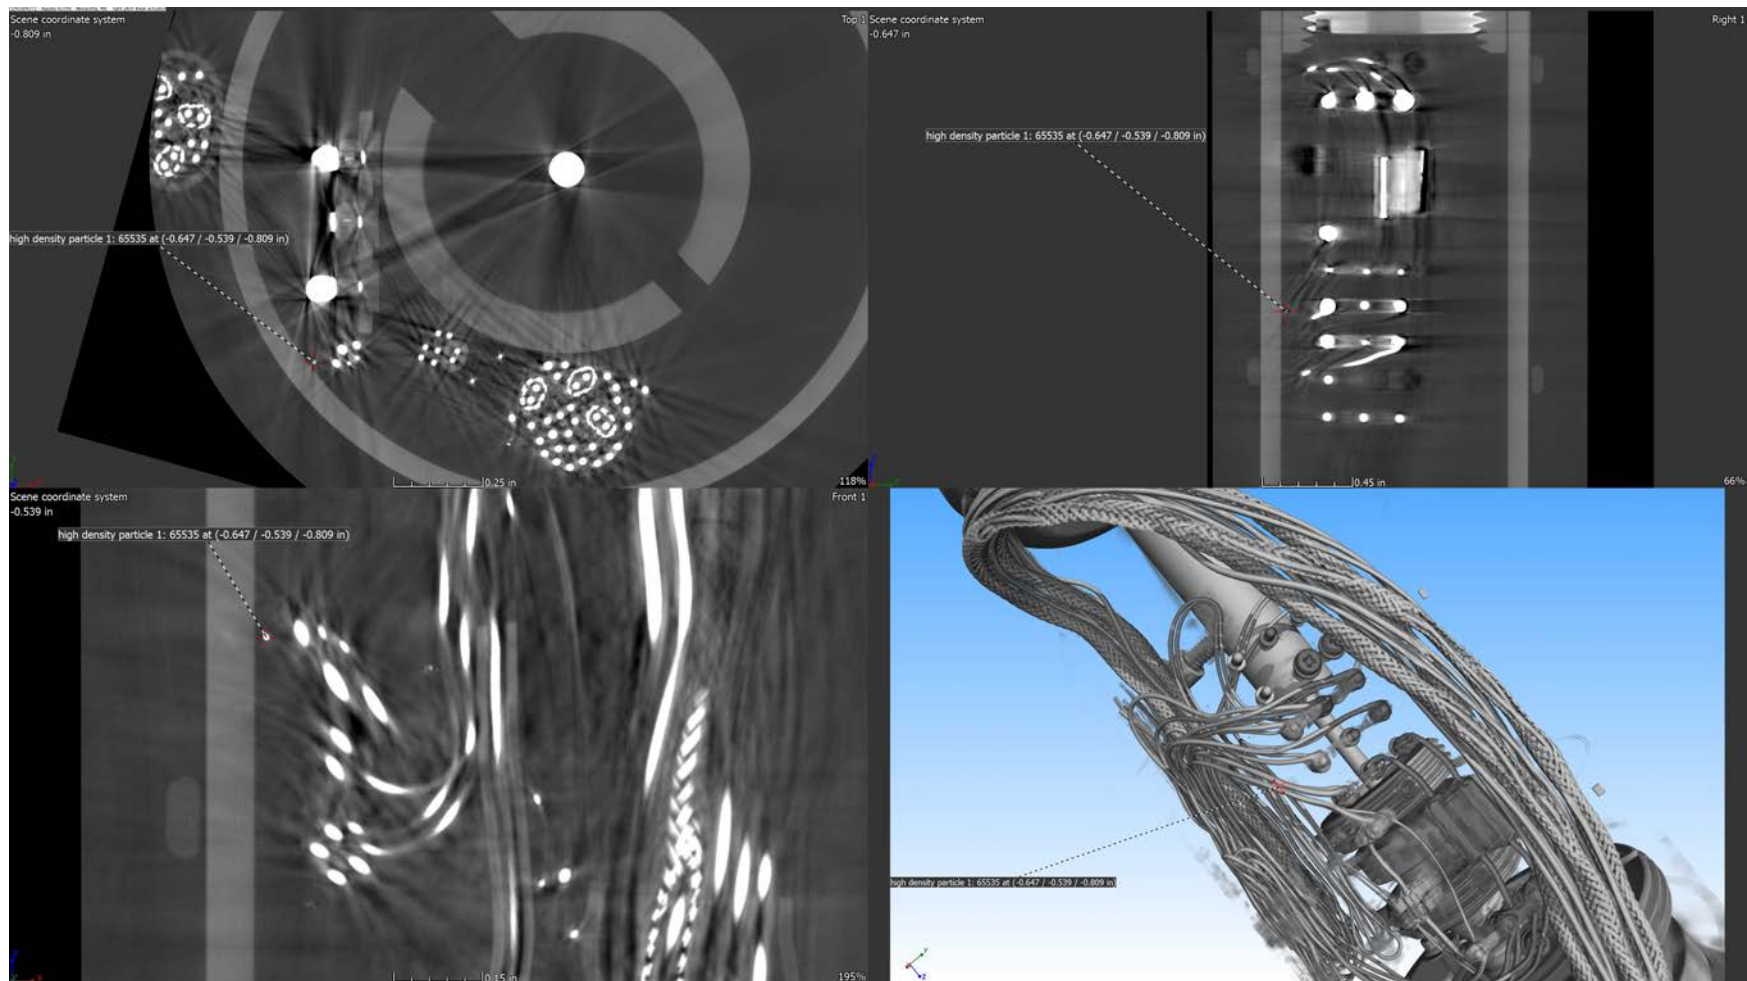
Figure 81  
Right pitch linear actuator – high density particle 1

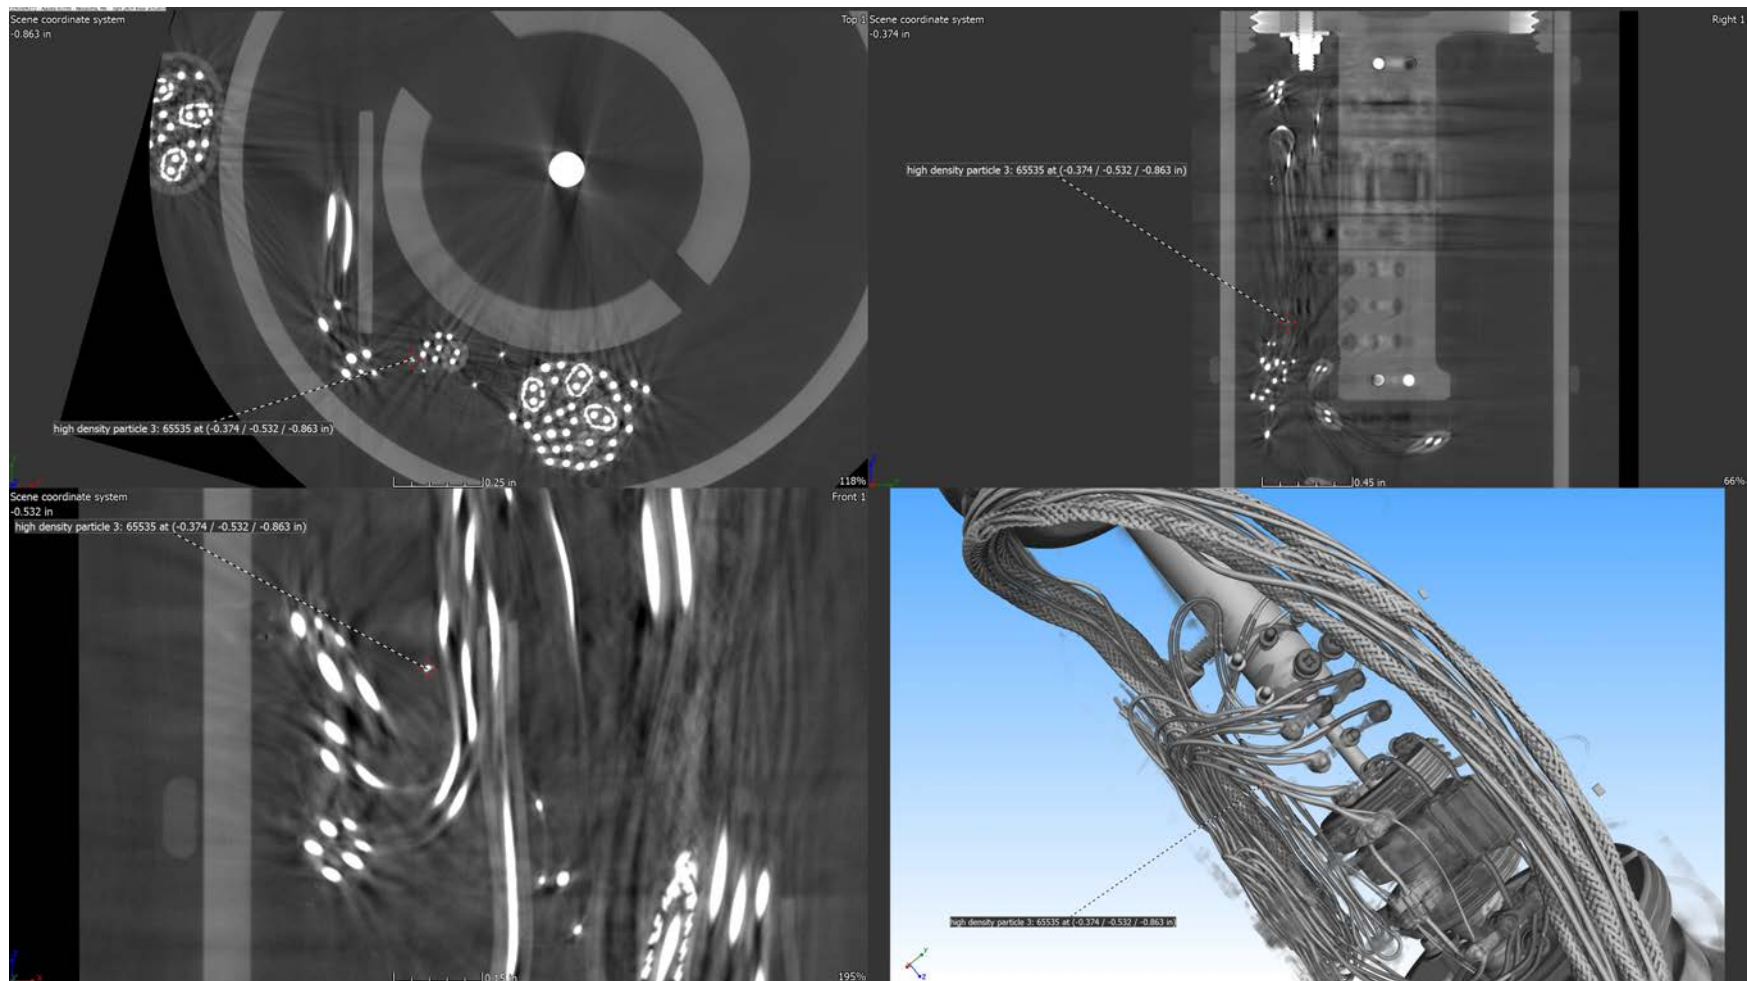
Figure 83  
Right pitch linear actuator – high density particle 3

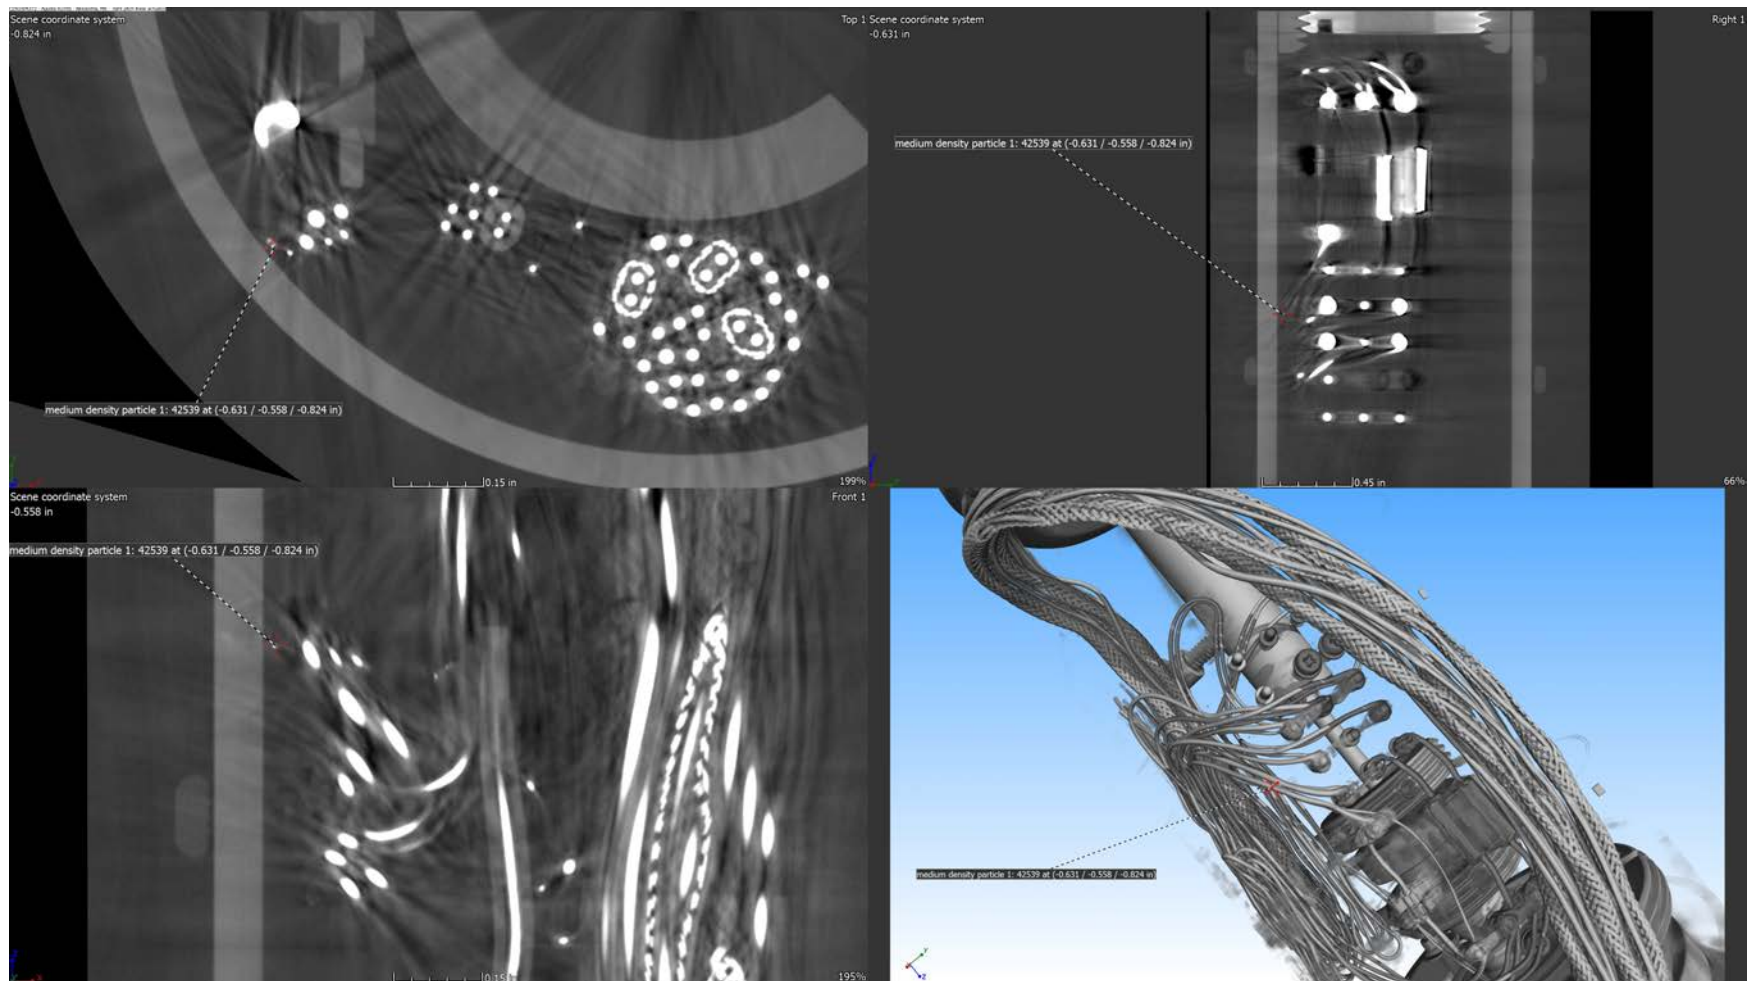
Figure 85  
Right pitch linear actuator – medium density particle 1
