**NATIONAL TRANSPORTATION SAFETY BOARD**

**Computed Tomography Specialist's Factual Report**

CEN-16-FA-372

Location: near Chandler Field Airport (AXN), Alexandria, Minnesota  
Date: September 17, 2016  
Time: 0207 central daylight time  
Airplane: Agusta S.p.A A109S helicopter, N91NM

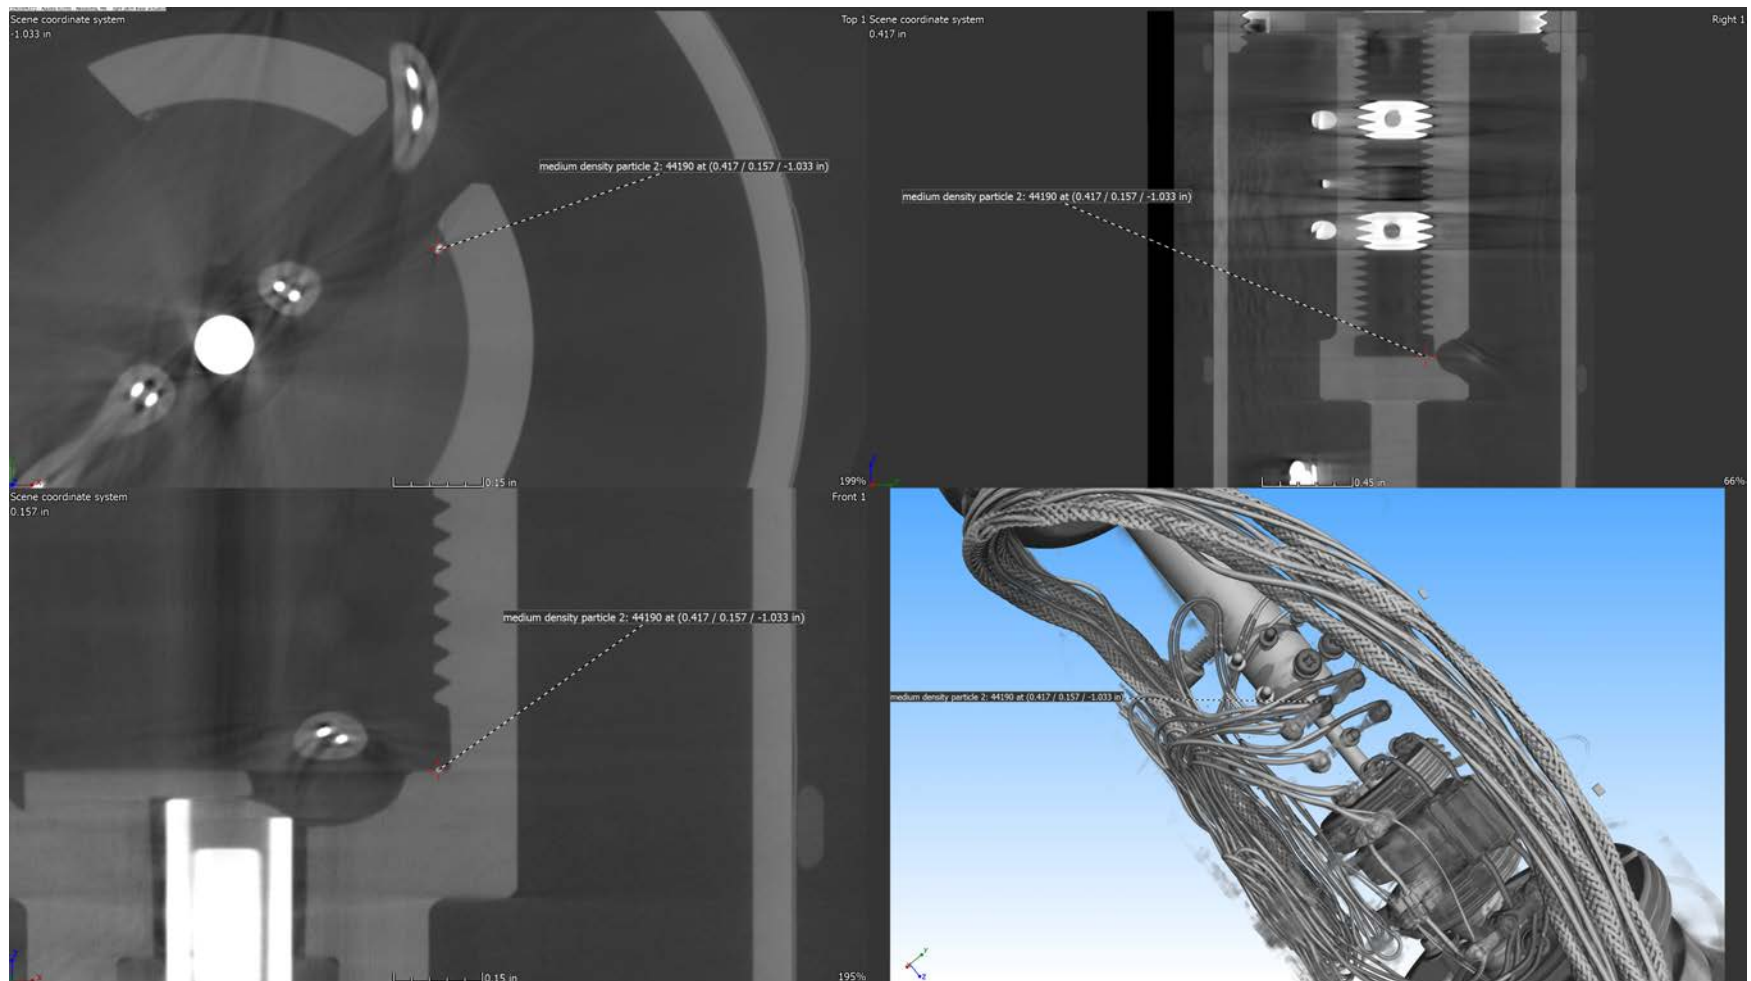
Figure 86  
Right pitch linear actuator – medium density particle 2
