# NATIONAL TRANSPORTATION SAFETY BOARD

MATERIALS LABORATORY FACTUAL REPORT

Report No. 16-099

Place : Zeeland, Michigan  
Date : June 27, 2016  
Vehicle : Enstrom 280, N518EG  
NTSB No. : CEN16IA238  
Investigator : Craig Hatch, AS-CEN

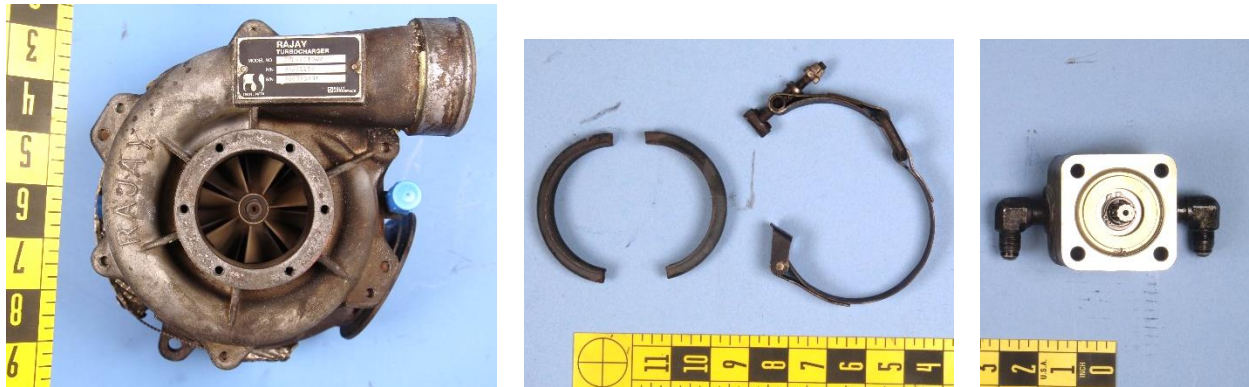
Figure 1 shows a photograph of the as-received band clamp, Rajay turbocharger assembly, and scavenge pump assembly. The label on the Rajay turbocharger was marked Model No. 36T5EE10J2. The Rajay turbocharger and scavenge pump assembly were intact.

Figure 1. As-received Rajay turbocharger assembly (left side of page), fractured band clamp assembly (center of page), and scavenger pump assembly (right side of page).

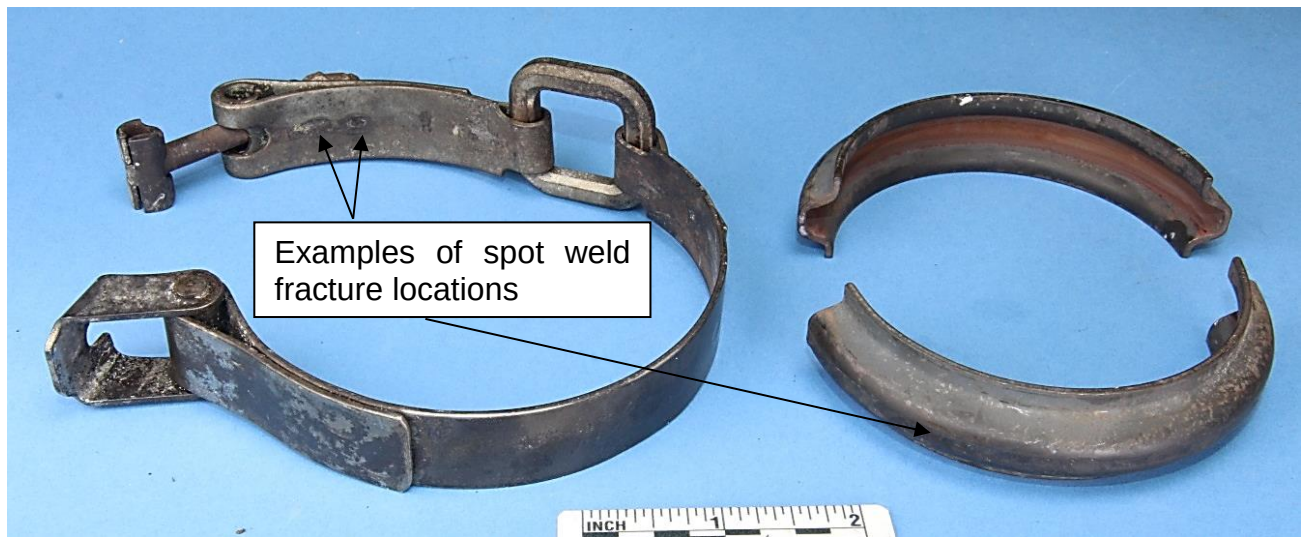
The band clamp assembly contained a strap portion and two U-shaped retainers (see figure 2). The bottom end of each U-shaped retainer is to be joined by several spot welds to the inner side of the strap portion. Examination of the band clamp assembly revealed the two U-shaped retainer portions fractured at all the spot weld locations. Figure 3 shows a photograph of the fracture face of two nearly adjoining spot welds. The separated parts from the band clamp assembly were ultrasonic cleaned with Alconox, a commercial detergent. Bench binocular microscope examination of the clamp assembly revealed the spot weld fracture faces were obliterated from relative movement between mating fractures. The contact faces between the strap portion and U-shaped retainer portions contained evidence of galling damage. Scanning electron microscope examination of the two spot weld fracture faces in figure 3 collaborated the findings of the binocular microscope examination.

Figure 2. Close-up view of the as-received band clamp assembly showing the strap portion (left side of page) and two U-shaped retainers (right side of page). The cross section of a U-shaped retainer appears similar to a “U” groove. The fractured spot welds coincided with the bottom of the “U” groove portion. Arrows indicate examples of spot weld fracture locations.

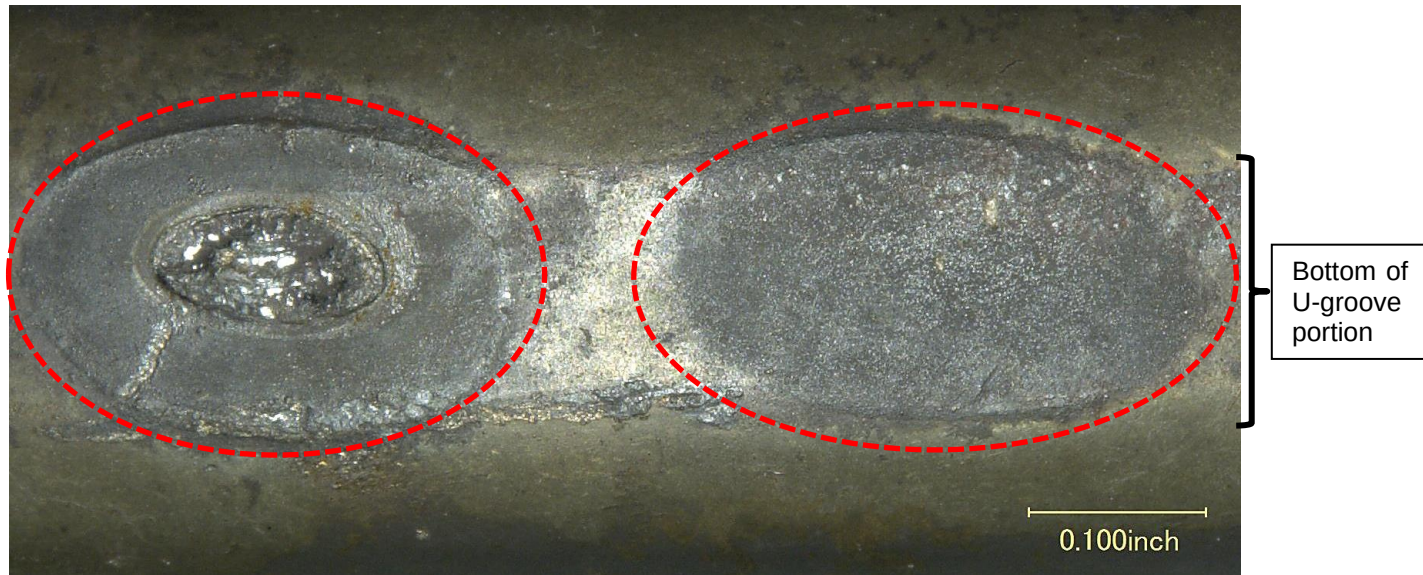
Figure 3. Close-up photograph of an isolated area on the external surface of the U-shaped retainer showing the fracture faces of two nearly adjoining spot welds, areas enclosed by dashed lines. The fracture faces showed evidence of galling damage.
