| Report number: <b>ML1010426</b> | |
| <p><b>Continental Motors, Inc.</b><br/> <i>Powering Aircraft Since 1929</i></p> <p><b>CONTINENTAL MOTORS<br/>METALLURGICAL REPORT</b></p> | <p><u>Distribution</u></p> <p>1] Phillip Grice</p> |
| Subject: AN911 J fitting from N857SW | |

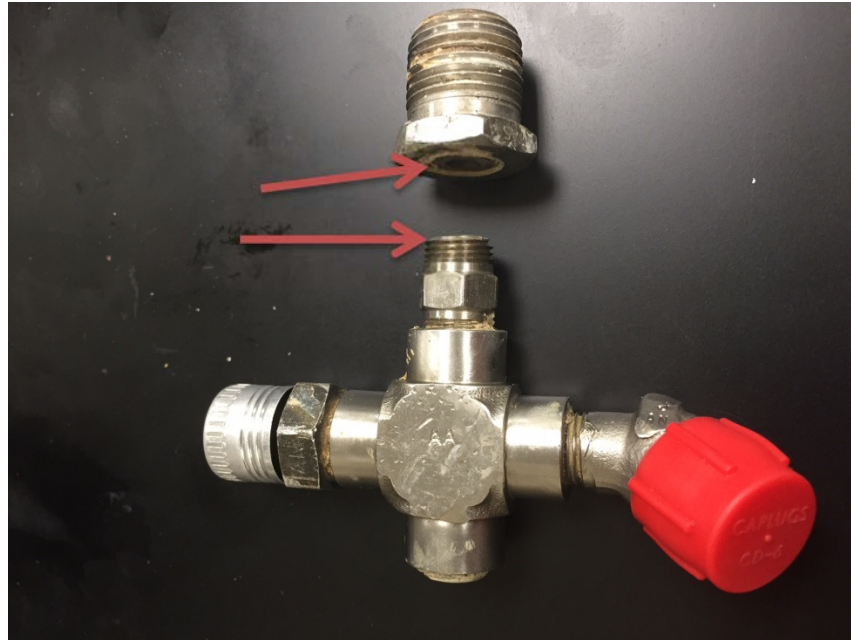
Figure 1 - As received condition with fracture surfaces indicated by arrows

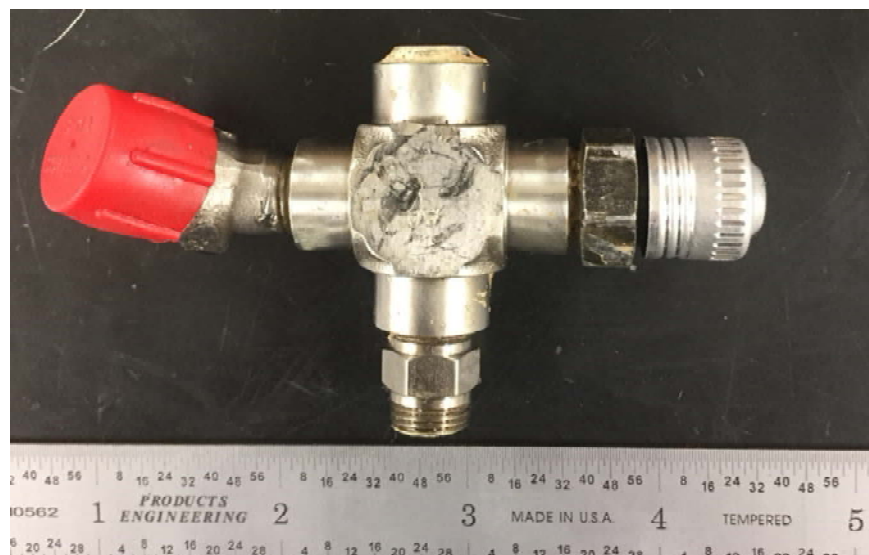
Figure 2 Fittings have had some wrench or vise damage

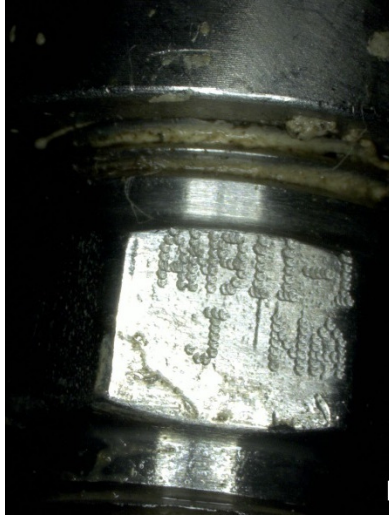
The as received condition is shown in figures 1 and 2. The fitting AN911 J, shown in figure 3, is commercially available pipe nipple fitting made of 304 stainless steel.

Figure 3 Bushing is part number AN911-1 J

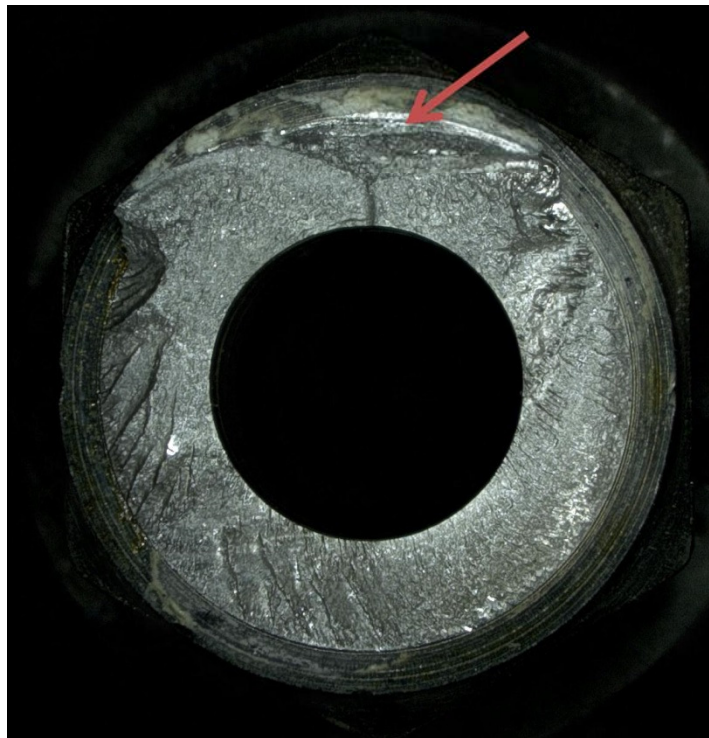
The fracture occurred in fatigue originating from a thread root at the joint made be the nipple and the mating bushing.

[1] The part separated in fatigue initiating at a thread root at the assembled intersection of the pipe nipple and bushing.

Figure 4 fracture surface of pipe nipple with initiation area indicated by the arrow

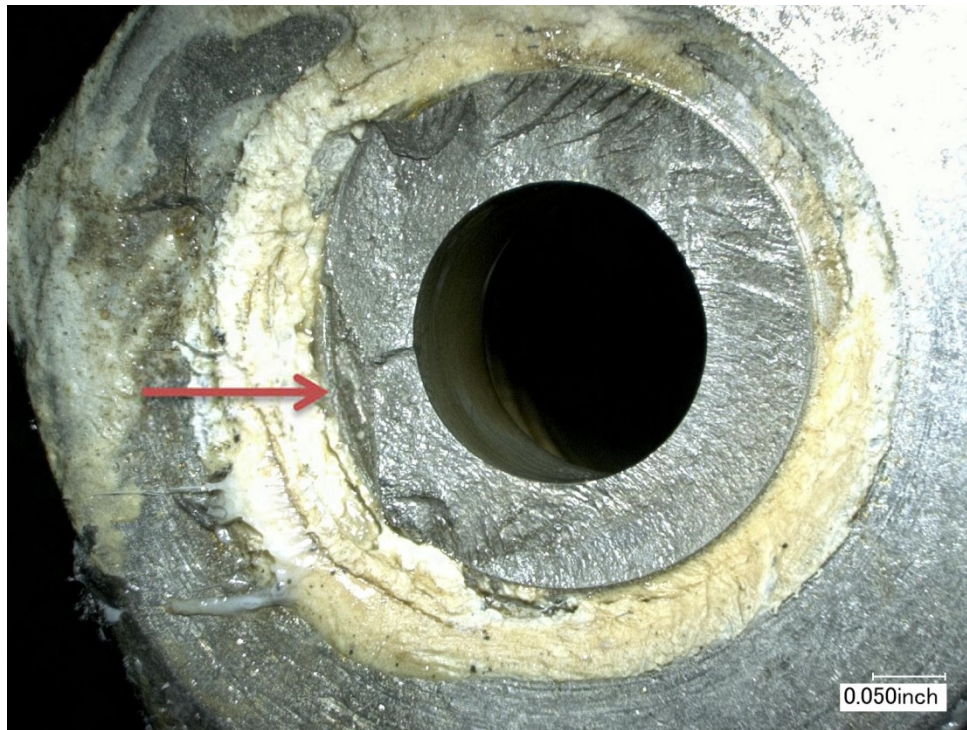
Figure 5 Bushing side fracture with initiation area with initiation area indicated by arrow
