# NATIONAL TRANSPORTATION SAFETY BOARD

MATERIALS LABORATORY FACTUAL REPORT

Report No. 16-077

Place : Shawano, Wisconsin  
Date : November 15, 2015  
Vehicle : Lancair IV, N10UU  
NTSB No. : CEN16LA043  
Investigator : Michael Folkerts, AS-CEN

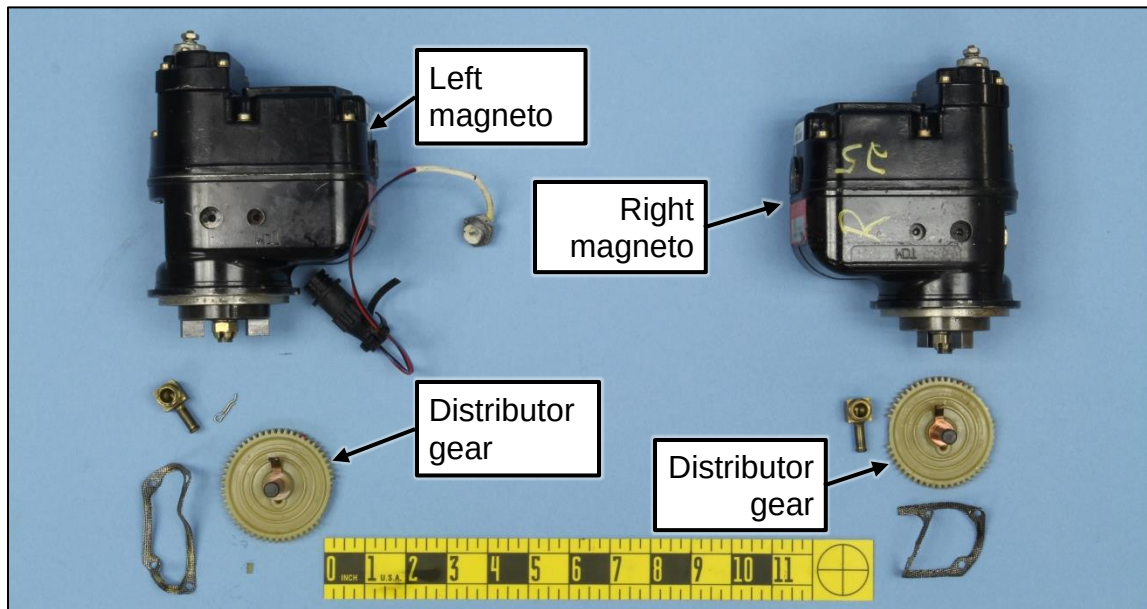
An overall view of the right and left magnetos with fractured distributor gears is shown in figure 1. Prior to receiving the parts at the materials laboratory, the magnetos had been disassembled and tested with replacement distributor gears. The magnetos were received with the original distributor gears removed from the magnetos and the replacement gears installed. Many teeth were fractured from each distributor gear installed at the time of the accident as shown in closer views of the distributor gears presented in figures 2 and 3.

Figure 1. Overall view of the submitted left and right magneto assemblies with fractured distributor gears.

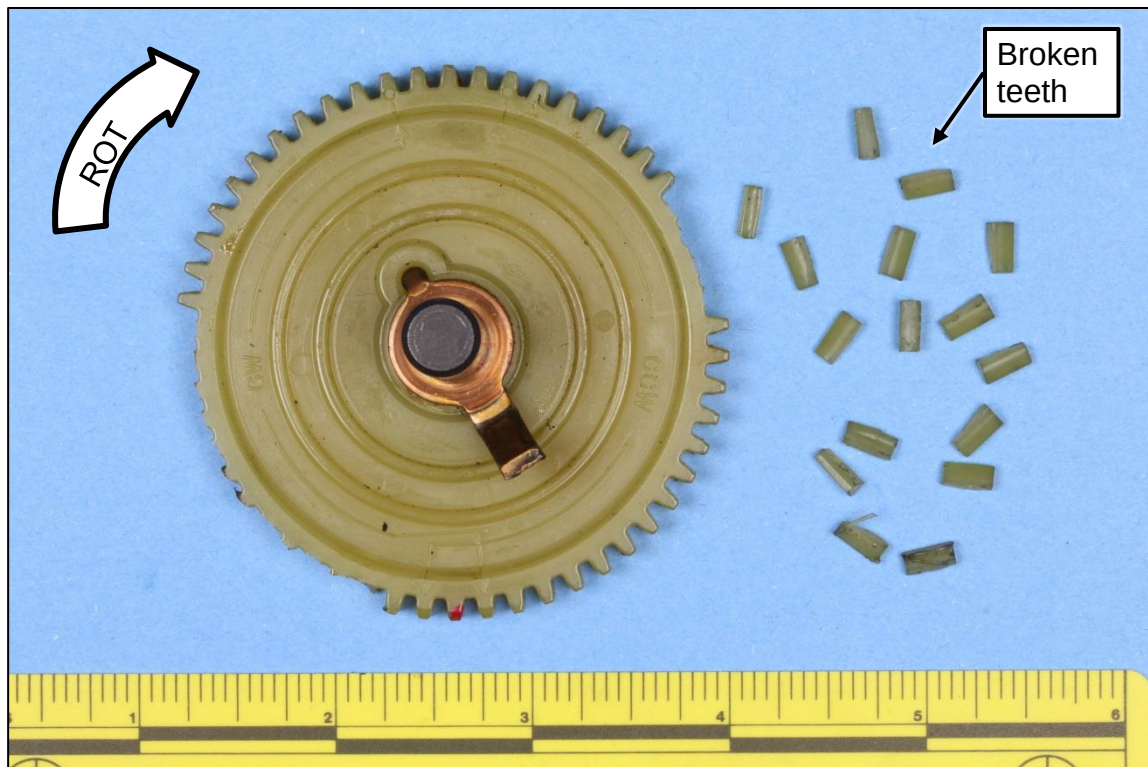
Figure 2. Closer view of the distributor gear assembly from the right magneto showing the side of the gear facing the distributor block with the pieces of broken teeth.

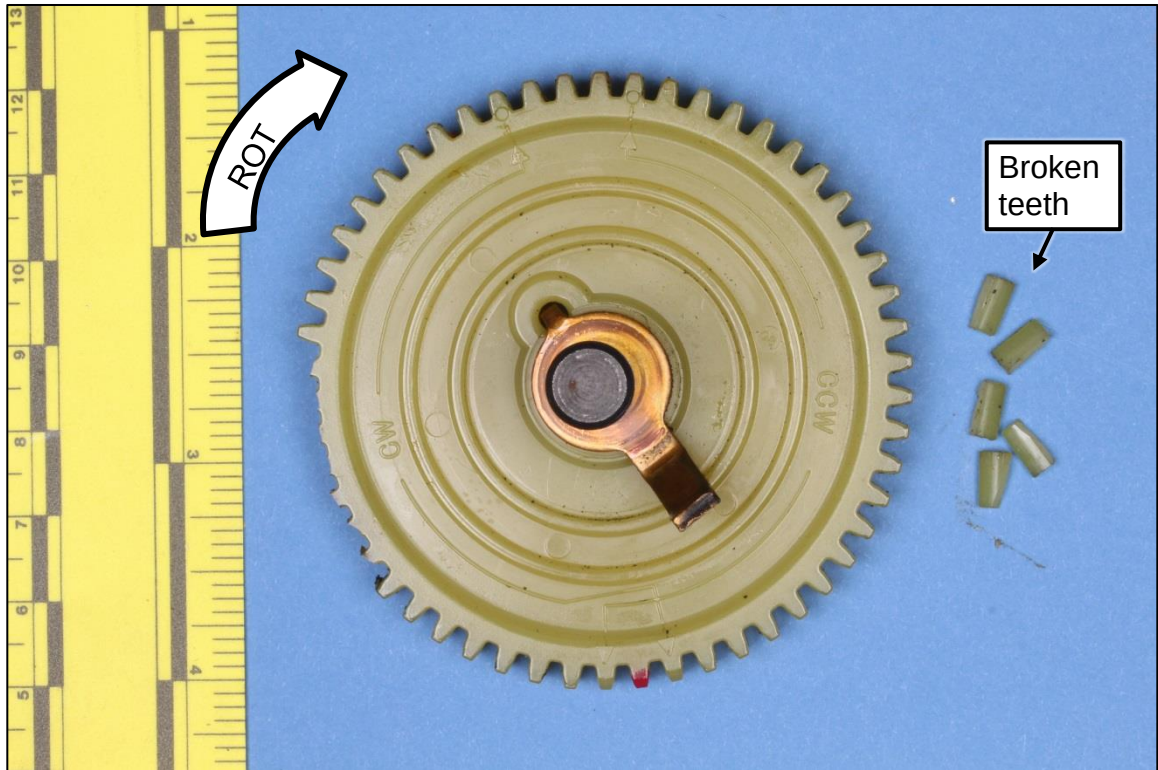
Figure 3. Closer view of the distributor gear assembly from the left magneto showing the side of the gear facing the distributor block with the pieces of broken teeth.

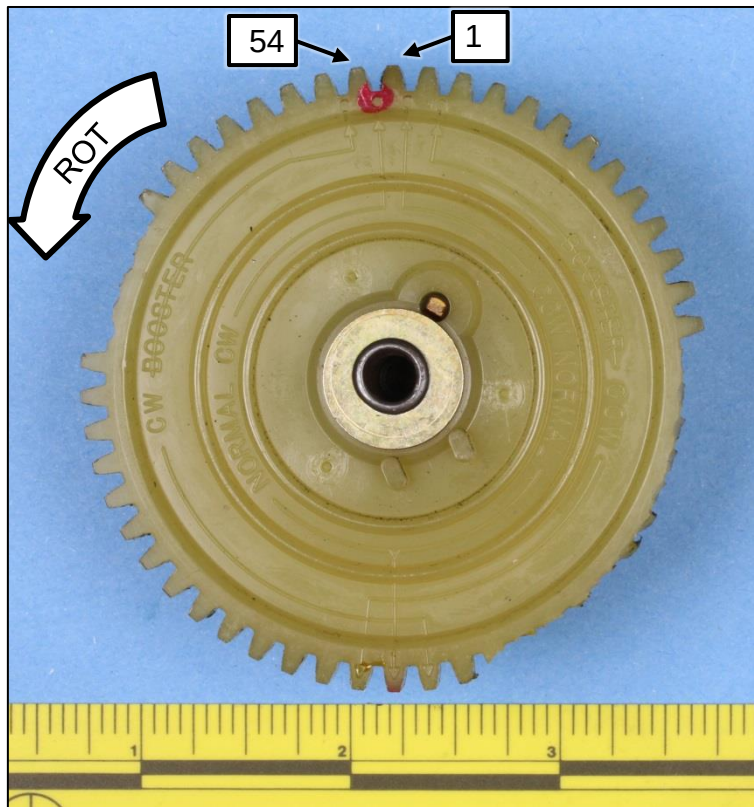
As viewed in figures 4 and 5 looking at the side of the distributor gear facing the coil, the distributor gears rotate in the counterclockwise direction under normal operation (see arrows indicating direction of rotation in each image). A timing mark on each gear, shown as a red mark at the root between two teeth, noted the location that should mesh with a chamfered tooth on the pinion gear. The distributor gears had 54 teeth, and for reference in this report, the teeth were numbered clockwise starting with the tooth on the clockwise side of the timing mark and ending with the tooth counterclockwise of the timing mark (see figures 4 and 5). Both gears shown in figure 4 and 5 had numbers "08" cast into the web, indicating the gears were manufactured in 2008.

Figure 4. Right distributor gear showing the side facing the coil. Teeth were numbered clockwise starting at the timing mark as shown.

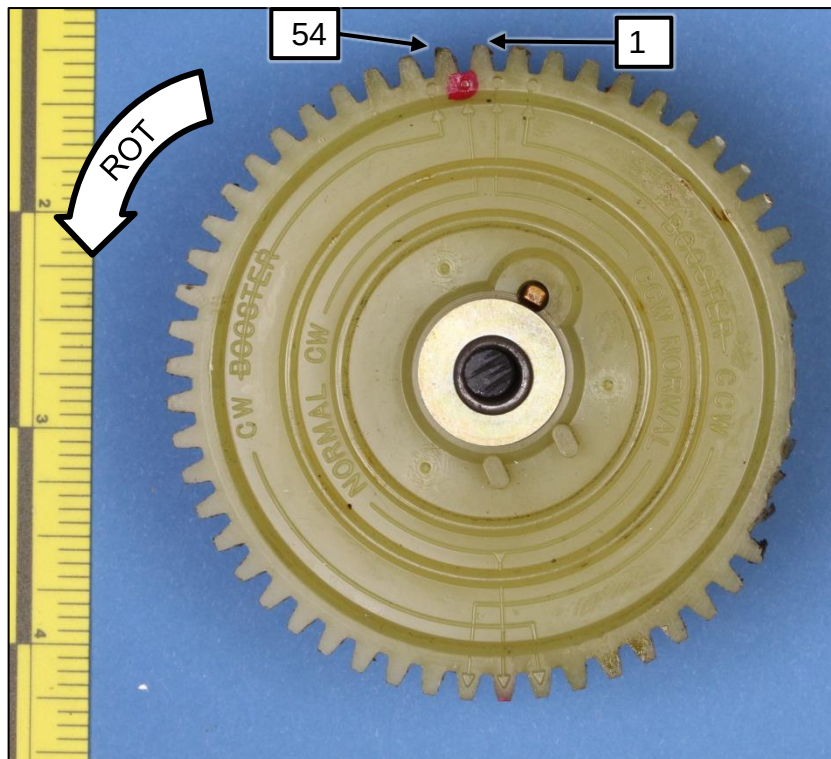
On the left distributor gear shown in figure 5, 8 teeth (numbers 13 through 19) were fractured. An overall view of the fractured teeth is shown in figure 8. The fracture features were generally similar to those observed on the right distributor gear, with a relatively smooth area at the fracture initiation side of the tooth covering approximately  $\frac{1}{4}$  to  $\frac{1}{2}$  of the fracture area, curving lines representing the fracture front at the boundary of the smooth area, and hackle features and multiple curving crack front lines between the smooth area and the fracture termination.

Figure 5. Left distributor gear showing the side facing the coil. Teeth were numbered clockwise starting at the timing mark as shown.

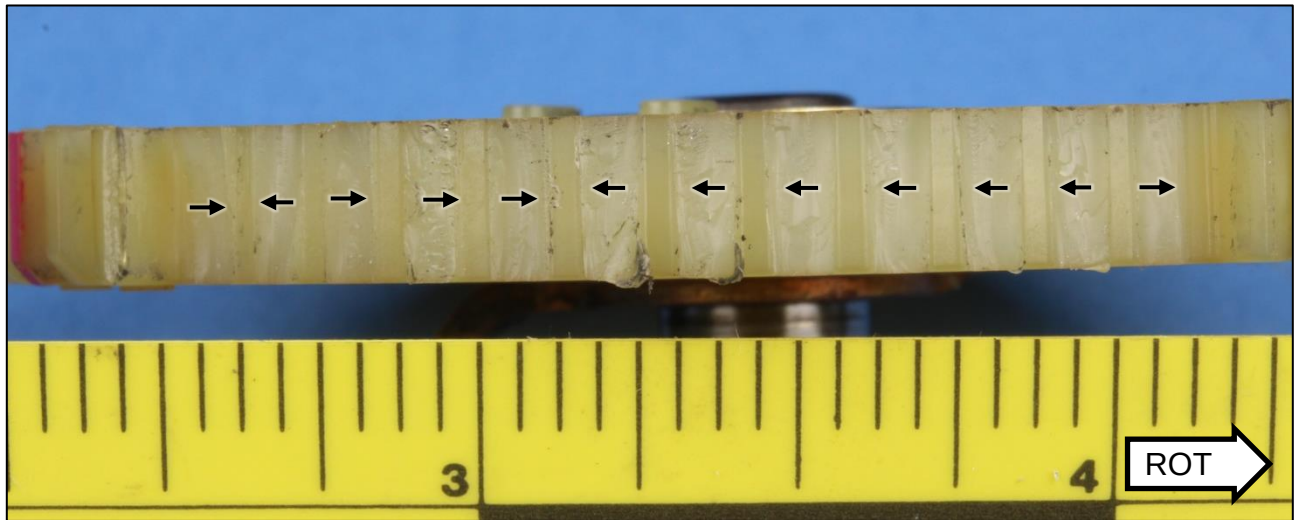
On the right distributor gear, 16 teeth (numbers 14 through 25 and 43 through 46) were fractured. An overall view of the fractured teeth from the larger of the two segments is shown in figure 6, and a closer view of a fracture surface displaying typical fracture features is shown in figure 7. The fracture features generally showed a relatively smooth area at the fracture initiation side of the tooth covering approximately  $\frac{1}{4}$  to  $\frac{1}{2}$  of the fracture area. Curving lines representing the fracture front were observed at the boundary of the smooth area. Hackle features and multiple curving crack front lines were present between the smooth area and the fracture termination.

Tooth fractures in the right distributor gear initiated at both the contact and the noncontact sides of the teeth. Teeth 14, 21 through 23, 25, and 43 had fractures initiating at the contact side, and teeth 15 through 20, 24, and 44 through 46 had fractures initiating at the noncontact side. Arrows in figure 6 indicate fracture propagation directions in each of the fractured teeth 14 through 25.

Figure 6. View of fracture features of the larger segment of broken teeth on the right distributor gear. Unlabeled arrows indicate the general direction of fracture propagation in each tooth.

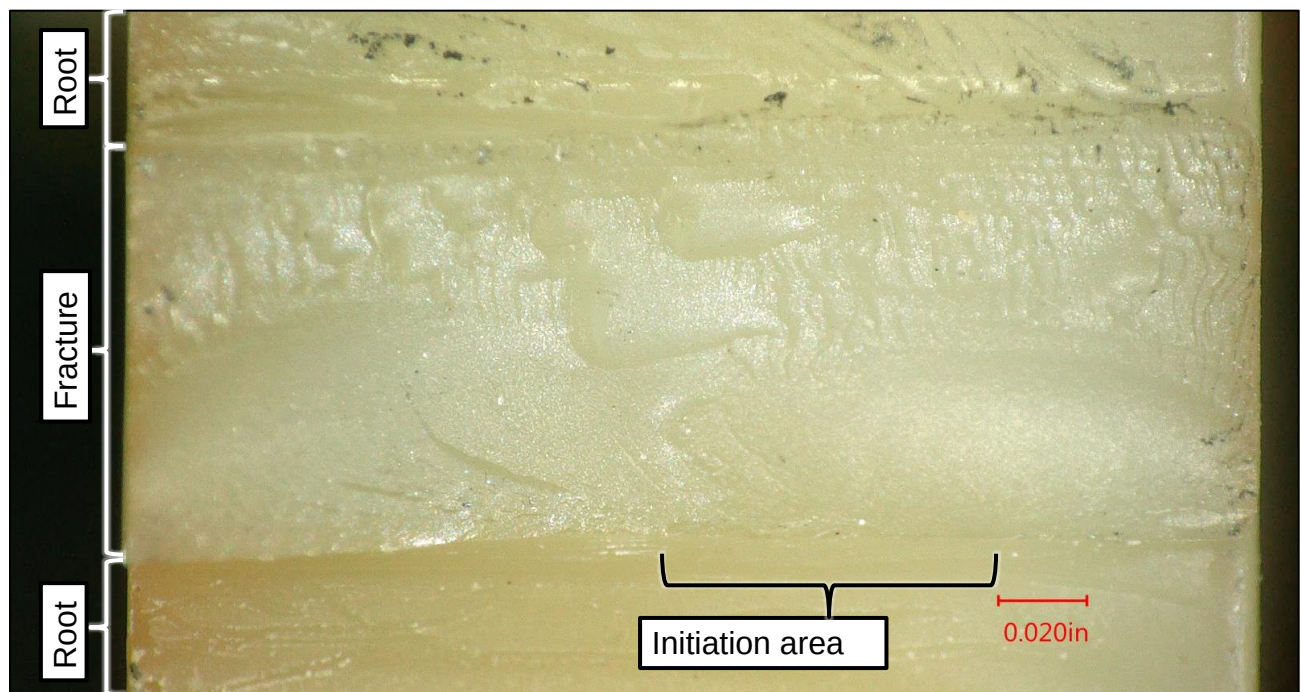
Figure 7. Close view of a tooth fracture surface from the right distributor gear.

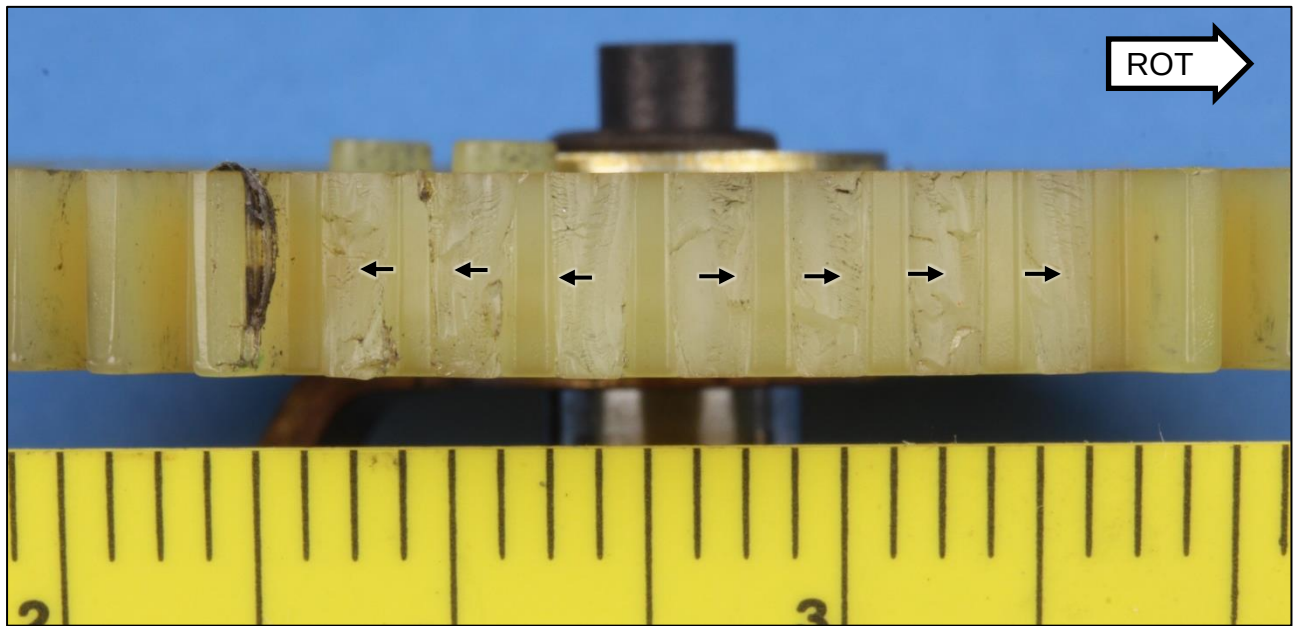
Tooth fractures in the left distributor gear initiated at both the contact and the noncontact sides of the teeth. Teeth 13 through 16 had fractures initiating at the contact side, and teeth 17 through 19 had fractures initiating at the noncontact side. Arrows in figure 8 indicate fracture propagation directions for the fractured teeth.

Figure 8. View of fracture features of broken teeth on the left distributor gear. Unlabeled arrows indicate the general direction of fracture propagation in each tooth.

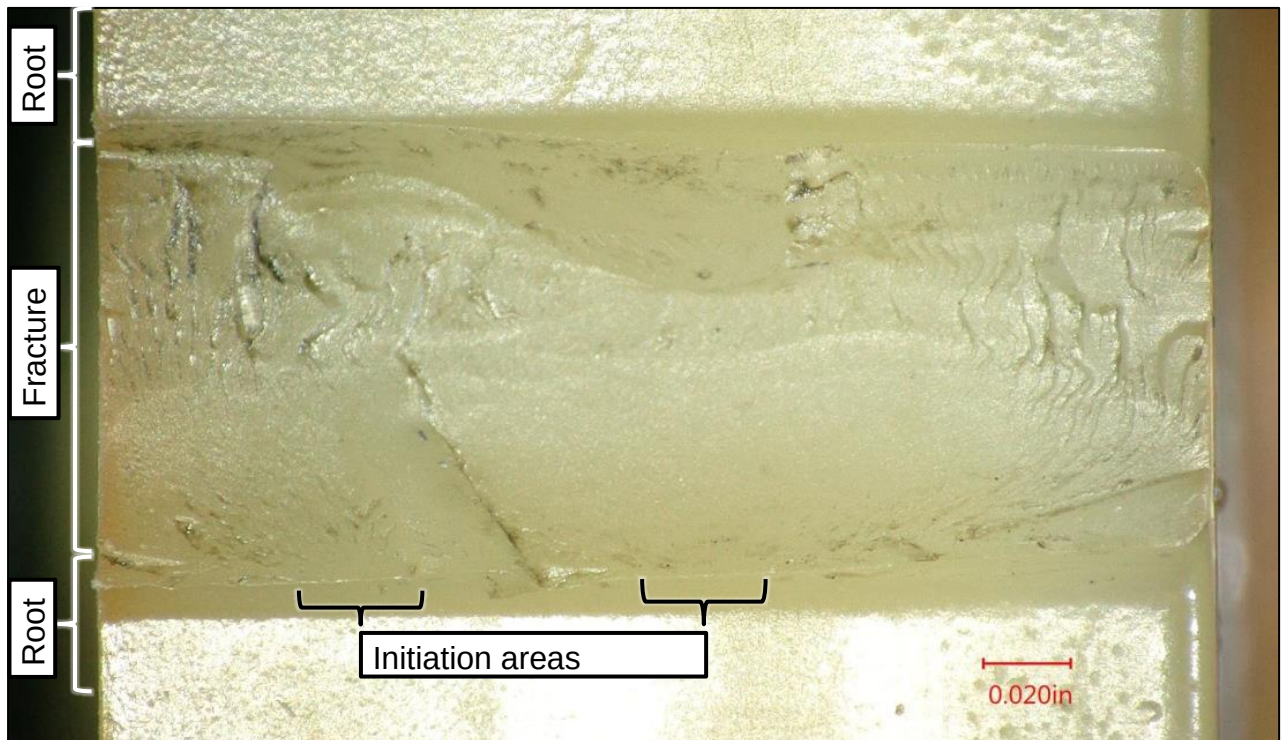
Figure 9. Close view of a tooth fracture surface from the left distributor gear.

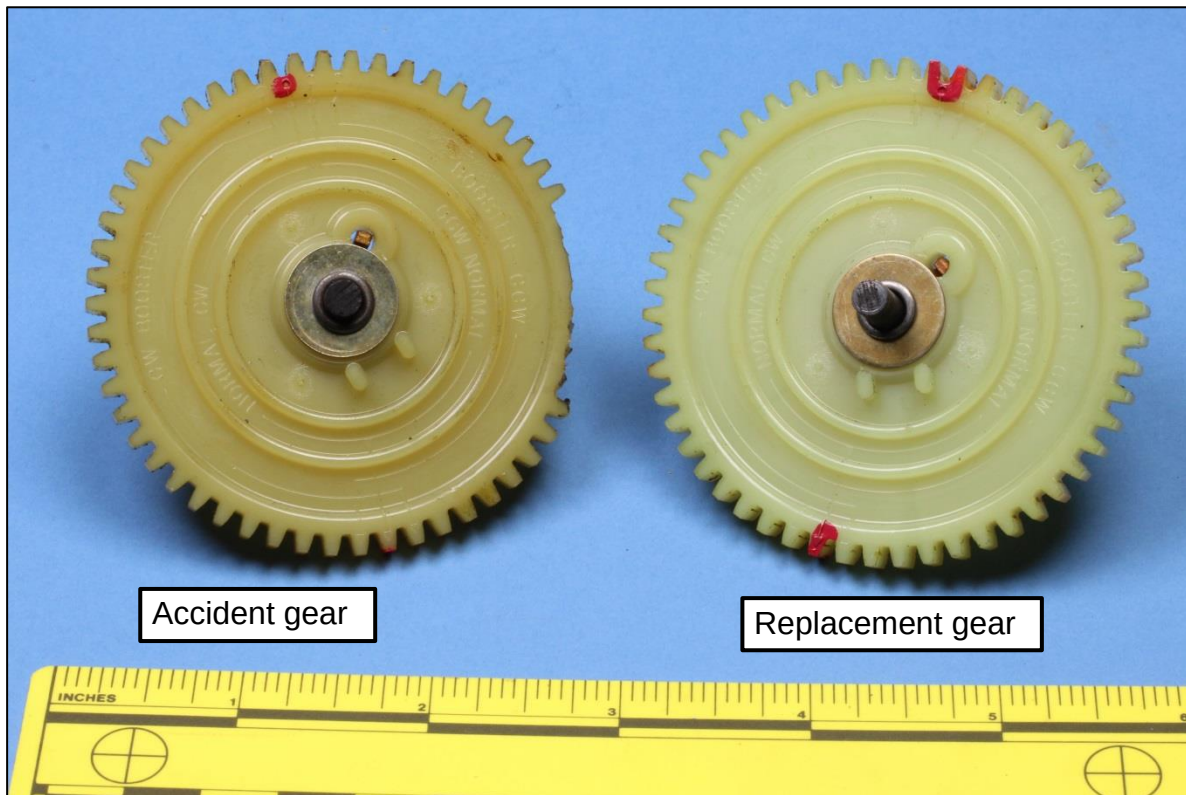
The left and right magnetos were disassembled, and replacement distributor gears that had been installed during testing of the magnetos were removed. The replacement gear from the right magneto had date code 11, and the replacement gear from the left magneto had date code 13. The replacement gears were a different color than the accident gears (see figure 10). The accident gears were darker with a brownish yellow color while the replacement gears had a yellowish white color.

Figure 10. Gear that was installed in the left magneto at the time of the accident (left) and the replacement gear that had been installed during testing of the magneto (right).

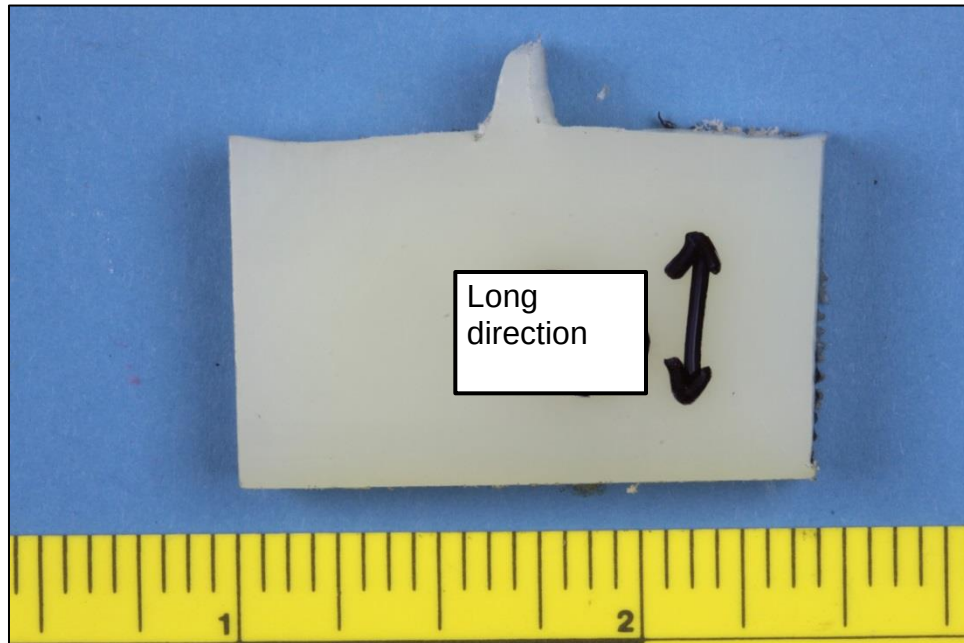
A ¼-inch thick sheet of nylon 6,6 formed into 24-inch by 48-inch panels was purchased from a commercial vendor. Using a handheld bandsaw, a shape approximately matching a tooth profile was cut from the sheet, and a small round file was used to round the corner at the base of the “tooth”. The resulting specimen is shown in figure 11, where arrows indicate the orientation of the long direction of the sheet. The specimen in figure 11 was placed in a vice, and the side of the “tooth” was impacted with a chisel and hammer. The resulting fracture surface is shown in figure 12. The fracture showed relatively smooth features across most of the fracture surface with curving fracture front lines and hackles toward the terminal side of the fracture.

Figure 11. Overall image of a laboratory impact specimen roughly fabricated into the approximate shape of a gear tooth in a  $\frac{1}{4}$ -inch thick sheet of nylon 6,6. Arrows on the specimen indicate the long direction of the original 24-inch by 48-inch sheet.

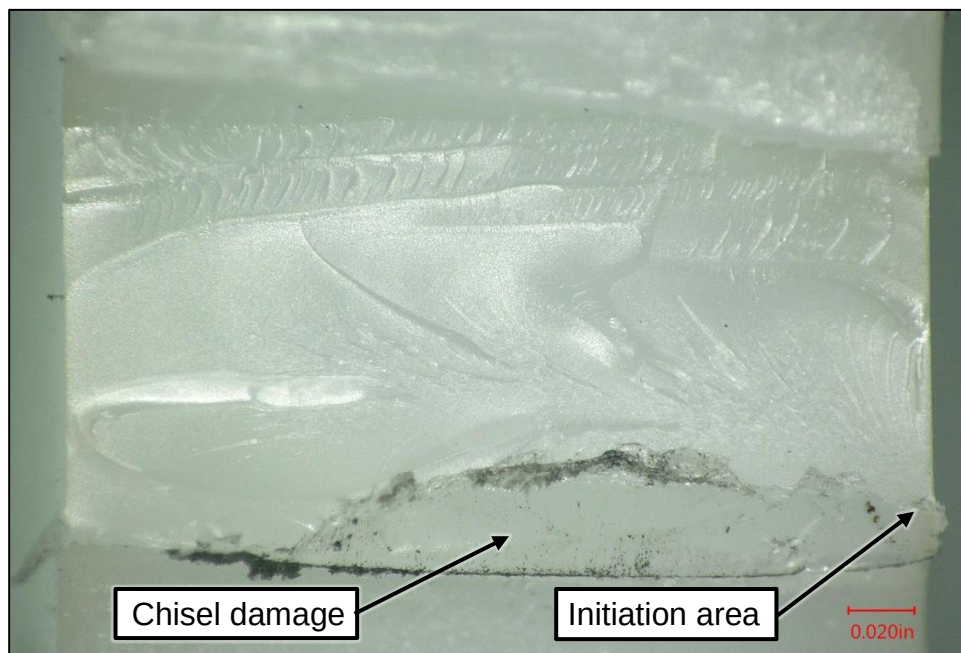
Figure 12. Fracture surface on the specimen in figure 11 after impact applied using a hammer and chisel.
