## 2. Purpose

This Airworthiness Bulletin (AWB) is a compilation of information contained in Airworthiness Advisory Circulars (AAC), Service Bulletins (SB), Service Difficulty Reports (SDR) and Advisory Circulars (AC) and will be revised from time to time to incorporate new magneto defects.

## Magneto Defects

**AWB** 74-005 **Issue :** 3  
**Date :** 20 October 2014

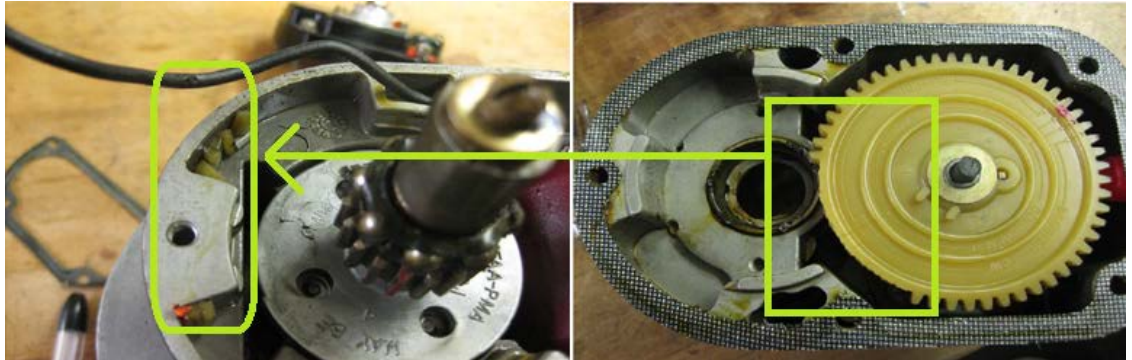
The magneto in Figure 3 (below) suffered teeth failure approximately 150 hours after the magneto was inspected in accordance with the 500 hour Continental Motors System Support Manual inspection. This issue was found when a magneto failed a dead cut test. When the magneto was opened - the

distributor gear was found with several gear teeth broken away from the gear. The teeth were retained inside the magneto case. No other parts were found out of place inside the magneto case. This magneto was documented to have approximately 1000 hours TSO (total since overhaul); however, overhauled magnetos may contain components which have been in service for many years.

Figure 3 - Broken Distributor Gear Teeth (Sourced from FAA Alert 401, December 2011)

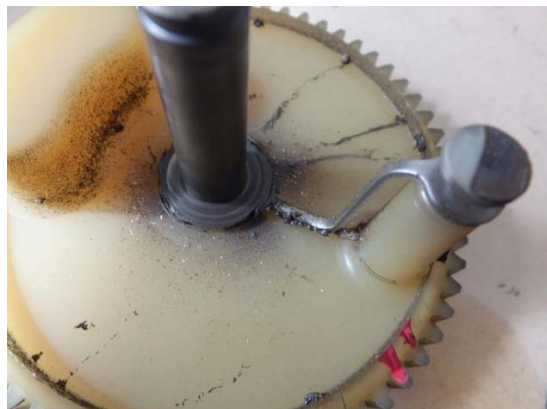
A distributor gear which either rotate sporadically or does not rotate due to broken teeth, may also result in additional internal arcing damage to other electrical components, such as tracking burns on the distributor cap and burnt high tension coils. See Figure 4.

Figure 4 - Arcing damage on distributor gear wheel

This is because the high tension electricity is still being generated as the magneto continues to operate and if the electrical energy cannot discharge at the spark plug, it seeks alternate paths to earth.

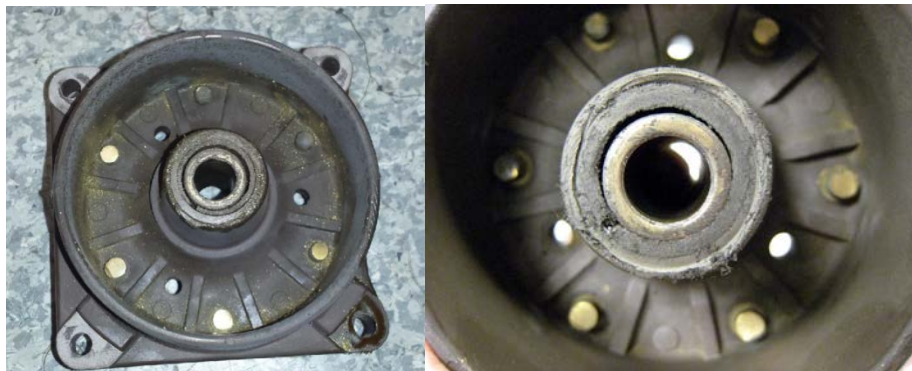
Magneto miss-firing and dead-cuts have been traced to the distributor wheel shaft bearing spinning and moving in the bearing block. 30 SDRs have been reported regarding this type of failure. On one occasion this problem caused an engine failure on take-off.

Figure 5 – Distributor Bearing block

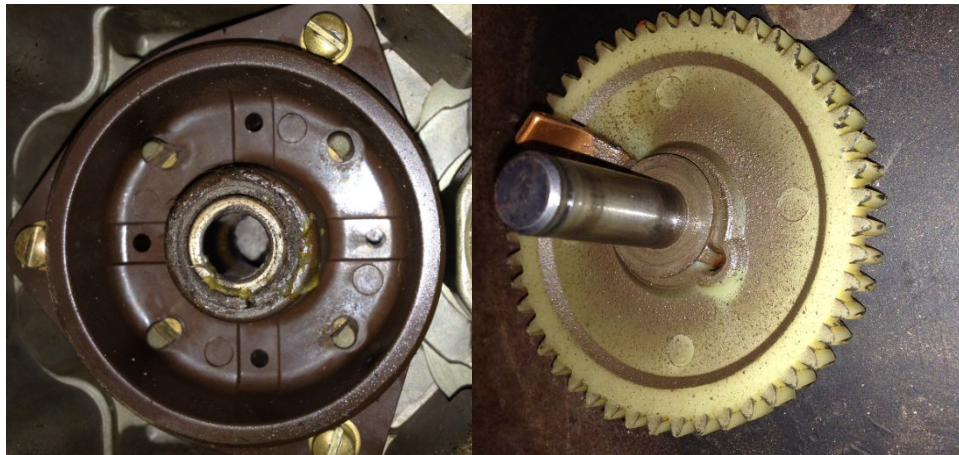
It is reported by magneto overhaul shops that despite close inspection of new distributor blocks, there is no way to determine if a new distributor block will prove to be reliable in service. This is currently the matter of an active on-going investigation in conjunction with manufacturers. In the CASA SDR database, there has been an approximately 70% increase in loose distributor block bearings in rotorcraft installations.

Figure 8 - Bushing failure

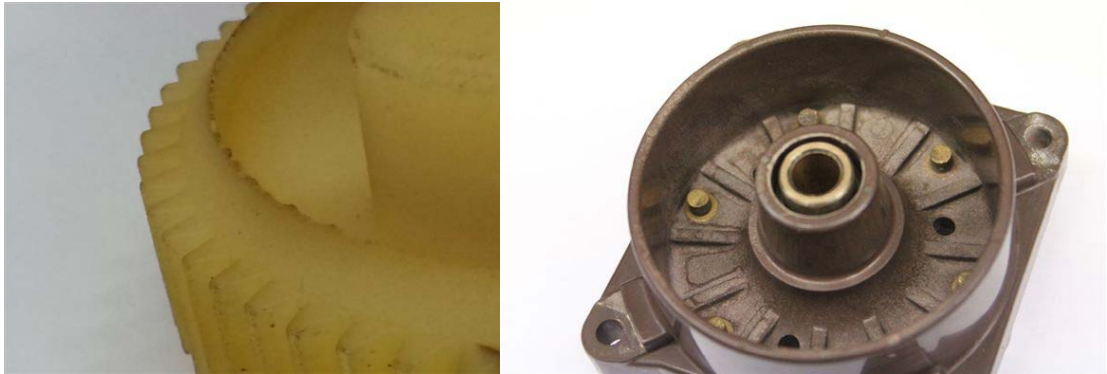
In one instance a magneto was inspected after an overhaul from an FAA approved overhaul facility (see Figure 10). The distributor gear and block were sandblasted during the previous overhaul, causing erosion to the parts.

Figure 10 - Eroded gear and block

Figure 10 shows sand blast beads were found in the block bushing. This issue was identified during an overhaul of the magneto.

Sandblasting is not an approved process during overhaul and this information was provided to the FAA to aid in their inquiries.

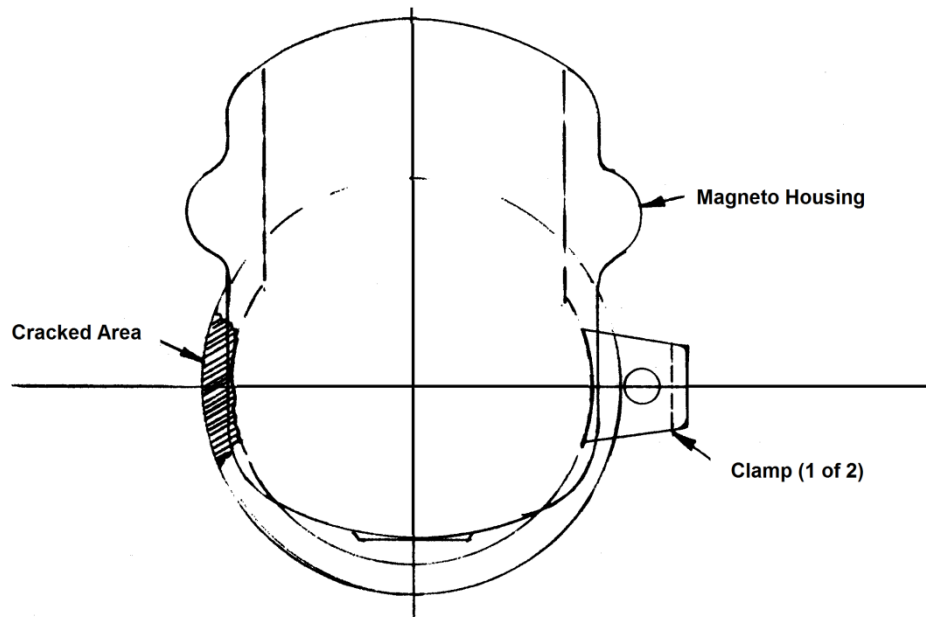
Figure 15 - From Slick SB 3-80B Broken Magneto flanges

An SDR was submitted to CASA where a manufacturing defect was identified in the housing casting. Failure occurred at the point of contact with the hardware. This caused the separation of a large portion of the flange from the housing.

LAMEs are reminded that extra precautions should be taken when new parts are drawn from stores and used during re-installation. The gaskets were all authentic Bendix magneto gaskets. It was their particular application that was faulty in these instances." Note in Bendix SB 3-80B, Bendix attributes broken magneto attachment flanges to over-torquing the attachment flange nuts.

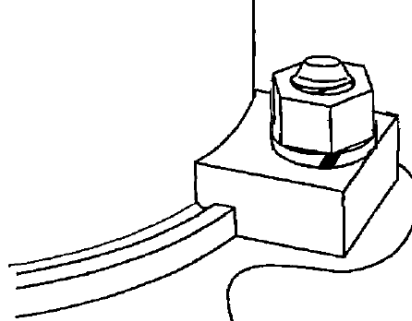
Over torqueing has also been attributed to distributor block cracks (SDR 510018733).

Figure 16 - Adapted from Slick SL3-92C

Example of over-torqued magneto gaskets has been reported to CASA. As a result the gaskets perished in service. Gaskets should not be re-used and the approved data documentation should be followed.

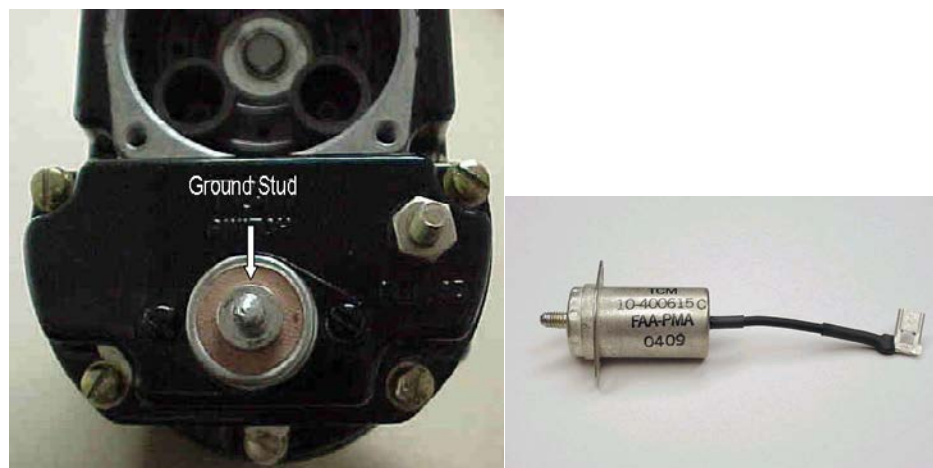
Teledyne Continental Motors has identified a quantity of particular magneto capacitors which may have ground stud (also referred to as the P-Lead stud) threads that do not meet specification. This may allow the ground wire (P-Lead) to come loose, resulting in a hot (live) magneto. A list of affected magnetos and capacitors are listed in the service bulletin.

Figure 17 - Capacitor

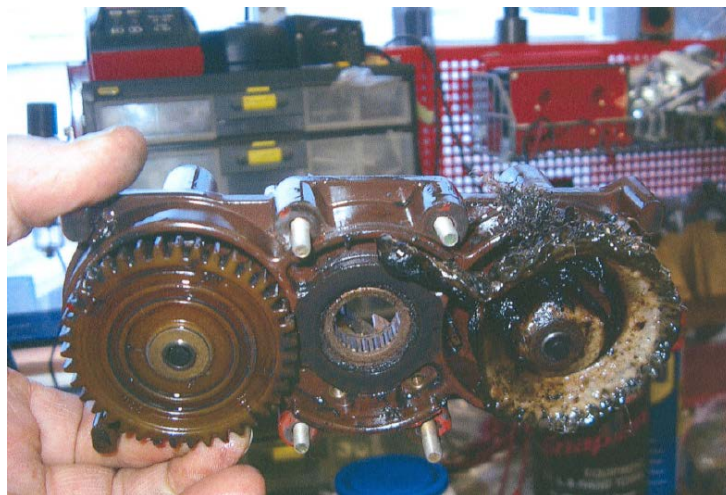
An SDR has identified missing bearing retainer plate screws. The magneto below in Figure 23, became heavily contaminated with engine oil which had entered the magneto via the missing retainer plate screws. The right hand distribution gear had suffered severe burning and melting. The gear was severely distorted and no longer in mesh with the drive gear.

Figure 23 - Missing bearing retainer plate screws

The magneto is typically designed to be a self-contained unit, not requiring engine oil for lubrication. Oil contamination causes such magnetos to malfunction and fail. Engine oil can enter the magneto via a damaged magneto engine oil seal. Oil seals are known to deteriorate with age, operating hours in service and exposure to heat, including hot engine oil. The sealing lip

of the seal wears against a rotating surface. Oil seals should be changed during magneto overhaul.

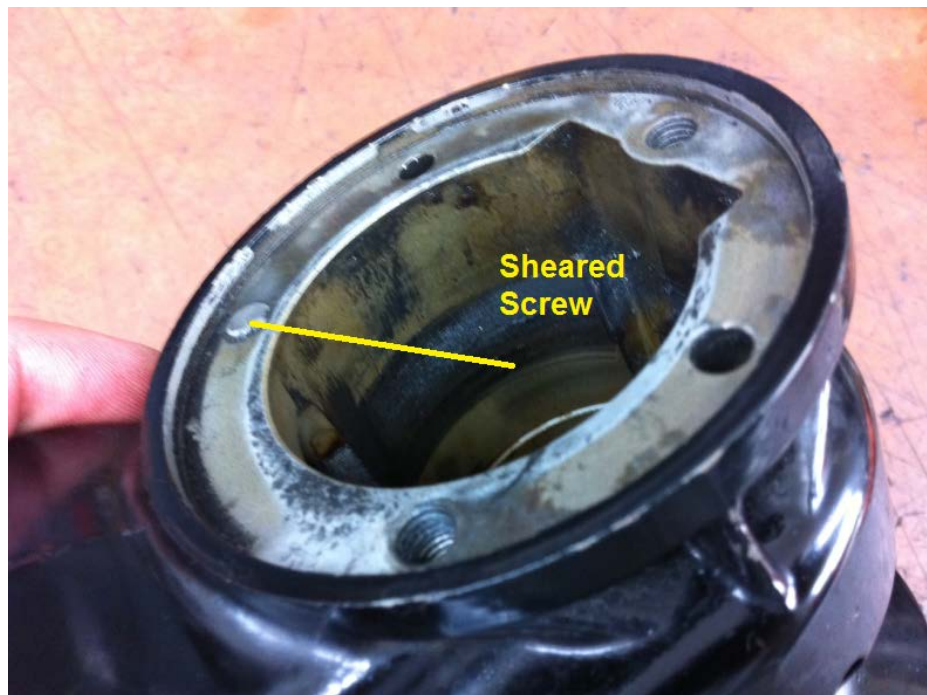
Incorrectly torqued magneto flange screws have caused the screws to shear. The stator below in Figure 24 was damaged by the magneto rotor as a result.

Figure 24 – Sheared screw
