# NATIONAL TRANSPORTATION SAFETY BOARD

## MATERIALS LABORATORY FACTUAL REPORT

Report No. 16-042

Place : Lake Elmo, Minnesota  
Date : December 11, 2015  
Vehicle : Globe GC1B, N78067  
NTSB No. : CEN16LA061  
Investigator : Joshua Lindberg, AS-CEN

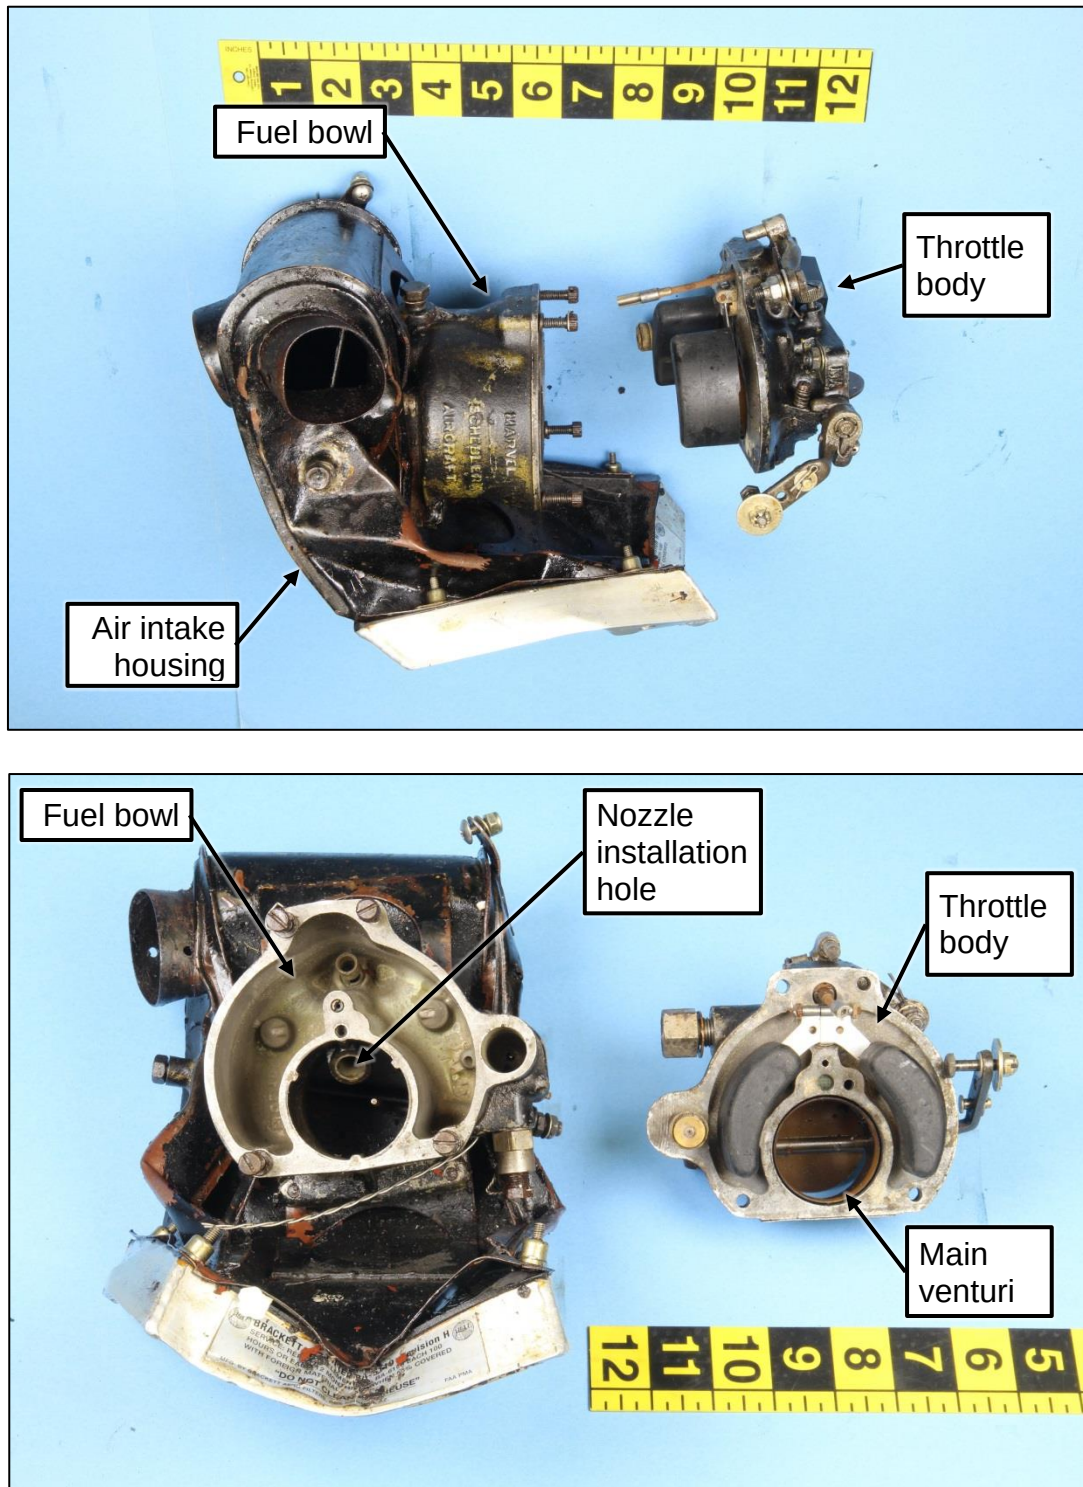
Multiple pieces were missing from the carburetor assembly. The nozzle was not located in the nozzle installation hole in the fuel bowl piece (see figure 1), and the primary venturi portion of the two-piece venturi was missing. The main venturi portion of the two-piece venturi is indicated in figure 1. Gaskets associated with the nozzle and the gasket between the fuel bowl and the throttle body were also missing. The interior

Figure 1. Overall views of the submitted components.

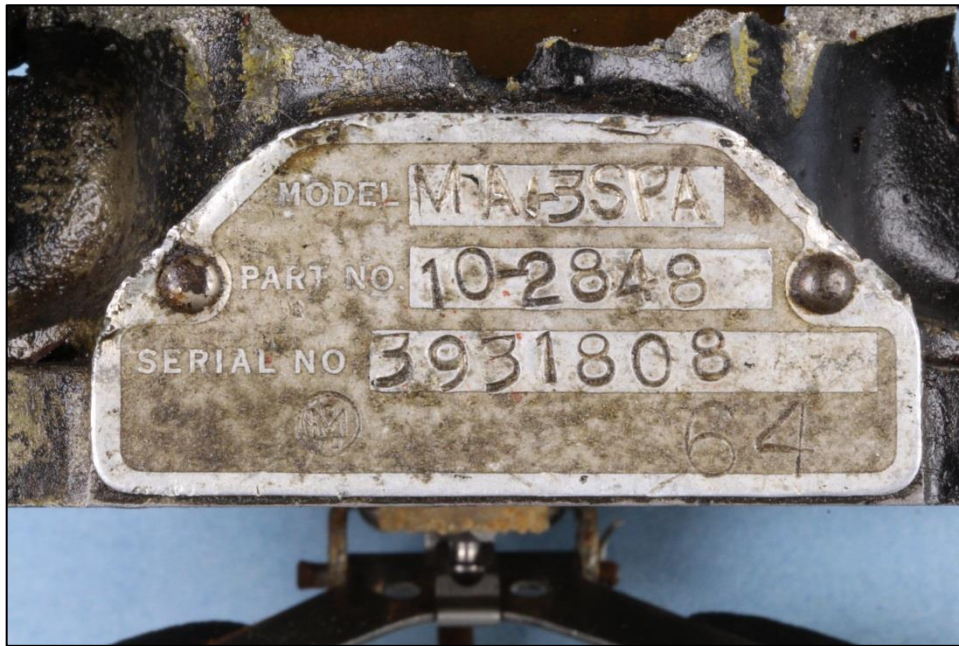
Overall views of the submitted components are shown in figure 1. The carburetor had a white data plate as shown in figure 2 with part number 10-2848 and serial number 3931808. No stamped "V" was present on the data plate that would have indicated that the two-piece venturi had been replaced with a one-piece venturi. According to Airworthiness Directive 98-01-06, Precision Airmotive Corporation (now Marvel-Schebler Aircraft Carburetors) MA-3SPA carburetors with a 2-piece venturi are to be inspected at each annual, 100-hour, or progressive inspection to determine if the primary venturi is loose or missing. The last inspection per AD 98-01-06 that occurred before the accident was reportedly accomplished on October 27, 2015.

Figure 2. Carburetor data plate.

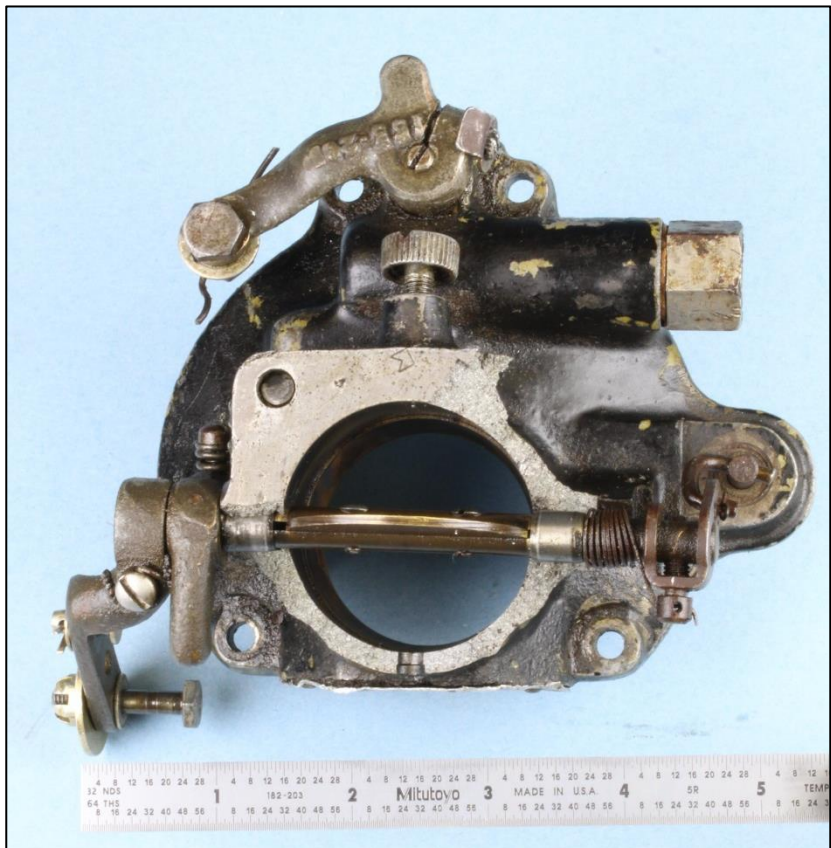
The carburetor was received in the disassembled condition shown. The air intake housing was crushed, and the throttle body was fractured at the intake manifold attachment flange (see figure 3). The fracture in the throttle body extended around  $\frac{3}{4}$  of the circumference, intersecting both holes for the throttle valve shaft. Fracture features had rough gray features consistent with overstress fracture of cast aluminum. One intake manifold attachment bolt was fractured and remained within the flange. Fracture features on the bolt had matte gray features consistent with ductile overstress fracture of the steel bolt.

Figure 3. Throttle body showing the fracture in the throttle body housing.

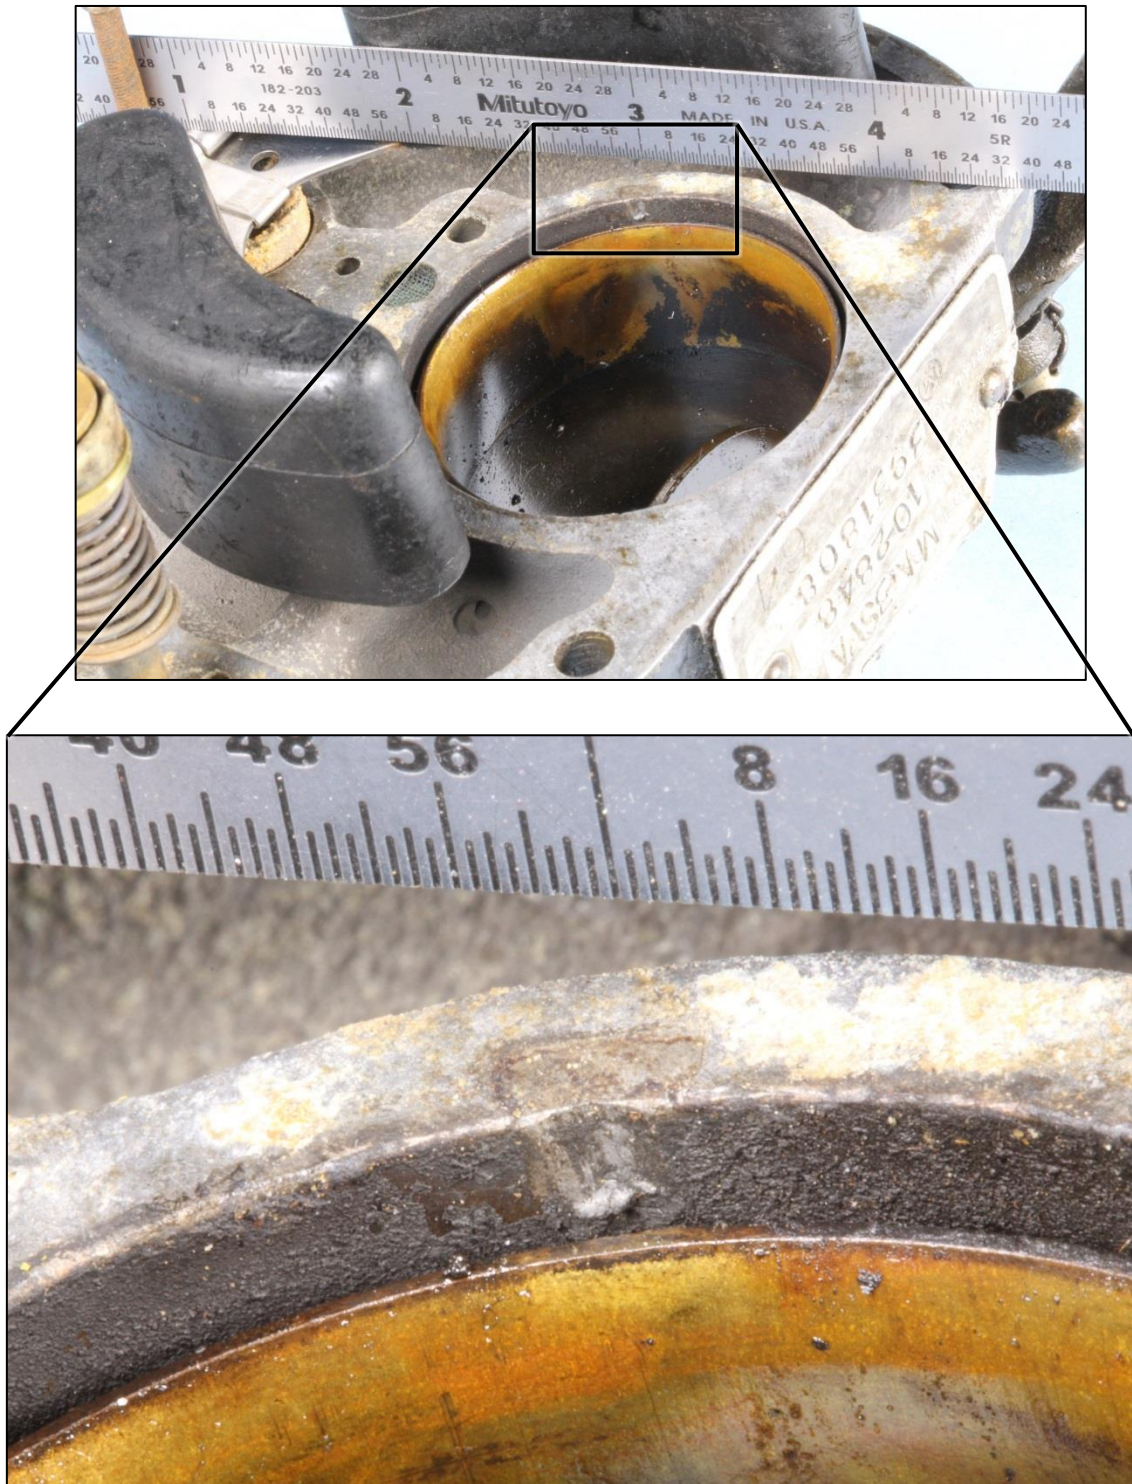
Closer views of the throttle body and main venturi are shown in figure 4. Sliding contact marks with a lip of material was observed at three locations on the throttle body adjacent to the main venturi, corresponding to contact with the three legs of the primary venturi. One of the sliding contact areas is shown magnified in figure 4.

Figure 4. Contact mark in the area where legs of the primary venturi would contact the throttle body as assembled in the carburetor.
