## The National Transportation Safety Board

Office of Aviation Safety  
Central Region  
Memorandum for the Record  
Engine Examination Factual  
Findings  
CEN16LA064  
Sulphur Louisiana  
November 24 2015

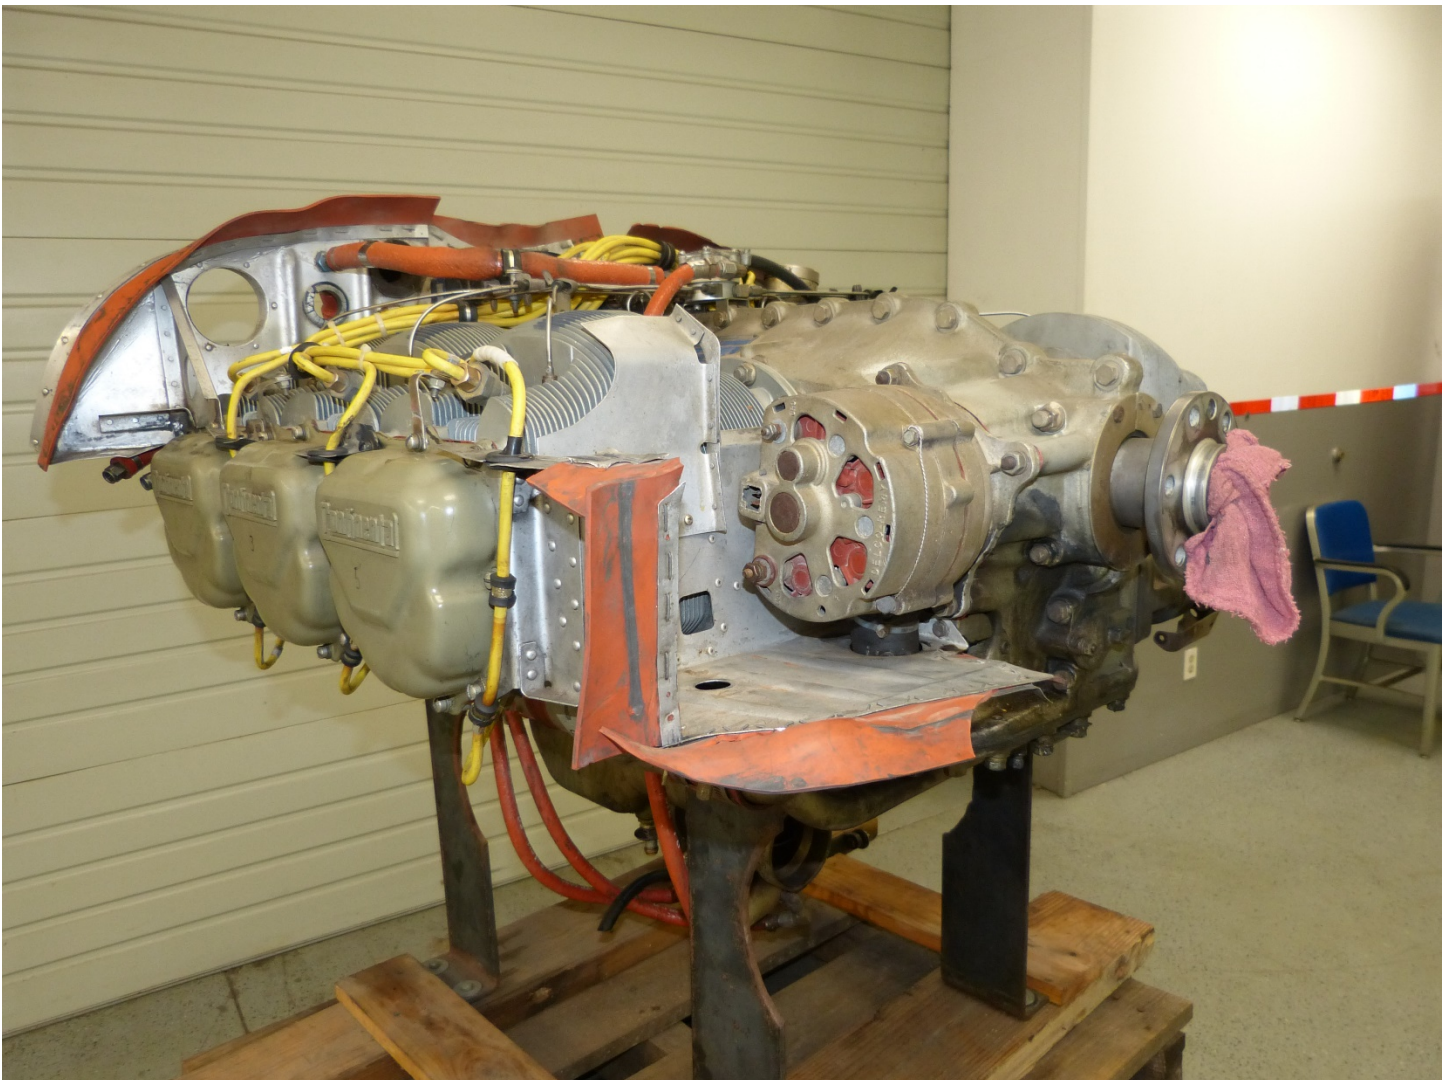
- The engine remained attached to the airframe and had no external damage, except for impact damage to the intake air box. The throttle and mixture controls were hooked up. All of the cylinders had chrome markings.
- The top spark plugs, and rocker covers were removed. The crankshaft was rotated by hand using the propeller. Continuity was confirmed to all cylinders and to the rear of the engine. Good thumb compression was confirmed on cylinders one through five. The cylinders were examined with a lighted

boroscope and the number six cylinder had heavy corrosion on the intake valve between the valve and the valve seat, so that the valve could not properly seat. The remainder of the cylinders had dark deposits on the cylinder domes and pistons.

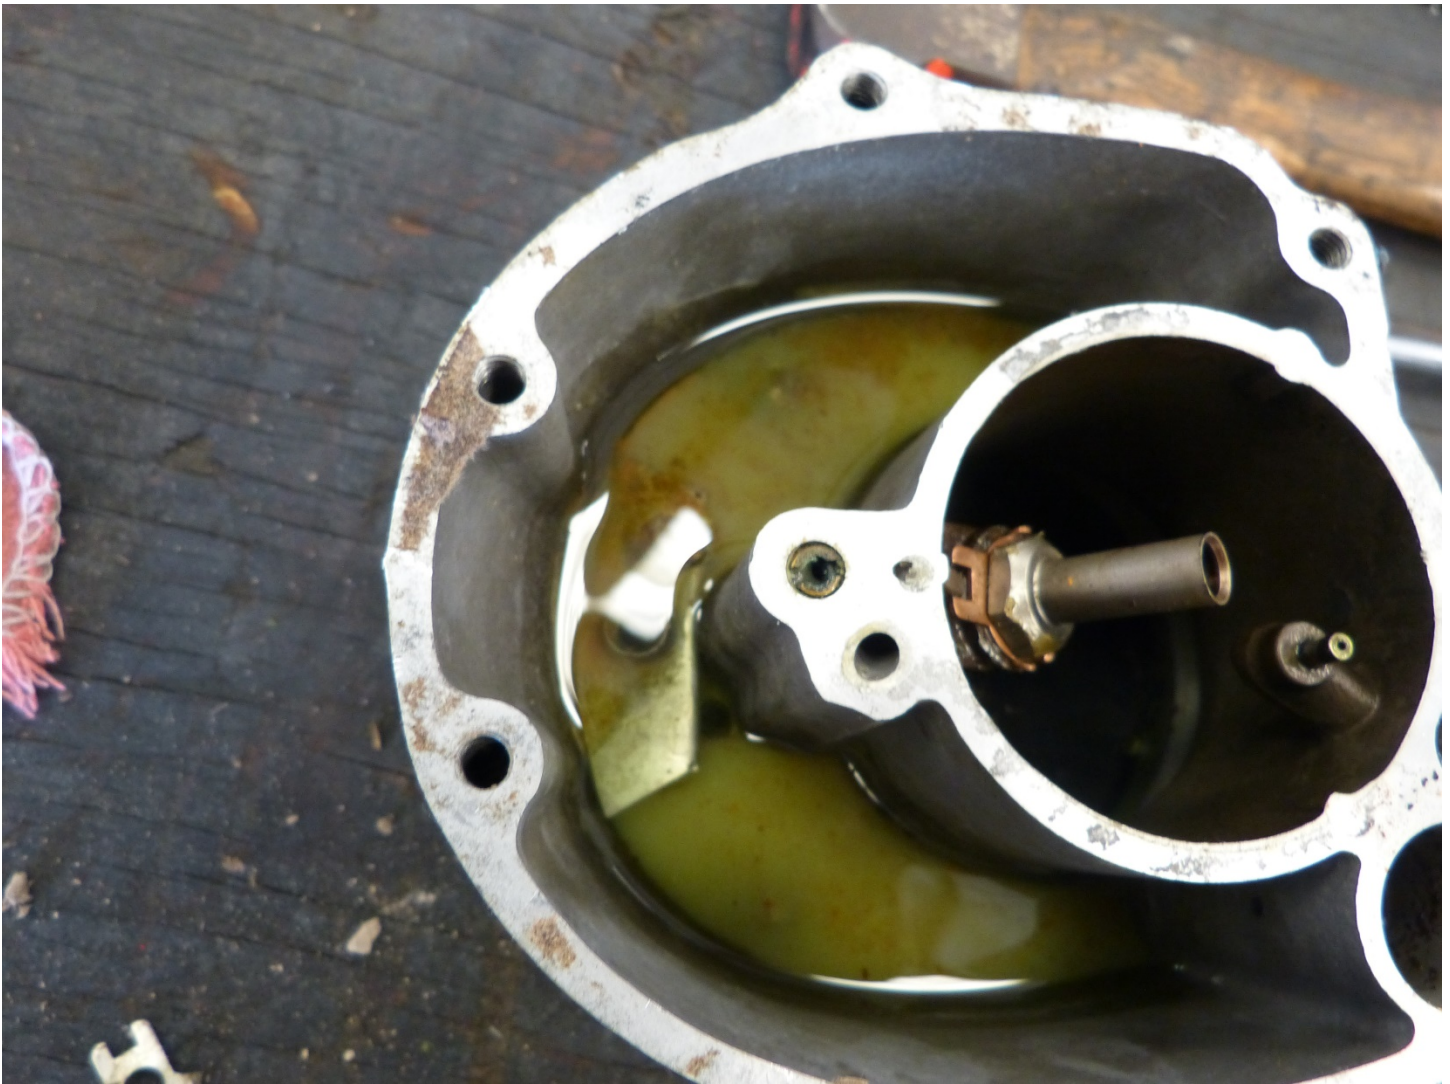
- The aircraft had been modified with a STC allowing the use of auto gas.
- The magneto impulse couplings snapped at top dead center on the number one cylinder.
- Spark Plugs: Champion, RWM-40E. The top spark plugs were removed and examined. They had normal wear when compared to the Champion Check-A-Plug comparison card, and dark deposits in the electrode areas.
- Carburetor: Marvel Schebler, MA-4-5, PN-10-3859-1, SN-MF-V-AI. The carburetor was not damaged. Rust and water were observed in the fuel inlet line. The inlet screen was wet with water and corrosion. The unit was disassembled, and the bowl was about half full of water and the bowl was also heavily corroded. The float and needle valve were intact and were free to move.
