# NATIONAL TRANSPORTATION SAFETY BOARD

## MATERIALS LABORATORY FACTUAL REPORT

Report No. 16-046

Place : Bulverde, Texas  
Date : January 31, 2016  
Vehicle : Aeronca O-58B, N47185  
NTSB No. : CEN16LA101  
Investigator : Andrew Todd Fox, AS-CEN

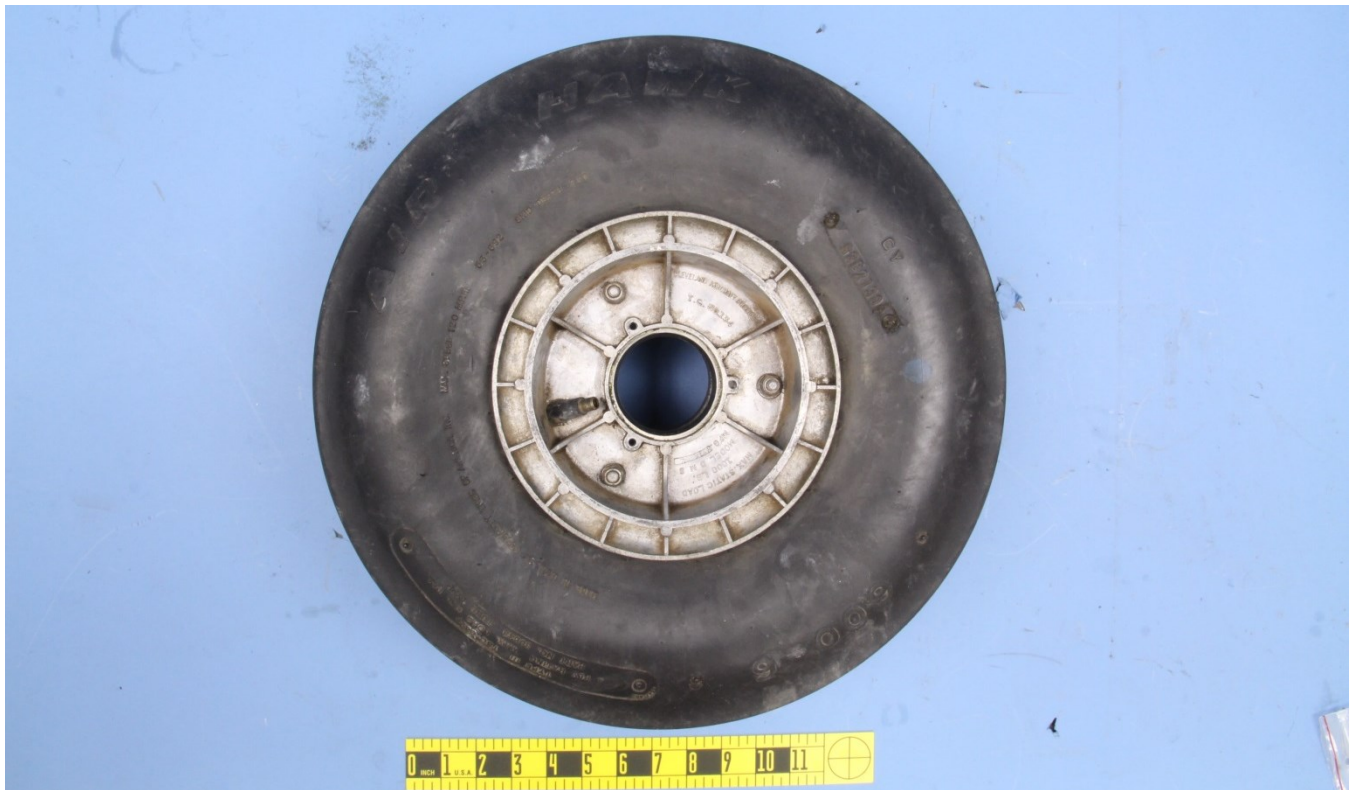
Figure 1 shows the wheel, including the tire and the hub casting, as received. The tire was disassembled, initially by removing the bolts connecting the sides of the wheel hub (see Figure 2a and Figure 2b). The tire and stem were then removed. Figure 2 shows the wheel hub and the brake drum riveted to the hub. This figure also shows the fracture surface of the inner bearing surface flange.

Figure 1 – The left main wheel hub and tire, as received.

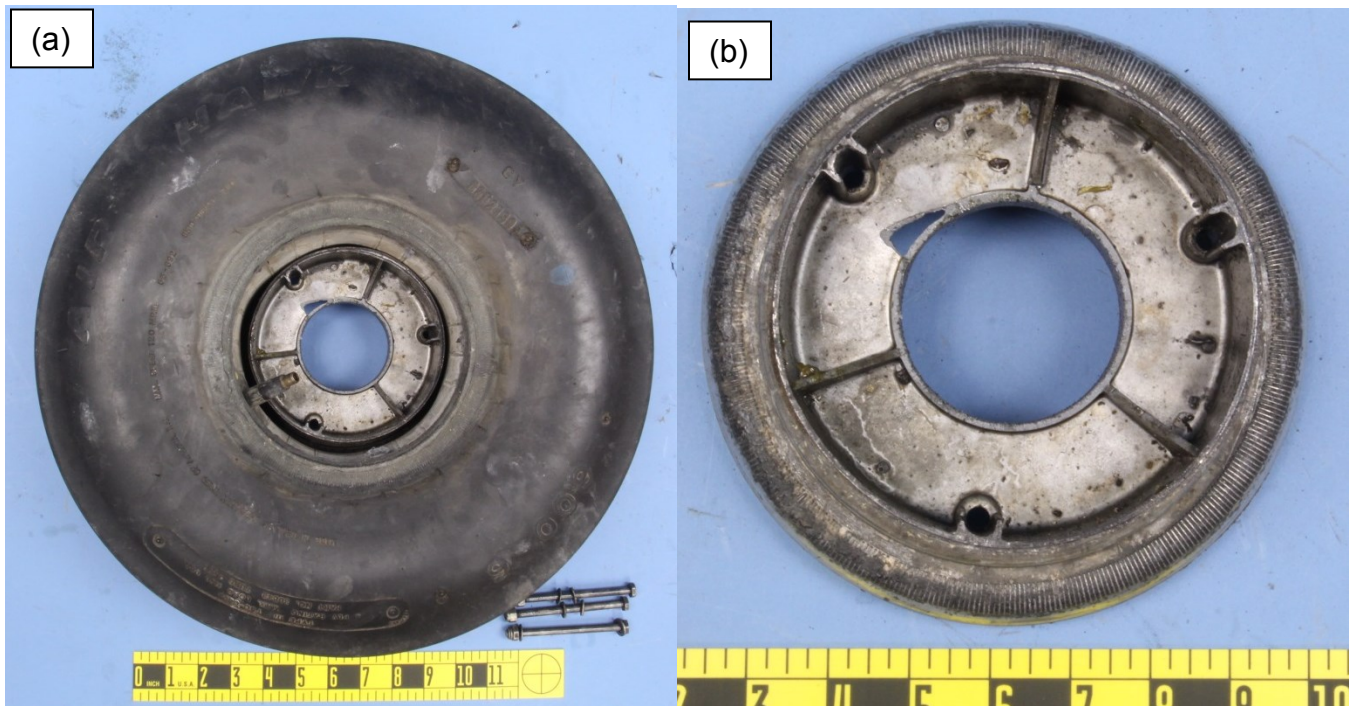
Figure 2 – The wheel hub after removal of (a) the outer half and (b) the rubber tire.

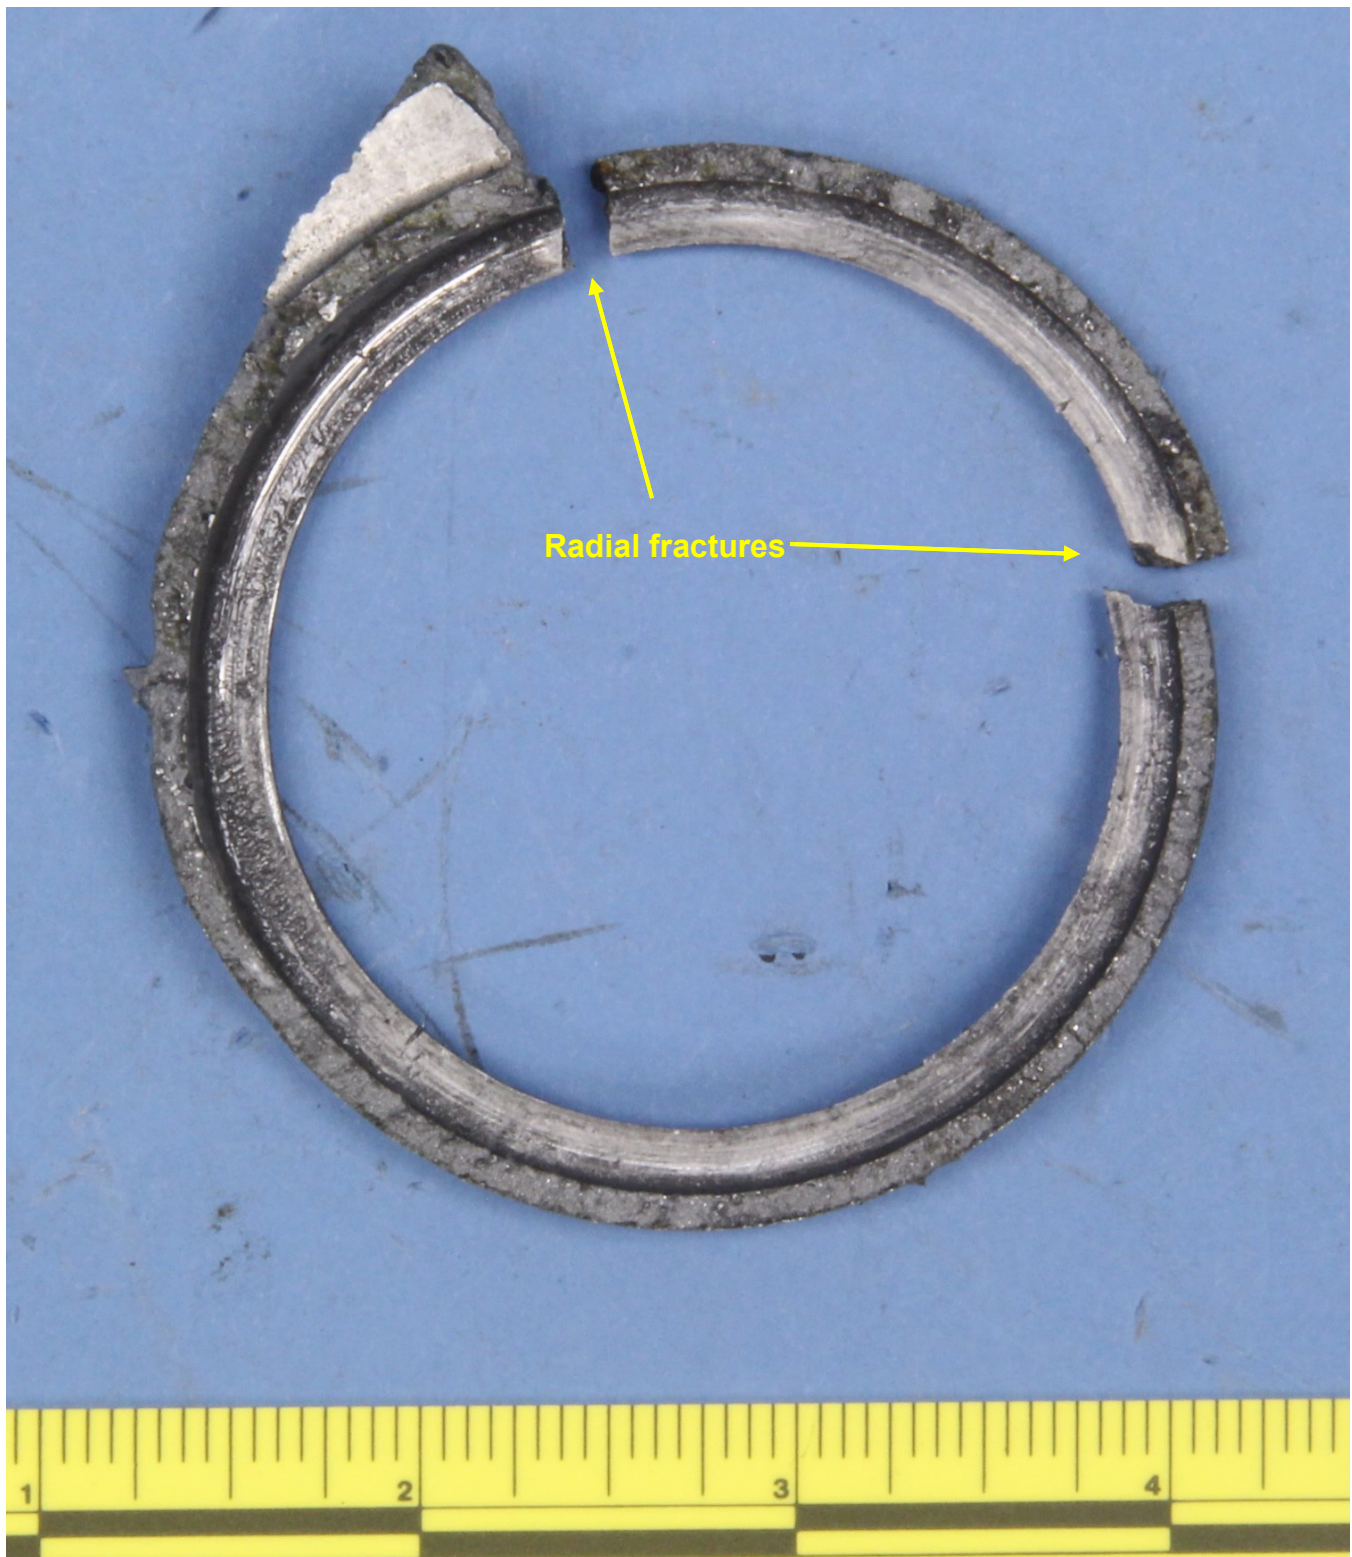
The mating fractured flange piece is illustrated in Figure 3, as received. The flange had separated from the rest of the wheel hub circumferentially. The circumferential fracture exhibited a bright luster, with a generally rough, tortuous surface. These fracture features were consistent with failure from overstress. In addition, the separated flange exhibited two

additional fractures oriented in radial directions. Both of these fractures exhibited features consistent with multiple fracture modes.

Figure 3 – The mating fractured inner bearing race flange, as received. The race flange had fractured circumferentially, as well as radially in two places. One of the radial fractures is shown in Figure 4.

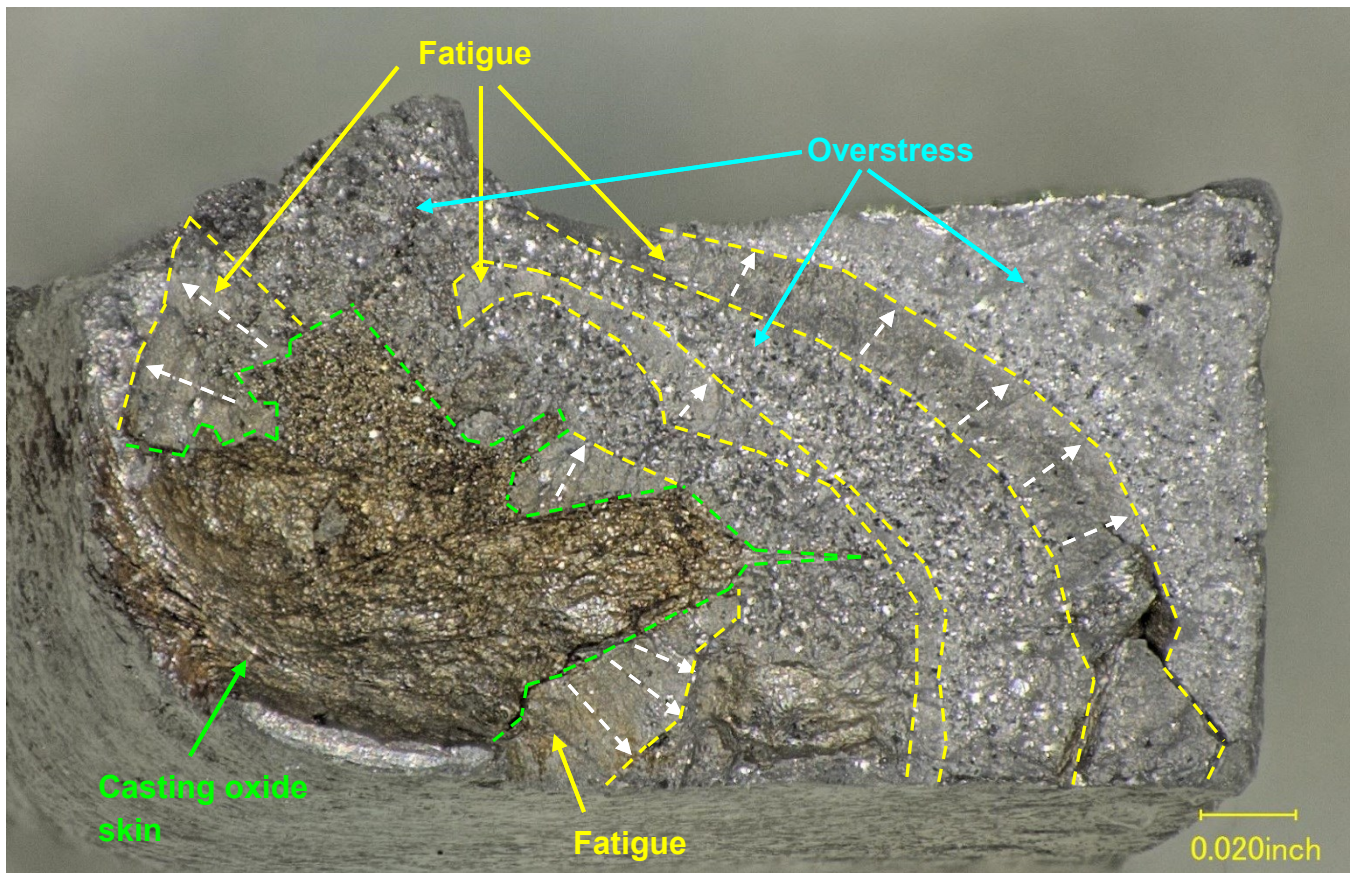
Figure 4 shows a closer view of one of the radial fracture surfaces. As denoted in Figure 4, the fracture surface exhibited features consistent with three different regions. The areas highlighted with the yellow dashed lines were progressive fracture regions, later determined to be fatigue (see Figure 5 and Figure 6). The fatigue regions tended to be banded intermittently with overstress regions. The initial fatigue cracks were adjacent to a gold-colored, lenticular, and rough-textured region. The crack arrest marks in these fatigue regions were consistent with the fatigue cracks propagating from the initial region.

Observations from examination of the two radial fracture surfaces and the opened crack were consistent with surface casting aluminum oxide “skins” that became incorporated inside the hub flange surface. These oxides would have been present since the part was cast at original manufacture. The alternating fatigue and overstress features would be consistent with spectrum loading, typical of those seen by a landing gear wheel.

Figure 4 – Closer view of the radial fracture surface on the wheel hub race flange, shown in Figure 3. The different fracture mechanism regions are highlighted, with the crack direction denoted by the arrows.

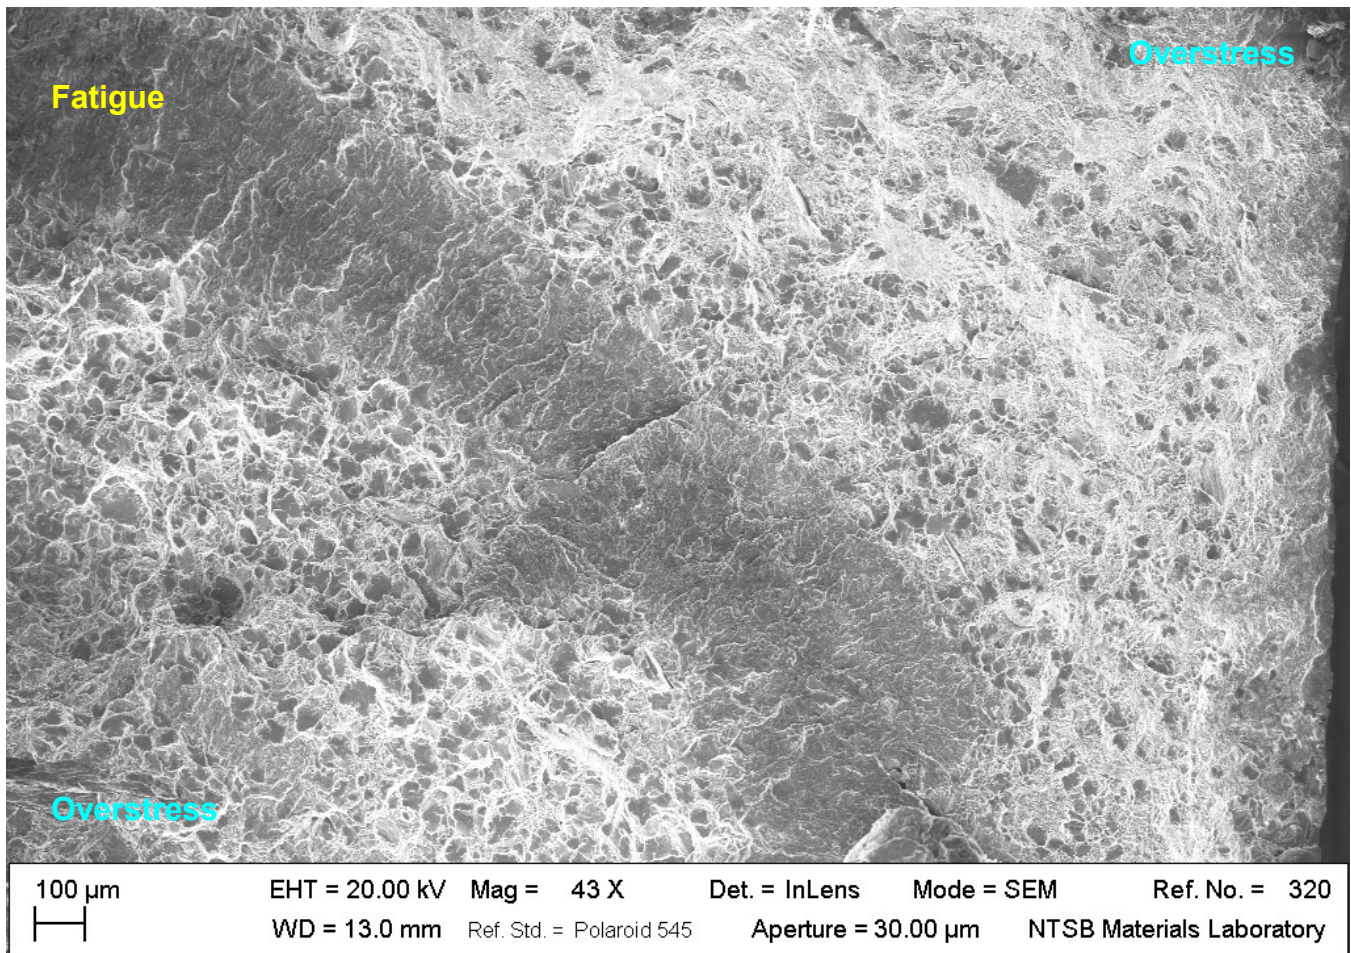
Figure 5 shows the most interior (or final) fatigue band on the radial fracture surface, as examined using a scanning electron microscope. Figure 6 shows a closer view of the fatigue band, revealing fatigue striations. The regions adjacent to the fatigue band exhibited dimple rupture consistent with overstress (Figure 7). This alternating banding of fatigue and overstress was consistent with the wheel hub flange having undergone high-cycle cyclic loading, with intermittent high stress events exceeding the local yield strength occurring during crack propagation.

Figure 5 – Secondary electron (SE) micrograph of the final fatigue band, shown between two overstress regions, on the radial fracture surface from Figure 4.

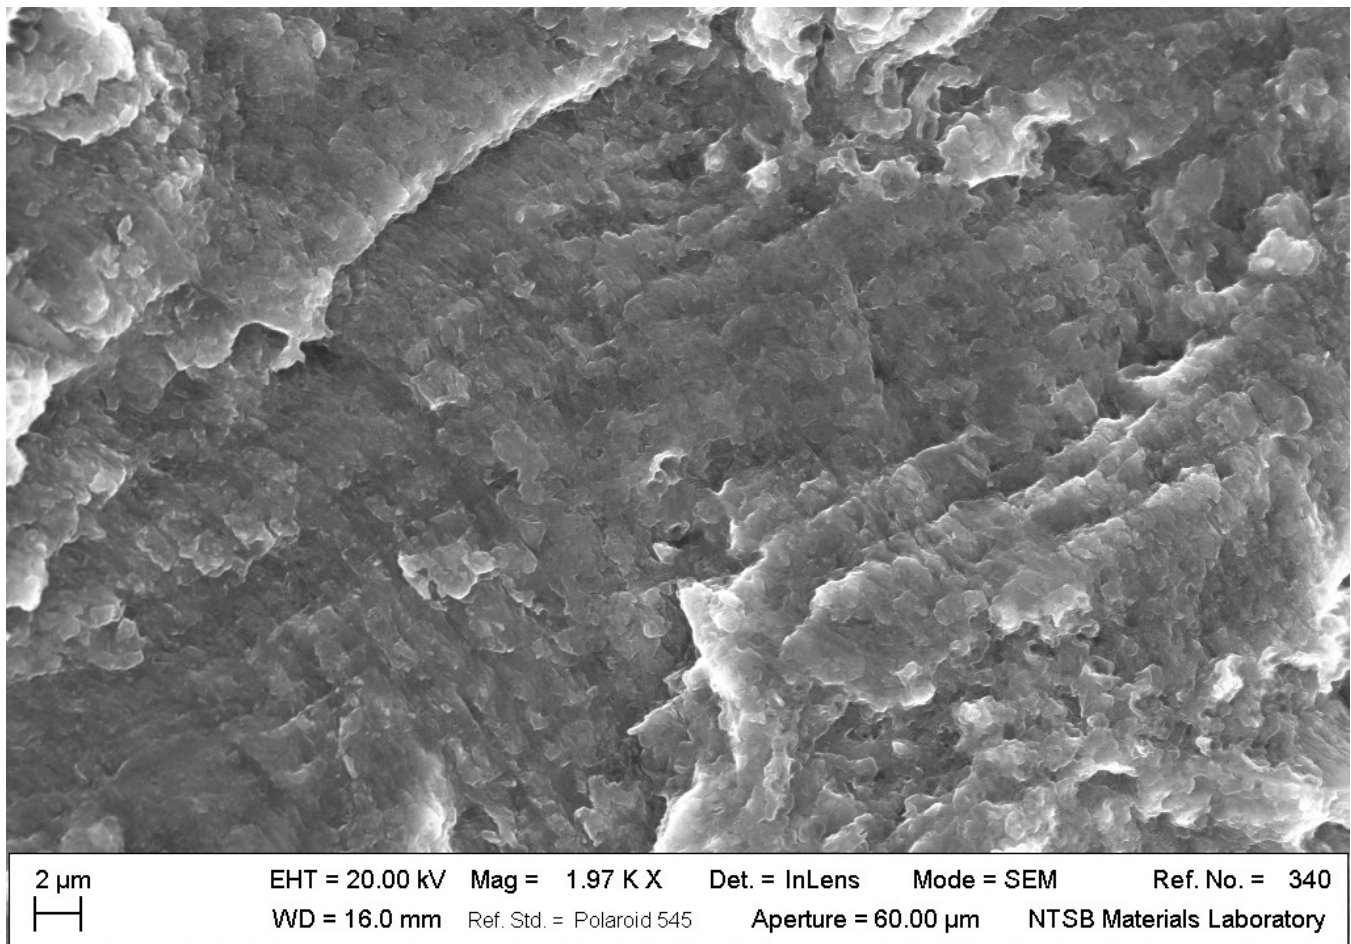
Figure 6 – SE micrograph showing striations in the final fatigue region of the radial fracture surface.

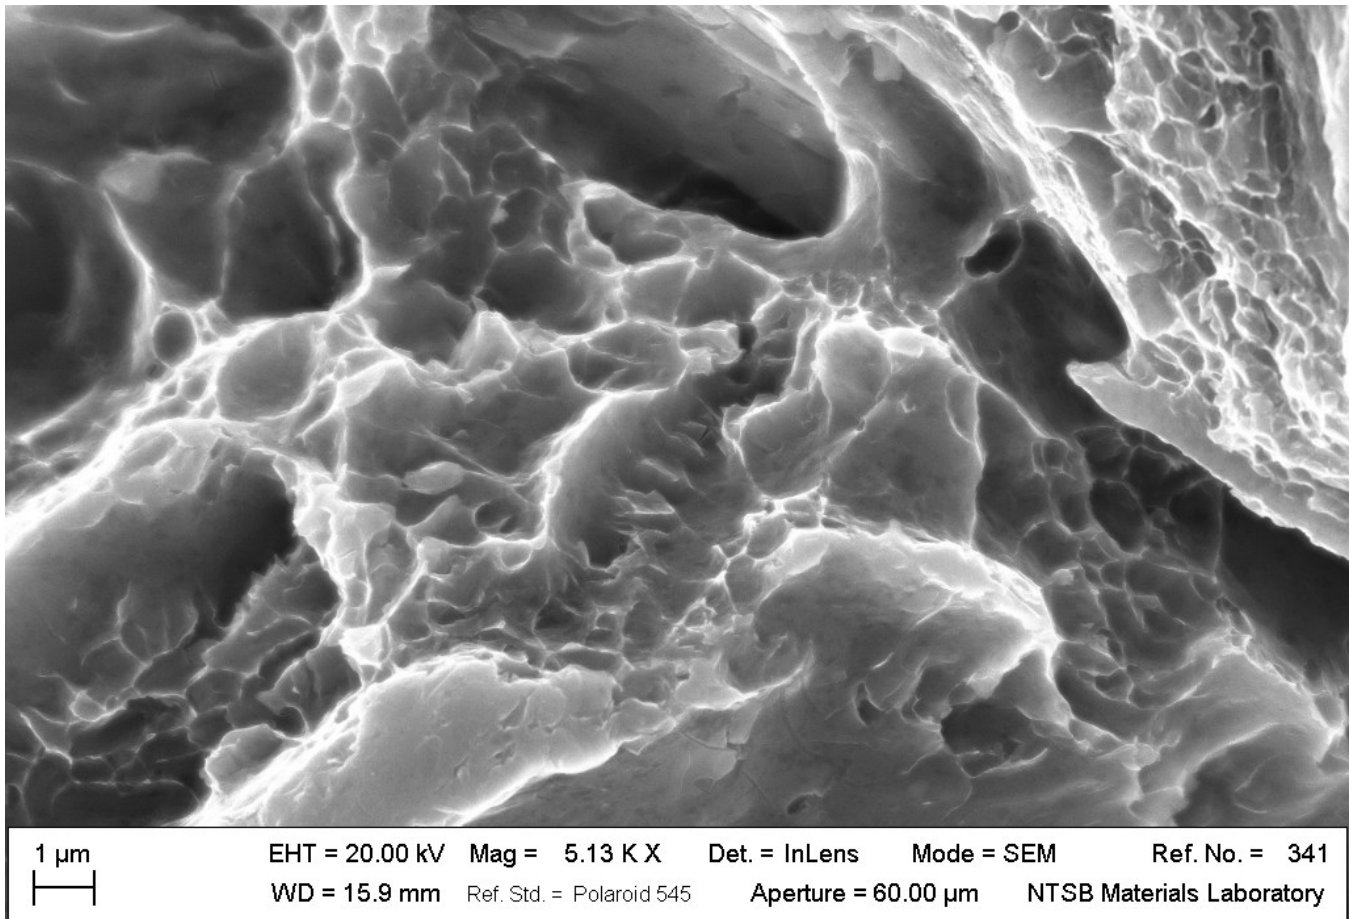
Figure 7 – SE micrograph showing dimple rupture in an intermediate overstress region on the radial fracture surface.

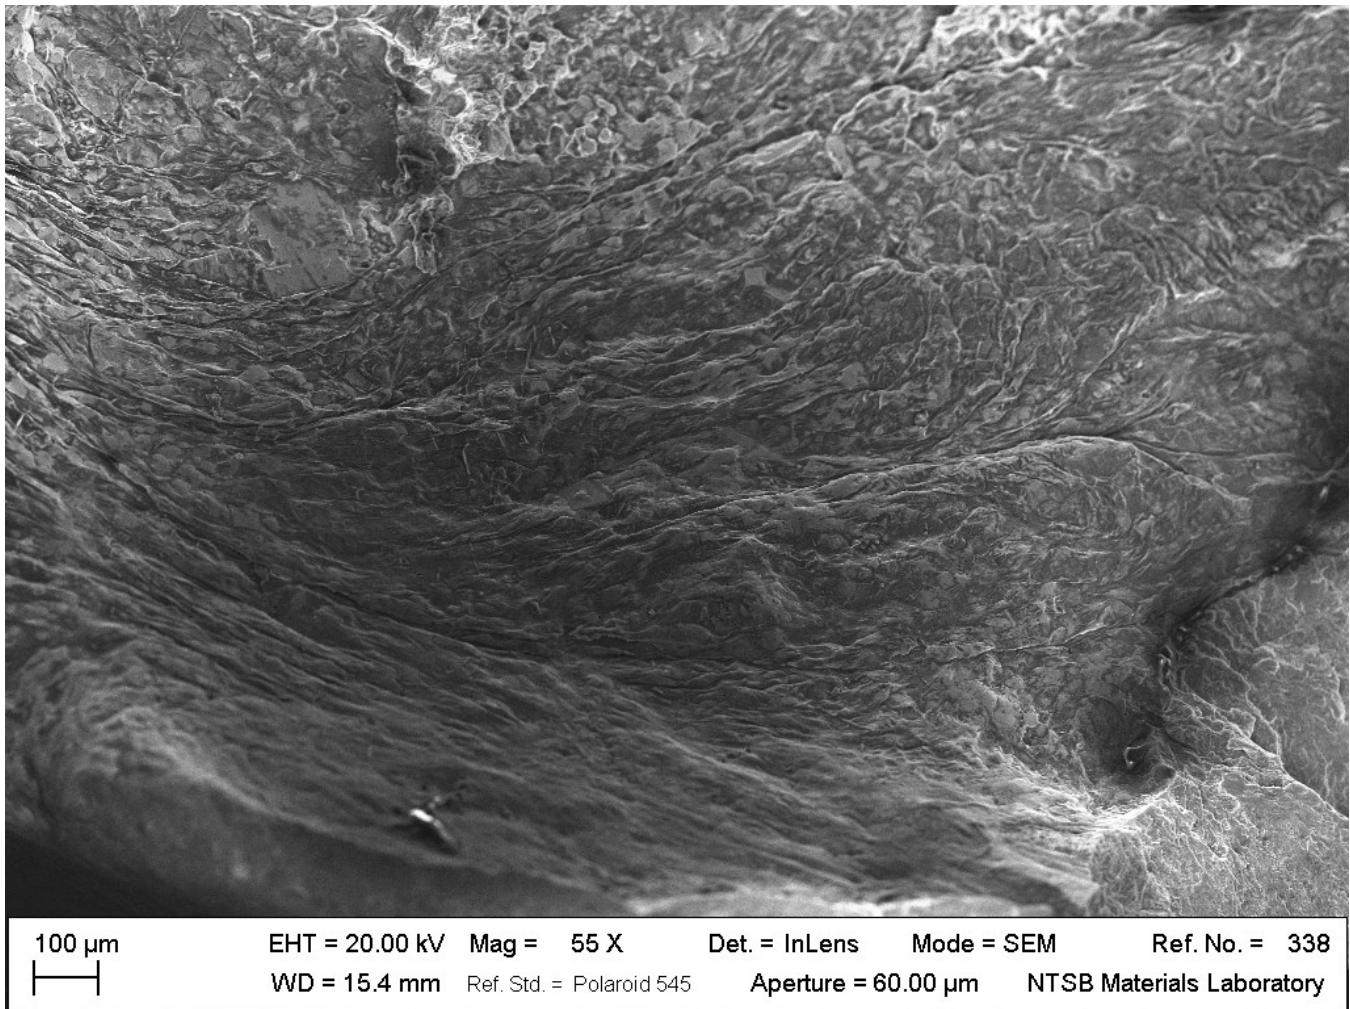
Figure 8 shows a closer view of the lenticular region near the crack initiation site. This region exhibited small folds with non-metallic material (Figure 9). Between this region and the initial fatigue regions, an area of globular non-conductive material was observed (see Figure 10). This material was examined using energy dispersive x-ray spectroscopy (EDS), and found to be consistent with oxides containing iron, calcium, zinc, sulfur, and sodium. When compared with the overstress regions on the radial fracture surface, EDS probes of the lenticular region contained higher weight percentages of iron and oxygen. These features were consistent with the thin oxide “skin” that forms on molten aluminum during the casting process in air.

Figure 8 – SE micrograph showing the oxide skin at crack initiation site on the radial fracture surface.

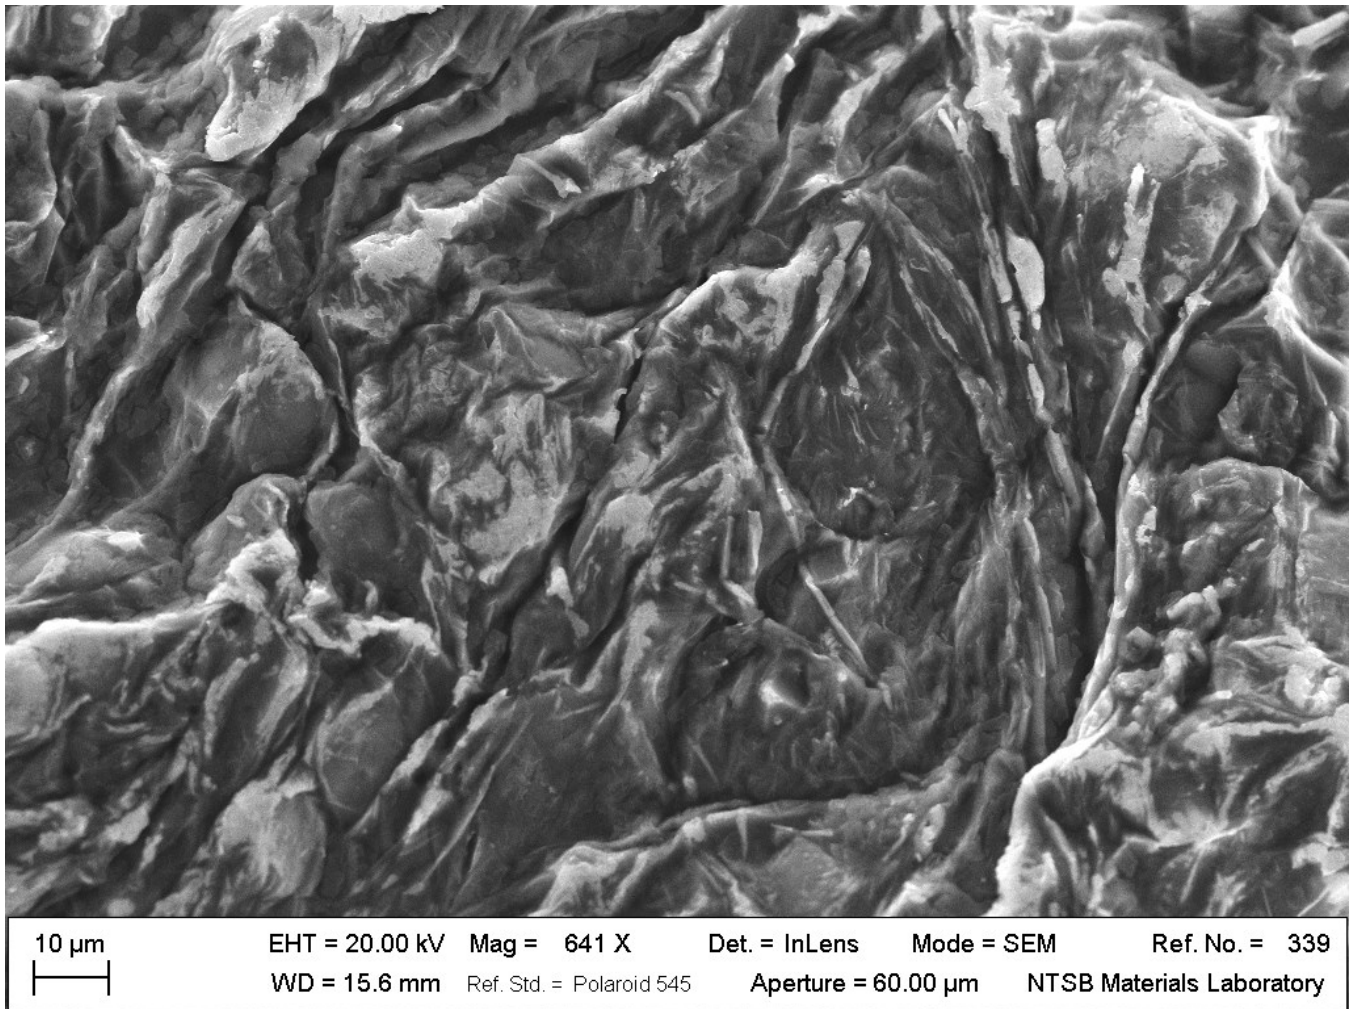
Figure 9 – SE micrograph showing a closer view of the lenticular oxide on the radial fracture surface near the initiation site.

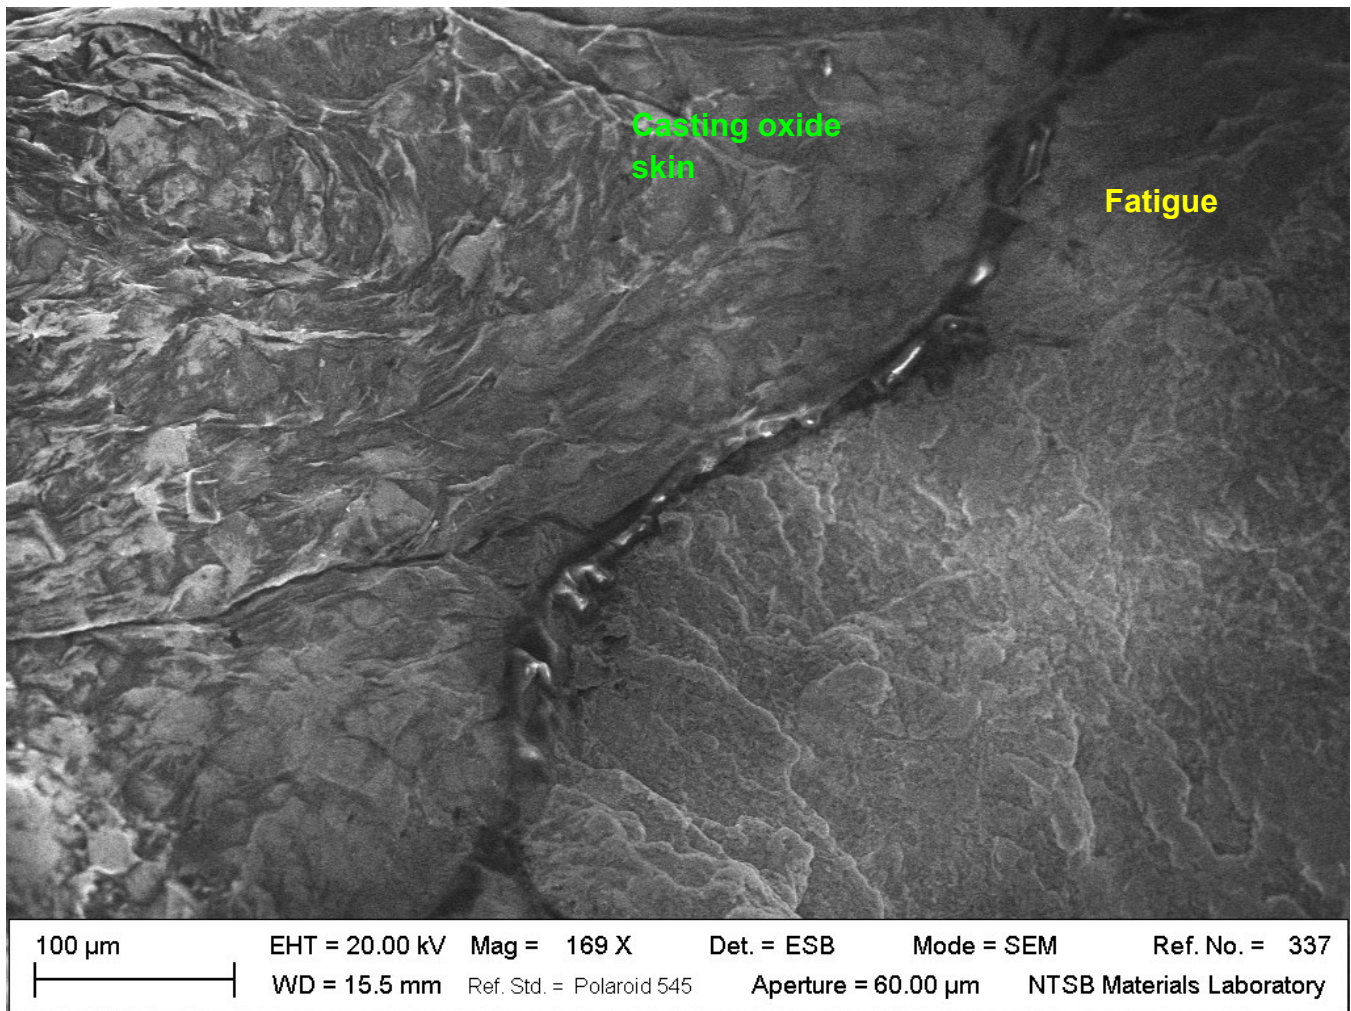
Figure 10 – Backscattered electron (BE) micrograph showing the contamination layer between the oxide skin and the fatigue region on the radial fracture surface.

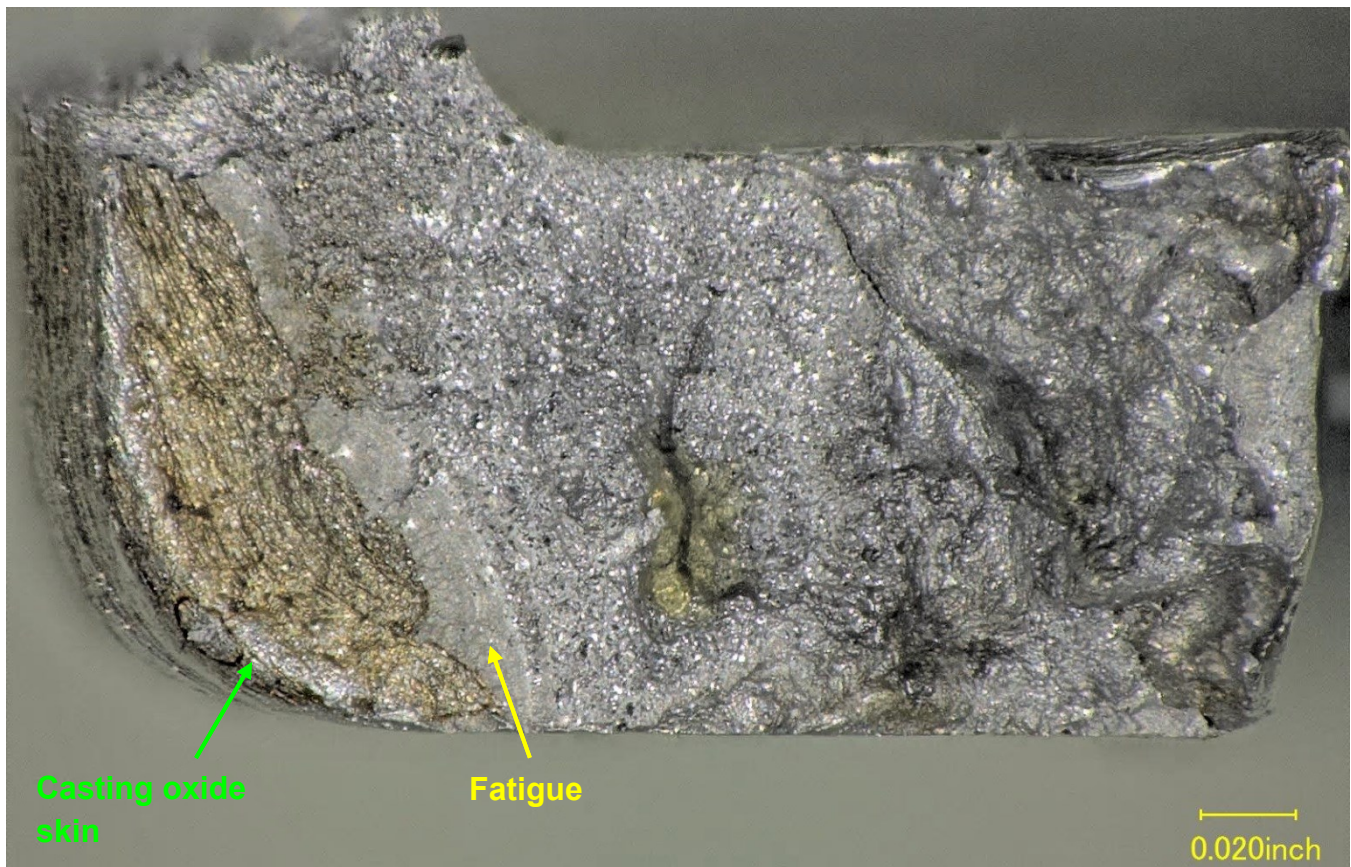
The other radial fracture surface is pictured in Figure 11. Similar to Figure 4, this fracture surface exhibited a casting oxide region, with small adjacent fatigue thumbnail cracks. The features in these fatigue cracks were consistent with having propagated from the oxide “skin.”

Figure 11 – Closer view of the second radial fracture surface, showing the oxide skin layer and a small fatigue region interior to the casting defect.

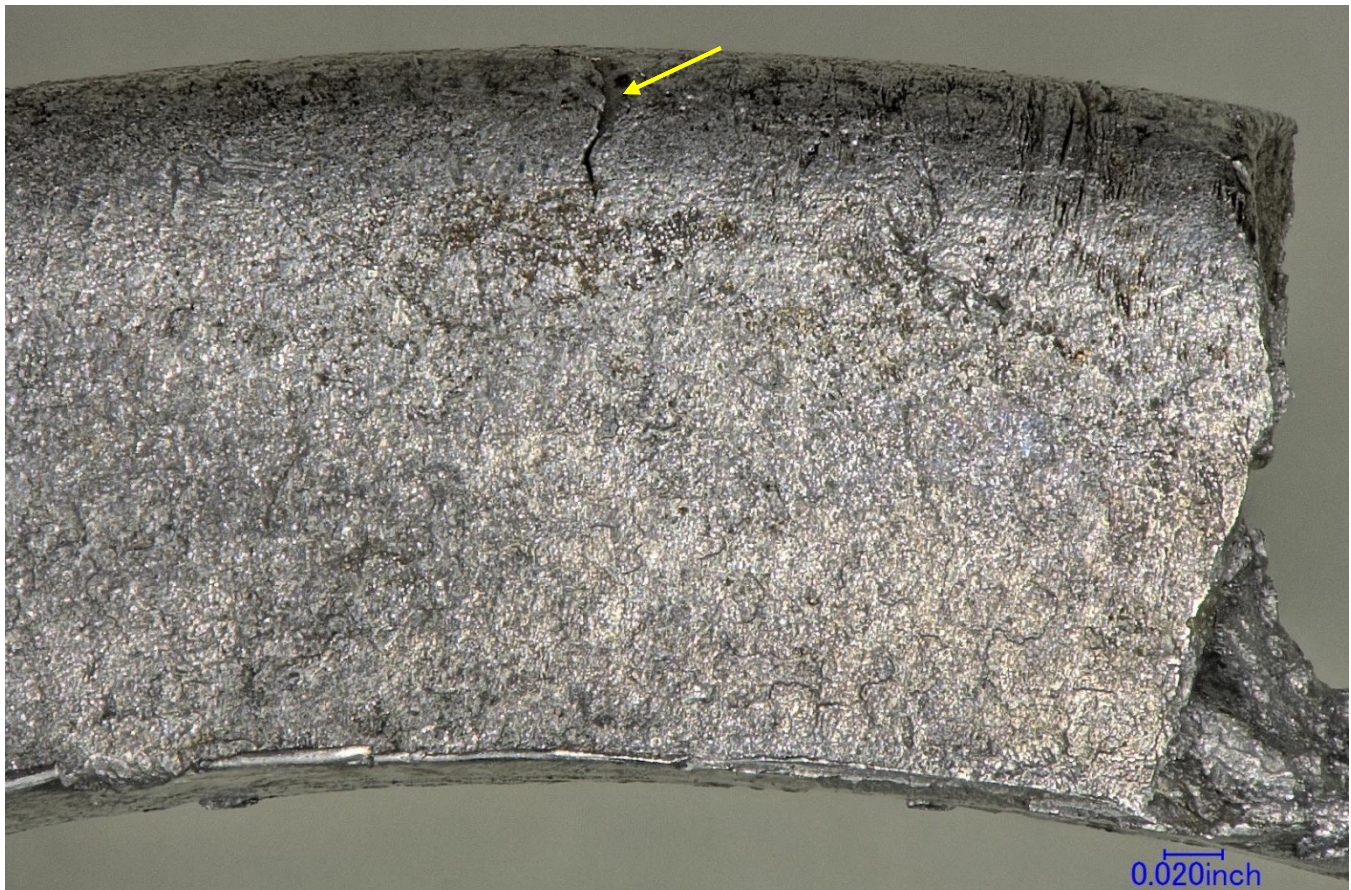
As shown in Figure 12, a crack was found adjacent to the second radial fracture surface. This crack was oriented parallel to the second radial fracture surface, having propagated in the same direction as the fracture surface fatigue cracks. The crack was intentionally backcut and overstressed (laboratory opened) to reveal the crack faces. Figure 13 shows one of the opened crack faces. Similar to Figure 12, the crack exhibited features consistent with a lenticular casting oxide and a thin fatigue region, which had propagated inward.

Figure 12 – A second crack (arrow) on the flange fragment near the radial fracture surface on the right (shown in Figure 11).

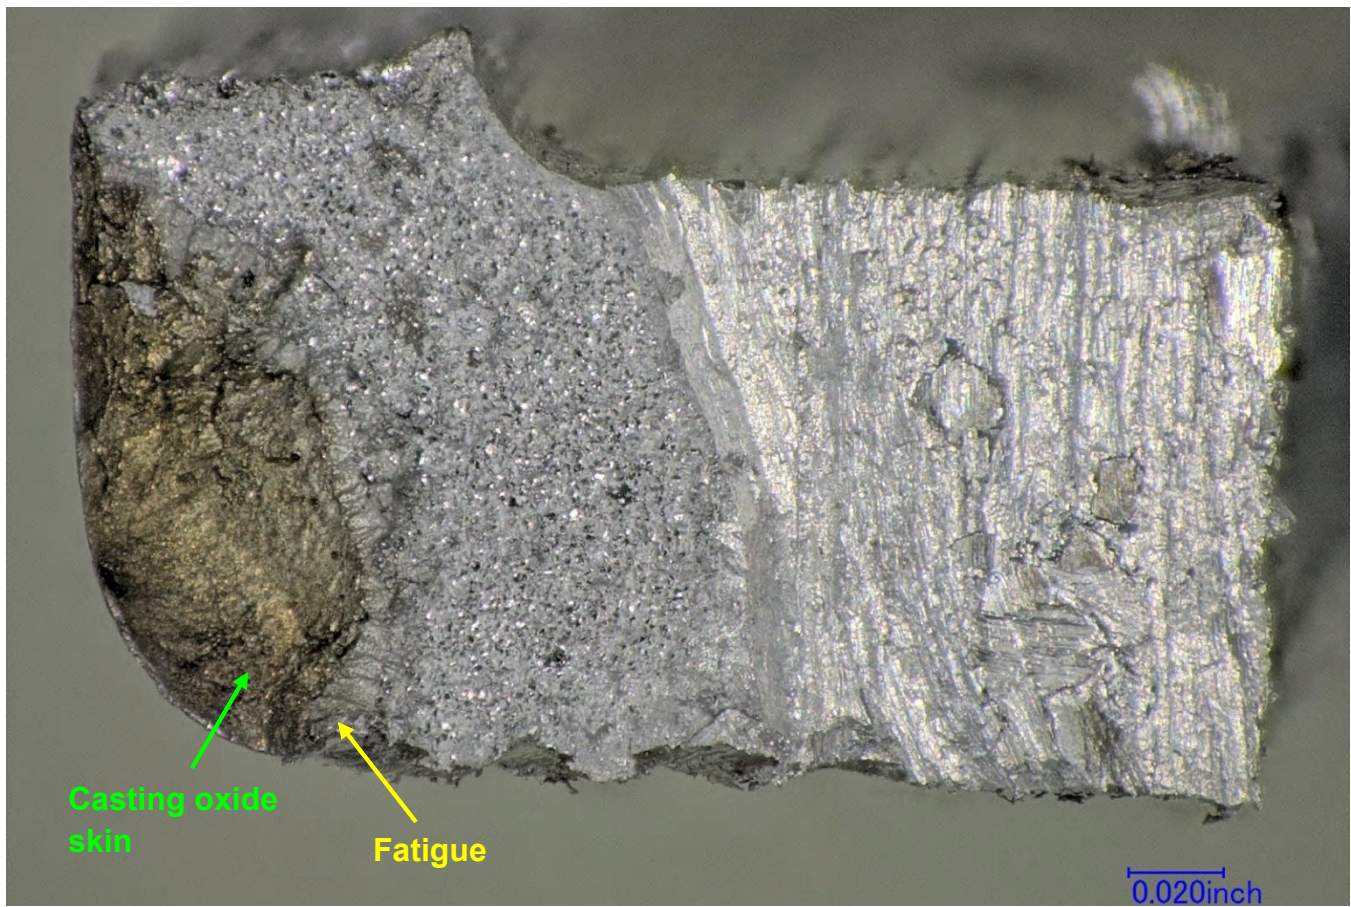
Figure 13 – The radial crack, shown in Figure 12, after laboratory opening, revealing a casting oxide fold and small fatigue region.
