# Continental Motors

## ENGINE EXAMINATION REPORT

| ENGINE MODEL | TSIO-520-P |
| FILE NUMBER | 15-415 |

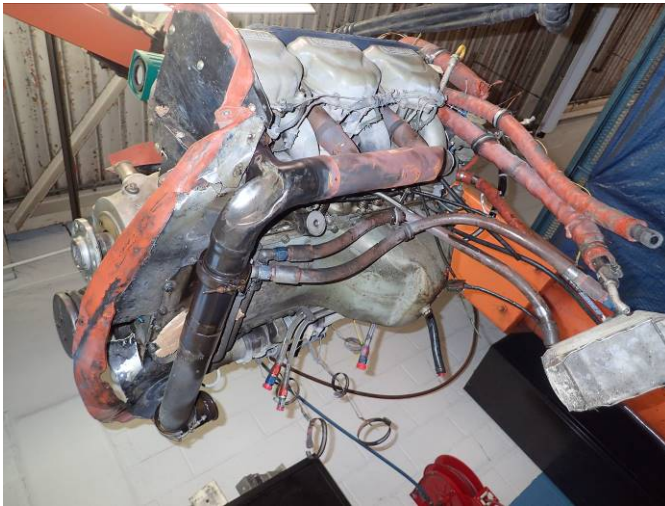
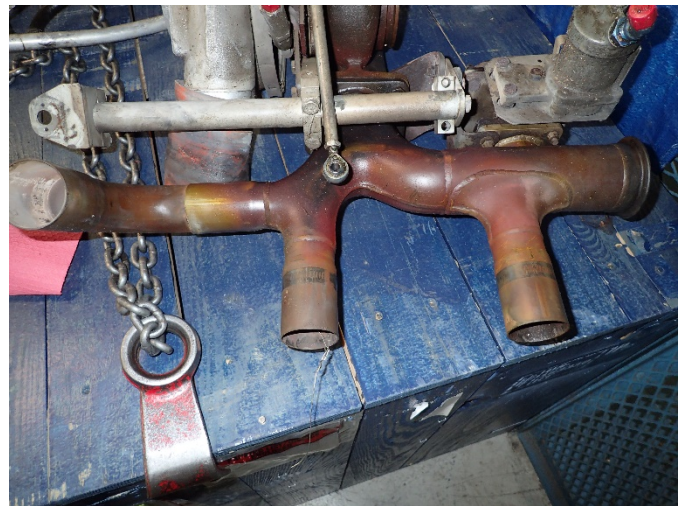
#### EXHAUST SYSTEM

Condition: The exhaust system displayed impact damage signatures and normal operating signatures. There were no anomalies noted with the exhaust system.

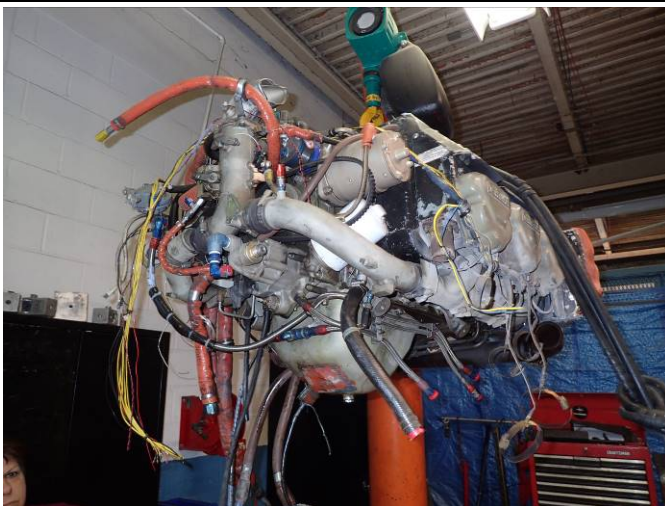
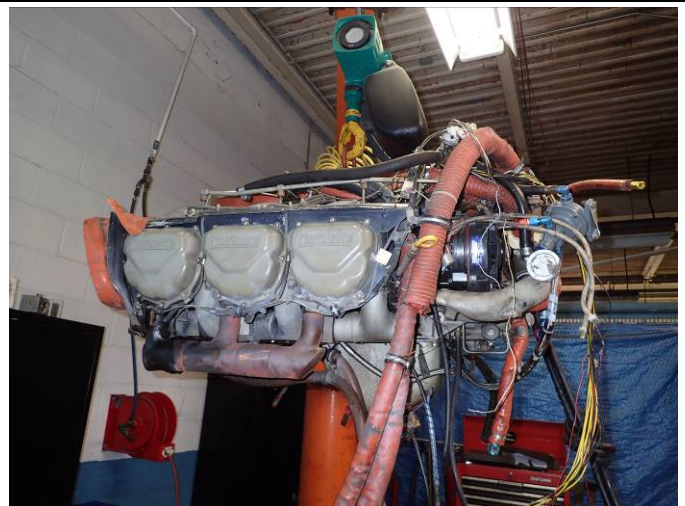
#### INDUCTION SYSTEM

Condition: The induction system displayed impact damage signatures and normal operating signatures. There were no signatures of induction leaks noted.

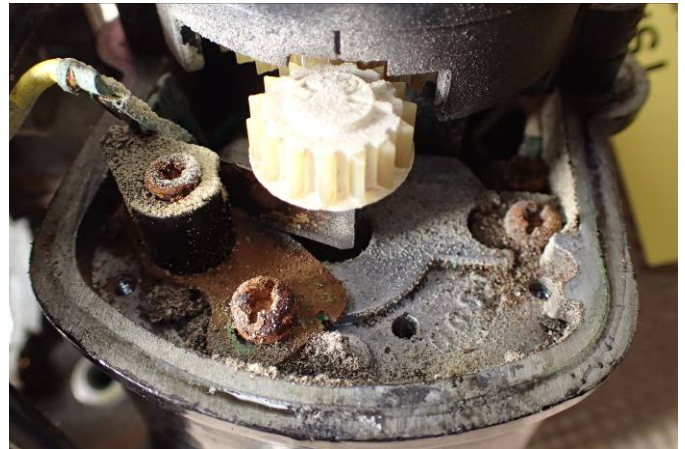
### LEFT MAGNETO

**Condition:** The magneto remained attached to its installation point and was undamaged. The magneto was removed from the engine and installed on a magneto test bench. It was noted that the magneto was not capable of producing a spark on any of the posts. The magneto was disassembled and it was noted that the internal components displayed a significant amount of corrosion. The magneto was further inspected and it was found that the magneto pressurization vent was completely blocked.

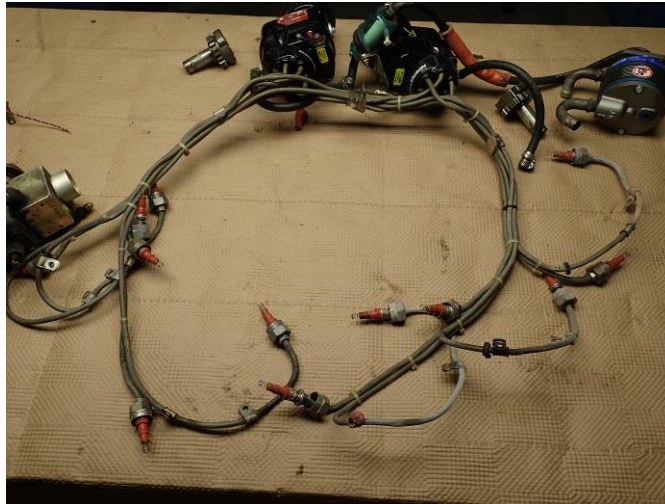
## IGNITION HARNESS

**Condition:** The ignition harness remained attached to the magnetos and to each of the spark plugs. The bottom odd cylinder ignition leads displayed a white discoloration. The remaining ignition leads displayed normal operating signatures.

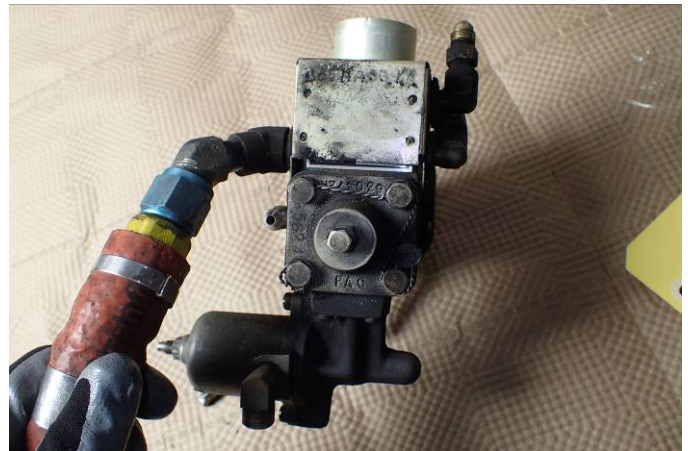
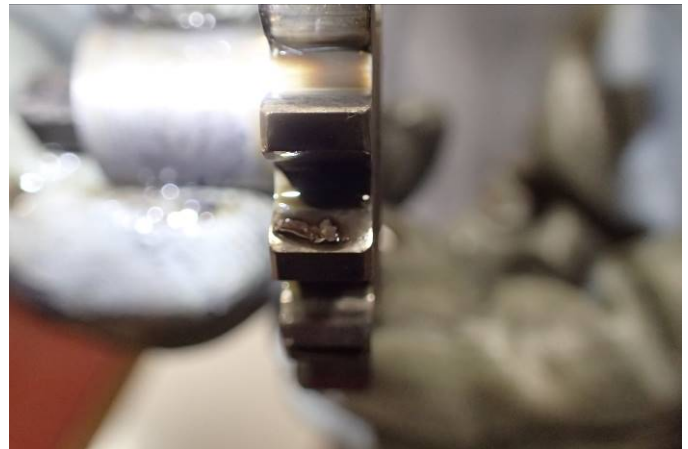
#### FUEL PUMP

Condition: The fuel pump remained attached to its installation point and was undamaged. The fuel pump was removed and it was noted that the fuel pump drive coupling remained intact; it was also noted there several flakes of metal were found between several of the fuel pump drive gear teeth. The fuel pump drive shaft was capable of rotation and there were no anomalies noted with the fuel pump.

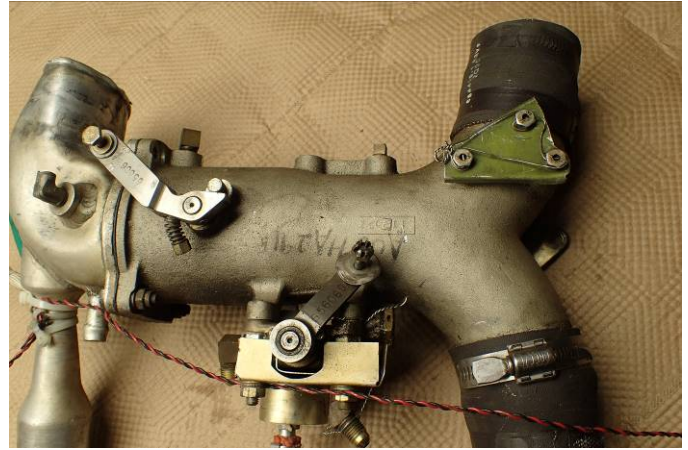
## THROTTLE BODY METERING UNIT

**Condition:** The throttle and fuel metering unit displayed some impact damage signatures. The throttle and mixture arms were capable of normal movement. There were no anomalies noted with the throttle and fuel metering assembly.

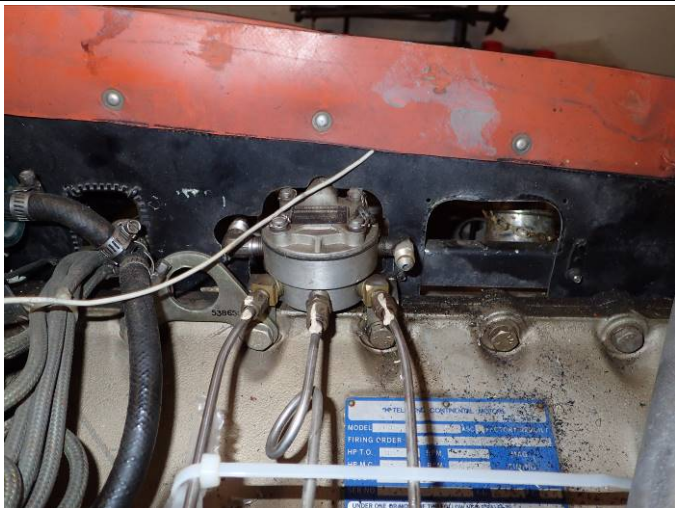
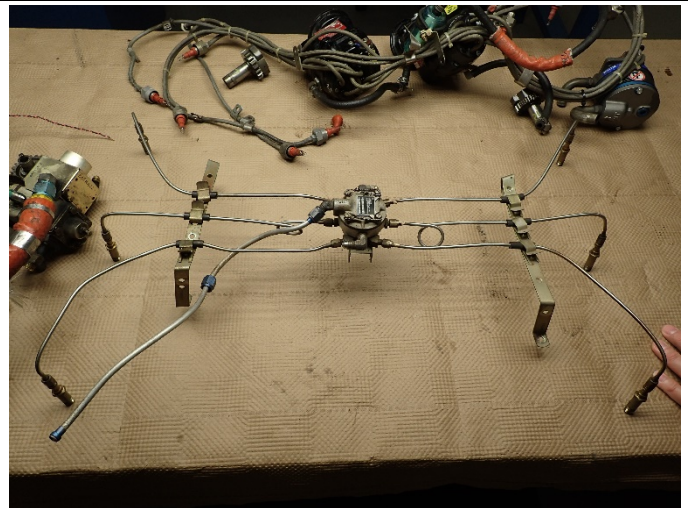
## FUEL MANIFOLD VALVE

**Condition:** The fuel manifold valve remained attached to its installation point and was undamaged. There were no signs of fuel leaks or any other anomalies noted with the manifold valve.

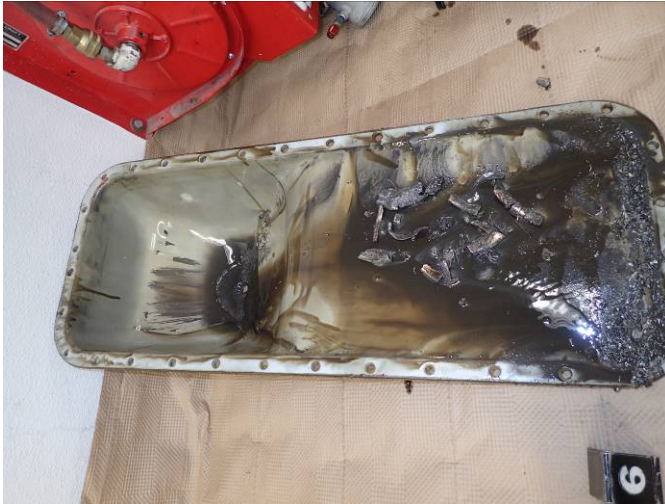
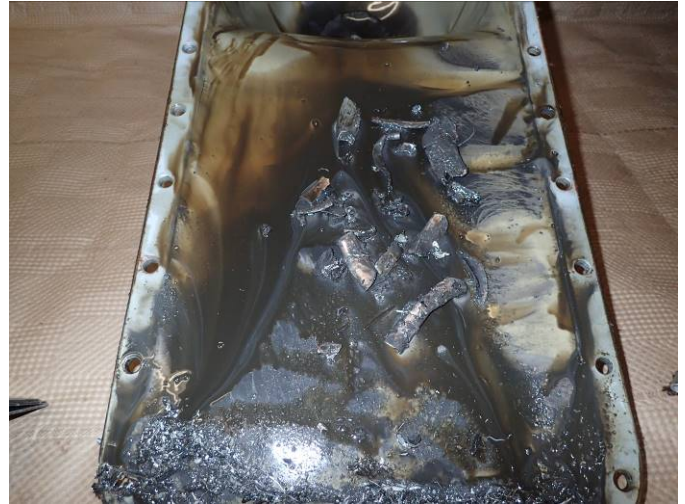
#### OIL SUMP

Condition: The oil sump remained intact and displayed impact damage signatures. The oil sump was removed and it was noted that there were several pieces of material consistent with bearing and piston material found in the oil sump.

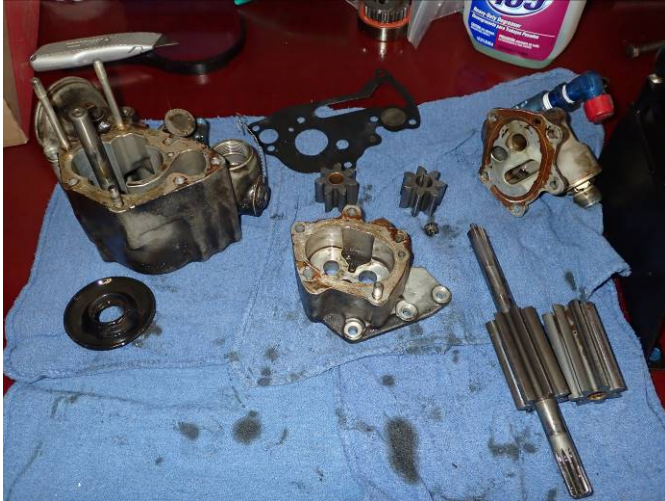
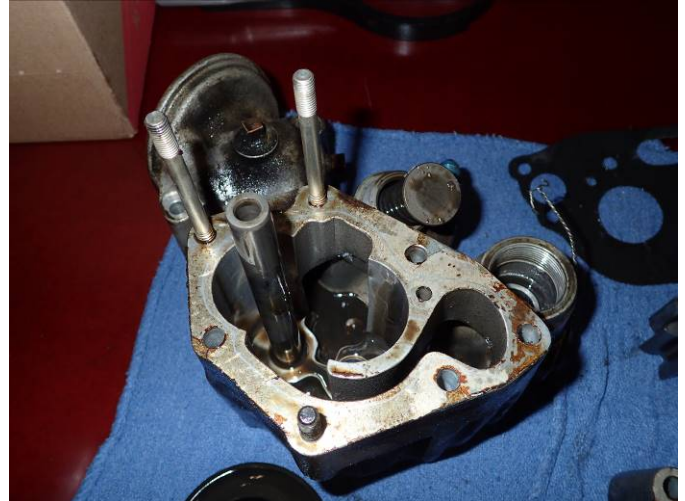
### OIL PUMP

Condition: The oil pump remained intact and undamaged. The oil pump and the scavenge pump were disassembled and the internal components were visually inspected. The oil pump housing displayed scoring consistent with hard particle passage. The oil pump and scavenge pump gears displayed normal operating and lubrication signatures. The oil pressure relief valve had several flakes of metal on the surface.

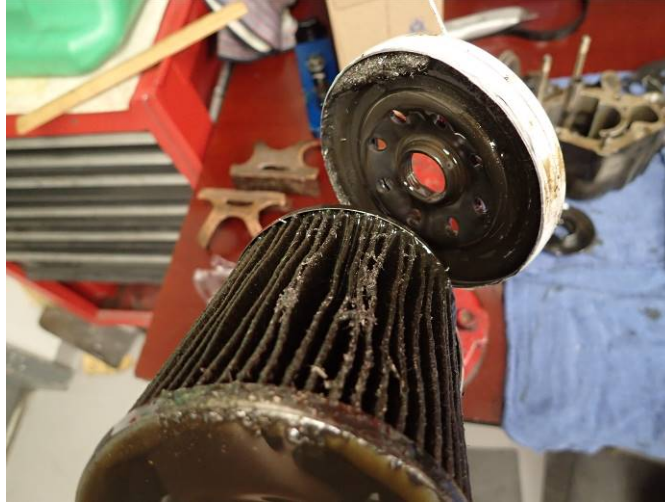
The oil filter remained attached to the oil filter adapter and remained intact. The oil filter housing was cut open and the filter pleats were inspected. The filter plates contained a significant amount of metallic particles within the pleats.

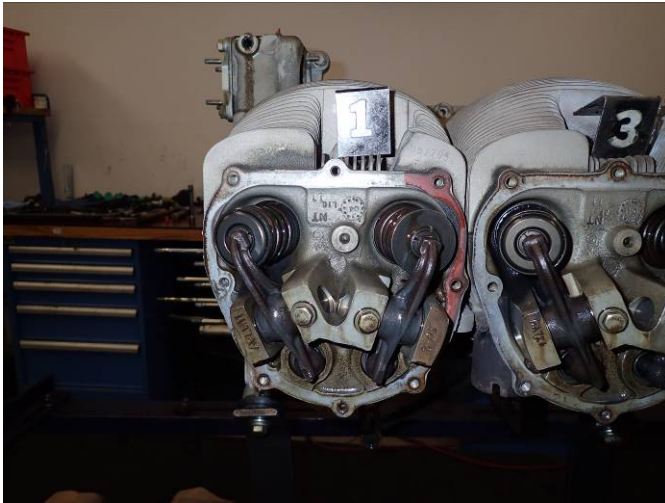
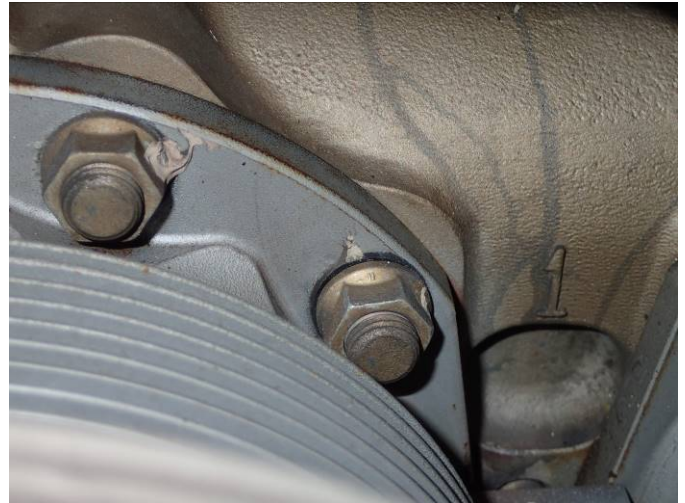
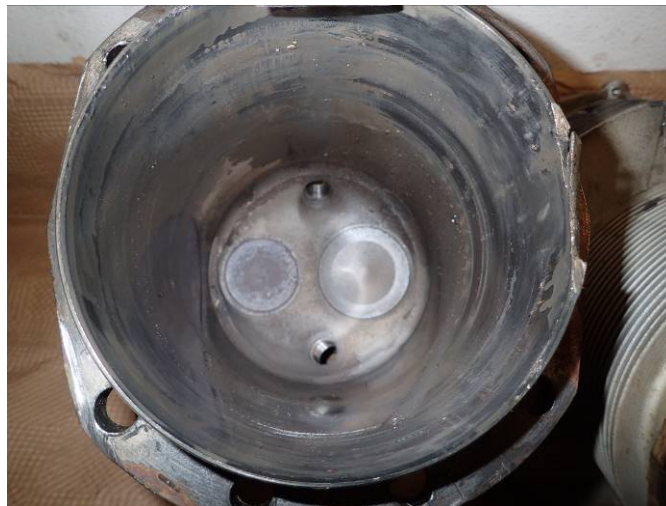
Condition: The cylinder remained attached to its cylinder bay and there was no external damage. One of the top cylinder hold down nuts was noted to be loose and was capable of being moved by hand. The remaining nuts were noted to have white torque putty. The cylinder was removed and it was noted that the cylinder skirt displayed mechanical damage. The cylinder bore, combustion chamber, and the overhead components (valves, rocker arms, push rods) displayed normal operating and lubrication signatures.

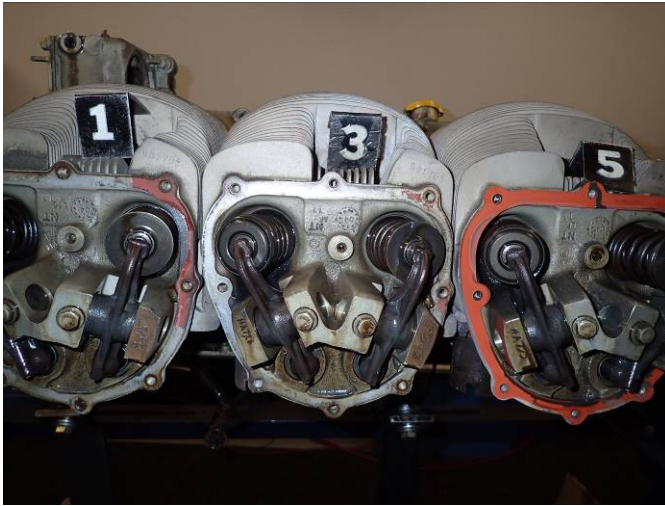
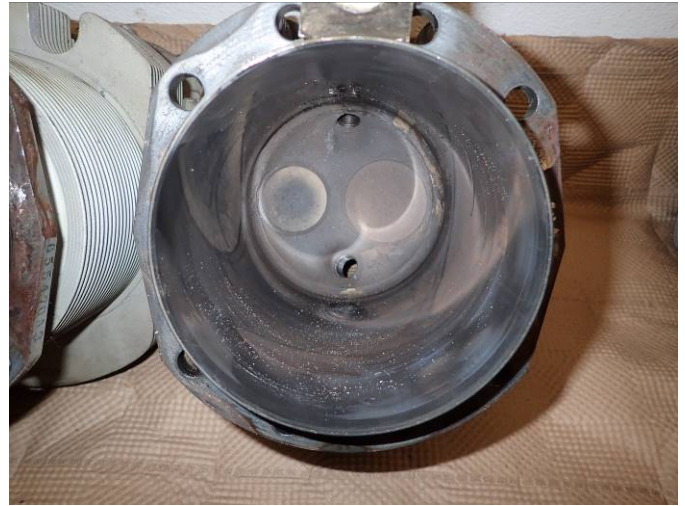
| <b>CYLINDER #3</b> | P/N: 655470A3 | S/N: AC05HA728 | Head Date: 08/17/05 |

| Condition: | The cylinder remained attached to its cylinder bay and was undamaged. It was noted that there was white torque putty on all of the cylinder hold down nuts for the studs and through bolts. The cylinder was removed and it was noted that the cylinder skirt was undamaged. The cylinder bore, combustion chamber, and the overhead components (valves, rocker arms, push rods) displayed normal operating and lubrication signatures. |

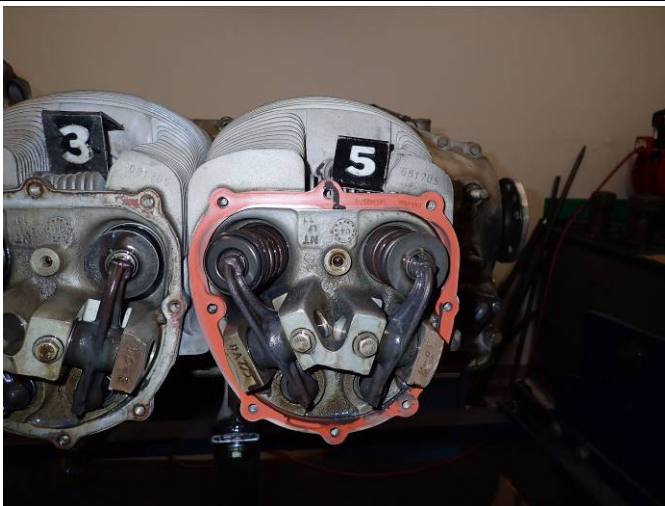
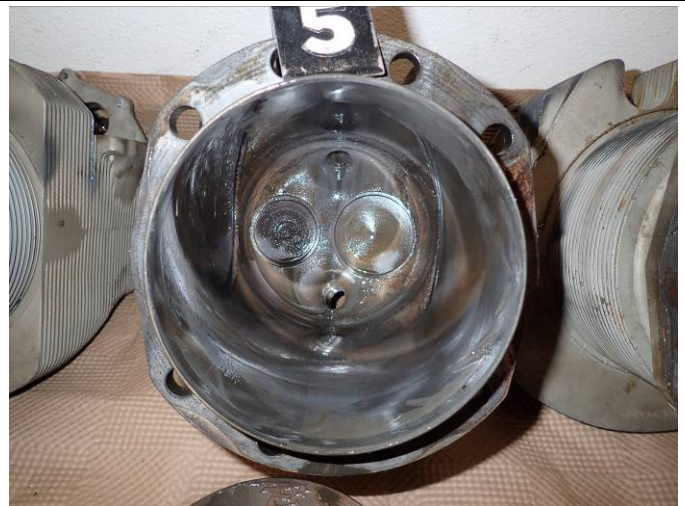
| <b>CYLINDER #5</b> | P/N: 655470A3 | S/N: AC05HA773 | Head Date: 08/17/05 |

| Condition: | The cylinder remained attached to its cylinder bay and was undamaged. It was noted that there was white torque putty on all of the cylinder hold down nuts for the studs and through bolts. The cylinder was removed and it was noted that the cylinder skirt was undamaged. The cylinder bore, combustion chamber, and the overhead components (valves, rocker arms, push rods) displayed normal operating and lubrication signatures. |

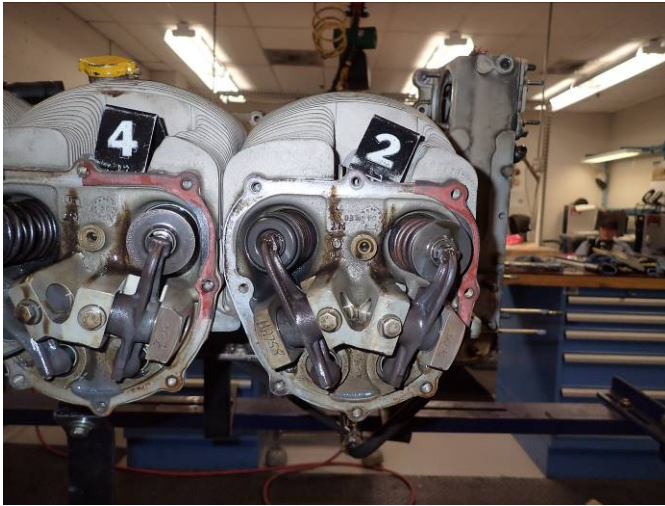
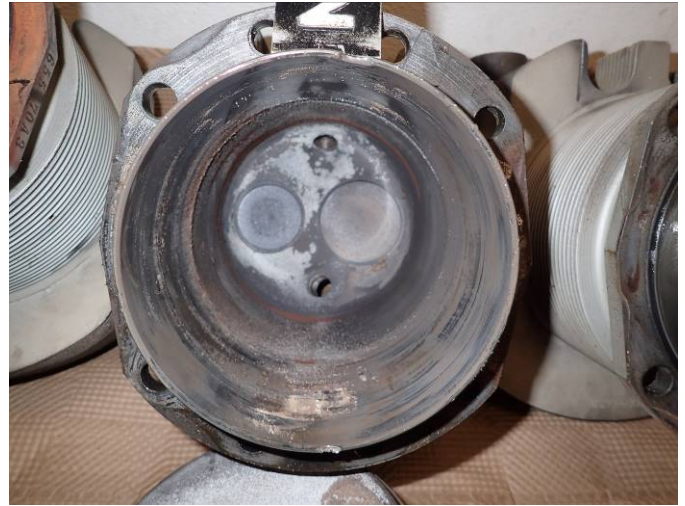
| <b>CYLINDER #2</b> | P/N: 655470A3 | S/N: AC05HA758 | Head Date: 08/17/05 |

**Condition:** The cylinder remained attached to its cylinder bay and there was no external damage noted. It was noted that there was white torque putty on all of the cylinder hold down nuts for the studs and through bolts. The cylinder was removed and it was noted that the cylinder skirt displayed mechanical damage. The cylinder bore, combustion chamber, and the overhead components (valves, rocker arms, push rods) displayed normal operating and lubrication signatures.

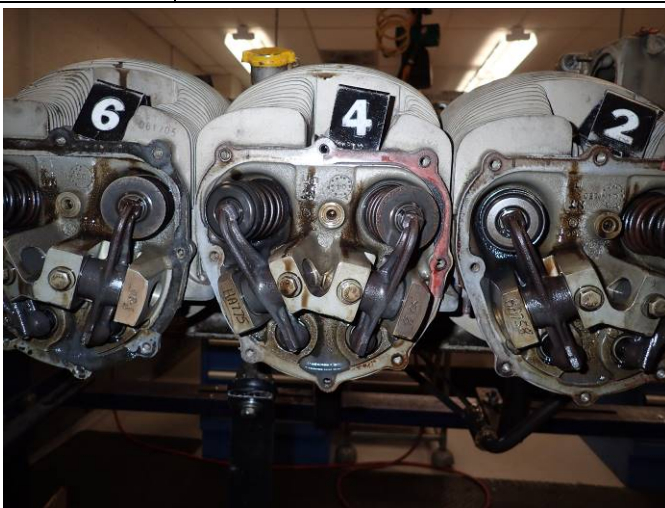
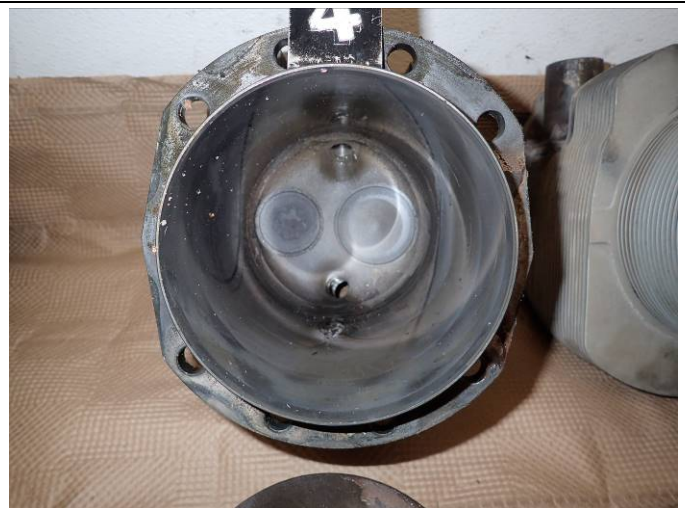
| <b>CYLINDER #4</b> | P/N: 655470A3 | S/N: AC05HA775 | Head Date: 8-05 |

**Condition:** The cylinder remained attached to its cylinder bay and was undamaged. It was noted that there was white torque putty on all of the cylinder hold down nuts for the studs and through bolts. The cylinder was removed and it was noted that the cylinder skirt was undamaged. The cylinder bore, combustion chamber, and the overhead components (valves, rocker arms, push rods) displayed normal operating and lubrication signatures.

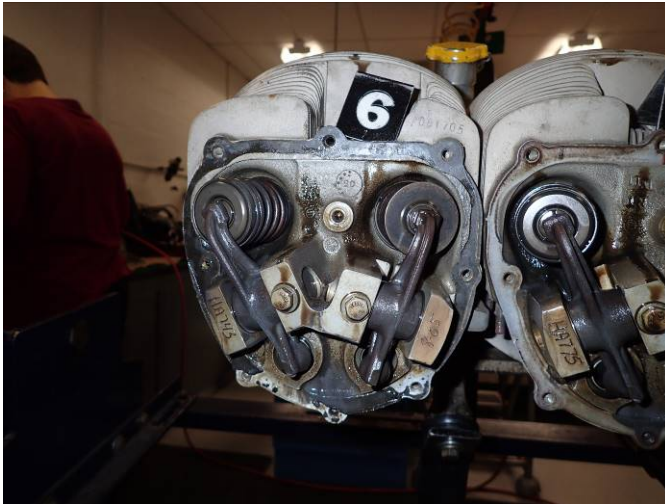
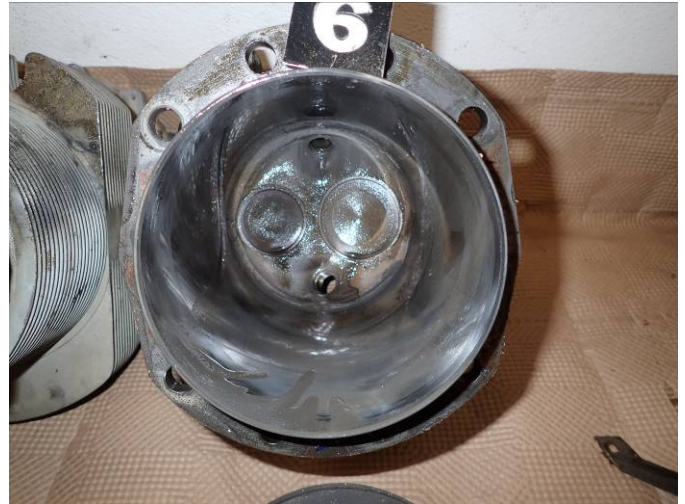
The cylinder remained attached to its cylinder bay and was undamaged. It was noted that there was white torque putty on all of the cylinder hold down nuts for the studs and through bolts. The cylinder was removed and it was noted that the cylinder skirt was undamaged. The cylinder bore, combustion chamber, and the overhead components (valves, rocker arms, push rods) displayed normal operating and lubrication signatures.

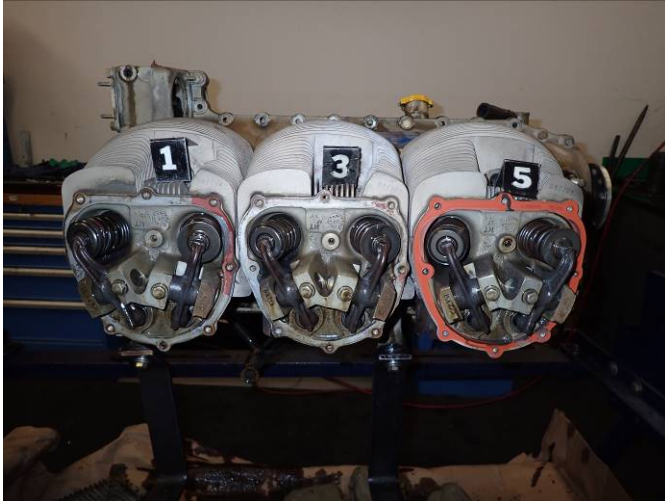
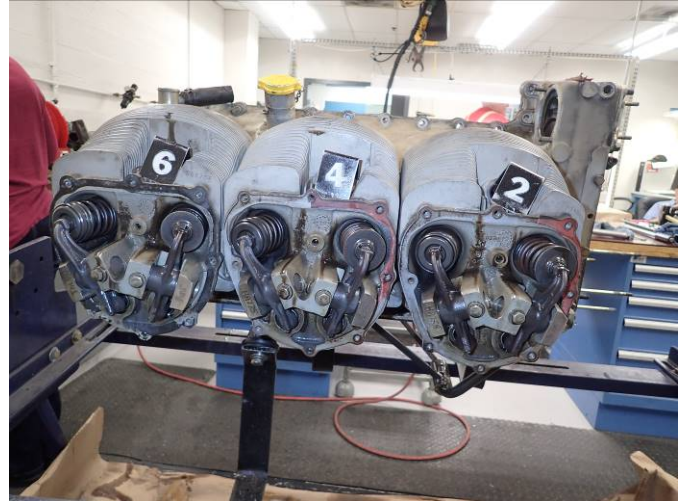
### ROCKER ARMS AND SHAFTS

Condition: All of the rocker arms displayed normal operating and lubrication signatures. There were no anomalies noted with any of the rocker arms.

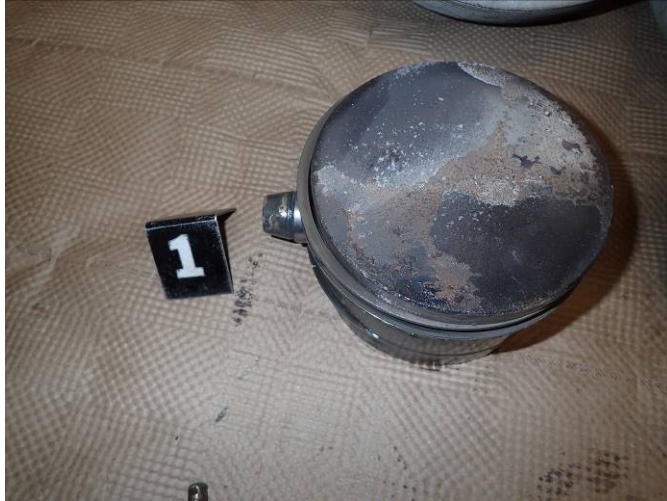
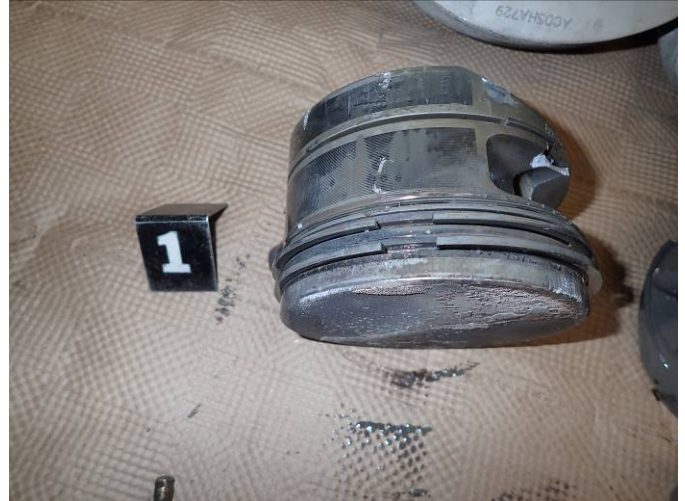
The piston remained attached to its connecting rod and displayed mechanical damage to the piston skirt. The piston face displayed normal combustion signatures. The rear piston ring was broken; the forward 3 piston rings were intact, and free to move in their grooves. There were no anomalies noted with the piston.

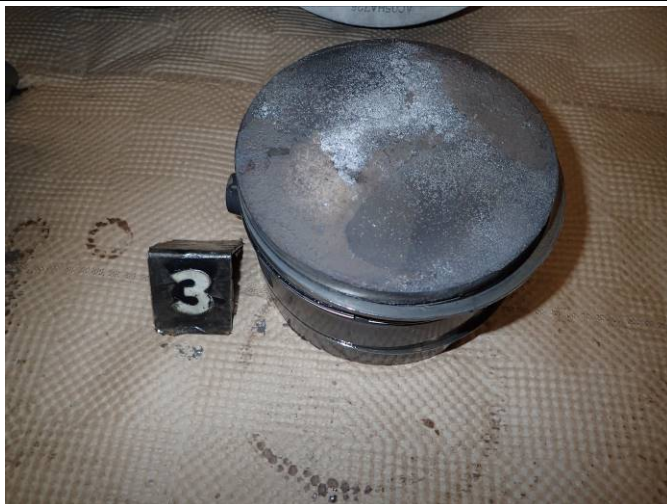
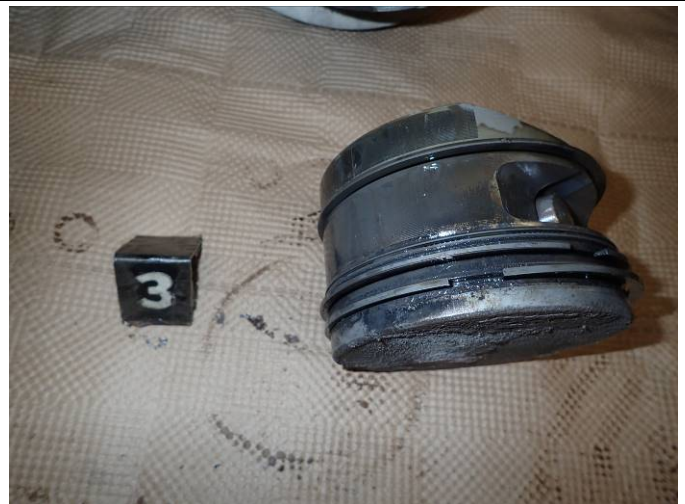
## #3 PISTON, RINGS AND PIN

The piston remained attached to its connecting rod and was undamaged. The piston face displayed normal combustion signatures. The pistons rings remained intact and were capable of normal movement in their grooves. There were no anomalies noted with the piston.

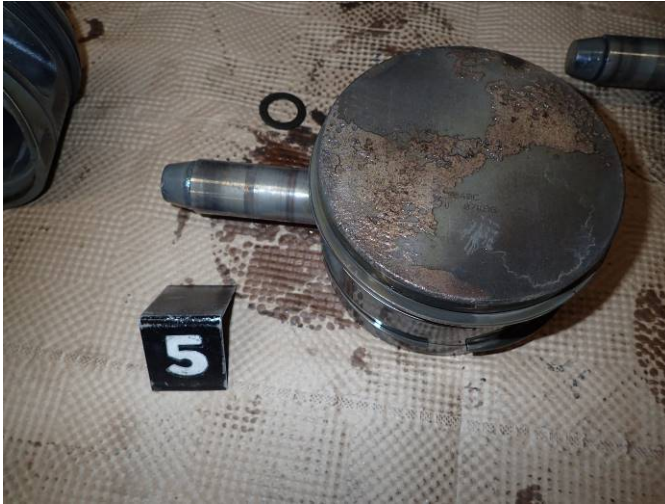
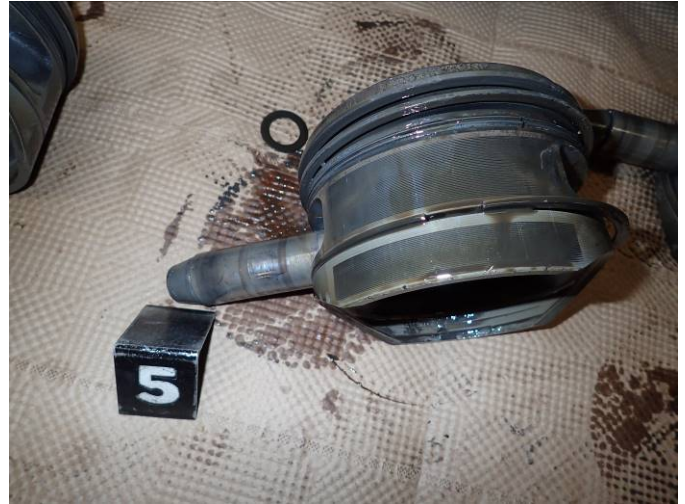
The piston remained attached to its connecting rod and was undamaged. The piston face displayed normal combustion signatures. The pistons rings remained intact and were capable of normal movement in their grooves. There were no anomalies noted with the piston.

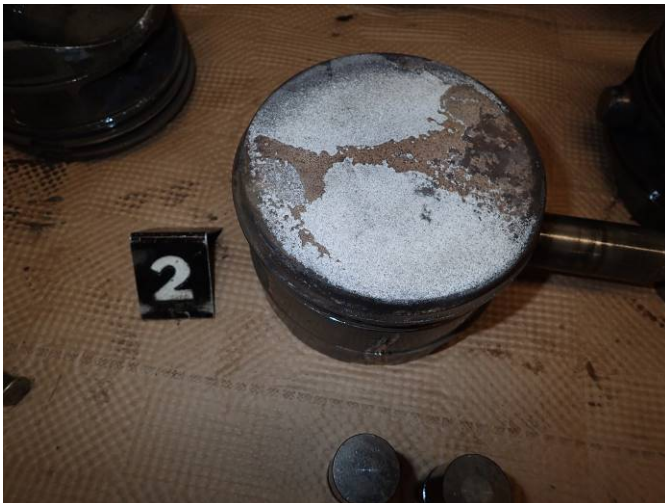
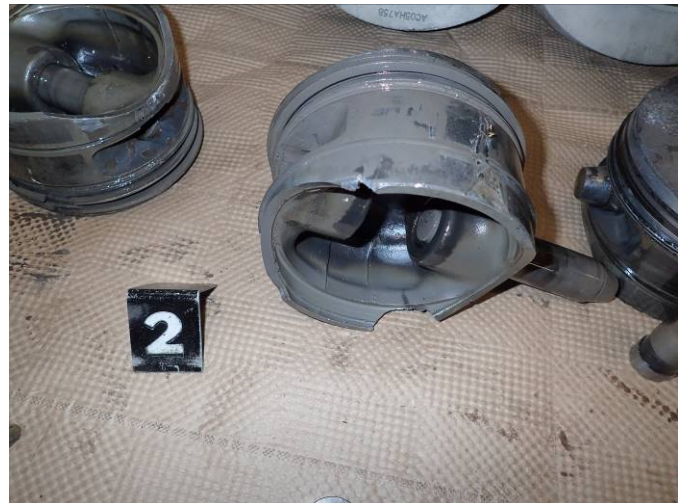
### #2 PISTON, RINGS AND PIN

The piston remained attached to its connecting rod and displayed mechanical damage to the piston skirt. The piston face displayed normal combustion signatures and some corrosion. The rear piston ring displayed mechanical damage and remained within its groove; the forward 3 piston rings were intact, and free to move in their grooves. There were no anomalies noted with the piston.

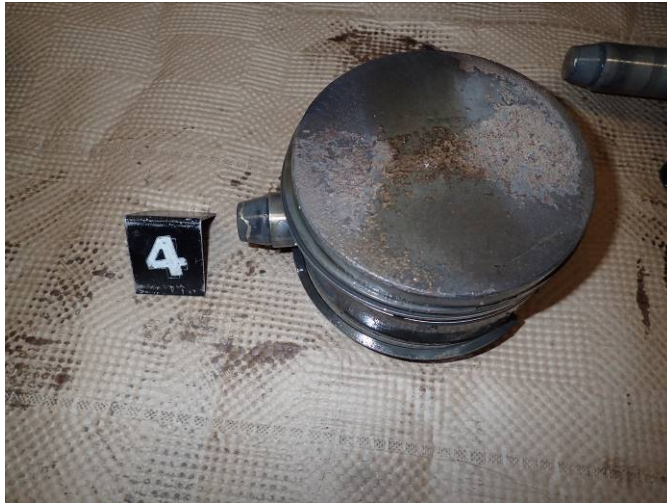
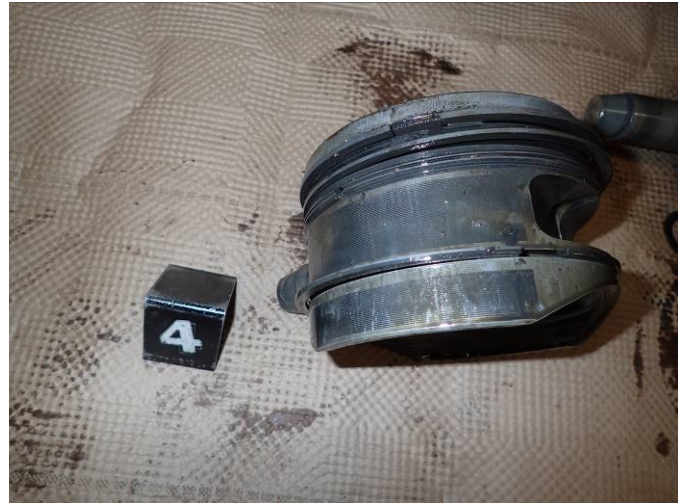
Condition: The piston remained attached to its connecting rod and was undamaged. The piston face displayed normal combustion signatures. The pistons rings remained intact and were capable of normal movement in their grooves. There were no anomalies noted with the piston.

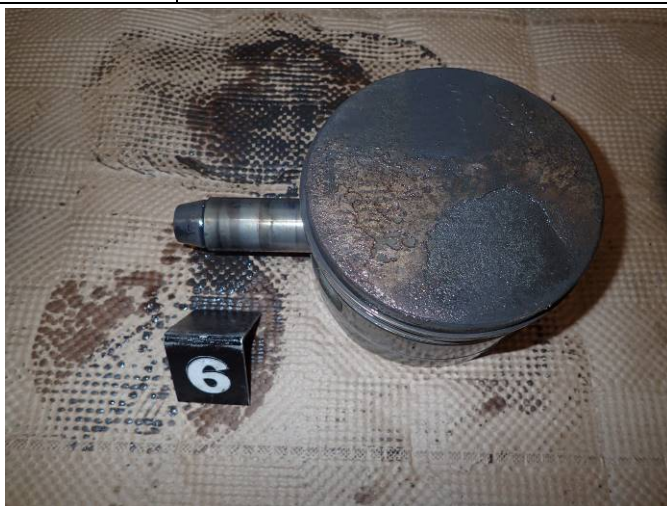
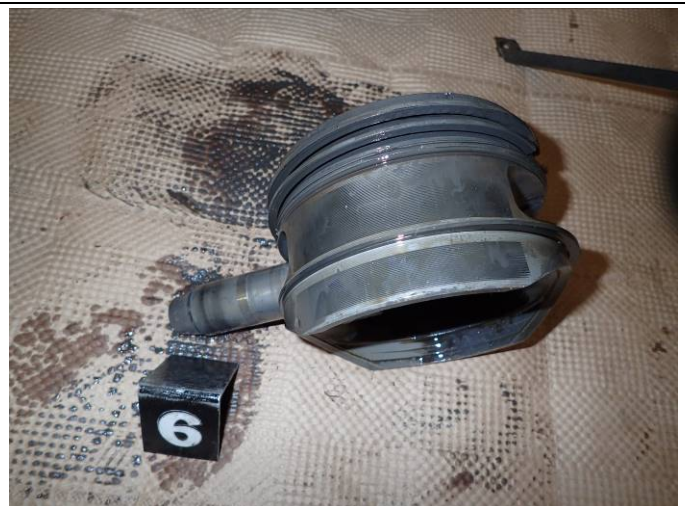
### #6 PISTON, RINGS AND PIN

Condition: The piston remained attached to its connecting rod and was undamaged. The piston face displayed normal combustion signatures. The pistons rings remained intact and were capable of normal movement in their grooves. There were no anomalies noted with the piston.

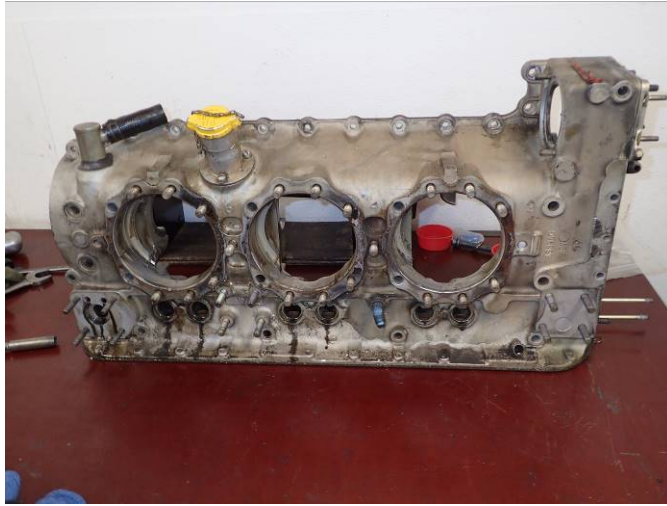
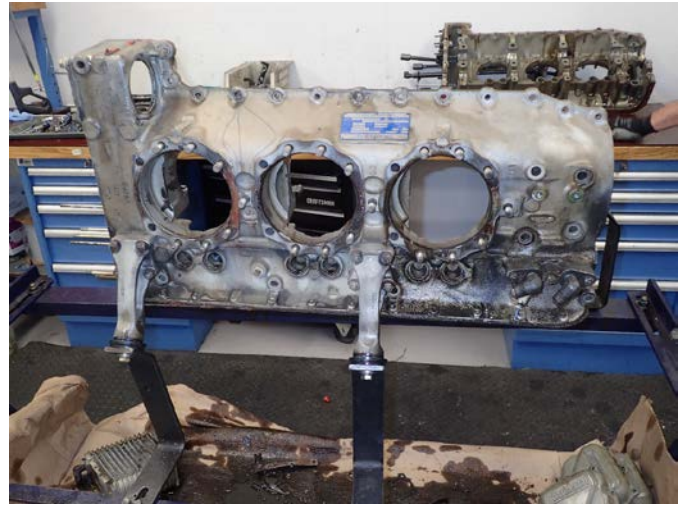
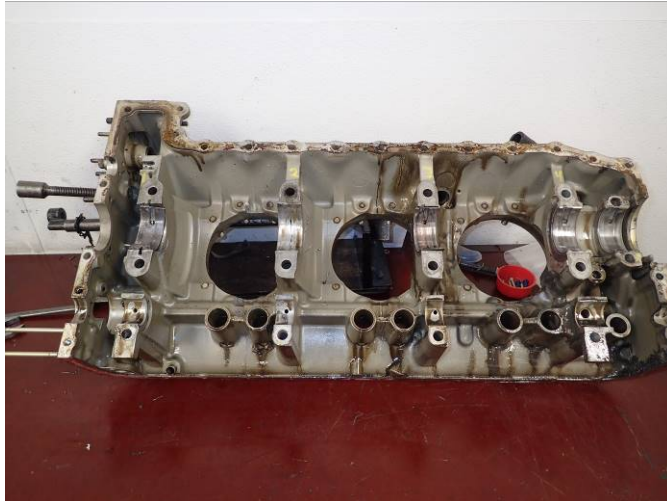
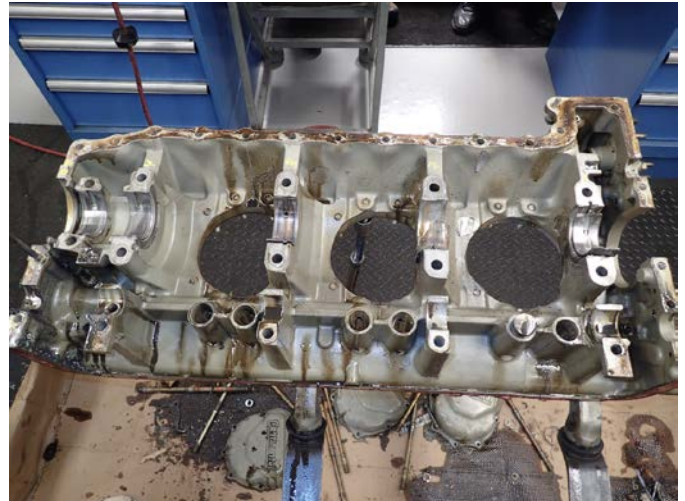
| CRANKCASE | Casting Number: | 1-3-5: 653961 | 2-4-6: 653960 | S/N: E209903R |
|---|---|---|---|---|
| Condition: | The external portion of the crankcase displayed damage in the area near one of the rear backbone bolts; the damage consisted of a crack and a small portion of the crankcase was pushed outward. The crankcase halves were split from one another and the internal portion of the crankcase was inspected. It was noted that there was mechanical damage to the #1 and the #2 cylinder bays. The #2 main bearing support displayed damage consistent with a bearing shift and a spun bearing. The #1 bearing support displayed minor bearing movement signatures. The #1 and the #2 main bearing supports displayed fretting near the through bolt holes. | | | |

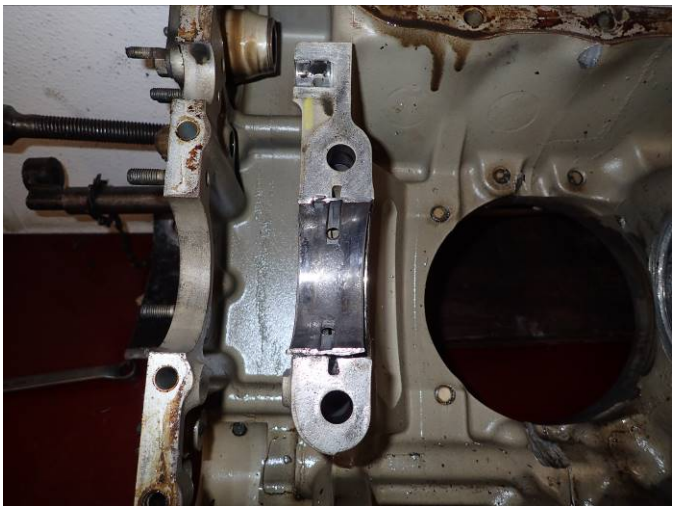
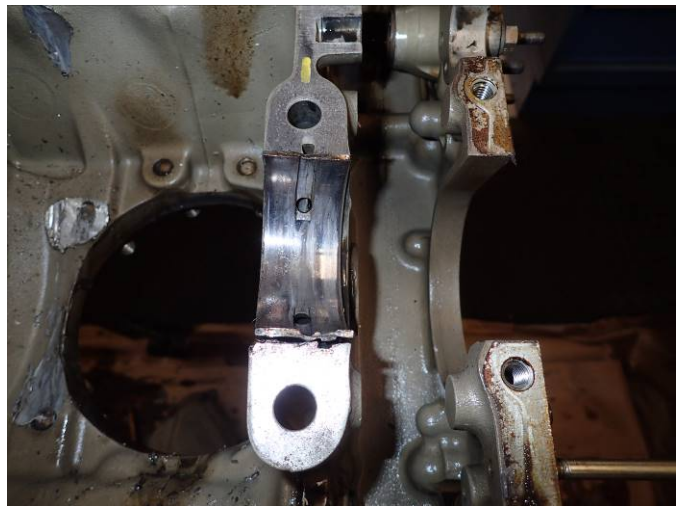
Condition: The bearings displayed normal lubrication signatures. The bearings displayed deformity consistent with minor bearing movement. It was noted that there was fretting on the bearing supports near the through bolt holes.

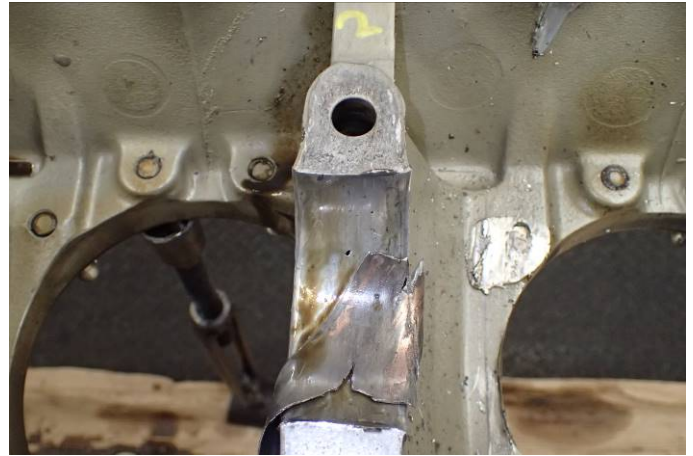
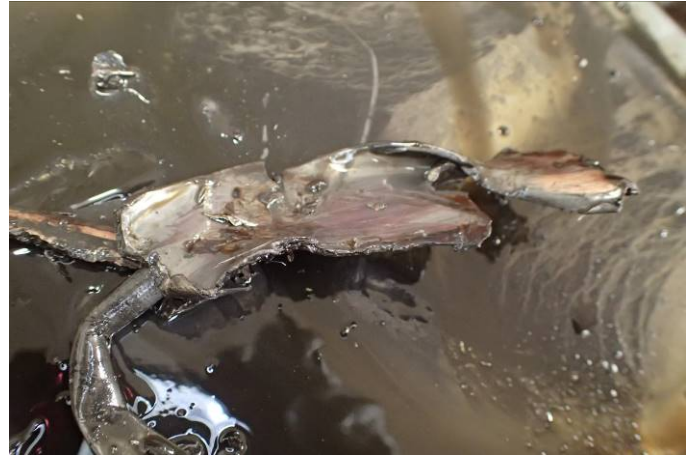
The bearings displayed damage consistent with a bearing movement event. Several portions of the bearing were located in the oil sump. One portion of the right side bearing remained within the bearing saddle; the bearing had extruded out of the bearing support.

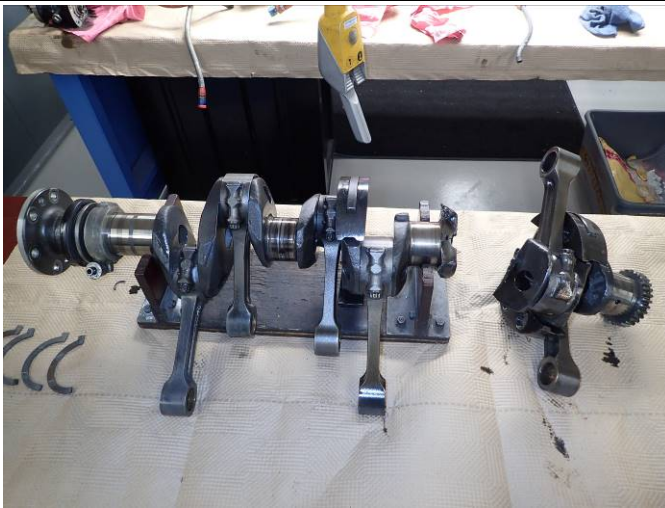
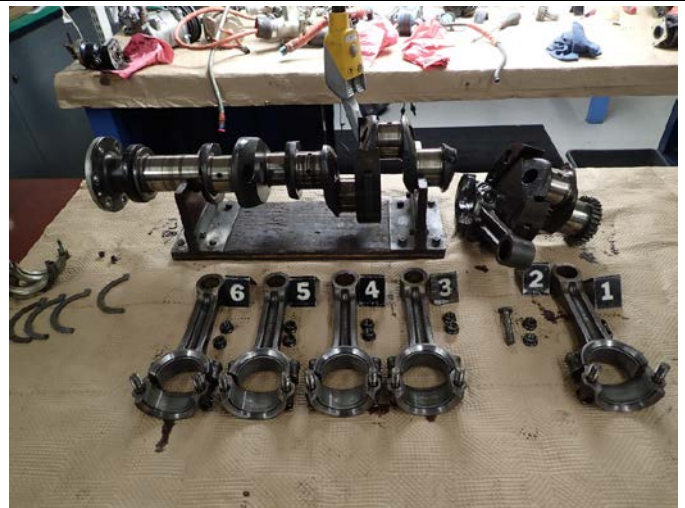
**Condition:** The crankshaft was fractured into two pieces; the fracture was located at the crankshaft cheek between the #2 main bearing journal and the #2 connecting rod journal. The #3 main journal displayed heat discoloration consistent with heat and scratches consistent with hard particle passage. The remaining main journals displayed normal operating and lubrication signatures. The #2 connecting rod journal was unable to be observed due to the #2 connecting rod being impinged in place on the journal. The connecting rod journals capable of inspection displayed normal operating and lubrication signatures.

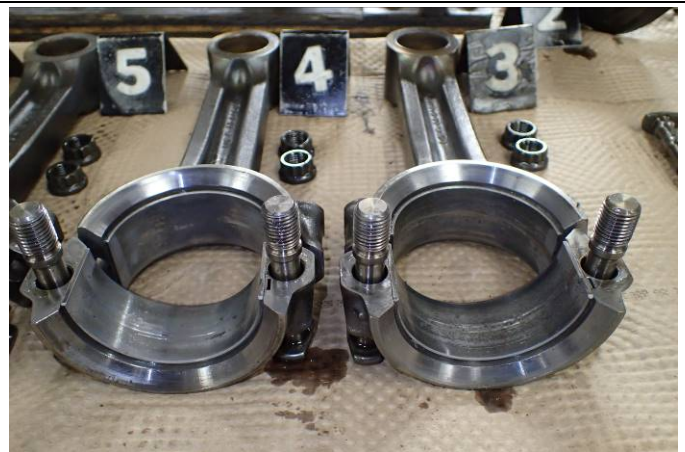
Condition: The connecting rod bearing displayed the incipient signs of lubrication distress. It was noted that the #3 connecting rod journal and bearing receive oil from the #2 main bearing journal.

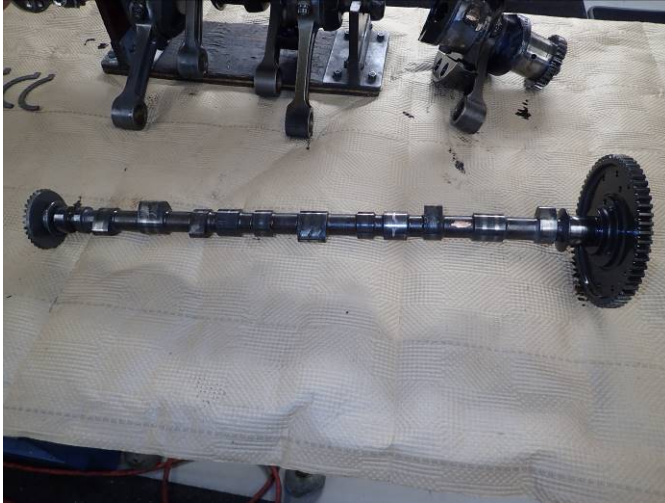
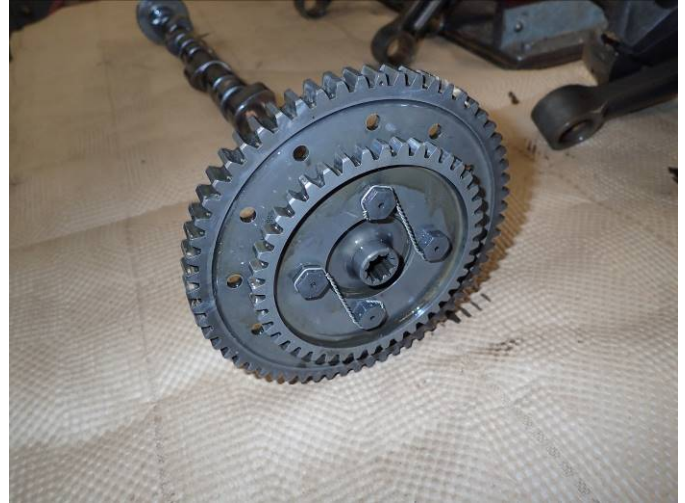
| CAMSHAFT | P/N: 655384 | S/N: Z05HA109 |
|---|---|---|
| Condition: | The camshaft was intact and displayed mechanical damage towards the rear of the camshaft. The camshaft gear remained intact and was secured. The camshaft lobes displayed normal operating signatures. | |

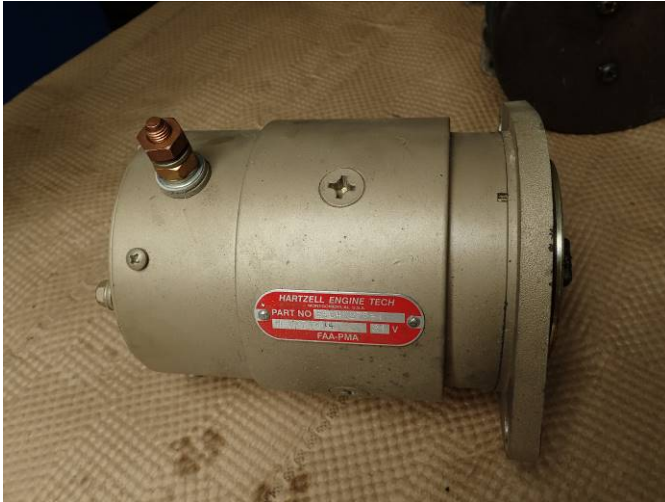
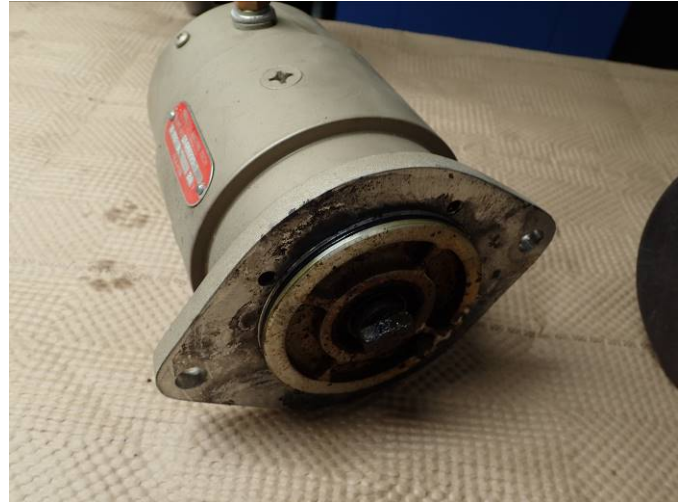
The starter remained attached to the starter adapter and was undamaged. There were no anomalies noted with the starter.
