# Continental Motors

## ENGINE EXAMINATION REPORT

| ENGINE MODEL | TSIO-520-P |
| FILE NUMBER | 15-415 |

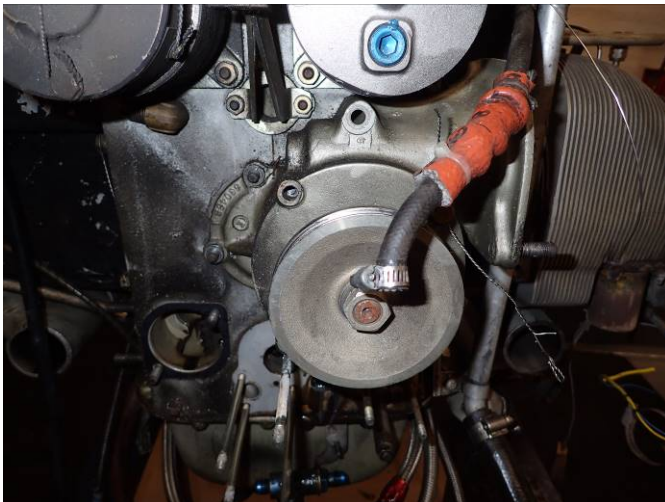
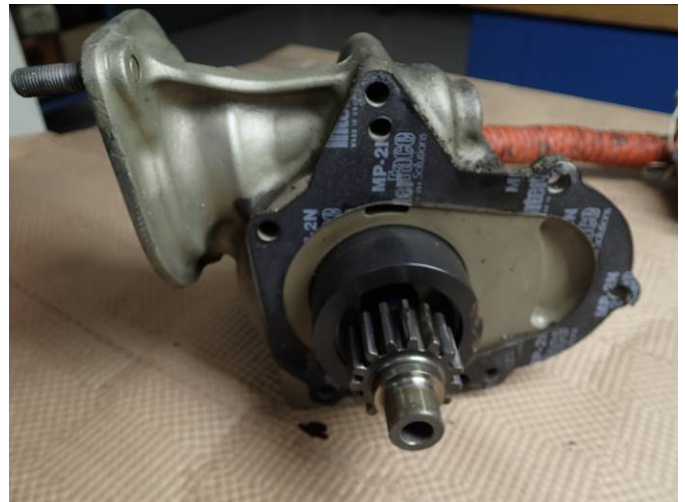
**STARTER ADAPTER**

The starter adapter remained attached to its installation point and was undamaged. There were no anomalies noted with the starter adapter.

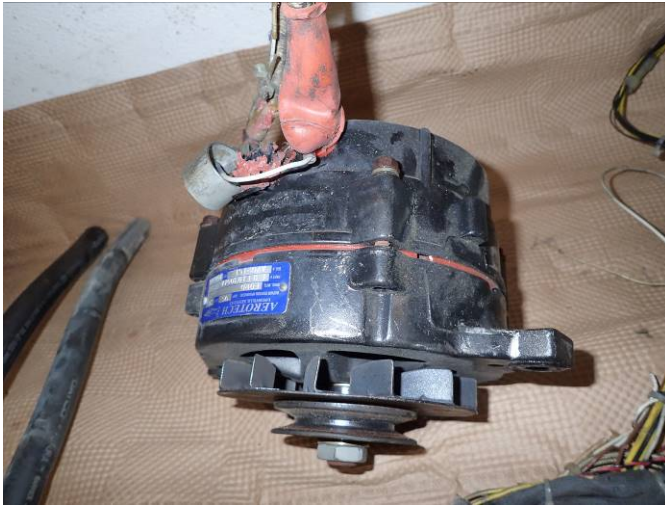
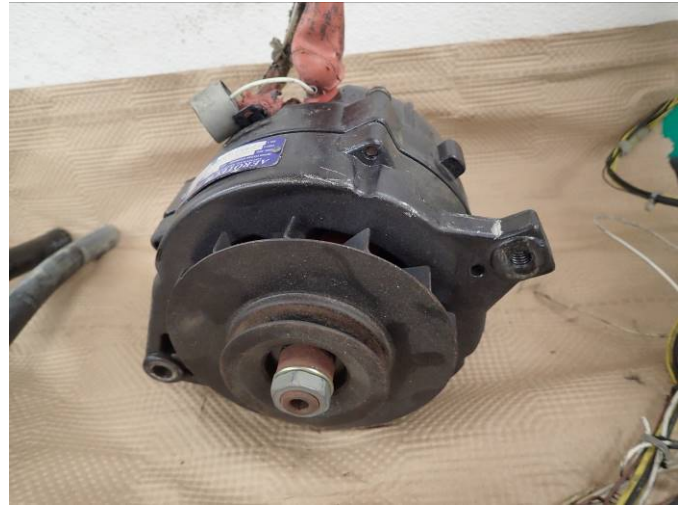
| Condition: | The alternator remained attached to its installation point and was undamaged. The alternator drive belt was noted to be no longer attached to the alternator drive pulley or to the starter adapter pulley. |

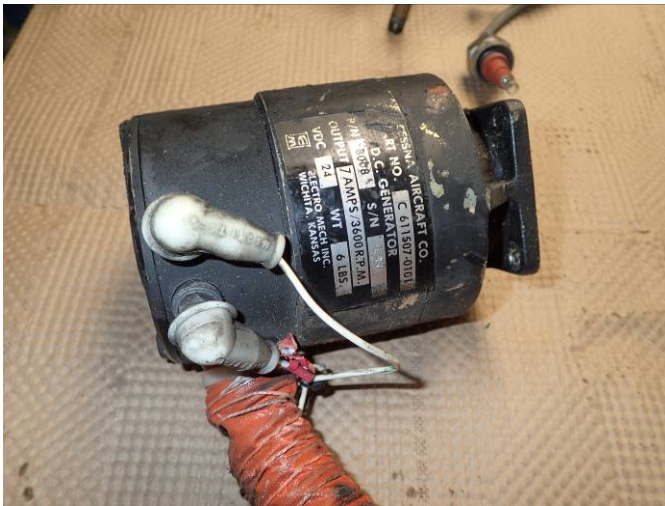
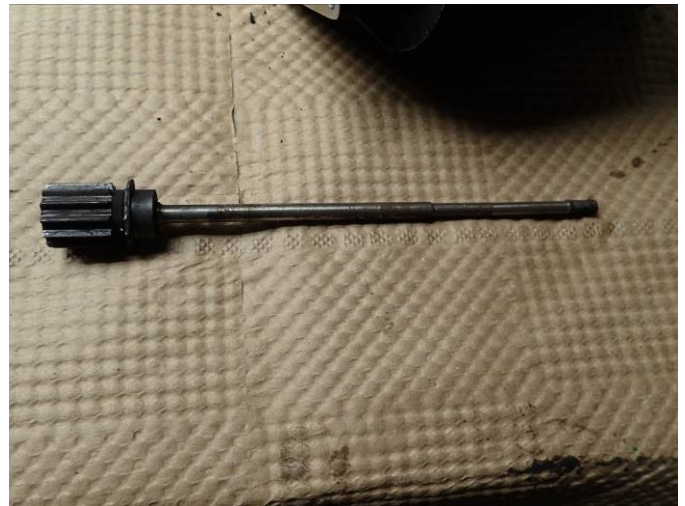
| Condition: | The secondary alternator remained attached to its mounting location and was undamaged. The generator was removed and it was noted that the drive shaft was not secured to the internal portion of the generator. |

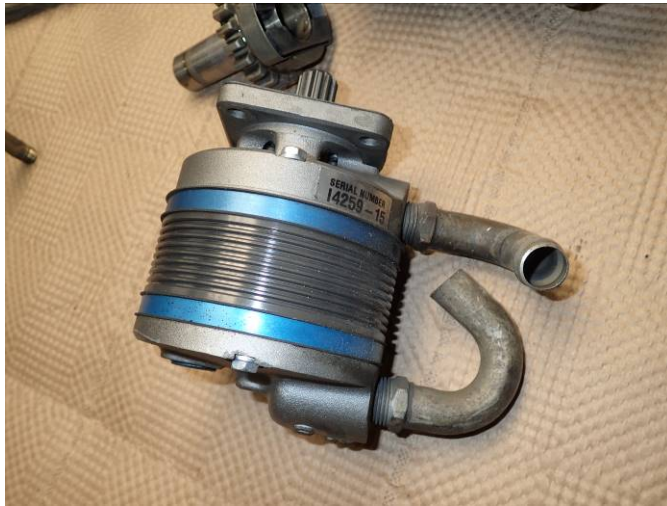
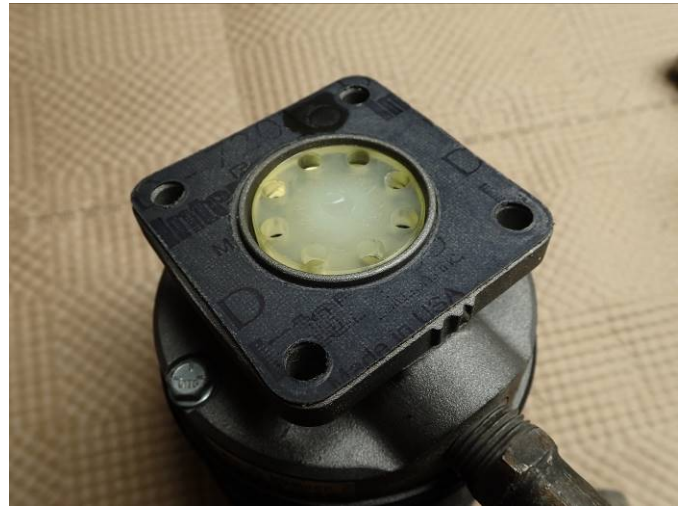
**Condition:** The vacuum pump remained attached to its mounting location and was undamaged. The vacuum pump sheer coupling was noted to be intact. There were no anomalies noted with the vacuum pump

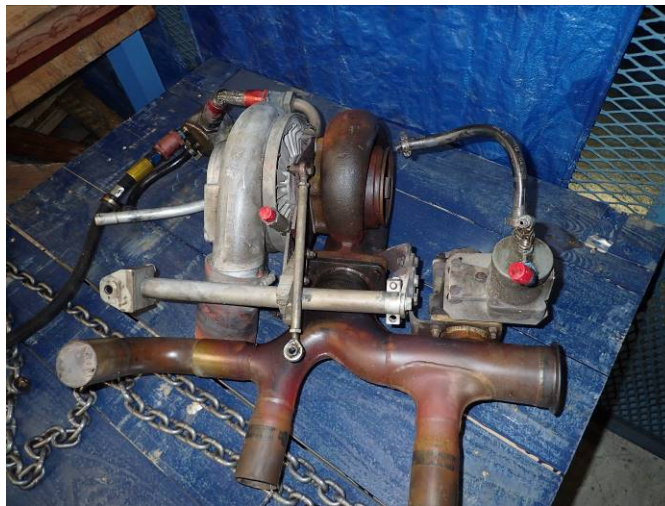
The turbocharger remained attached to the exhaust system and had been removed from the engine with the right side exhaust. The turbine and the compressor were capable of rotating freely and both sections displayed normal operating signatures.

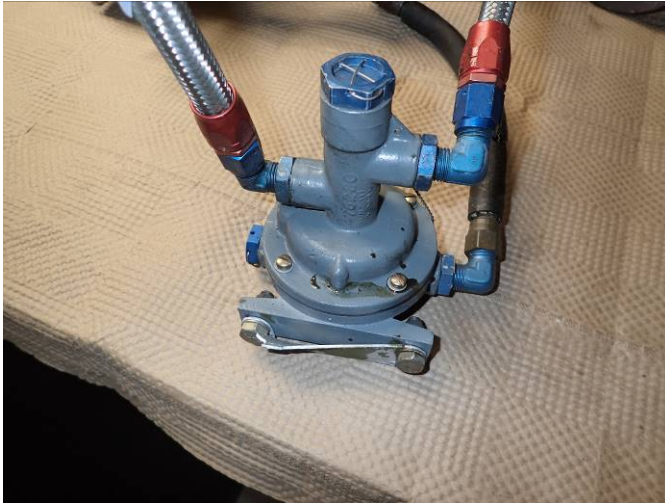
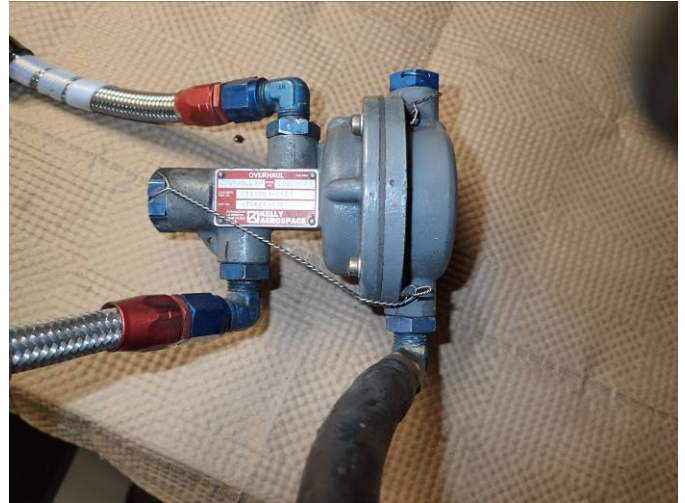
Condition: The turbocharger controller displayed normal operating signatures. There were no anomalies noted.

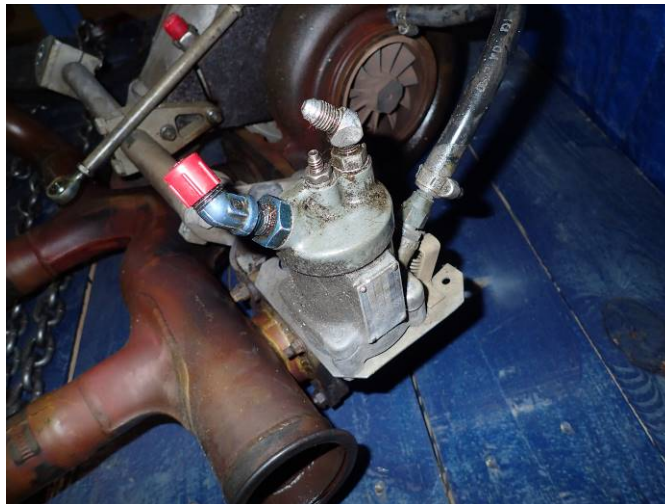
## WASTEGATE

Condition: The wastegate remained attached to its installation point and was undamaged. There were no anomalies noted with the wastegate.
