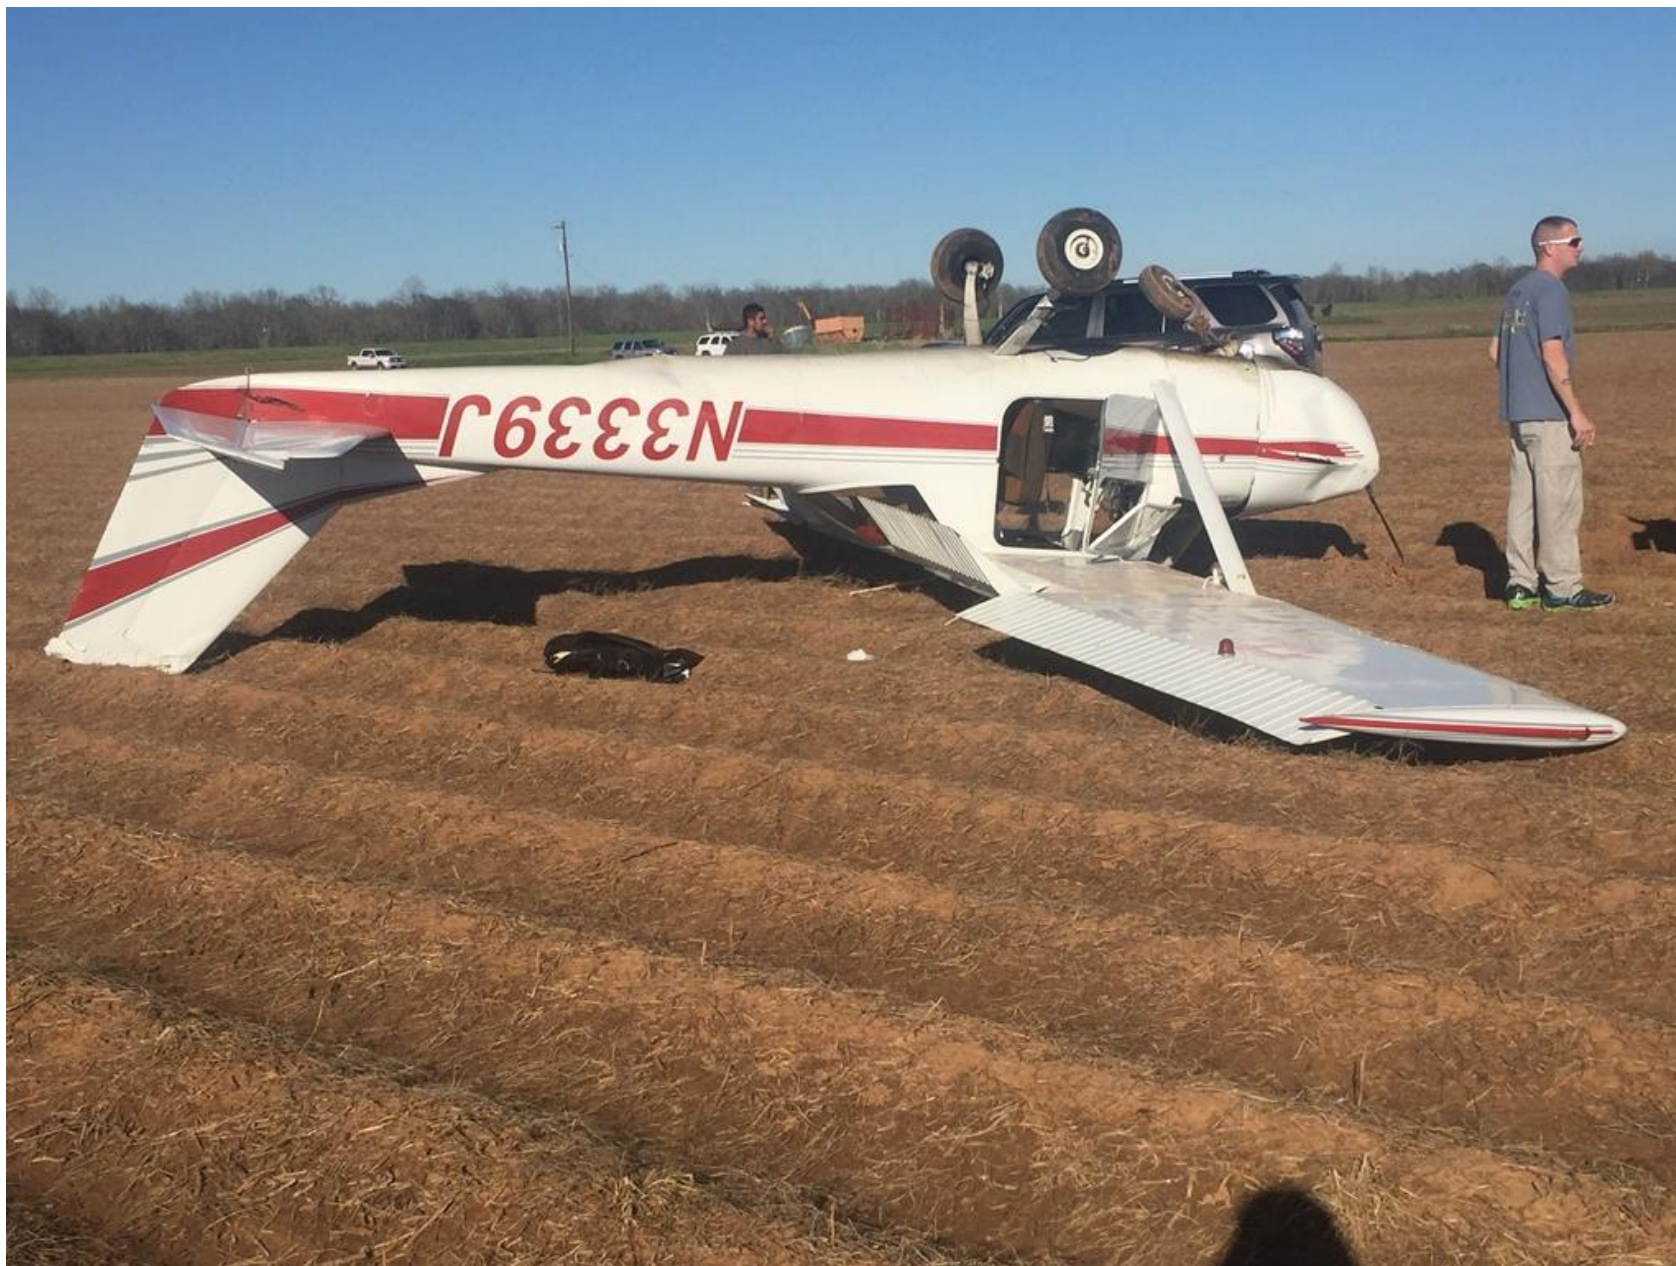
**Photo 1 – Accident airplane inverted in the field (provided by the FAA).**

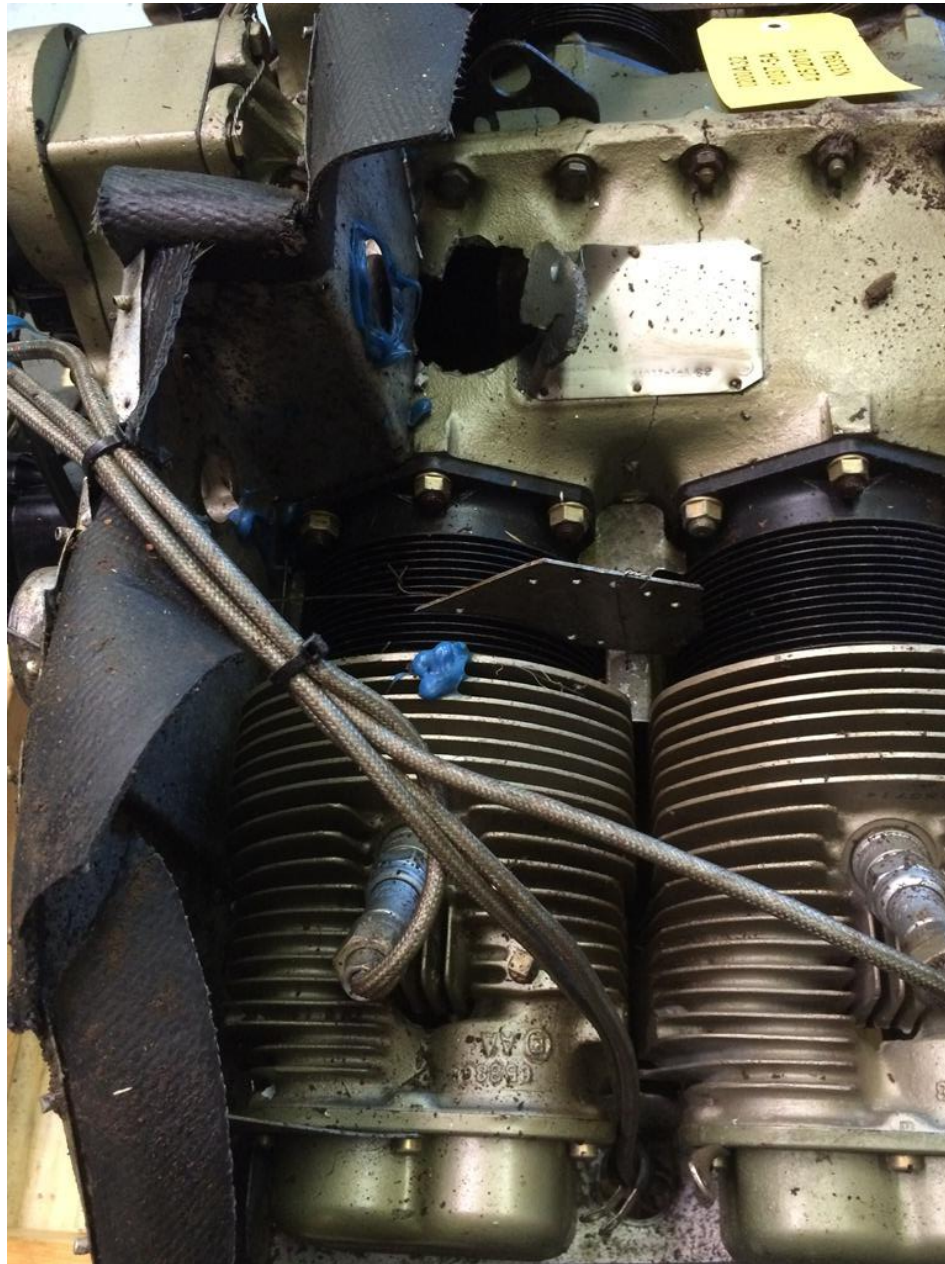
**Photo 2 – Hole in the crankcase.**

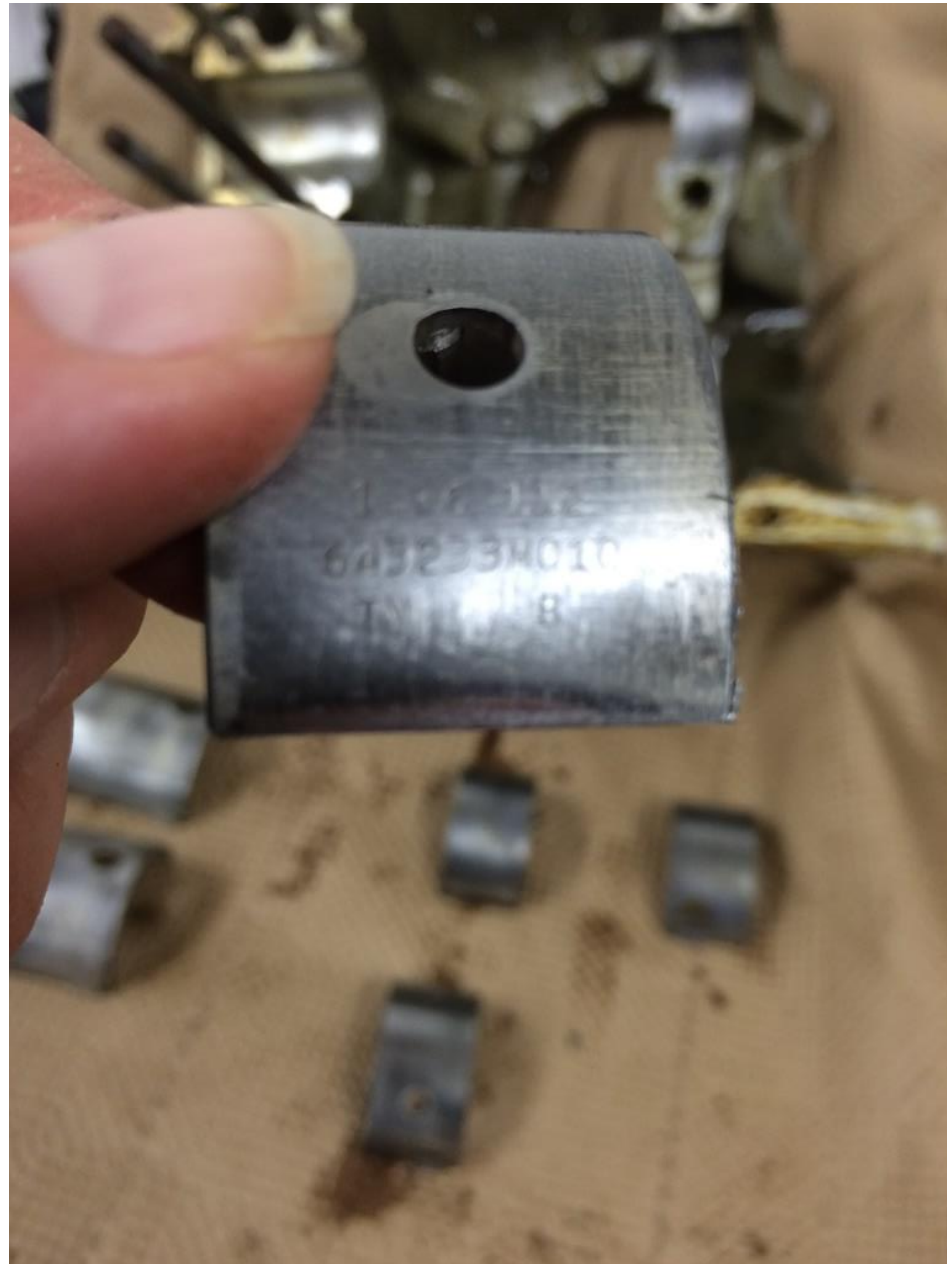
**Photo 3 – Installed main crankshaft bearing.**

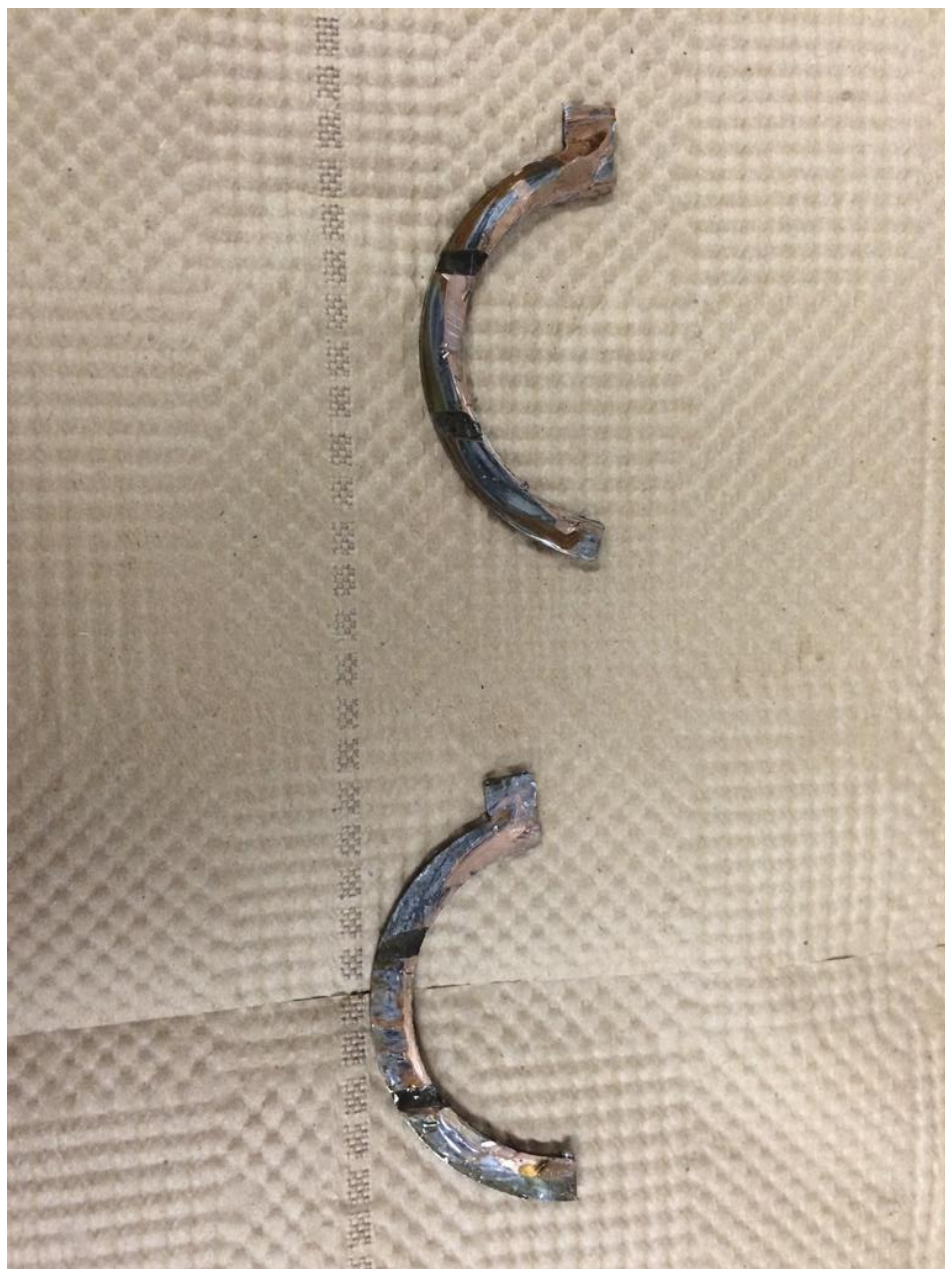
**Photo 4 – Installed thrust washers.**
