| TITLE<br><br>SERVICE LETTER #155 | BY<br>Leland Snow | CHK'D | MODEL<br>See Below |

Vertical Fin Front Spar Fitting

All AT-402, AT-402A, AT-402B aircraft

All AT-502, AT502B aircraft serial no. 502-0031 thru 502B-0398

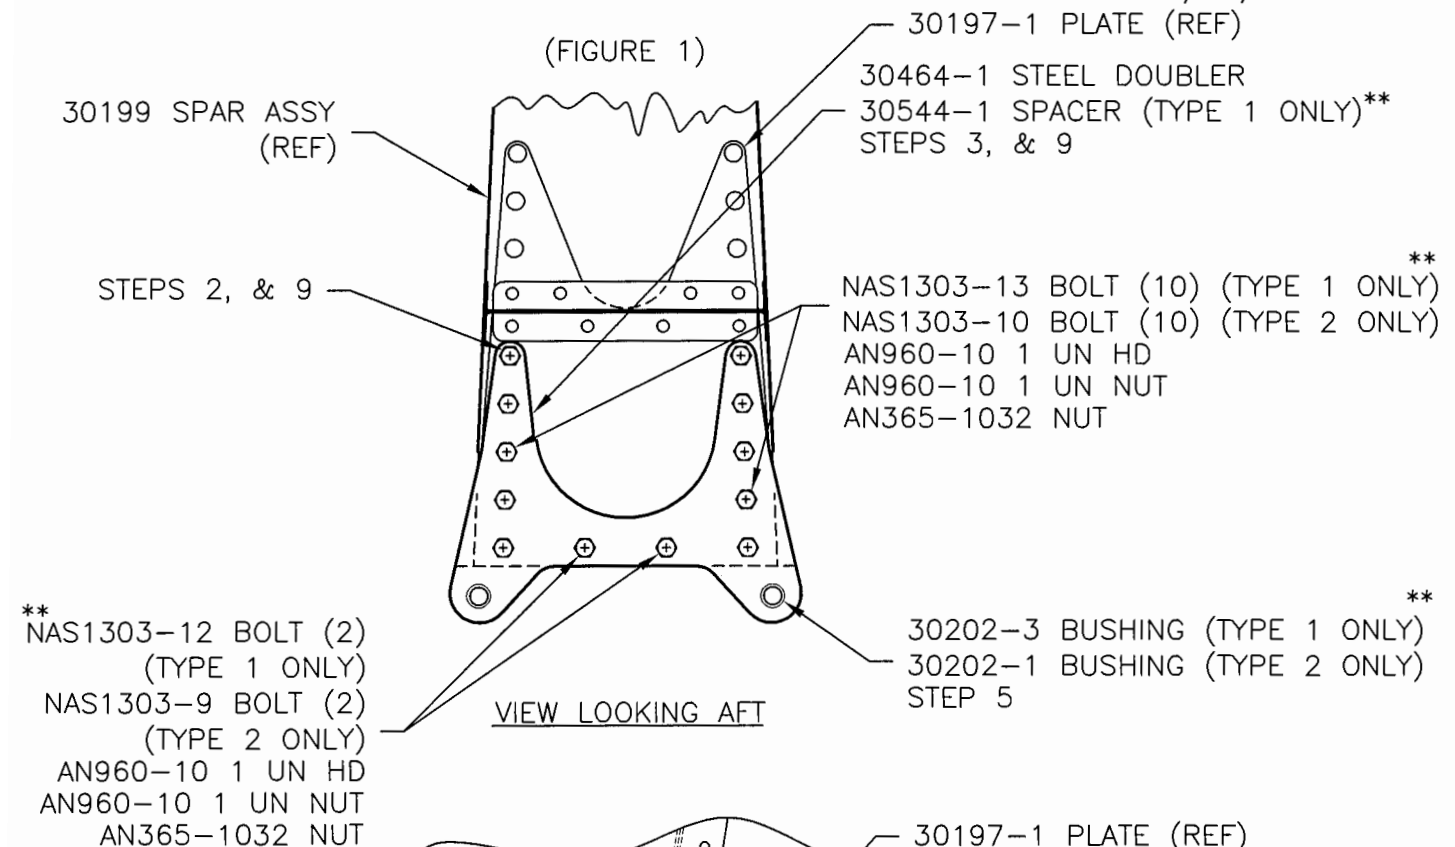
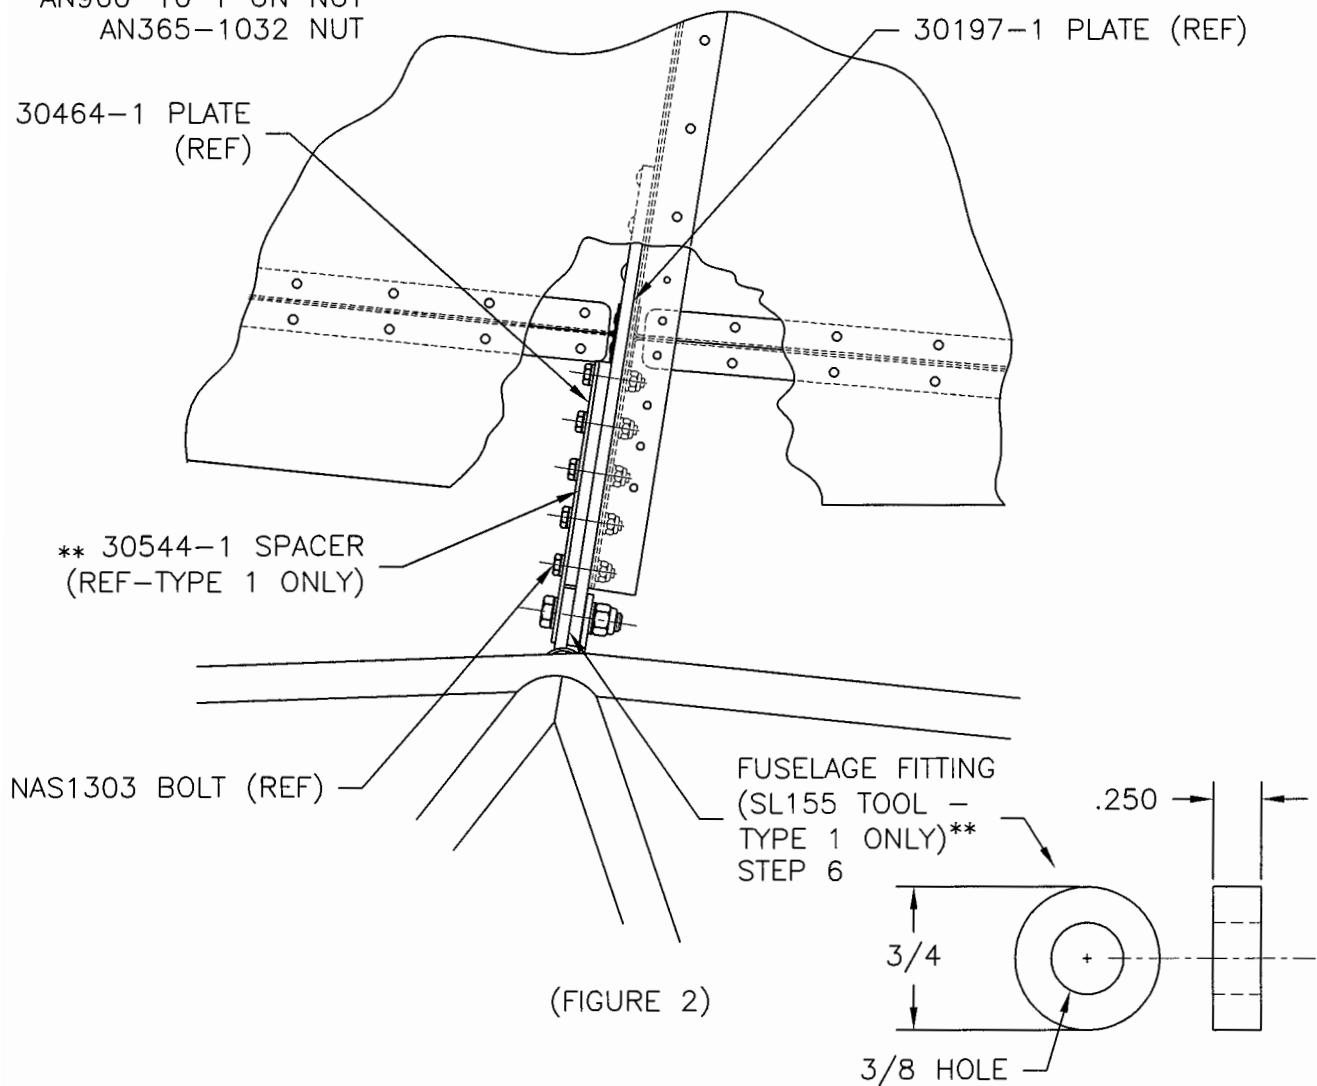
However, it has recently been learned that in Australia an AT-502 was found to have a failure of the vertical fin front spar attach fitting even though the fitting was the 1/4" thick version. The rear spar had not yet failed, and the cracked fitting was found during a routine inspection. The aircraft had approximately 2,500 hours total time.

This Service Letter calls for the installation of a steel doubler to be installed on the forward side of the vertical fin front spar fitting, in a similar way as for S/L #138, except that a 1/4" spacer plate

1. Remove the rudder from fin. Remove fin from aircraft.
2. Remove the lower 12 NAS1446 lockbolts that attach the front spar fitting to the front spar. Use a chisel to cut the lockbolt collars free from the lockbolts.
3. Remove excessive paint and/or sealer from the forward face of the 30197-1 plate. Prime with a suitable aircraft primer, as no bare aluminum should be permitted.
- \*4. For Type 1, position the 30464-1 steel doubler and 30544-1 spacer on forward face of the 30197-1 plate.  
For Type 2, position the 30464-1 steel doubler on the forward face of the 30197-1 plate.

- \*5. For Type 1, insert 30202-3 bushings (2) into 30464-1 steel doubler. For Type 2, insert 30202-1 bushings (2) into 30464-1 steel doubler.
- \*6. For Type 1, temporarily position the round SL155 spacer tool between the 30197-1 plate and 30464-1 steel doubler to represent fuselage fitting. Install original NAS1306 bolts and hardware thru mating parts and tighten bolts.  
For Type 2, install original NAS1306 bolts and hardware thru mating parts and tighten bolts.

- 7. Back drill the 30544-1 spacer and the 30464-1 steel doubler to match the 30199 spar assy 3/16 dia. It may be necessary to use an angle drill to reach the top holes. Use care when drilling to assure good holes perpendicular to the plate.

- 8. Install the NAS1303 bolts and hardware, noting the different lengths shown in Figure 1. Torque to 60-70 inch-pounds.
- 9. Seal around doubler, spacer, and bolts with PR1422A-2 sealer to prevent moisture from entering joint.

- \*10. Remove original NAS1306 bolts (and, for Type 1, SL155 tool).
- 11. Paint reworked area with a suitable paint to match the aircraft exterior color.

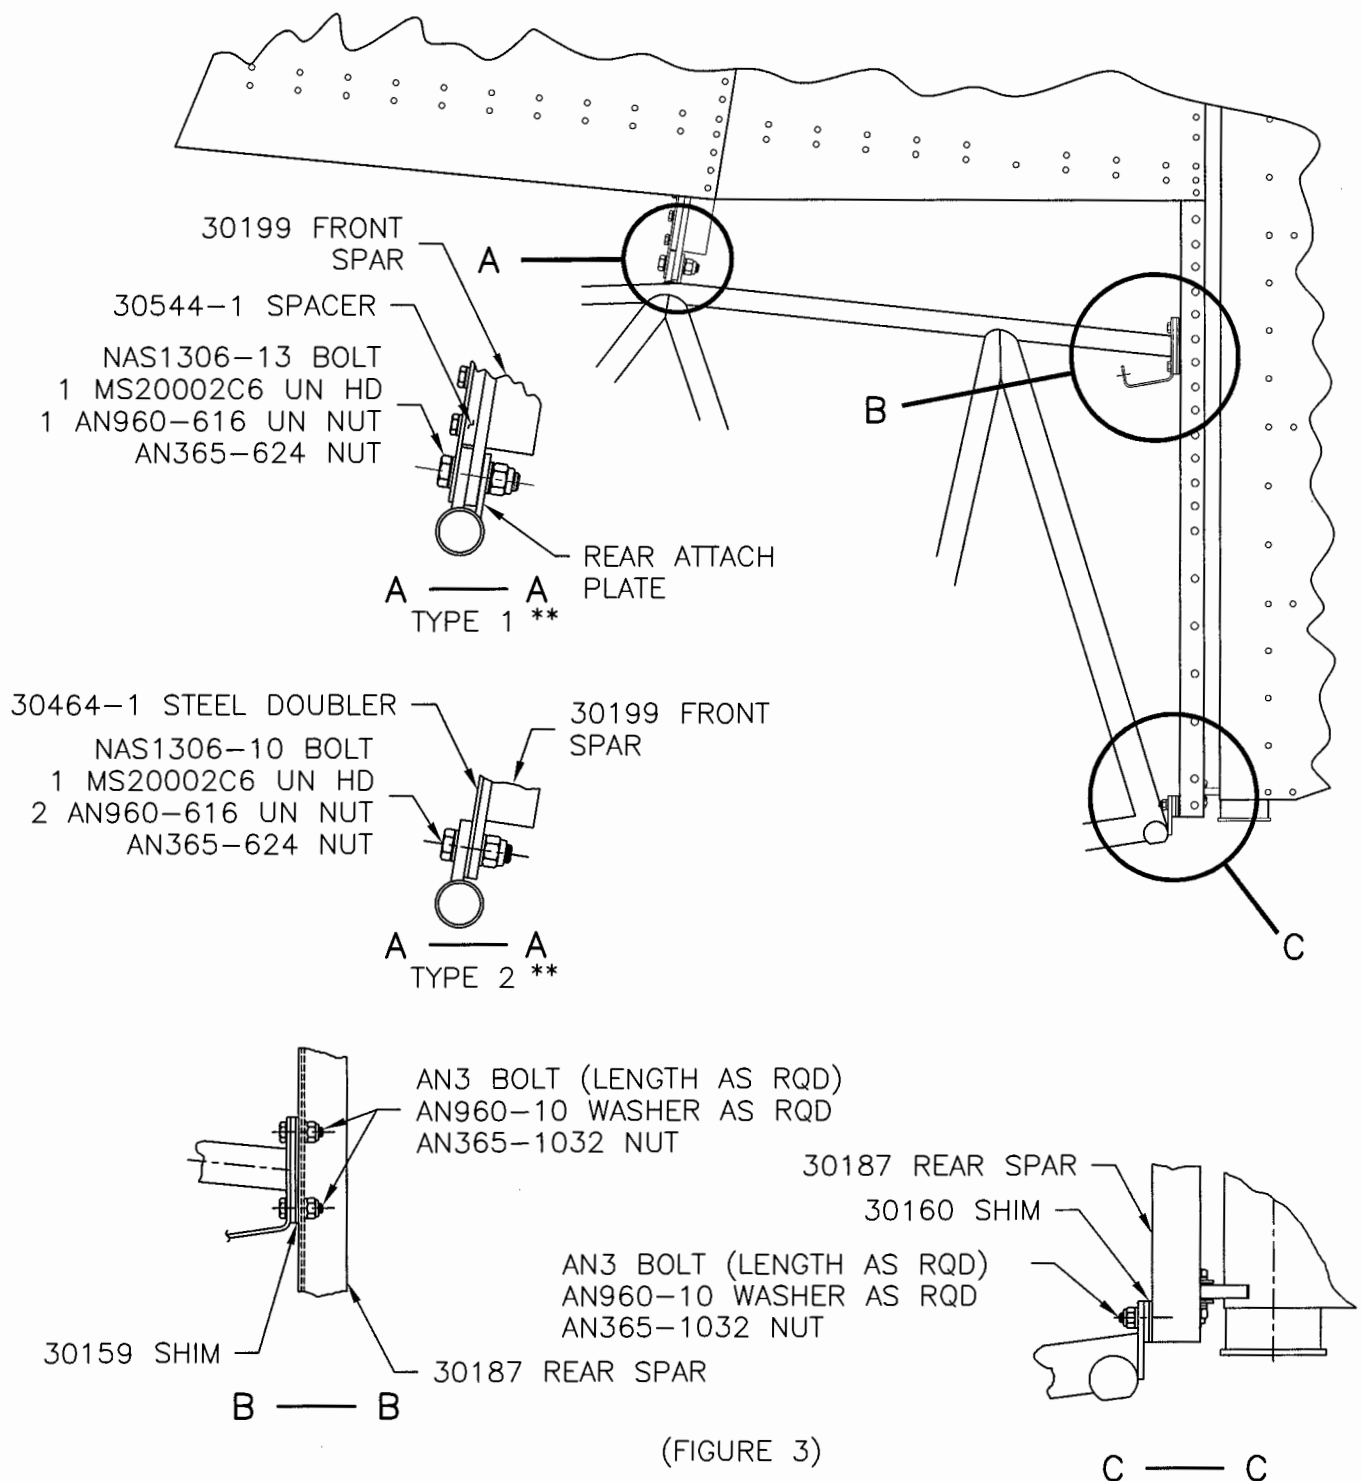
Reference: Figure 3

\*For the purposes of this Service Letter, we will refer to this configuration as Type 2 with the configuration described previously referred to as Type 1. View A-A on page 4 illustrates the differences in the two, with Type 2 not having the rear attach plate.

- 12. Reinstall vertical fin on aircraft.
- 13. Complete the vertical fin installation as shown in Views A-A, B-B, C-C. Torque for the NAS1306 bolts is 35 ft-lbs.
- 14. Reinstall rudder on fin, attach control cables and pushrod.
- 15. Fill out FAA form 337 and make Aircraft Logbook entry stating that Air Tractor Service Letter #155 has been complied with.
